Geosynthetic Reinforced Soil for Low-Volume Bridge Abutments

Final Report

Sponsored by
Iowa Highway Research Board
(IHRB Project TR-621)
Iowa Department of Transportation
(InTrans Project 10-380)

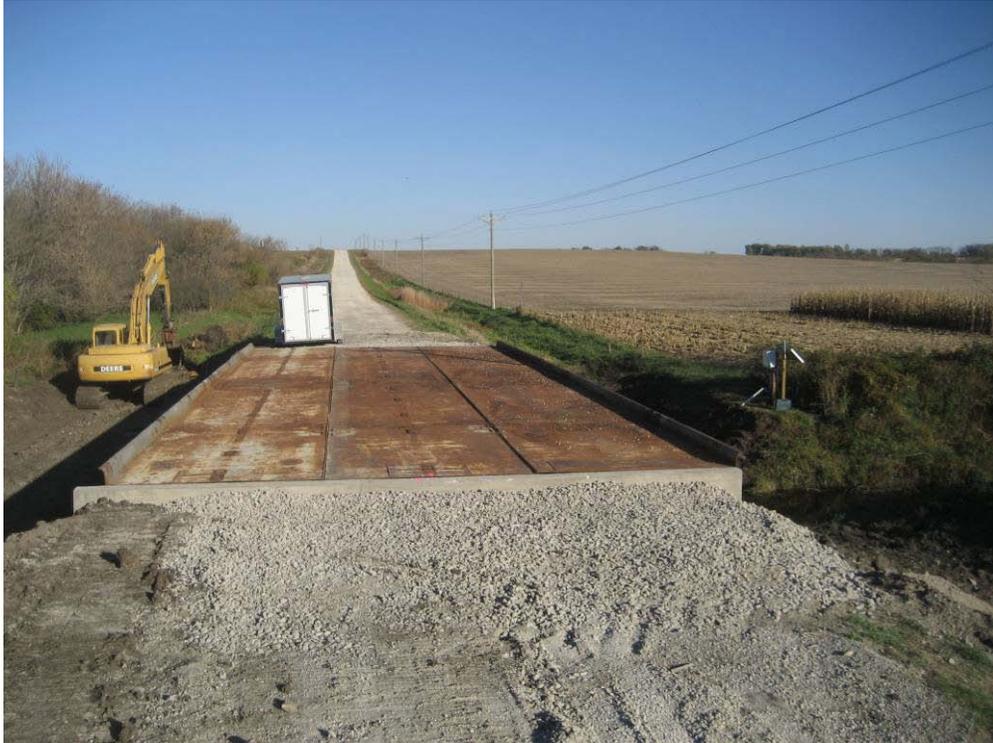
Figure 48. Bridge 2 — Picture of all three RRFCs placed on the footings

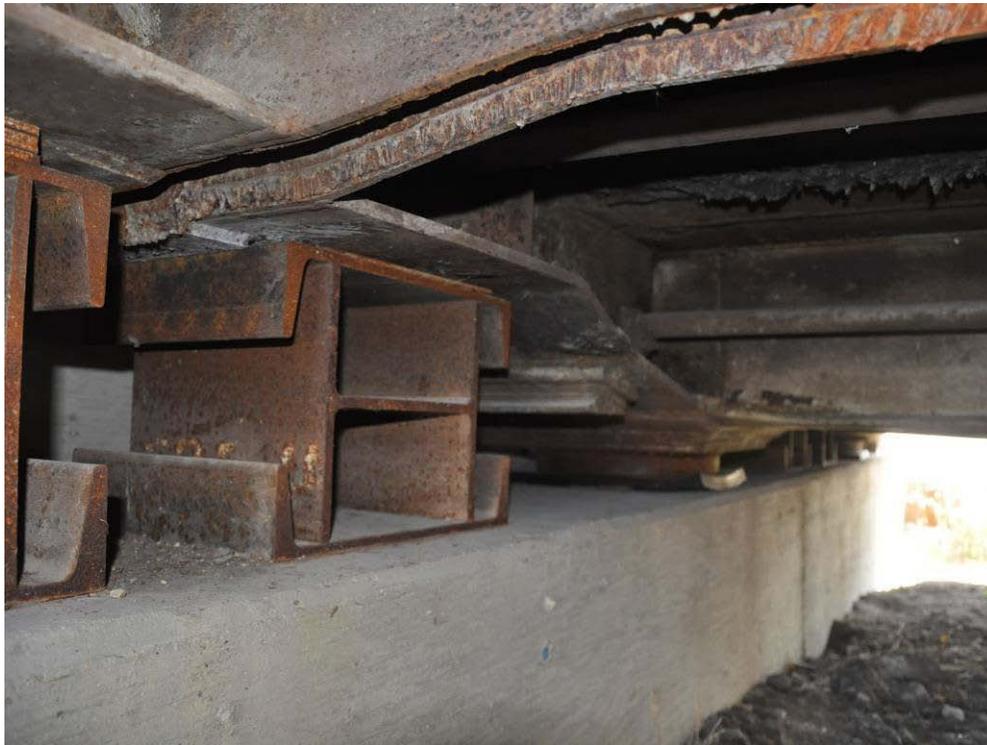
Figure 49. Bridge 2 — W-sections confined with inverted channel sections placed between the footing and the RRFCs

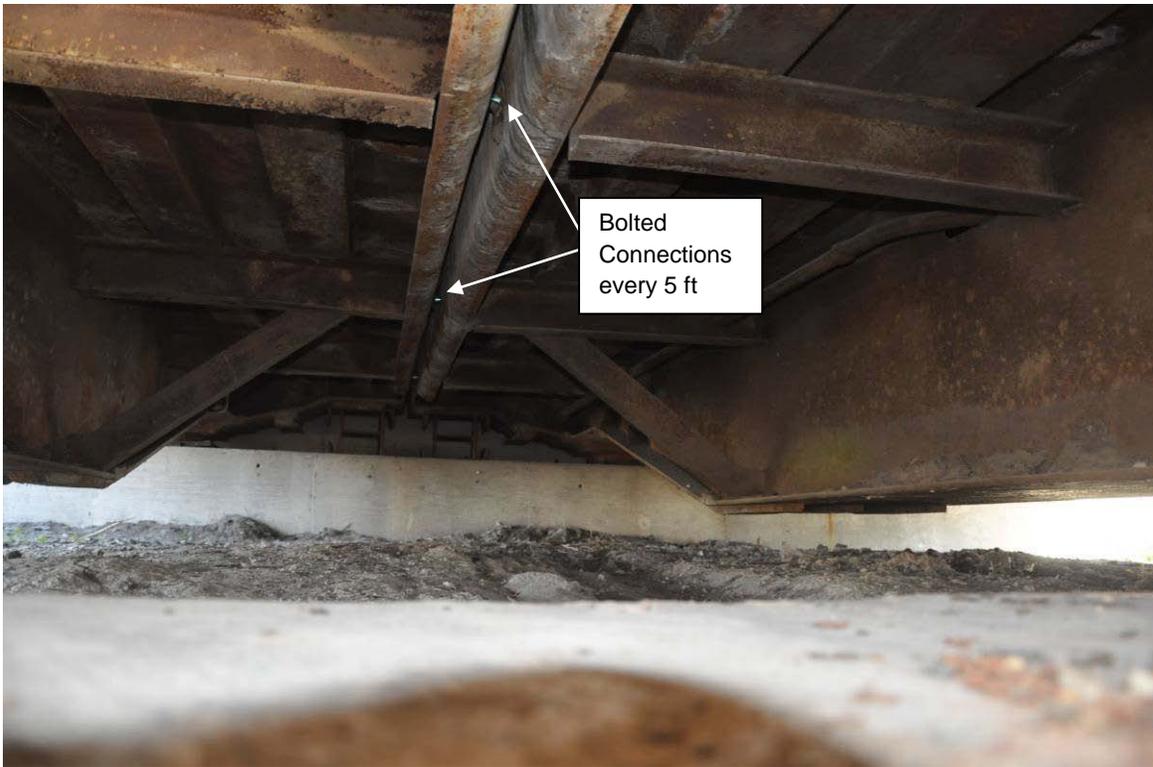
Figure 50. Bridge 2 — Bolted connections every 5 ft between the RRFCs

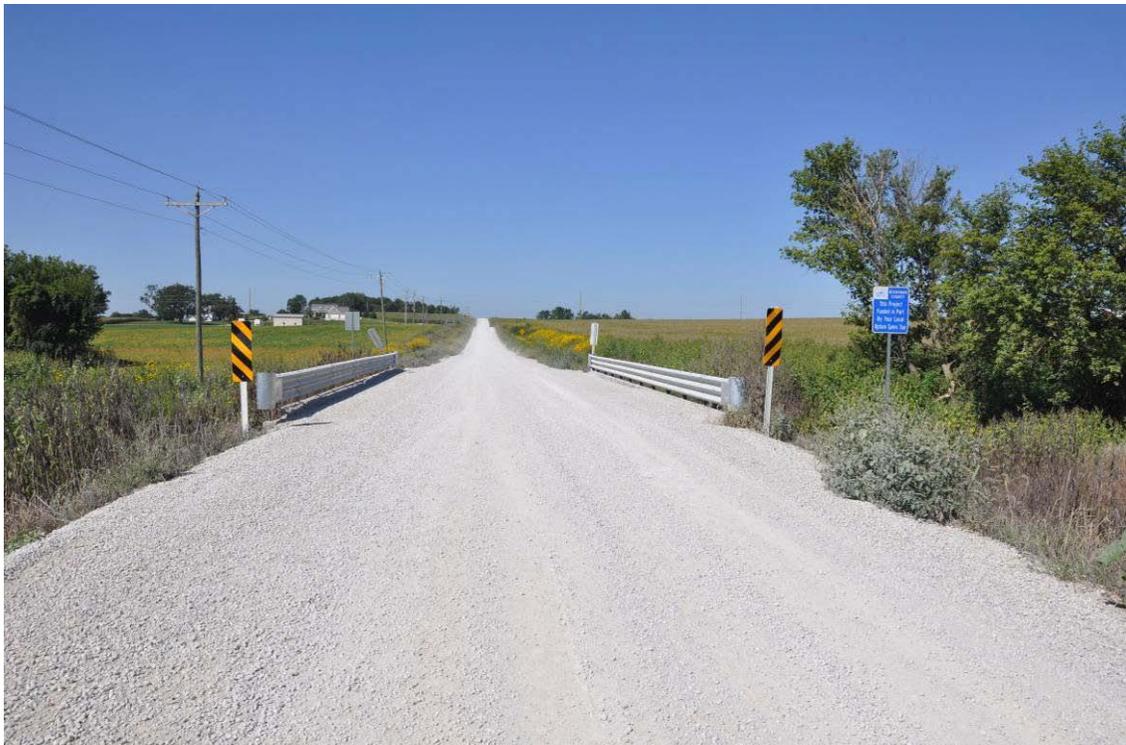
Figure 51. Bridge 2 — Picture of the completed bridge

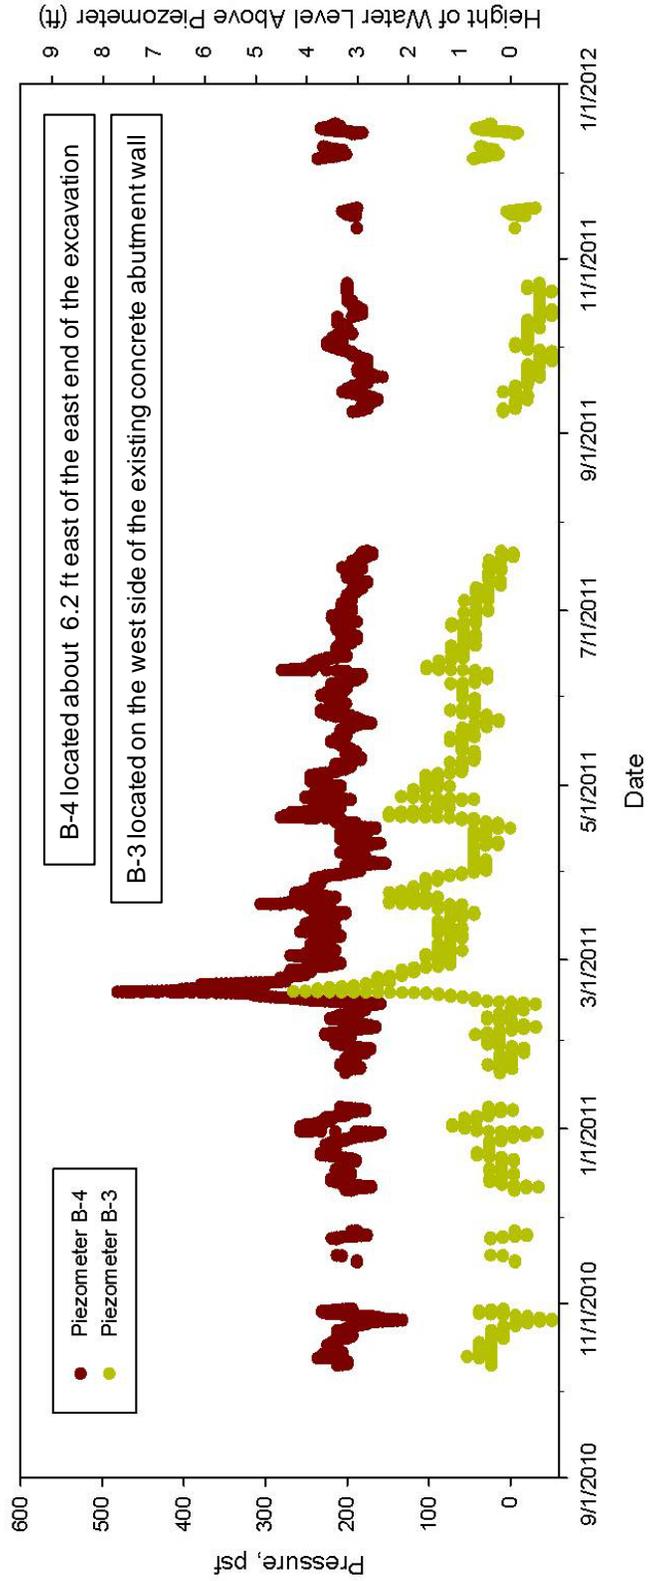
Figure 54. Bridge 2 — Piezometer pore pressure readings monitoring in B-3 and B-4

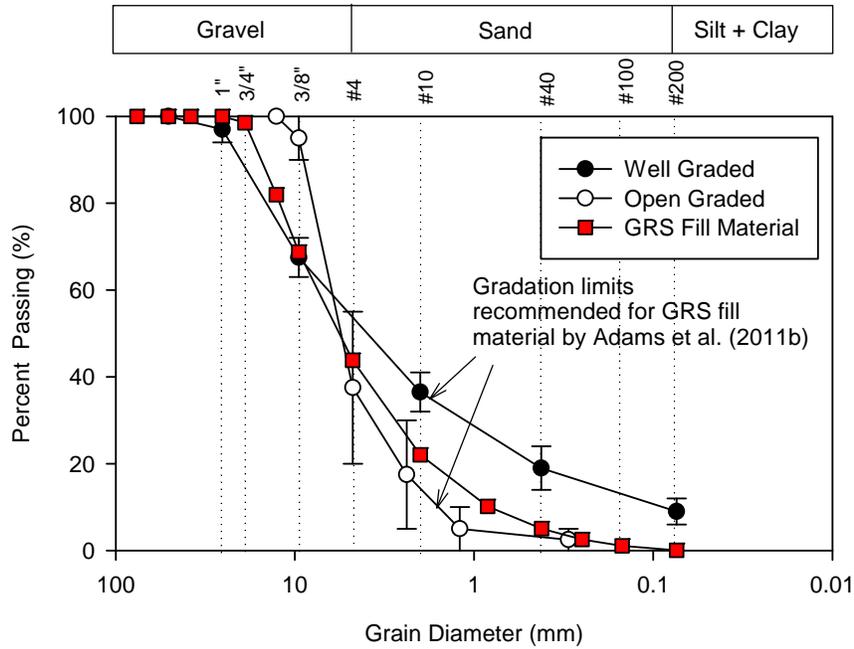
Figure 55. Bridge 2 — Grain-size distribution curve of GRS fill material in comparison with Adams et al. (2011b) recommended gradation limits

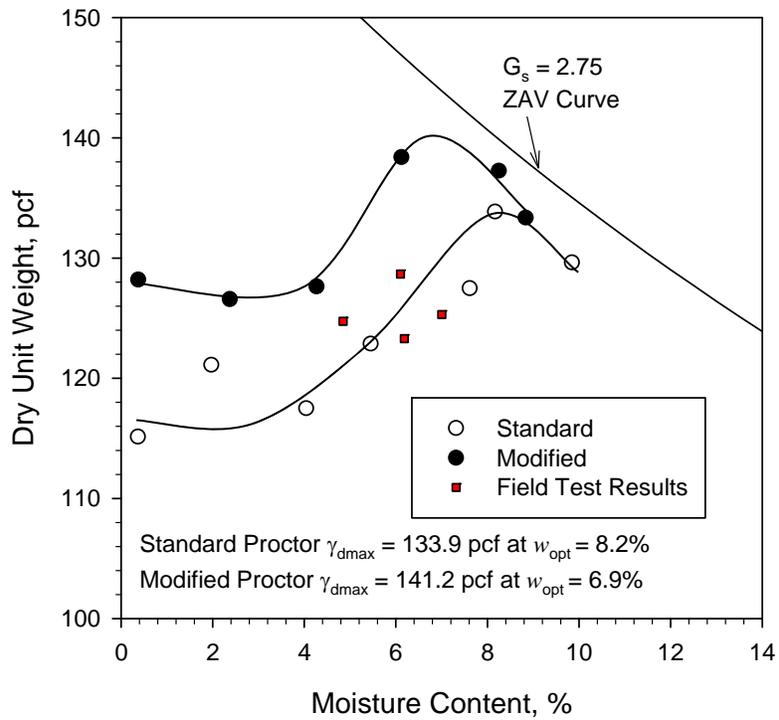
Figure 56. Bridge 2 — Proctor compaction test results for GRS fill material

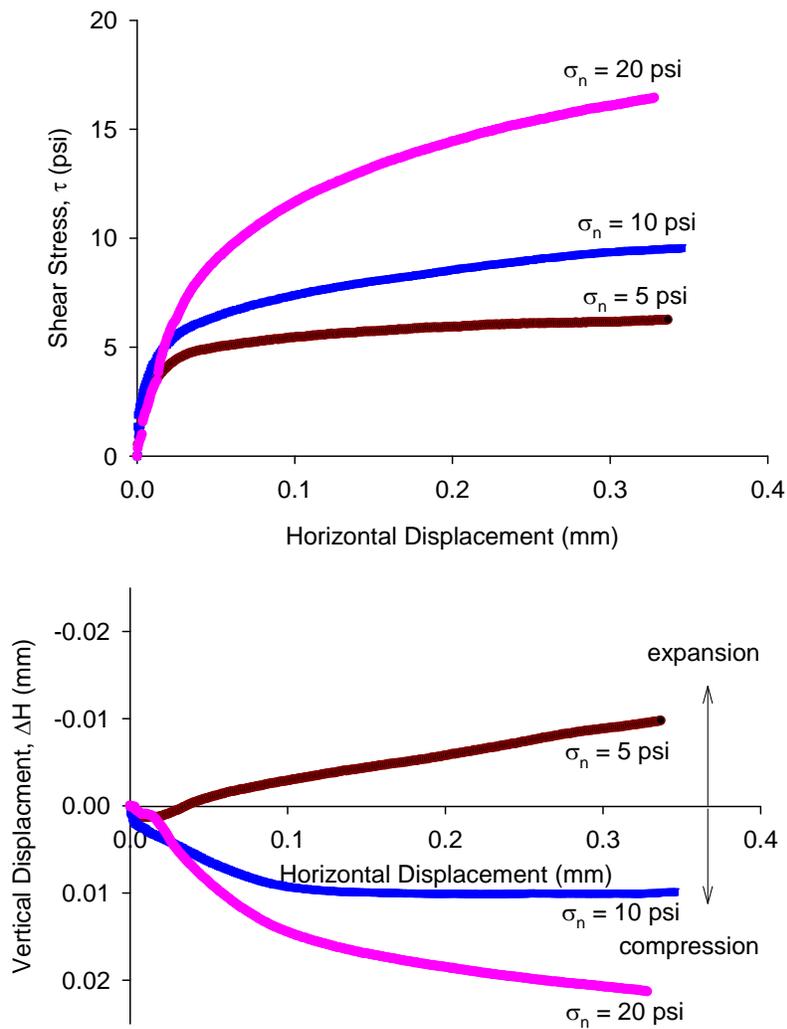
Figure 57. Bridge 2 — Plot of shear stress versus horizontal displacement (top) and change in sample height versus horizontal displacement (bottom) for three different applied normal stresses for compacted GRS fill material

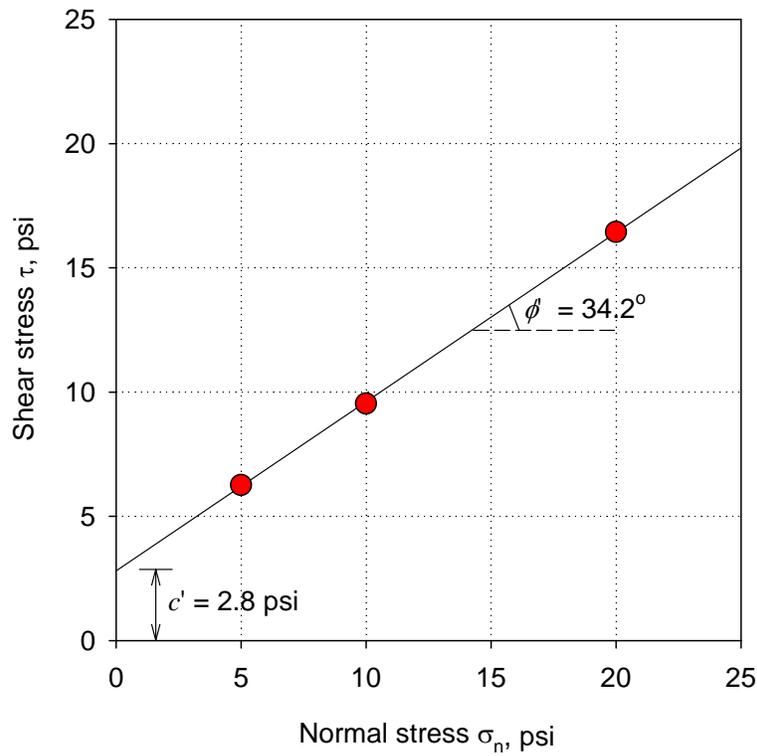
Figure 58. Bridge 2 — Mohr-Coulomb failure envelope from direct shear tests for compacted GRS fill material

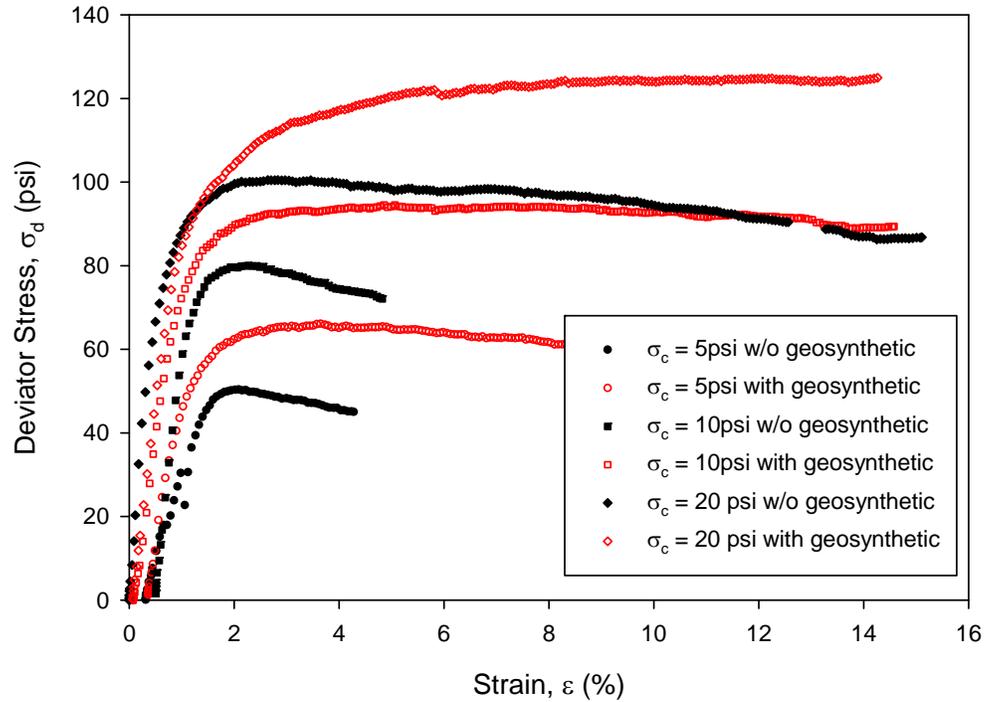
Figure 59. Bridge 2 — Deviator stress versus strain plots from CD tests from shearing phase for granular fill material with and without geosynthetic reinforcement

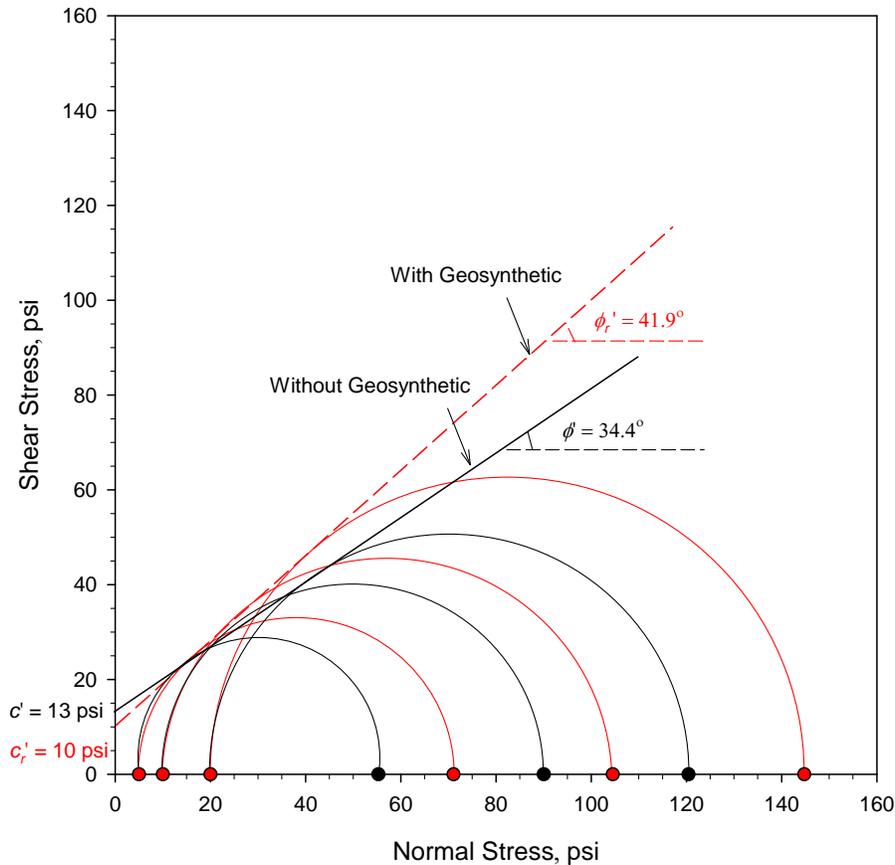
Figure 60. Bridge 2 — Mohr-Coulomb failure envelopes from CD tests for granular fill materials test with and without geosynthetic reinforcement

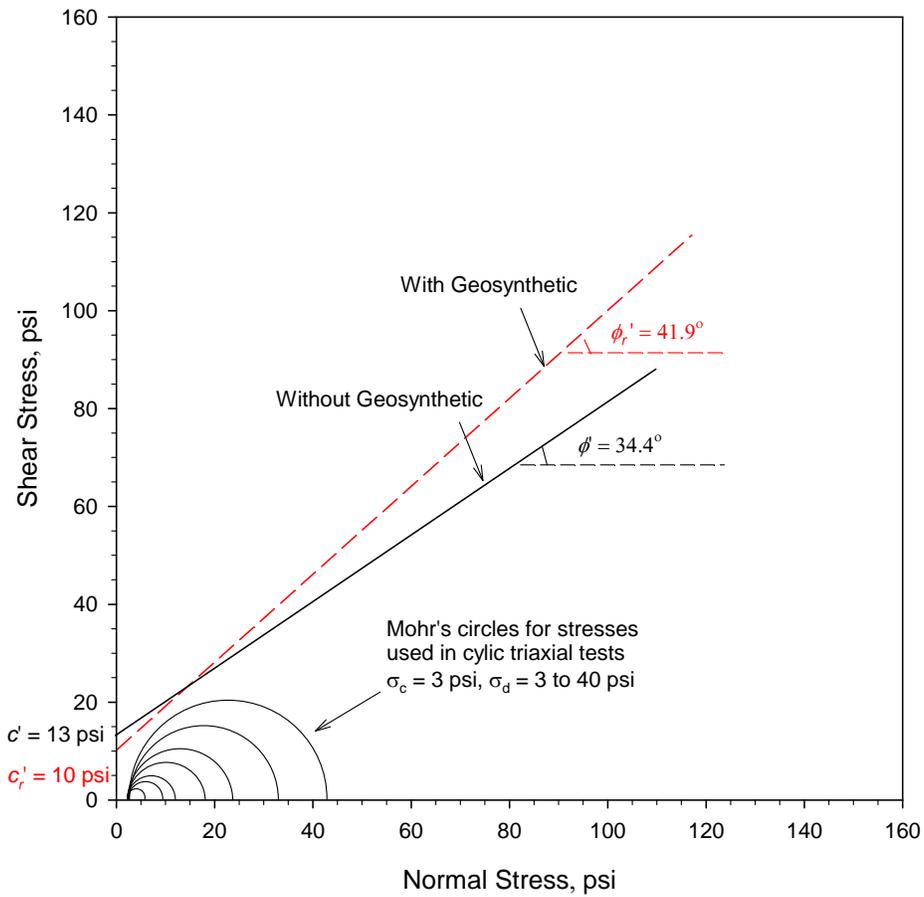
Figure 61. Bridge 2 — Mohr circles for stresses applied during repeated loading cyclic triaxial tests

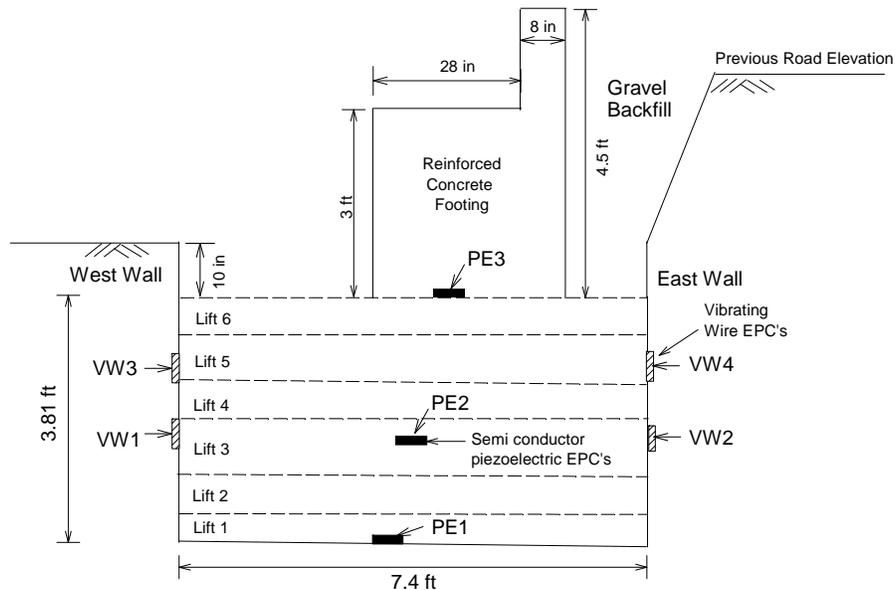
Figure 63. Bridge 2 — Cross-sectional view of the GRS fill material and location of semiconductor and vibrating wire EPCs embedded in the fill

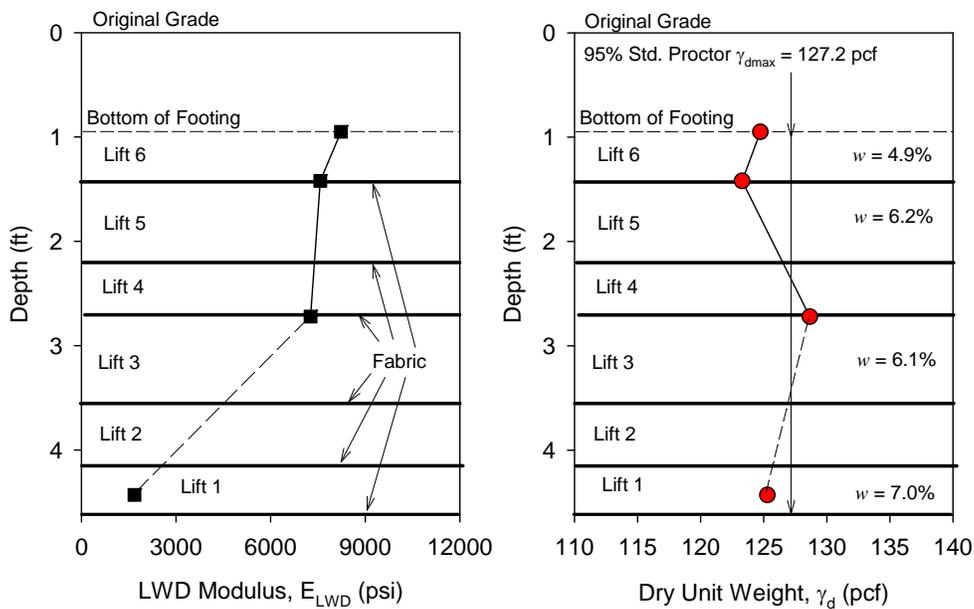
Figure 65. Bridge 2 — In-situ LWD and NG test results of each GRS lift

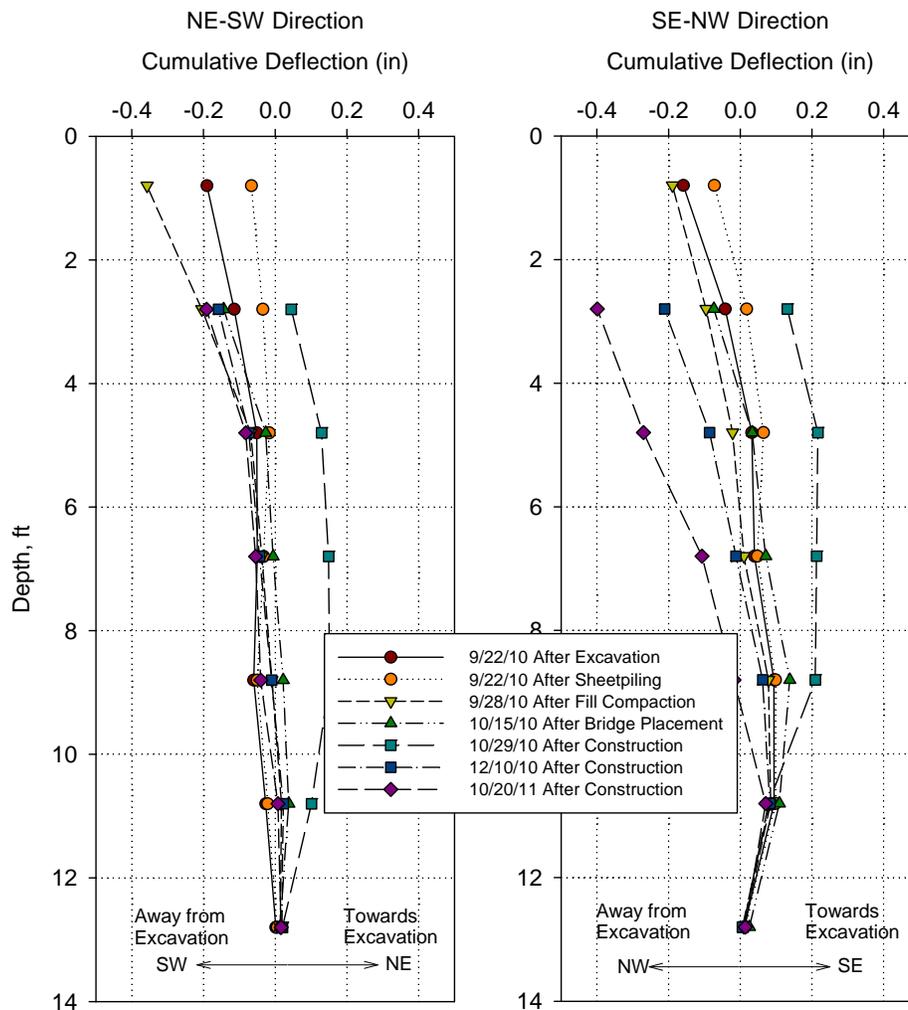
Figure 66. Bridge 2 — Inclinometers results for B-1

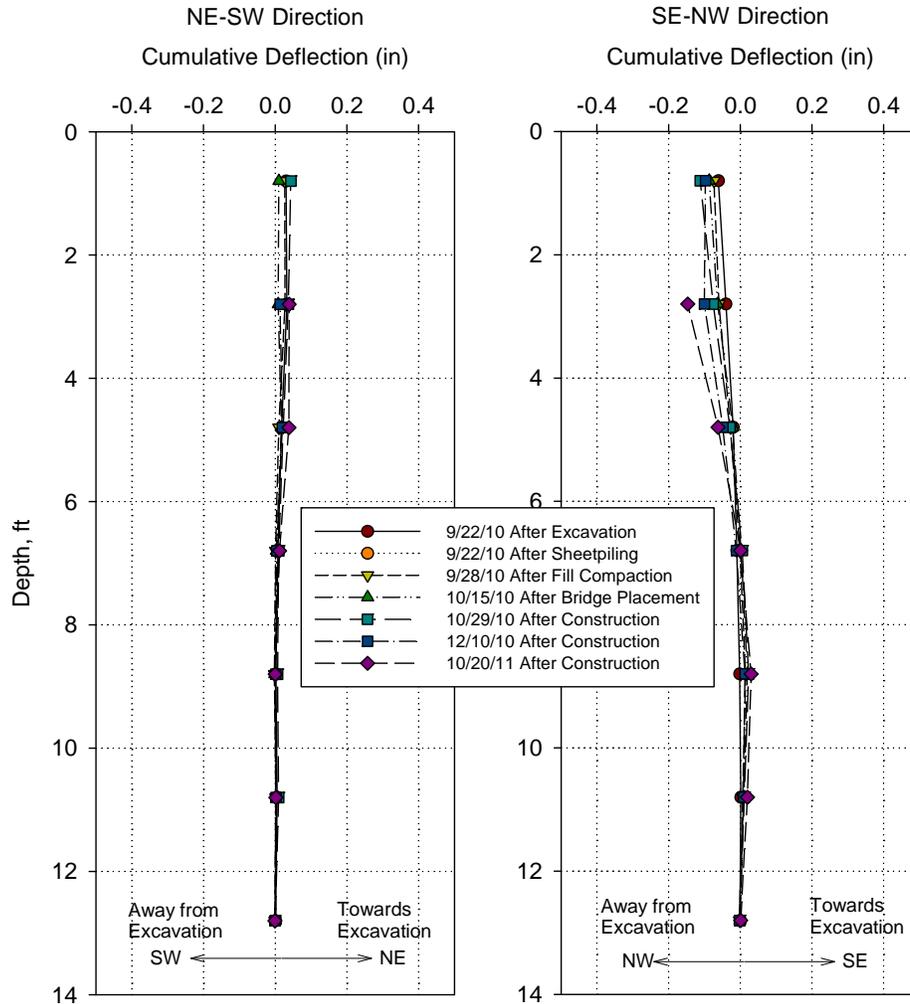
Figure 67. Bridge 2 — Inclinerometers results for B-2

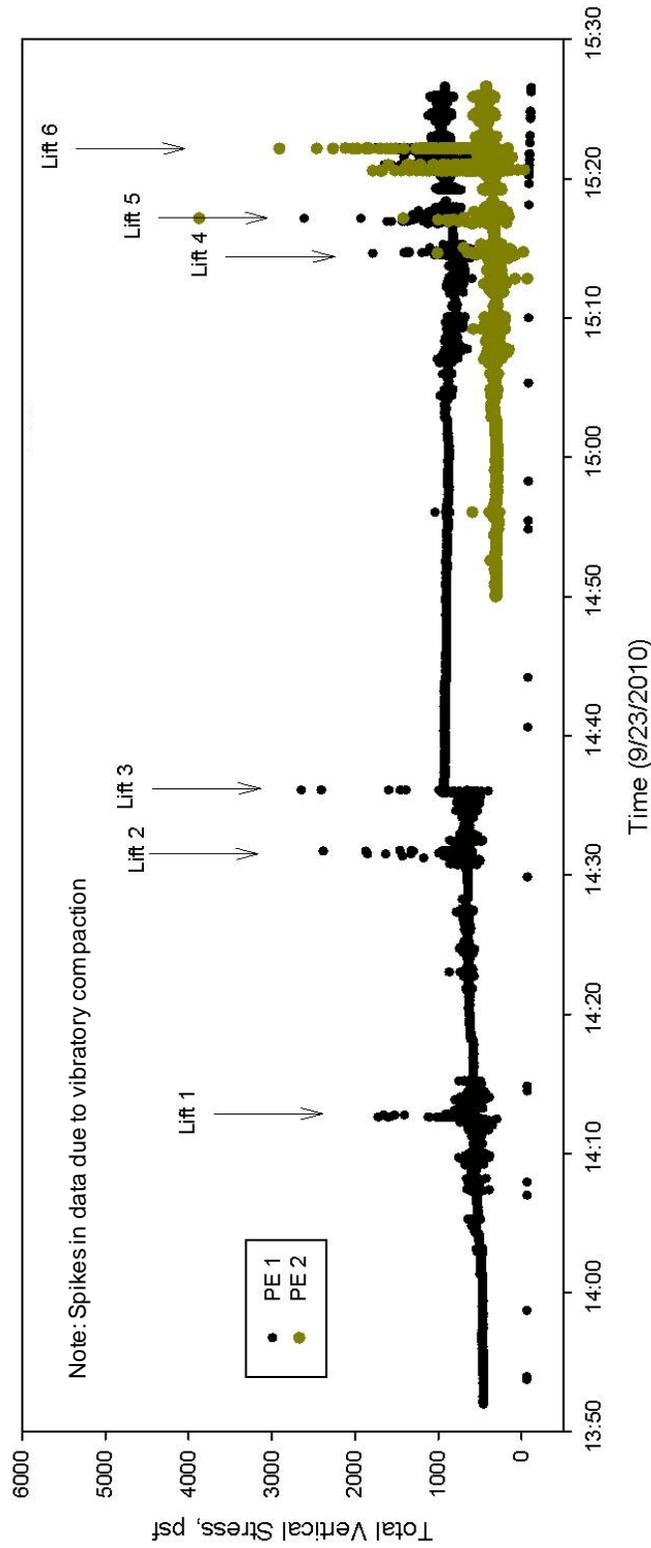
Figure 68. Bridge 2 — In ground total vertical stresses in PE 1 (at the bottom of the excavation) and PE 2 (at about 2.2 ft below footing) during compaction of GRS fill material in excavation

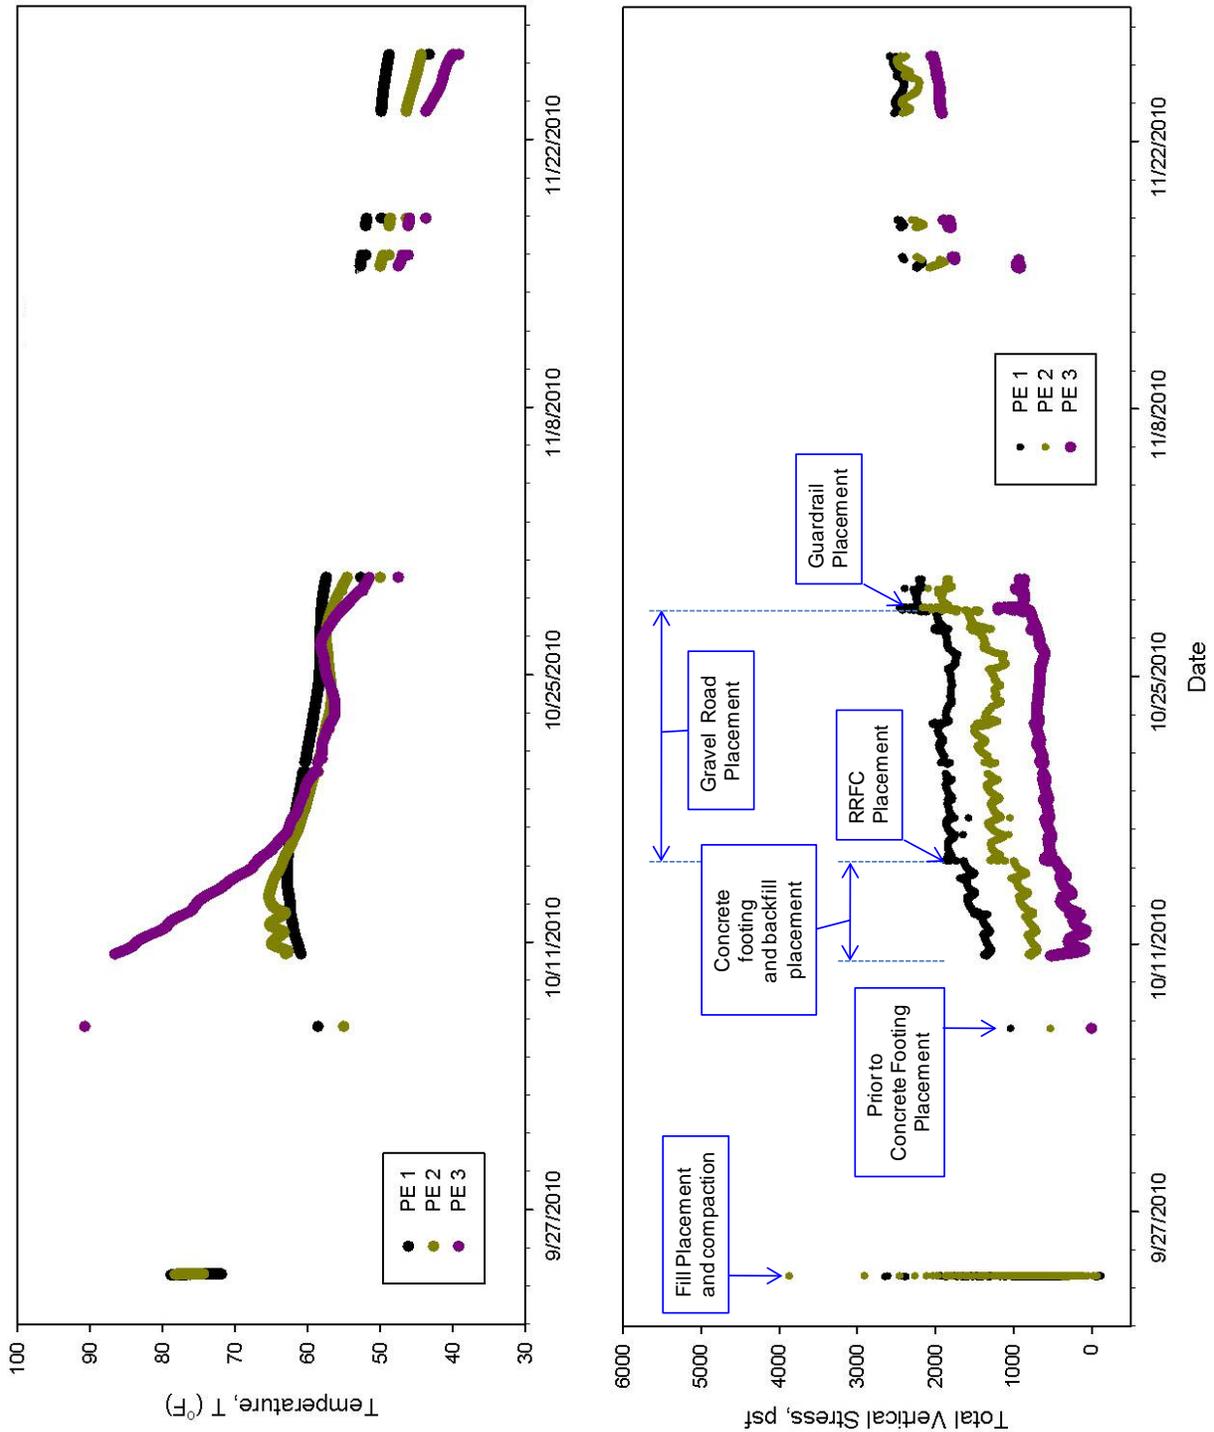
Figure 69. Bridge 2 — In ground total vertical stresses and temperature readings from 9/23/2010 to 11/26/2010 in PE 1 (at the bottom of the excavation), PE 2 (at about 2.2 ft below footing), and PE 3 (at the bottom of the footing)

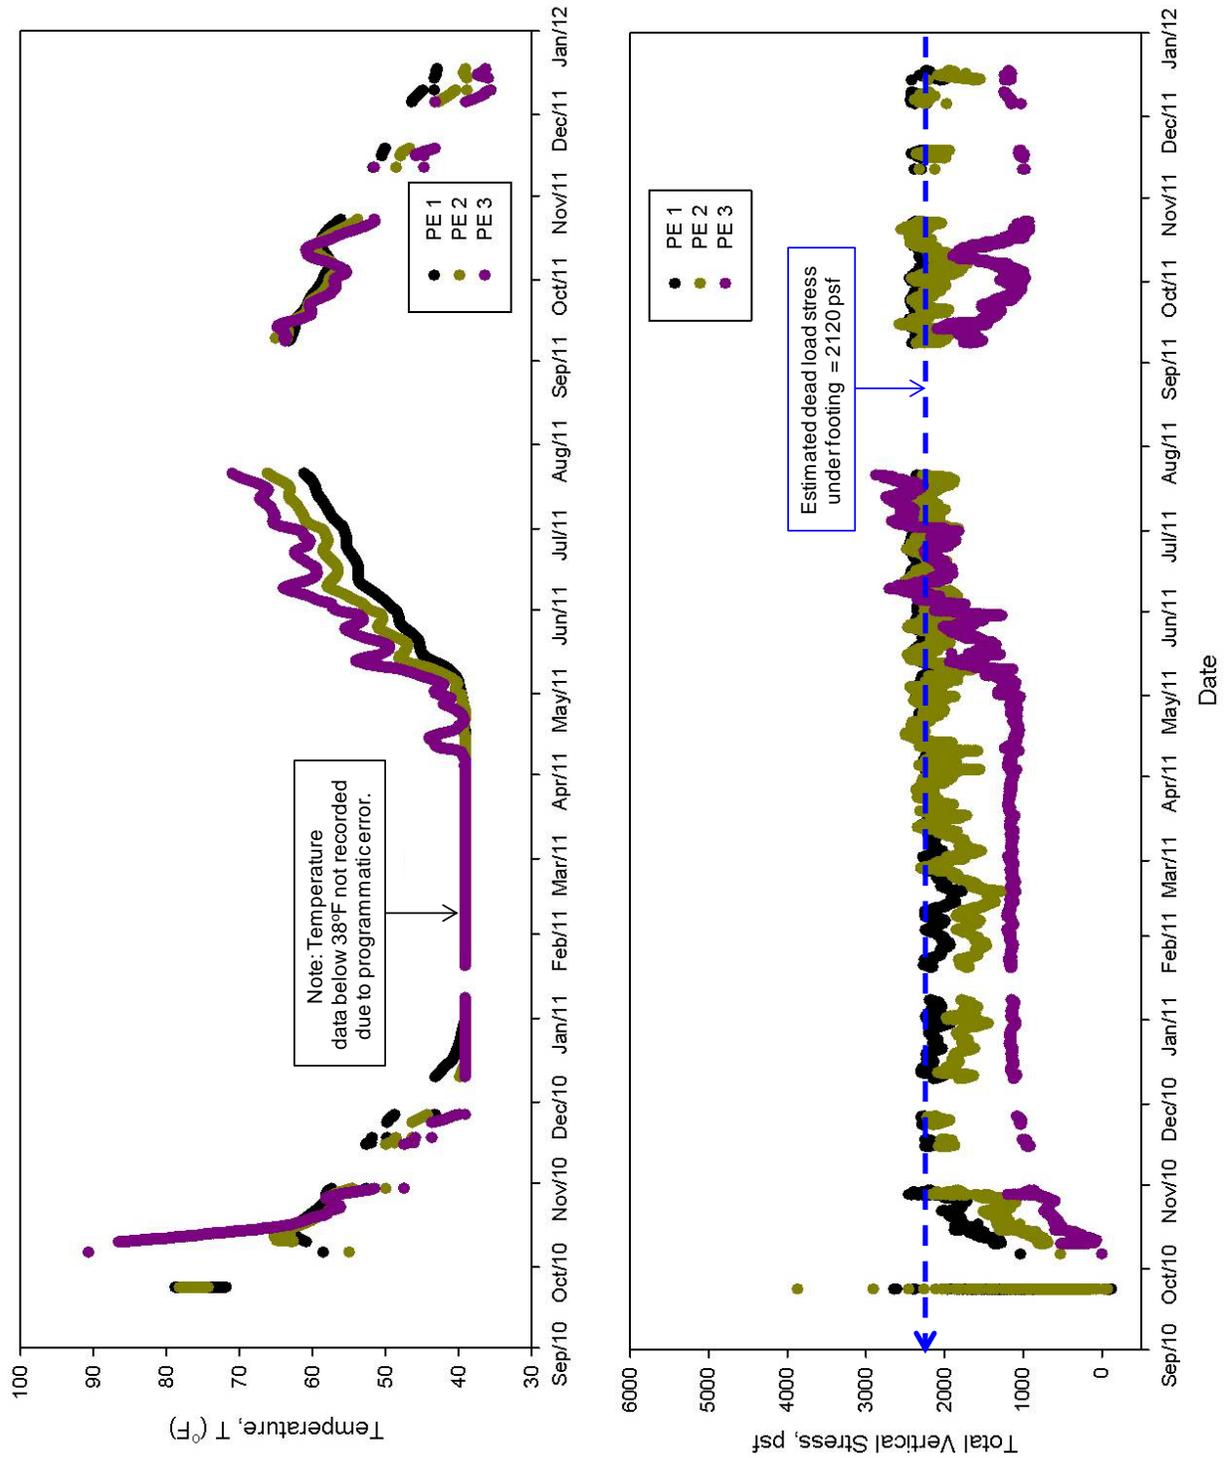
Figure 70. Bridge 2 — In ground total vertical stresses and temperature readings in PE 1 (at the bottom of the excavation), PE 2 (at about 2.2 ft below footing), and PE 3 (at the bottom of the footing) for the full project period

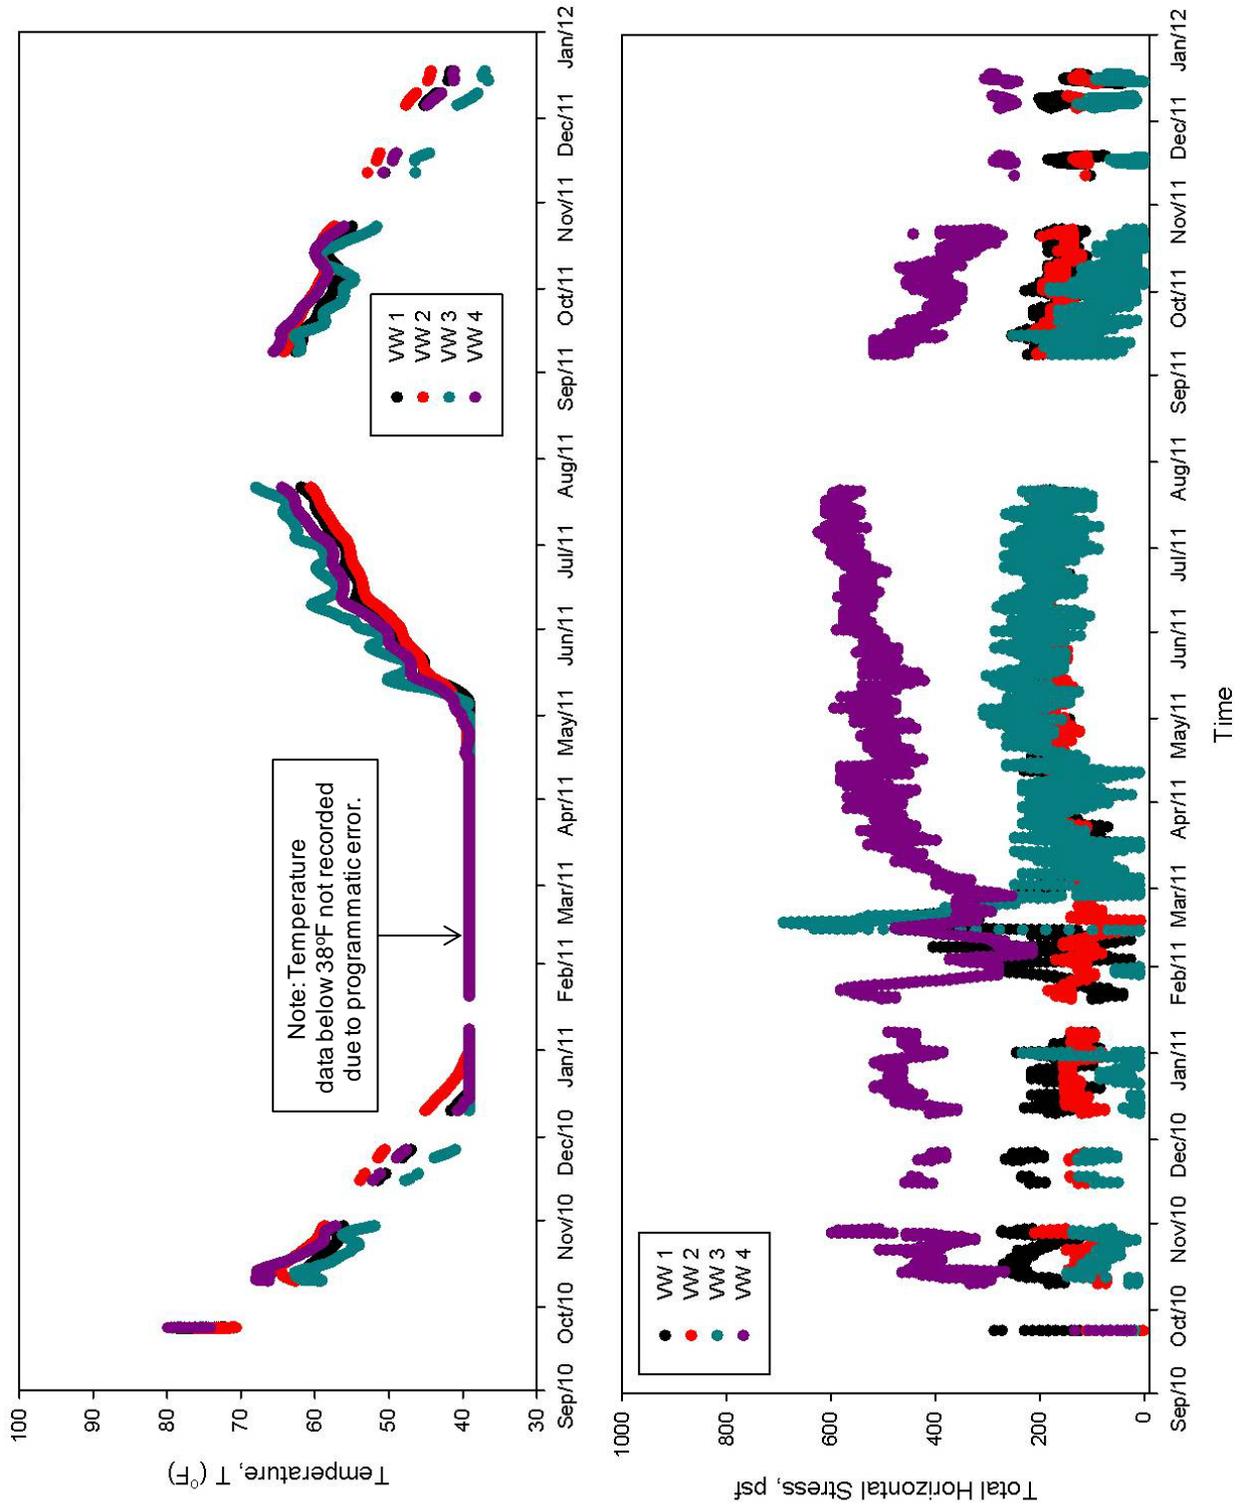
Figure 71. Bridge 2 — In ground total horizontal stresses and temperature readings in vibrating wire EPCs for the full project period

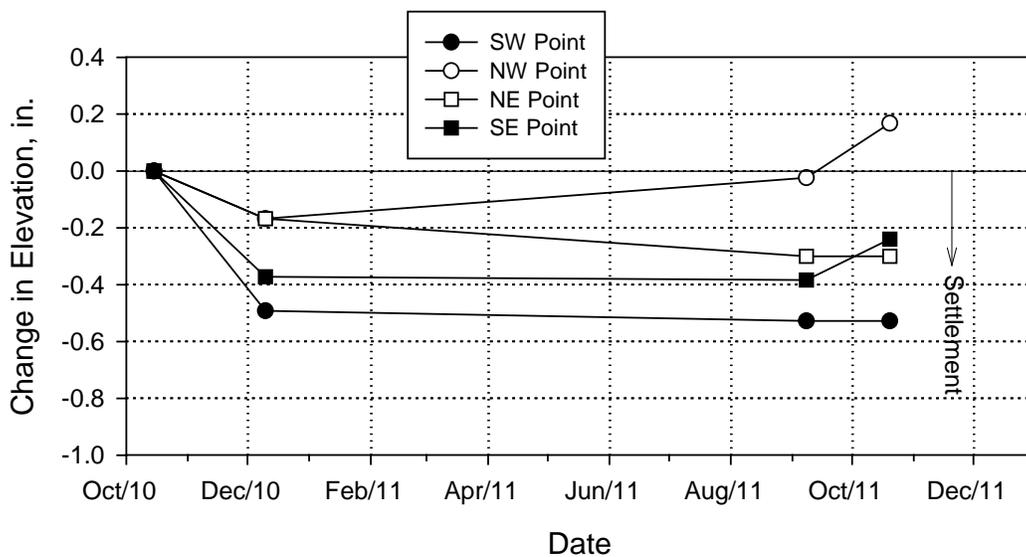
Figure 72. Bridge 2 — Abutment elevation monitoring results

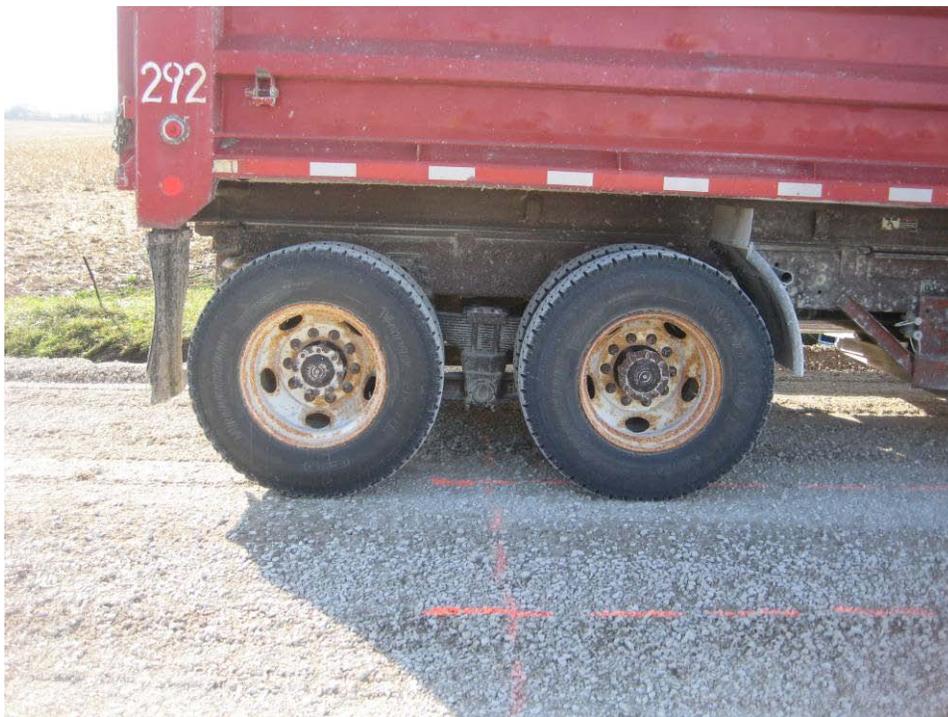
Figure 75. Bridge 2 — Center of tandem axle positioned over a desired location along the bridge

The bridge was divided into three lanes: north, center, and south. Each lane was about 8.6 ft wide, which is equal to the width of the RRFCs (Figure 74). The test truck was about 7.5 ft wide (Figure 73); therefore, the truck was effectively on only one RRFC when positioned in a lane. Bridge deflection testing under static live loads was conducted by positioning the center of the tandem axle (Figure 75) at bridge center span, along all three lanes. Bridge deflection measurements were obtained on the north and south sides of the bridge at the center span, before and during loading.

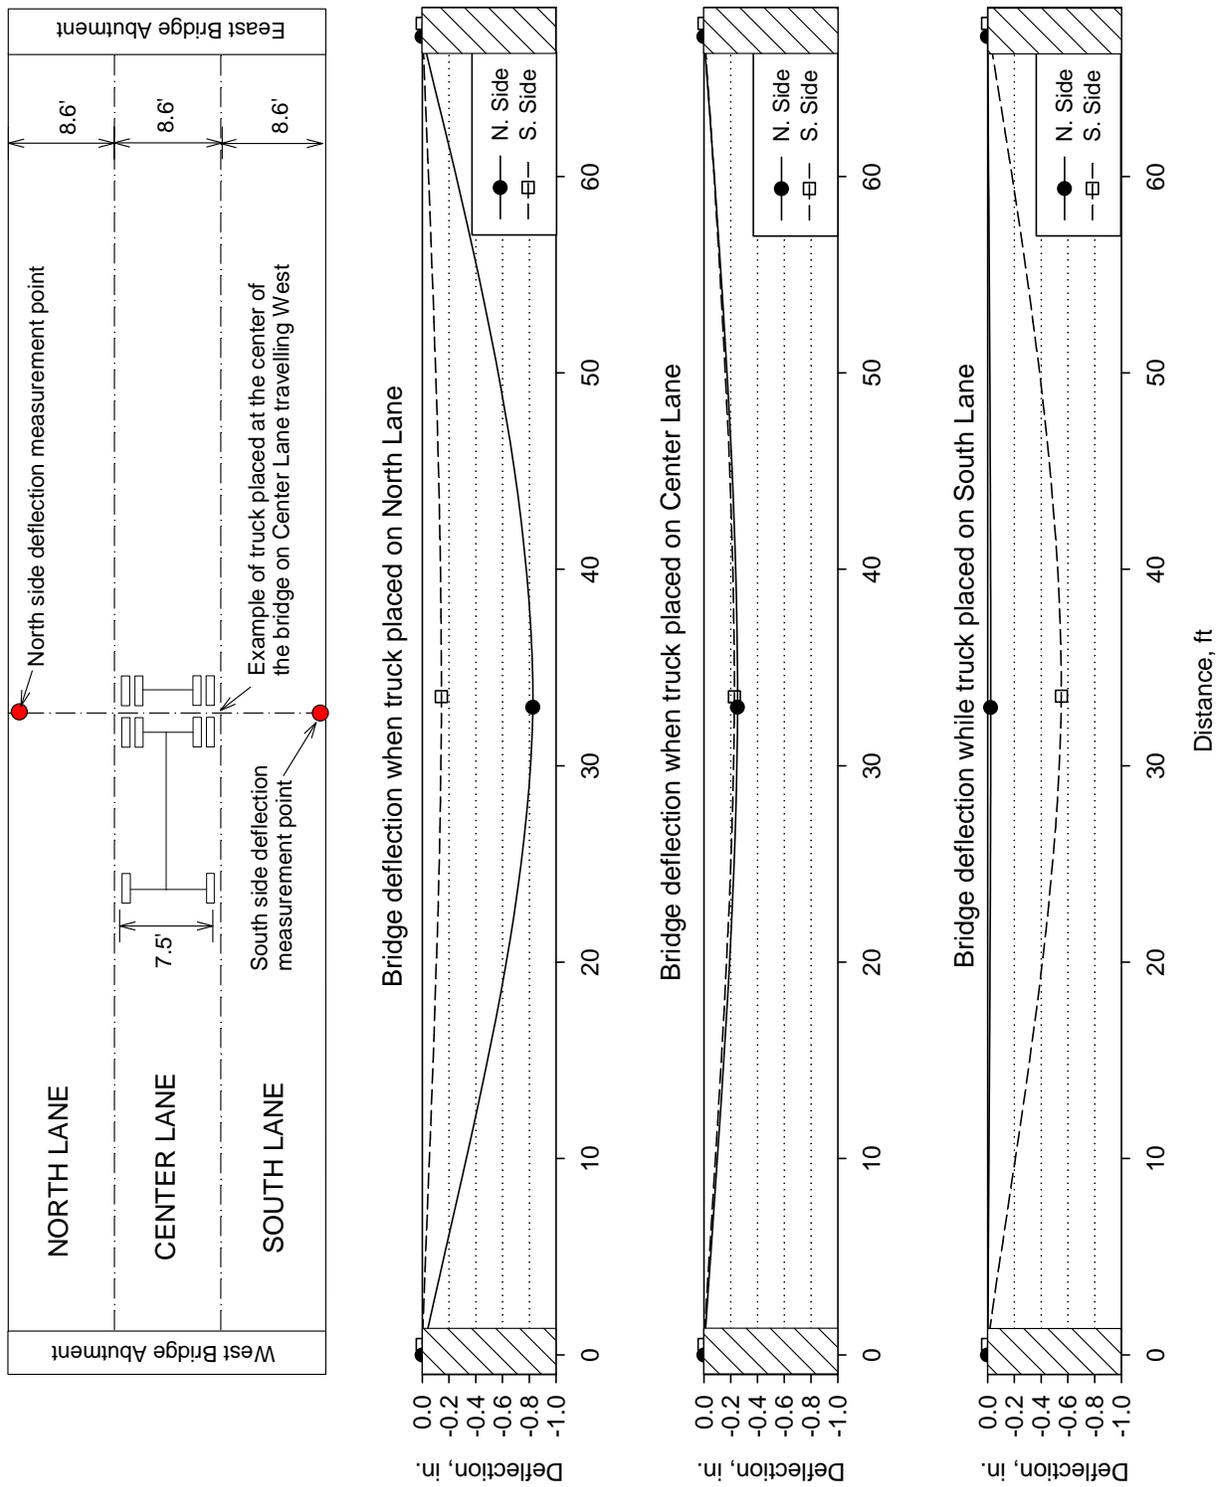
Figure 76. Bridge 2 — Bridge deflections at center when truck is positioned at the bridge center in north, center, and south lanes (10/29/2010)

- Bridge 2: Static LL tests indicated non-uniform deflections transversely across the bridge at the center span (with a differential deflection of up to 0.8 in.) when the truck was positioned along the edges. This suggests poor load transfer across the RRFCs. A maximum deflection of about 0.9 in. was measured during static LL testing. The maximum measured deflection was close to but less than the AASHTO allowable deflection. However, it must be noted that the AASHTO allowable limits are based on a 72 kip three-axle test truck, while the test truck used in this study weighed about 52 to 53 kips.
