Geosynthetic Reinforced Soil for Low-Volume Bridge Abutments

Final Report

Sponsored by
Iowa Highway Research Board
(IHRB Project TR-621)
Iowa Department of Transportation
(InTrans Project 10-380)

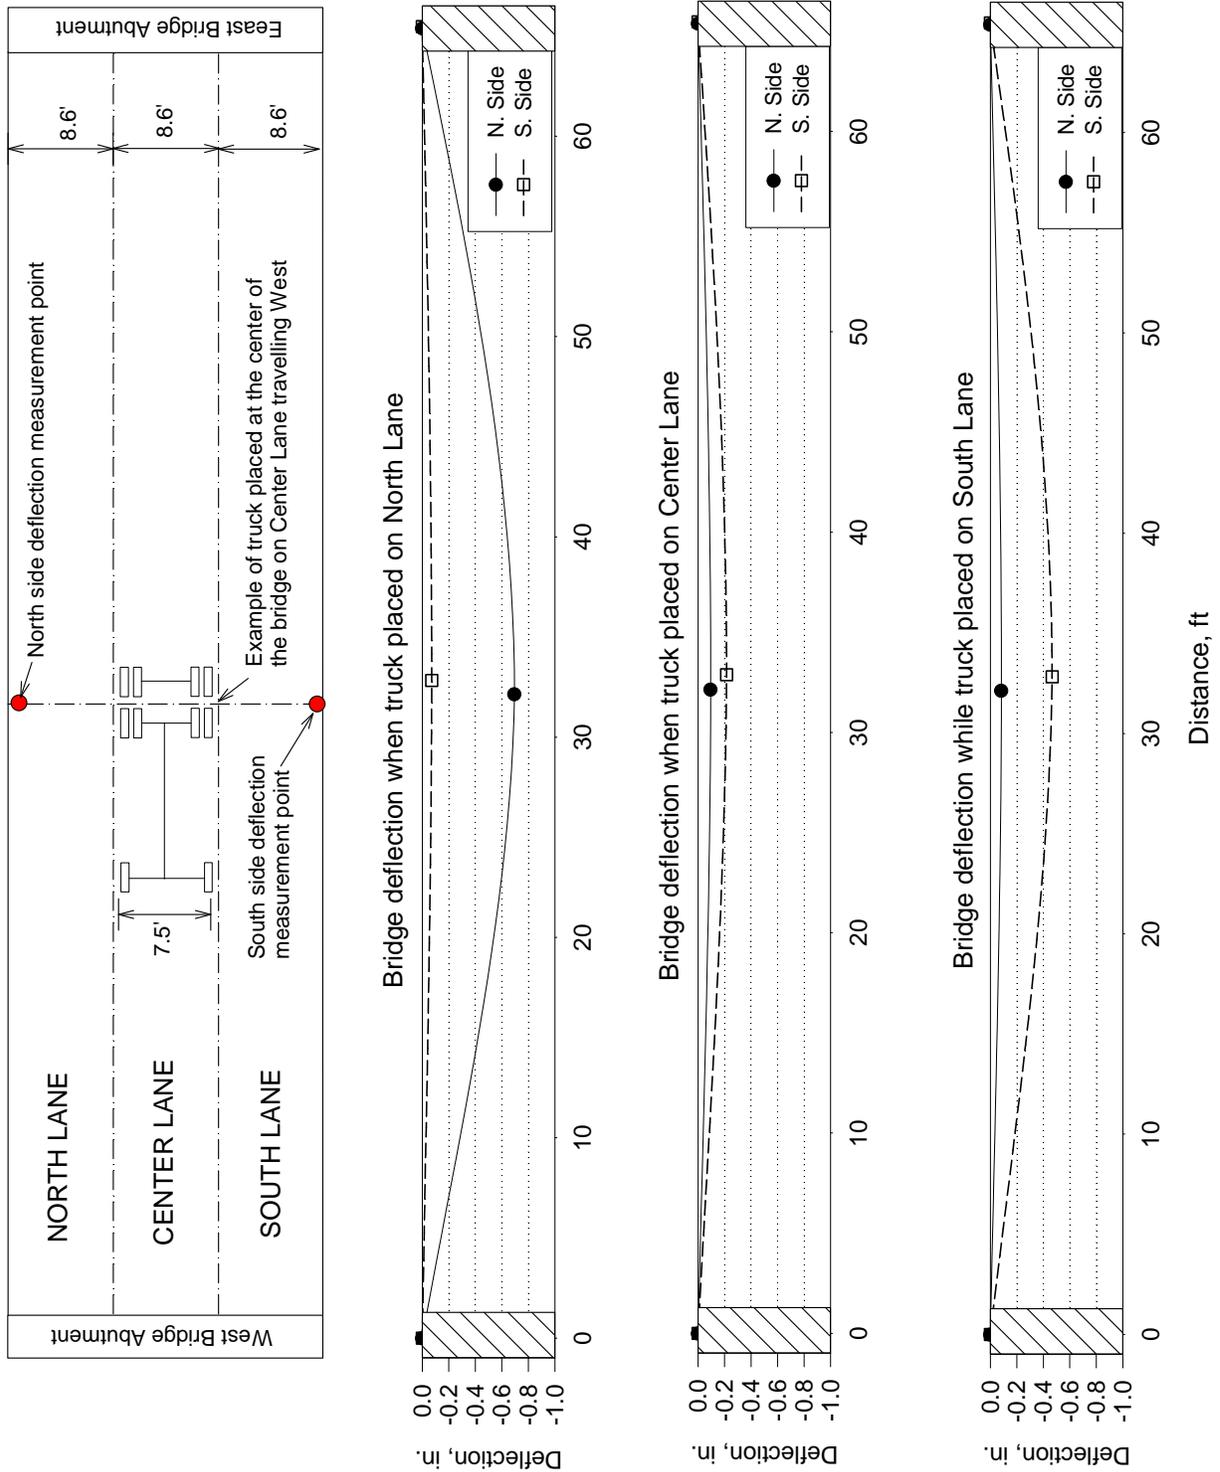
Figure 77. Bridge 2 — Bridge deflections at center when truck is positioned at the bridge center in north, center, and south lanes (10/20/2011) – Truck travelling east to west

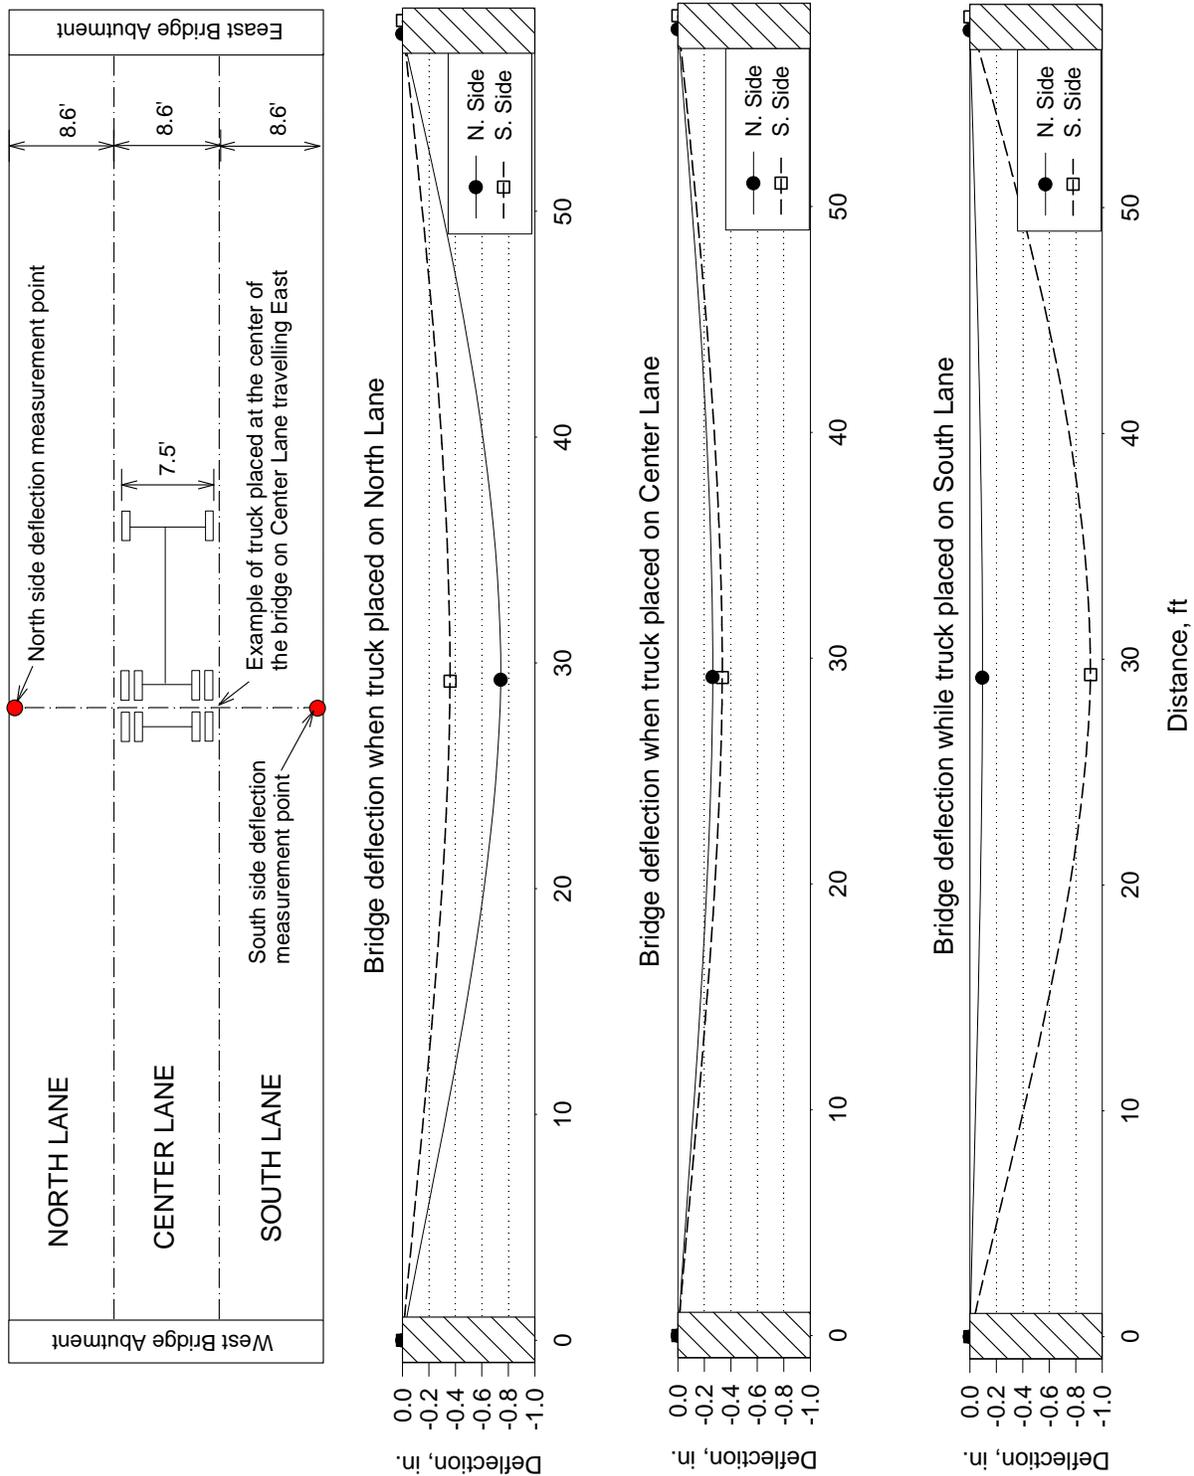
Figure 78. Bridge 2 — Bridge deflections at center when truck is positioned at the bridge center in north, center, and south lanes (10/20/2011) – Truck travelling west to east

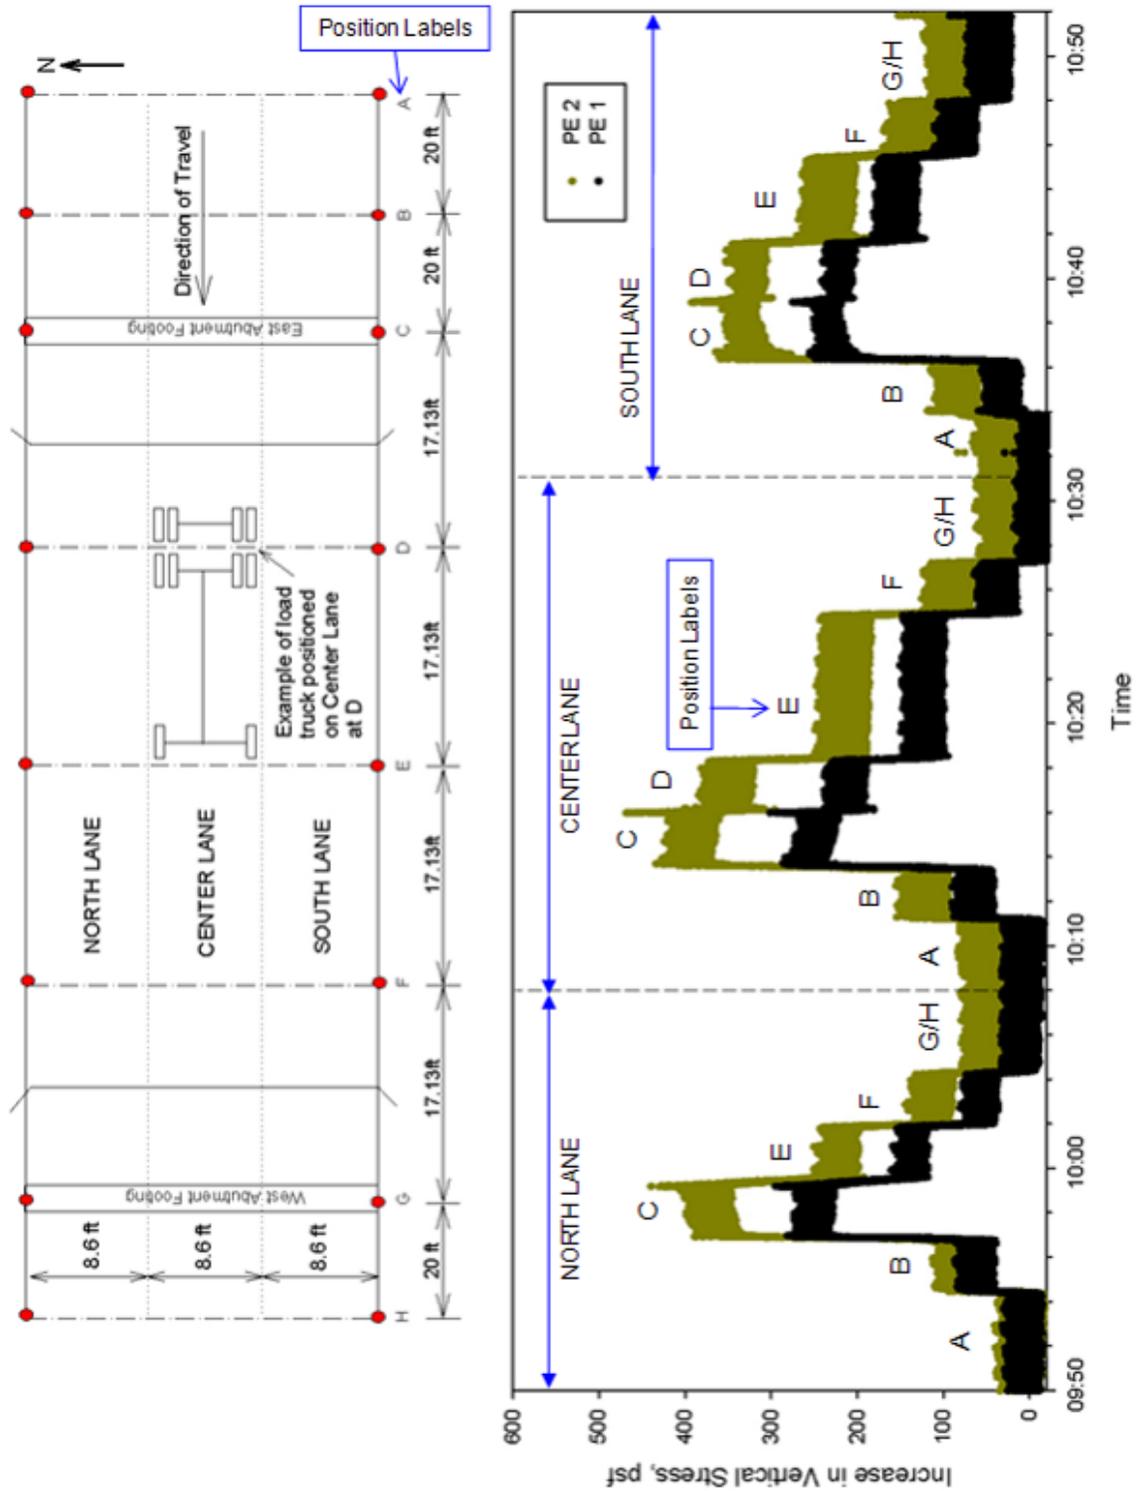
Figure 79. Bridge 2 — Increase in total vertical stresses in PE 1 (at the bottom of the excavation) and PE 2 (at about 2.2 ft below footing) during static load testing on north, center, and south lanes (10/29/2010)

- Bridge 2: Peak increase in vertical stresses in the GRS fill material was observed when the test truck was positioned directly above the footing, as expected. Peak increase in horizontal stresses in the excavation at the GRS/existing soil interface was observed when the test truck was positioned either directly above or within 20 ft of the footing. The estimated vertical stress increase under LL using elastic solutions compared well with the measured vertical stress increase values from EPCs. The horizontal stress increase under LL were lower than the estimated values from elastic solutions, as the elastic solutions used do not account for the lateral restraint effect in the reinforced soil layers, which causes a reduction in the horizontal stresses.

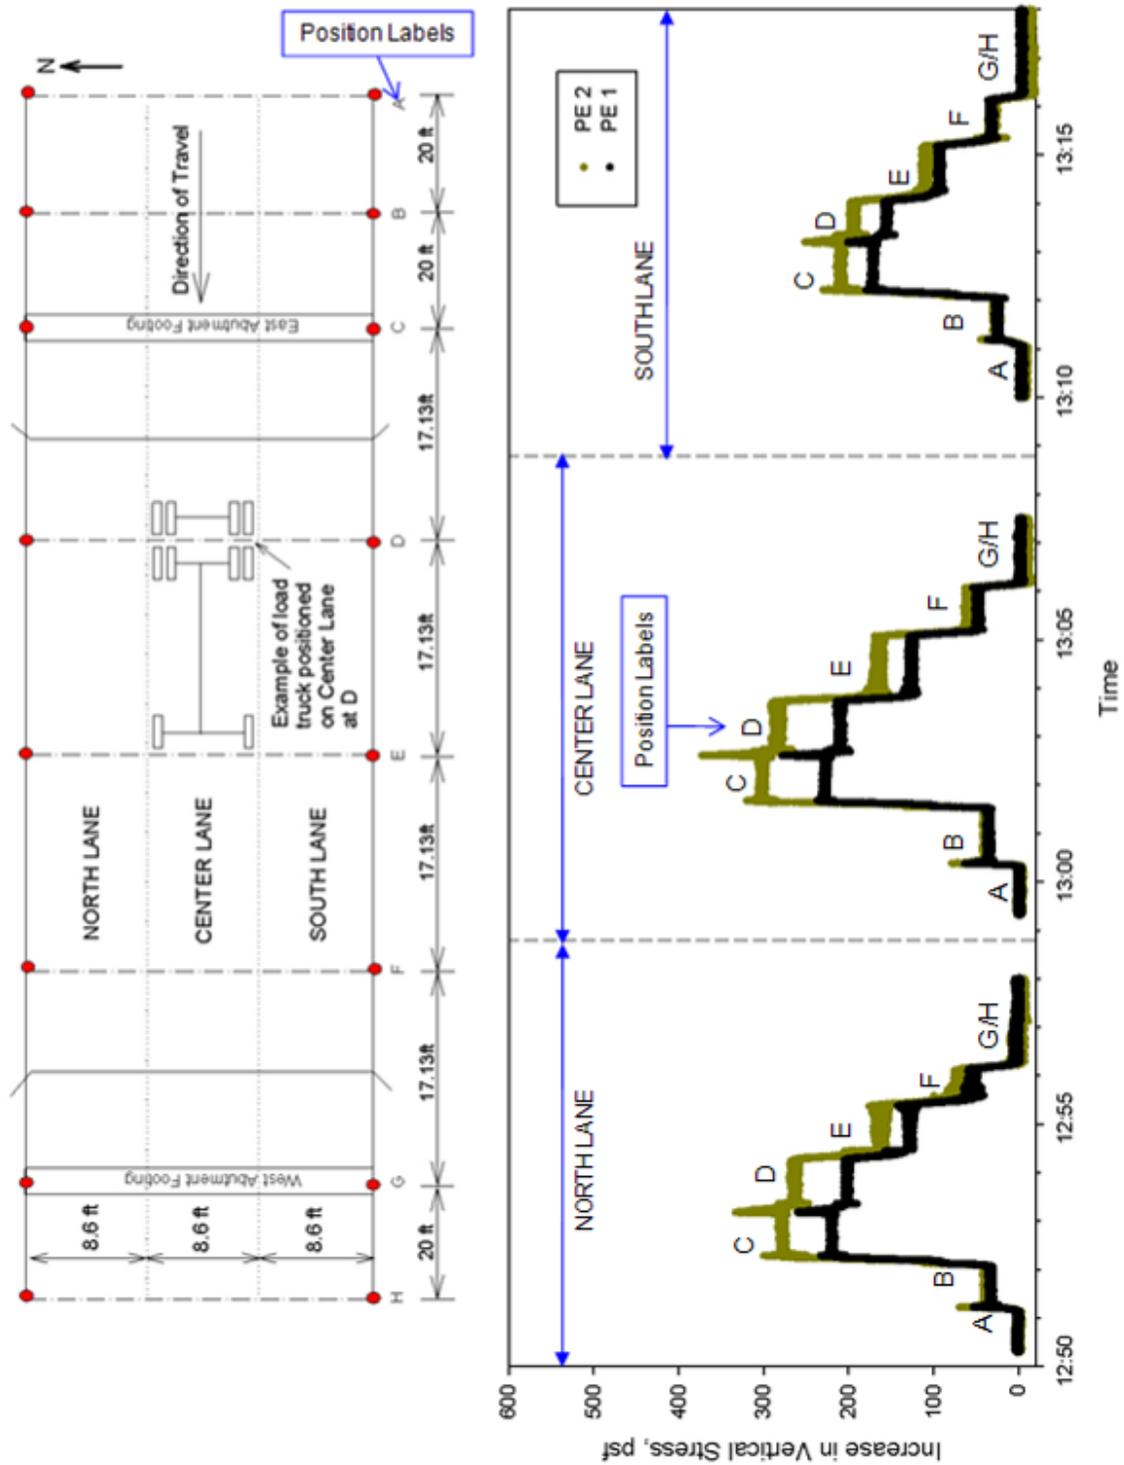
Figure 80. Bridge 2 — Increase in total vertical stresses in PE 1 (at the bottom of the excavation) and PE 2 (at about 2.2 ft below footing) during static load testing on north, center, and south lanes (10/20/2011)

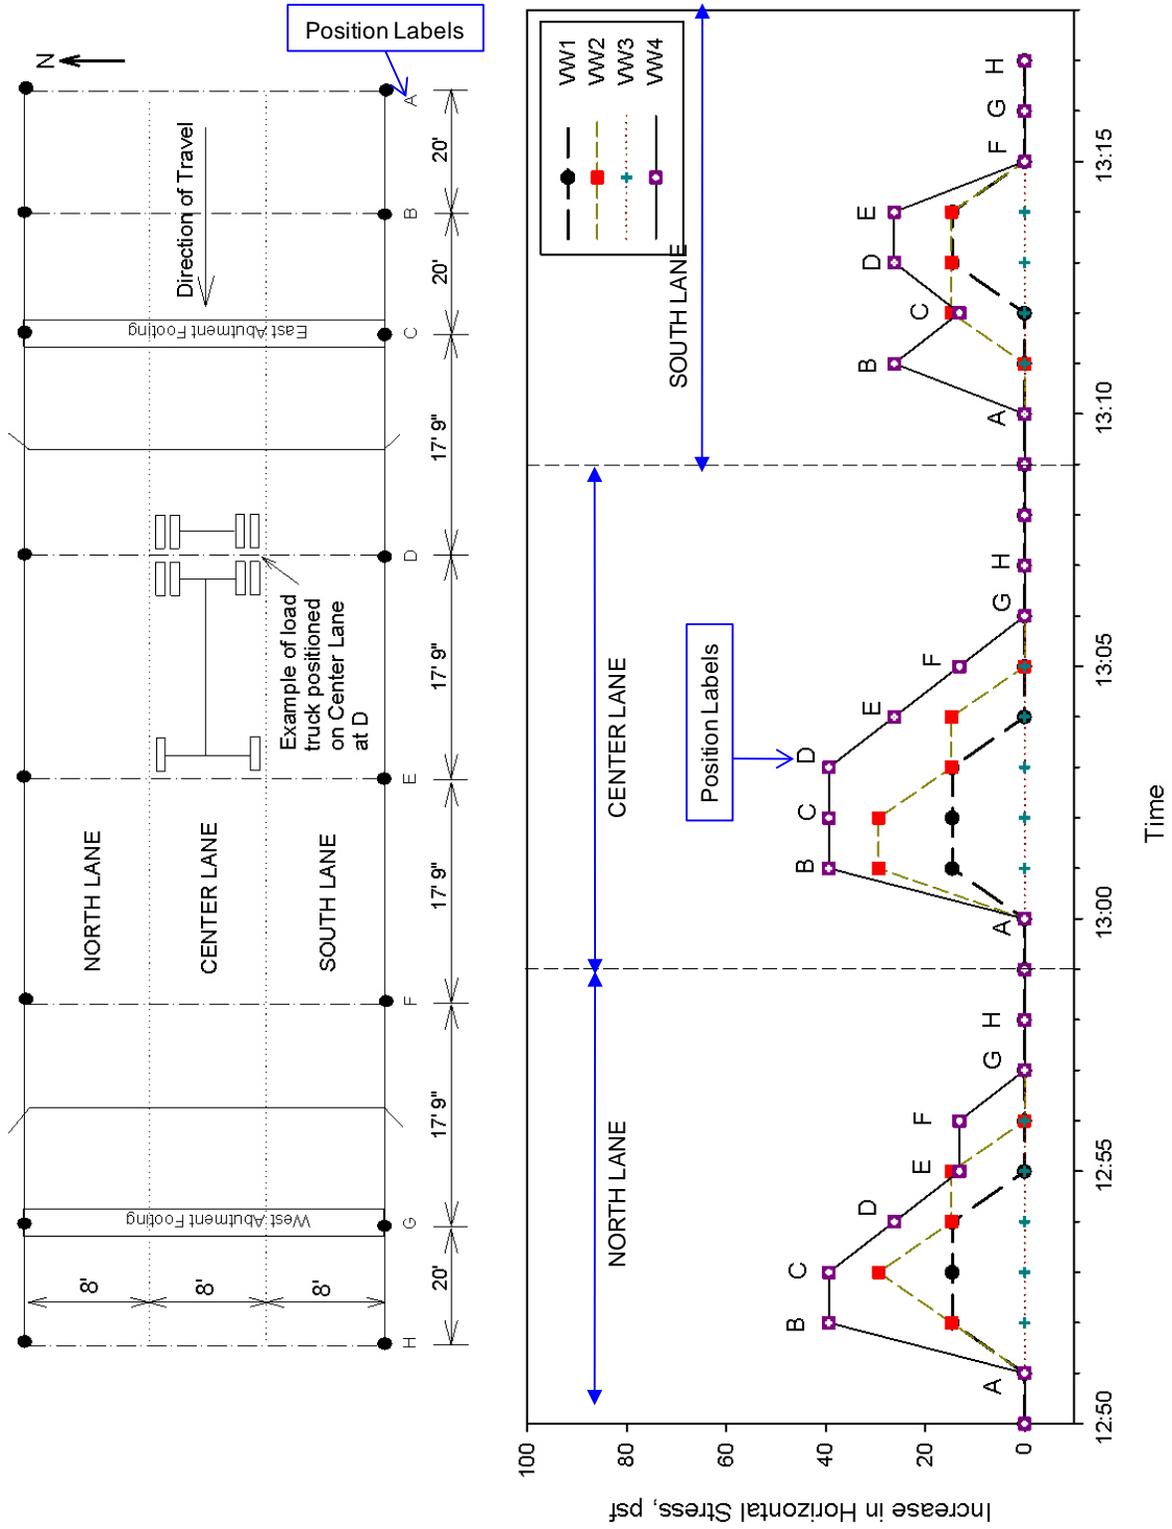
Figure 81. Bridge 2 — Increase in total horizontal stresses against the excavation walls during static load testing on north, center, and south lanes (10/20/2011)

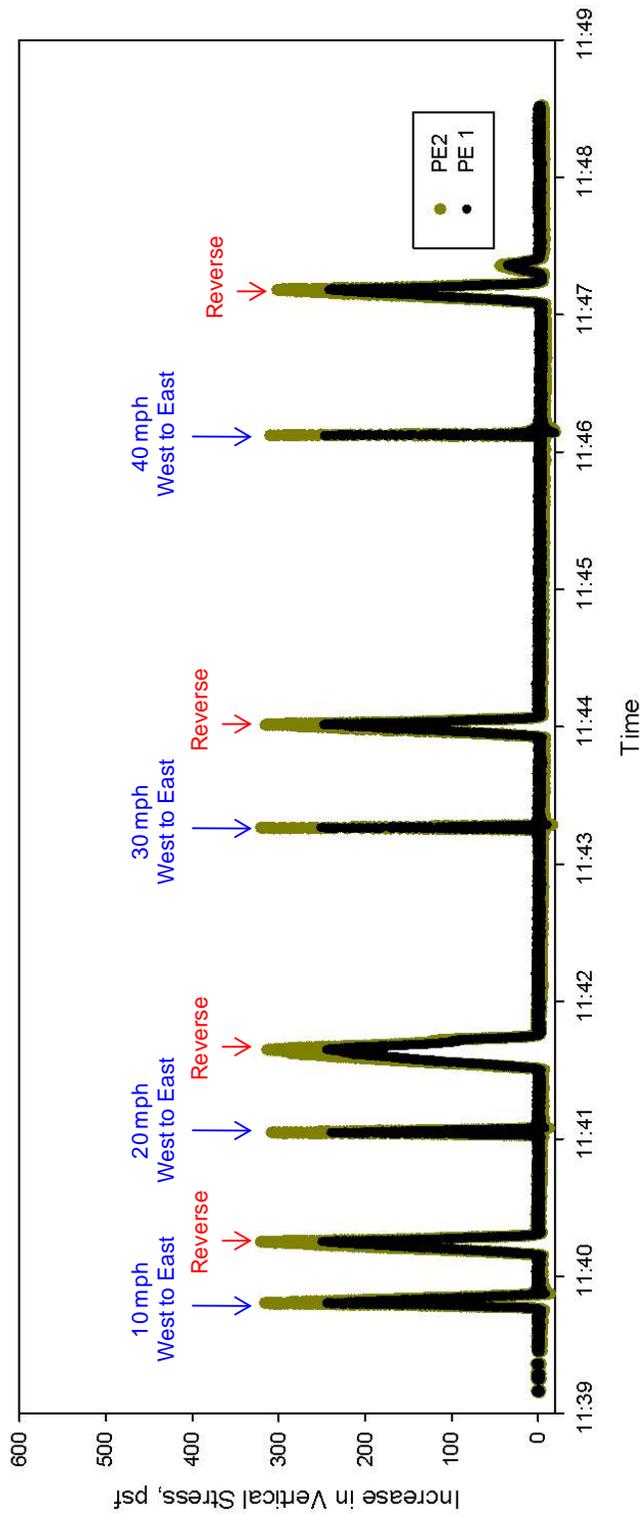
Figure 82. Bridge 2 — Increase in total vertical stresses in PE 1 (at the bottom of the excavation) and PE 2 (at about 2.2 ft below footing) during dynamic loading at 10 to 40 mph on center lane (10/29/2010)

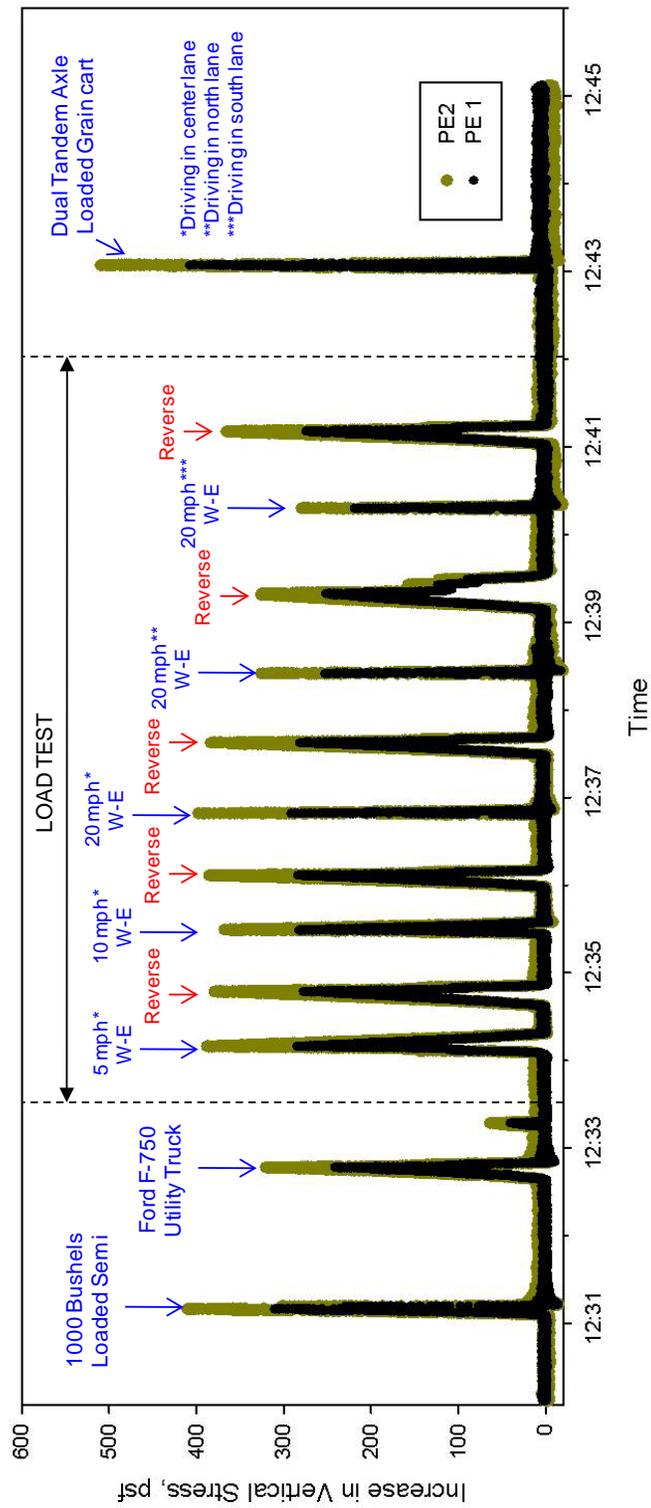
Figure 83. Bridge 2 — Increase in total vertical stresses in PE 1 (at the bottom of the excavation) and PE 2 (at about 2.2 ft below footing) during dynamic loading under husbandry traffic and load test vehicle (10/20/2011)

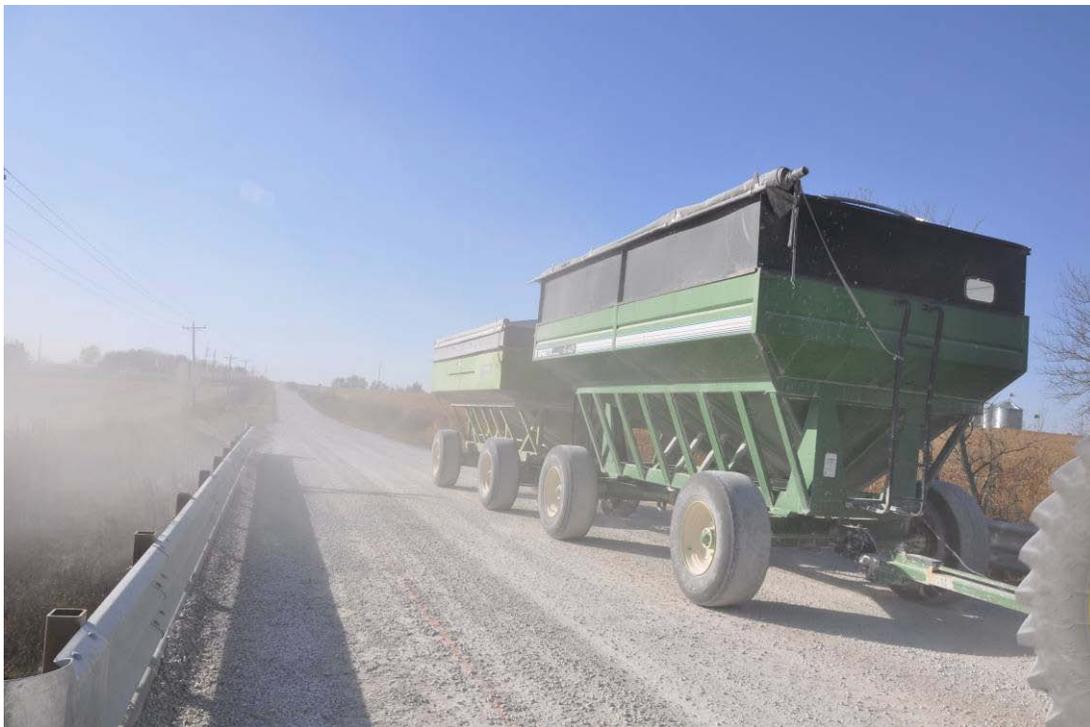
Figure 84. Bridge 2 — Dual tandem axle loaded grain cart passed over the bridge during 10/20/2011 load testing

Also shown in Figure 83 are increase in vertical stresses under a 1000 bushel loaded semi-truck, a Ford F-750 utility truck, and a dual tandem axle loaded grain cart (Figure 84), that passed the bridge during the 10/29/2011 load testing. The increase in vertical stress under loaded semi truck was about 1.3 times higher than the increase in vertical stress under the loaded test truck. The increase in vertical stress under loaded grain cart was about 1.6 times higher than the increase in vertical stress under the loaded test truck.

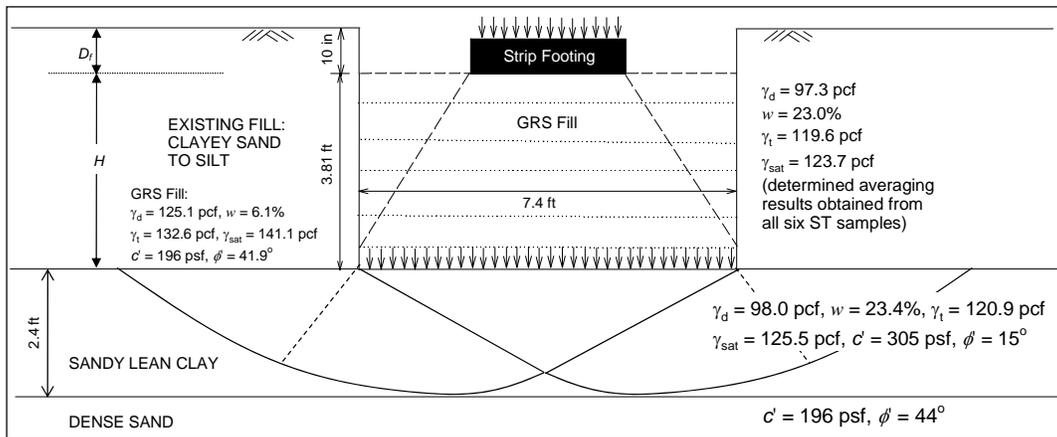
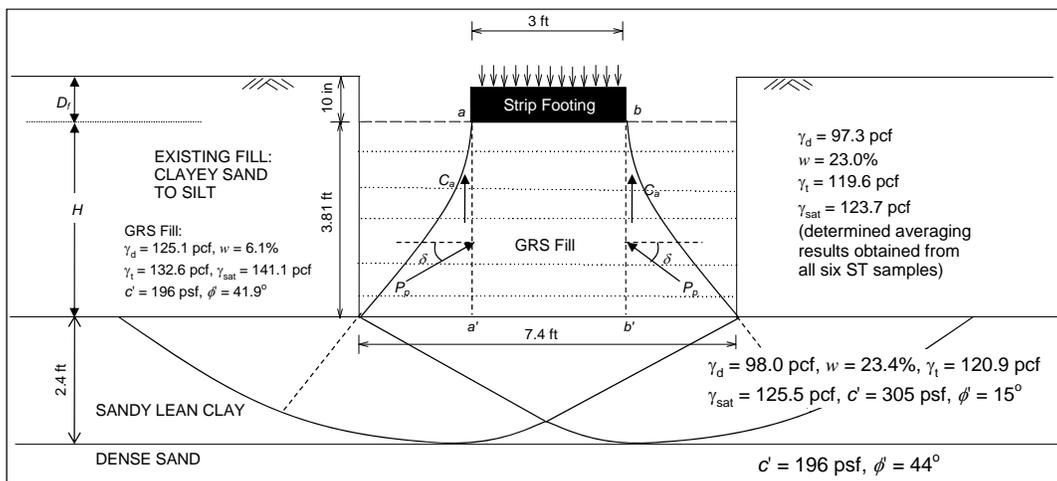
- Bearing capacity analysis was conducted for three potential failure modes: A – bearing capacity failure within the foundation soil, B – bearing capacity failure within the GRS fill material, and C – punching shear failure through the GRS fill material and bearing capacity failure in the foundation soil. Analysis results indicated lowest factor of safety (FS) values (1.8 to 2.6) for failure mode B and they were lower than the minimum recommended value ($FS_{\text{GRSBearing}} \geq 3.5$) by the FHWA. For failure modes A and C, a case with the water table at the surface of the GRS fill material showed the lowest FS values in case of dead load + live load and were lower than the recommended value ($FS_{\text{Bearing}} \geq 2.5$) by the FHWA.

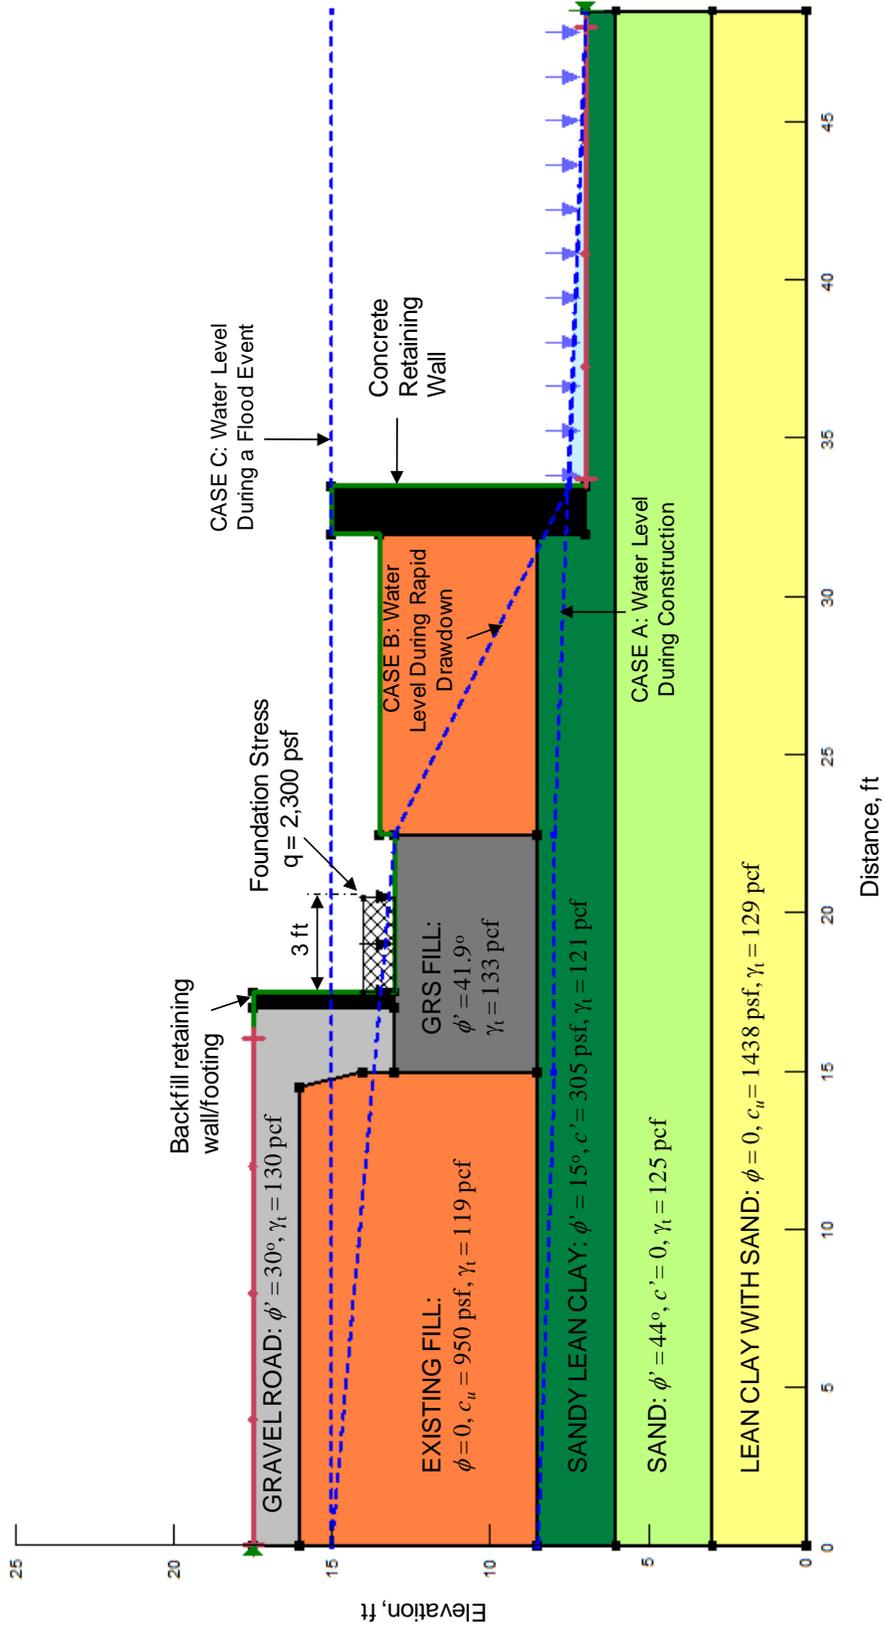
Figure 86. Bridge 2 — Cross-section setup for slope stability analysis

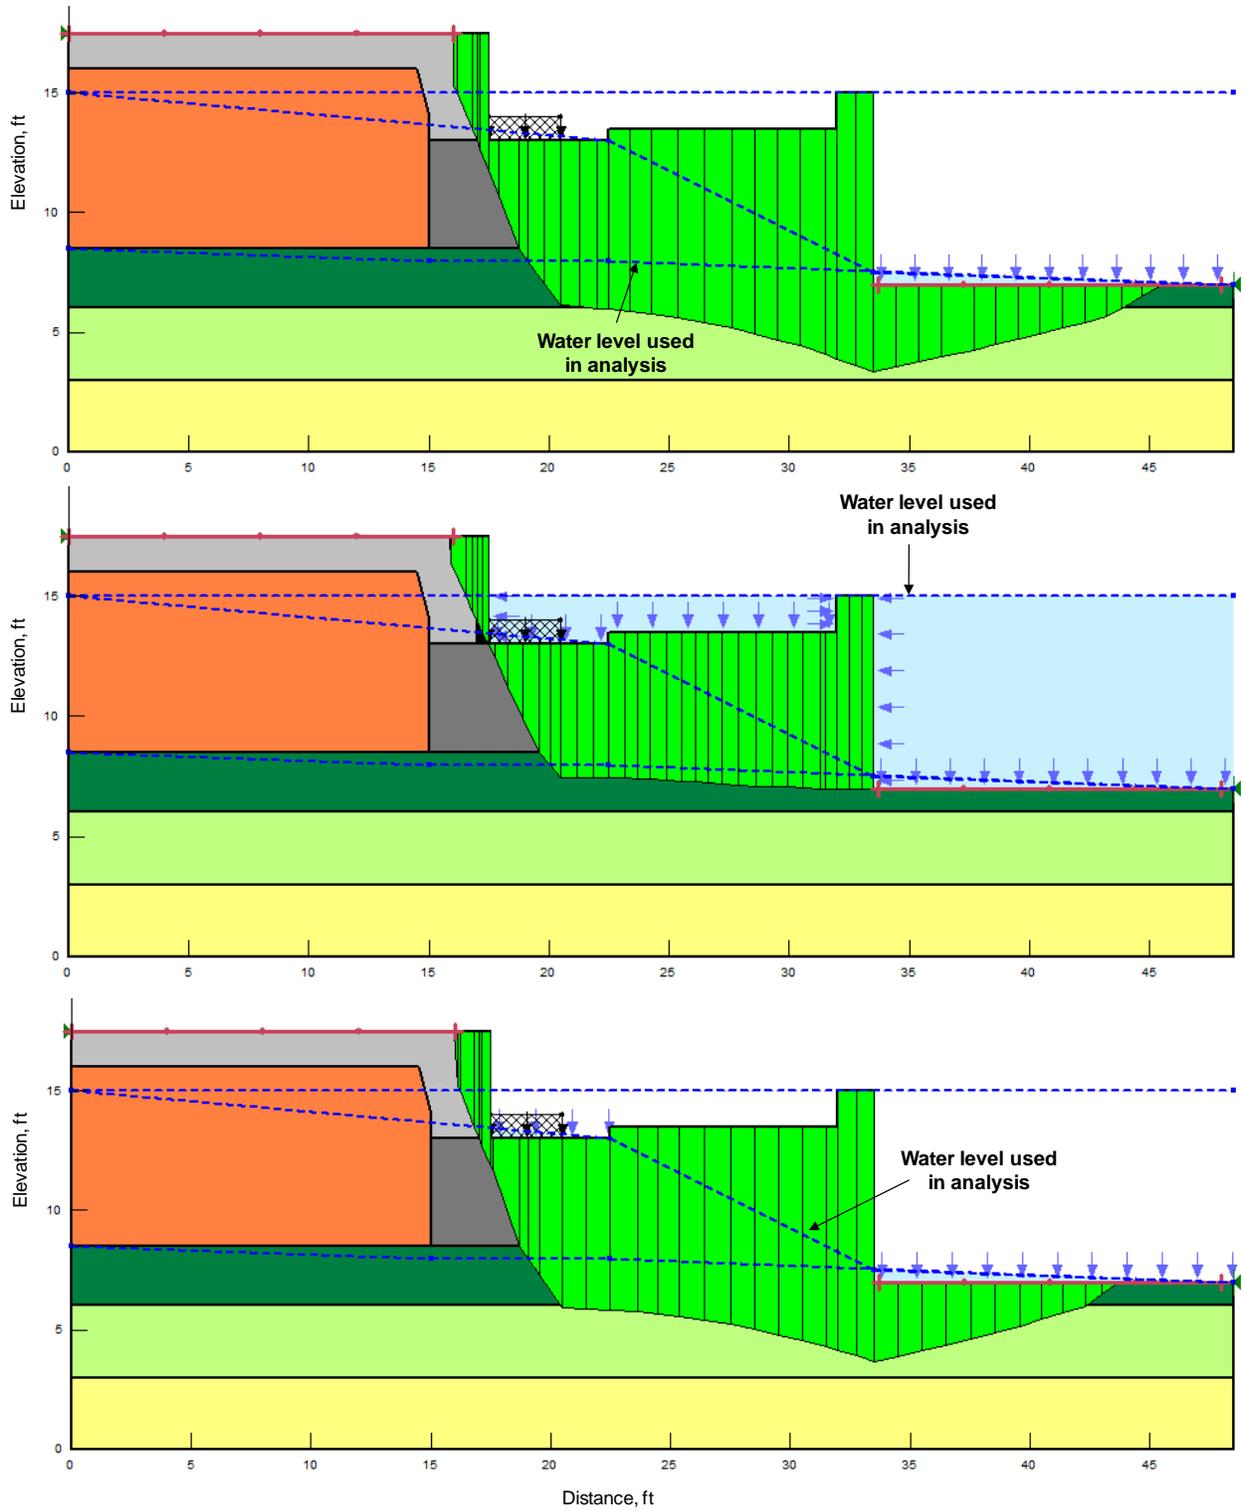
Figure 87. Bridge 2 — Global stability analysis for three different water level conditions

- Global stability analysis was conducted using three water table scenarios: A – water level at the base of the GRS fill material, B – water level during flooding, and C – water levels in a rapid draw down condition. The analysis indicated that the FS values for both rapid draw down and flooding cases (1.2 to 1.4) were lower than the recommended minimum ($FS_{\text{Stability}} = 1.5$) by the FHWA. The potential failure surfaces were at the interface of the GRS fill material and the underlying weaker foundation layer.

- Slope stability analysis on the Bridge 2 abutment indicated potential failure surfaces at the interface of the GRS fill material and the underlying weaker foundation layer. Obtaining subsurface soil information prior to bridge construction is recommended, so that excavation depths to determine any weak foundation layers can be determined prior to construction. If soil boring information is not available, at least testing at the bottom of excavation must be conducted to determine if the foundation layers are stable.

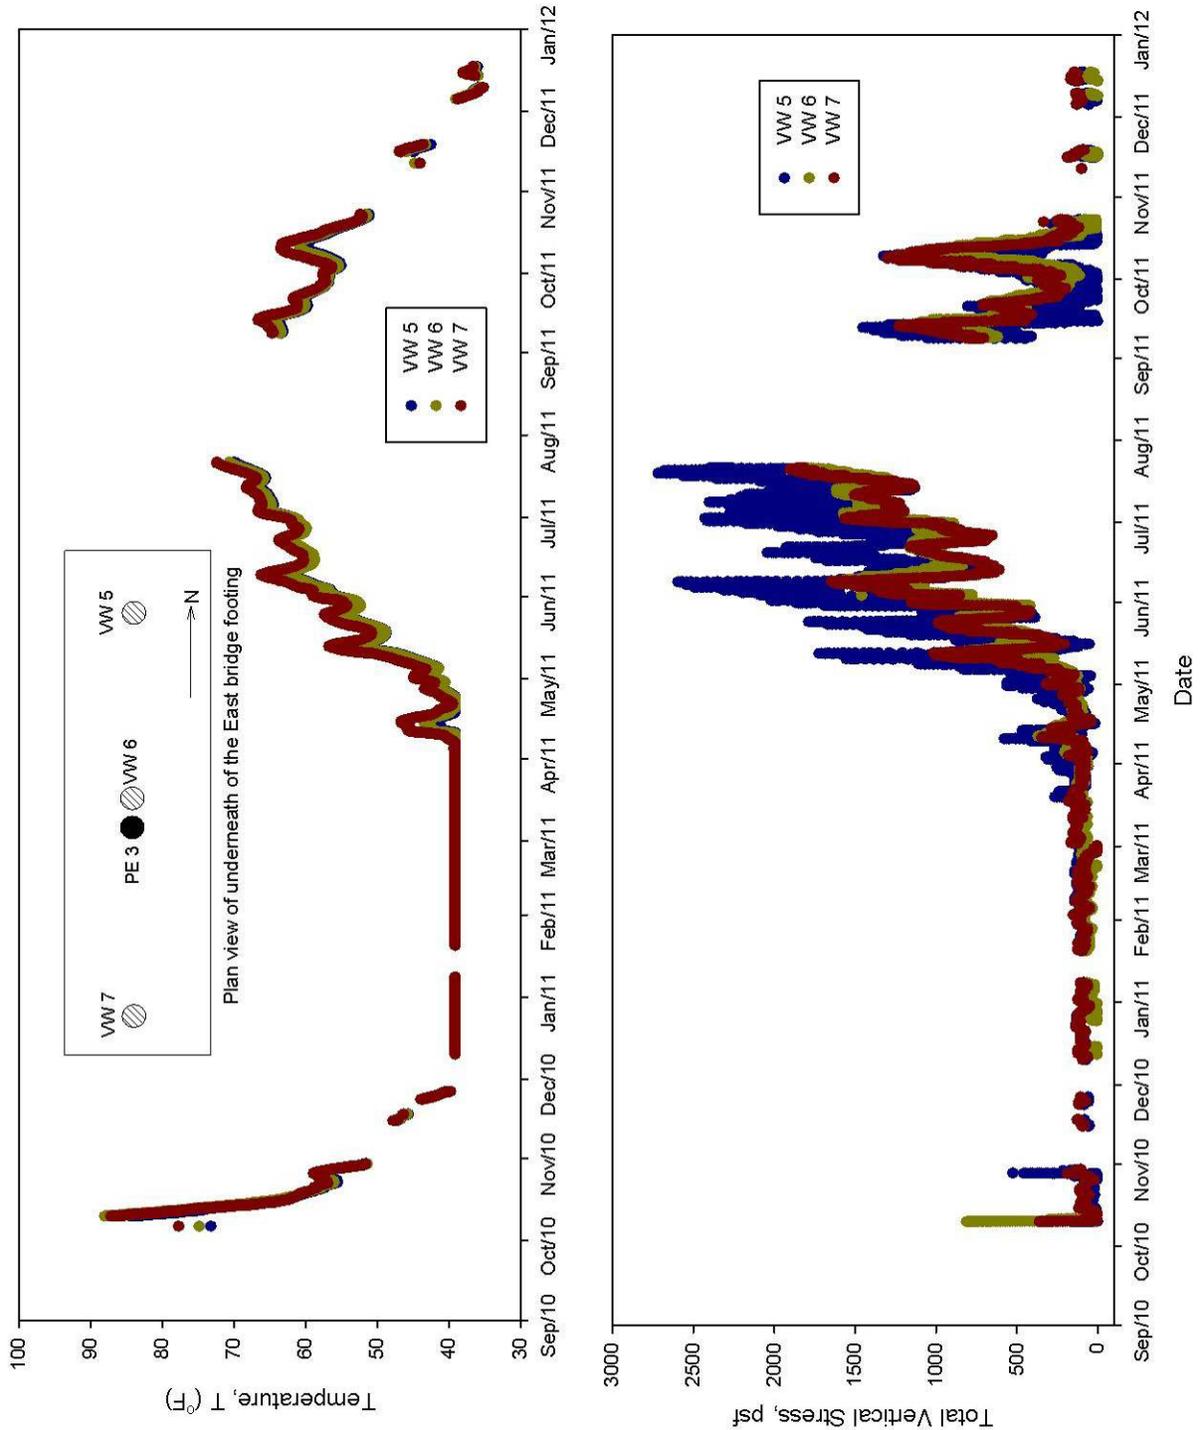
Figure B.1: Bridge 2 — Vertical stresses and temperature readings in vibrating wire EPCs installed under the footing
