## Florida Department of Transportation Research

### Base Connections for Signal/Sign Structures

BDK75 977-32

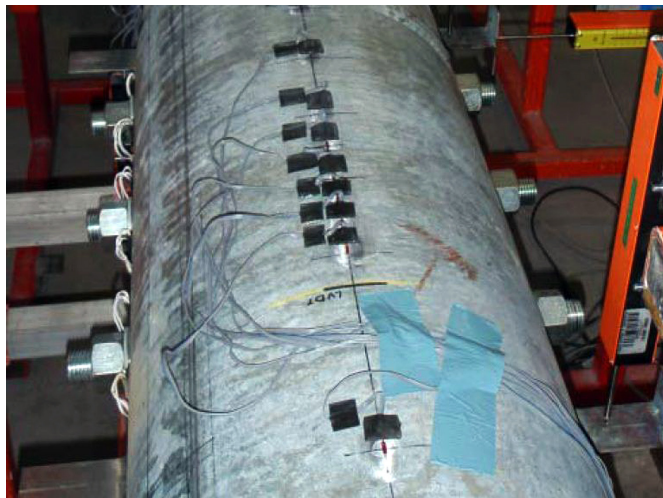
*The telescopic splice with strain gauges placed on the compression face of the outer pole.*

The results of the test program provide a detailed representation of the behavior of the telescopic connection components. The data and observations during and after testing reveal how the load is transferred along both the length of the telescopic splice and across the through-bolts. The tapered through-bolted telescopic base connection was shown to be a viable alternative for transferring both flexural and torsional loads as applied to cantilever signal or sign structures.
