## Office of Innovation, Partnerships & Energy Innovation, Research & Implementation Section Executive Summary Report

### Verification of Rut Depth Collected with the INO Laser Rut Measurement System

Report Number: FHWA/OH-2011/18

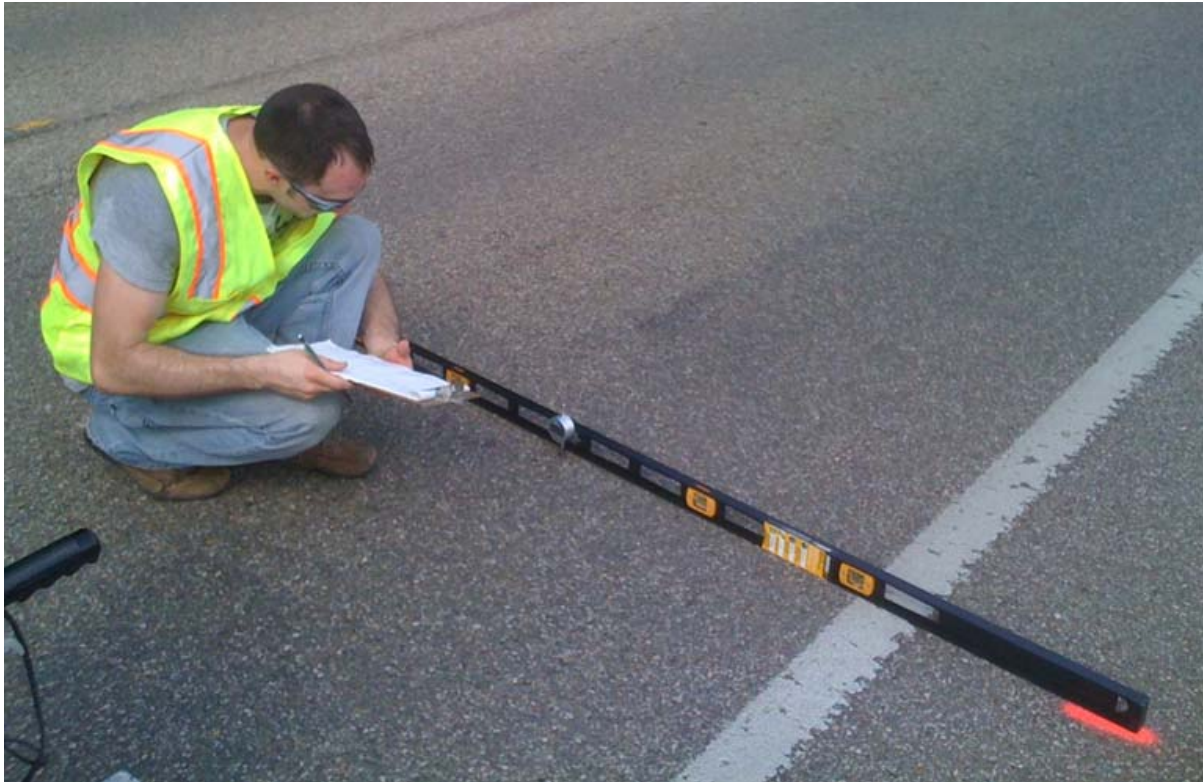
**Above: Measuring rut depth with straight edge and dial gauge.**

Since 1985, ODOT has been manually collecting rut depth data using a straight edge and dial gauge (S&G). This method is slow and dangerous to pavement condition raters when traffic control is not available. According to the Pavement Condition Rating (PCR) procedures, the rating team is instructed to stop at 1 mile intervals along the predetermined roadway section and evaluate a 100 ft (30.5 m) section of pavement. While this method may be sufficient in many cases, there is potential for raters to overlook short sections of deeper than typical rutting. Also, there have been numerous instances, according to ODOT Infrastructure Management workers, when the level of traffic prevented them from obtaining the necessary number of rut depth measurements to properly evaluate a pavement section. To solve this problem, ODOT purchased two inertial road profilers; one from Pathway Services and one from Dynatest. Both vehicles use rear-mounted INO Laser Rut Measurement Systems (LRMS). These systems utilize two 3D laser profilers and allow the collection of transverse road profiles and calculation of rut depth measurements while the vehicle is in motion, even at high speeds. With the LRMS, numerous rut measurements can be obtained at short intervals over the entire section in a much shorter period of time. The safety risk for the rating team is greatly reduced because they can obtain measurements without leaving the vehicle and without interfering with traffic flow.

During the initial preparation for this project, it was discovered that the straight edge and dial gage being used by the ODOT technicians was only 4 ft (1.22 m) in length.

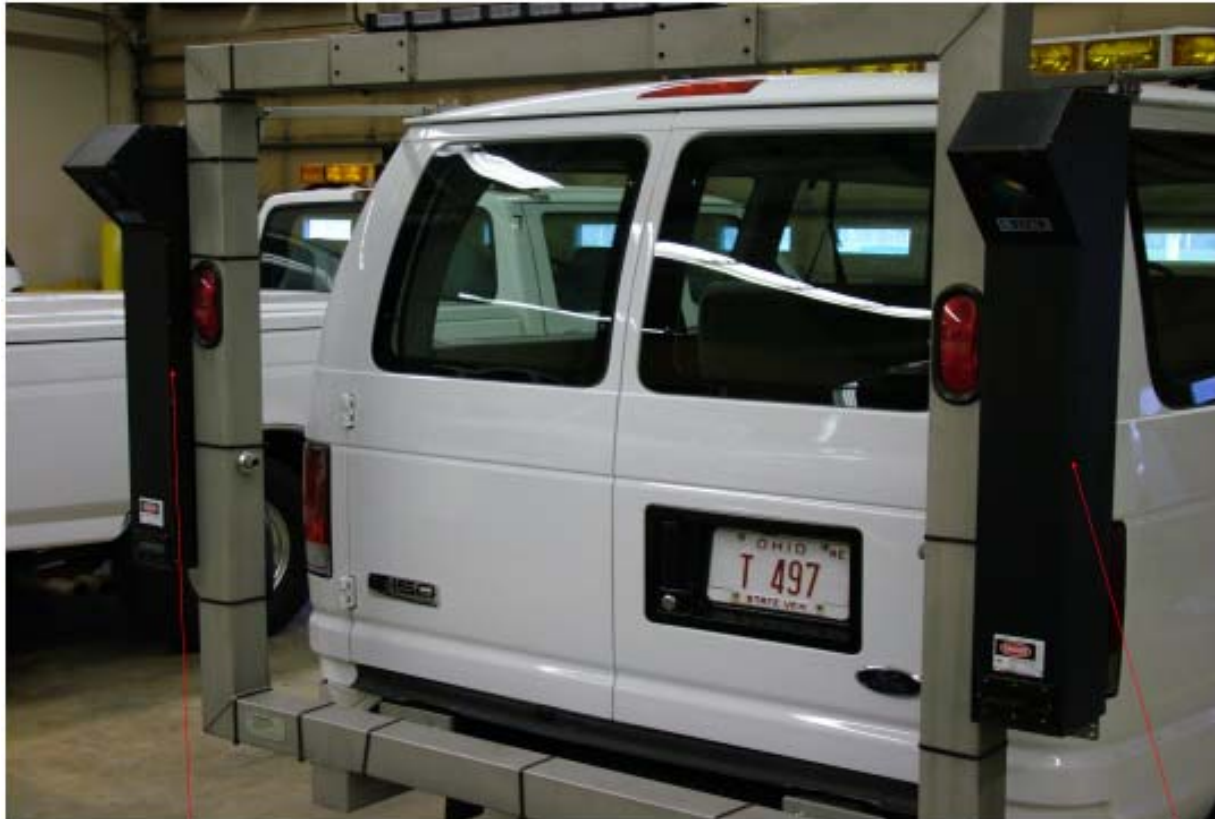
**Below: INO Laser Rut Measurement System mounted on Dynatest profiler vehicle.**

profilometer, 8 ft S&G, and 4 ft S&G. Workers from the ODOT Infrastructure Management division made five runs at each site with the Dynatest profiling vehicle over a greater length of pavement that contained each 200-ft (60.96 m) section. As the vehicle approached the test sections, the system was switched to rapid-fire mode in order to provide a greater number of measurements for analysis
