# Evaluation of Pavement Surface Friction Treatments

# JOINT TRANSPORTATION RESEARCH PROGRAM

Report Number: FHWA/IN/JTRP-2012/04

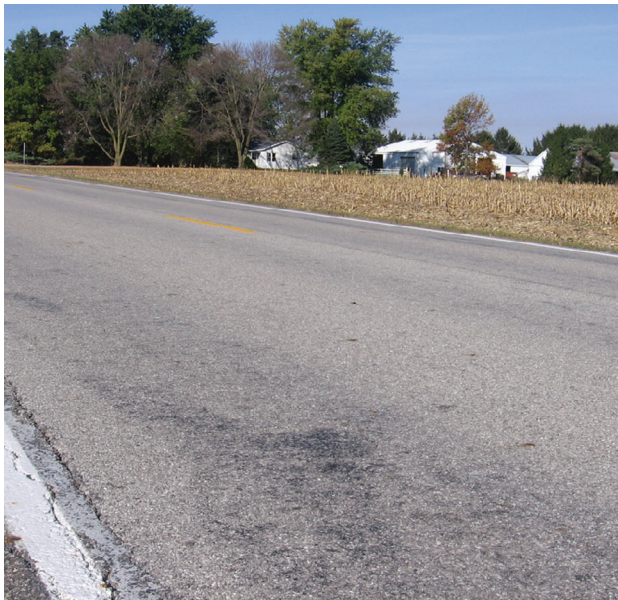
Figure 2.1 Photo of a Typical Single Chip Seal Pavement after 36 Months of Service

Therefore, a double chip seal can apply to pavements in poor conditions, where a single chip seal may not perform well, and provide a quieter and smoother riding surface (12). Currently, a single chip seal is commonly used by INDOT. Figure 2.1 shows a typical single chip seal pavement in Indiana.

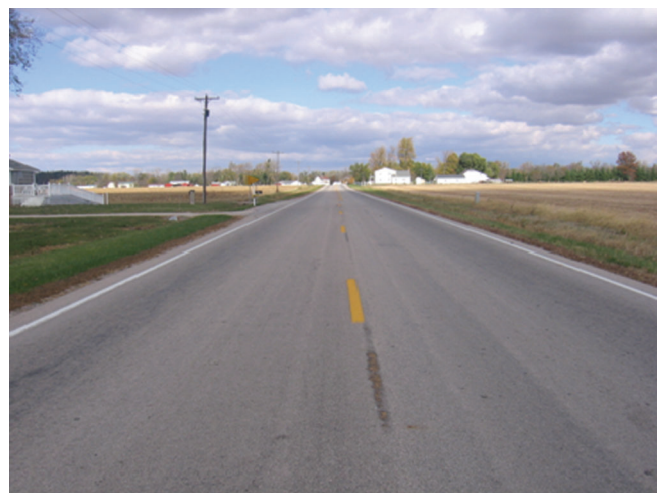
Figure 2.2 Photo of a Typical Fog-Chip Seal Pavement after 24 Months of Service

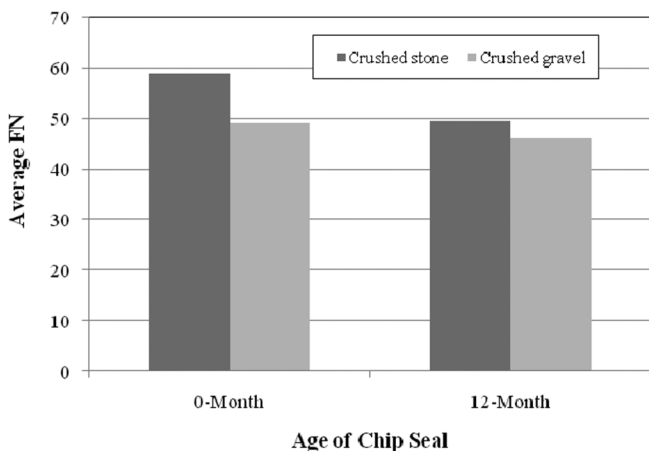
Figure 2.6 Comparison of Friction Numbers by Aggregate Type

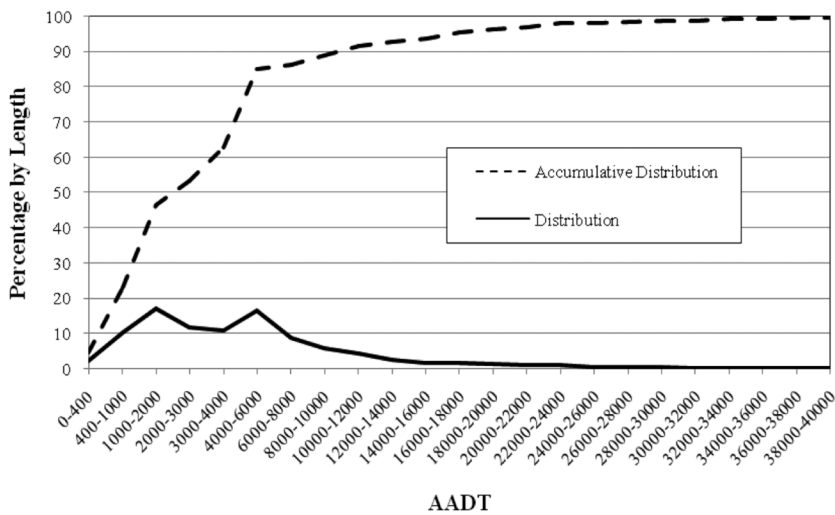
Figure 2.9 Percent Distribution of Total Road Length by AADT

Based on David Peshkin's survey (17), high traffic volume roads in rural areas may be as those roads with AADT greater than 5,000. INDOT maintains approximately 10,000 centerline miles of non-interstate roads. The lowest AADT was 15 on SR-166 and the highest AADT was approximately 80,000 on US-30. Figure 2.9 shows the percent distribution of the road length by AADT. Apparently, a large portion of the non-interstate roads carried 1,000 to 6,000 AADT, and more than 90% of non-interstate roads carried an AADT less than 12,000. In order to facilitate pavement engineers to select surface treatment and materials, the non-interstate roads are further grouped into three traffic levels, such as light, medium and high. Table 2.5 shows the total length of roads in each traffic level and

associated percentage. It should be pointed out that the definition of traffic level is not a pure science and involves engineering judgment. However, the total length of the roads in each traffic level as shown in Table 2.5 accounts for approximately one third of the total length of all non-interstate roads.

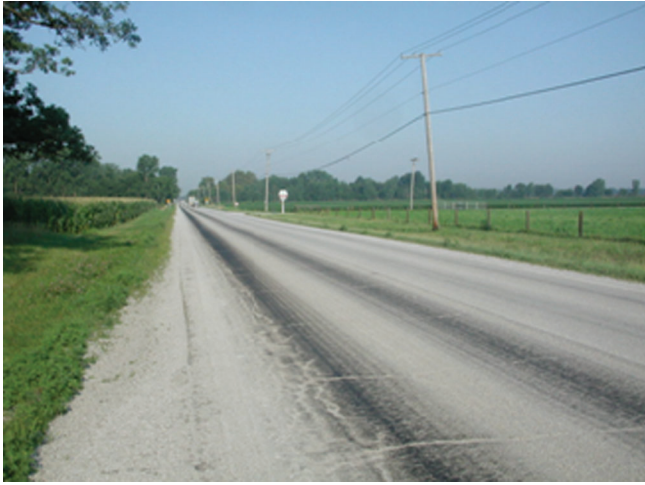
Figure 2.10 Photo of a Chip Seal on SR-10 after 36-Months of Service

rich surface, and therefore aggravate bleeding. Some researchers indicated that the better existing pavement condition, the longer the chip seal will last (18). Also, aggregate gradation also affects the friction performance. In general, the failure of a chip seal can be easily identified from the visual appearance of the chip seal as shown in Figure 2.10.

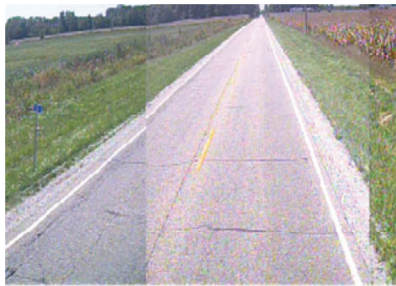
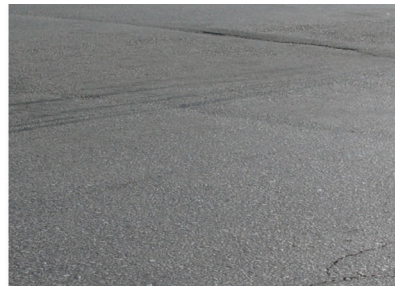
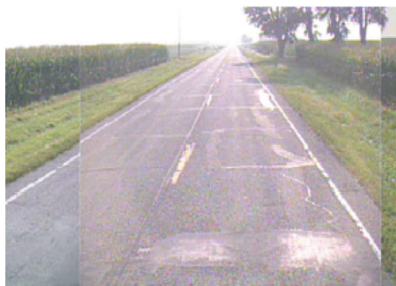
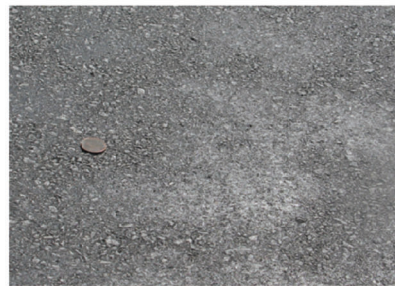
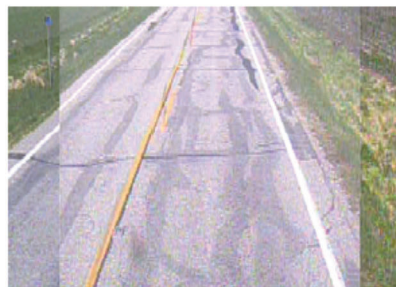
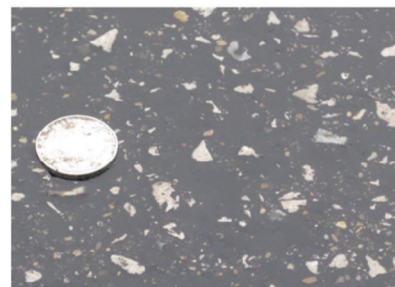
(a) SR-10 before Chip Seal

(b) SR-10 after Chip Seal

(c) US-421 before Chip Seal

(d) US-421 after Chip Seal

(e) US-36 before Fog-chip Seal

(f) US-36 after Fog-chip Seal

Figure 2.11 Photos and Close-ups of Three Chip Seals with Low Friction

Presented in Figure 2.11 are the photos of the pavements before chip seal and the close-ups of surfaces in the wheel paths after chip seal for three test sections, including two chip seals on SR-10 and US-421, respectively, and one fog-chip seal on US-36. All the three test sections have experienced poor surface friction. As indicated in the close-up view on SR-10, the chip seal experienced significant loss of aggregate and bleeding. For the chip seal on US-421, there was no sufficient coarse aggregate, resulting in a smooth surface texture. Due to the use of wrong fog seal material in the test section on US-36, the fog-chip seal demonstrated not only insufficient cover aggregate, but also binder-rich surface. Table 2.6 shows the pavement conditions before chip or fog-chip seal in these three sections, and associated traffic volumes.

The old pavement on SR-10 demonstrated moderate roughness and light rutting and its overall condition was rated good. On US-421, the old pavement experienced fair roughness and very light rutting and its overall condition was rated excellent. The old pavement in the fog-chip seal section on US-36 demonstrated fair roughness and light rutting, and its overall condition was rated fair. Seemingly, chip seal may not be a right treatment for SR-10, taking into account the combined effect of old pavement condition and traffic. For the chip seal on US-421, it appears that the aggregate gradation contained only a small percentage of coarse particles. Therefore, the surface did not have sufficient resistance to traffic grinding. While the traffic was not high on US-36, the old pavement condition that was rated fair might have affected the performance of the fog-chip seal. While the contributing factors to the failures in these three sections were not readily apparent, care should be exercised when applying chip seal to a pavement when its overall condition level or surface roughness is rated fair or worse, or there is rutting  $>0.25''$ .

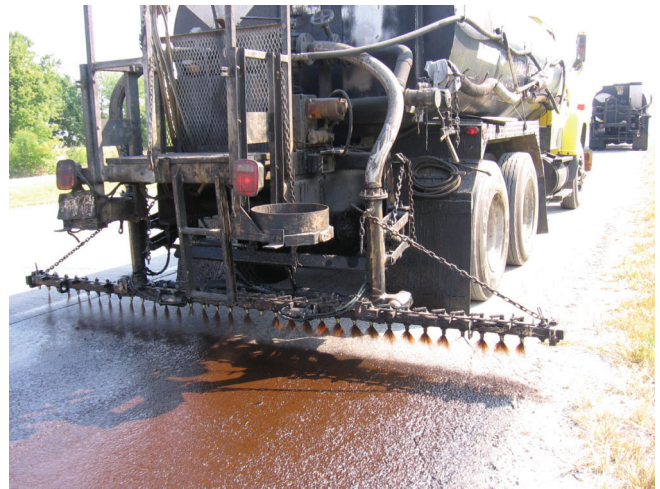
Figure 3.1 Application of Fog Seal on US-36

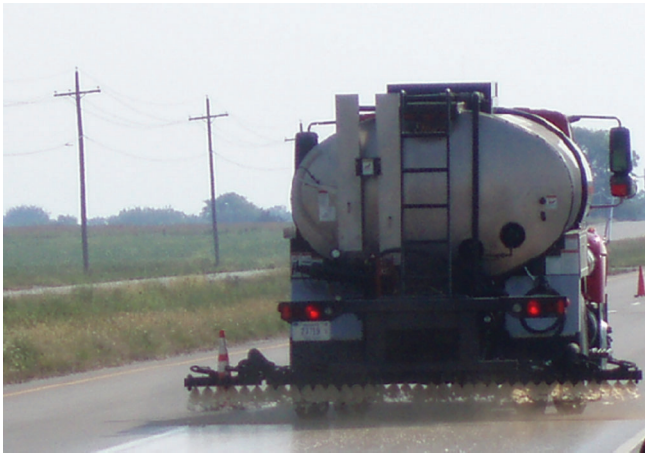
Figure 3.2 Application of Rejuvenating Seal on US-40 (Courtesy of Jusang Lee, INDOT)

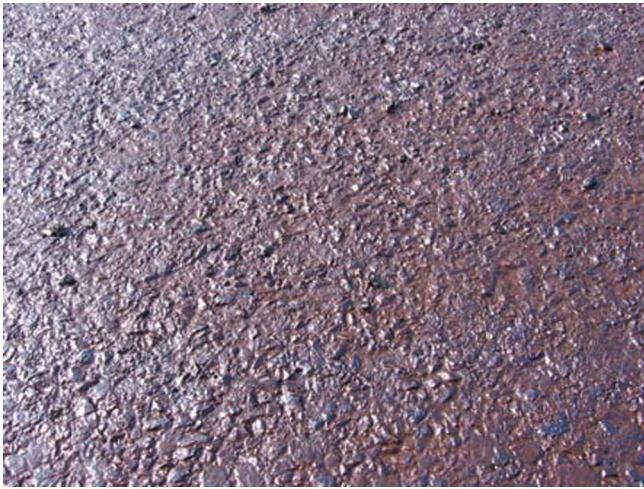
Figure 3.3 Close-up of Pavement Surface after Fog Seal

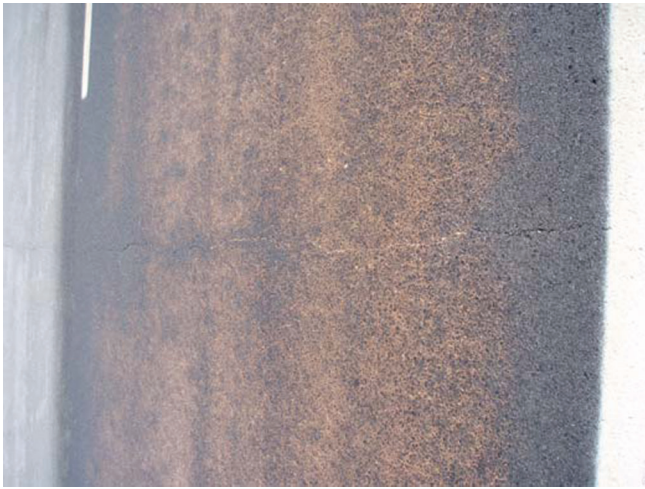
Figure 3.5 Close-up of a Cured Rejuvenating Seal on US-40 (Courtesy of Jusang Lee, INDOT)

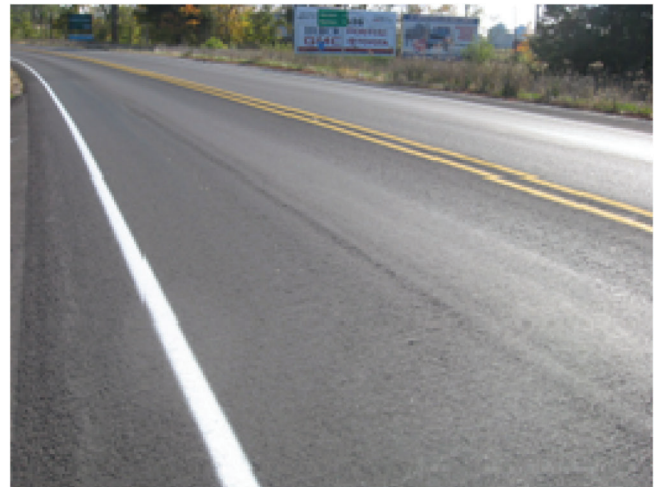
Figure 4.2 Photo of a Fresh Microsurfacing Pavement

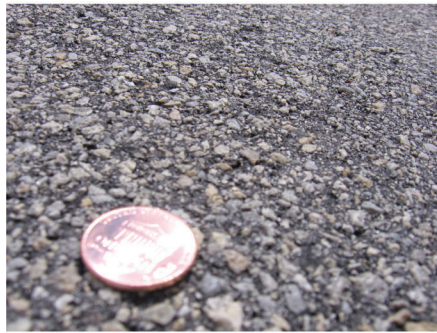
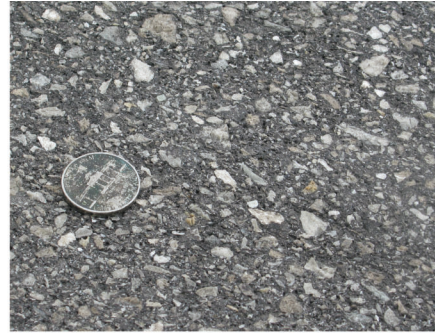
(a) SR-227

(b) SR-70

Figure 4.4 Close-up Views of Microsurfacing Pavement Surfaces

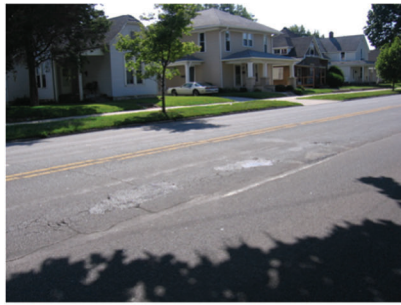
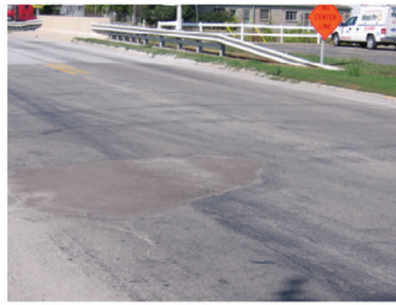
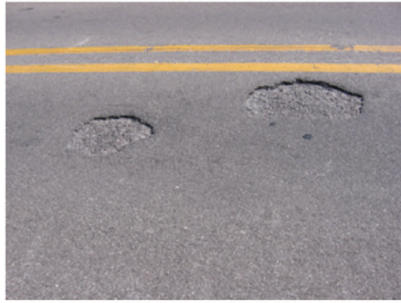
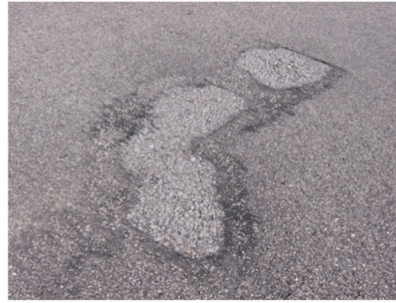
Figure 4.6 Delamination in the early Stage in Microsurfacing

The test sections on SR-70 and SR-227 are both carrying light traffic. However, delamination occurred approximately in July 2011, after 36 months of service on SR-70 and 22 months of service on SR-227. It was observed that the microsurfacing delamination commonly started at the interface between the old pavement surface and microsurfacing and the old pavement surface was exposed in the affected area after surface delamination occurred. Seemingly, it is probably the bonding at the interface that might have caused surface delamination. Reflective cracking was also observed in the microsurfacing test sections, particularly on SR-56. The test section on SR-56 is divided into two segments

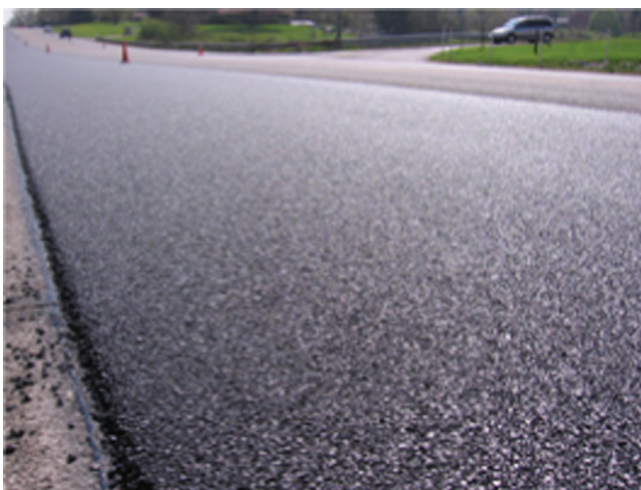
Figure 5.1 Photo of a Freshly Placed UBWC

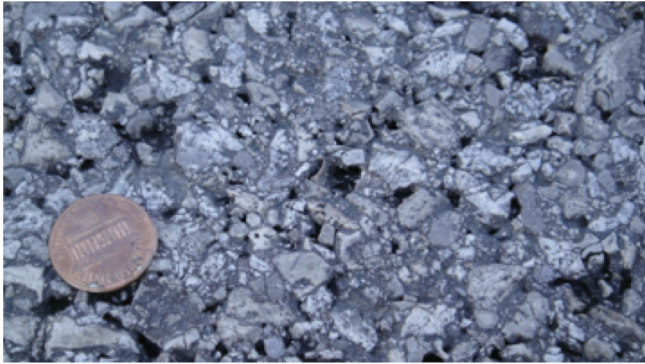
Figure 5.4 Close-up of Polished UBWC Surface on SR-114

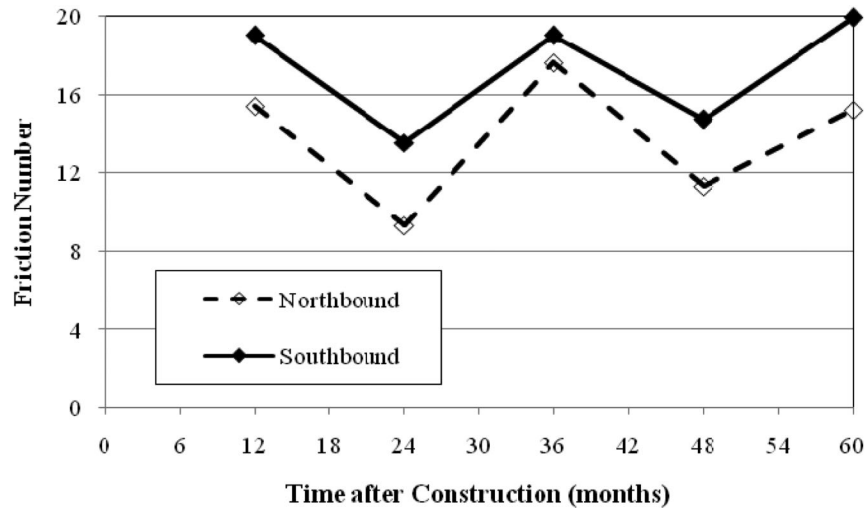
Figure 6.2 Friction Test Results in the Test Section on I-465

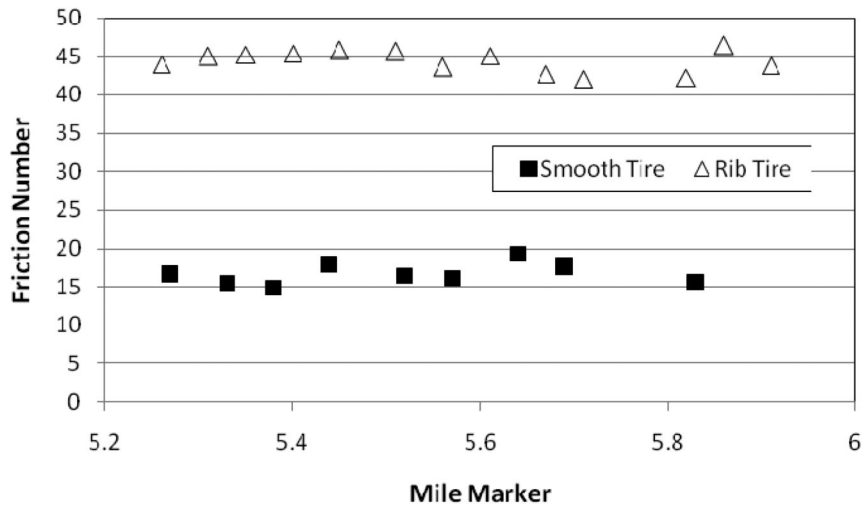
Figure 6.3 Friction Test Results Using Smooth and Rib Tires on I-465

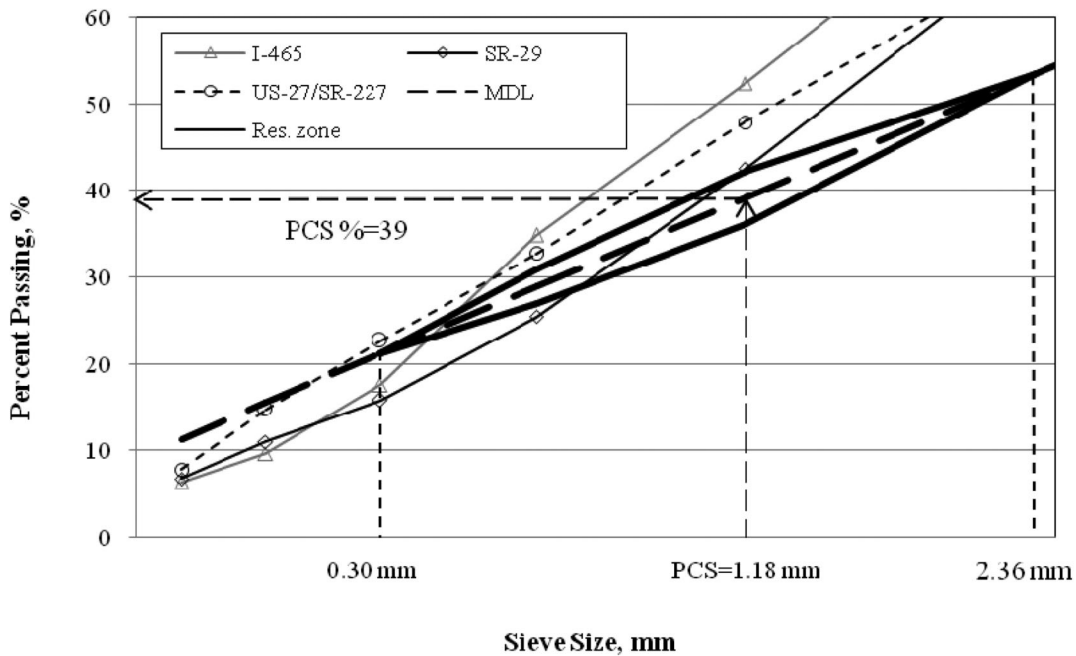
Figure 6.7 Gradation Limits for the Three 4.75-mm Dense-Graded Mixes

Transportation (MDDOT) (60), Georgia Department of Transportation (GADOT) (61), Ohio Department of Transportation (OHDOT) (44), and AASHTO (62), respectively. The 4.75-mm mixes used by INDOT are slightly finer than those used by other DOTs. Since the restricted zone requirement has been removed, it becomes critical to ensure the aggregate gradation to pass below the PCS control point so as to enhance the friction properties of 4.75-mm dense-graded mixes. In reality, it was observed that a 9.5-mm mix with the aggregate gradation passing through the restricted zone and above the PCS control point exhibited poor friction performance (63).

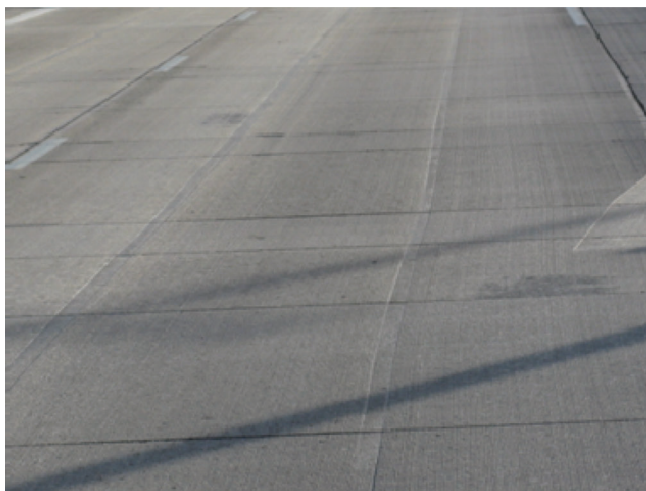
Figure 7.1 Continuous Grinding on US-50

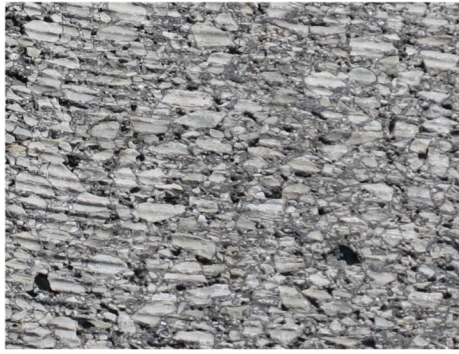
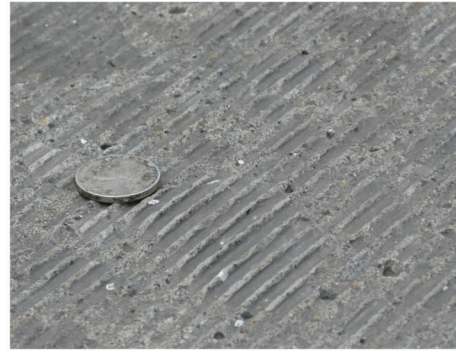
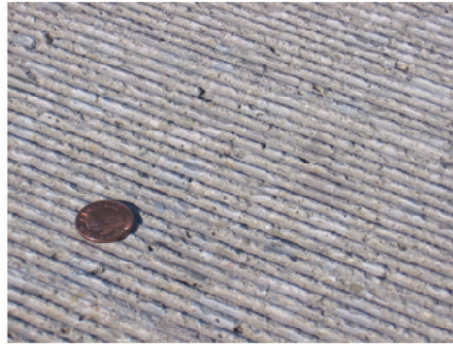
Figure 7.2 Close-Up Views of Three Ground Surfaces

For a newly ground surface, thin fins remained in the ground surface commonly produces great surface friction. However, those thin fins may be knocked off quickly by one or two passes of traffic, which results in land area with a uniform height. Consequently, a smooth grinding texture will be created and a steady-state friction can be generated. Presented in Figure 7.4 are the friction numbers measured over time in the three profile milling test sections shown in Table 7.1. Due to limited availability of profile milling projects, no newly ground pavement project was available during the study period and the most recent profile milling project was the one on SR-1621 that was completed in July 2007. It is shown that the friction number was

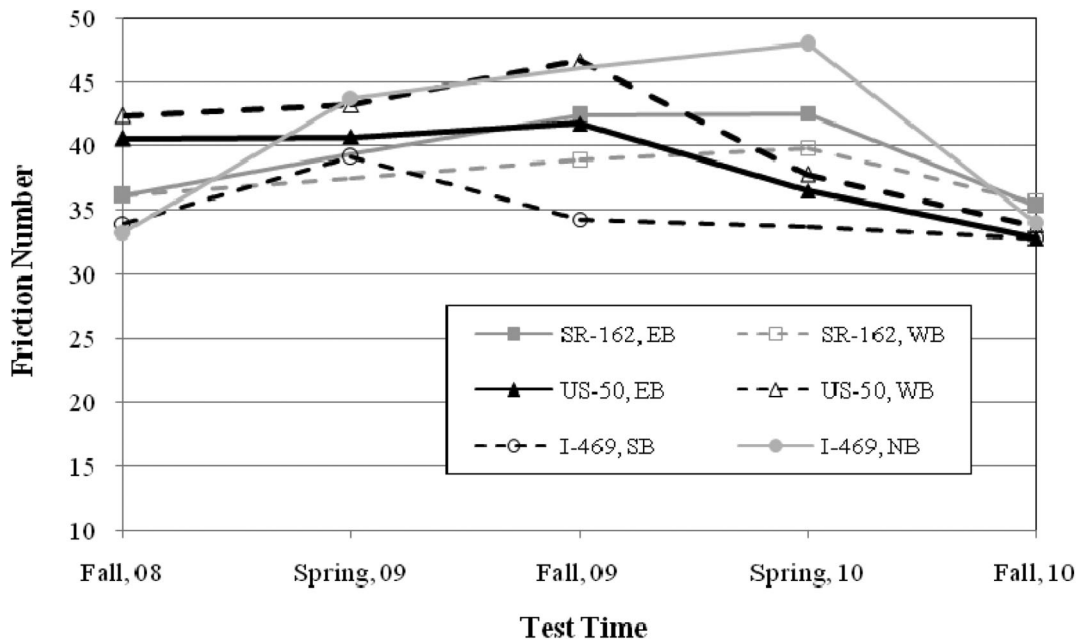
Figure 7.4 Friction Measurements over Time on Ground Surfaces
