SOIL STABILIZATION FIELD TRIAL

INTERIM REPORT I

K.P. George

DEPARTMENT OF CIVIL ENGINEERING
UNIVERSITY OF MISSISSIPPI

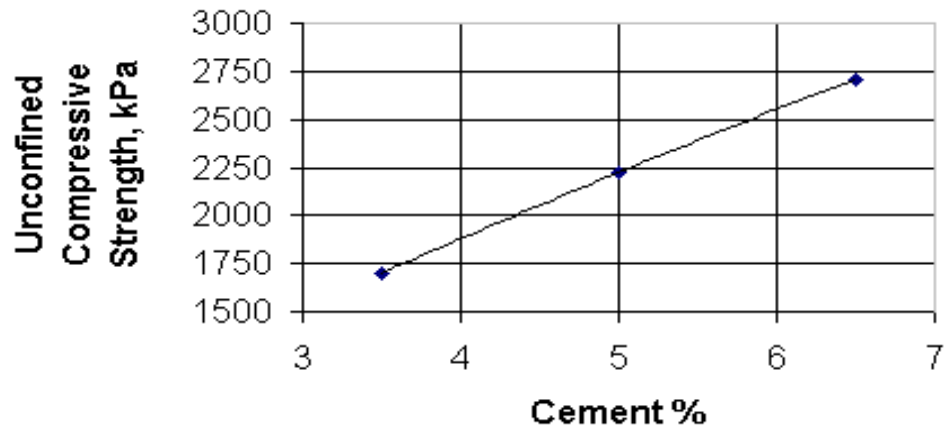
Figure 3.2 Compressive strength vs cement dosage. 1 kPa = 0.145 psi

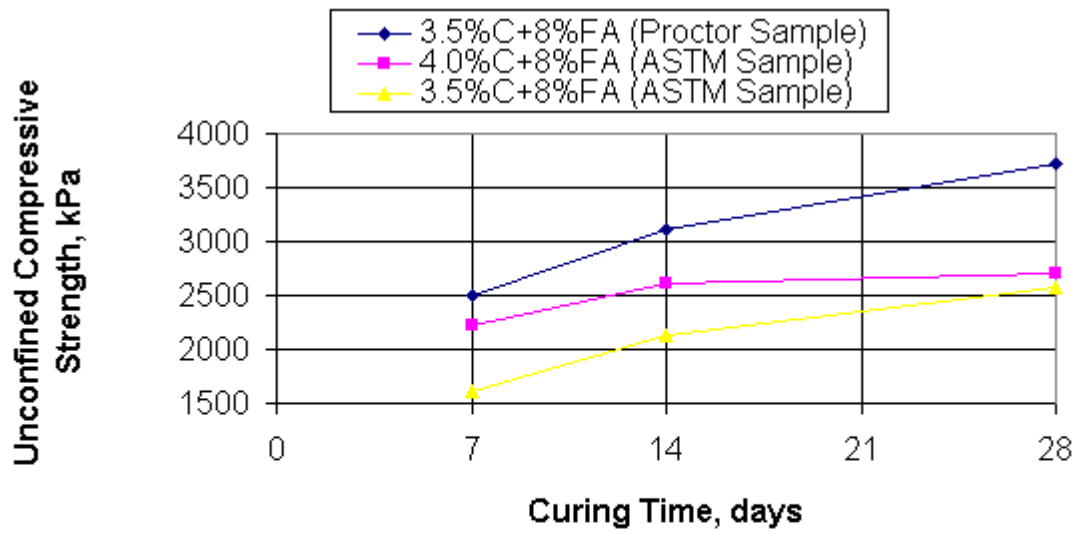
Figure 3.3 Compressive strength increase with time. 1 kPa = 0.145 psi

A rule of thumb for selecting the additives when using both cement and fly ash is to replace 2% of the cement with fly ash (class C); cement replacement at 1:4 ratio. Accordingly, the preliminary design called for 3.5% cement and 8% class C fly ash. Whether this combination of additives satisfies the strength criterion is verified by strength-testing two mixtures: first, 3.5% cement and 8% fly ash and second, 4% cement and 8% fly ash. Prior to strength testing, the samples were submerged in water for 4 hours in accordance with the ASTM test procedure. Figure 3.3 compares the strengths of the two additive combinations to note that the 3.5% cement (with 8% fly ash) provides the required 28-day strength of 2.4 MPa (350 psi) in ASTM-size samples. (The rationale for selecting 350 psi is included in Appendix A1). In fact, the strength of the 4% cement plus 8% fly ash mixture is well above the criterion, and hence not considered any further. Comparing the strengths of ASTM size samples with the Proctor Samples (see Figures 3.3), it is noted that the Proctor

samples are on average 30% stronger than the ASTM counterparts. Recommended additives, therefore, amount to 3.5% cement and 8% fly ash.

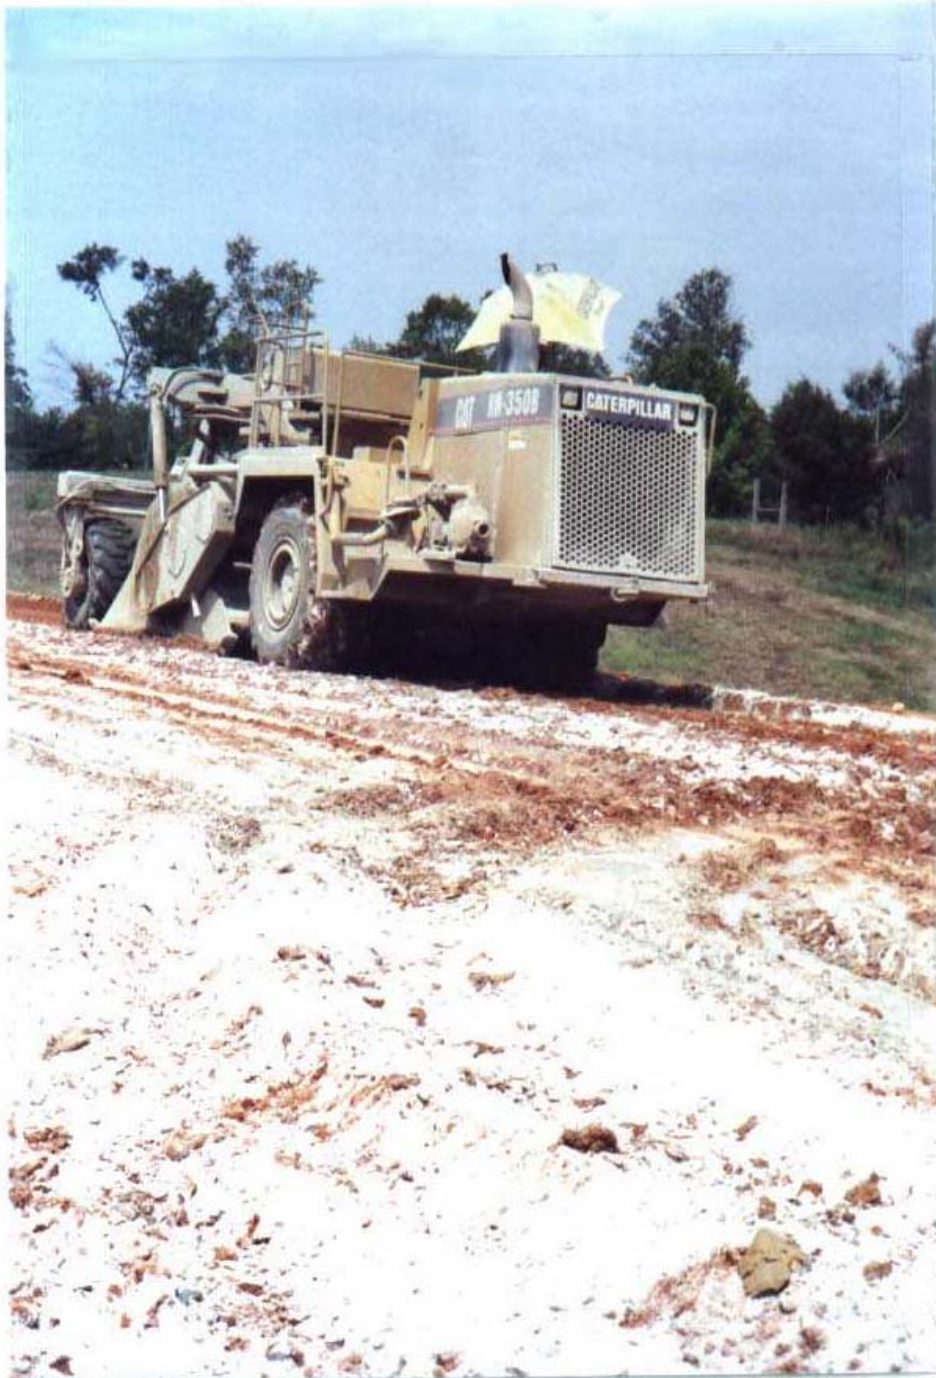
Figure 4.1 Dry mixing soil and lime employing a rotary mixer.

Step 1. One or two passes of dry mixing, employing a rotary mixer to incorporate the additive, such as cement (see Figure 4.1)

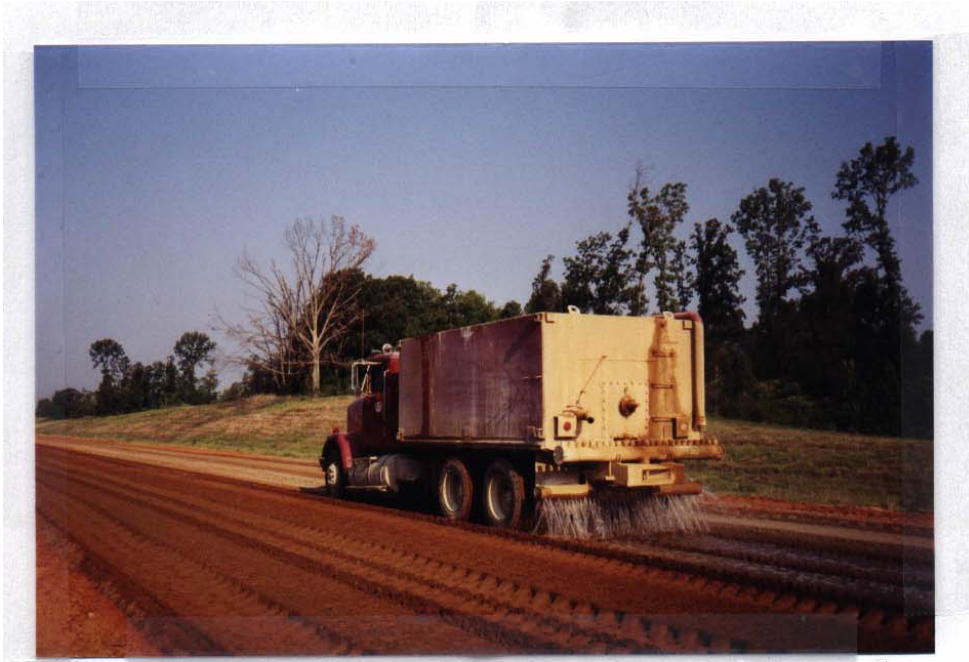
Figure 4.2 Water being added to the dry-mixed soil and additive(s).

Step 2. Water added (water quantity is approximated) (see Figure 4.2)

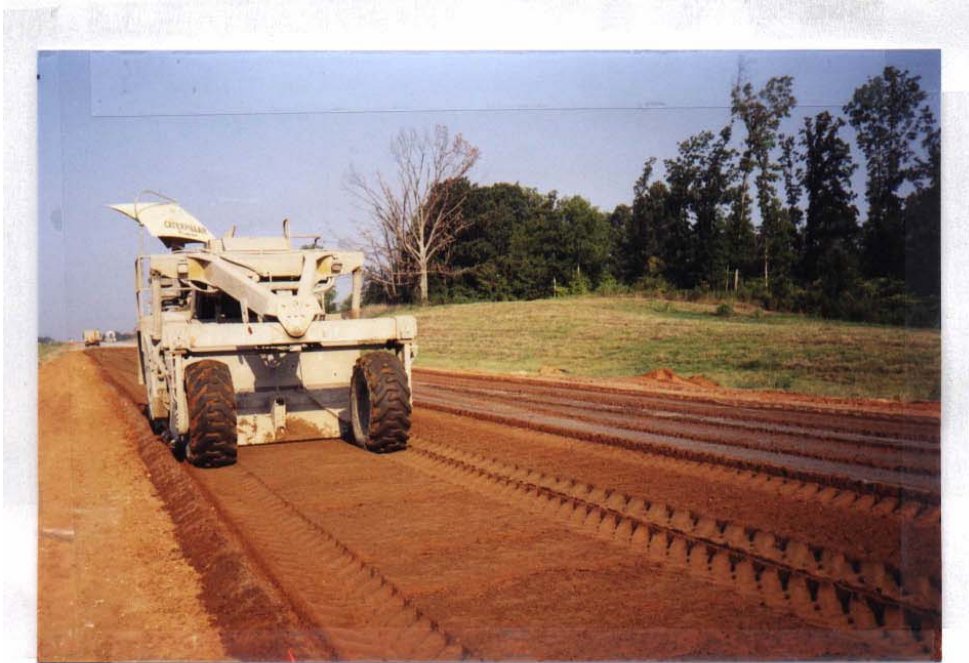
Figure 4.3 Wet-mixing of soil and additive(s).

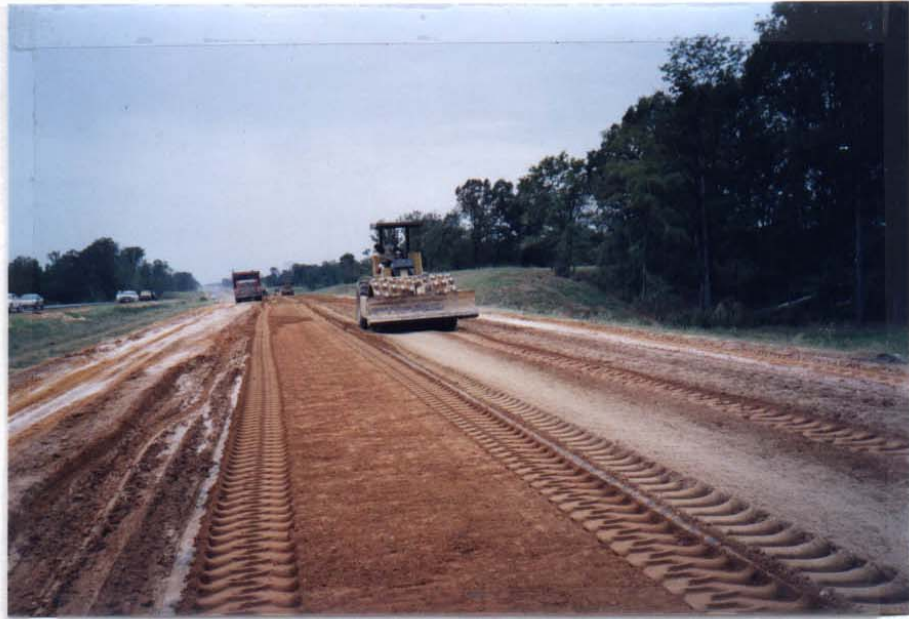
Figure 4.4 Initial compaction by sheep-foot roller.

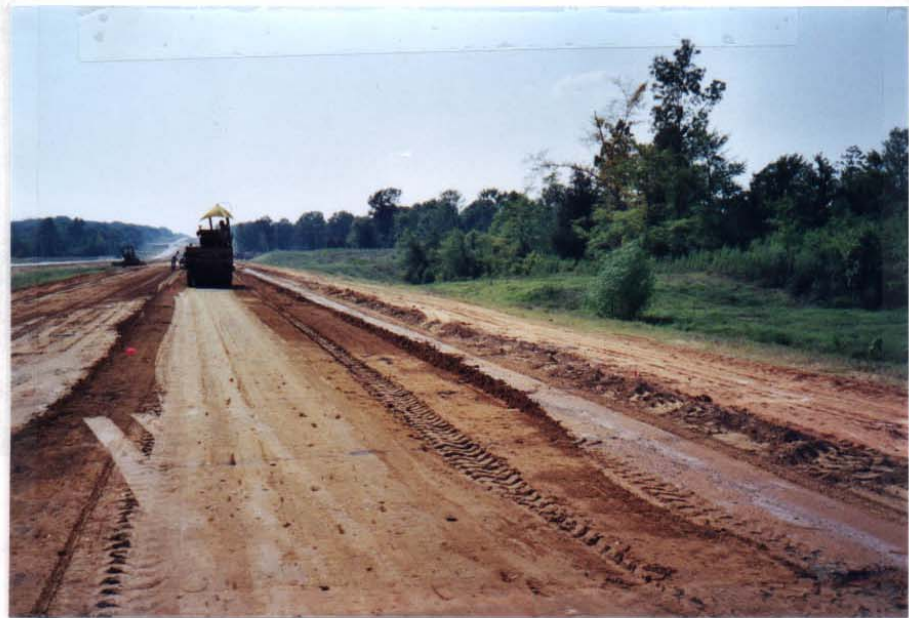
Figure 4.5 Finish-compaction by rubber-tired roller.

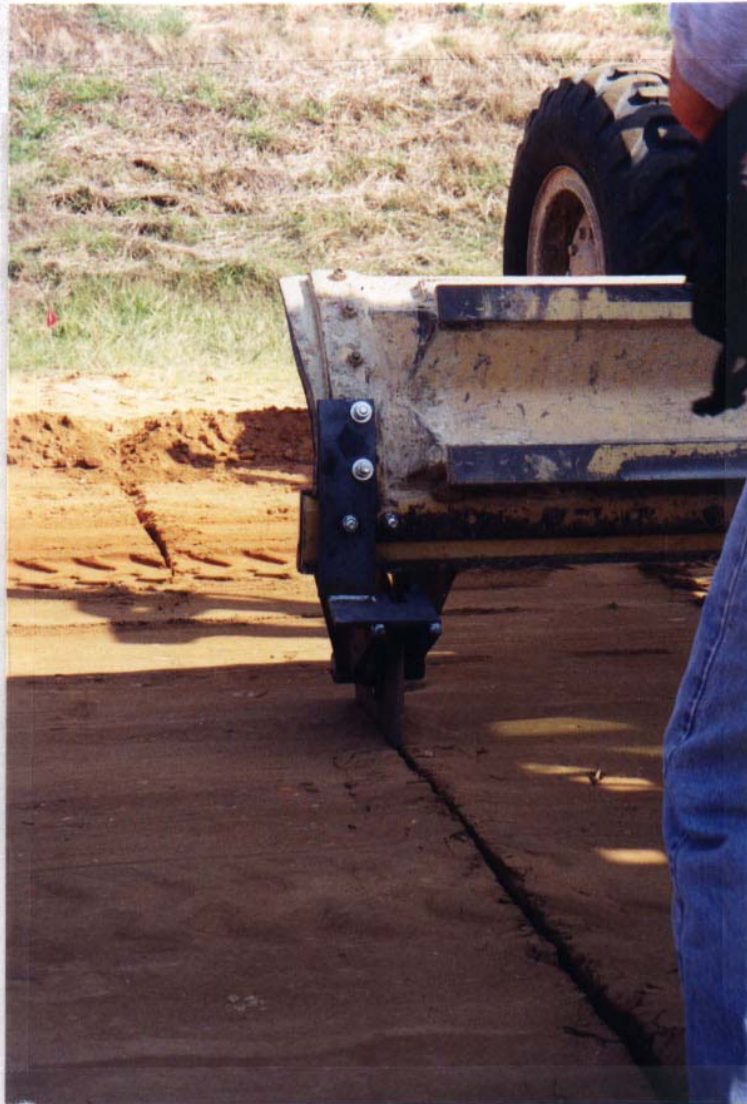
Figure 4.6 Grooves being cut in partially compacted layer employing a rotary blade.

The depth of the groove was controlled by the experienced motor grader operator. The groove width made with this device was somewhat in excess of 13mm (1/2 inch) at the top of the

groove, exceeding the desired groove width. Should this technique be adopted as a standard construction method, it is recommended to reduce the thickness of the rotary cutter.

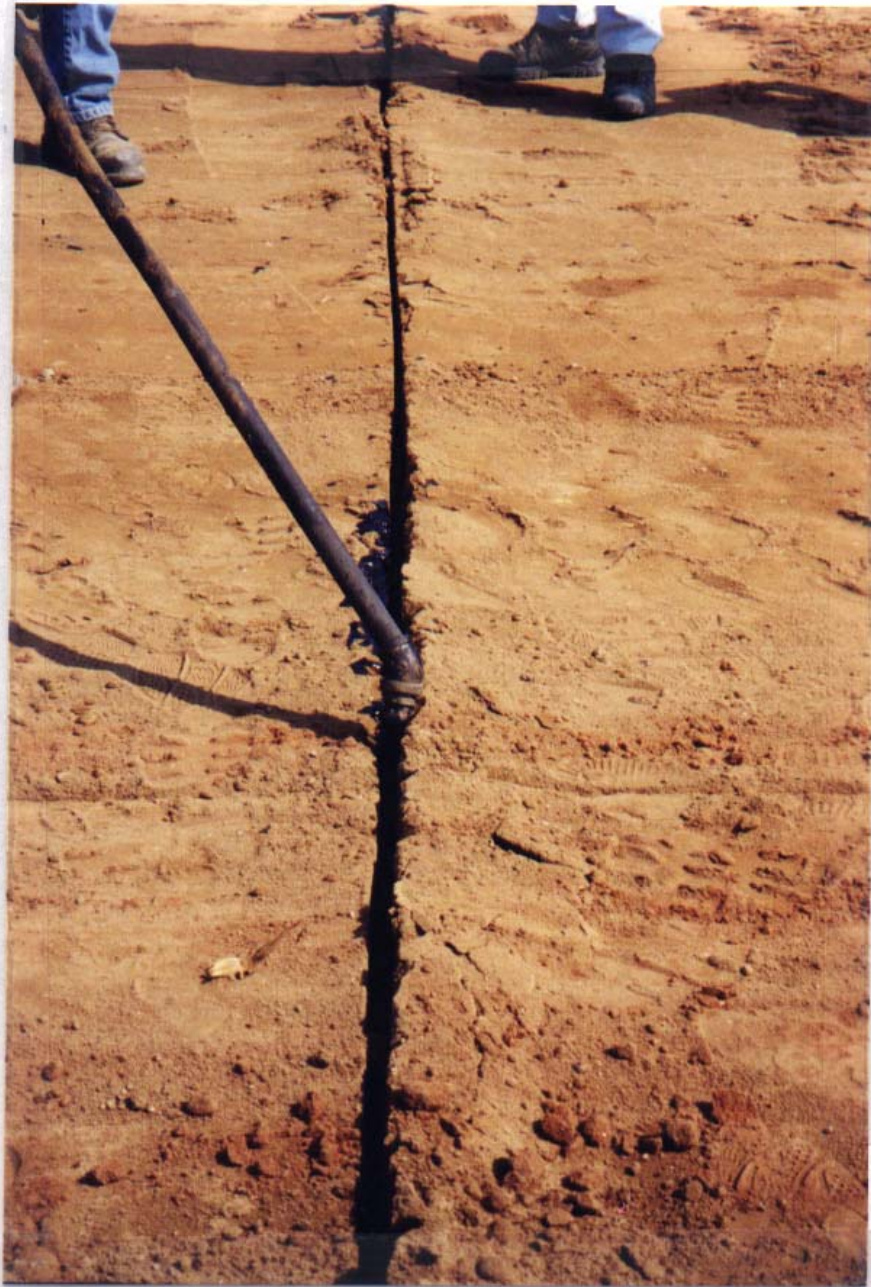
Figure 4.7 Grooves being filled with emulsion.

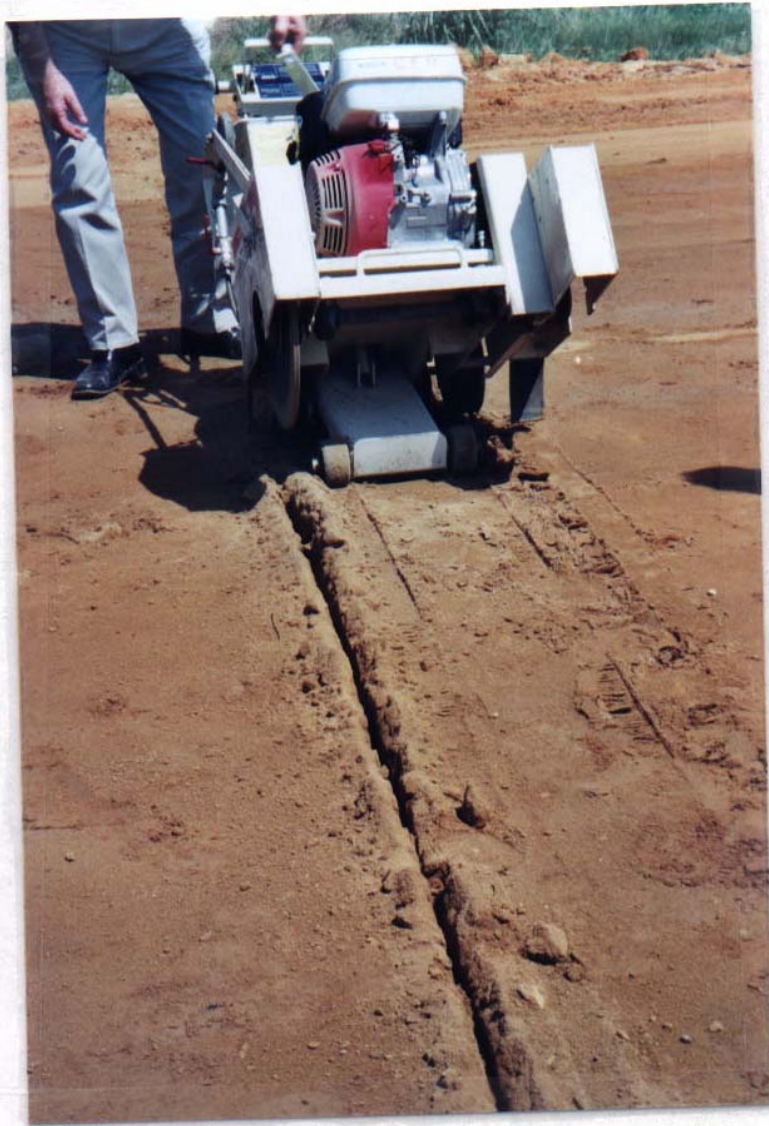
Figure 4.8 Grooves being cut in compacted layer employing a concrete saw.

This subsection was watered, mixed and fully compacted prior to attempting any precutting operation. The contractor attempted to use a concrete saw to cut the grooves (Figure 4.8). Two problems became apparent as the sawing operation proceeded which resulted in the termination of

this groove cutting technique. One problem was that the width of the grooves exceeded the 5mm (3/16 inch) requirement. The other problem was the length of time needed for the sawing operation. Based on the time required to cut several grooves with the concrete saw, it was estimated that more than two and one-half hours would be required to complete the sawing of this subsection. This would result in almost four hours elapsing between wet mixing to final rolling to close the grooves. Any closure of the grooves from final rolling that long after wet mixing would be detrimental to the stabilized material; therefore, attempts were discontinued to use this segment of road as a precut test subsection.

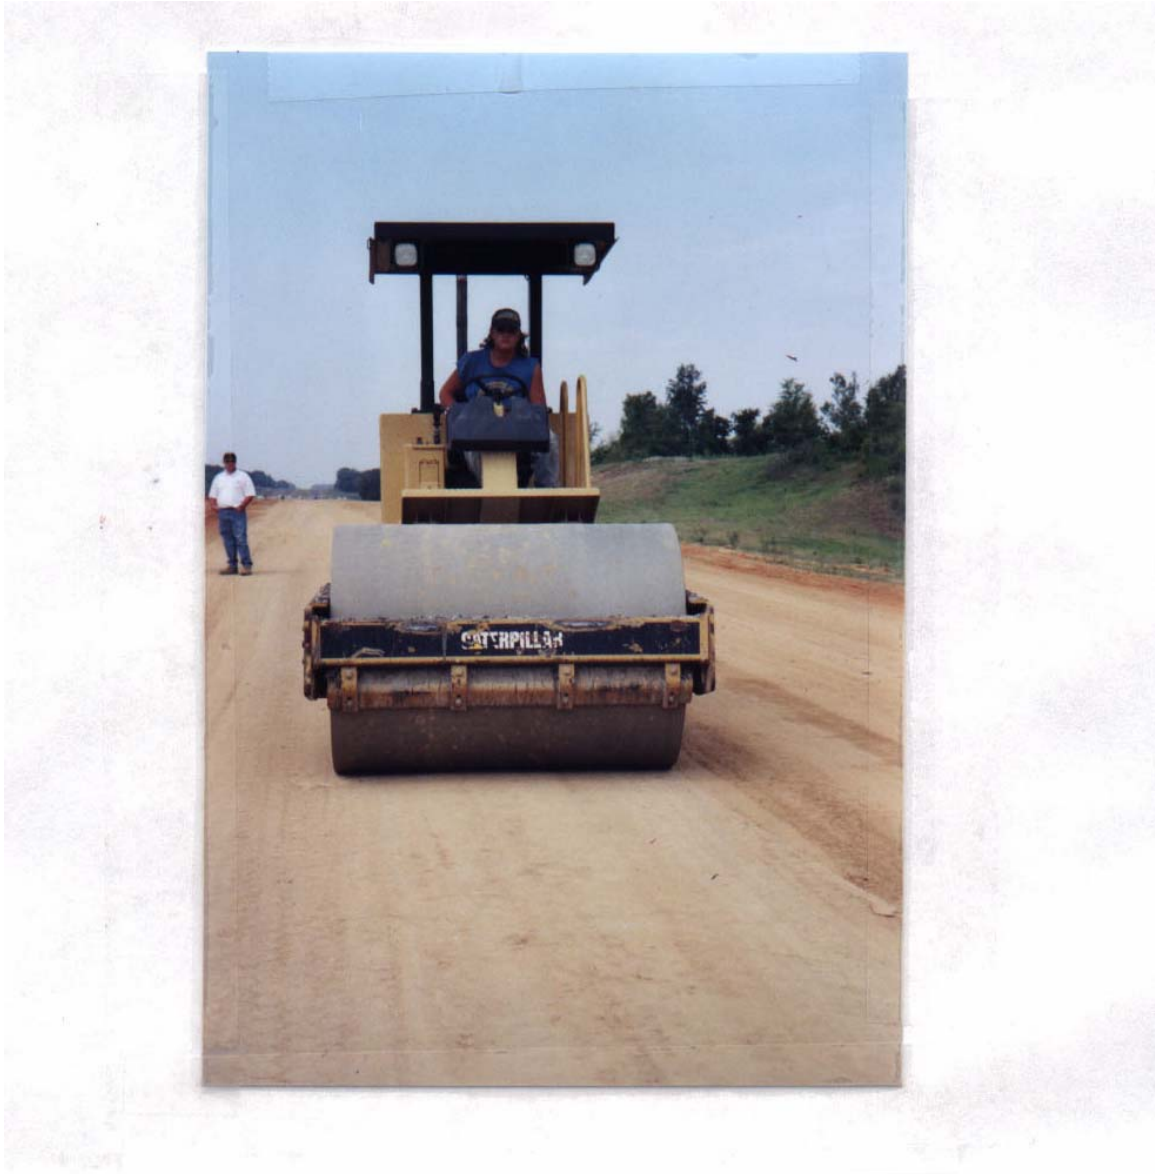
Figure 4.9 Vibration roller in operation precracking the layer after 24 hours.

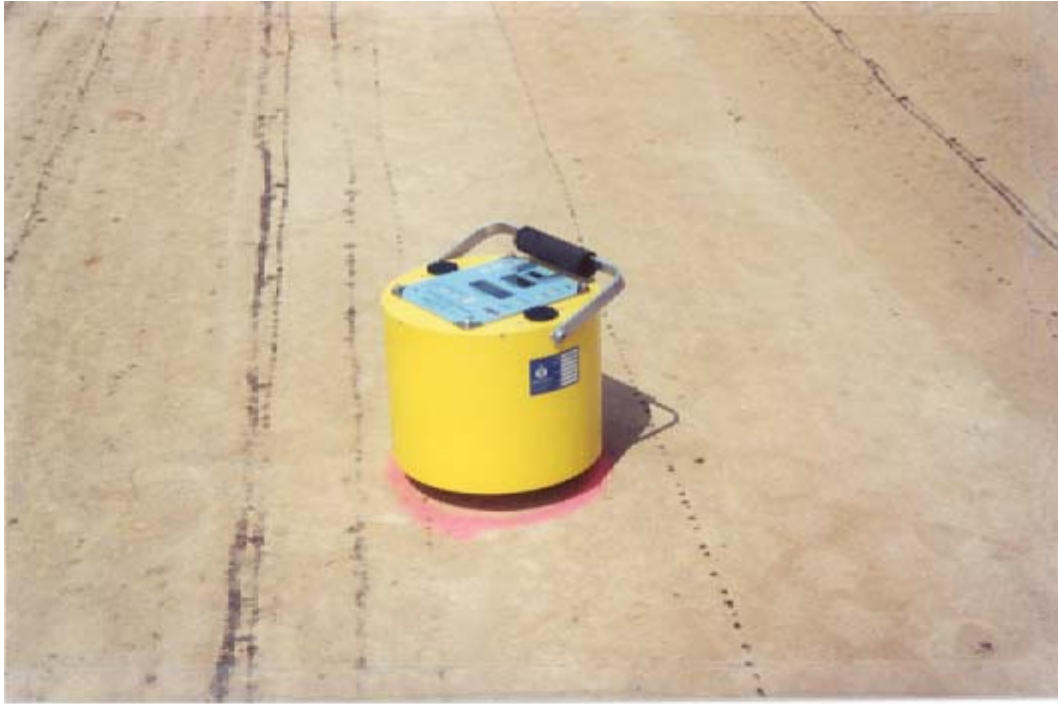
Figure 4.11 Geogauge in operation evaluating modulus of layer in-place.

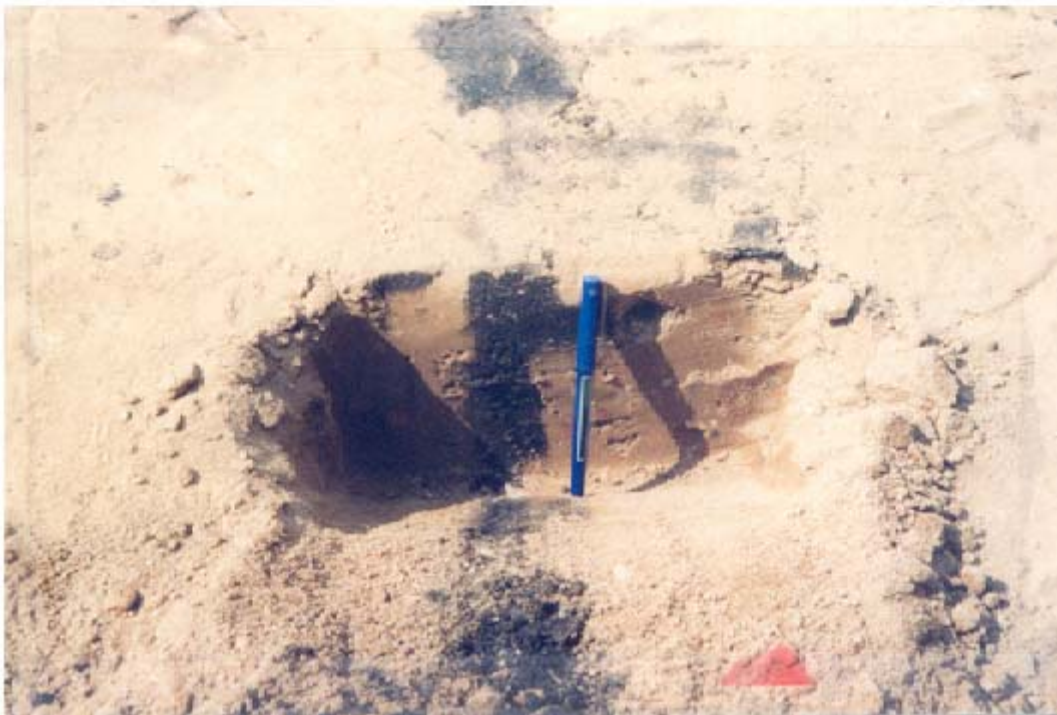
Figure 4.12 Cross section through a precast joint filled with emulsion.

A post-mortem examination (Figures 4.12 and 4.13) revealed that the joints were not adequately closed following this construction sequence. Two potential explanations include not blading the surface soon after filling the grooves with emulsion and the inadvertent addition of excess water before adequately closing the grooves with stabilized material. An overall view of the finished surface can be seen in Figure 4.14.

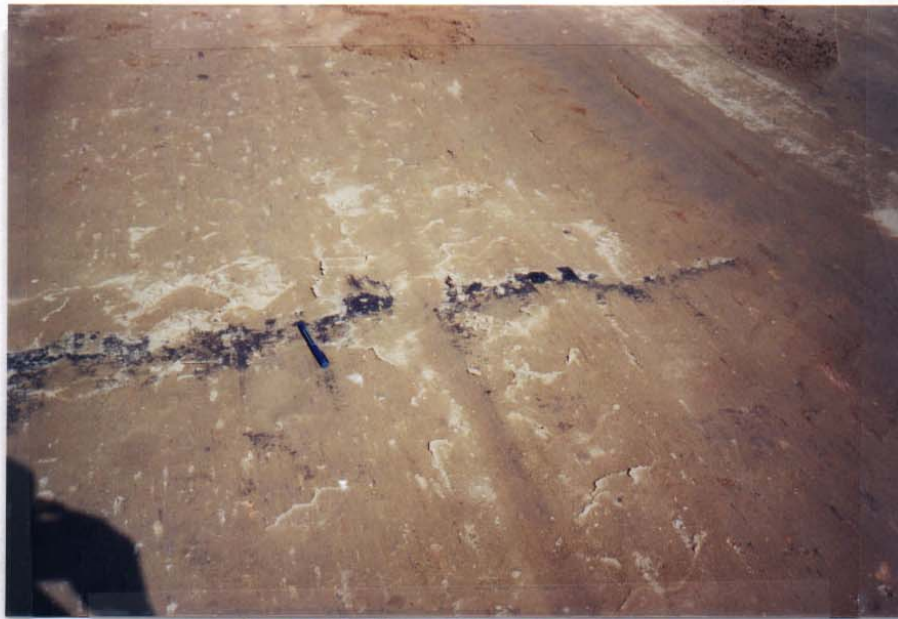
Figure 4.13 Close-up view of a precut joint.

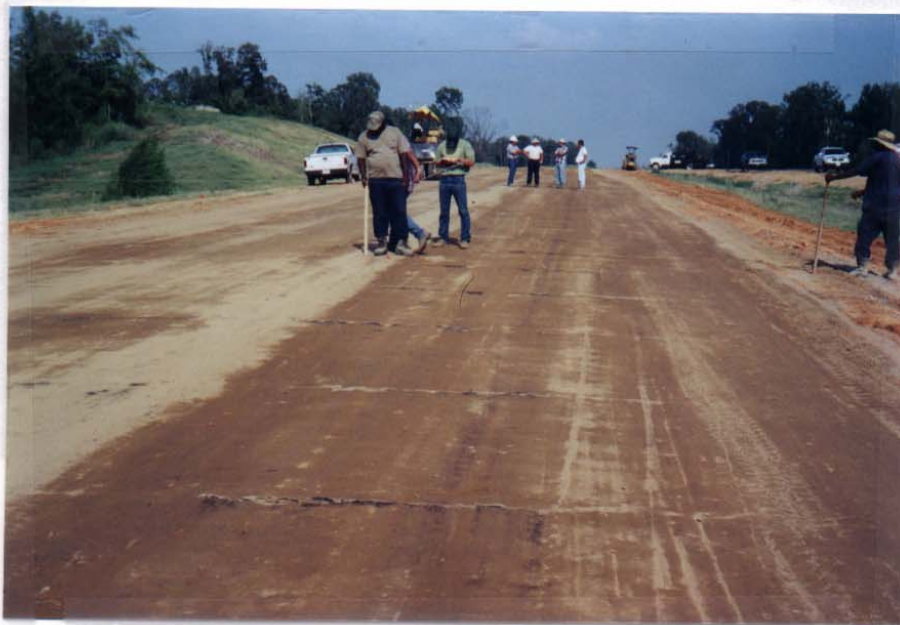
Figure 4.14 Visible precut joints after final grading and compaction.

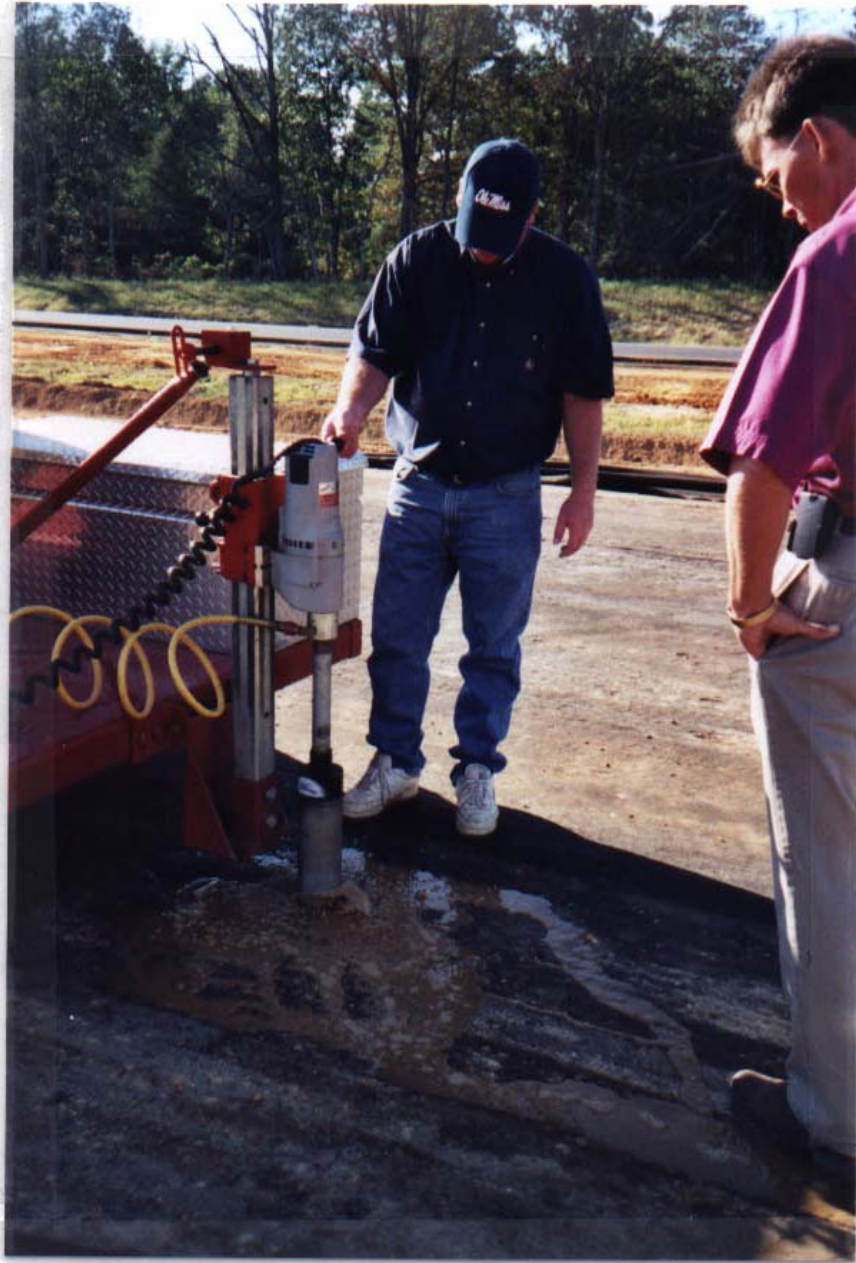
Figure 4.15 Core drill in operation.

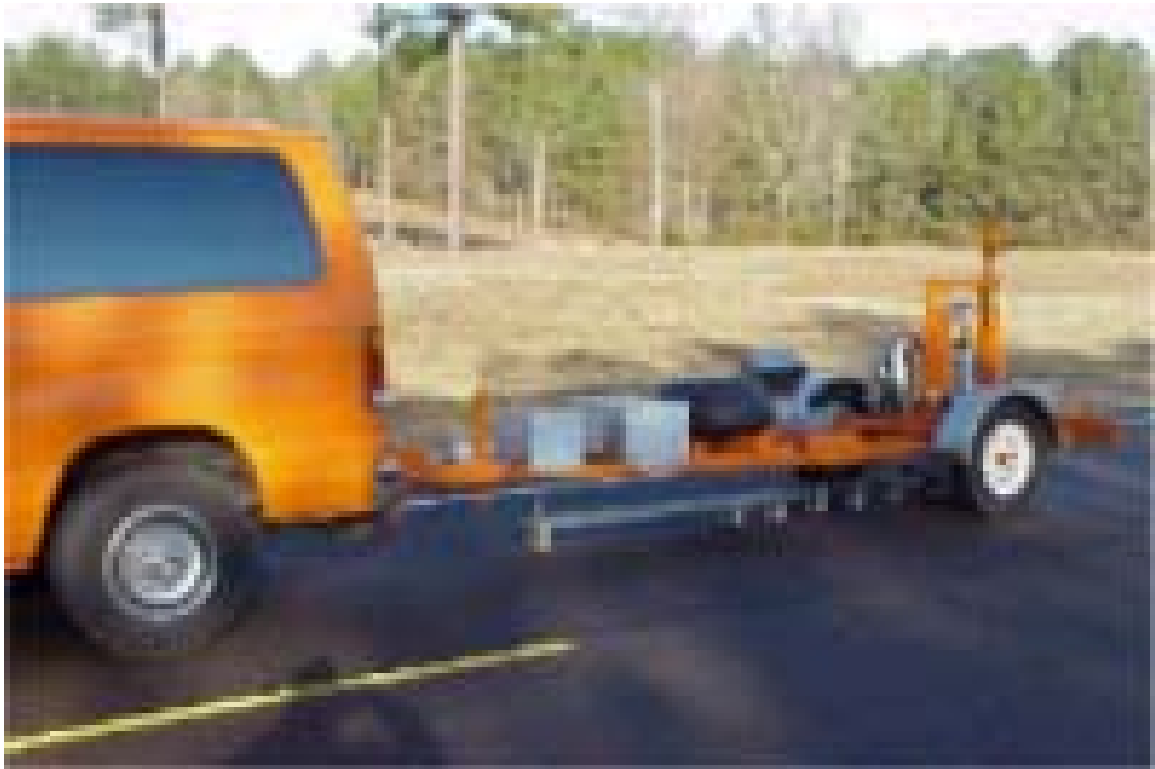
Figure 4.16 Falling Weight Deflectometer in operation.

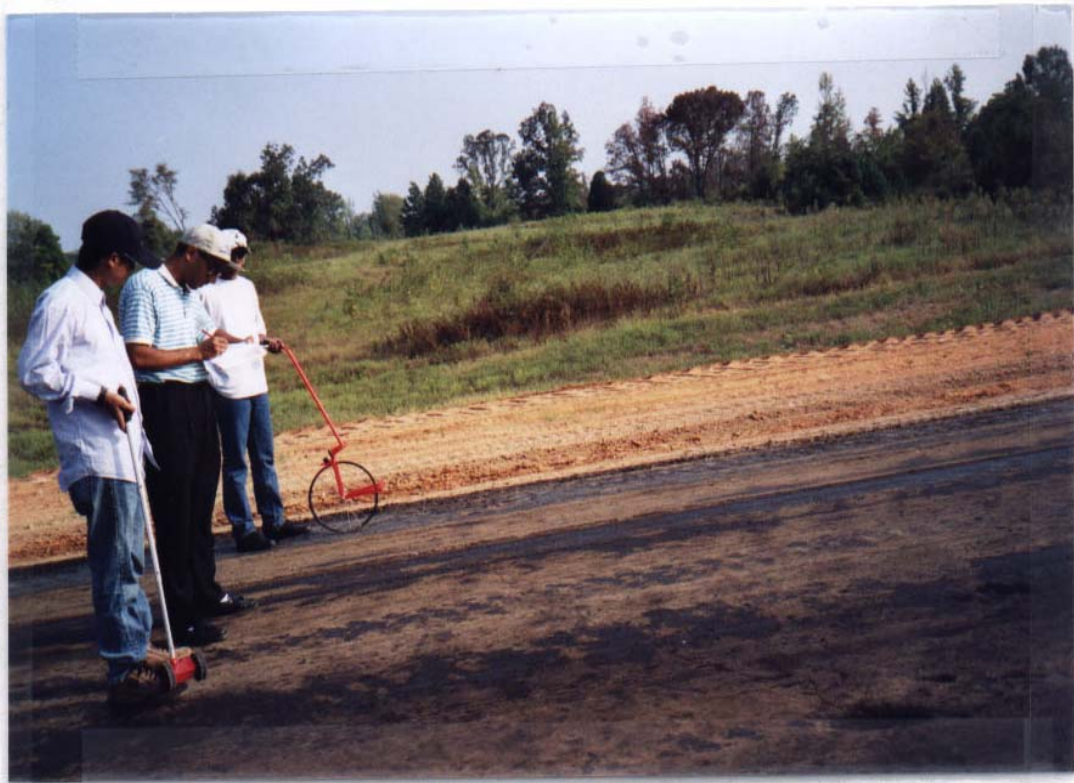
Figure 4.17 Survey crew measuring and mapping cracks.

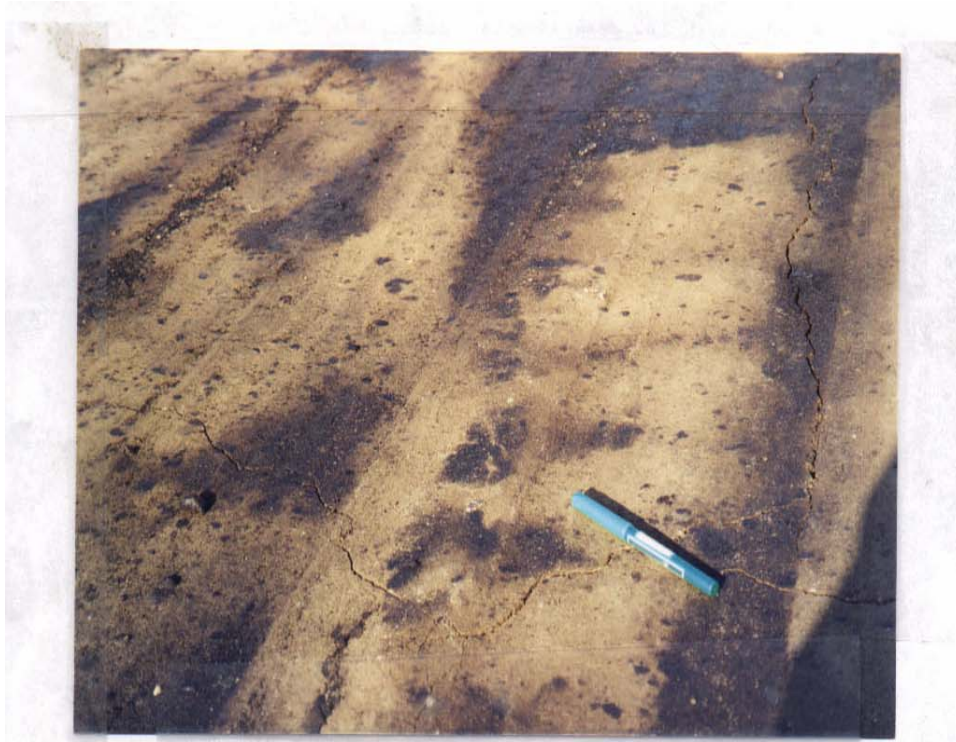
Figure 4.19 Medium severity cracks in section 1A, control cement, fourteenth day.

What follows is a series of pictures from the five sections captured during the 14-day survey. Random, medium severity cracks in the control cement subsection (190+00 to 195+00) can be seen in Figure 4.19. In Figure 4.20, the transverse crack is medium severity in comparison to low severity longitudinal cracks, again in Section 1A. In the Precut Section 1B (195+00 to 200+00), however, the cracks were predominately in the transverse direction with a few longitudinal cracks as well. Very few cracks appeared in the precracked section (200+00 to 210+00), as attested to by the almost crack-free surface in Figure 4.21. Again, random cracks,

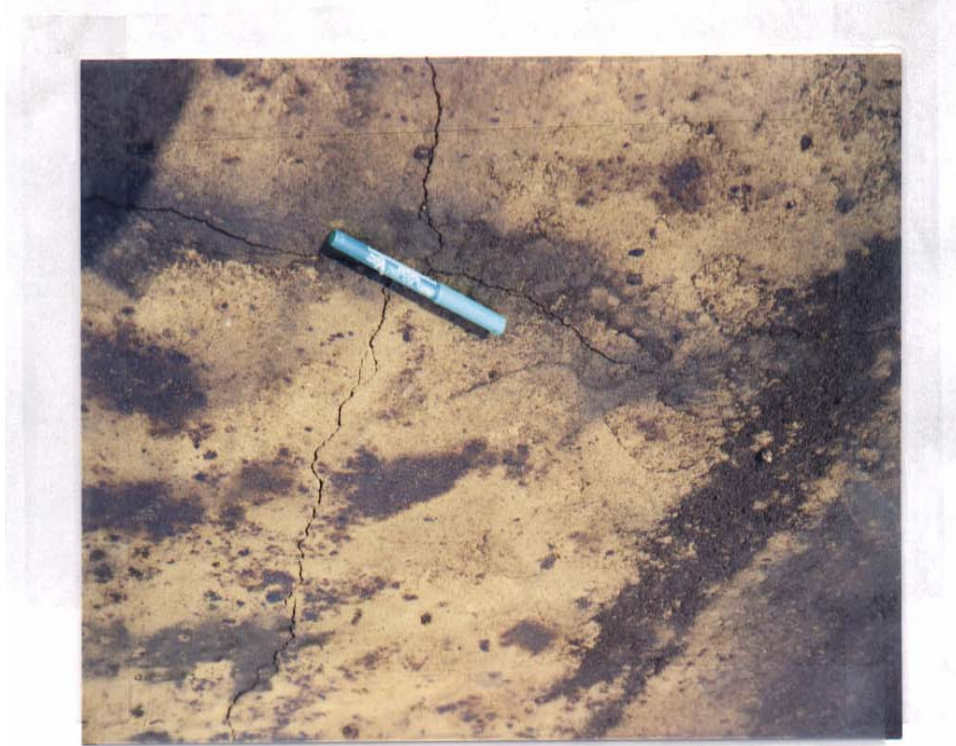
Figure 4.20 Medium transverse and low longitudinal cracks in section 1A, control cement, fourteenth day.

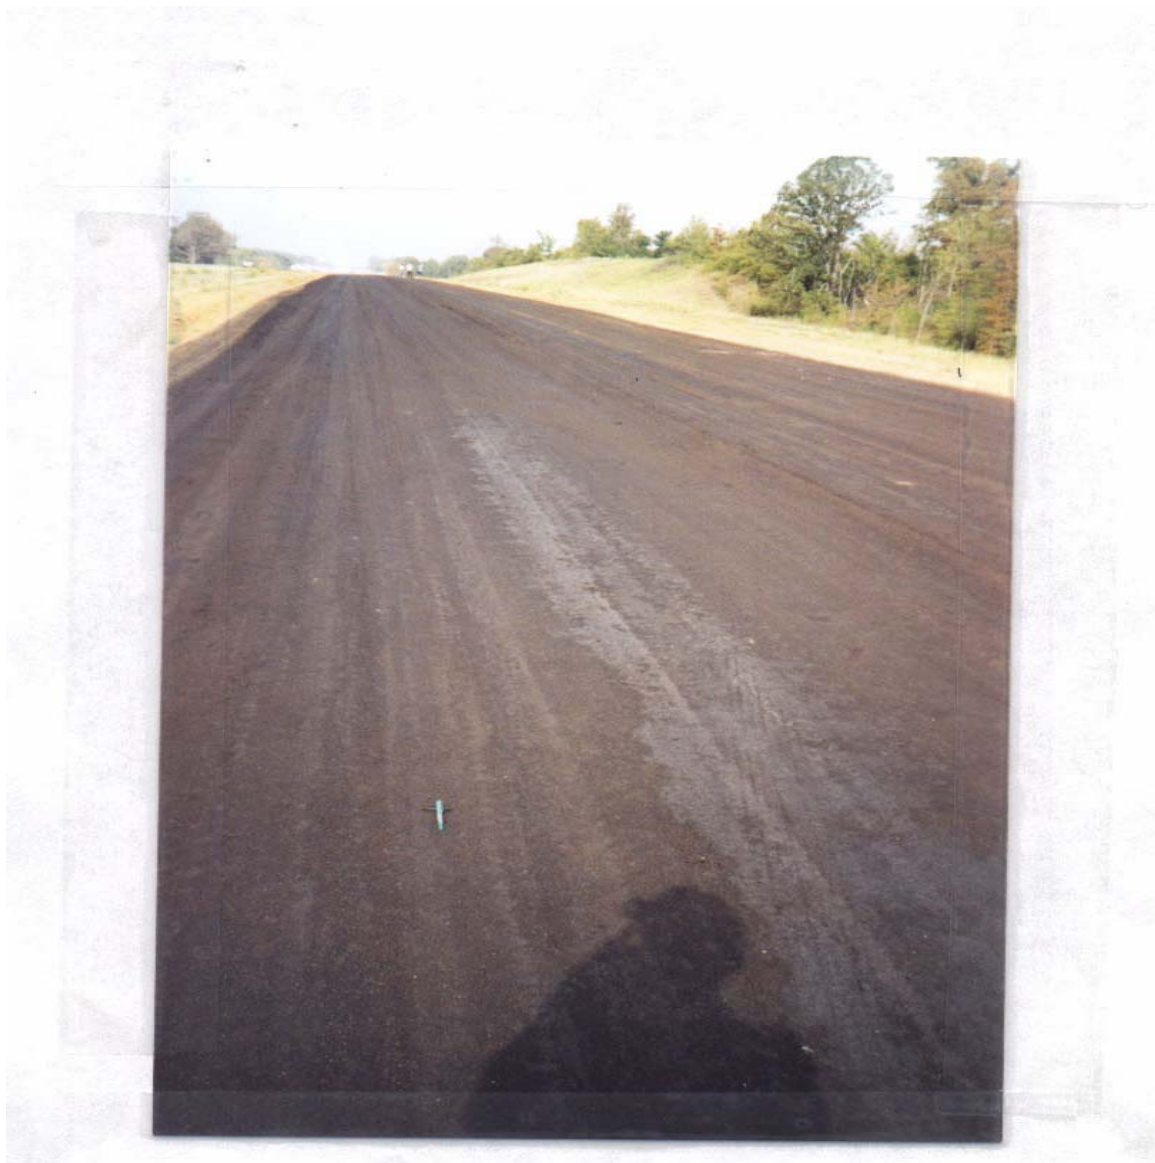
Figure 4.21 Crack-free surface of section 2 (precracked), fourteenth day.

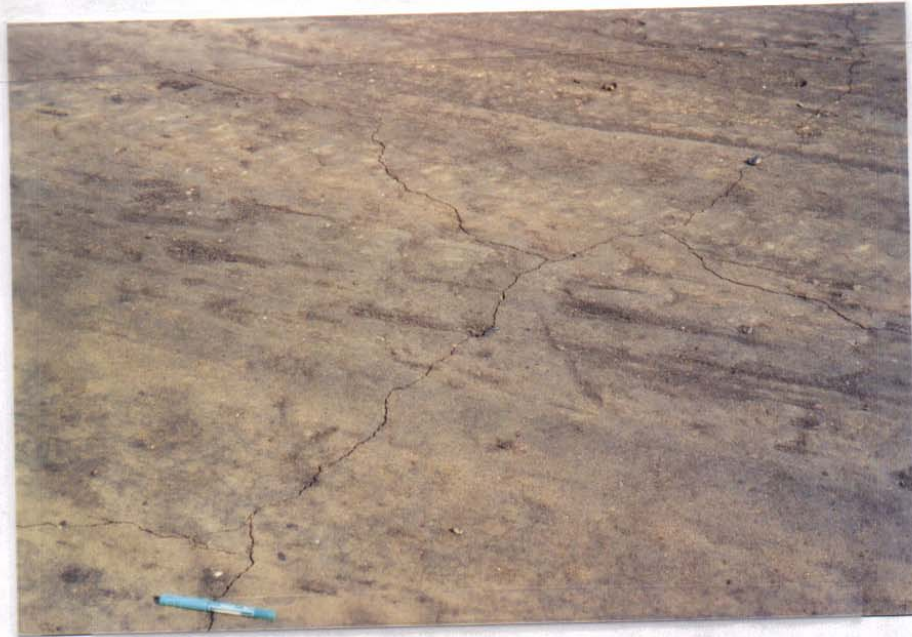
Figure 4.22 Random cracks in section 3A, control cement, fourteenth day.

similar to those observed in section 1A, covered the complementary control cement, subsection 3A (200+00 to 205+00) (see Figure 4.22). For reasons not yet clear, the cracks in the cement-fly ash section appeared slightly more severe than those in the control cement section, as captured in Figure 4.23. Owing to excessive moisture during compaction, the first third of the LFA section (240+00 to 243+00) underwent severe cracking. What is shown in Figure 4.24 is typical block cracking observed in this segment of the LFA section. Typical cracks in the LFA section were of low severity and Figure 4.25 attests to this conclusion. With the cracks in the first third of the LFA section drastically different from what has typically been observed in the second half and also in adjacent LFA sections, a decision was made to substitute the first 152m (500 ft) by another segment of equal length, beginning at 250+00 and ending at 255+00. This 152m (500 ft) section is designated section 6 alternate. What is shown in Figure 4.26 is a view (westward) of the two subsections, constructed on two different days – the lighter surface in the background is the tail end of the original LFA section 6 (240+00 to 250+00) and the dark surface in the foreground portrays the new segment (245+00 to 250+00). Partly owing to better curing, the cracks in the well-cured half were much less than those observed in the poorly cured former half (background versus foreground). Based on this result, the author cannot overemphasize the importance of adequate curing in abating shrinkage cracks.

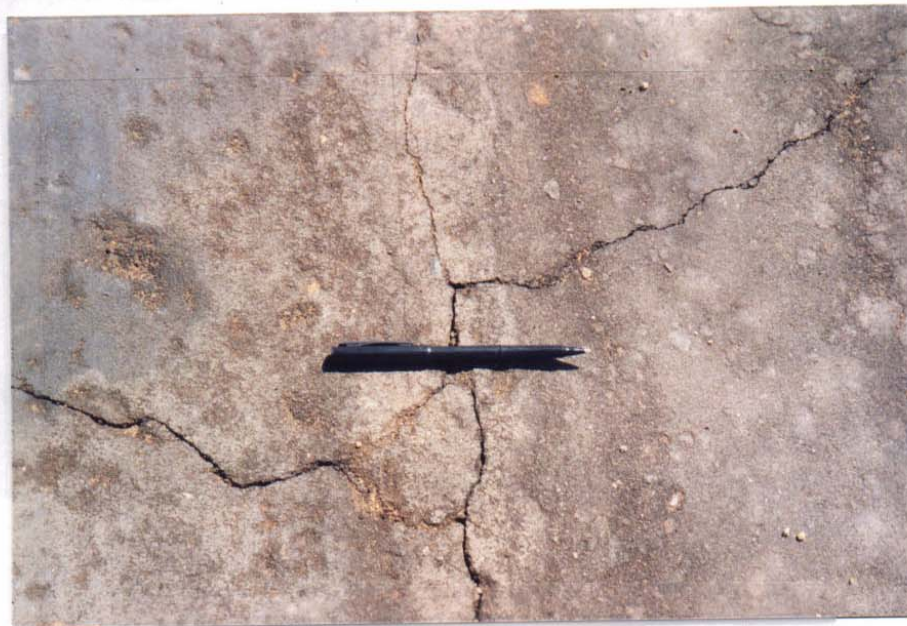
Figure 4.23 High severity cracks in section 4, cement-fly ash, twenty-eight day.

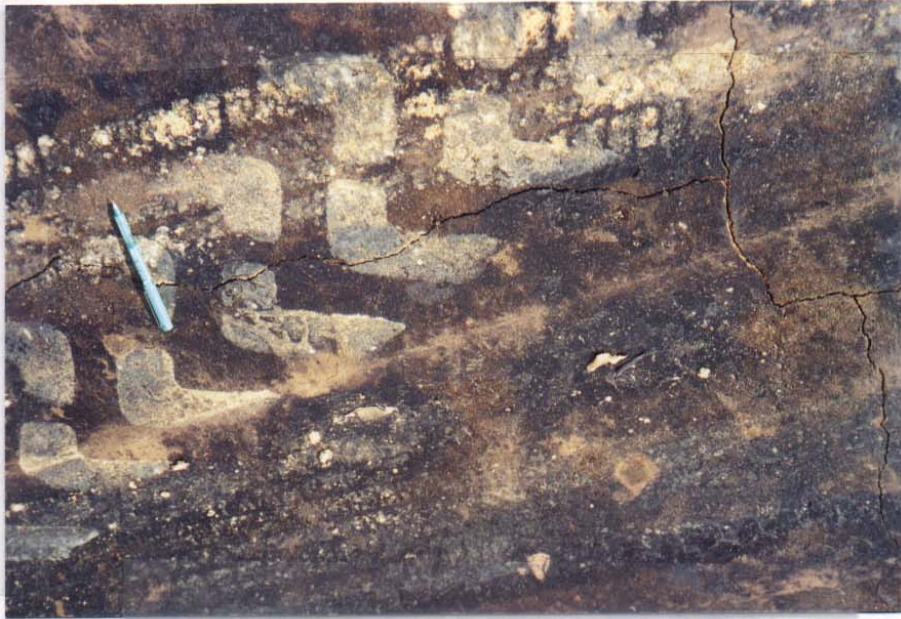
Figure 4.24 High severity cracks in section 6, lime – fly ash, 241 + 50, fourteenth day.

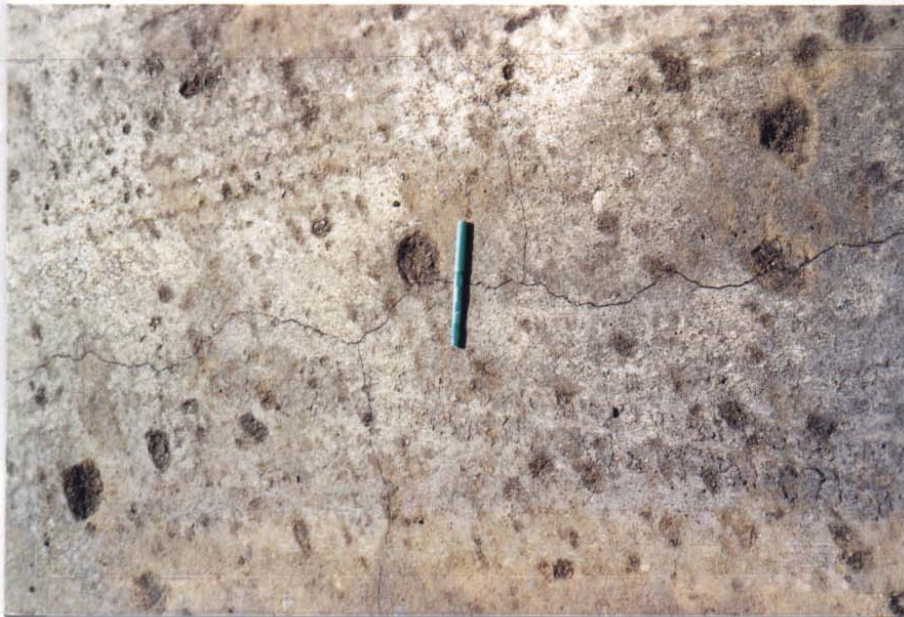
Figure 4.25 Typical crack in lime – fly ash section, 189 + 50, approximately twentieth day.

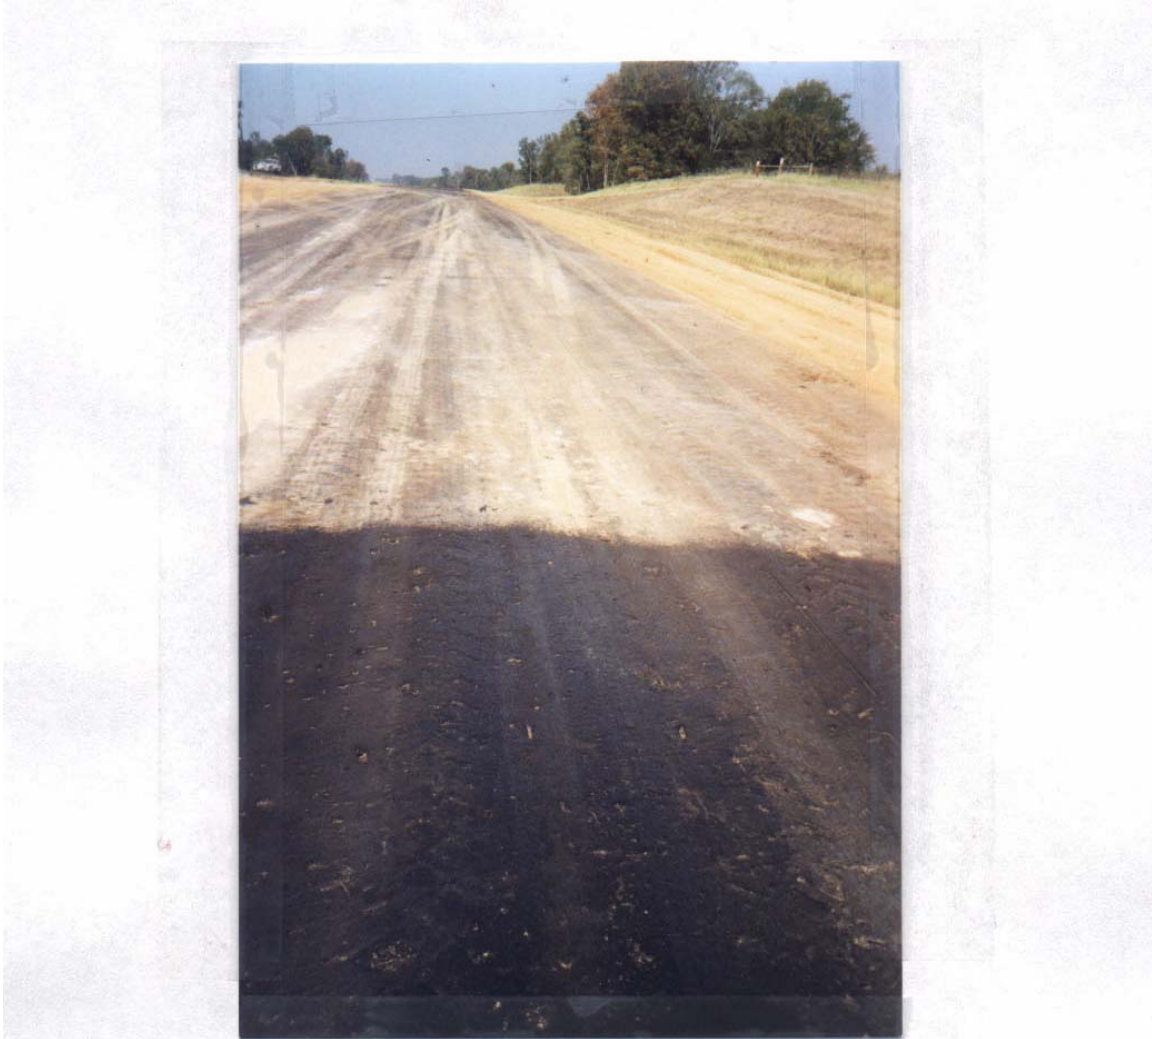
Figure 4.26 Comparison of emulsion retained, section 6 (alternate) in the foreground and section 6 in the background, fourteenth day.
