SOIL STABILIZATION FIELD TRIAL

INTERIM REPORT I

K.P. George

DEPARTMENT OF CIVIL ENGINEERING
UNIVERSITY OF MISSISSIPPI

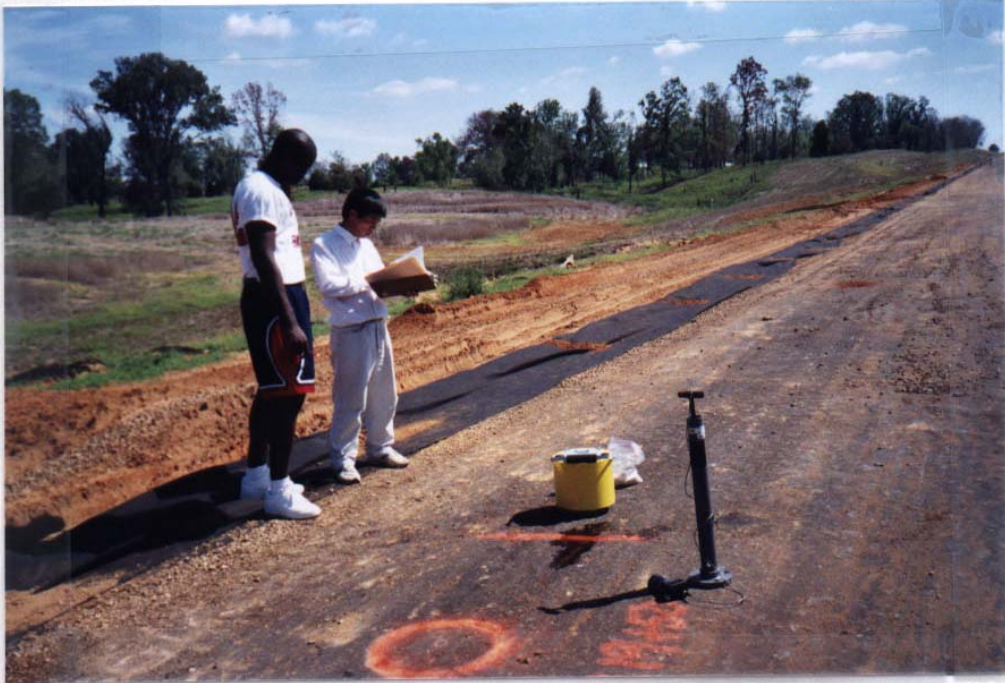
Figure 4.28 View of geogauge (left) and Clegg impact hammer (right).

presented in Figure 4.27 (31). Figure 4.28 is a view of the test in progress, with geogauge on the left and the Clegg hammer on the right. This impact-testing device, despite not being recognized as a standard test, was beneficial in evaluating the strength gain of stabilized material as time progressed. Note that at early stages, good cores could not be obtained. Clegg hammer strength values obtained at four, seven and 28 days are tabulated in Table 4.4.

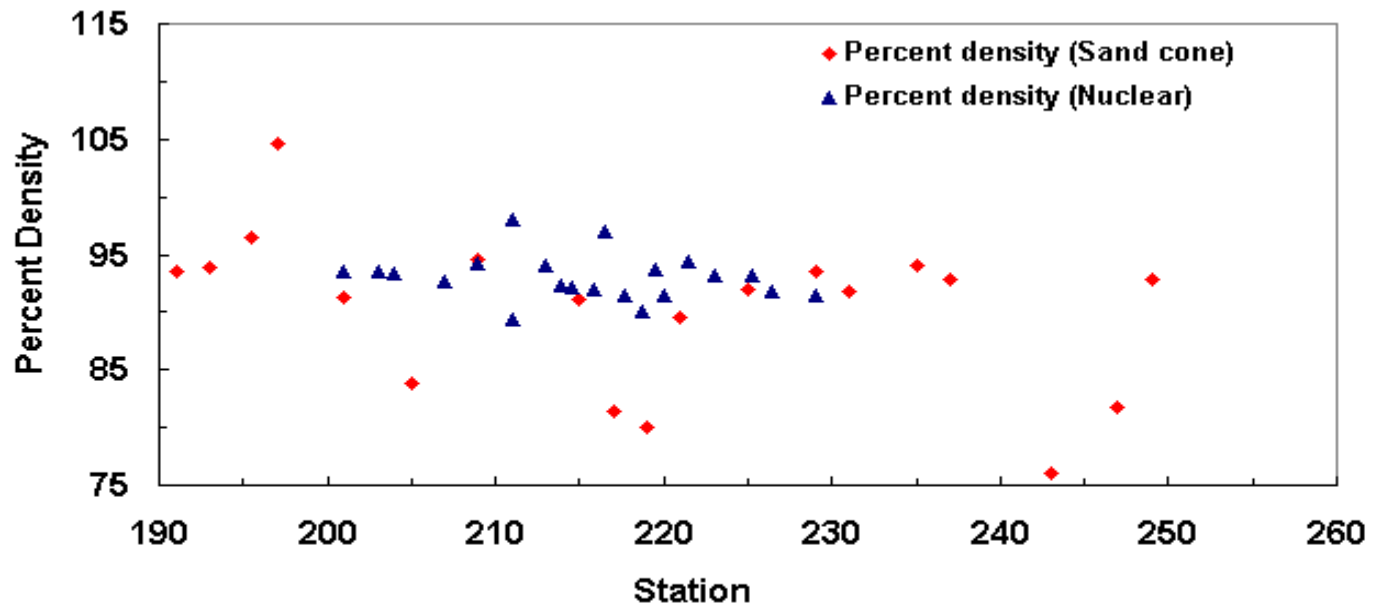
Figure 5.2 Density determined by (i) Sand cone and (ii) Nuclear density device.

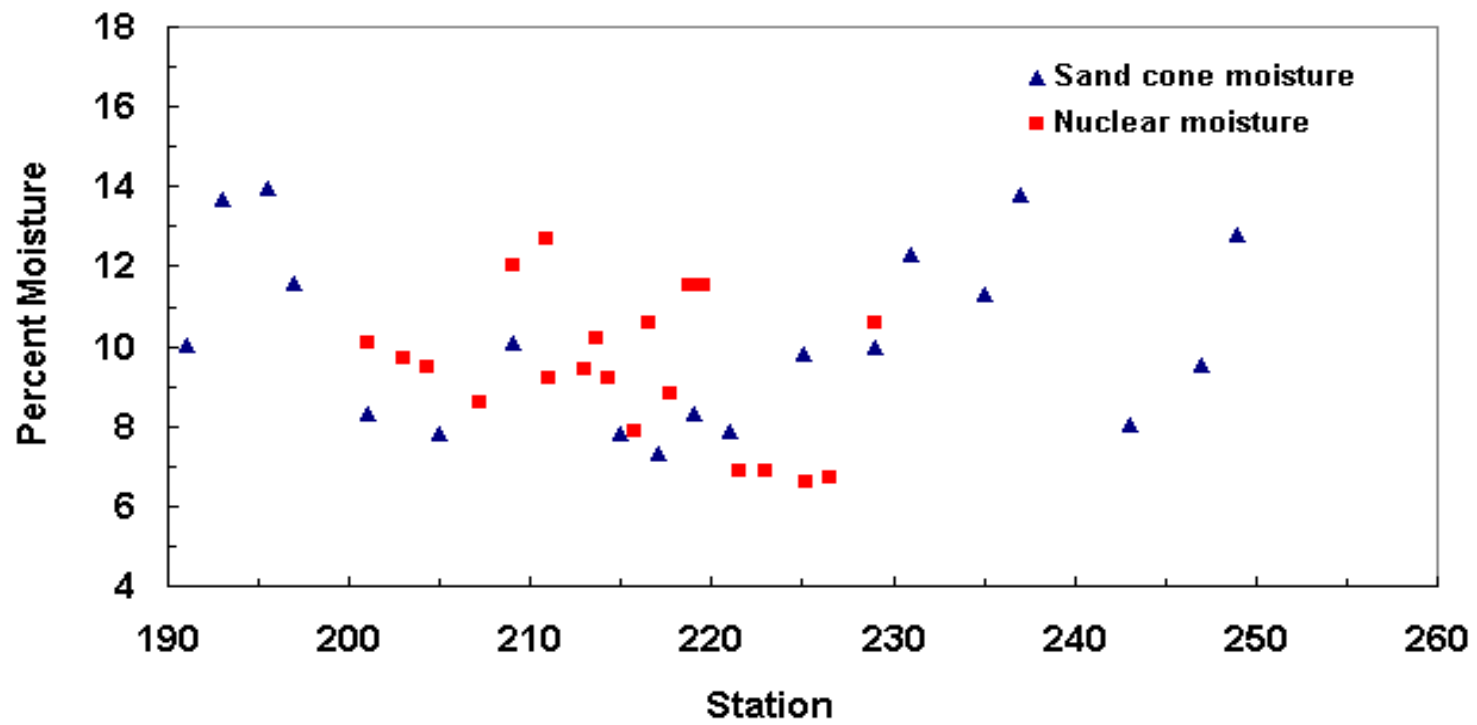
Figure 5.3 Moisture determined by (i) Speedy moisture meter and (ii) Nuclear moisture meter.

Again, moisture determined from sand cone samples (by Speedy Moisture Meter) and those obtained from nuclear gauge are plotted in Figure 5.3. Moisture determined using the nuclear gauge appears somewhat uniform from section to section, with moisture values on average 10%. It is important to note that the moisture (determined by Speedy Moisture Meter) in the first subsection, 1A, was high—in the 14 percent range. The relatively extensive cracks in this section, in comparison to the replicate section 3A, is a testimonial for the detrimental effects of excessive moisture in cement-treated material.

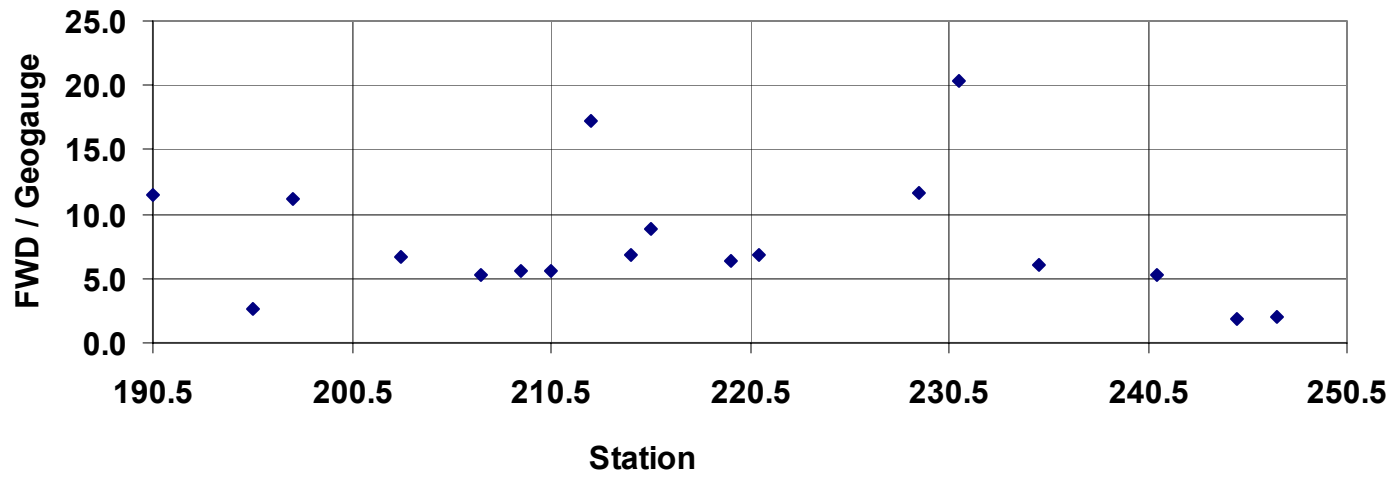
Figure 5.4 Spatial variation of ratio of FWD and geogauge moduli, 28 days.

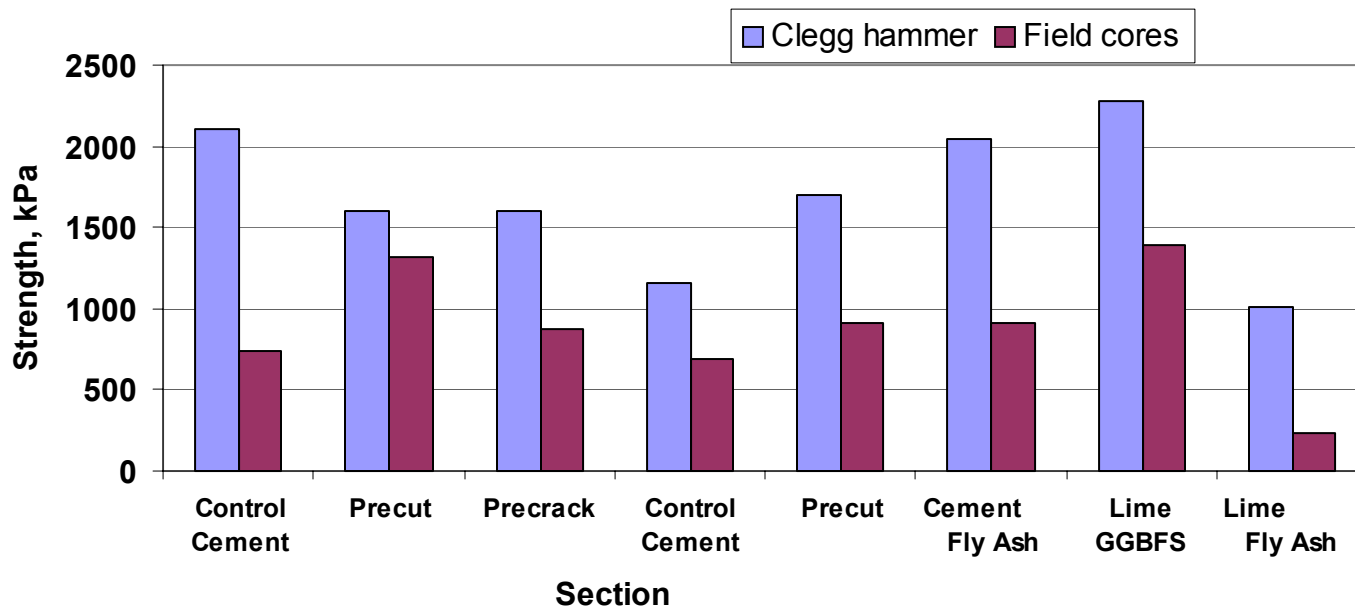
Figure 5.8 Comparison of field core strength with clegg hammer strength, 28 days.
1 kPa = 0.145 psi

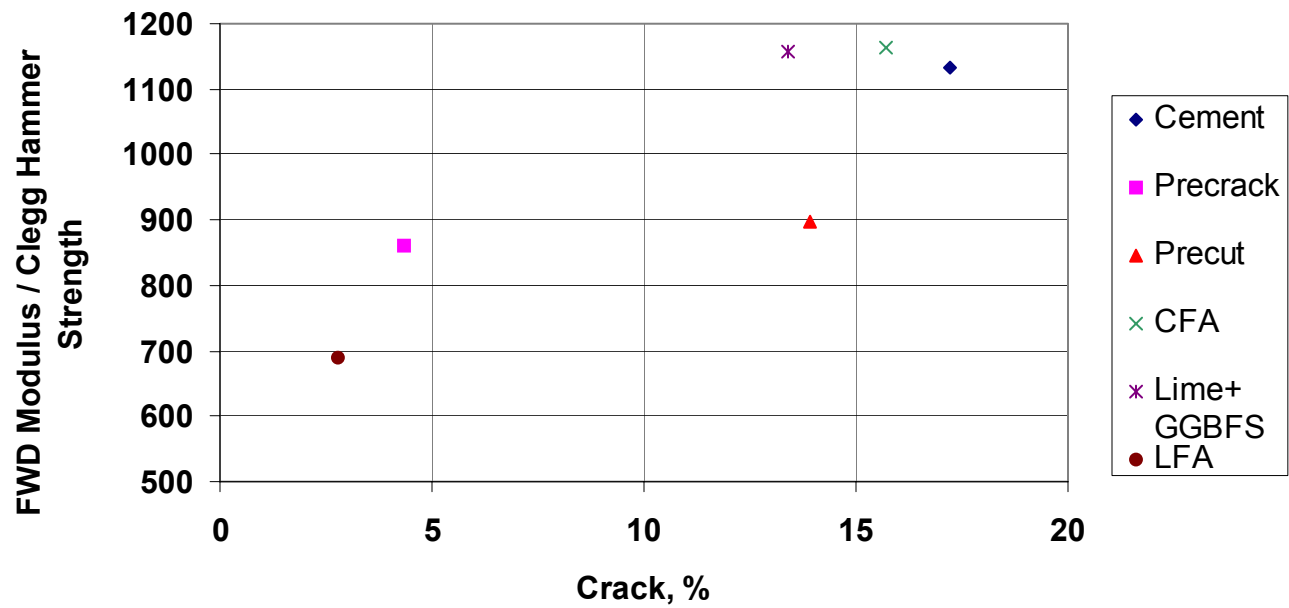
Figure 5.9 Modulus strength ratio plotted against crack density, 28 days.

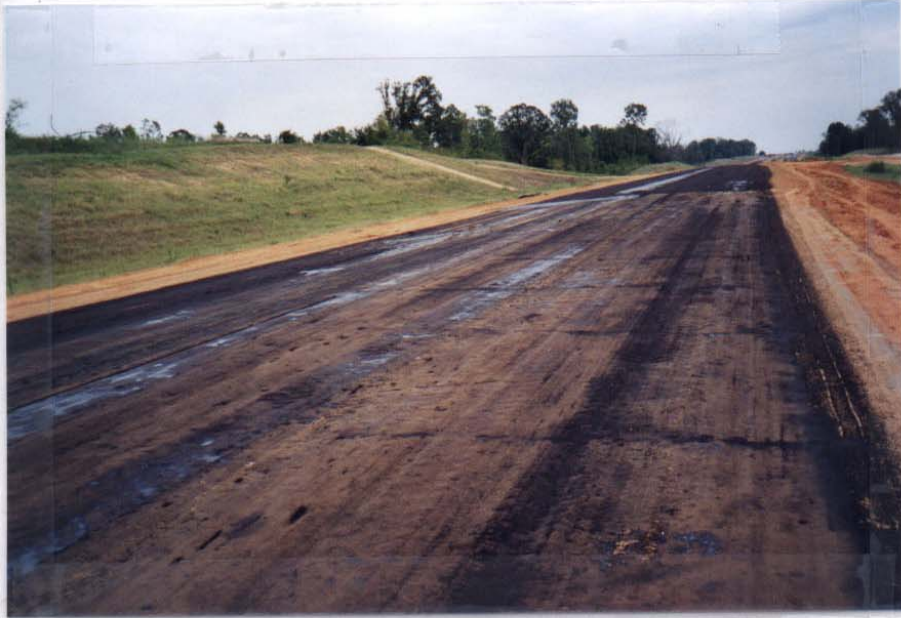
Figure B1 Section 1B (precut) in the foreground and section 2 in the background.
Contrast in emulsion application.

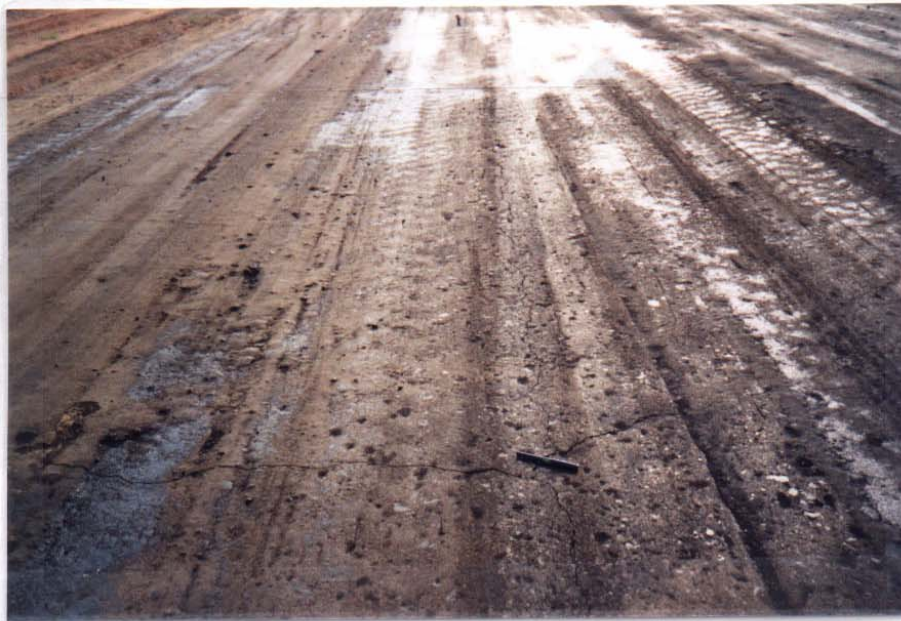
Figure B2. Medium severity crack in section 1A, control cement, nineteen days.

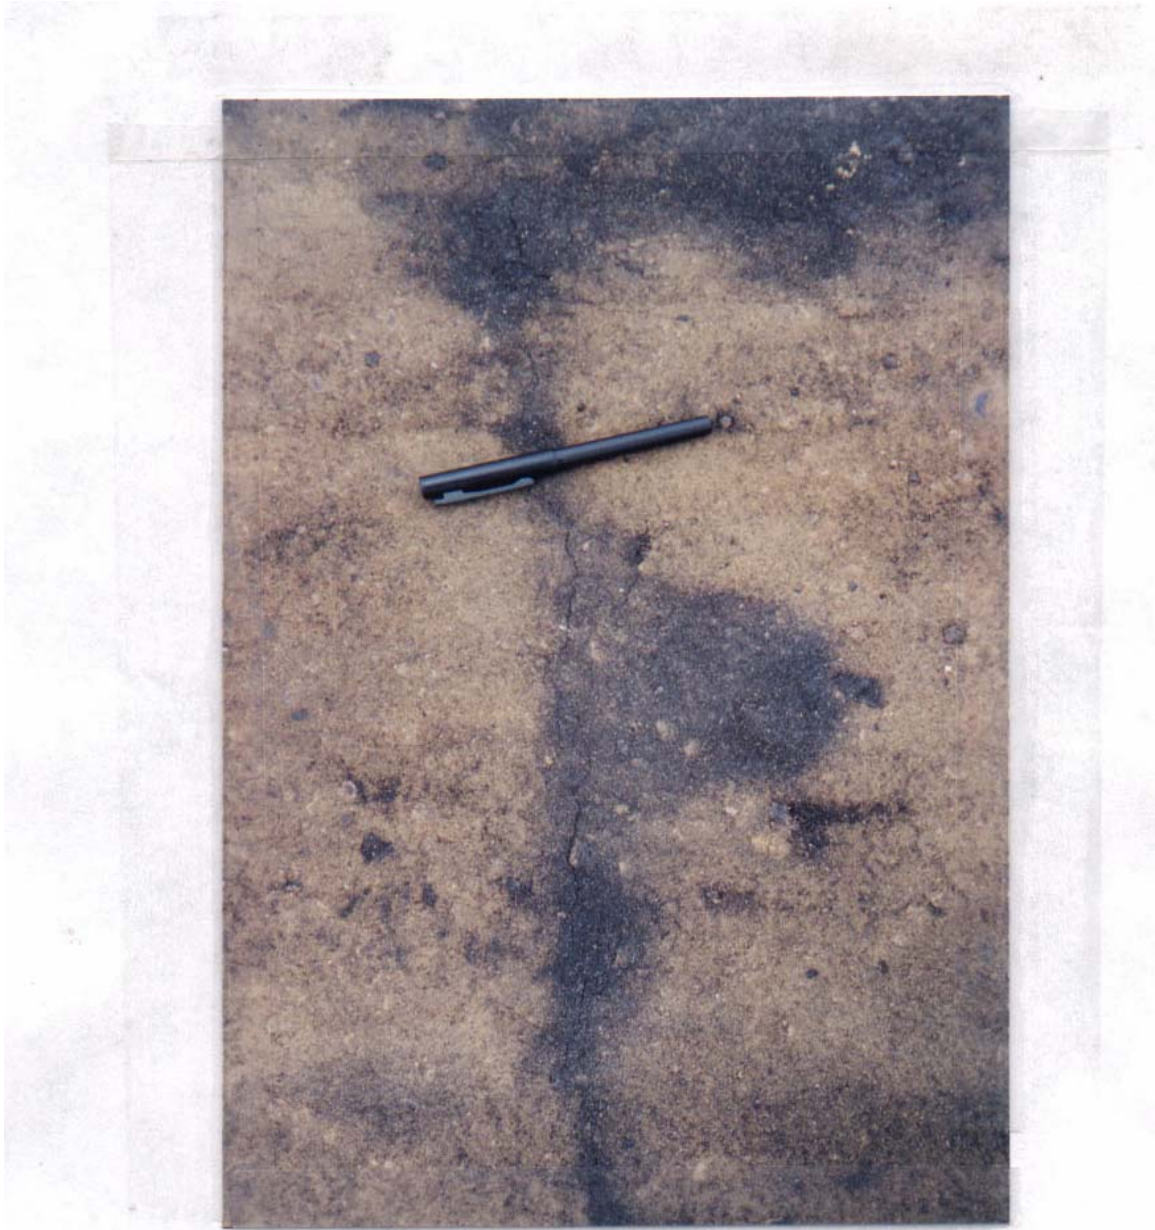
Figure B3 Transverse crack along a precut groove, section 1B, seventh day.

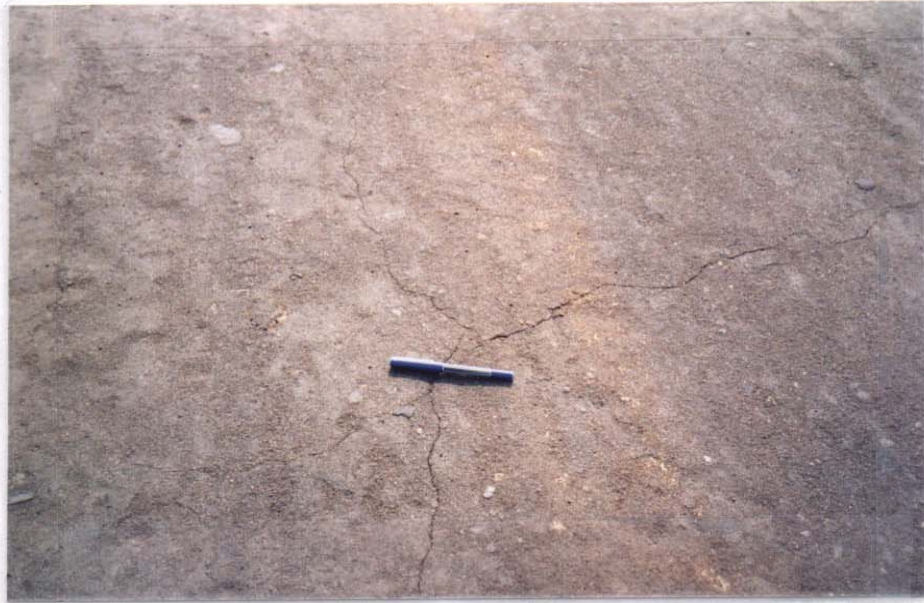
Figure B4 Transverse and longitudinal cracks in section 2 (precracked), nineteenth day.

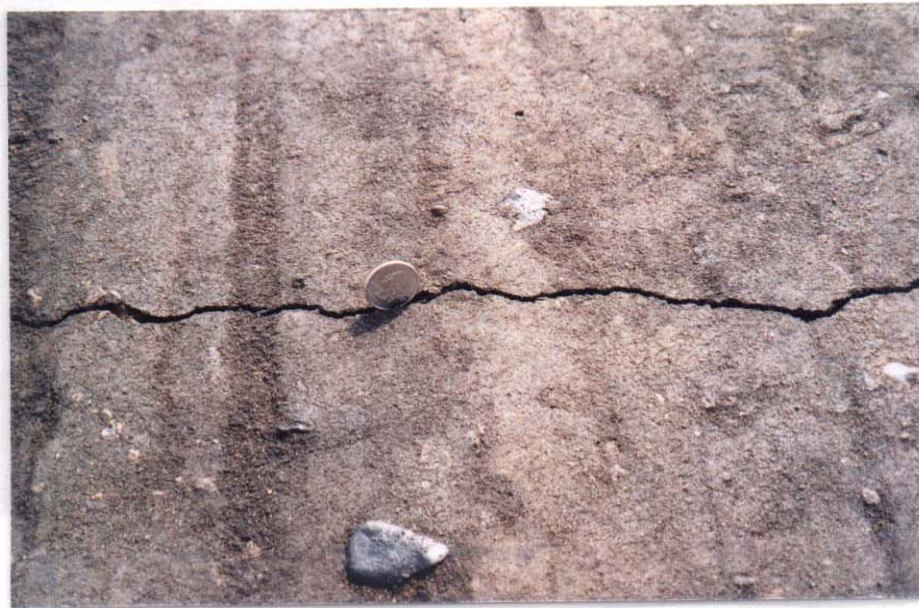
Figure B5 High severity longitudinal crack in section 4, cement – fly ash, 221 + 50, nineteenth day.

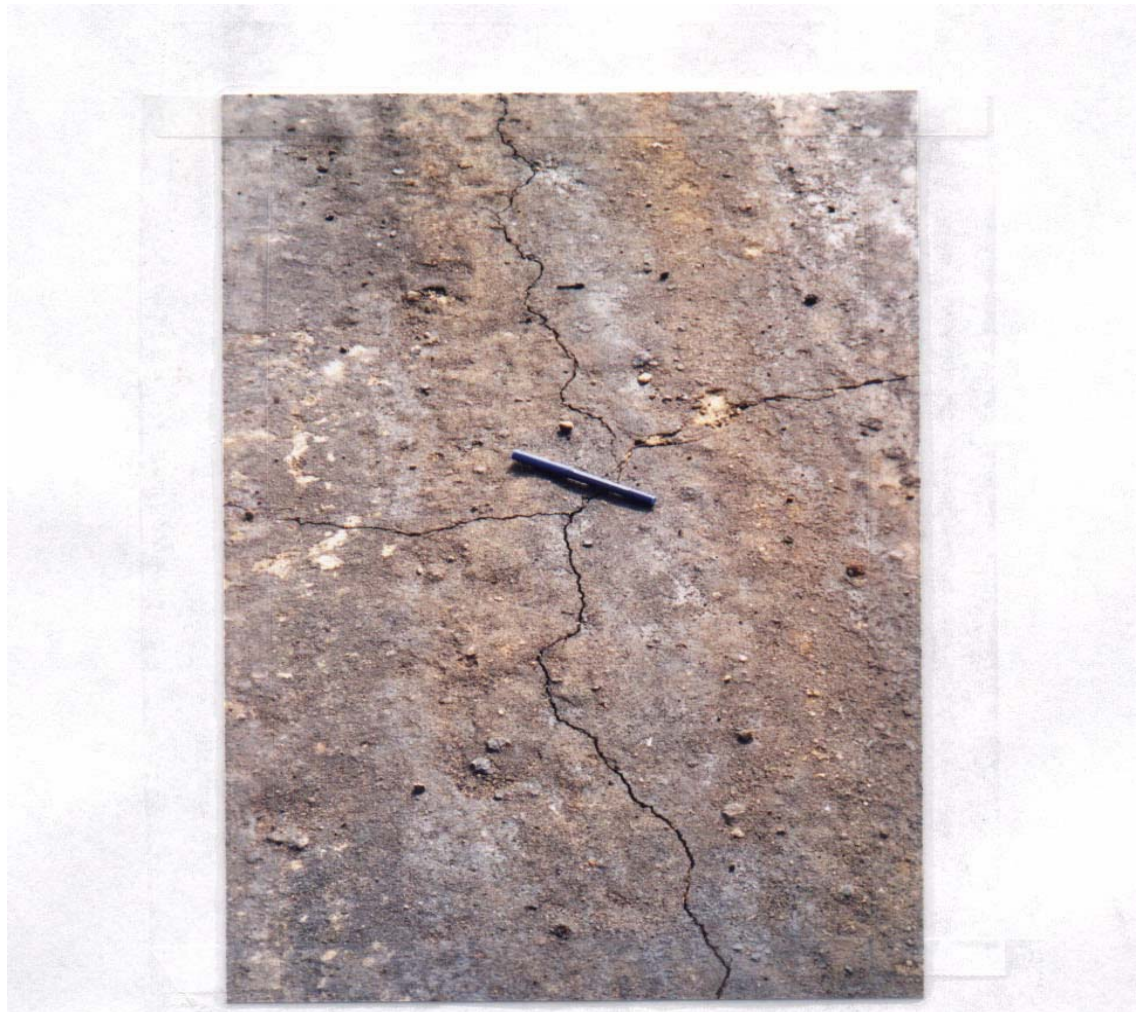
Figure B6. Medium severity crack in section 5, lime – GGBFS, nineteenth day. Curing compound completely vanished.

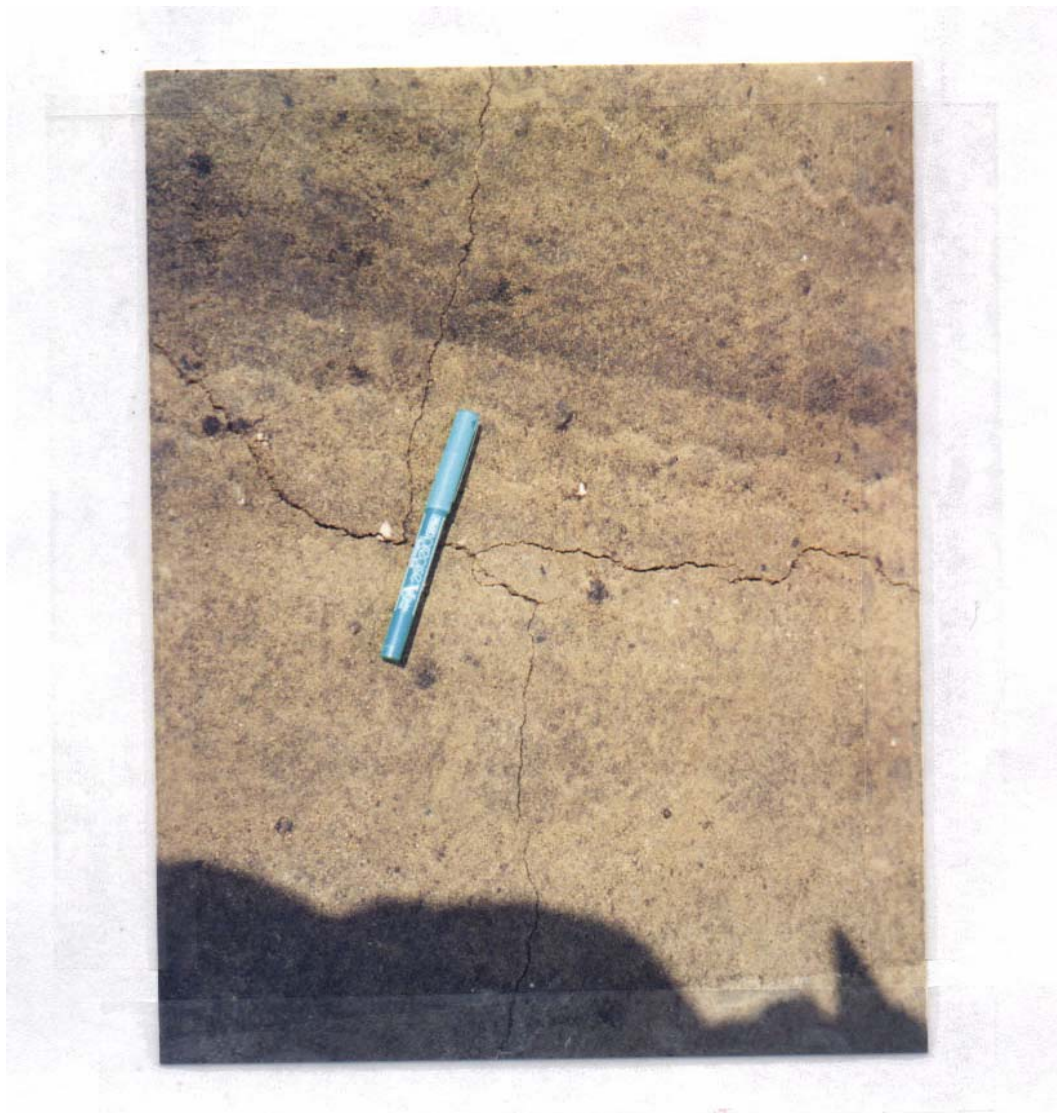
Figure B7. Meandering cracks in lime – fly ash section, 14 days.

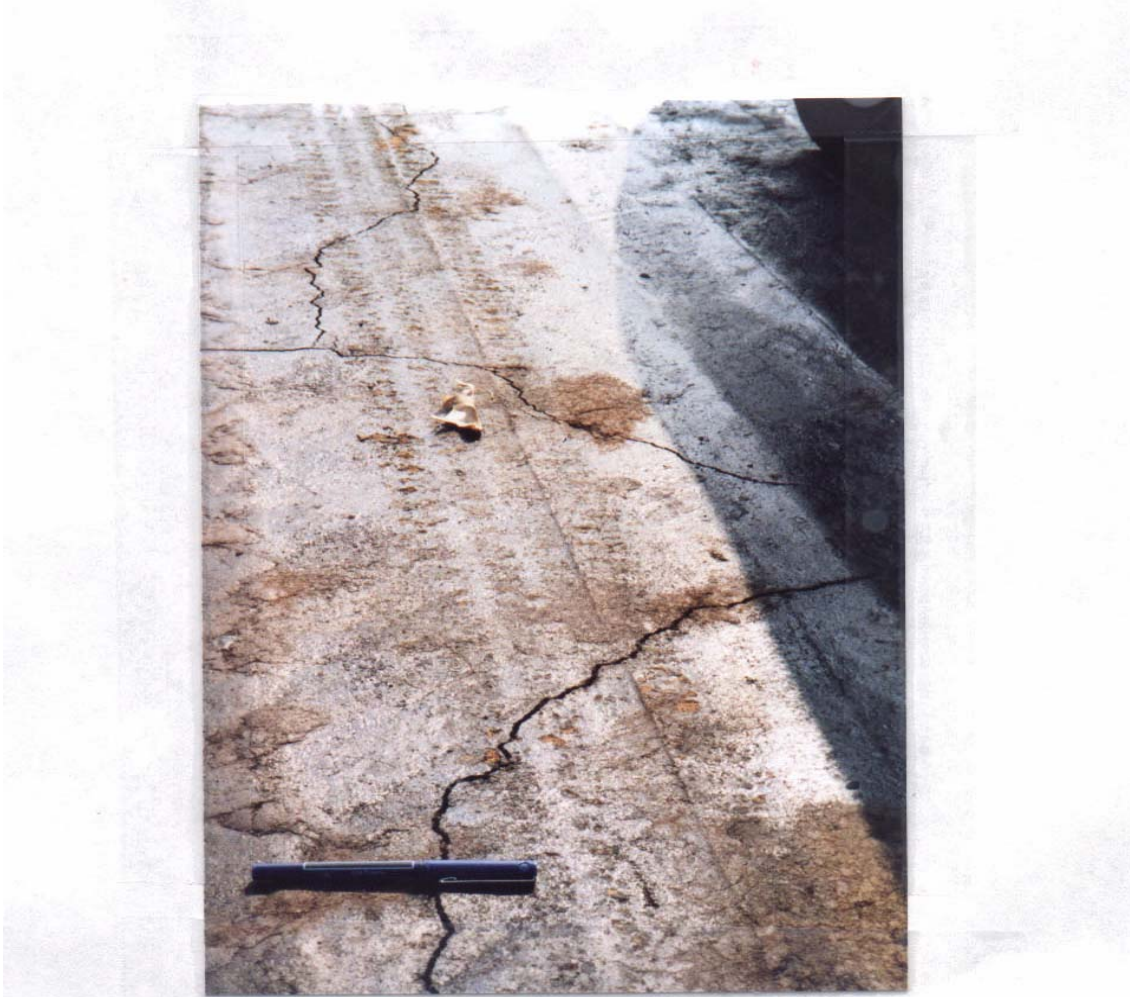
Figure B8. High severity cracks in lime – fly ash section, 241 + 50, nineteen days.

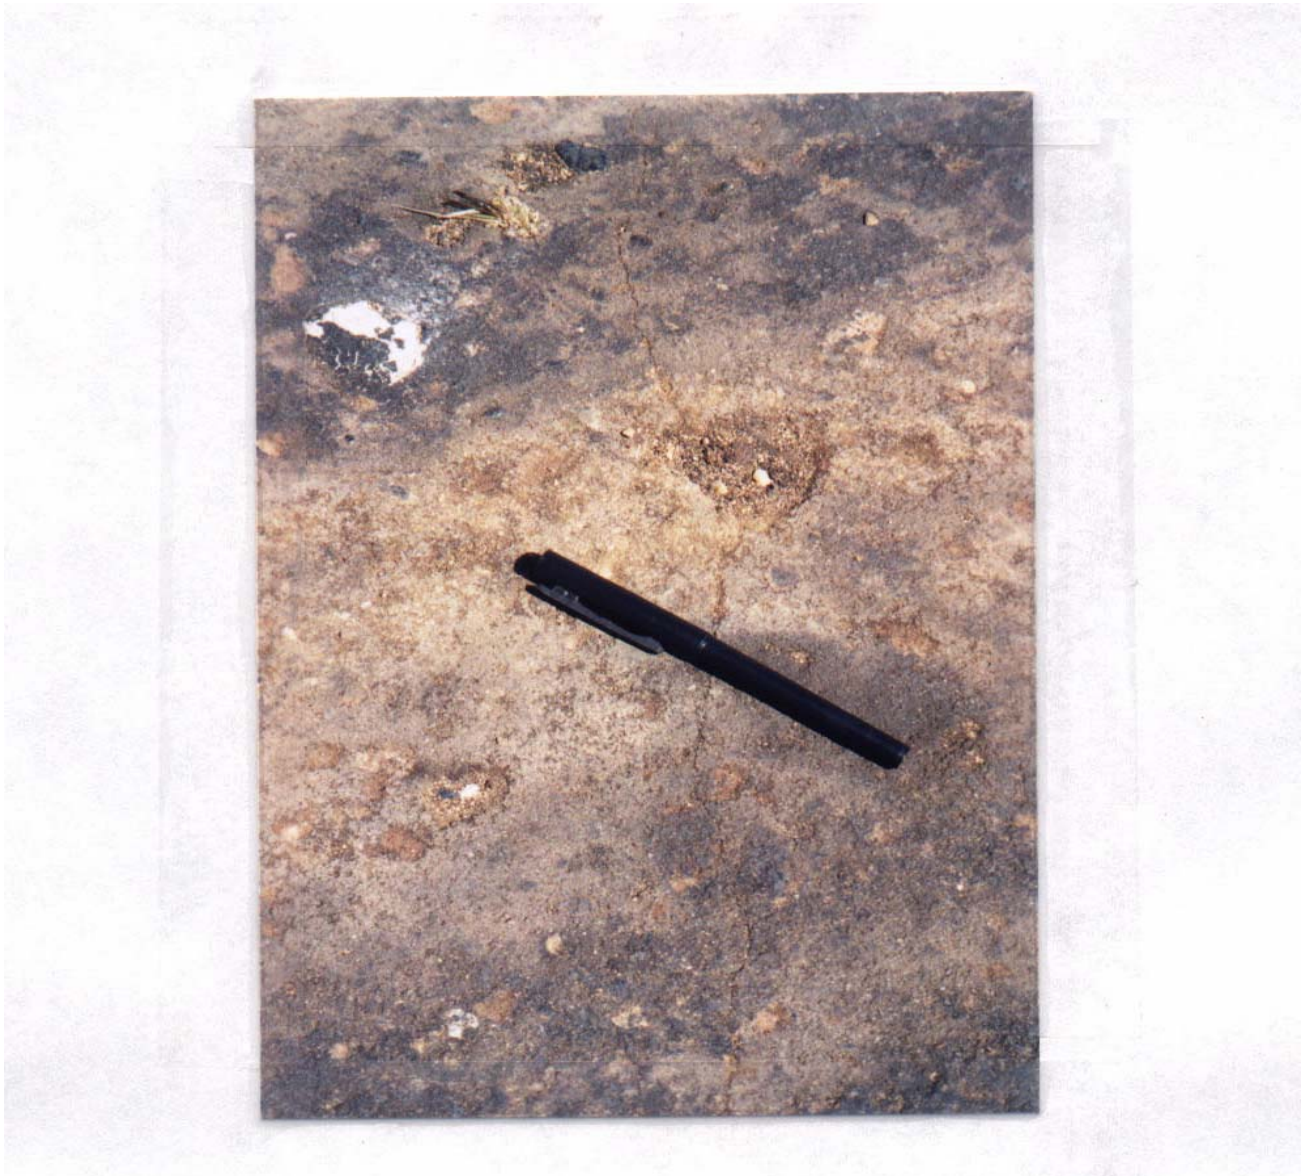
Figure B9. Fine crack in lime – fly ash section, section 6 (alternate), twenty eight days.
