DIAGNOSTIC EVALUATION AND REPAIR OF DETERIORATED CONCRETE BRIDGES

FINAL REPORT

Conducted by the
DEPARTMENT OF CIVIL ENGINEERING
UNIVERSITY OF MISSISSIPPI

In Cooperation with
THE MISSISSIPPI DEPARTMENT OF TRANSPORTATION

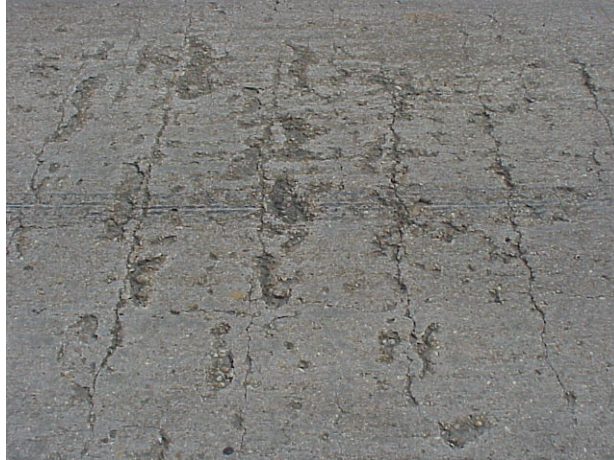
Nonstructural cracks can be caused by thermal expansion and contraction of concrete, contraction of the concrete during the curing process, or temperature gradients within massive sections of concrete. Also, the presence of rust stains around nonstructural cracks normally indicates corrosion of steel reinforcements in a concrete member. These cracks generally do not affect the load-carrying ability of a member, but may lead to higher susceptibility to other types of deterioration.

Figure 3.1.1 *Non-structural cracking due to thermal expansion and contraction observed in MDOT District I.*

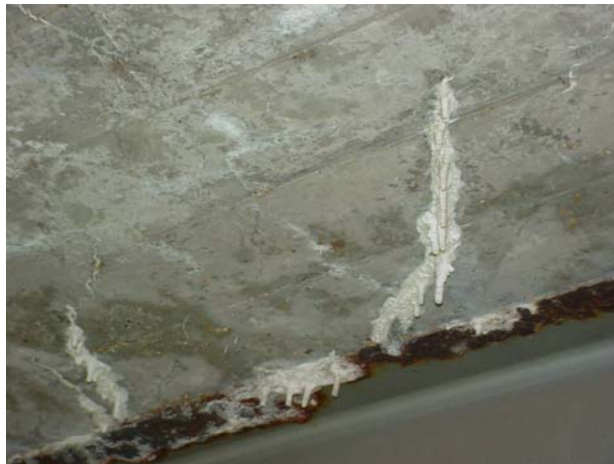
Figure 3.1.2 *Non-structural cracking leading to efflorescence observed in MDOT District I.*

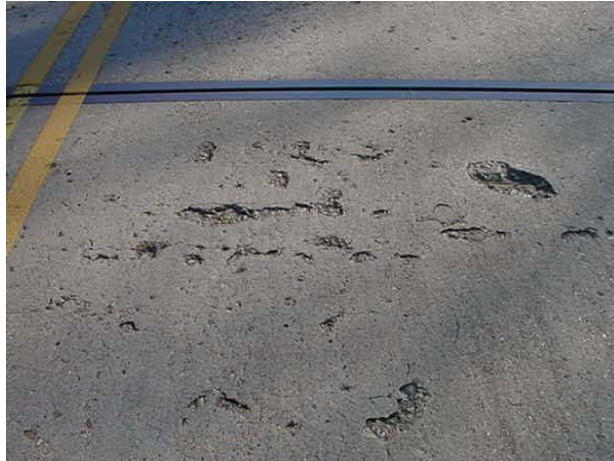
exposing coarse aggregates. Severe scale is the loss of surface mortar greater than 1 inch deep where coarse aggregate particles are lost and reinforcing steel is exposed.

Figure 3.1.3 *Light scale observed in MDOT District V.*

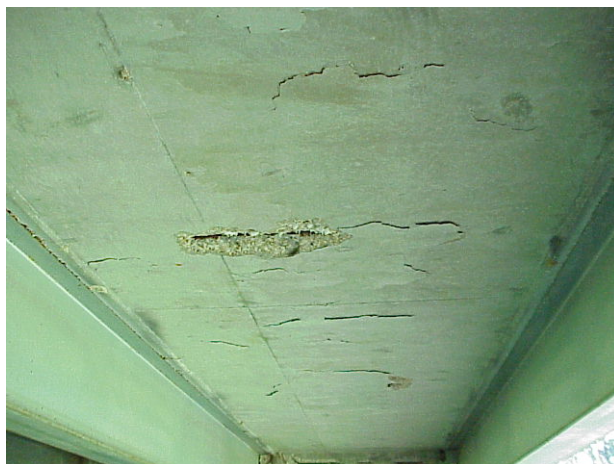
Delamination is the separating of concrete layers at or near the outermost layer of reinforcing steel. Delamination is caused by the expansion of corroding reinforcing steel and can lead to severe cracking. Rust can occupy up to ten times the volume of the corroded steel which it replaces.

Figure 3.1.4 *Delamination and spall (due to corrosion) observed in MDOT District I.*

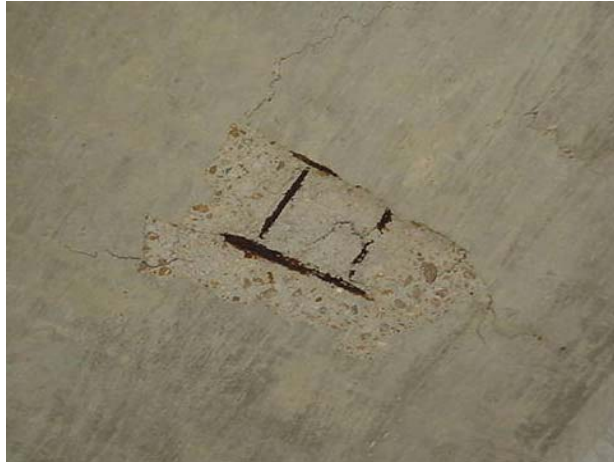
Figure 3.1.5 *Non-structural cracking and loss of mass due to corrosion observed in MDOT District V.*

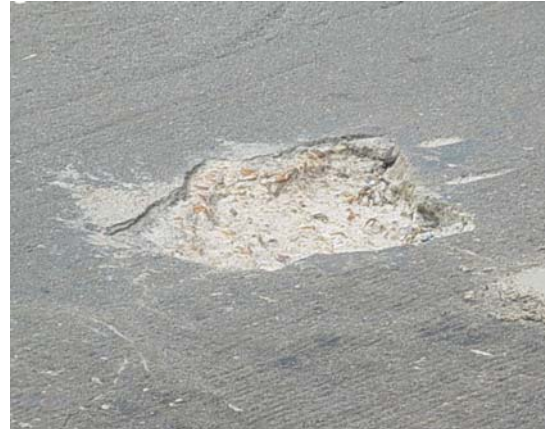
Figure 3.1.7. *Spall observed in MDOT District II.*

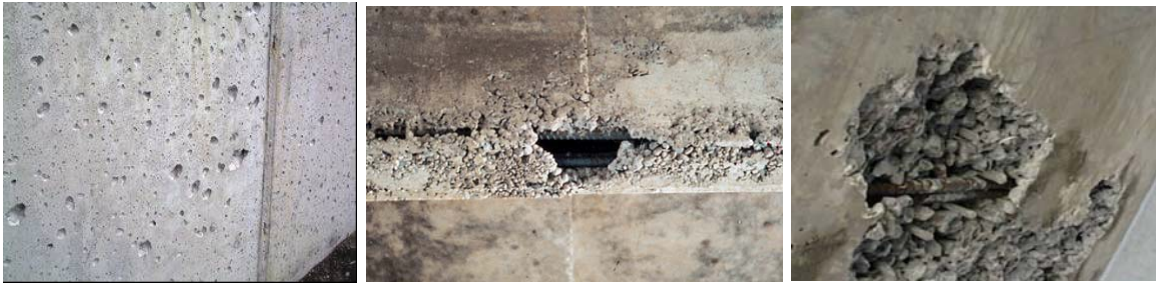
Hollow spaces or voids within concrete are known as honeycombs. They are caused during construction when improper vibration results in the separation of coarse aggregates from the fine aggregates and cement paste.

Figure 3.1.10 *Examples of construction defects.*

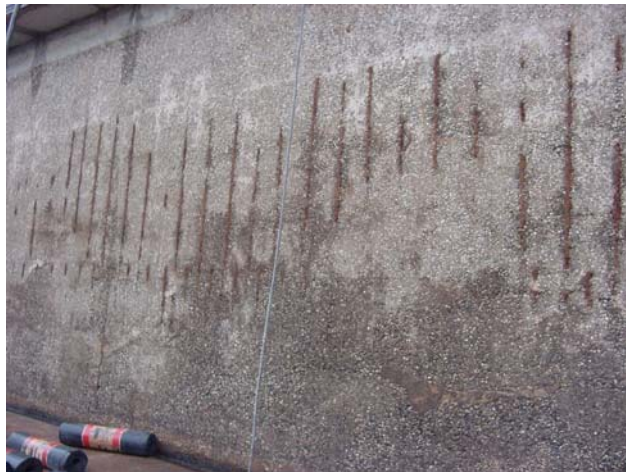
Another source of construction defects is related to insufficient concrete cover which may be caused by shift or cage shift, improper fabrication of steel, or improper placement of forms.

Figure 3.1.11 *Example of construction defects (insufficient concrete cover).*

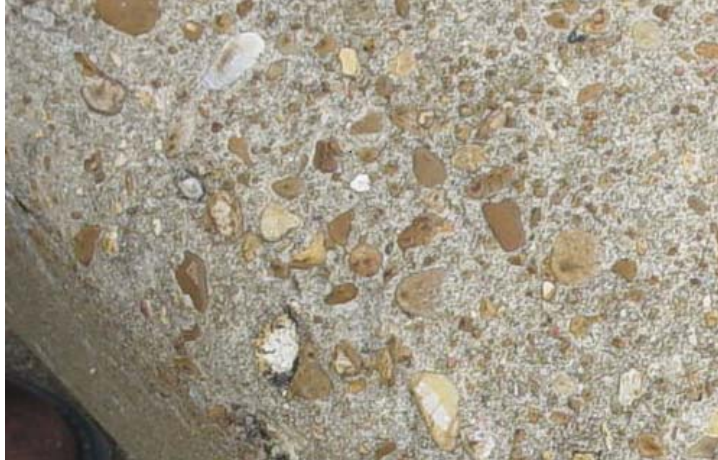
Pop-outs are a result of alkali-silica reactions taking place in concrete. Conical fragments break out of the surface of the concrete leaving small holes. Shattered aggregate particles will usually be found at the bottom of the hole.

Figure 3.1.12 *Pop-outs observed in MDOT District II.*

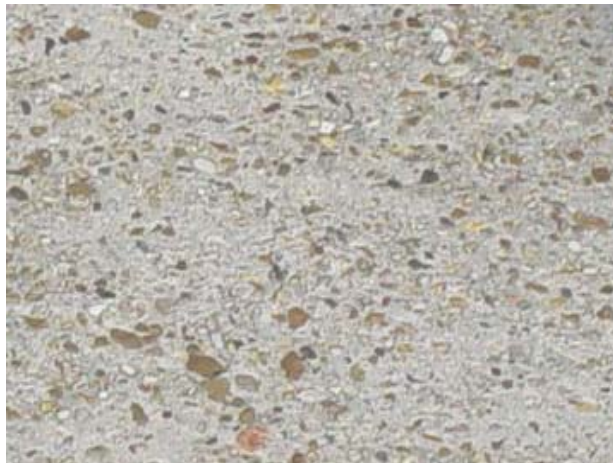
Vehicular traffic causes wear on bridge decks throughout the life of the structure.

Figure 3.1.13. *Wear observed in MDOT District VI.*

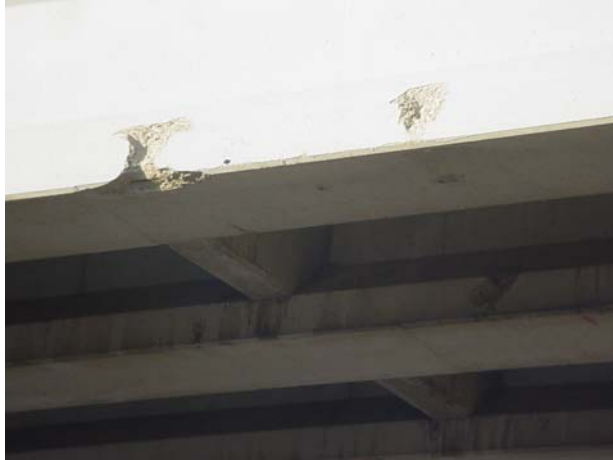
Vehicular collisions can cause severe damage to bridges and overpasses.

Figure 3.1.14. *Collision damage observed in MDOT District VI.*

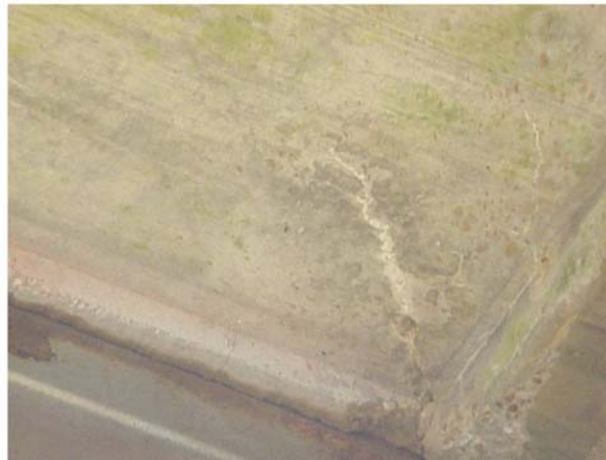
Overloading of bridges will result in structural cracking due to excessive vibration or deflection.

Figure 3.1.15 *Shear Crack observed in a bridge deck in MDOT District VI.*

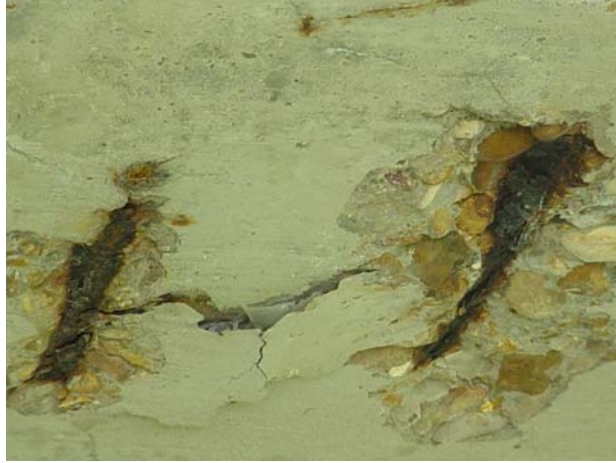
Figure 3.2.12 *Example of corrosion of reinforcement in a bridge deck in District 1.*

The rust occupies a much larger volume than the original steel and causes the build up of bursting forces at the surface of the reinforcement (Figure 3.2.11). Because concrete is weak in tension these bursting forces quickly cause the concrete to crack parallel to the reinforcement direction and eventually, to spall away from rebars (Figure 3.2.12).

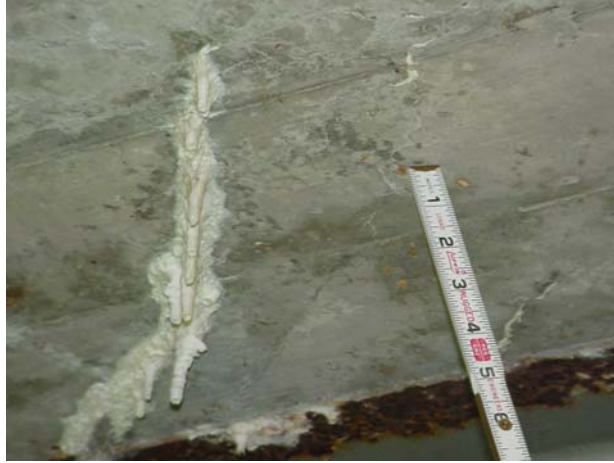
When water from rain, condensation, or melting snow and ice is introduced into the concrete mix, contamination can occur. Pure or soft water from these sources contains little or no calcium ions. Therefore, they tend to hydrolyze or dissolve the calcium containing products in the concrete mix. Eventually, the process leaves behind silica and alumina gels with little or no strength. Efflorescence occurs as white calcium deposits leach from the concrete (Figure 3.2.13). This is the most common sign of deterioration in Mississippi.

Figure 3.2.13. *Example of efflorescence in District 1.*

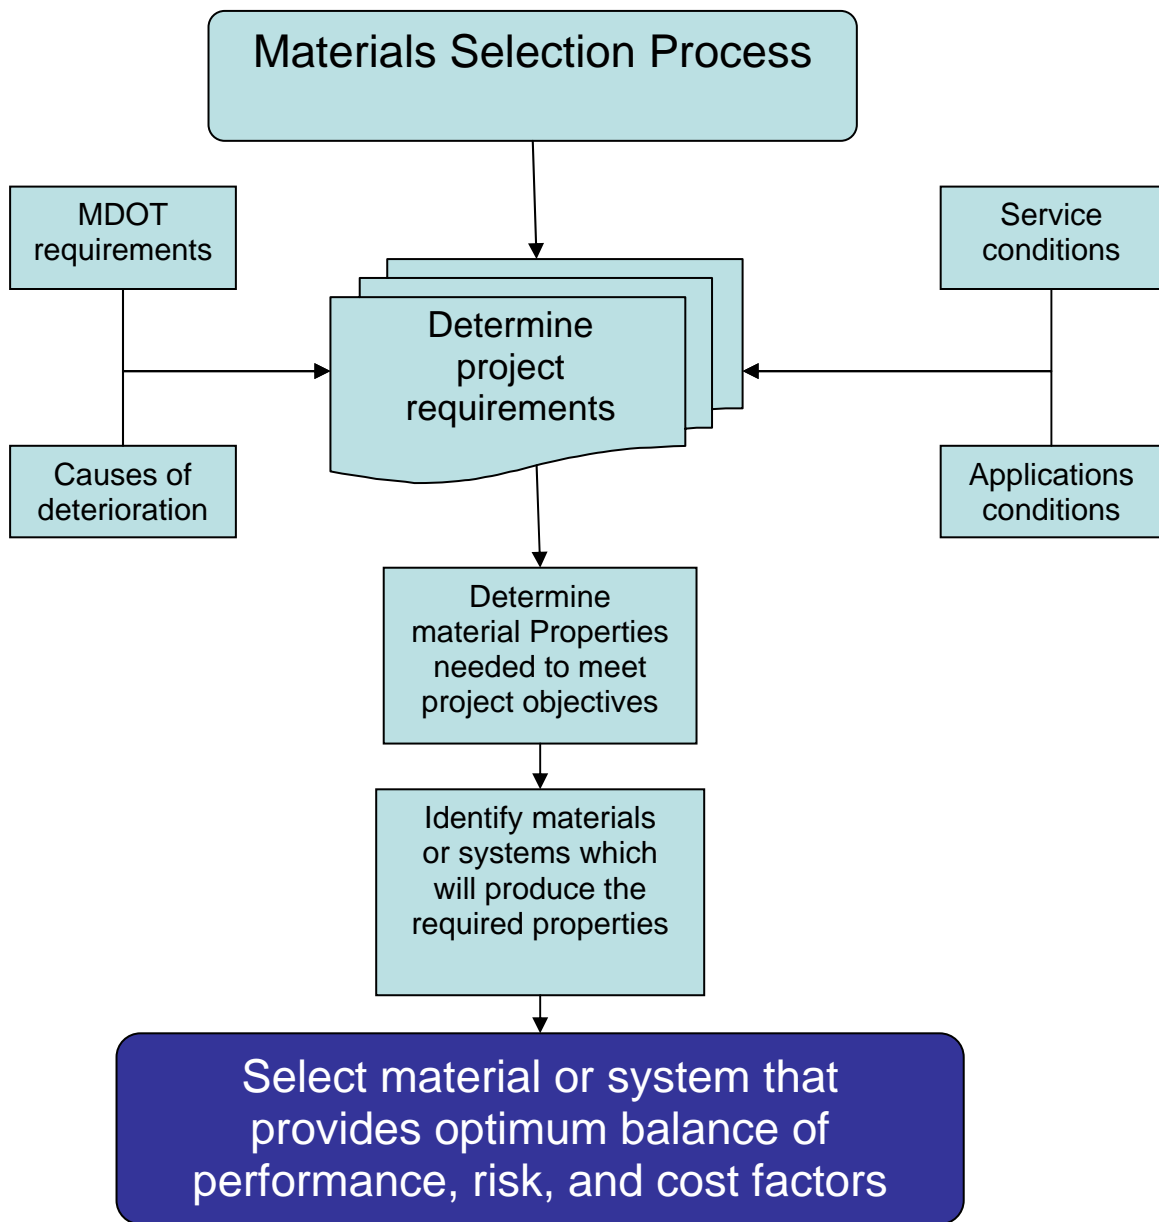
A guideline for the selection of repair materials is shown in Figure 4.1. Typical characteristics of selected repair materials are shown in table 4.1 [129].

Figure 4.1 Procedure for selection of repair materials [129].

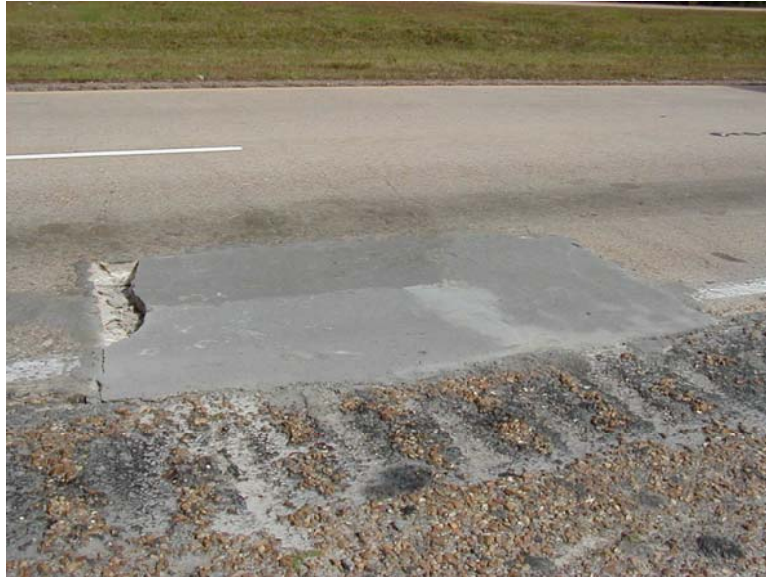
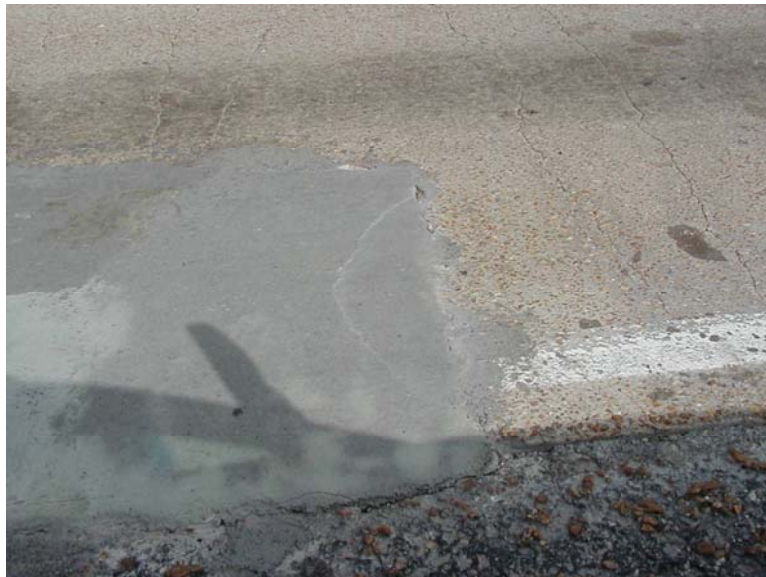
1- Spalling of repair material from concrete

Figure 4.2 *A case study of failure in repair material due to the size of repaired area.*

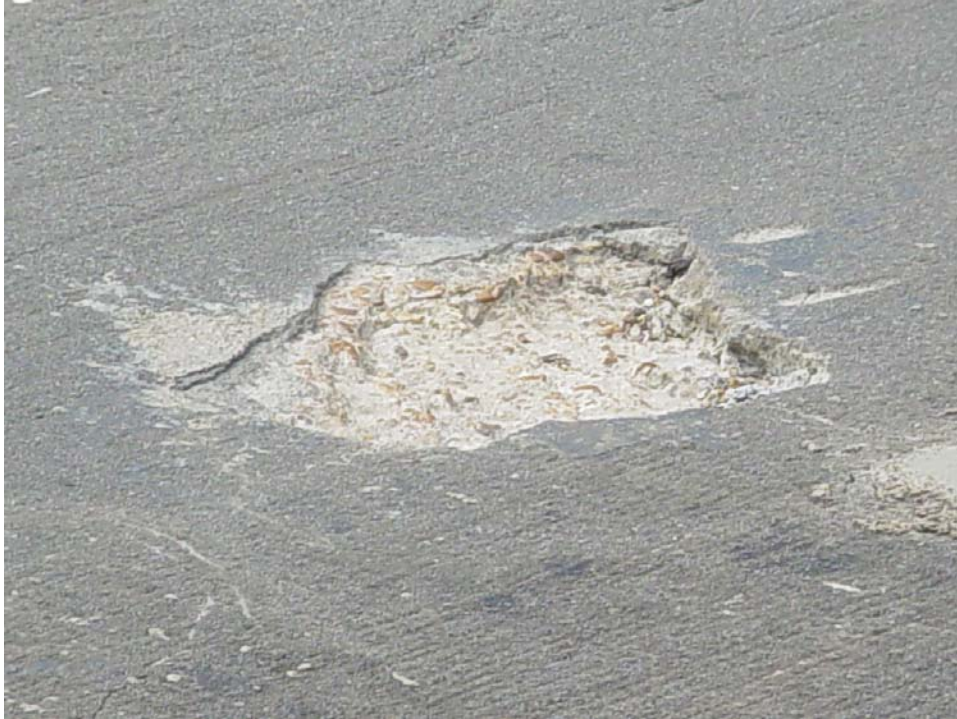
Figure 4.3 *Spalling of repair material from parent concrete*

This is a common problem that was observed in many repaired bridges in Mississippi. By examining the failed section it is clear that the repair material bonded extremely well to the parent concrete. By looking at the above picture all one can see is parent concrete (no repair material was left behind). This is a common problem associated with not cleaning and preparing the concrete surface properly before applying the repair material. Thus the problem is not the selection of the right repair material, but rather surface preparation (See section 4.1).

- 1- Don't cut an area of concrete to prepare for repairing
- 2- If there is a need to repair a large area, then one must use expansion joints

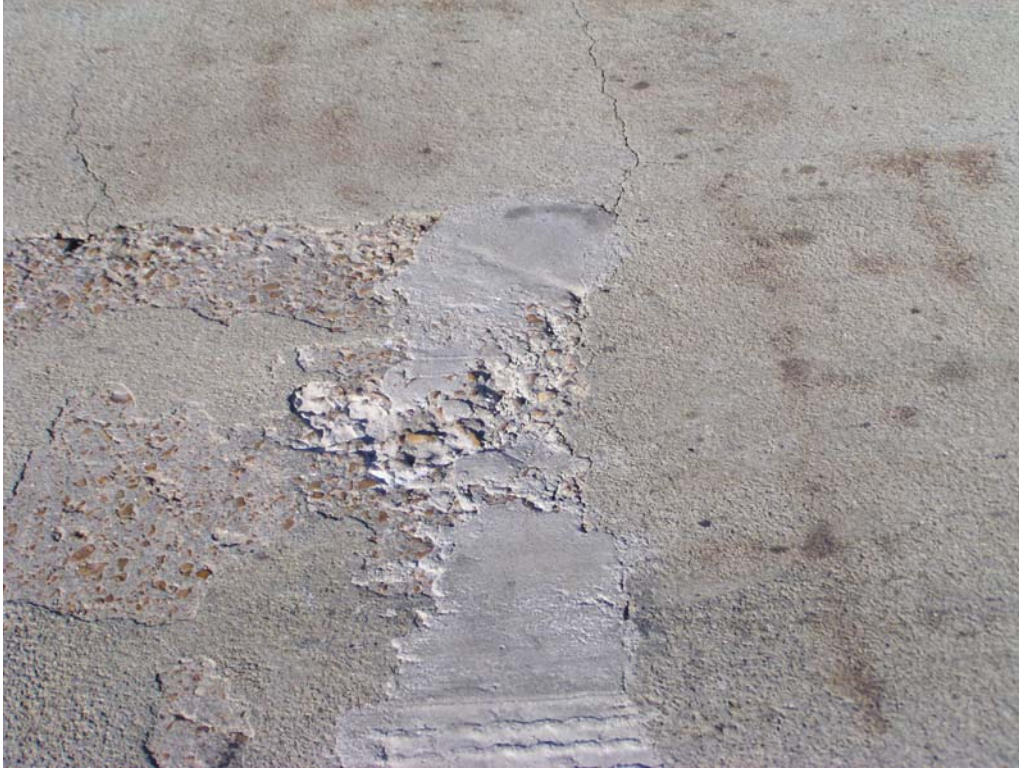
Figure 4.4 *A case study showing improper use of repair technique*

This is a case study that was examined in District III. By examining, one can observe the discoloration of bridge deck due to underlying corrosion. Thus patching repair material at the surface will not solve the problem. Proper cleaning of reinforcement or at least sealing of corrosion cracks is recommended in this case.

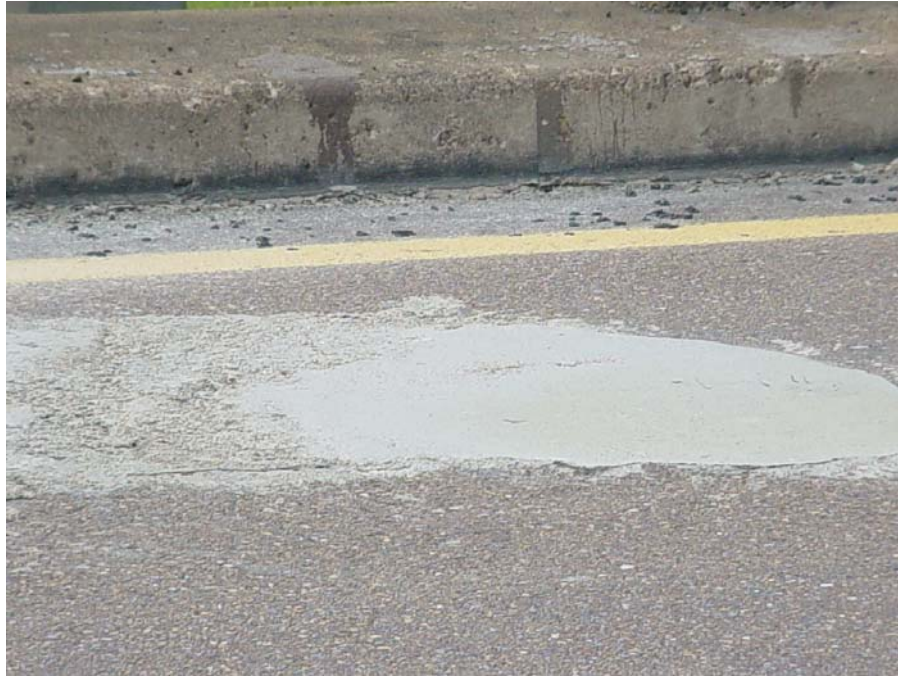
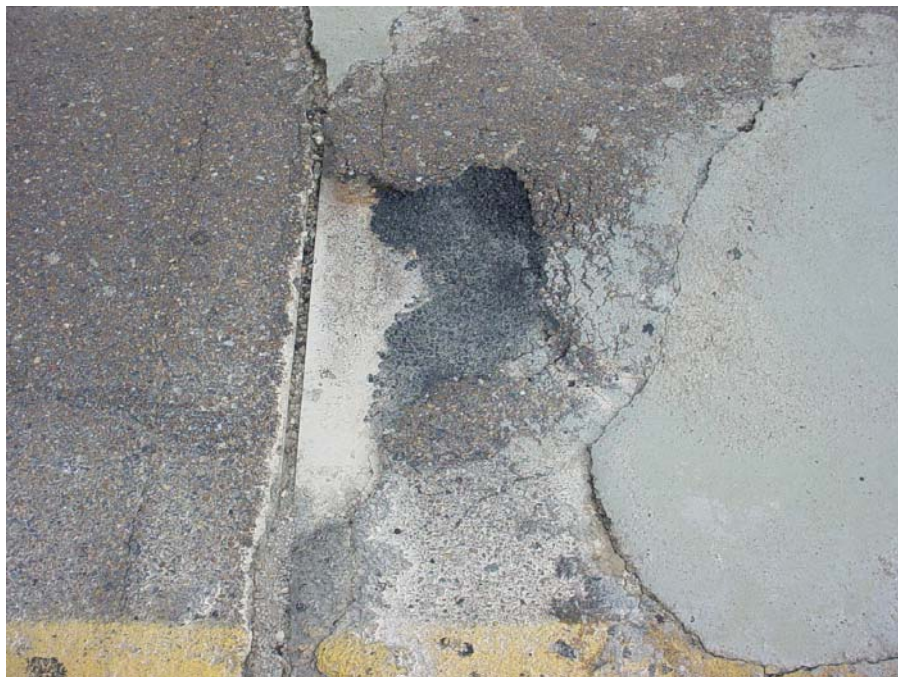
Figure 4.5 *Abrasion of repair materials*

Abrasion of repair materials is another common problem that was observed in many districts. Before selection of any repair material, abrasion resistance of the material needs to be provided by repair materials manufacturers.

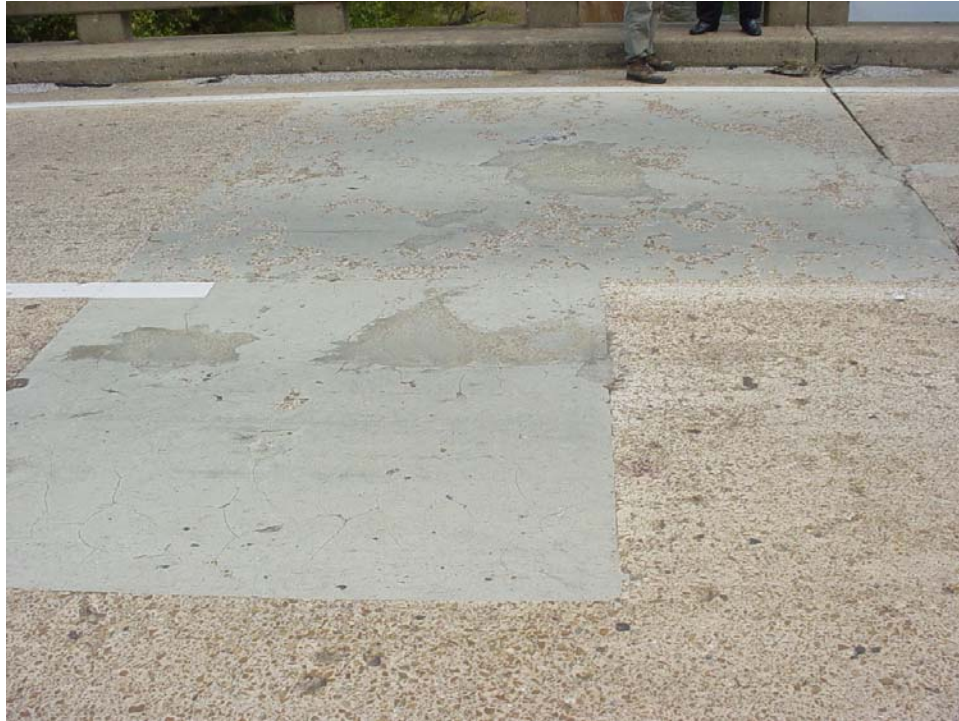
Figure 4.6 Cracking of repair materials

In this case a very thin layer of patching material was used to repair a concrete bridge deck which was deteriorated by abrasion. Apparently the repair material itself was damaged as cracks are noticed everywhere. This could be due to the use of repair material with a low tensile strength.

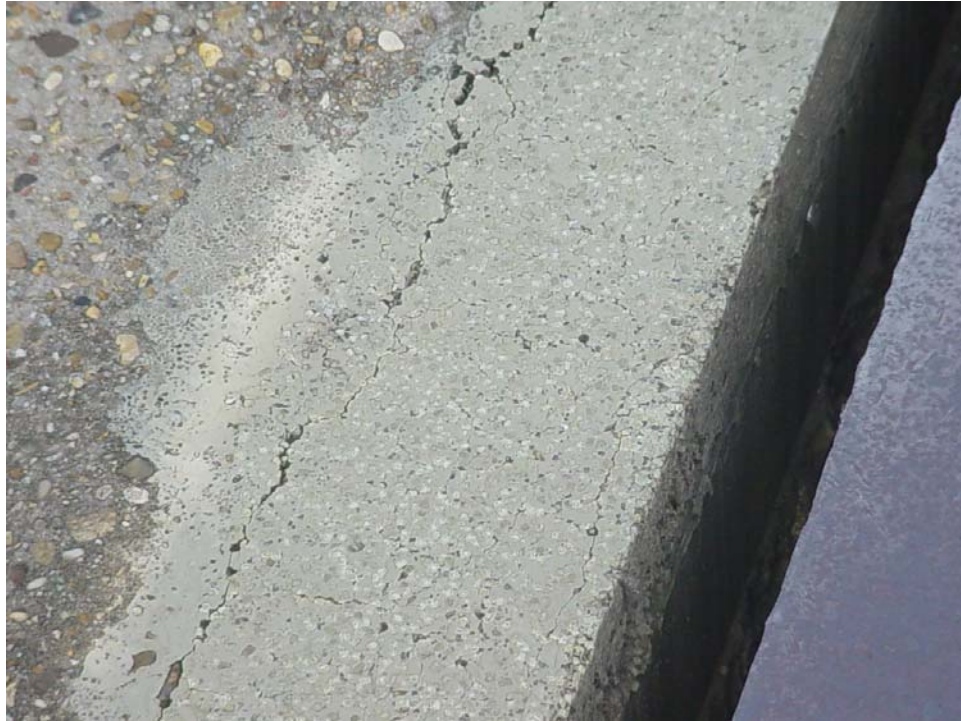
Figure 4.7 *Repair of joint failure due to continuous dynamic impact of traffic*

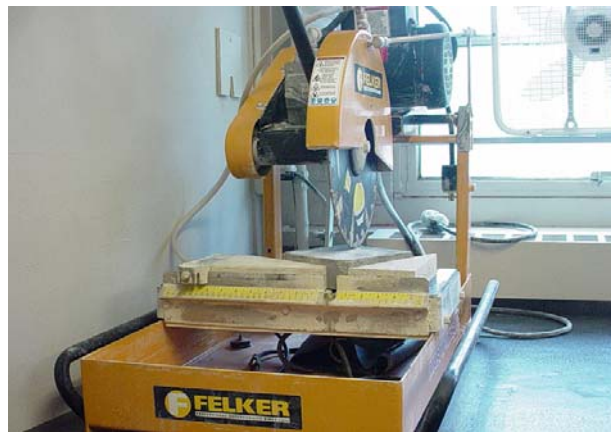
The test program required the splitting of the plaques in two halves along a 30° angle. Before splitting the plaques, the plaques were grooved by a cutting wheel to a depth of about 5mm to ensure a perfect half split at the required angle of the plaque (Figure 5.1). Concrete plaques were then assembled with a trapezoidal steel plate and an elastomeric pad. A steel rod was located on the top of the plaque to help in guiding and promoting the crack along the desired angle. Compression loading was then applied slowly at a constant rate until the plaque was fractured (Figure 5.2). This procedure will assure a natural rough surface of crack. The fractured plaque is now ready for repair (Figure 5.3).

Figure 5.1 *A groove was made on every concrete plaque at an angle of 30 degrees.*

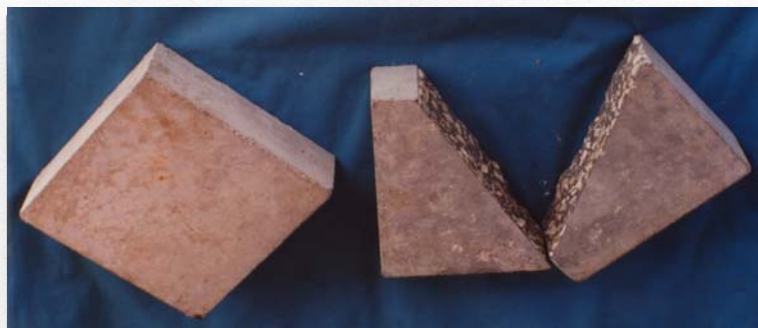
Figure 5.3 Assembly for splitting concrete plaques at controlled angle

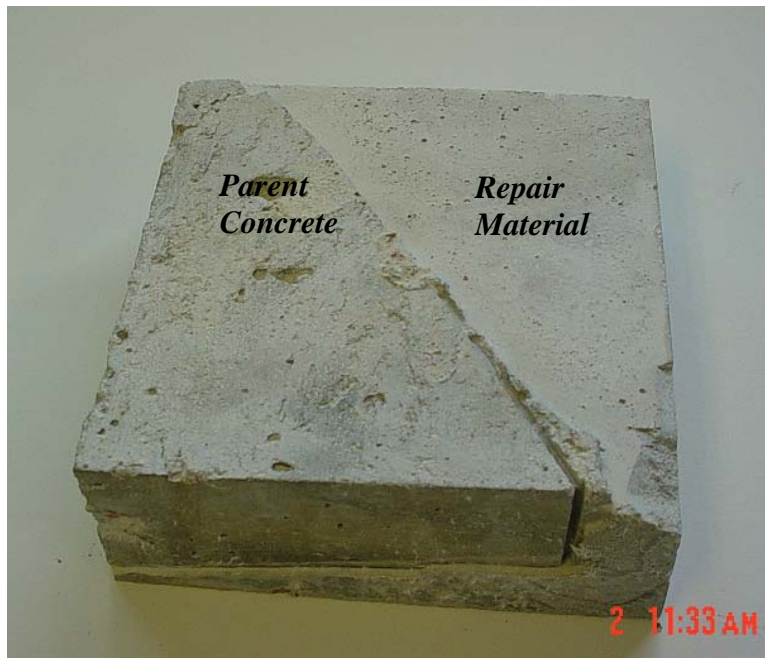
Figure 5.5 *Typical repaired concrete plaque.*

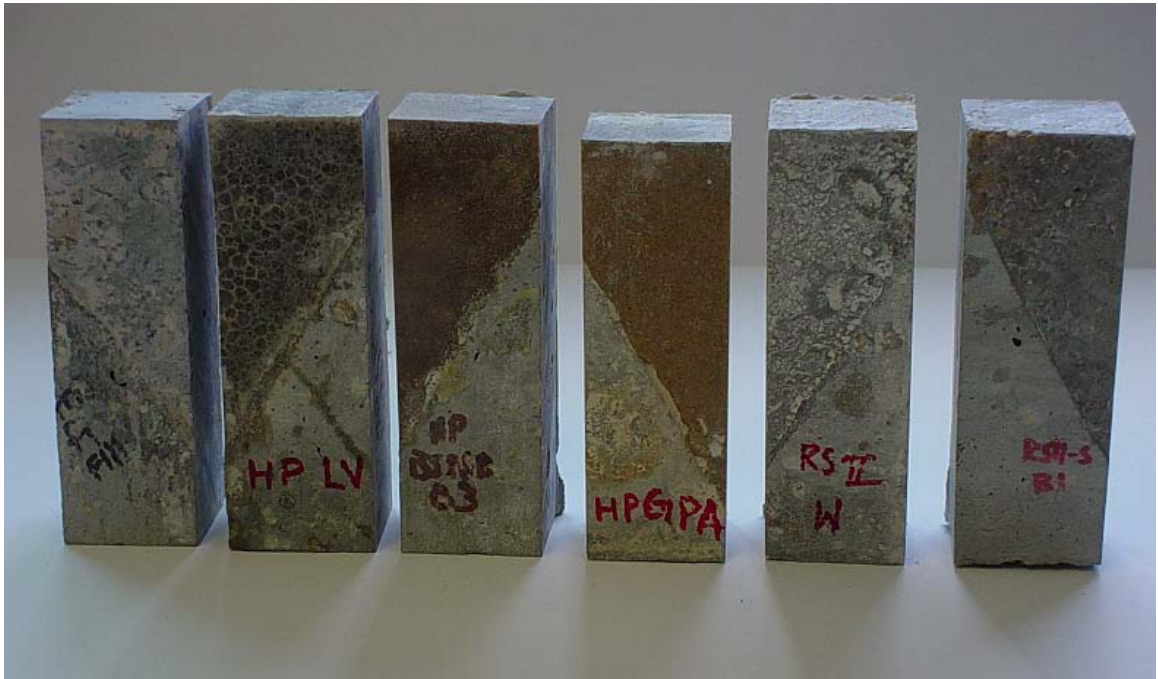
Figure 5.7 Typical test specimen from resin based repair materials (Pot Fill, HP LV, HP Binder, HP GPA, Resurf II Summer, and Resurf II Winter).

The sawn prisms of 55 x 55 x 150 mm (5.906 x 5.906 x 2.165 in.) are the repair material - concrete composite specimens to be used for the slant shear test (Figures 5.7 and 5.8).

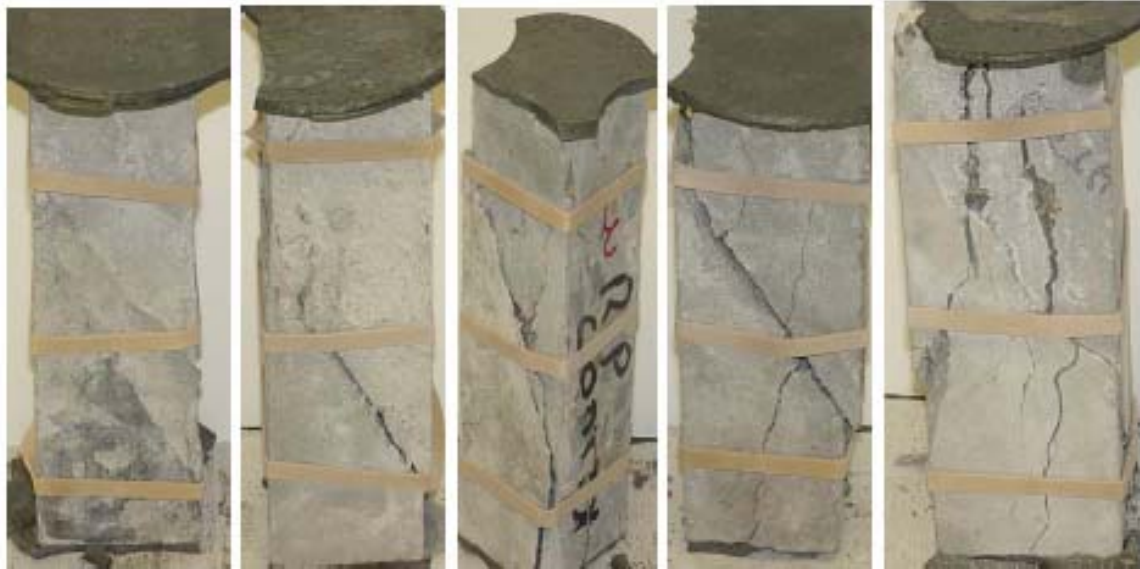
Sample1
MOF(iii)

Figure 5.12 *Mode of failure of concrete plaques repaired using Road Patch.*

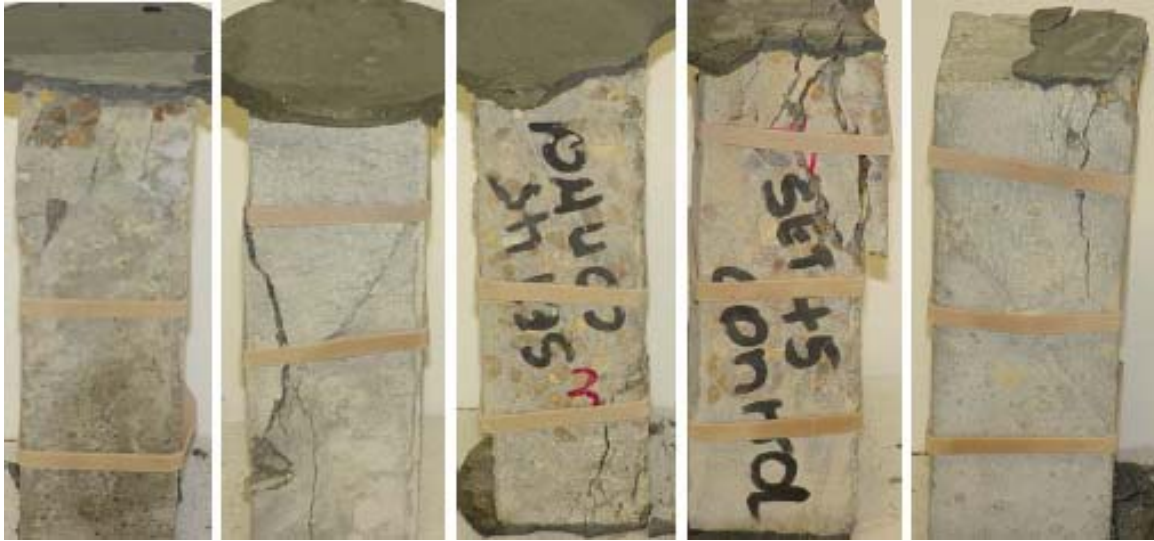
Sample1
MOF(i)

Figure 5.14 *Mode of failure of concrete plaques repaired using Set 45.*

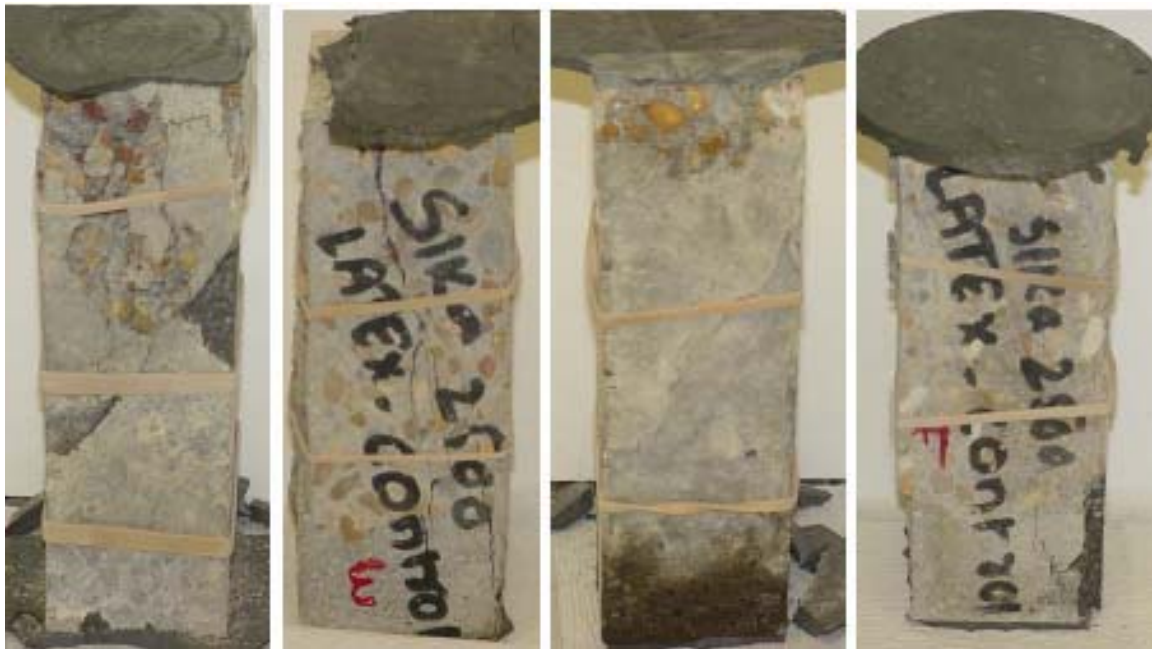
Sample1
MOF(ii)

Figure 5.17 *Mode of failure of concrete plaques repaired using Sika 2500 mixed with Latex.*

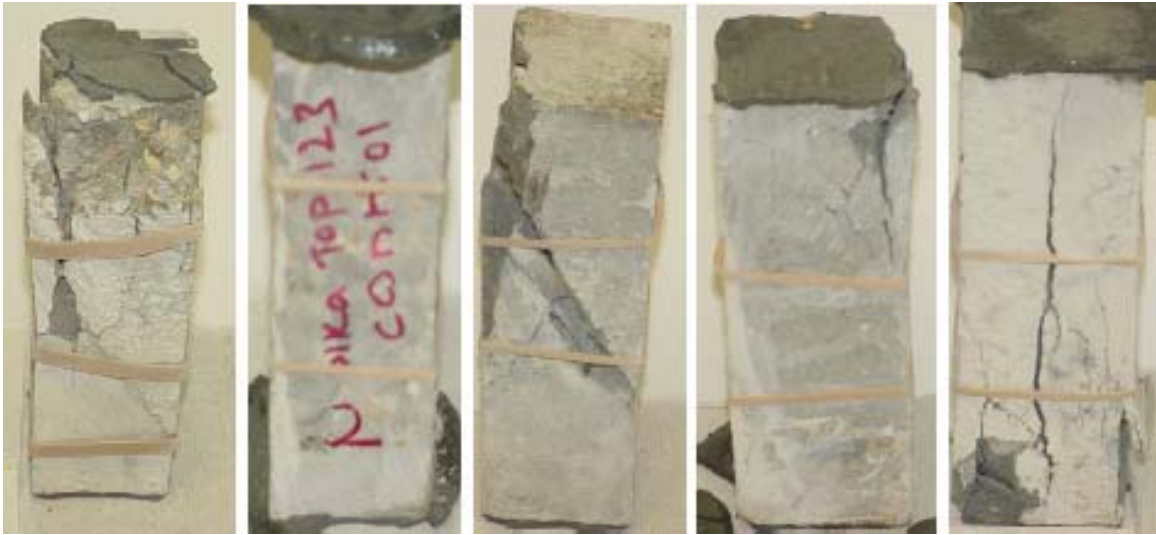
Sample1
MOF(iv)

Figure 5.18 *Mode of failure of concrete plaques repaired using Sika Top123 Plus.*

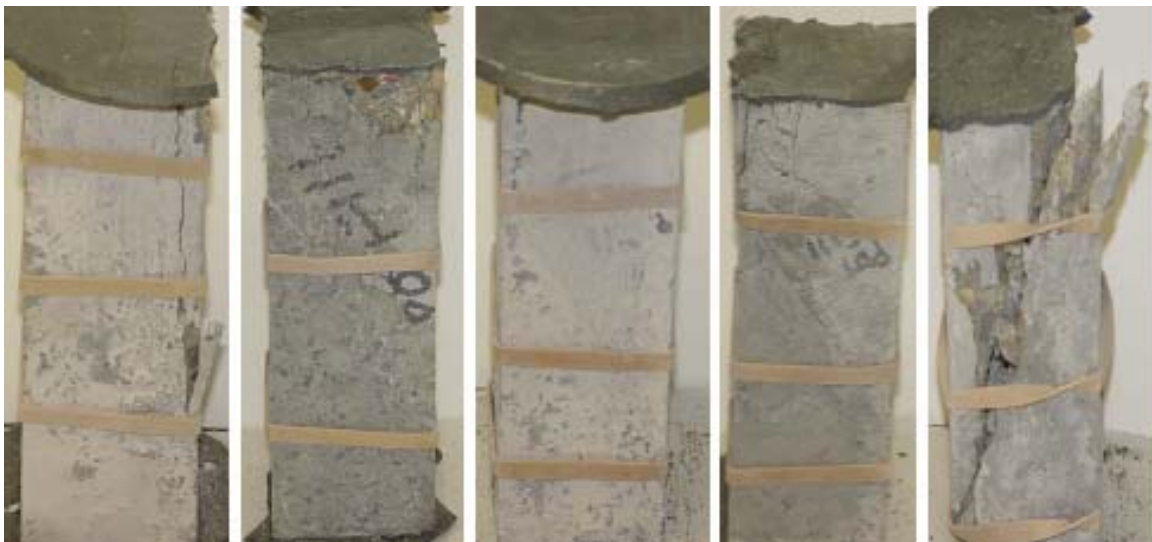
Sample1
MOF(iii)

Figure 5.19 *Mode of failure of concrete plaques repaired using Pot Fill.*

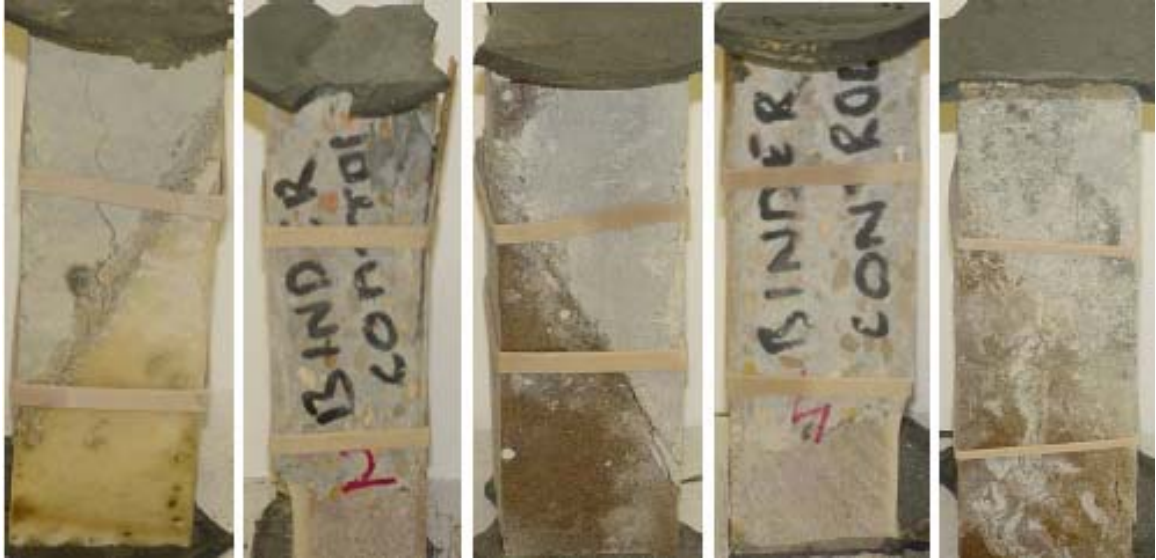
Sample1
MOF(ii)

Figure 5.20 *Mode of failure of concrete plaques repaired using HP Binder.*

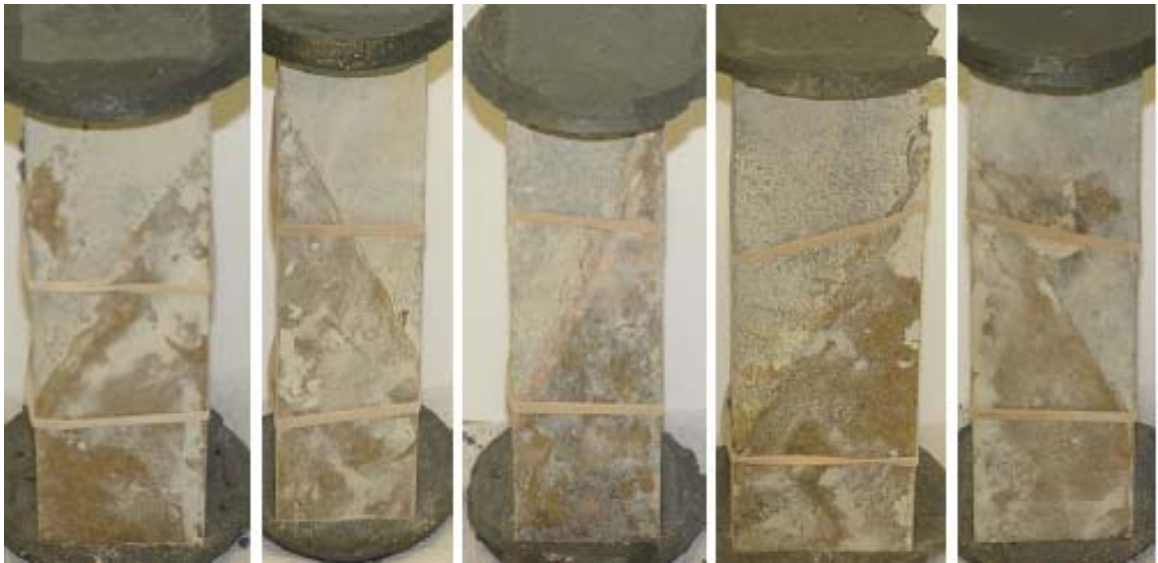
Sample1
MOF(ii)

Figure 5.21 *Mode of failure of concrete plaques repaired using HP GPA.*

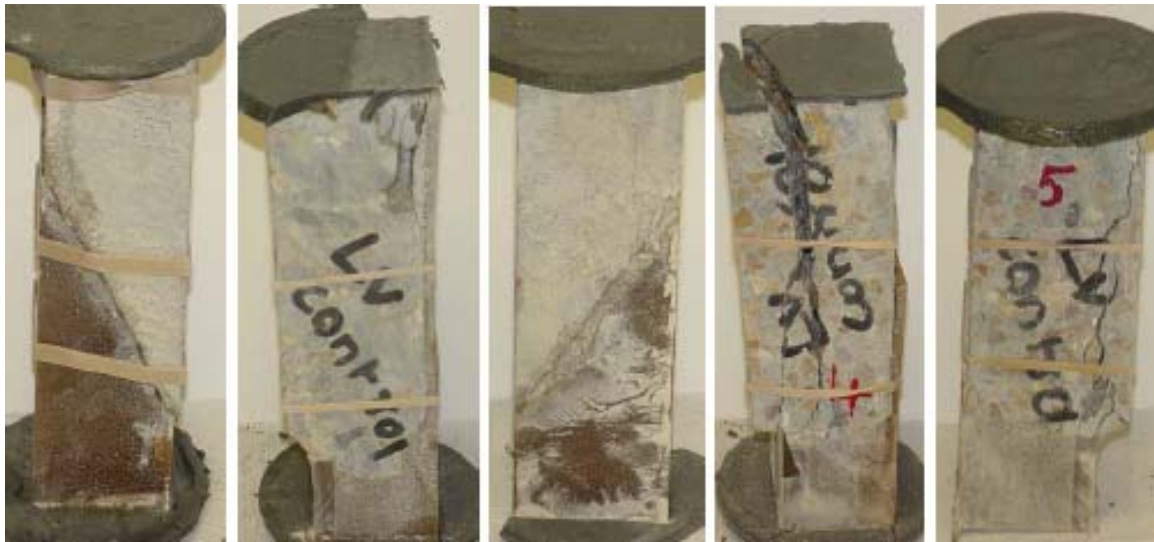
Sample1 MOF(ii) Sample2 MOF(ii) Sample3 MOF(ii) Sample4 MOF(iii) Sample5 MOF(iii)

Figure 5.22 Mode of failure of concrete plaques repaired using HP LV.

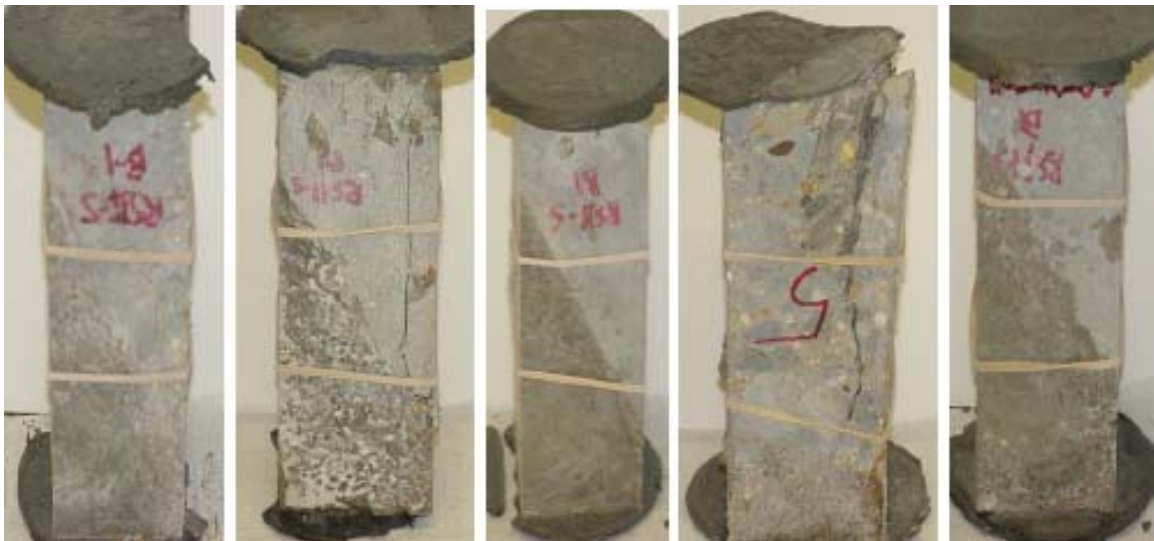
Sample1 MOF(iv) Sample2 MOF(iii) Sample3 MOF(iv) Sample4 MOF(iv) Sample5 MOF(iv)

Figure 5.23 Mode of failure of concrete plaques repaired using Resurf II (summer cured).

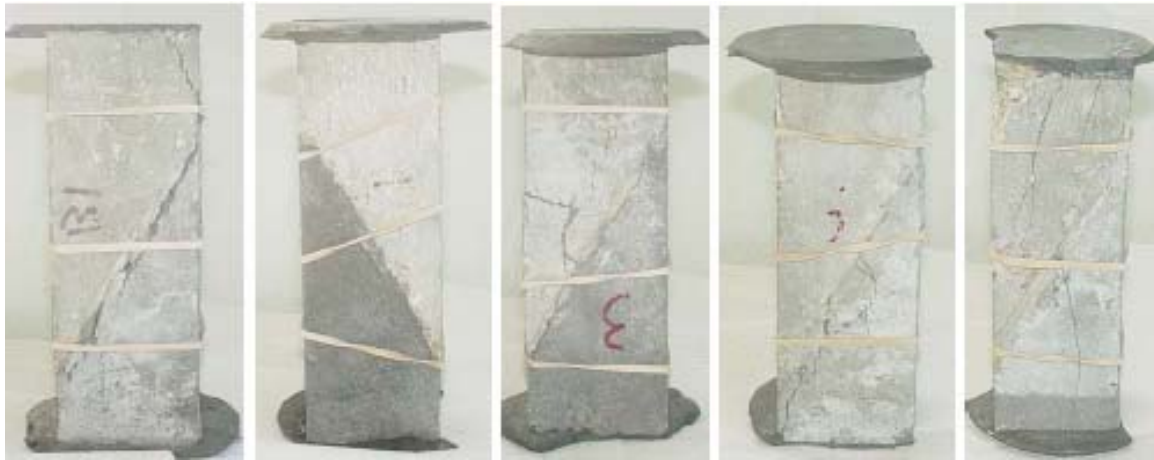
Mode of failure of concrete plaques repaired using Road Patch and subjected to 60 thermal cycles

Sample1
MOF(iii)

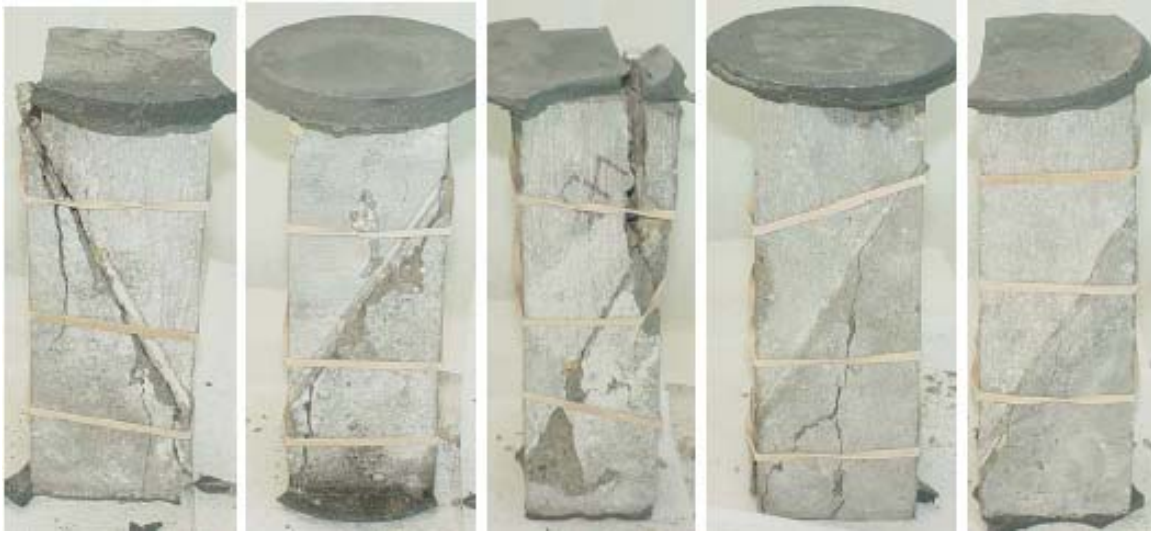
Mode of failure of concrete plaques repaired using 14K HY Flow and subjected to 60 thermal cycles

Sample1
MOF(iii)

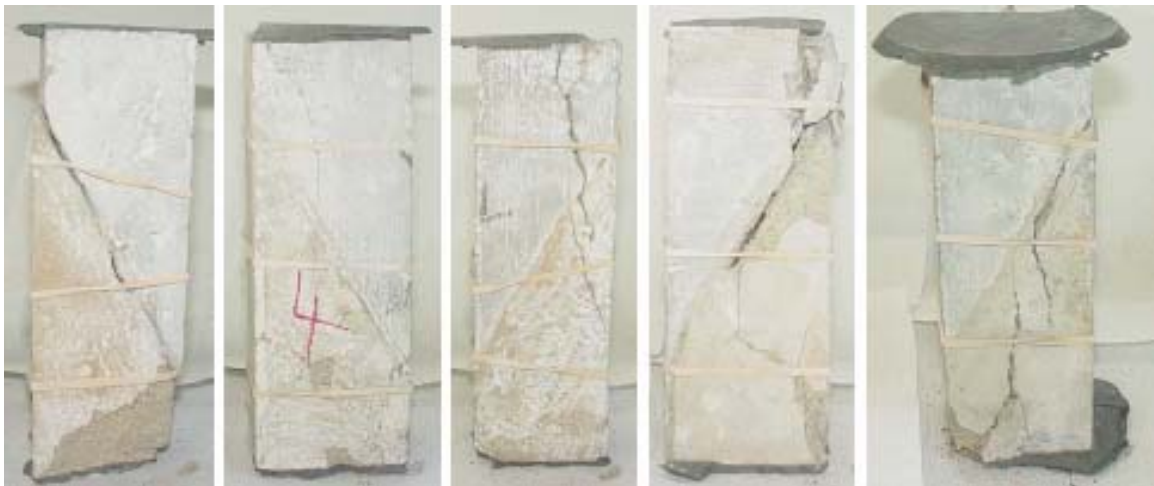
Mode of failure of concrete plaques repaired using Set 45 and subjected to 60 thermal cycles

Sample1
MOF(iii)
