1. Report No. FHWA/TX-12/0-6408-1		2. Government Accession No.		3. Recipient's Catalog No.	
4. Title and Subtitle RESEARCH AND RECOMMENDATIONS FOR A STATEWIDE SIGN RETROREFLECTIVITY MAINTENANCE PROGRAM				5. Report Date December 2011 Published: April 2012

**RESEARCH AND RECOMMENDATIONS FOR A STATEWIDE SIGN
RETROREFLECTIVITY MAINTENANCE PROGRAM**

Report 0-6408-1
Project 0-6408
Project Title: Development of a Statewide Sign Maintenance Program

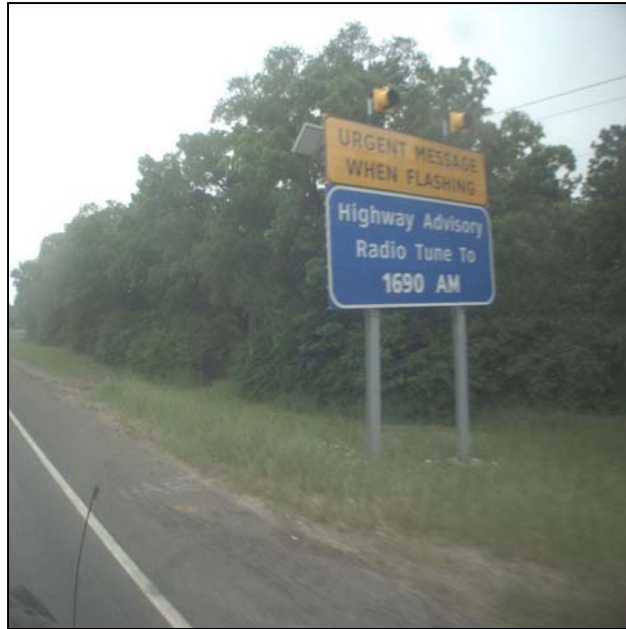
This section contains the researchers' analysis of the data set for both the closed-course and open-road evaluations. The final data set was delivered and enclosed in a zip folder that was approximately 26 megabytes. The folder contained one Excel® spreadsheet and 382 sign image files. Each sign image file was labeled with a sign ID number that corresponded to the appropriate sign information contained in the spreadsheet. The spreadsheet columns included sign ID number, color, message content, size, location, post and support information, face direction, GPS data, sheeting type, entrance angle, and computed retroreflectivity. The retroreflective measurements included only sign background measurements (no measurements were made of the signs' legends) and were at an observation angle of 0.2° and an entrance angle of -4.0° . The spreadsheet and sign images provided sufficient information to cross-reference the information. Figure 6 shows one of the sign images that were included in the zip folder.

Figure 6. Example of Image File.

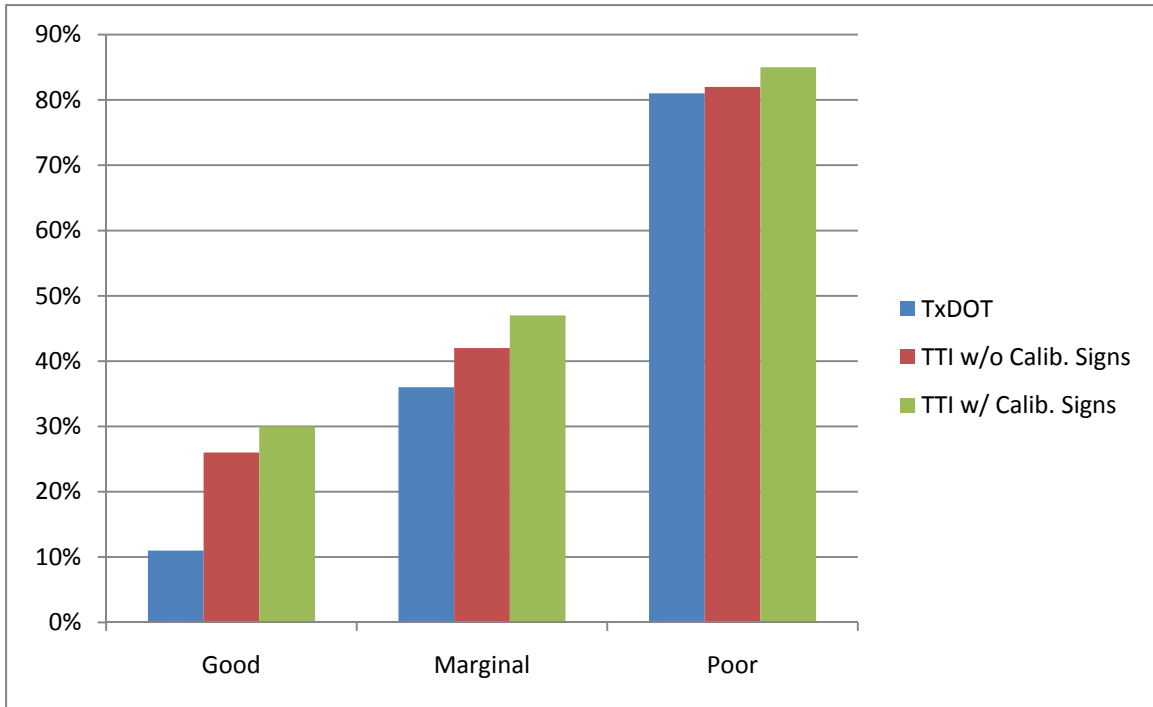
Figure 8. Percent of All Test-Track Signs that Were Failed by Participants, by Sign Category (All Colors).
