Measurement of the Pore Size Distribution of Limestone Aggregates in Concrete Pavement Cores: Phase I

Final Report

Kansas State University

**THE KANSAS DEPARTMENT OF TRANSPORTATION
TOPEKA, KANSAS**

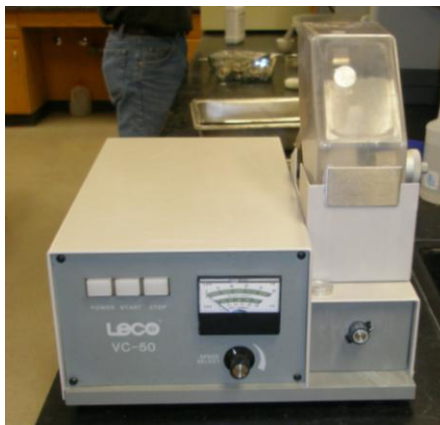
FIGURE 2.1
Leco VC-50 Precision Saw
Used to Remove Limestone
Aggregates from Concrete
Cores

1. The concrete core was cut in sections perpendicular to the core length using the Leco VC-50 precision saw shown in Figure 2.1. The cross sections were then trimmed to isolate individual aggregates. The selected aggregate was then sanded flat using 600 grit sandpaper and cleaned using compressed air.

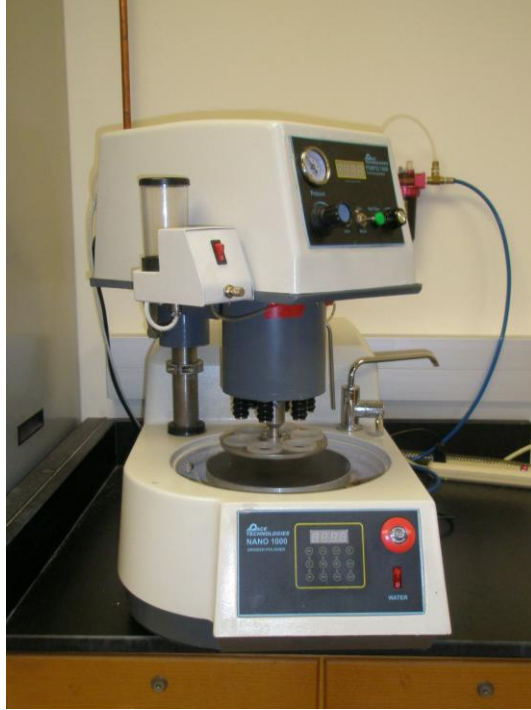
FIGURE 2.2
NANO 1000 Grinder Polisher with
FEMTO 1000 Automated Polishing
Head Used in this Study

6. The sample was cleaned in an isopropanol ultrasonic bath. The sample was then polished using the NANO 1000 grinder/polisher with the FEMTO 1000 automated polishing head (Pace Technologies) as shown in Figure 2.2. A propylene glycol drip was used for sample lubrication. Samples were cleaned between each automated polishing step in the isopropanol ultrasonic bath. The samples were polished at 200 rpm and 55 psi using the following polishing pads and diamond abrasive material:

- a. 9 µm diamond suspension on Texpan polishing pad for 2 hours
 - b. 3 µm diamond suspension on Texpan polishing pad for 1.5 hours
 - c. 1 µm diamond suspension on Atlantis polishing pad for 1.5 hours

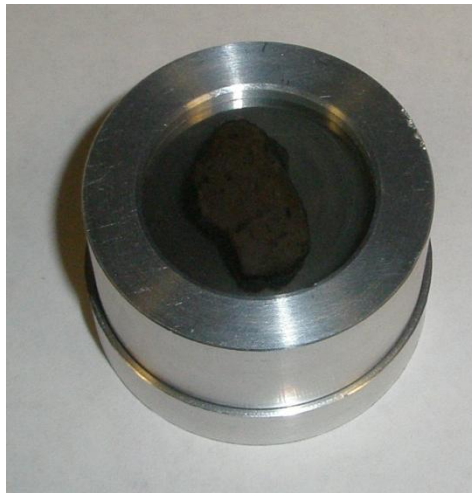
FIGURE 2.4
Polished Aggregate Sample in
Custom-Made Aluminum SEM
Sample Mount

8. Image the sample in the SEM in backscattered electron mode. The FEI Nova NanoSEM 430 microscope located at the Kansas State University Microscopy Facility was used in this study. The images used for pore size distribution were taken using 600 times magnification. A custom made specimen mount shown in Figure 2.4 was used to keep the aggregate level in the microscope to eliminate the need for refocusing the SEM for each image.

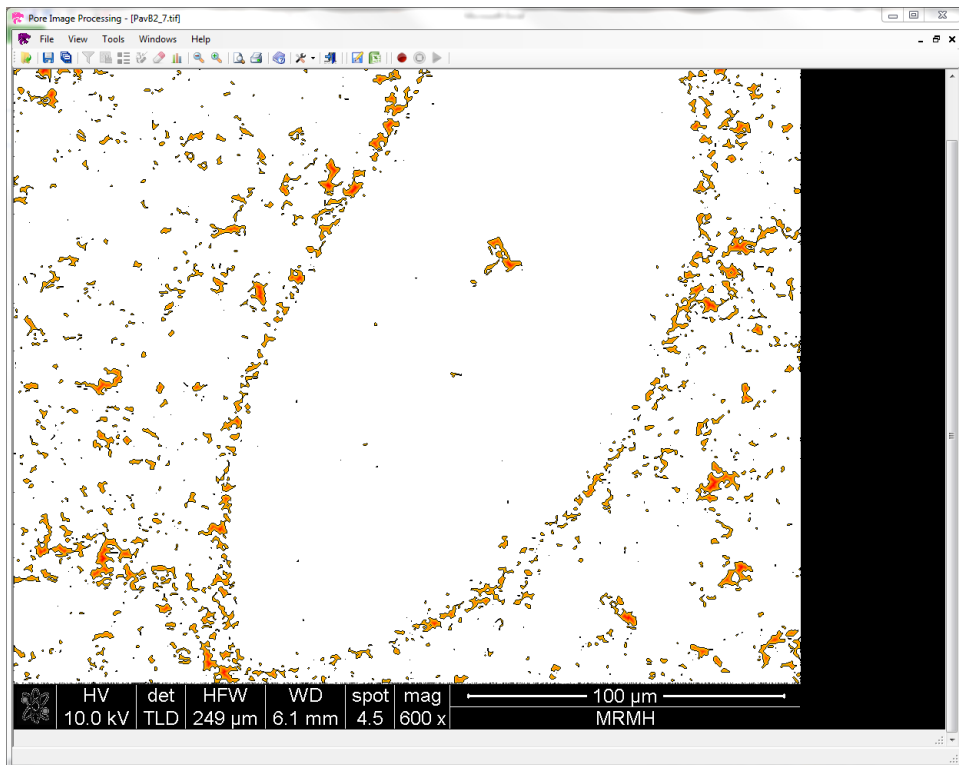
FIGURE 2.8
Pores Detected from the Same Image Shown in Figure 2.7

from the lighter-colored solid limestone, individual pores were detected as shown in Figure 2.8. Once the pores were detected, the pixels in each pore were assigned to a layer based on how close the pixel was to the exterior of the pore. A pixel that was touching a limestone pixel would be assigned to layer one, whereas a pixel that had one pixel in between it and the edge of the pore would be assigned to layer two. The number of pixels in each layer, the total pore area, and maximum pore width were then calculated.

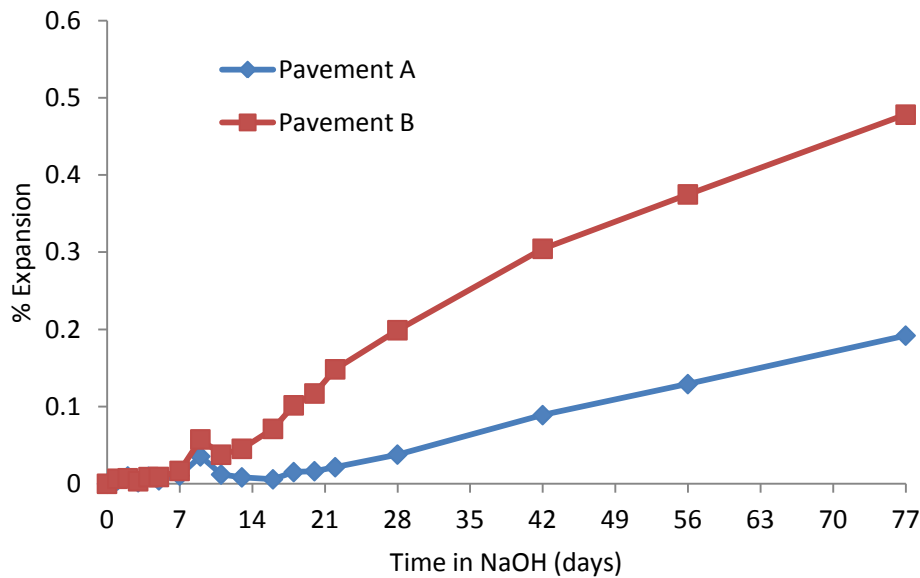
FIGURE 3.1
Expansion of Concrete Pavement Cores after Soaking in 1N NaOH Solution

Testing for potential AAR expansion was performed by soaking three cores from each pavement in a 1N NaOH solution for 11 weeks. The average expansion for each pavement core set is shown in Figure 3.1. The small amount of expansion seen during the first week of soaking is less than what would normally be expected to occur with mortar bar specimens normally used in ASTM C 1260. This is because it takes twice as much time for alkalis to reach the center of the cores as it would the smaller mortar bar specimens that have a one inch by one inch cross section. Higher potential expansion seen in pavement B indicates that the aggregates used in pavement B have the potential for AAR reaction and deterioration given enough alkalis and water, which are much more prevalent at the joints.

Software for automating image analysis of aggregate pores in SEM images has been developed and used on samples taken from two different concrete pavements with different levels of field performance. A procedure has also been developed for sectioning, epoxy impregnating, and polishing limestone coarse aggregates from concrete cores for SEM image analysis. SEM image analysis showed that the aggregates from pavement B had a higher total porosity, and higher amount of small pores. Aggregates from pavement A however had a higher percentage of small pores (below $10 \mu\text{m}^2$). The aggregates in pavement B showed a high potential for future AAR expansion given enough moisture and alkalis, which would be more available at the joints.

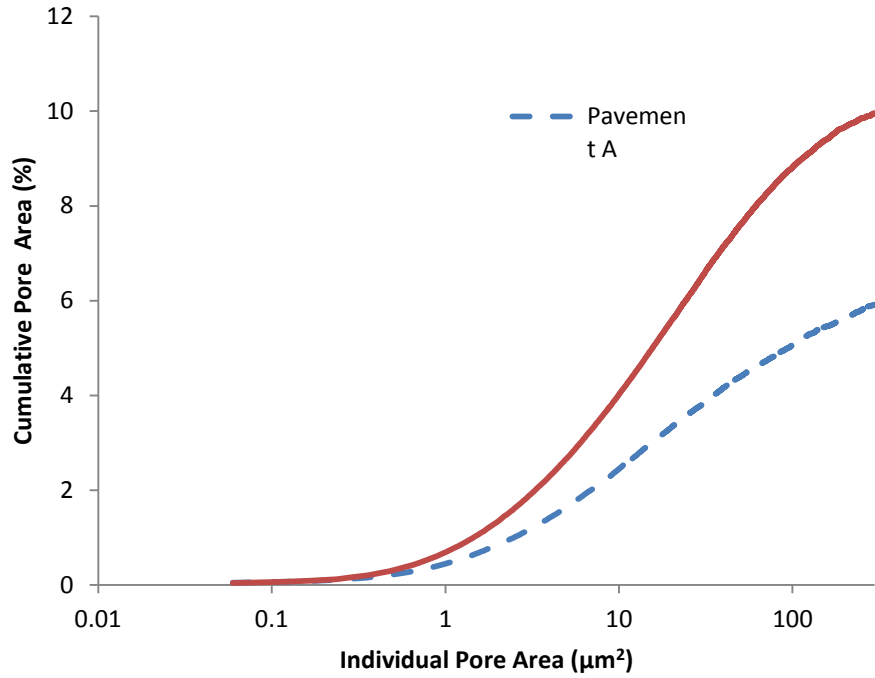
FIGURE 3.2
Limestone Aggregate Pore Size Distribution

Approximately 50 SEM images for three aggregates from each pavement were taken for aggregate pore size distribution quantification. Pavement B showed a higher total aggregate porosity than pavement A as shown in Figure 3.2. Figure 3.2 gives the limestone aggregate pore size distribution as a function of the aggregate pore area, instead of the oft-used pore diameter. This is because aggregate pores are not spherical in shape, making the pore area a more accurate description of the pores. Figure 3.3 shows the number of pores per unit of area for each pore size. Aggregates in pavement B showed a much higher number of pores with an area between 0.1 and 1.5 μm^2 . The number of aggregate pores with an area below 0.1 μm^2 was similar for both pavements; however this is because these pores were represented by only one pixel in the images. Smaller pores can be quantified in Phase II if desired by using a higher magnification which is recommended. This would, however, require taking more SEM images to image the same amount of aggregate area. The saw-tooth pattern shown in the aggregate pore size distribution in Figure 3.3 is likely an artifact of the discrete nature of pore areas and likely would be smoother when using a higher microscope magnification. The normalized cumulative pore size distribution for aggregate pores with an area less than 297.4 μm^2 (5000 pixels) was calculated by dividing the cumulative pore size distribution by the total area of the pores within this size, as shown in Figure 3.4. This showed that the pores in the aggregate from pavement A had a higher percentage of smaller pores than the aggregate from pavement B, although a smaller total amount.
