RESEARCH REPORT

LONG-TERM BED DEGRADATION IN MARYLAND STREAMS (PHASE 2): BLUE RIDGE AND WESTERN PIEDMONT PROVINCES

Project Number SP109B4K
FINAL REPORT

March 2012

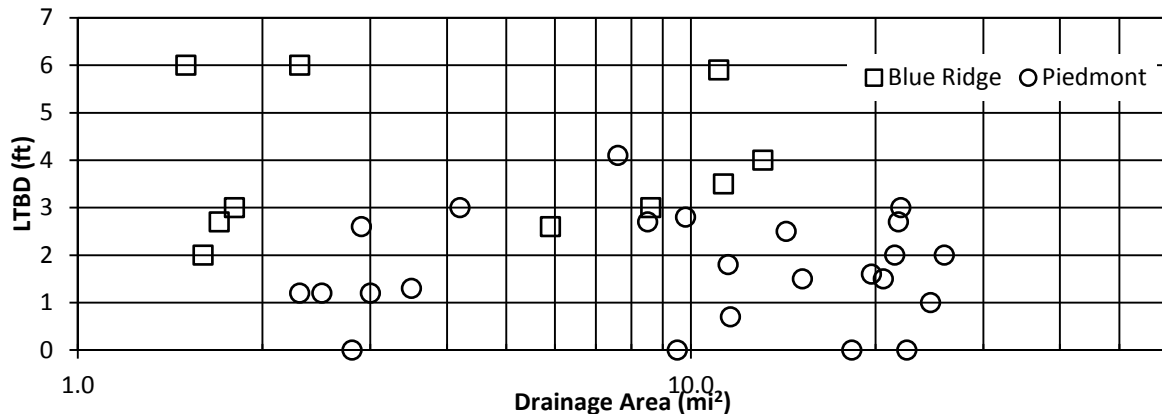
Figure 4.1. Variation of LTBD with drainage area for each physiographic province.

Maximum and minimum values of LTBD in the Blue Ridge were higher than those in the Piedmont, which suggests that rates of LTBD differ between the two provinces. Although the datasets are too small to draw a reliable conclusion about a relationship between LTBD and drainage area in each region, the data do not suggest even a weak correlation between the two variables (Figure 4.1).

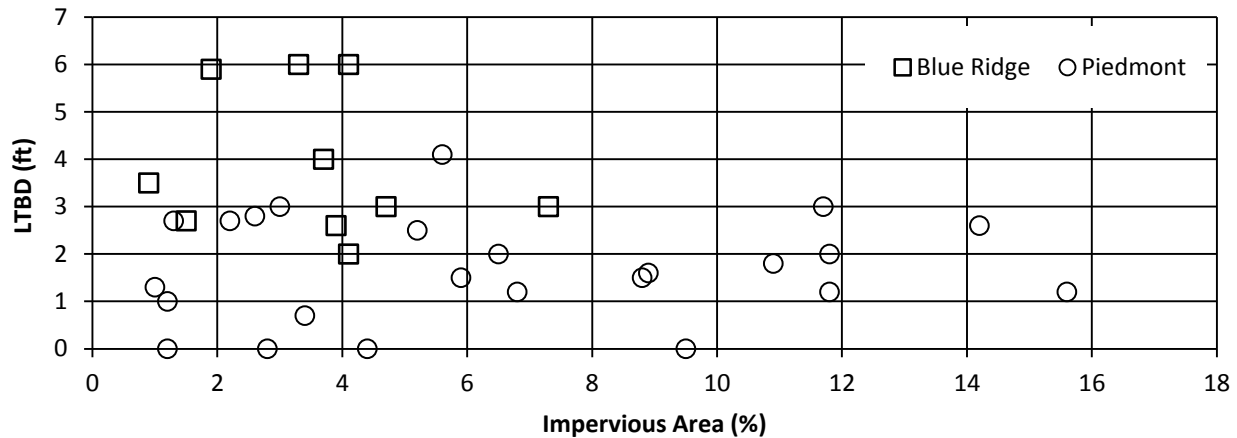
Figure 4.2. LTBD as a function of impervious area.

Impervious area varied from 0.9 percent to 7.3 percent in the Blue Ridge and from 1.0 percent to 15.6 percent in the Piedmont. The effect of impervious area was examined to determine whether use of sample sites with imperviousness of between 10 percent and 16 percent would introduce another factor that would influence LTBD. The variation of LTBD (Figure 4.2) indicates that impervious area has no correlation with LTBD for Piedmont streams with watershed imperviousness of 0 percent to 16 percent.

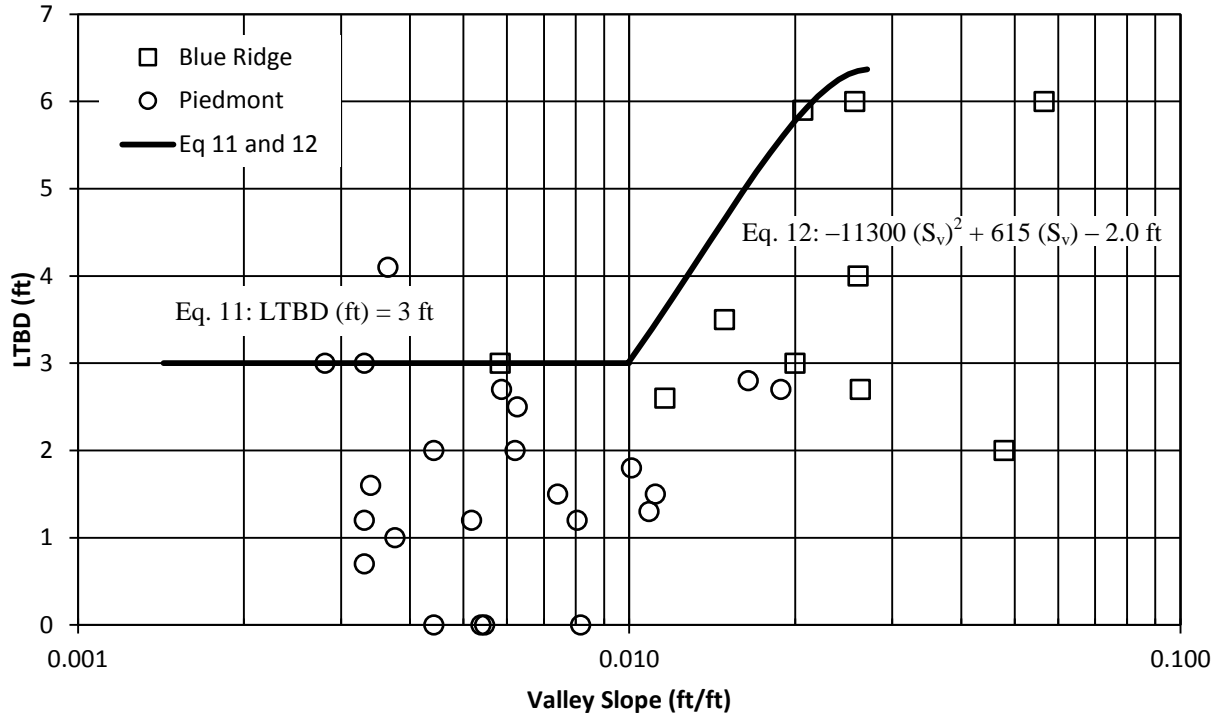
Figure 4.3. LTBD as a function of valley slope.

Valley slopes in the Blue Ridge were steeper than those in the Piedmont. Maximum values of LTBD increased in the Blue Ridge in the range of slopes from 0.01 to 0.02. This trend of increased maximum LTBD with slope in the Blue Ridge is similar to that found in the same range of valley slopes in Phase 1 study sites in western Maryland. The conservative upper limit curve that described the LTBD observed at Phase 1 sites as a function of valley slope (S_v) was given as

Data from the Piedmont do not indicate an increase in maximum observed LTBD with slope. One reason for this lack of correlation may be the similarity of the slopes in the sample: few stream reaches in the western Piedmont with watershed areas greater than 1 mi² have slopes that exceed 0.012 ft/ft. The two sample points (44 and 45) (Photo 4.1) where the valley slope exceeds 0.012 ft/ft in the Piedmont are located near the base of Catocin Mountain and within 1 mile of the Blue Ridge Physiographic region border.

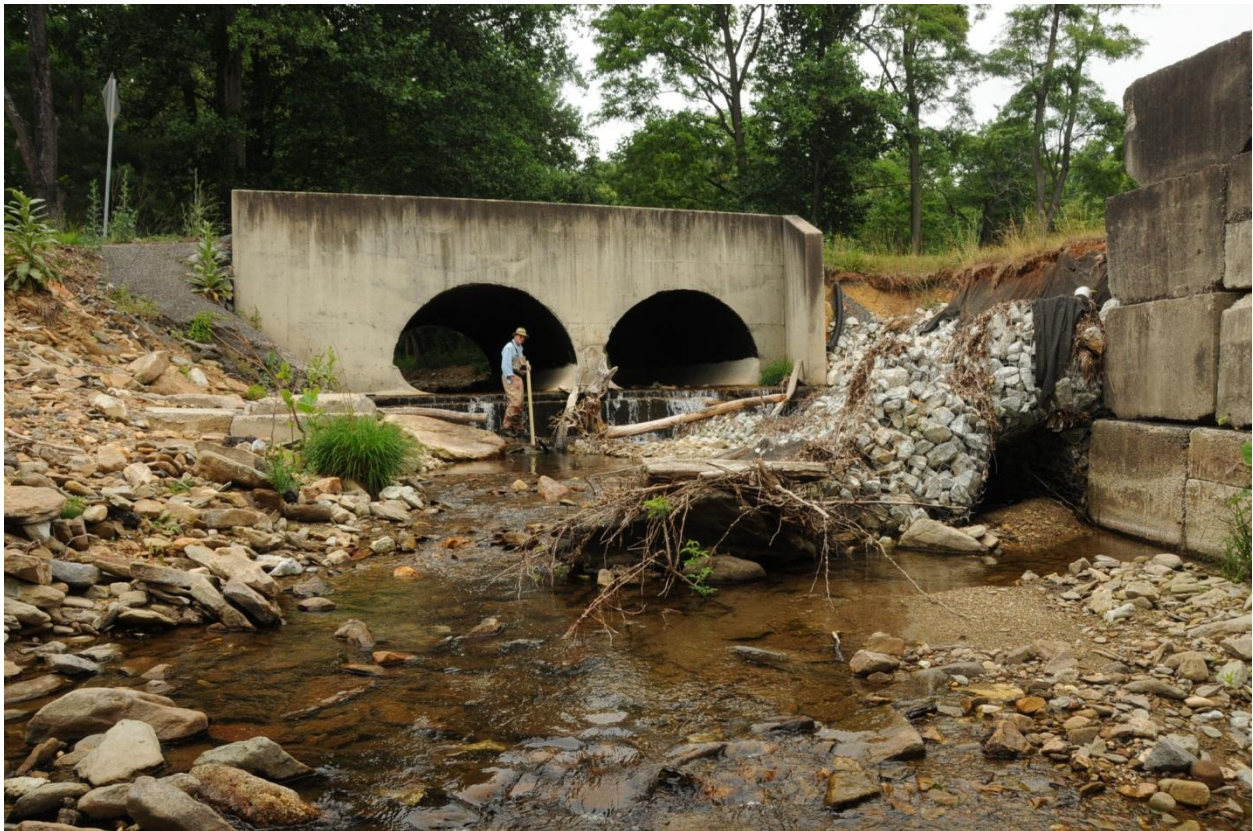
Photo 4.1. LTBD measured at the culvert outlet of Site 45.

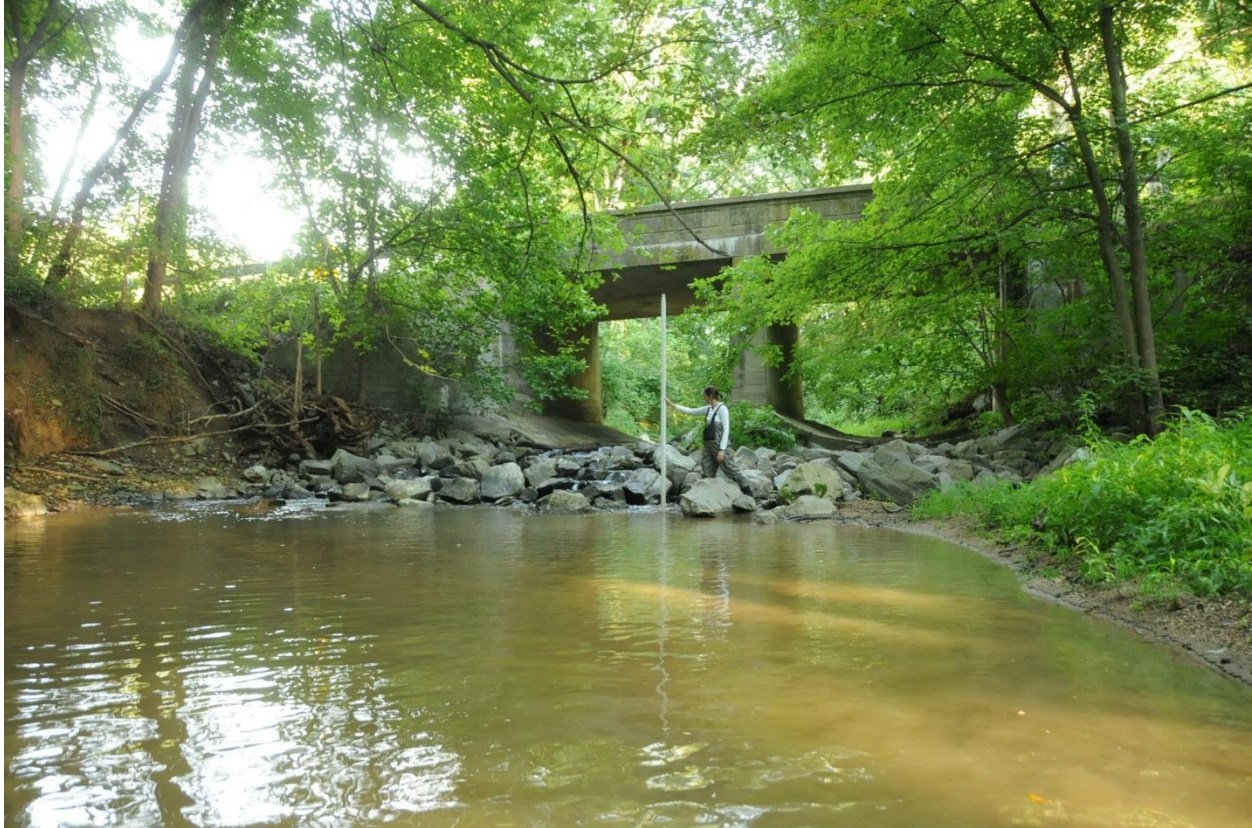
Photo 4.2. LTBD measured downstream of bridge at Site 50.

Eq. 11 and 12 that describe a conservative upper limit curve for the western Maryland data provide an upper bound for all of the Phase 2 Piedmont data except for Site 50 (Photo 4.2). This site is

different than other sites because the bridge at this location was founded on the sediment deposit of a milldam that is now breached. The breached dam is located approximately 570 ft downstream of the bridge where LTBD was measured. The dam height was estimated to be approximately 8 ft over the current water level. This sample site illustrates that Eq. 11 does not provide a conservative upper limit curve for sites located on sediment deposits formed in the backwater of dams or other structures that previously caused aggradation of the valley with fine sediment. Removal of these structures may cause LTBD to be significantly larger than at other sites in the same region.

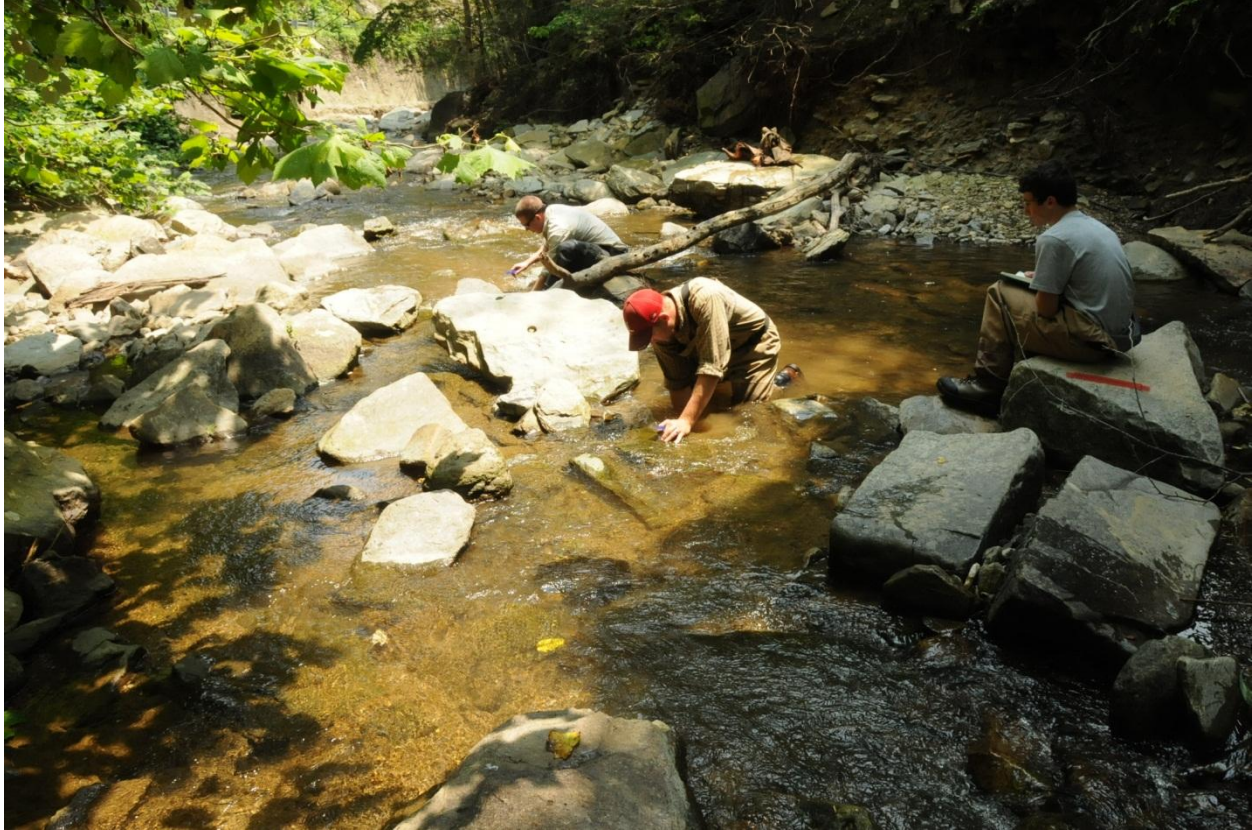
Photo 4.3. Boulder armor at Site 29.

Data from the Blue Ridge and Piedmont indicate that BMI is not a good index to predict the observed LTBD (Figure 4.5). One reason for the lack of correlation of LTBD with BMI is the dependence of BMI on the measured D_{50} at each site. As channels degrade vertically, they tend to erode into larger bed material; therefore at some sites, the measured bed material may be larger than it would have been prior to channel degradation. At several sites, the bed was armored with material that was substantially larger than the material in the channel banks that may represent the characteristics of the bed prior to channel degradation (Photo 4.3).

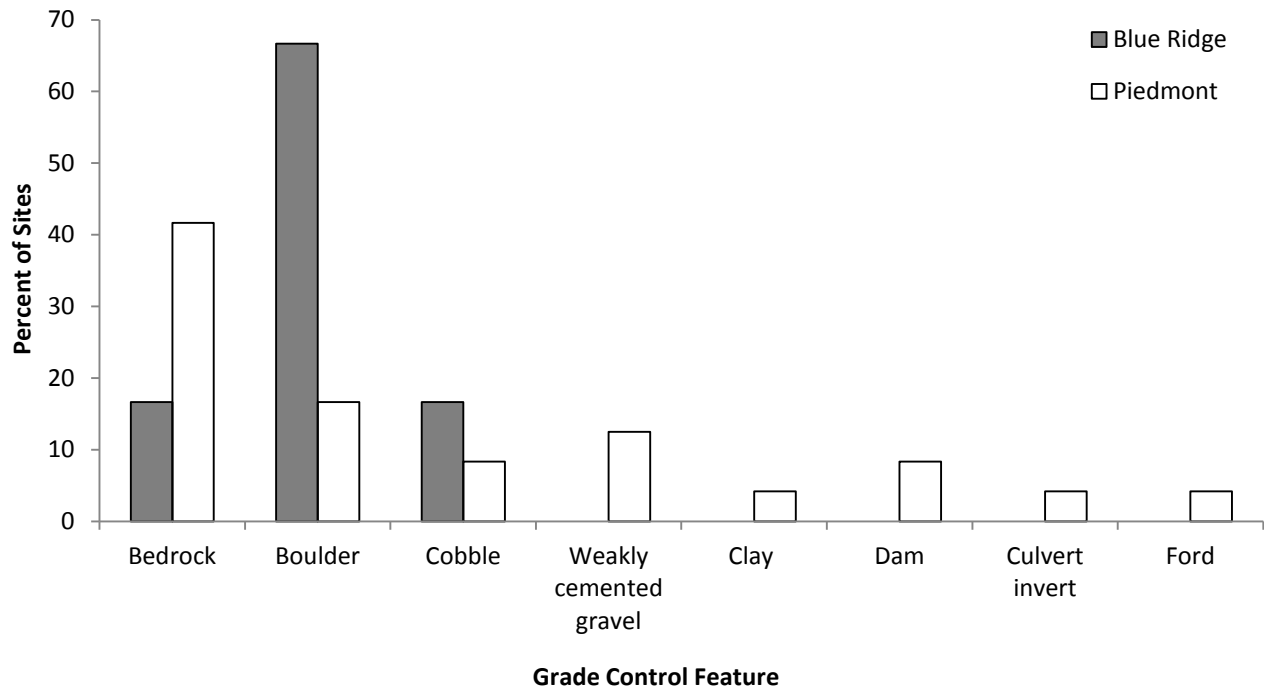
Figure 4.6. Grade control features identified in Blue Ridge and western Piedmont streams.

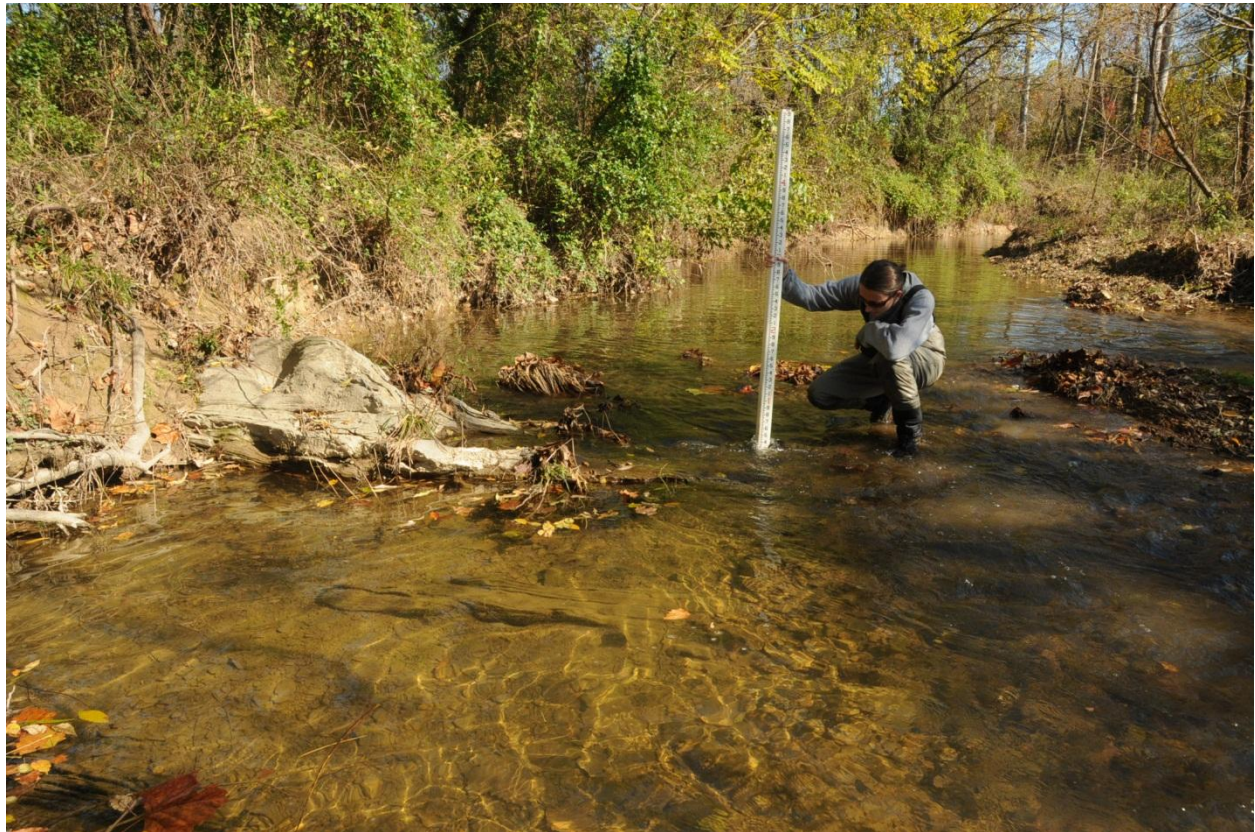
Photo 4.4. Bedrock exposed in streambed downstream of Site 49.

- The most frequent apparent form of bed control (42 percent) in the Piedmont was bedrock exposure (Photo 4.4). **Bedrock exposure** was typically but not always observed in stream reaches along the edge of valleys near the base of hillsides. Unlike bedrock steps that formed bed controls in highly resistant bedrock observed in western Maryland, fractured and weathered bedrock was most commonly observed in pools, shallow runs, or riffles with drops as small as 0.1 ft. The low-flow water surface slope was rarely controlled by exposed bedrock. Instead, it was controlled by cobble or gravel riffles. Because the fractured and weathered bedrock does not form the highest points in the channel profile during low flow, it may or may not be controlling the stream grade.

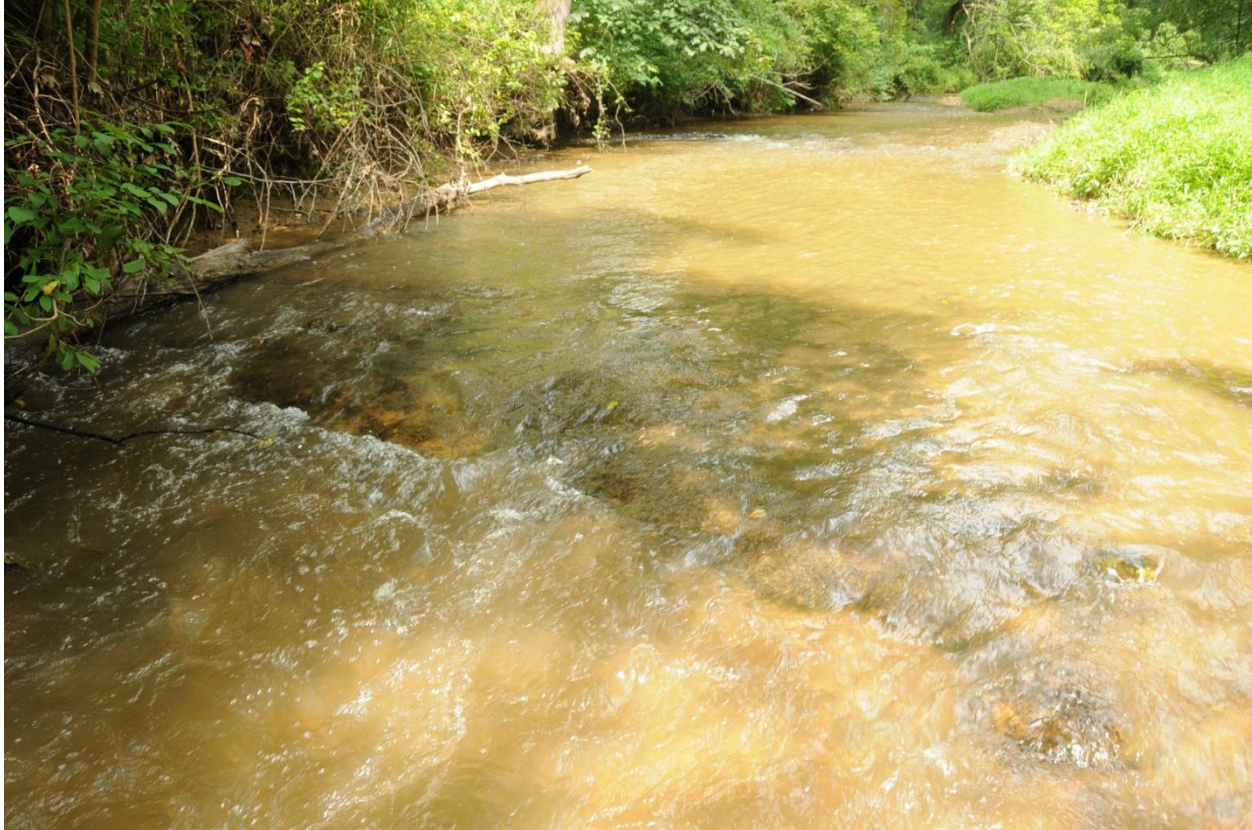
Photo 4.5. Step in channel profile composed of weakly cemented gravel downstream of Site 36.

- **Cobble-armored reaches** that provided bed control were observed at 8 percent (2 sites) of Piedmont sites.
- **Weakly cemented gravel layers** (Photo 4.5) form bed control at 13 percent (3 sites) of Piedmont sites. Small steps formed by the erosion of the gravel layers migrate upstream as headcuts, and they represent a gradual upstream progression of bed degradation.
- **A thick deposit of clay** was observed at Site 55 in a small tributary to the Potomac River. No bed control features were observed within 1000 ft downstream of the site.
- **Two dams, a culvert invert, and a ford** were identified as downstream controls at the remaining four sites in the Piedmont.
