Driver Reaction at Railroad Crossings

UTCA Report Number 08401
August 2012

UTCA Theme: Management and Safety of Transportation Systems

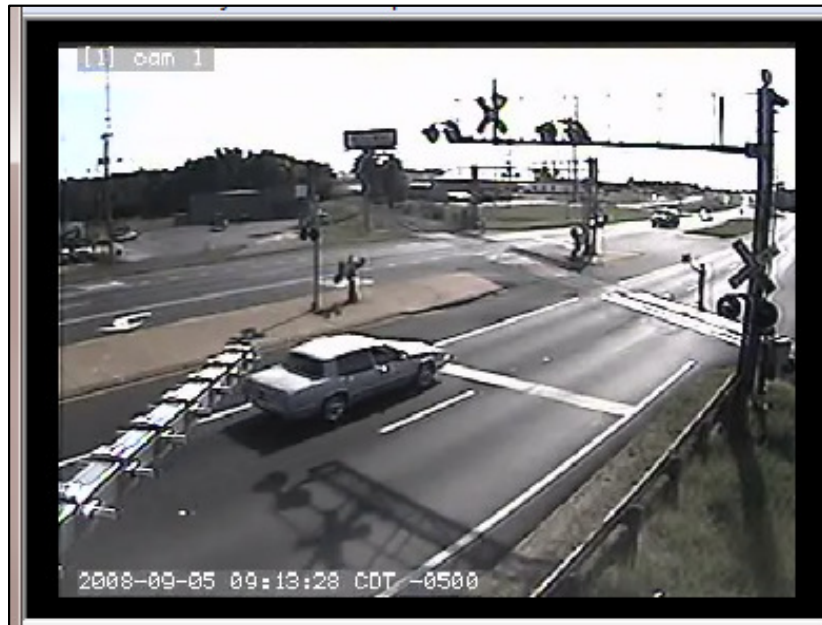
Figure 3-1. The crossing before gate installation

The research team planned to analyze the images to compare driver behavior before and after the Quixote system was added. Figure 3-1 shows a train at the crossing before the gates were added. In the pre-gate (before) case, as the train approached the crossing, two flagmen descend from the train and trigger flashing warning lights. Then, they stand in the roadway and use flags to stop vehicles prior to the passage of the train. After the train passed, they turn off the warning

lights and re-join the train. In Figure 3-1, a flagman is visible in the far right lane stopping a passenger vehicle. Conversations with representatives from the Gulf and Ohio Railroad confirmed that in general, the intervention of the flaggers was required to stop traffic: signing and flashers were insufficient.

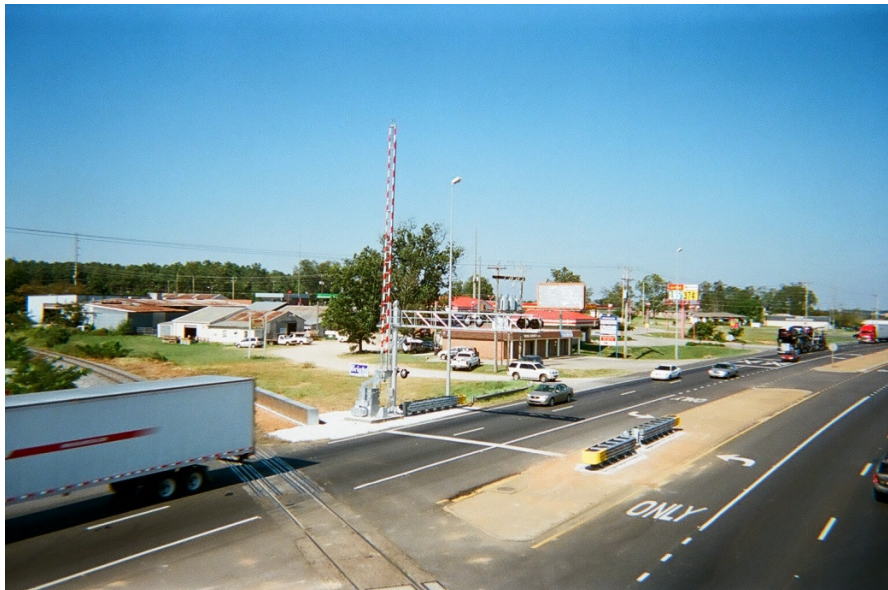
Figure 3-3. Northbound lanes after installation

Figures 3-3 and 3-4 present photographs of northbound and southbound approaches after installation of the gates. Figure 3-3 depicts the northbound lanes and the gate in the vertical position. Figure 3-4 shows the southbound lanes and the gate after it has descended and been locked in place.

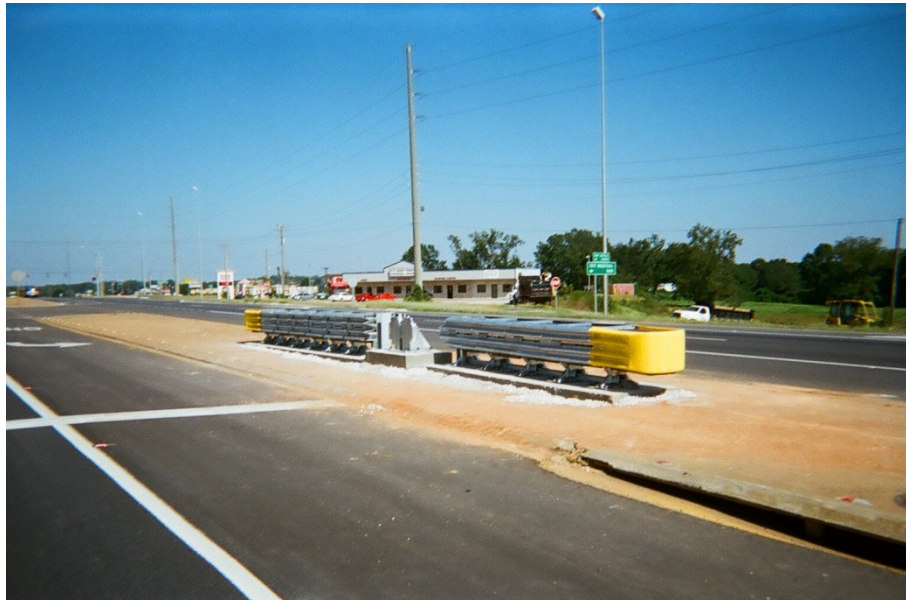
Figure 3-5. Locking mechanism for northbound lanes

Figure 3-5 shows a closer view of the mechanism which locks the gates serving the northbound lanes.

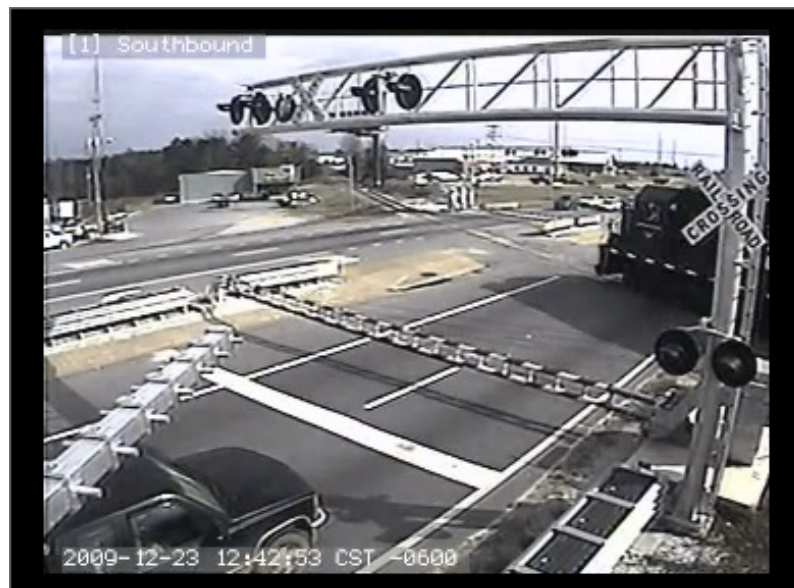
Figure 4-1. Southbound post-gate digital image

Figures 4-1 and 4-2 show examples of the post-gate images. Both figures demonstrate the difficulties the research team experienced to detect when flashers stopped and end and the inability to see more than one or two rows of stopped vehicles.
