**Rapid Construction of Pacific Street Bridge**

**PROJECT: SPR-PL-1 (037) P587**

FINAL REPORT

NEBRASKA DEPARTMENT OF ROADS

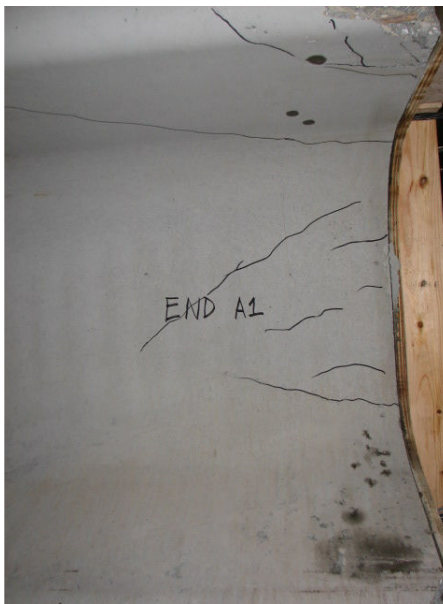
*Figure 2.7.1: A1 end zone cracking*

The girder experienced a slight amount of end zone cracking. The majority of the cracks were very small and difficult to see without very close inspection. The cracks were highlighted with marker and are shown in Figures 2.7.1 - 2.7.4.

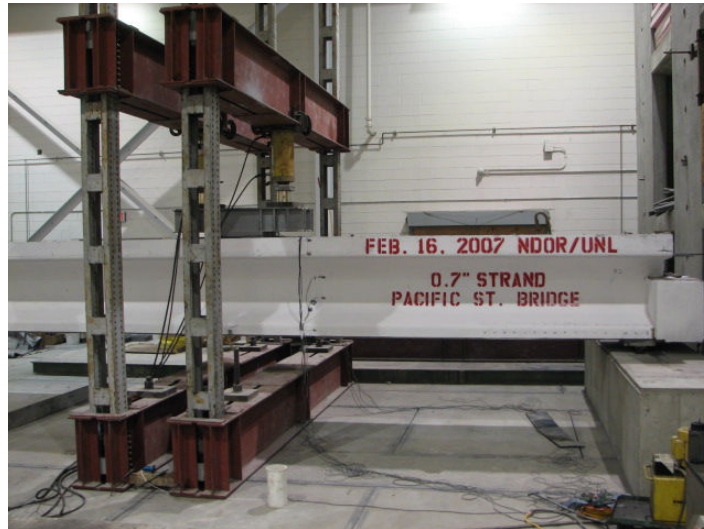
*Figure 2.11.1.2: Girder test setup, double jacks and frames*

The actual girder is shown in Figure 2.11.1.2 and is the 15' end of the asymmetrical load. The diaphragm is visible on the end as well as the strain gauges placed in a vertical line 3 feet from the centerline of loading. The strain gauges were placed away from the point load to avoid premature failure of the gauge by cracking or spalling concrete. A deflection gauge was attached exactly below the center of the load point, 15 feet from the girder end.

Two 400 kip jacks were used in a series to achieve the predicted capacity required to reach ultimate flexural strength. The two jack loading was balanced on a spread beam which had a 24” by 30” base plate loading to neoprene pads and then to the girder. The load was applied in 50 kip increments up to failure.

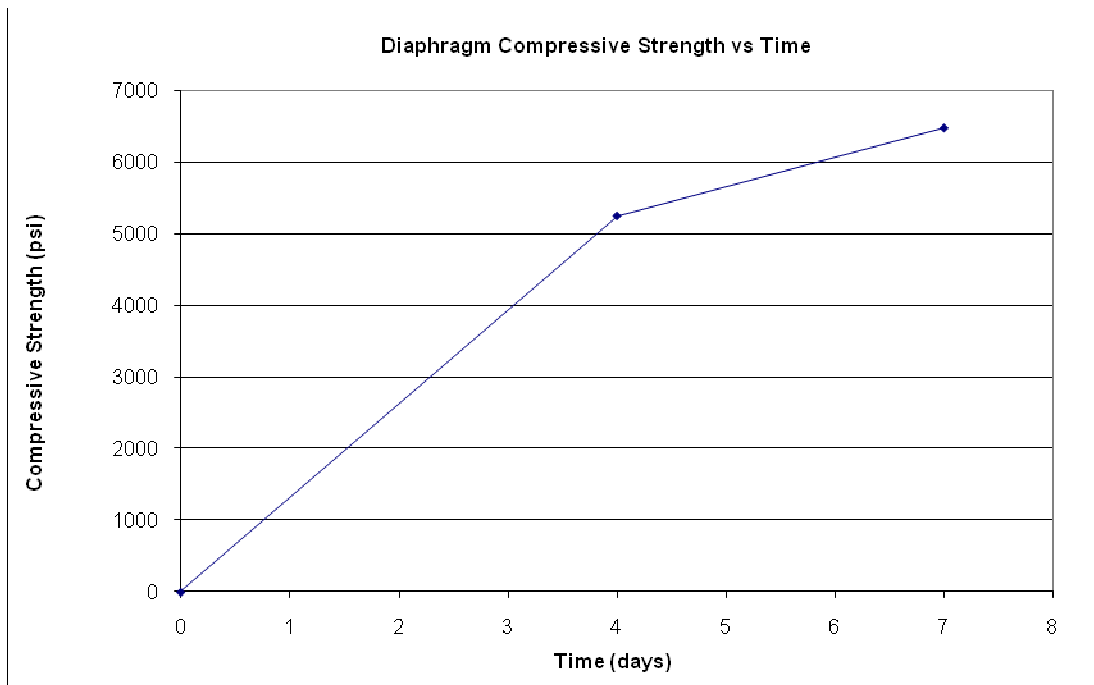
*Figure 2.11.2.3 Diaphragm compressive strength versus time*

the deck. The diaphragm just had to be a minimum compressive strength of 6 ksi, which was exceeded.

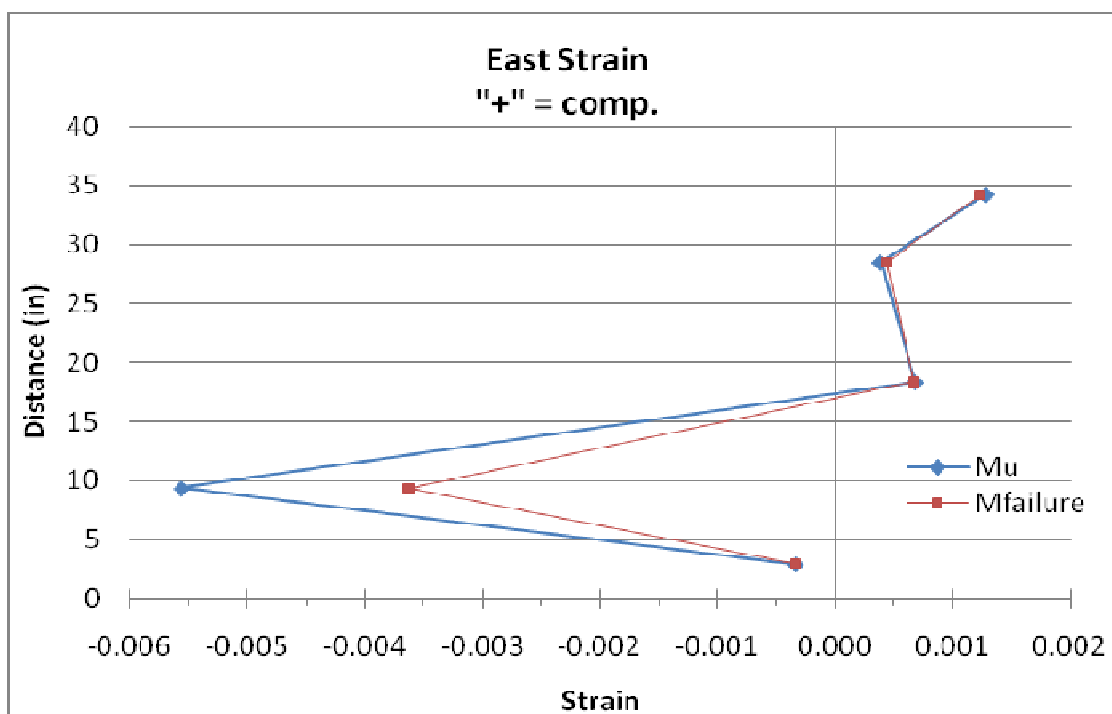
Figure 2.11.4.1: Strain East side of girder at ultimate load and at failure load

A total of 10 strain gauges were attached 3' from the centerline of the load point and 12' from the girder end. On each side, 5 strain gauges were placed in a vertical column. The gauges were placed near the surface of the deck, near the surface of the top girder flange, low and high web positions, and at the centroid of the prestressing tensile steel. The following Table 2.11.4.2 is a summary of the strain values at various heights of the girder 12' from the girder end. Both ultimate load and at failure load strains are summarized.

The strain at ultimate load is a maximum value of 0.00129 recorded from the top east strain gauge 1.125 inches from the top of the deck. In Table 2.11.4.2, compression is positive. The strains are plotted in Figure 2.11.4.1 - 2.11.4.2.

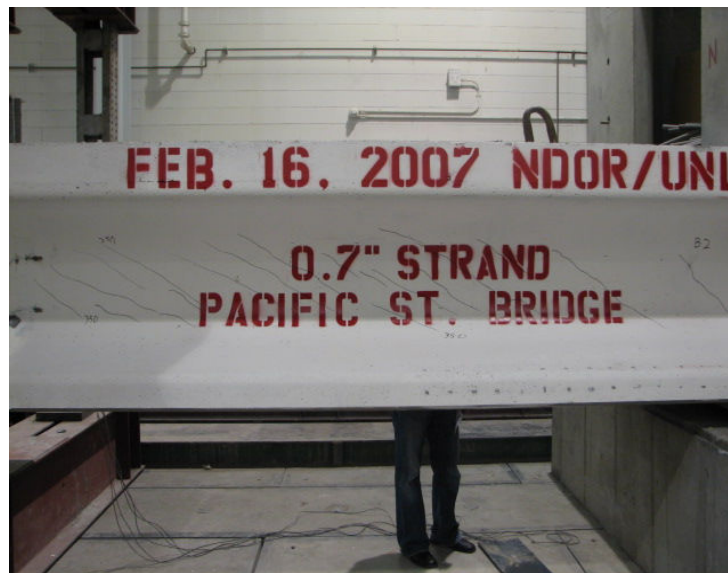
*Figure 2.11.4.3: Shear cracking in the web*

The progression of the test and results are shown in the following figures. Figure 2.11.4.3 shows shear cracking occurring in the web during the loading increments of 50 kips. The shear cracks are propagating through the flange as shown in Figure 2.11.4.4. The immediate shear failure is shown in Figure 2.11.4.5. Upon failure, the beam cambered upward and had a brittle explosion of the web and bottom flange. The shear distribution is shown in Figure 2.11.4.6. Flexure cracking was present at the load point and is shown in Figures 2.11.4.7. Another sign of flexural failure is the deck compression cracking at the load point and the buckling of the #5 bar in the deck shown in Figure 2.11.4.8. The deck cracked where the camber occurred and is shown in Figure 2.11.4.9.

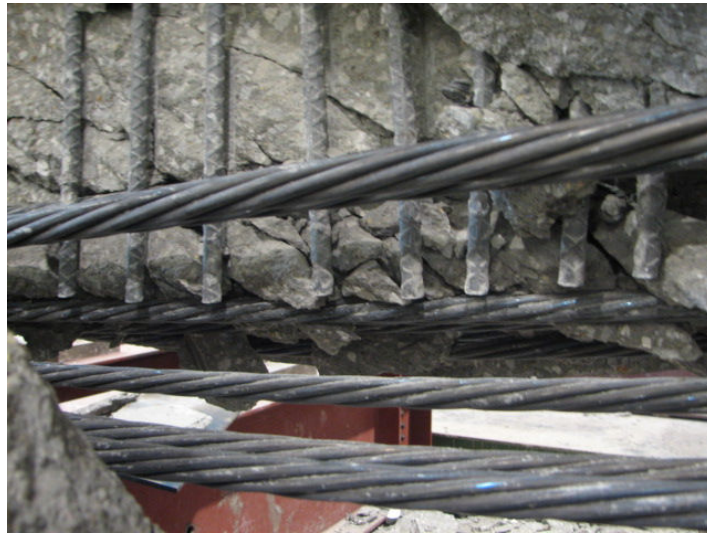
*Figure 2.11.4.10: Shear reinforcement non-bent in bottom flange*

The shear reinforcement was not detailed with a 90 degree bend in the bottom flange. The reinforcement was underdeveloped and allowed the web to separate from the bottom flange which resulted in a shear failure. Figure 2.11.4.10 display the straight shear reinforcement bars.

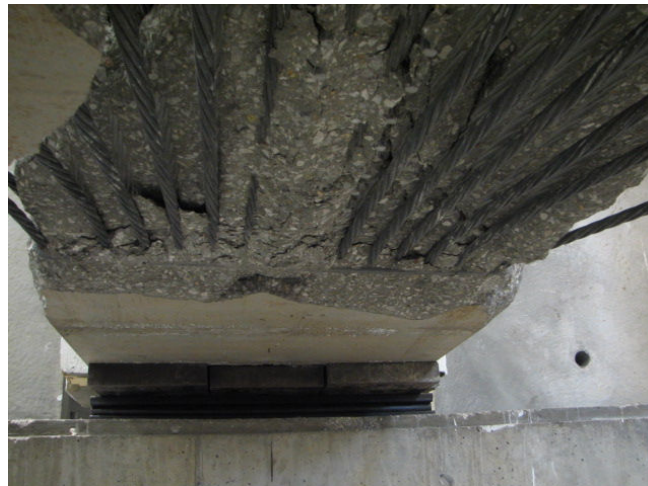
*Figure 2.11.4.11: Confined flange non-failed*

The hairpin confinement detail was effective throughout the transfer length. The hairpins were placed at 3” centers for 45 inches at each girder end. The confinement kept the bottom flange from splitting from the web. The unfailed portion of the web and hairpin are shown in Figure 2.11.4.11. Longitudinal bottom flange cracking and loose strands are shown in Figure 2.11.4.12 - 2.11.4.13.

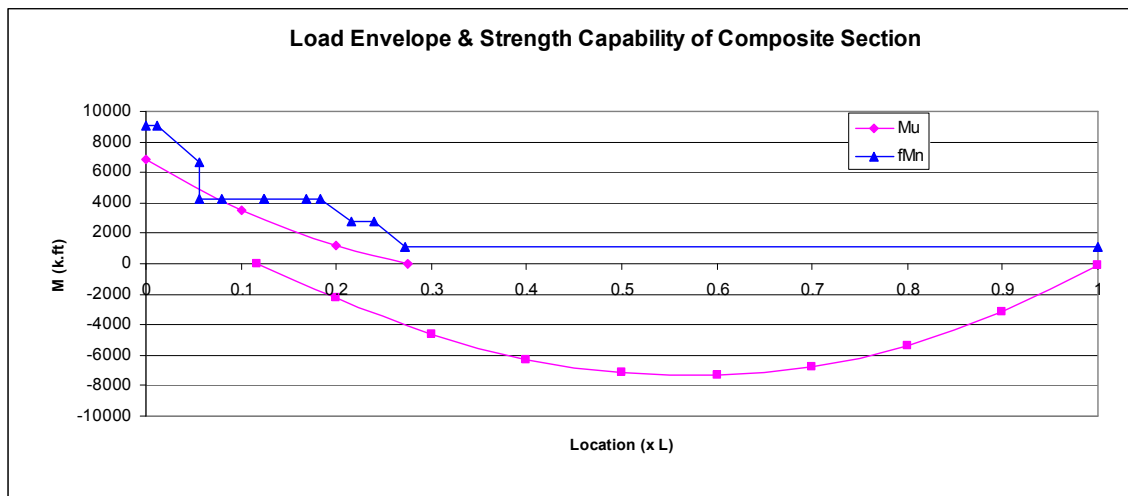
*Figure 3.2.2: Load Diagram and Cutoff Design for Composite Section*

For the 125'-125' two-span target bridge, the diagram of the factored load envelope shows that the negative moment due to the deck weight exists within 0.25L of the pier ( $0.25 \times 125 = 31.2$  ft). Concentration and crack will happen if the section changes suddenly. Therefore the threaded rod and #8 bars need to be staggered. The extending length after the cutoff point is the greater value between  $L_d$  and  $12d_b$ .

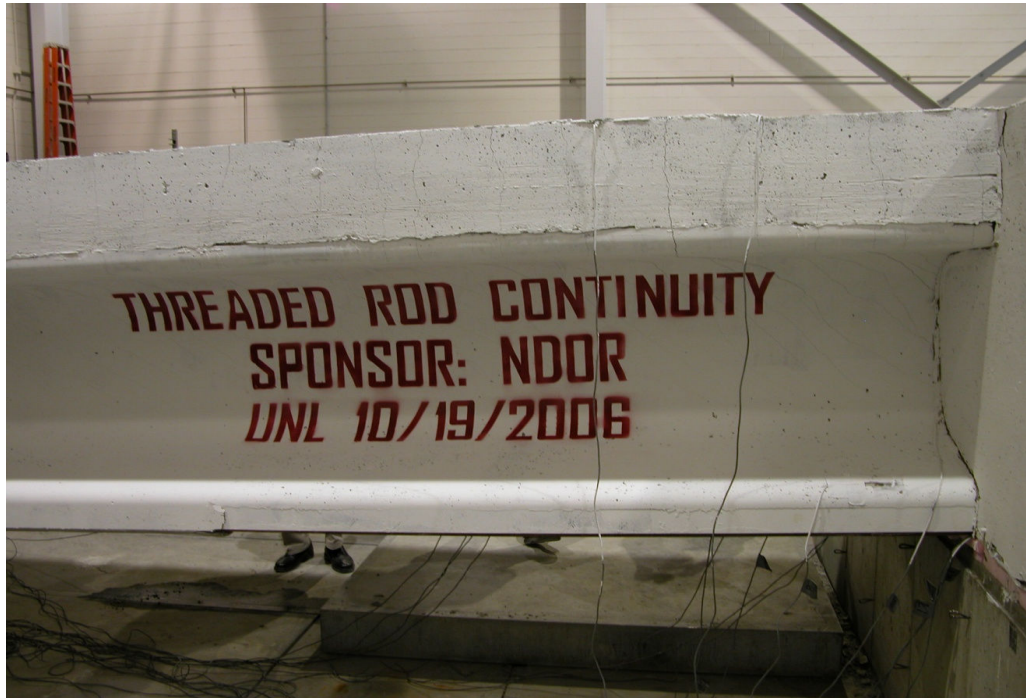
*Figure 3.3.20: Final Flexural-shear Crack near the Pier,  $P = 324$  kips*

A large crack occurred at the lifting point because we did not cut the lifting out. In an actual bridge, it is cut.

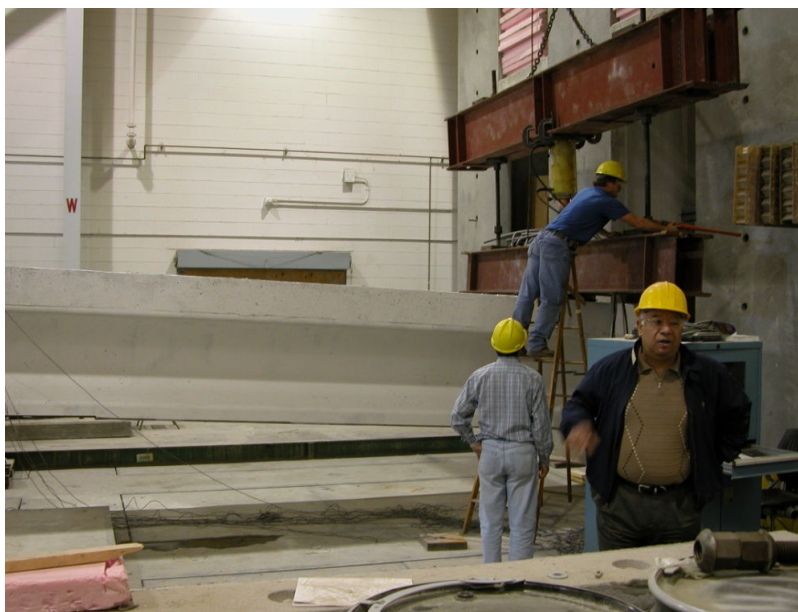
*Figure 3.3.21: Deflection at 324 k*

The maximum load is 324 kips. A large deflection was observed. The rotation at the loading end prevented further loading.

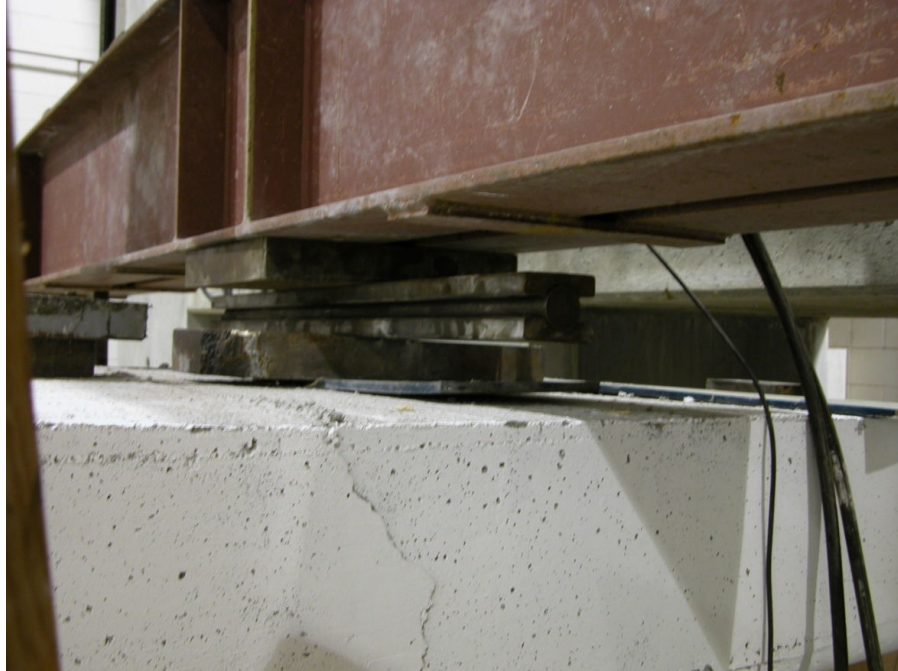
*Figure 3.3.25: Add a Roller to Achieve Larger Rotation*

The authors added a roller underneath the steel beam to allow the end of the girder to freely rotate. Then the beam was reloaded again until the sole plate buckled at the face of the diaphragm when load was equal to 382 kips. Everything was fine in the deck.

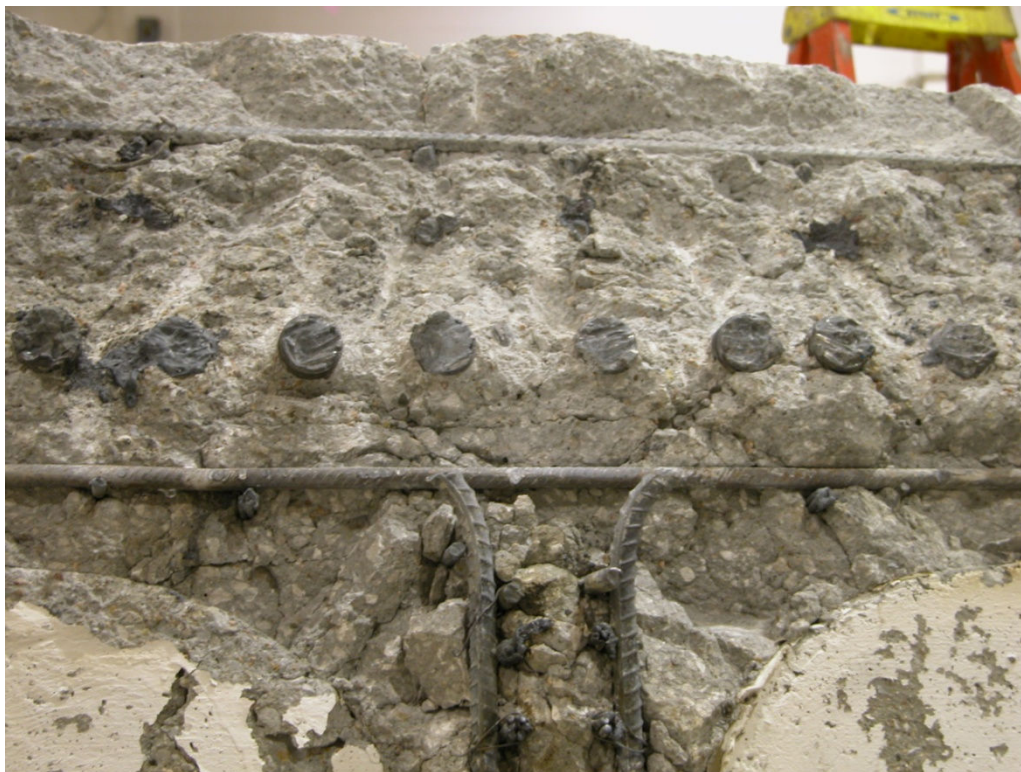
*Figure 3.3.30: No Slippage between TR and the Concrete around them*

When the specimen was taken apart at the face of the diaphragm, there was no crushing of concrete around the TR or slippage between the concrete and the TR, as shown in Fig. 3-56.

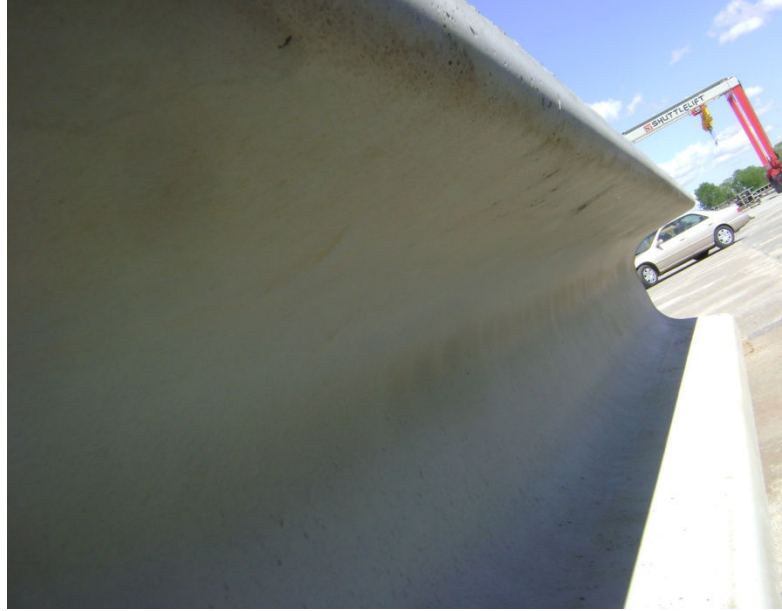
*Figure 4.3.10: Girder after release*

Little to no cracking was noticed on the girders after release as shown above.

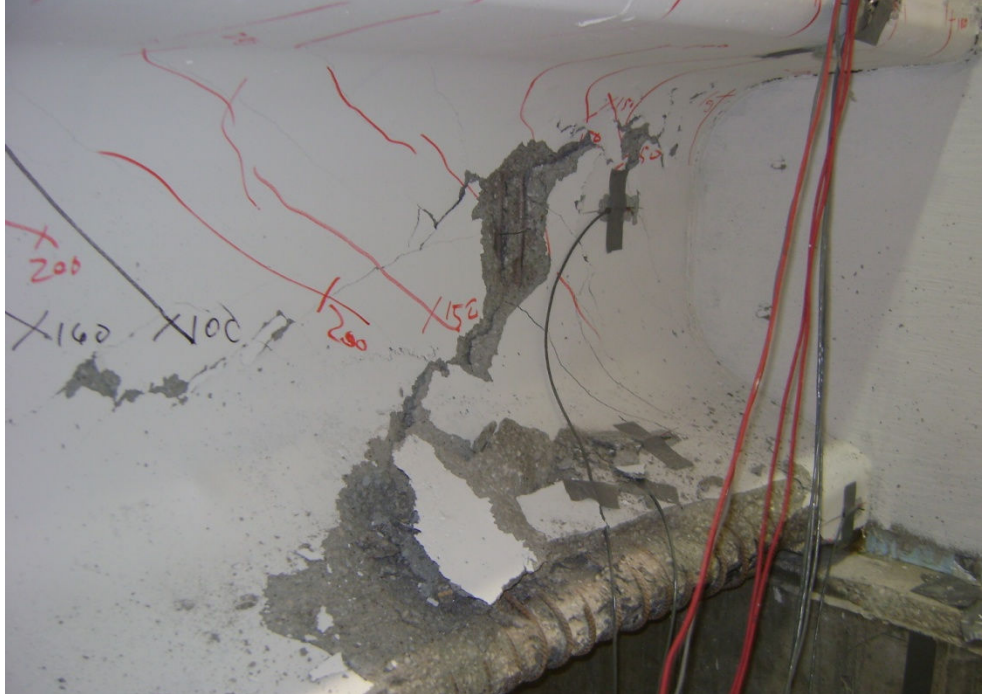
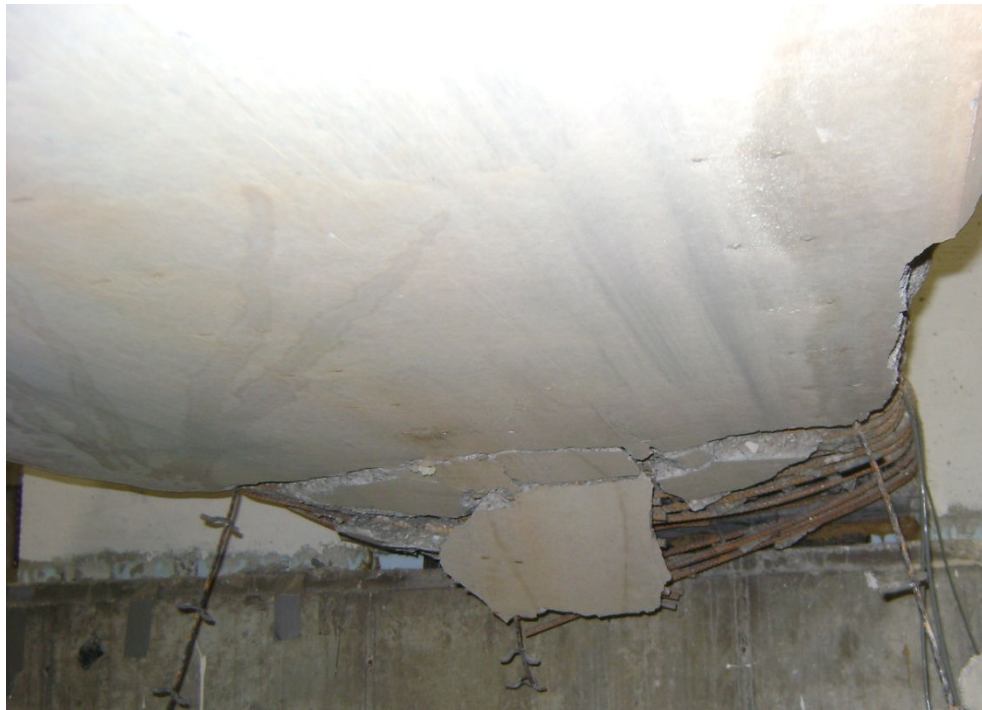
*Figure 4.6.2.1: Failure near diaphragm*

Predicted Failure Load	Tested Failure Load	Mode of Failure
260 kips	261,777 lb	Compression of bottom flange

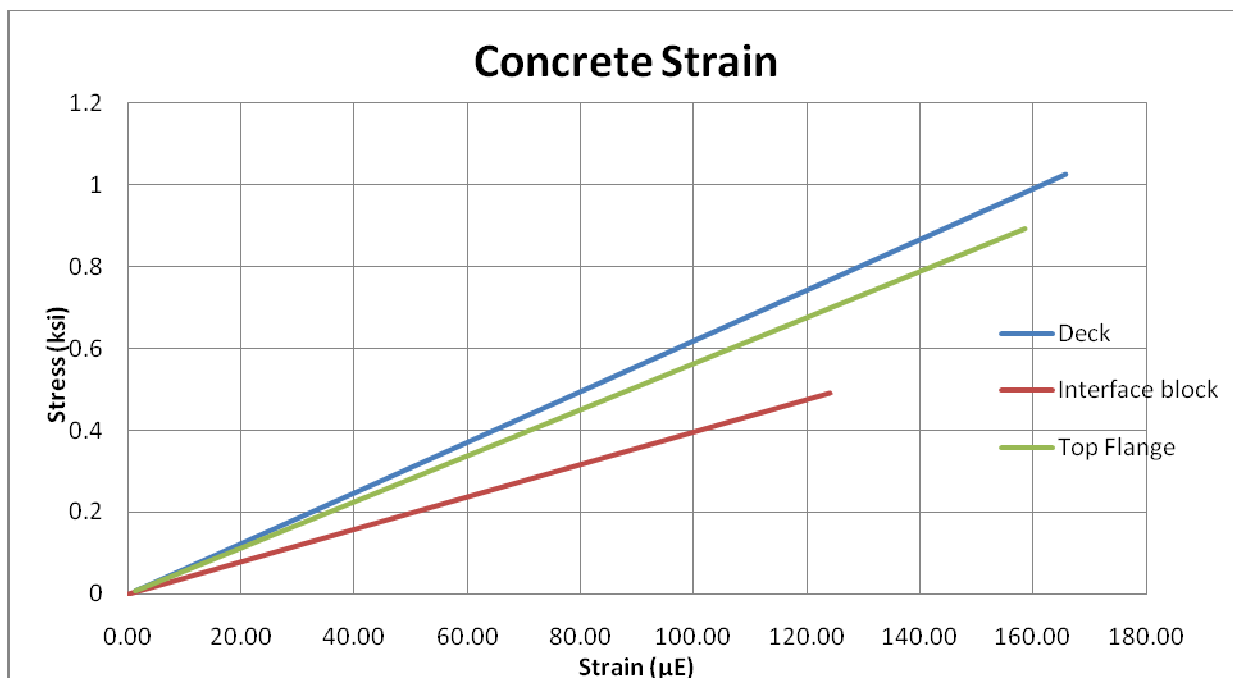
*Figure 4.6.2.6: Stress-strain diagram of deck, interface, and top flange*

The stress in the top two layers reached a maximum of around 1ksi. This is much less than the compressive strengths of the deck and interface block concrete on the test date, which were 10.4 ksi and 4.3 ksi, respectively. The strain in the top flange reached 0.5 ksi, which is significantly less than the girder compressive strength of 8.6 ksi on the date of the test.

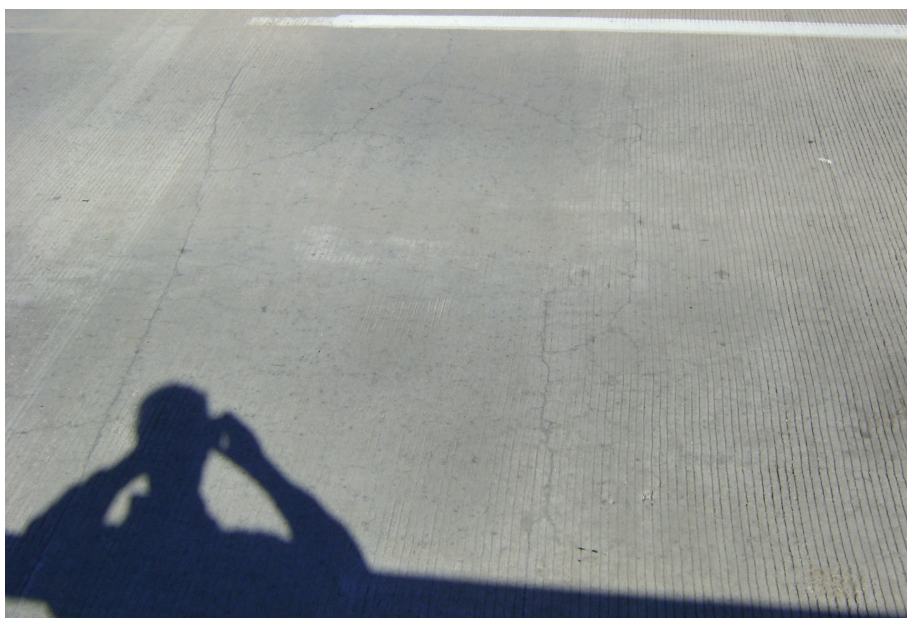
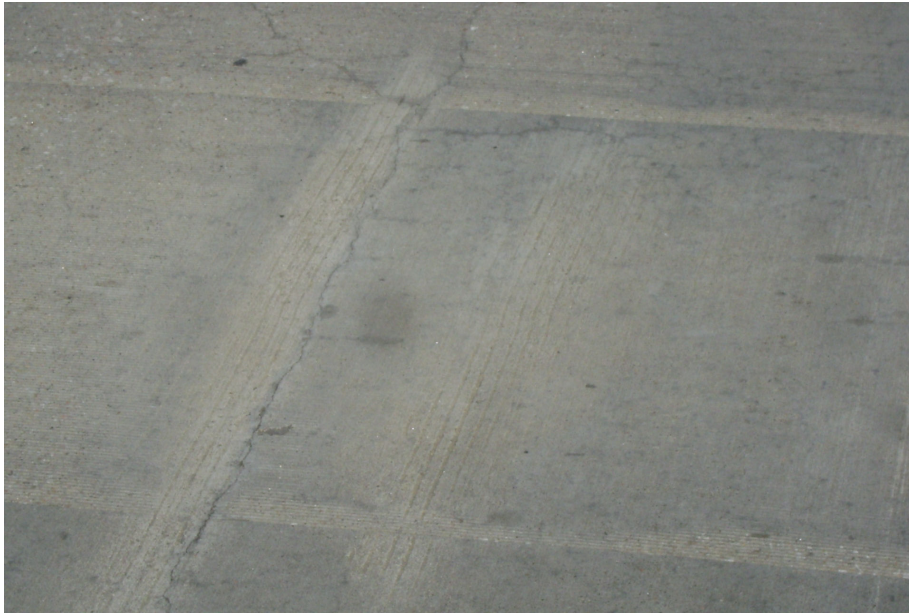
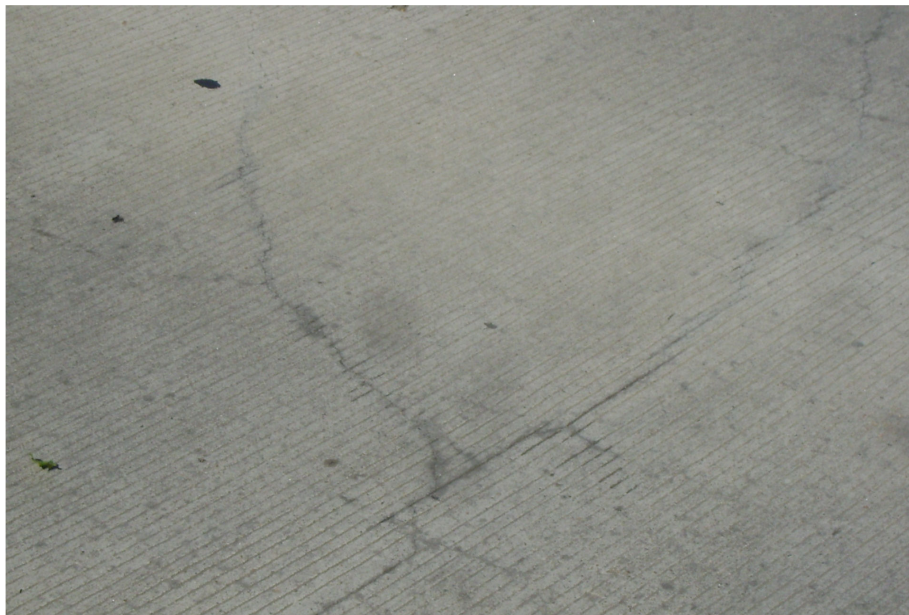
*Figure A.15: Shrinkage Cracking*

It should be noted that the Pacific Street Bridge has experienced an unusual amount of cracking. The contractor reported difficulties with weather that caused a delay during placement and probably led to increased shrinkage in pavement. Another possibility is that slag was added for the first time to the 7BD-4000 mix used for bridge decks; however, this is not thought to be a reason for cracking.
