1. Report No. FHWA/TX-11/0-6022-2		2. Government Accession No.		3. Recipient's Catalog No.	
4. Title and Subtitle RECOMMENDATIONS FOR DESIGN, CONSTRUCTION, AND MAINTENANCE OF BRIDGE APPROACH SLABS				5. Report Date September 2011 Published: May 2012

# **RECOMMENDATIONS FOR DESIGN, CONSTRUCTION, AND MAINTENANCE OF BRIDGE APPROACH SLABS**

Project 0-6022  
Report 0-6022-2  
Project Title: Recommendations for Design, Construction, and Maintenance of  
Bridge Approach Slabs

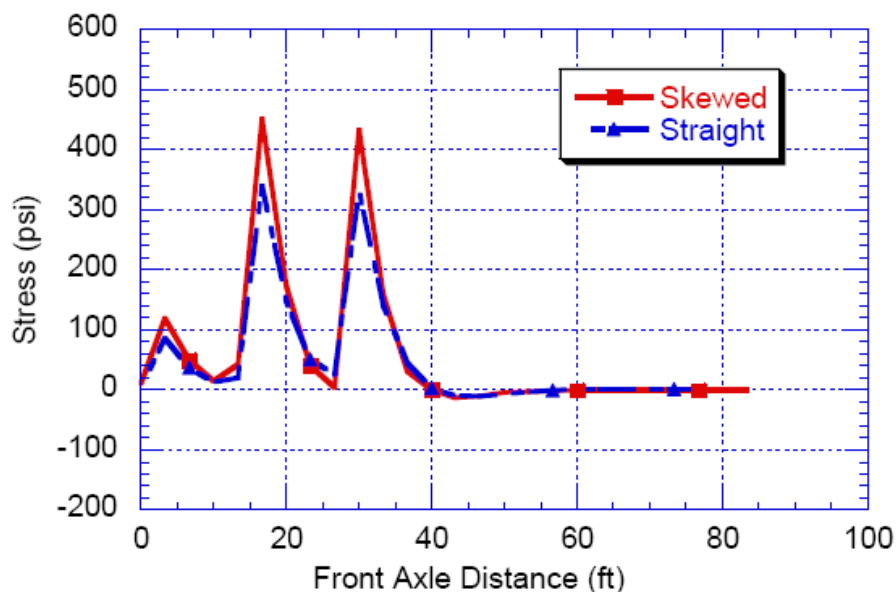
Additionally, higher rates of settlements at the bridge exit were considered to be accountable to the effect of the skew angle of the approach slab as well as improper compaction conditions in hard-to-reach soil areas close to the abutments (Nassif, 2002).

**Figure 2.7. Variation of Tensile Axial Stress with Front Axle Distance for Skewed and Straight Approach Slabs (Nassif, 2002).**

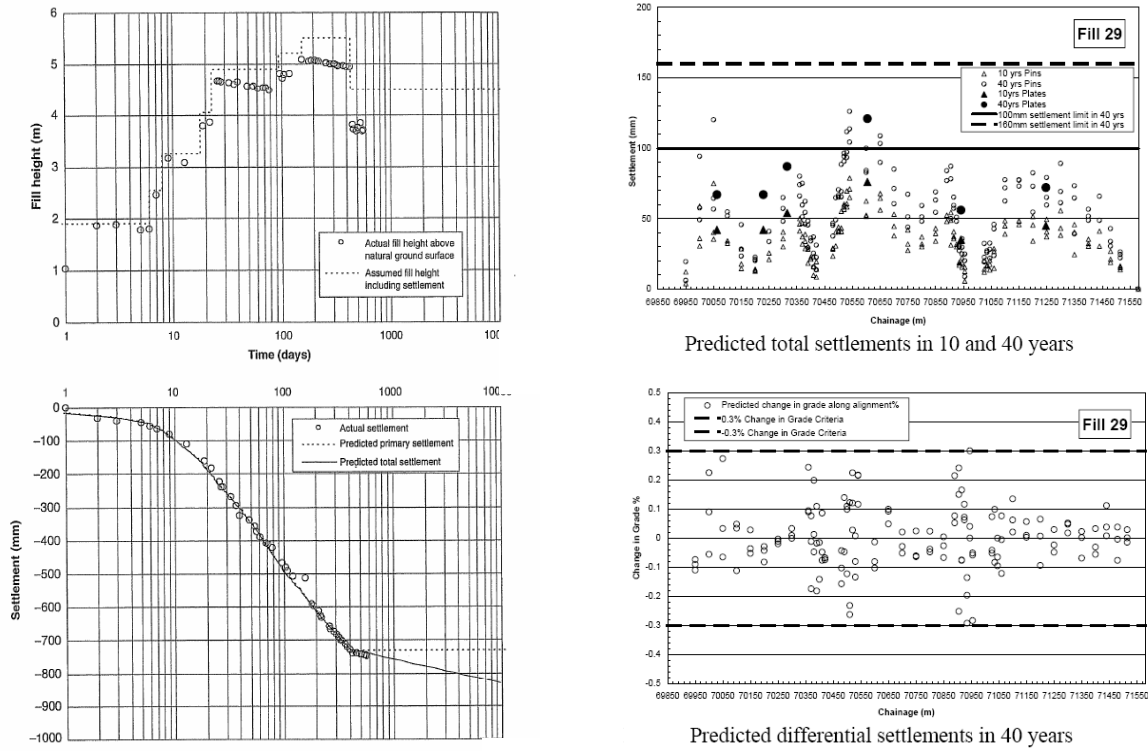
Figure 2.14 presents the measured and predicted settlements in the soft foundation soil during and after the construction stages. In this figure, the long-term settlements were predicted based on the ratio  $(c_\alpha/1+e_0)$ , where  $c_\alpha$  is the secondary compression index and  $e_0$  is the initial void ratio. The long-term differential and total settlements are predicted from back-calculated analysis of measured data from settlement plates also presented in the same figure. From this graph, note the reduced rate of long-term creep settlements after the removal of the surcharge and after the completion of construction (Hsi and Martin, 2005).

**Figure 2.14. Measured and Predicted Settlements with Time (Hsi and Martin, 2005) (a) during Construction Stages and (b) after Construction Stages.**

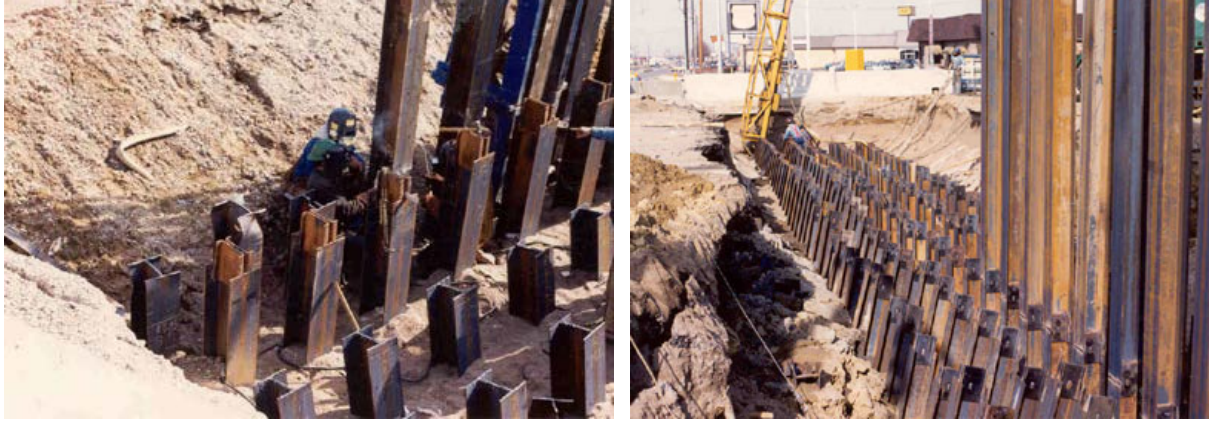
**Figure 2.43. Example of Bridge Foundation Using Steel H-Piles.**

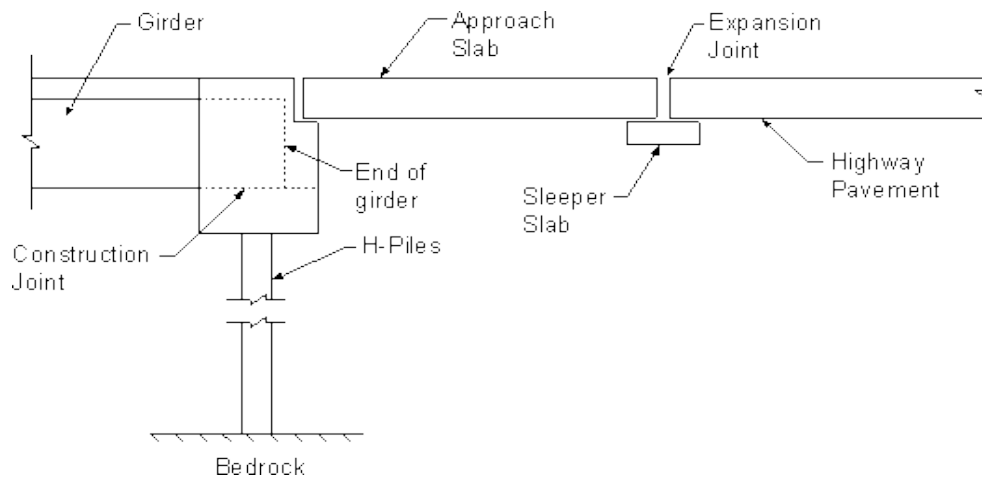
**Figure 2.54. Schematic of an Integral Abutment System with a Sleeper Slab.**

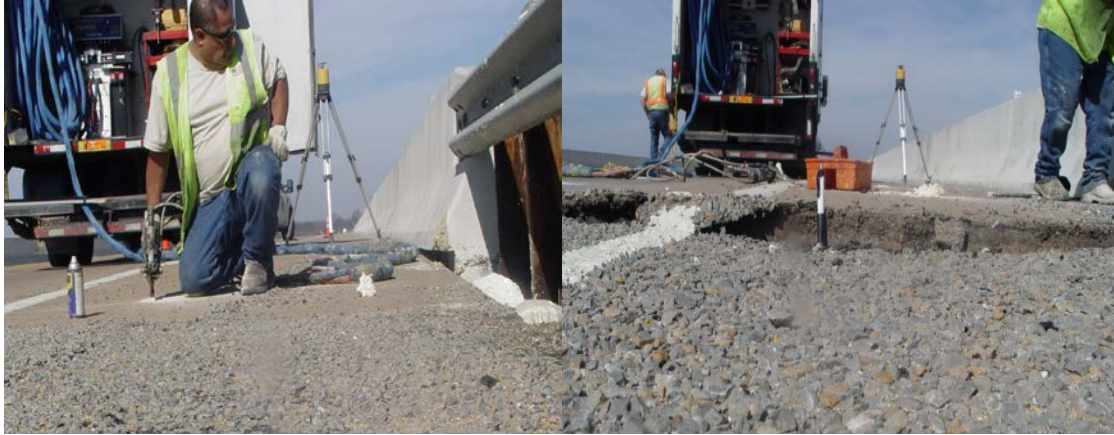
**Figure 2.67. Position of Approach Slab during and after the Urethane Foam Injection Process.**

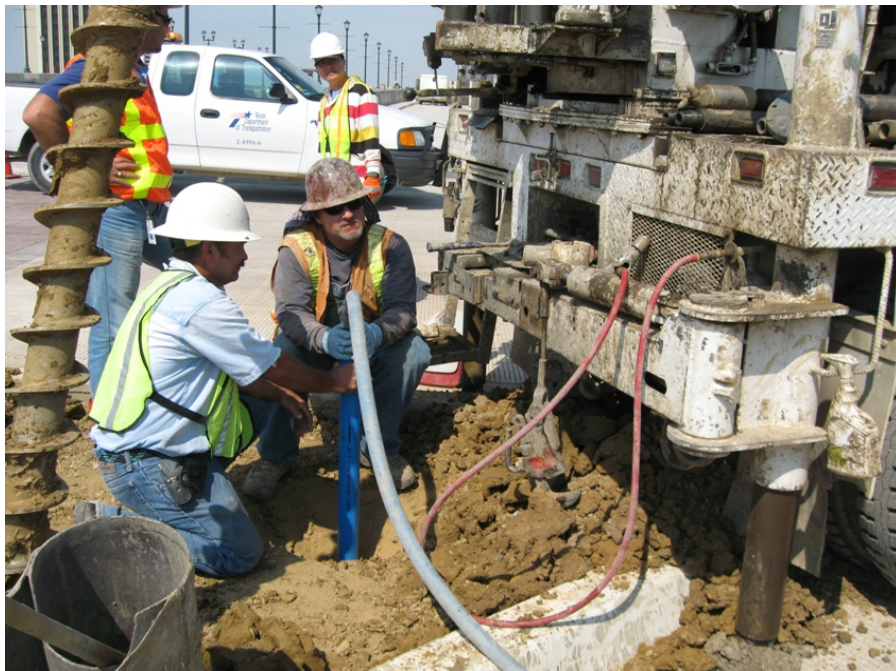
**Figure 6.19. Water Was Filled into the Casing to Avoid Floating due to Buoyancy.**

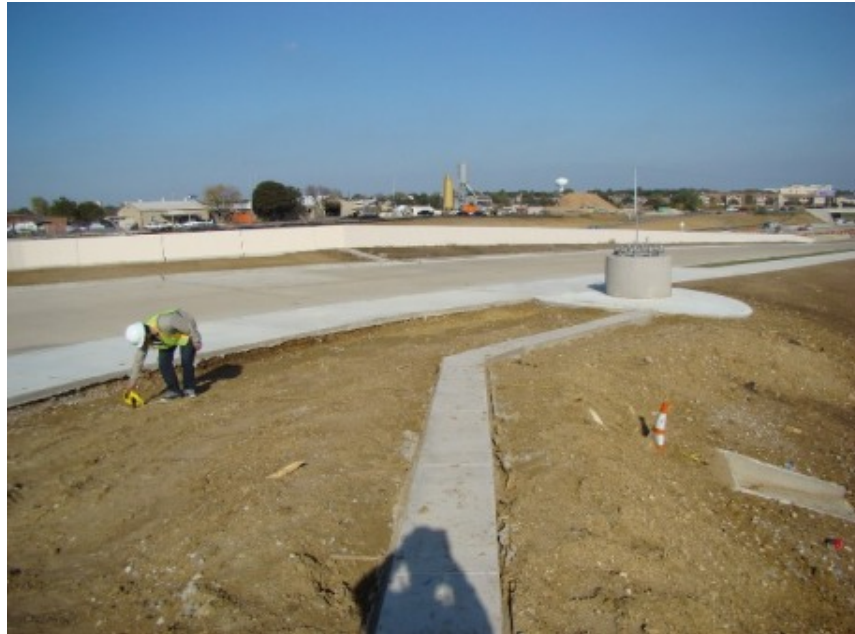
**Figure 7.4. The Location of the Broken Casing.**

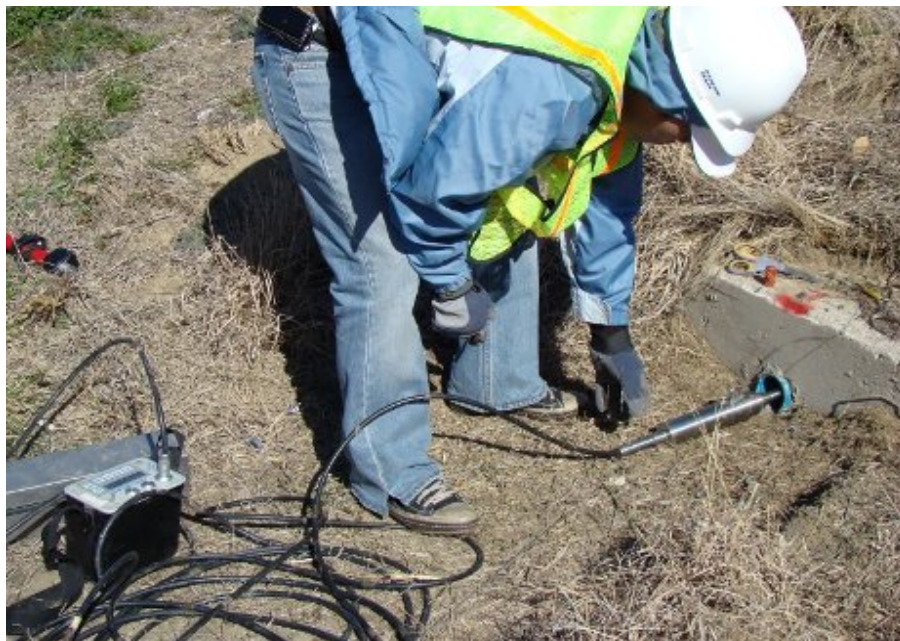
**Figure 7.5. Inclinometer Data Collection Process.**

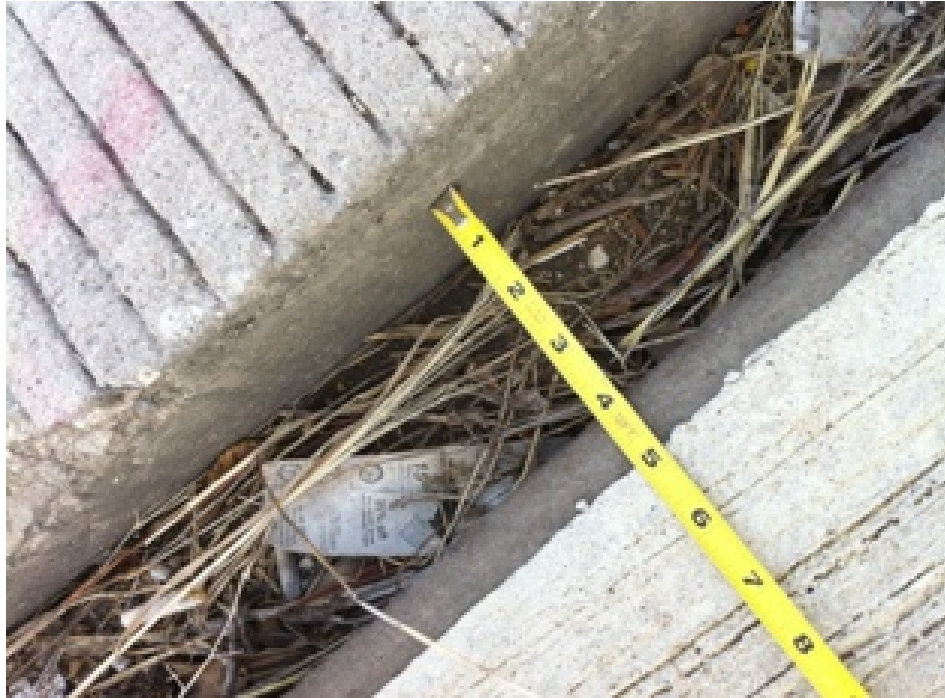
**Figure 7.24. Lateral Movement of the Platform around Inclinometer V4.**

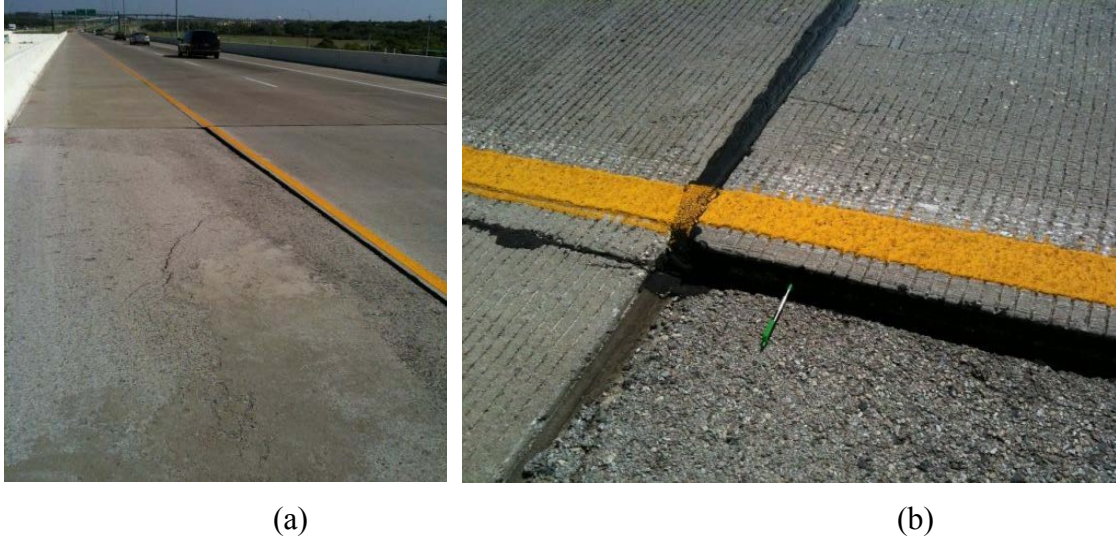
**Figure 7.25. Opening Observed between the Highway Mainlanes Pavement and Its Shoulder.**

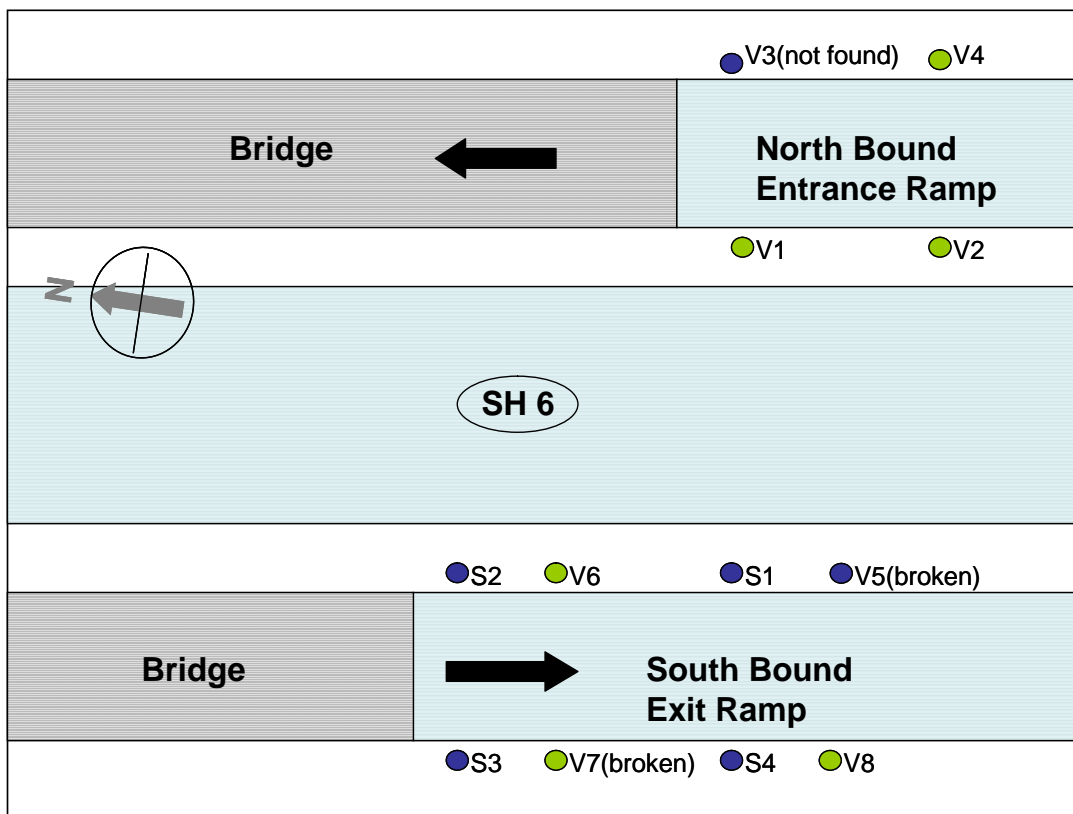
**Figure 7.29. Instrumentation on SH 6 over US 90A, Houston, Texas.**

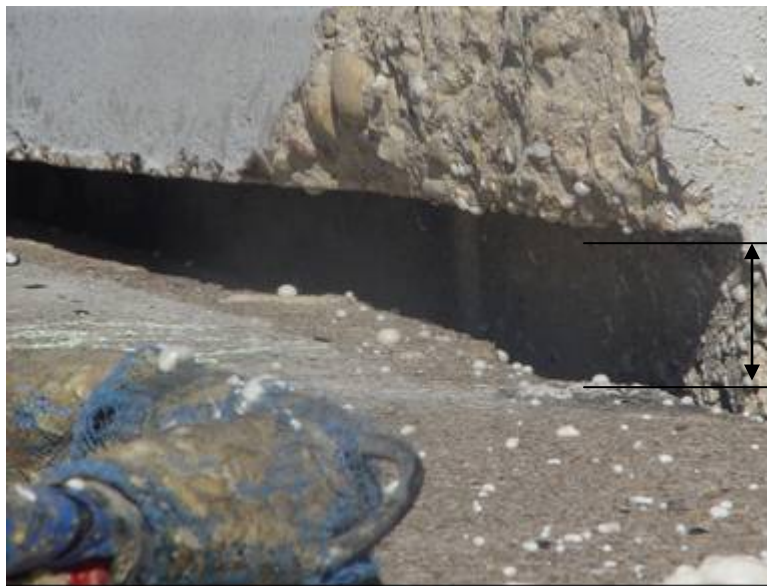
**Figure 9.3. Settlement of the Approach Slab.**

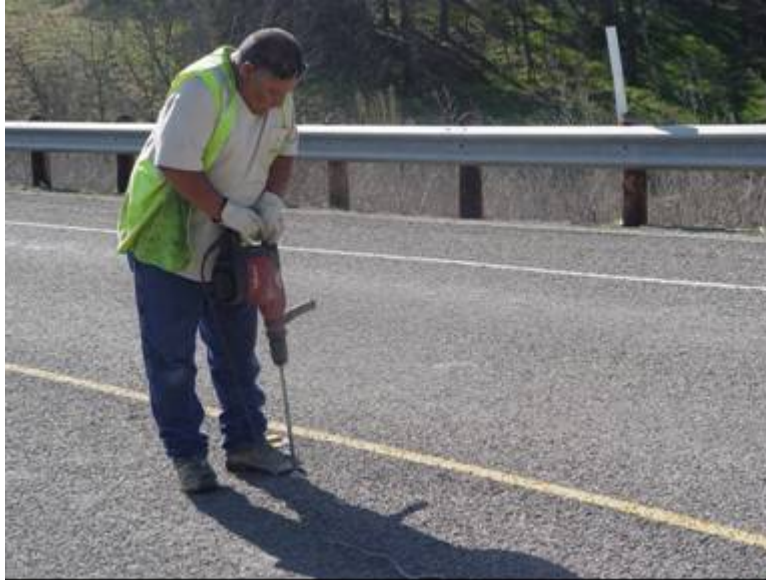
**Figure 9.6. Drilling Holes into the Approach Slab.**

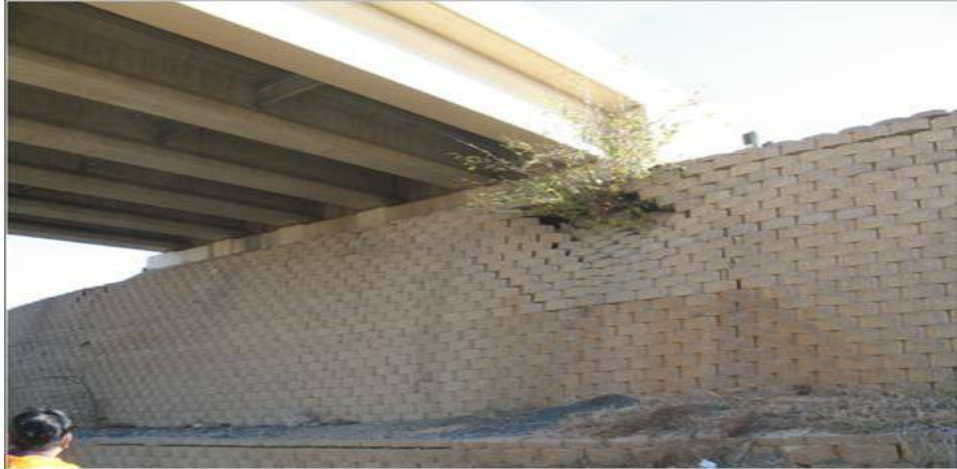
**Figure 9.15. Failure of the Modular Block Wall.**

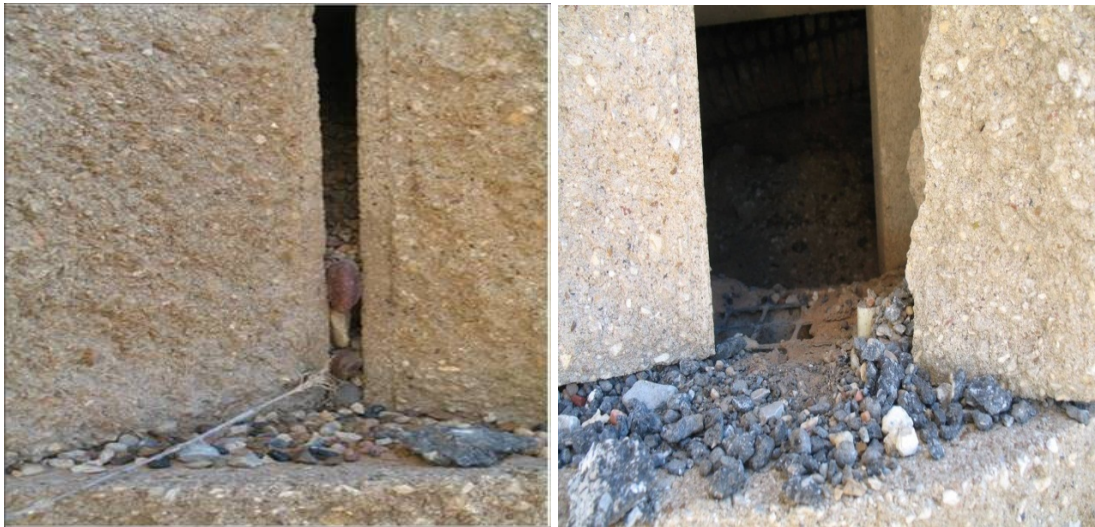
**Figure 9.16. Erosion of the Soil under the Slab.**
