Assessment of the Durability of Wet Night Visible Pavement Markings: Wet Visibility Project Phase IV

Final Report VCTIR 12-R13

**ASSESSMENT OF THE DURABILITY OF WET NIGHT VISIBLE PAVEMENT
MARKINGS: WET VISIBILITY PROJECT PHASE IV**

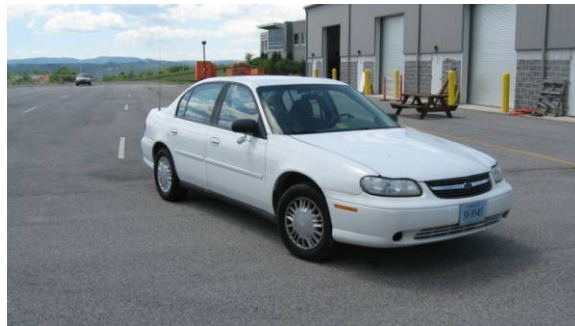
Figure 3. 2003 Chevy Malibu used by participants.

Subjects drove one of two 2003 Chevrolet Malibus (Figure 3) while an in-vehicle experimenter rode in the back seat. The Malibus were equipped with a Data Acquisition System (DAS), which recorded vehicle network data and four camera views inside and around the vehicle. The DAS also recorded button presses entered by the experimenter.

For 14 of the 24 participants, the vehicles were also equipped with a luminance camera developed by VTTI. The luminance cameras took photos as the participants drove the experimental vehicles. The resulting images were later analyzed by an experimenter using proprietary software, which gives the luminance and contrast of the selected part of the image.

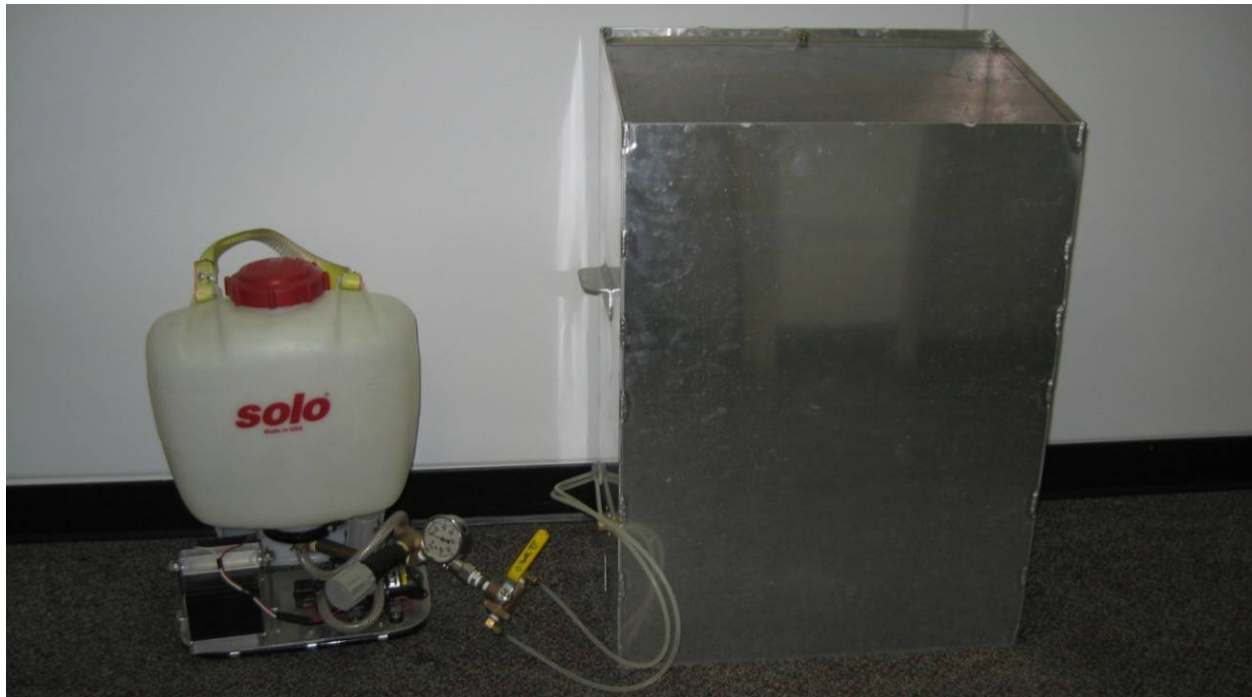
In addition to the human subjects experiment, the retroreflectivity of the markings was recorded at different intervals after installation in order to assess each marking's performance over time. Retroreflectivity is the measurement of how much light is returned to a viewer's eyes when looking at an object; in this case, a pavement marking. Retroreflectivity was recorded for four different conditions: dry, recovery (i.e., the "bucket test"), 1 inch per hour of rain, and 2 inches per hour of rain. The retroreflectivity was measured using an LTL-X retroreflectometer, and the rain conditions were created by using a rain box built by VTTI (Figure 5).

Figure 5. VTTI's rain box.

The dry condition was recorded first. The LTL-X was placed on a predetermined location on the marking facing the direction of traffic flow, and three readings were taken. The "bucket test" was performed next by soaking the line in front of the LTL-X with water from a tank in the back of a pickup truck. A hose coming from the tank was held over the line, and water was poured for several seconds in order to ensure coverage of the entire area. After about 45 seconds, three measurements were taken roughly 2 seconds apart. Next, the rain box was placed over the line in front of the LTL-X, and the 1 inch per hour nozzle was turned on. After

about 30 seconds, measurements were taken with the LTL-X approximately every 2 seconds until three consistent readings were found. If an inconsistent reading was found (greater than a 10% difference), another set of three measurements would be taken. Those three readings were recorded. The rain box was then switched to the 2 inch per hour nozzle. After another 30 seconds, measurements were taken again approximately every 2 seconds until three consistent readings were found. Those three readings were then recorded. Repeating the measurement was not performed for the bucket test as this test is time-sensitive and the results could be impacted by a time delay.

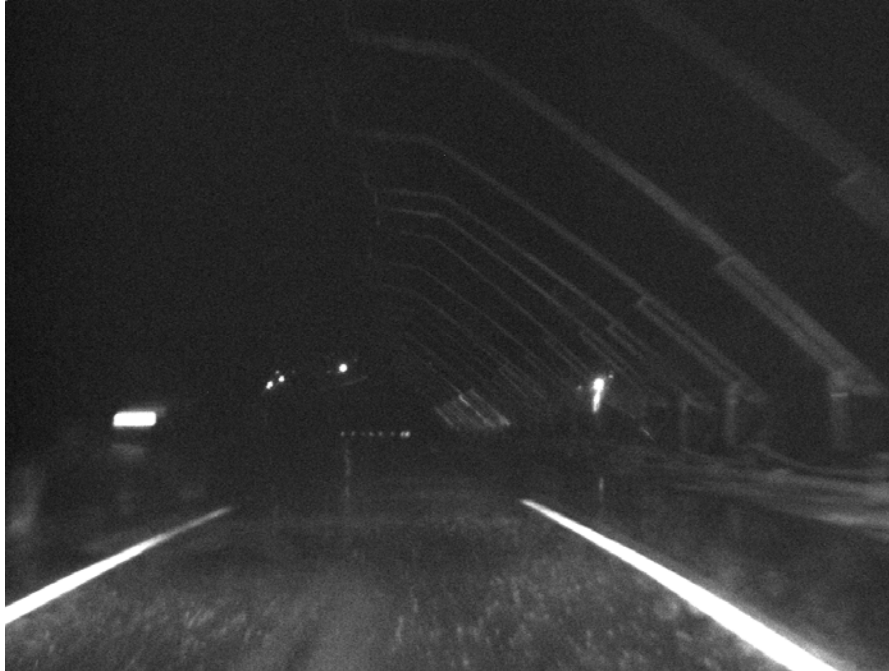
Figure 7. Luminance camera image.

$$Retroreflectivity = Luminance / Illuminance * 1000$$

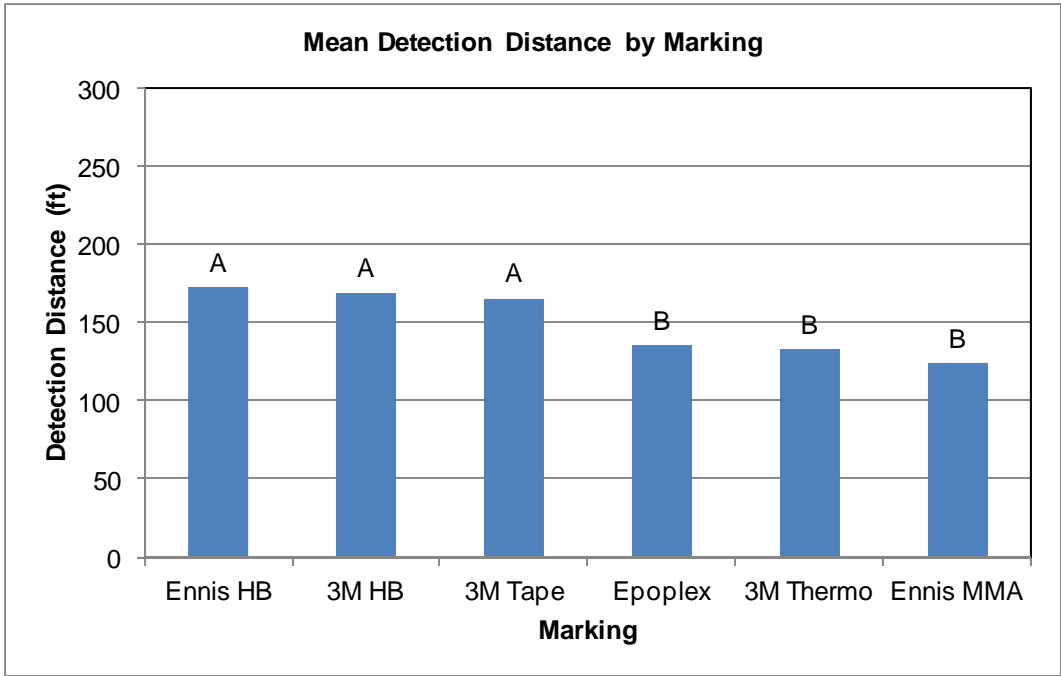
Marking was also found to be a significant factor for Detection Distance. Figure 9 shows that the Ennis High-build Paint, 3M High-build Paint, and 3M wet-reflective tape were detected at significantly longer distances than the other markings. The Student Newman-Keuls (SNK) groupings are shown above each bar indicating which pairwise comparisons were not significantly different (those which share same letter), and which pairwise comparisons were significantly different (those with different letters).

Figure 9. Mean Detection Distance by Marking.

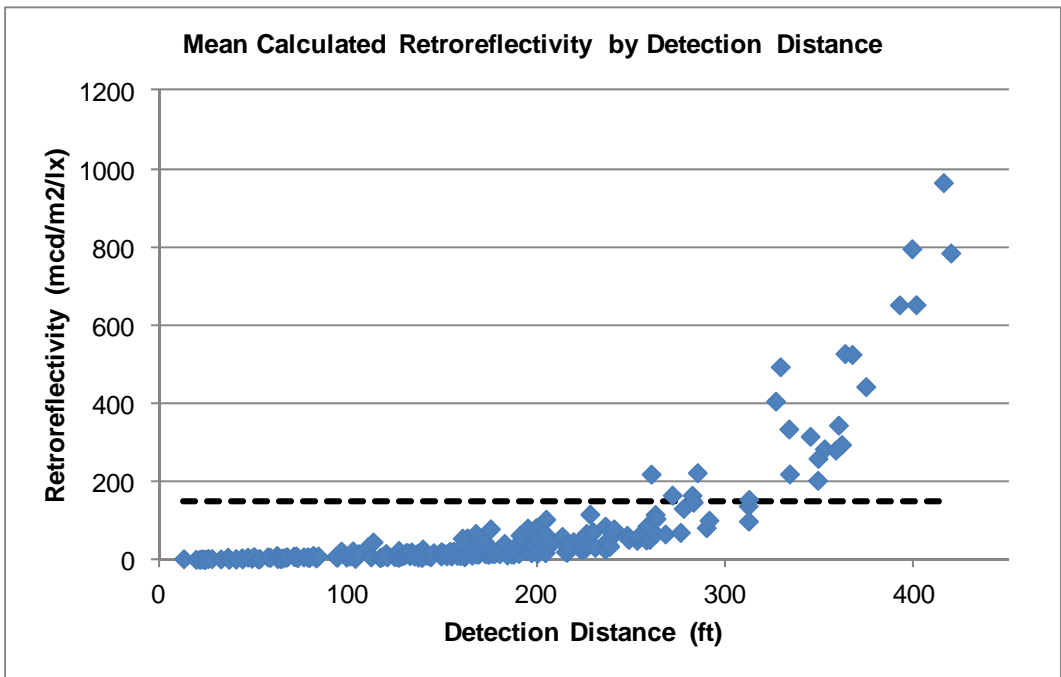
Figure 11 shows the relationship of detection distance and calculated retroreflectivity, along with the recommended minimum retroreflectivity (dashed line). The data from this experiment seem to support the idea of diminishing returns on retroreflectivity above 150 mcd/m²/lx.

Figure 11. Mean calculated retroreflectivity by Detection Distance.

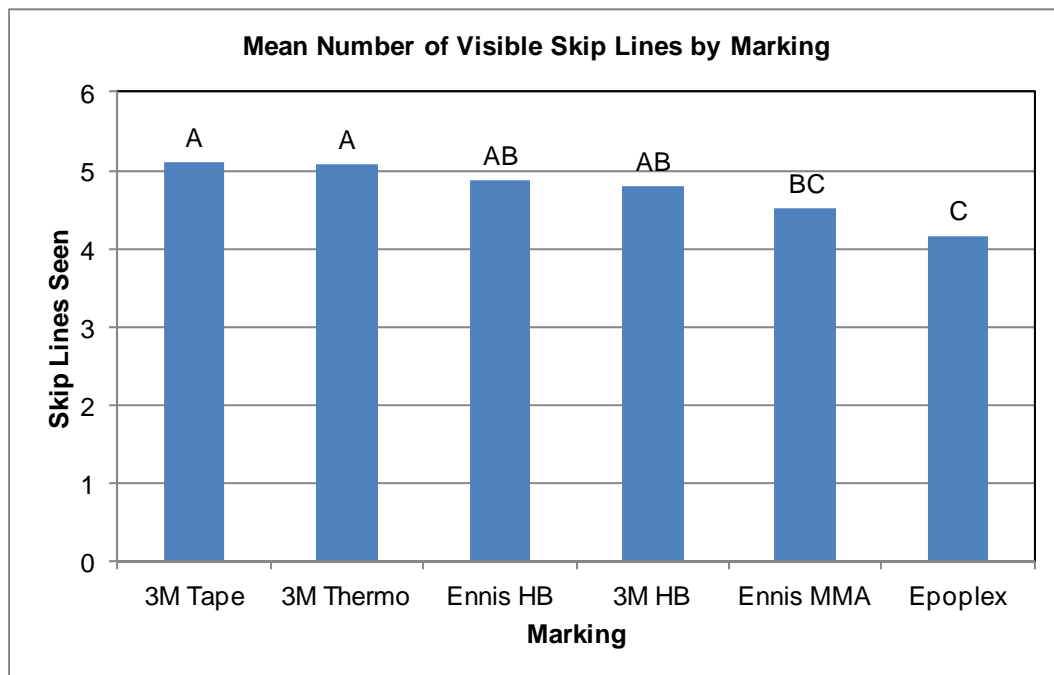
Skip Count was significantly affected by Marking. As seen in Figure 12, participants were able to see significantly fewer skip lines for Epoplex Glomarc 90 than was the case for most other Markings. The Ennis MMA was significantly lower than the 3M Tape and 3M Thermoplastic but was not significantly different from any other marking.

Figure 12. Mean number of visible skip lines by Marking.

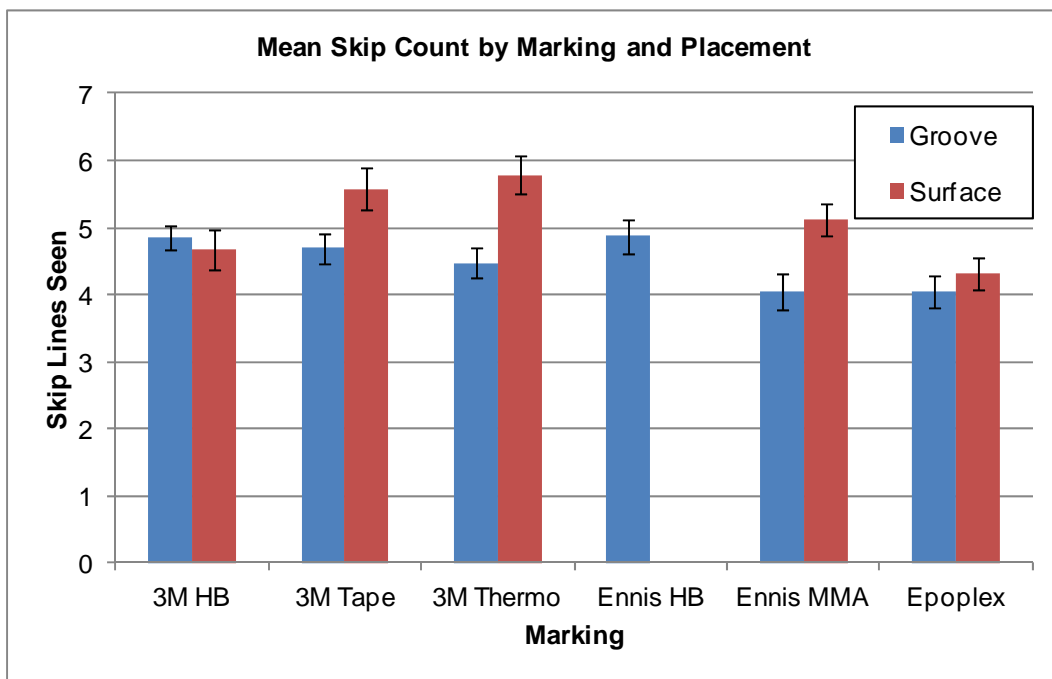
A significant interaction between Marking and Placement was found for Skip Count. As seen in Figure 13, the 3M Tape, the 3M Thermoplastic, and the Ennis MMA each had significantly higher skip counts when applied to the surface as opposed to in a groove. These three markings also had the deepest grooves (200 mils for the MMA and 120 mils for both the tape and the thermoplastic). This may mean that either the groove depth helped to hide the lines when viewed from a distance or that the thickness of the materials made them more apparent at long distances when applied to the surface.

Figure 13. Mean number of visible skip lines by Marking and Placement.

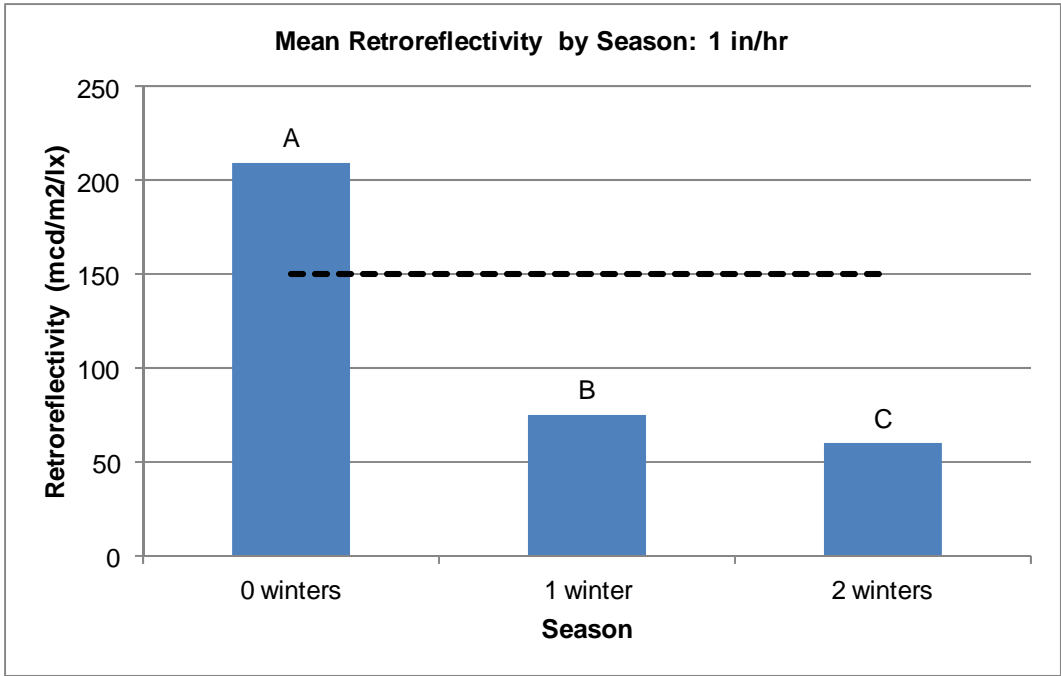
The significant effect of Season is shown in Figure 15. Season was divided into means for “0 winters” (months 3 and 6), “1 winter” (months 11, 16, and 18), and “2 winters” (month 23). The mean retroreflectivity for all markings dropped far below the minimum after the first winter. Another significant drop in mean retroreflectivity occurred after the second winter; however, this drop was much less severe.

Figure 15. Mean retroreflectivity by Season for edge-line analysis: 1 in/hr.

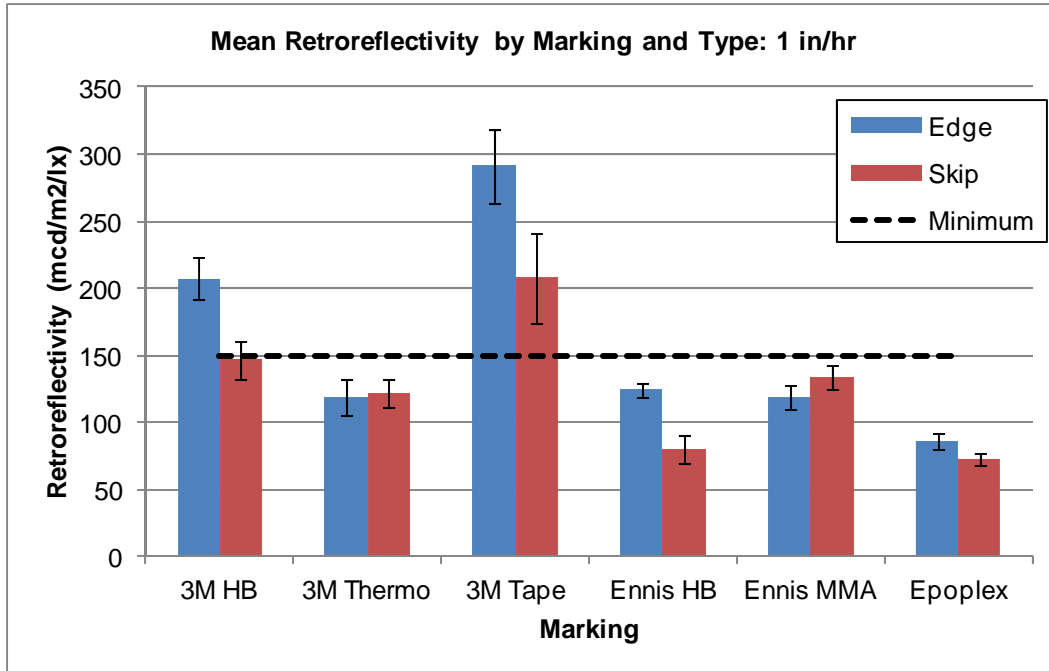
The interaction of Marking and Type was found to be significant for 1 in/hr rain conditions. Figure 20 shows that while edge lines had significantly higher retroreflectivity for most markings, there was no significant difference for the 3M Thermoplastic or the Ennis MMA.

Figure 20. Mean retroreflectivity by Marking and Type for type analysis: 1 in/hr.

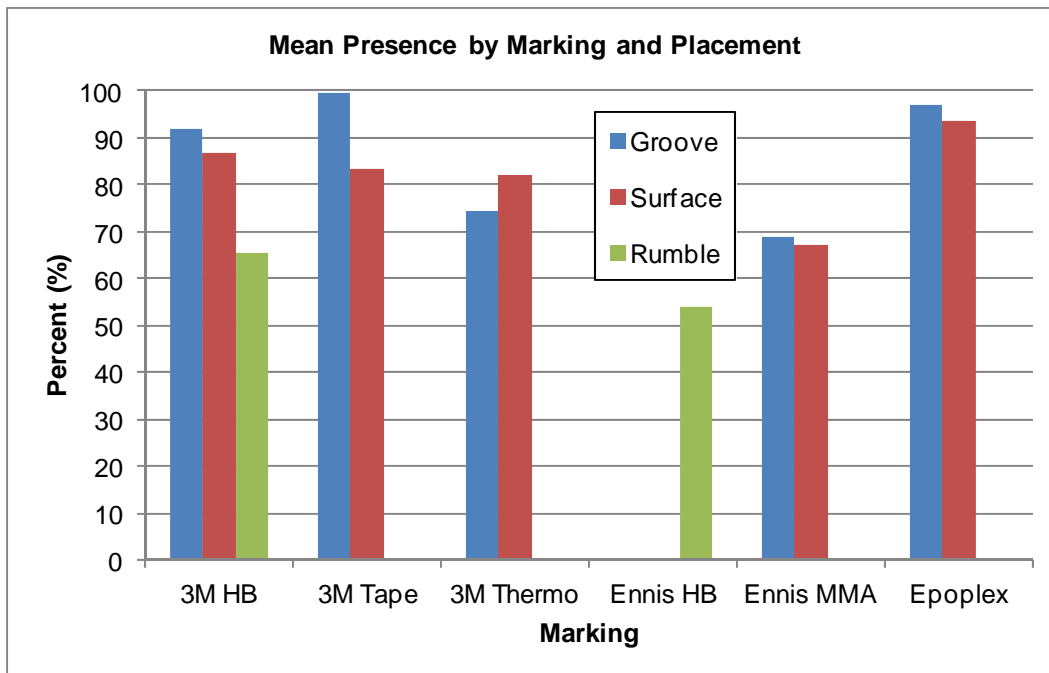
Figure 29 shows the mean Presence for each Marking and Placement. As shown, the grooved 3M High-build, 3M Tape, and Epoplex had Presence of over 90%. The Ennis MMA had the lowest presence for both grooved and surface-applied markings; however, this is likely due to the nature of the marking as it does not completely cover the road surface. The two rumble-stripped markings also had low Presence as the “crowns” of the rumble strips were exposed and received heavy damage.

Figure 29. Mean Presence by Marking and Placement.

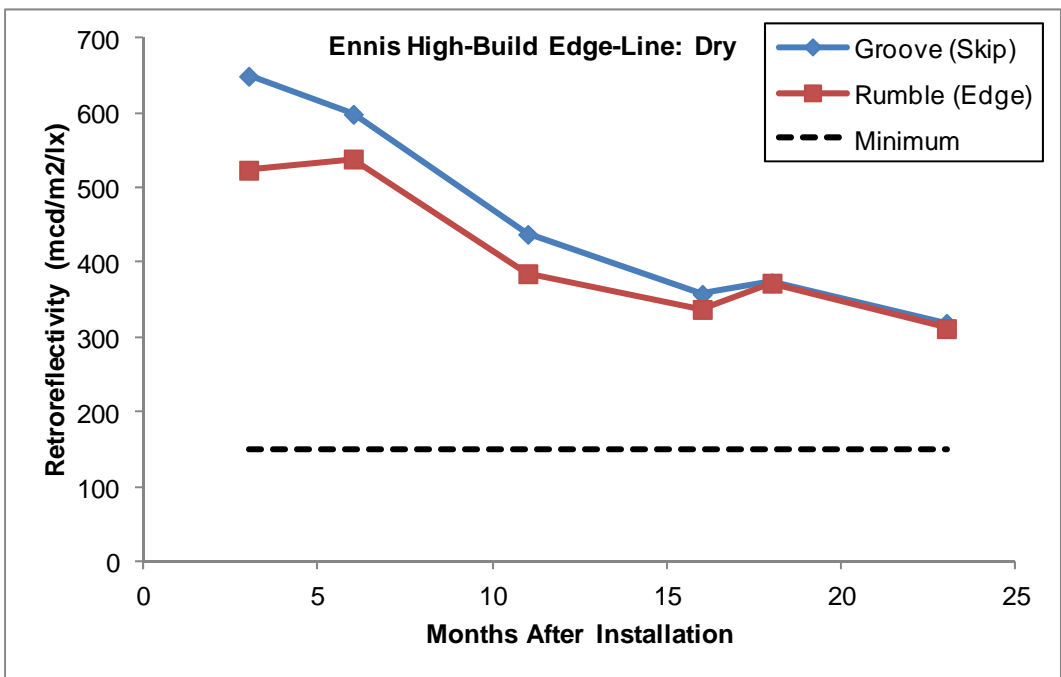
Figure 32. An example of a time plot for dry conditions.

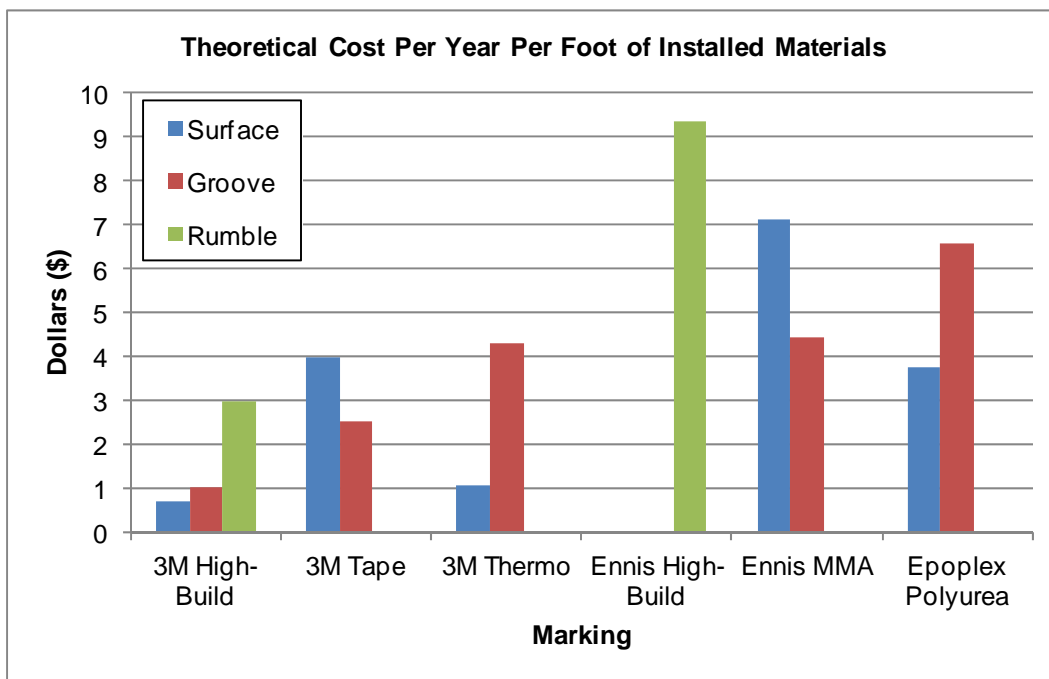
Figure 33. Cost based on estimated lifetime for maintaining wet retroreflectivity for 1 in/hr of rain.

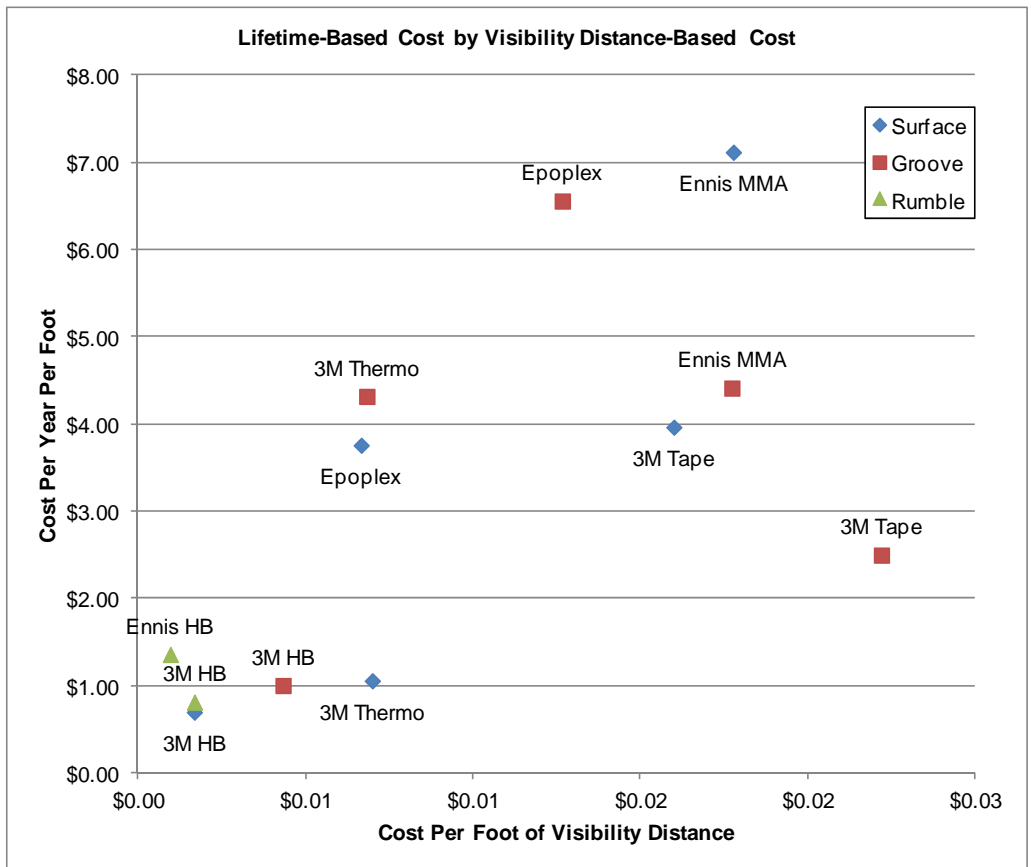
Figure 37 shows the cost based on estimated lifetime by the cost per foot of visibility distance. All four installations of the high-build paints are shown to be the most cost-effective when both values are considered.

Figure 37. Cost for each marking by both estimated lifetime and cost per foot of visibility distance.
