PORTABLE CONCRETE BARRIER CONDITION AND TRANSITION PLAN SYNTHESIS

FHWA/MT-12-002/8117-41

Final Report

THE STATE OF MONTANA
DEPARTMENT OF TRANSPORTATION

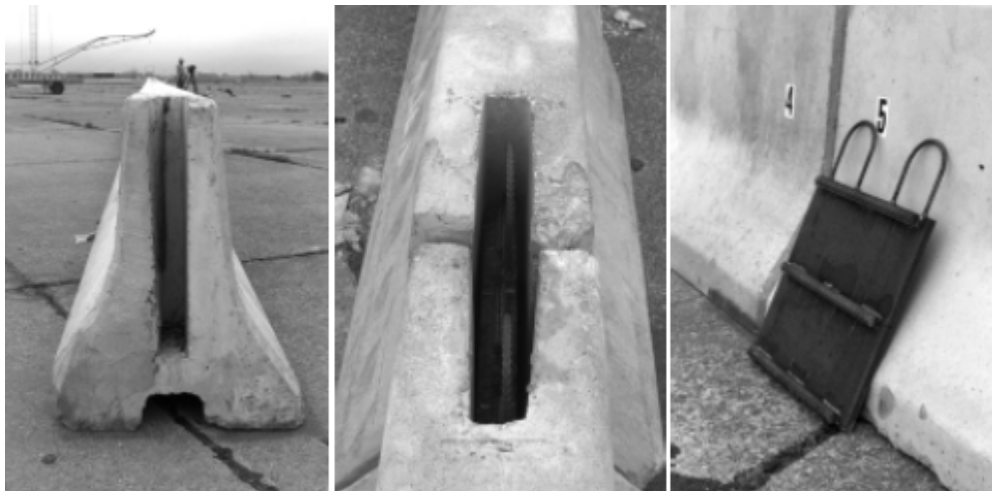
Figure 8: Texas grid-slot connection (Bligh et al., 2002)

Bligh et al. evaluated a Texas PCB system employing a grid-slot connection (Bligh et al., 2002). The barrier was a Type 2 design with grid-slots and steel straps used for connection of segments (see Figure 8). The grid-slot connection used a prefabricated tie bar grid which was inserted into slots formed in the concrete of adjacent barrier segments. The steel strapping was placed at the base of the segments spanning the joint and anchored into each segment using two bolts on each side. During crash tests using NCHRP 350 guidelines, the barrier deflected four feet, which satisfied the test criteria (Bligh et al., 2002). It should be noted the steel strapping connection was used in conjunction with the grid-slot system after previous crash tests on the grid-slot system alone yielded excessive (although still passing NCHRP 350) barrier deflections.

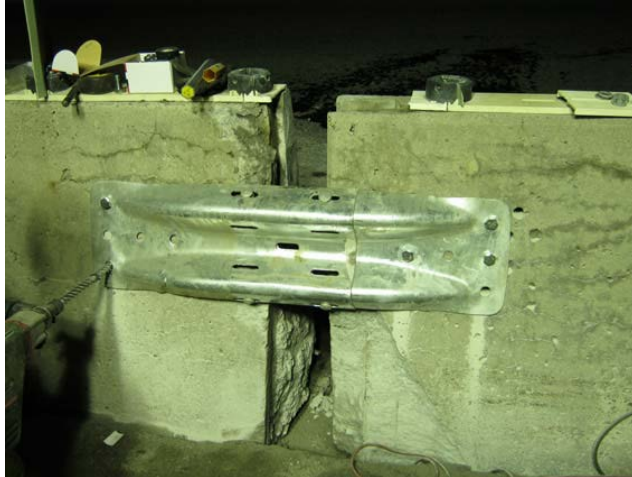
Figure 17: Maine repair of a PCB joint experiencing ASR expansion (Peabody, 2011)

Peabody discussed ASR as a mechanism responsible for expansion issues with a section of PCB along I-295 in Portland, Maine (Peabody, 2011). ASR is a chemical reaction between the alkalis present in the cement and silica in the aggregate that forms an expansive gel causing cracking and movement of the concrete (Peabody, 2011). The PCB section in question had an epoxy coated rebar grid and slot connection which was filled in with grout. A grout failure due to ASR had resulted in the movement of barrier at the joints, with road salts used in winter maintenance possibly contributing to the conditions observed. To address the issue, the offending barrier was moved to leave a 6 inch gap between it and the adjacent barrier. The barriers were then joined by a metal guardrail section (see Figure 17). This repair represented the only discussion of any retrofit approach (albeit site-specific) to addressing an issue with PCB joints (not specifically a metal corrosion issue however).

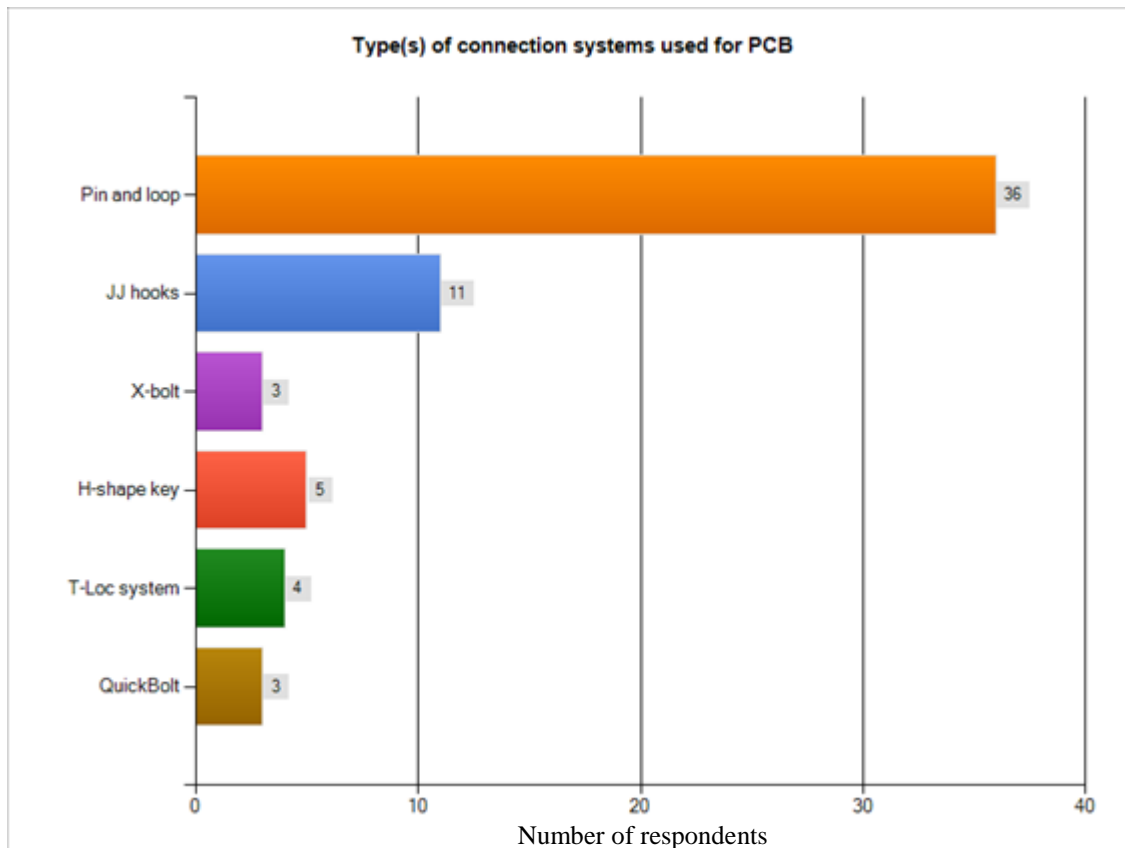
Figure 22: Types of connection systems in use

Respondents were next asked about the types of connection systems used with their PCB. A total of 39 respondents answered the question, while 5 did not answer for unknown reasons. As in the case of barrier shape, respondents were given the choice of specific systems (pin and loop, JJ hooks, H-shape key, T-Loc system, X-bolt, and QuikBolt), as well as the option of specifying another system. The results presented in Figure 22 indicate pin and loop connectors are almost universally used by agencies, and MDT also currently uses this connection type. This corresponds to the body of PCB literature, which frequently mentions the use of pin and loop connections. JJ hooks were used by a moderate number of agencies, while remaining connection systems such as the cross (X) bolt, H-shaped key, T-Loc and QuikBolt were used in limited numbers. Slot and rebar grid/plate systems were also indicated in supplemental text responses by three states. In some cases these are proprietary systems, while in others, they have been developed by a specific state, which may explain their lower usage. Note an agency may employ more than one connection system, based on specific needs. Additional text responses provided the following information regarding connection systems:

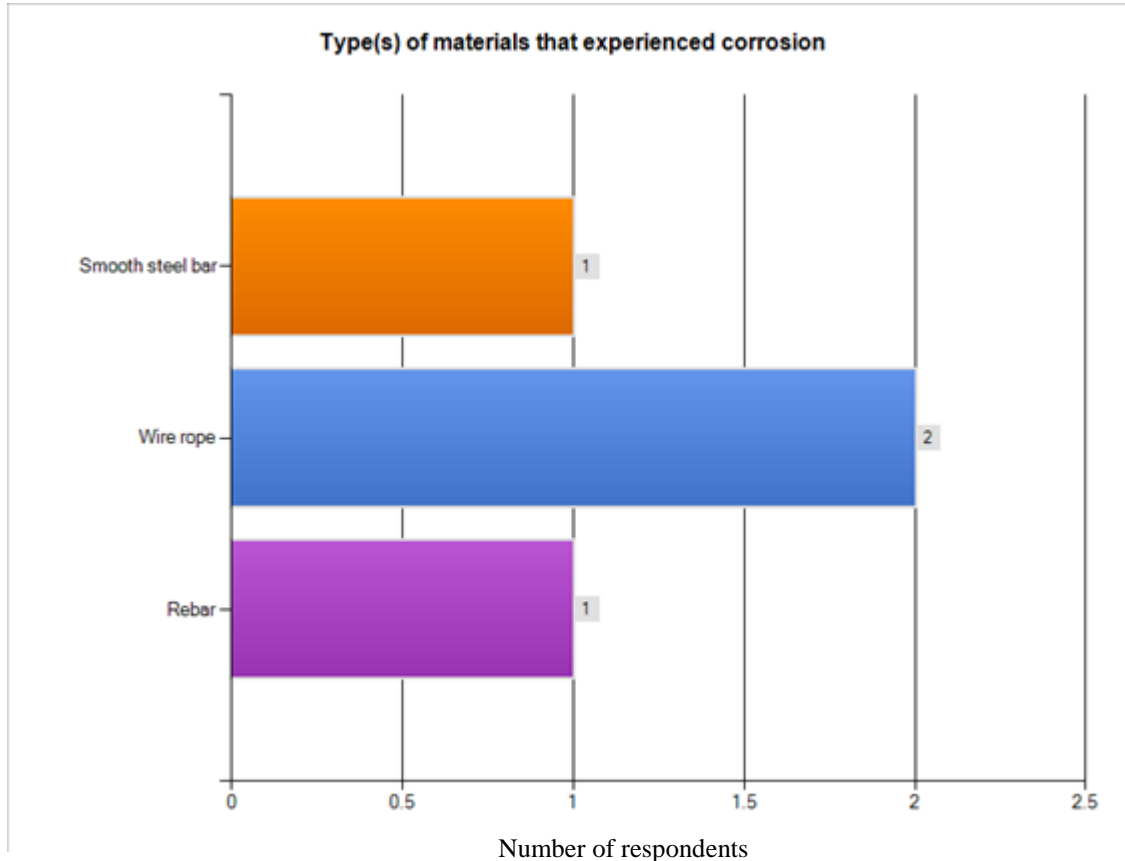
Figure 26: Materials used in corroded connections

A follow-up question asked what materials were used for the connection systems that had experienced corrosion. As Figure 26 indicates, corrosion occurred to smooth steel bar at one agency, wire rope at two agencies and rebar at one agency. These results are not surprising, as each of these materials when left untreated is susceptible to corrosion. While presented as additional choices, stainless steel and epoxy coated bars were not indicated as experiencing corrosion. Although the small sample size does not preclude the possibility, it is unlikely these materials would have experienced significant corrosion (outside of material defects) given that they are specifically used to mitigate corrosion. In addition to the responses presented in Figure 27, Puerto Rico provided textual information indicating none of the materials applied to its case.
