Final Report

EVALUATION OF ASPHALT RUBBER MEMBRANCE INTERLAYER
(ARMI) USING THE UNIVERSITY OF FLORIDA'S COMPOSITE SYSTEM
INTERFACE CRACKING (CSIC) TEST

UF Project No.: 00083937

Contract No.: BDK75 977-60

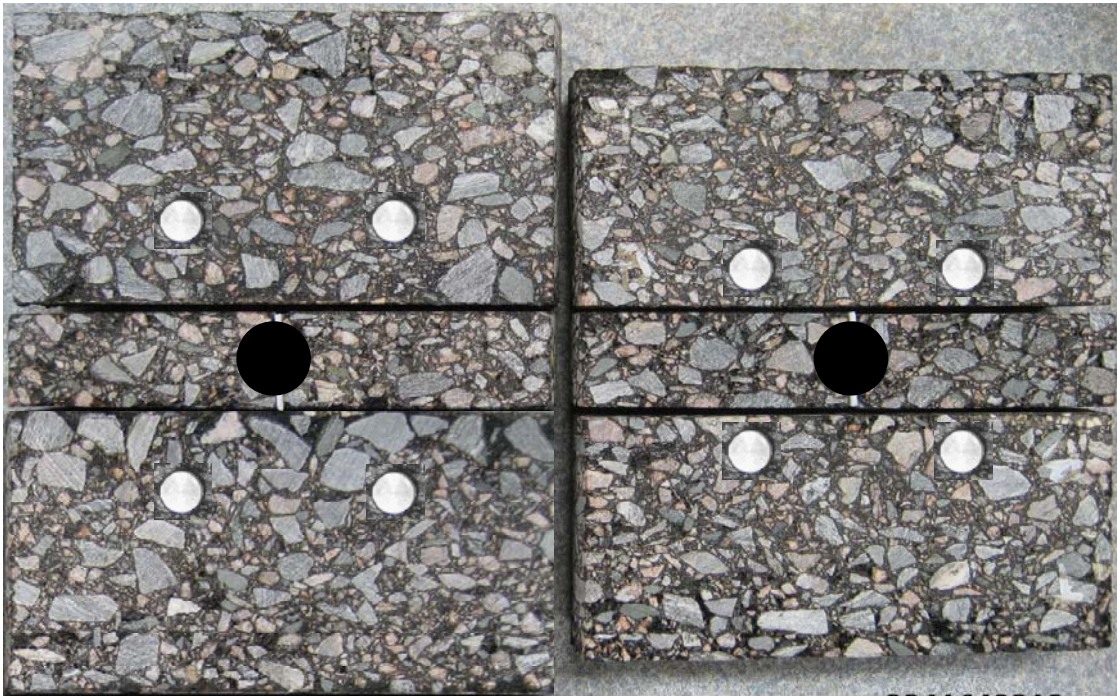
Figure 2-2. Typical composite specimens with ARMI layer (left) and without ARMI layer (right) ready to be glued together with epoxy

As also shown in Figure 2-1, previous pavement layers were trimmed off at the interface for both ARMI and control sections. ARMI layers were estimated to be 0.5-inch, and the top parts of both cores, whether with ARMI or without, were also trimmed, leaving 3.0-inch and 2.5-inch for cores with ARMI and without, respectively (See Figure 2-1). A 1.0-inch layer was retrieved from the top parts for both cores and used as central loading spacer. Two half specimens were expoxied to the central loading spacer to form a completely symmetrical composite specimen for testing (See Figure 2-2). Teflon spacer was introduced to represent an existing crack, which more effectively concentrated stress at the interface. A diamond-tip coring tool was used to introduce the 3/4-inch hole though which loading was applied. The specimen's curved ends were reinforced with carbon fiber to eliminate a potential bending failure. Five composite specimens each were prepared for both with ARMI and without ARMI.

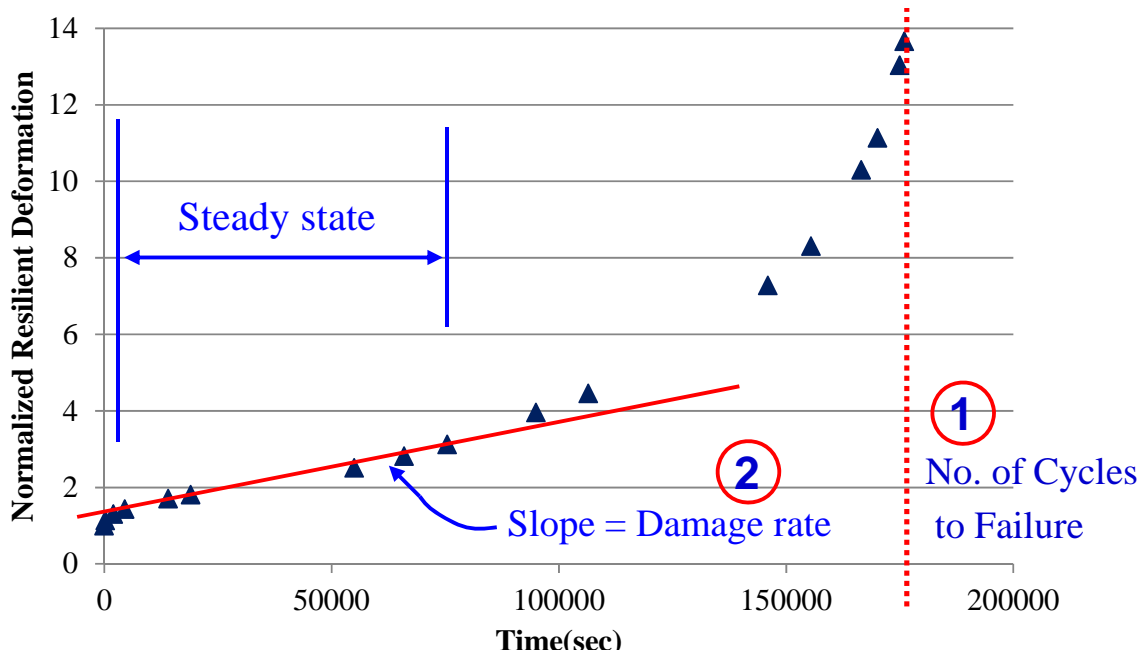
Figure 3-1. Typical recoverable deformation and damage rate

A typical recoverable deformation versus time plot is shown in Figure 3-1. As shown in this figure, the recoverable deformation versus time curve can be divided into three stages: the initial stage, which was known to involve changes in temperature and local damage adjacent to the loading yokes; the second stage, which involved steady-state damage; and the final stage, when the crack propagated rapidly and the specimen breaks. The damage rate is defined as the slope of the steady state response portion of recoverable deformation progression curve as shown by the line in Figure 3-1.

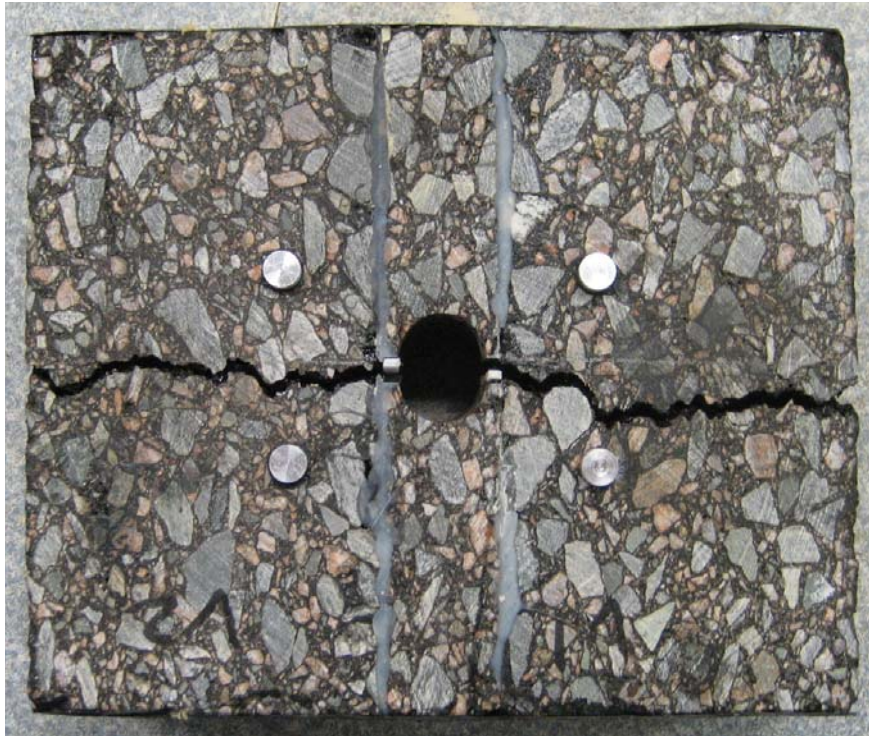
Figure 3-2. Typical failure mode of composite specimen

Repeated load fracture tests were performed on three composite specimens each for both with ARMI and without ARMI under the same peak load. Number of load cycles to failure and damage rate were obtained for each test. Typical failure mode for both types of composite specimens is shown in Figure 3-2. The number of loading cycles to failure and damage rate results are presented in Figures 3-3 and 3-4, respectively.

Figure 3-2 clearly indicated that cracking did initiate within the ARMI and propagated through the ARMI and into overlays. This cracking process successfully simulated the reflective cracking mechanism with ARMI. Figures 3-3 and 3-4 clearly indicated that specimens without ARMI outperformed the specimens with ARMI in terms of reflective cracking resistance. It appears that ARMI not only cannot delay reflective cracking but to some extent reduces

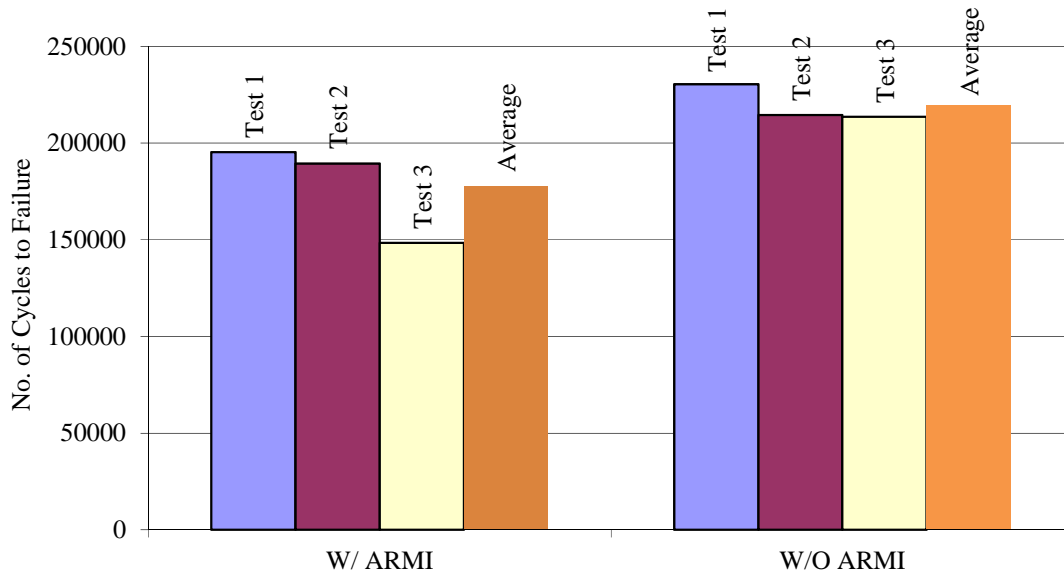
Figure 3-3. Number of cycles to failure

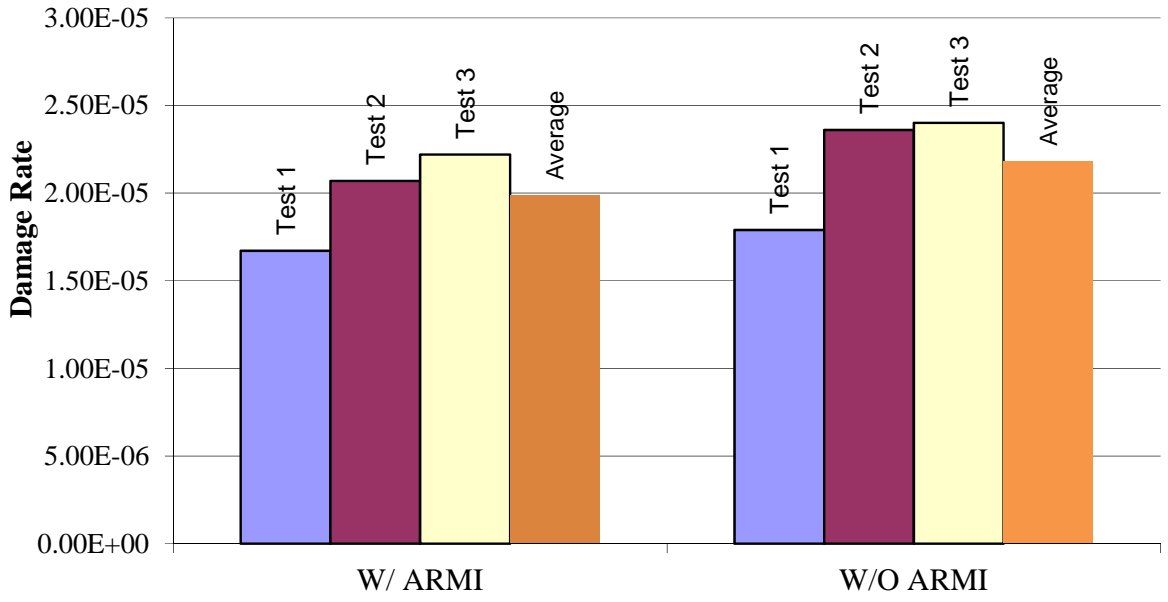
Figure 3-4. Damage rate
