Final Report

Safety and Driver Behavior Studies at Multiple Lane Approaches to Stop-Controlled Intersections

May 2010

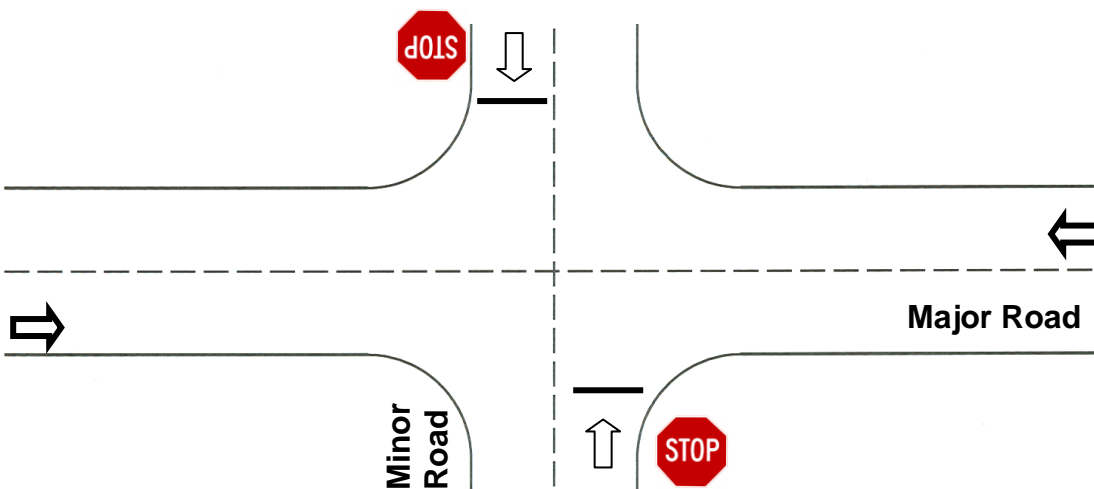
Figure 1.1 Generic Diagram of 2-Way Stop-Controlled Intersection

A two-way stop-controlled intersection is the most common type of intersection in the United States (2). In general, it involves a minor roadway with a stop-controlled approach intersecting a major roadway with no control as shown in figure 1.1.

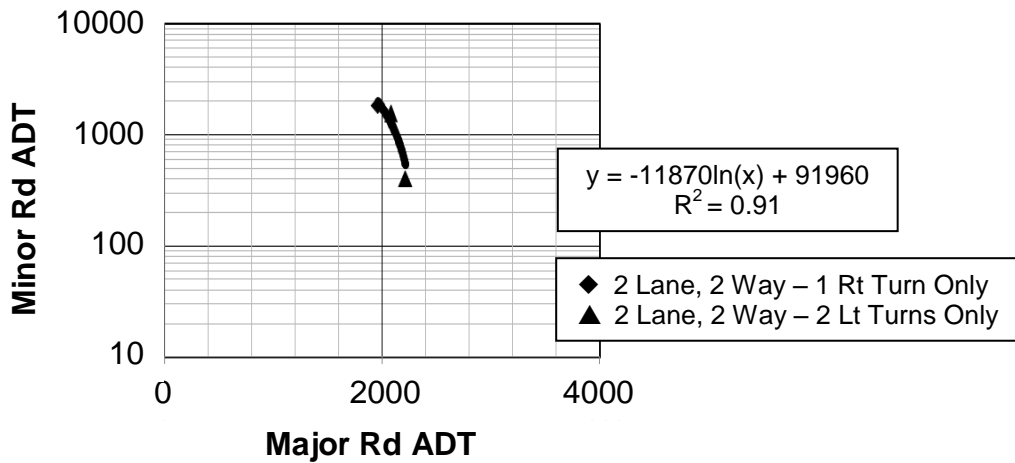
Sites with 4-lane major roads had so few occurrences in the database (four), they were compiled into all posted speed groups and a best-fit equation was developed. Figure 7.4 shows the results. Although the adjusted R^2 value is 0.60, since so few sites were available it is doubtful that the equation is a good predictor of suitable MLA-type intersections along 4-lane major road facilities. However, two of the four 4-lane major road sites that were removed from the database due to the 3-year accident rate being higher than the statewide average were in urban areas, which may indicate that urban scenarios are not well suited for MLA-type intersections connecting to 4-lane major facilities.

Figure 7.1 Results of Major ADT vs. Minor ADT Relationship at Intersections of 2-Lane, 2-Way Roadways with Below Average 3-yr Accident Rates, Major Rd Speed Limit = 60 mph

Figure 7.2 Results of Major ADT vs. Minor ADT Relationship at Intersections of 2-Lane, 2-Way Roadways with Below Average 3-Yr Accident Rates, Major Rd Speed Limit = 65 mph

Figure 7.3 Results of Major ADT vs. Minor ADT Relationship at Intersections of 2-Lane, 2-Way Roadways with Below Average 3-Yr Accident Rates, Major Rd Speed Limits = 60 and 65 mph

Figure 7.4 Results of Major ADT vs. Minor ADT Relationship at Intersections of 4-Lane, 2-Way Roadways with Below Average 3-Yr Accident Rates, Major Road Speed Limit = 60 and 65 mph

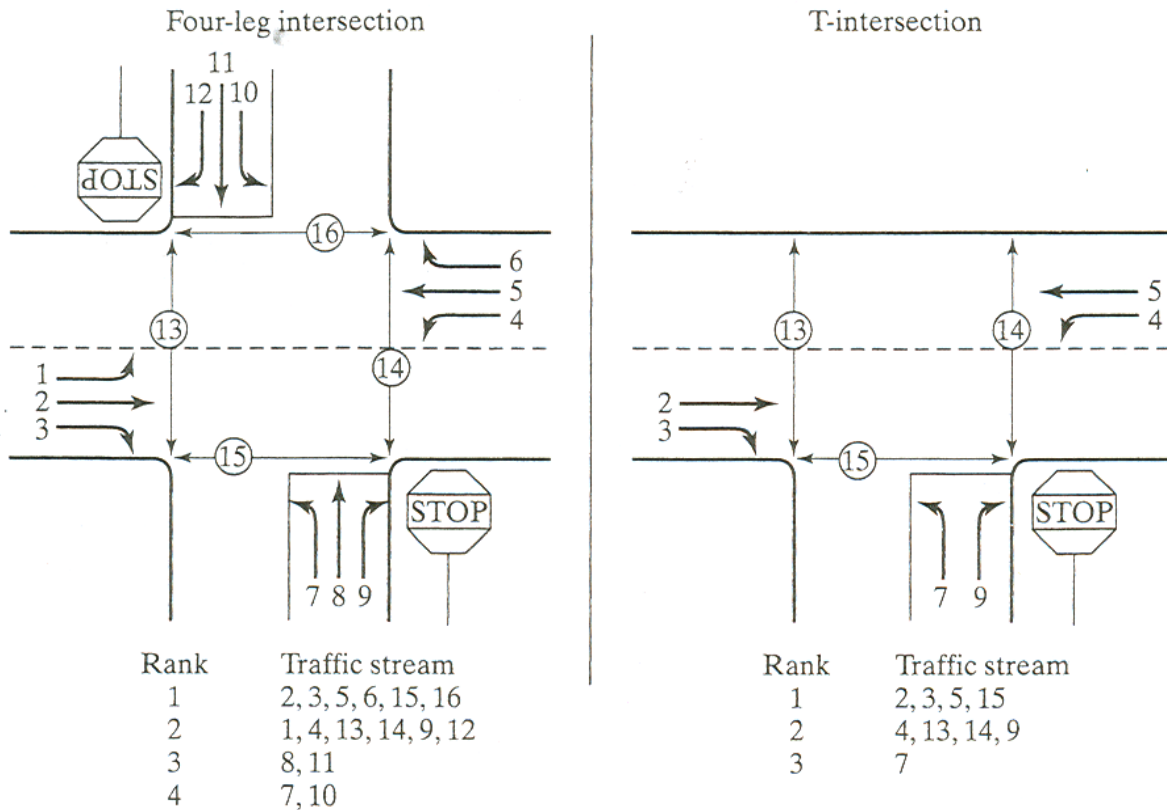
Figure 1.4 Priority of Vehicle and Pedestrian Movements at a 2-Way Stop-Controlled Intersection (12, p. 17-4)

Figure 1.4 is reproduced below to show the priority of movements at a two-way stop-controlled intersection, which would be included in the *a priori* driver frame of reference. As described previously, according to these guidelines, if a left- and right-turning vehicle are simultaneously stopped at the same stop-controlled approach, the right-turning vehicle has priority over the left. The right-turning driver only requires a suitable gap in traffic from the major road approaching the intersection from his/her left side instead of conflicts from the left, far and right sides. A left-turning vehicle has the lowest priority of all movements due to the number of potential conflicts that must be considered by the driver.

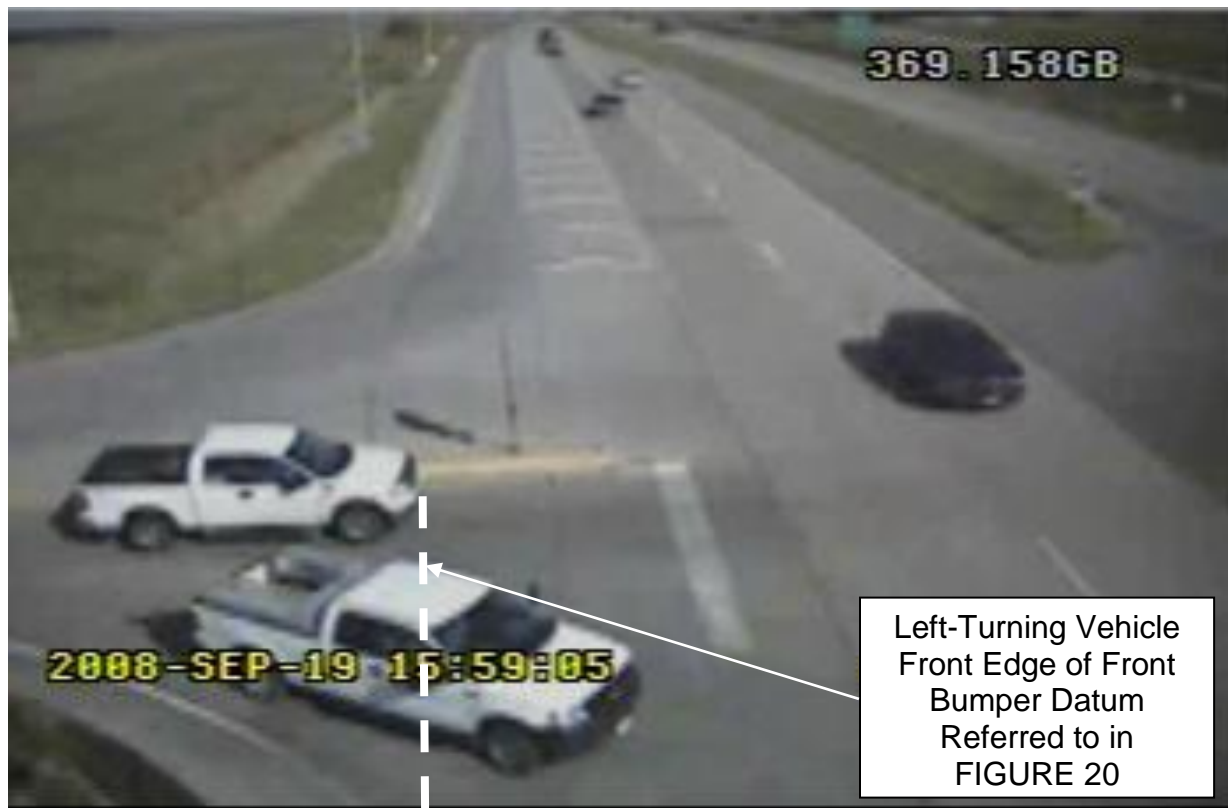
Figure 8.1 Photograph of Typical Driver Behavior at MLA Intersection, US Hwy 77 & East Junction N-41

Hwy 77 (expressway) and Nebraska Hwy 41 (two-lane two-way highway). The photograph was taken from a pole-mounted camera as part of a current NDOR research study on offset right-turn lanes (ORTLs) titled “*Conditions Warranting Offset Right-Turn Lanes (ORTL) for Improved Intersection Sight Distance*”, (NDOR Project SPR-P1(06)P592).

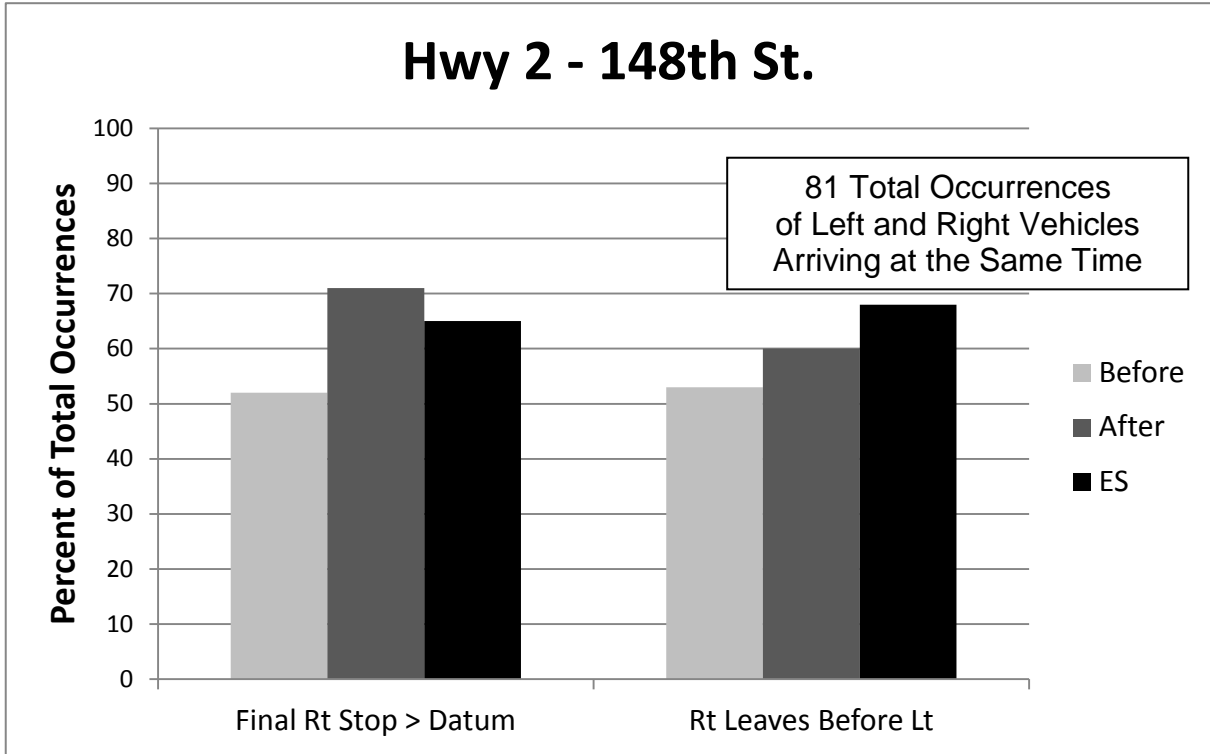
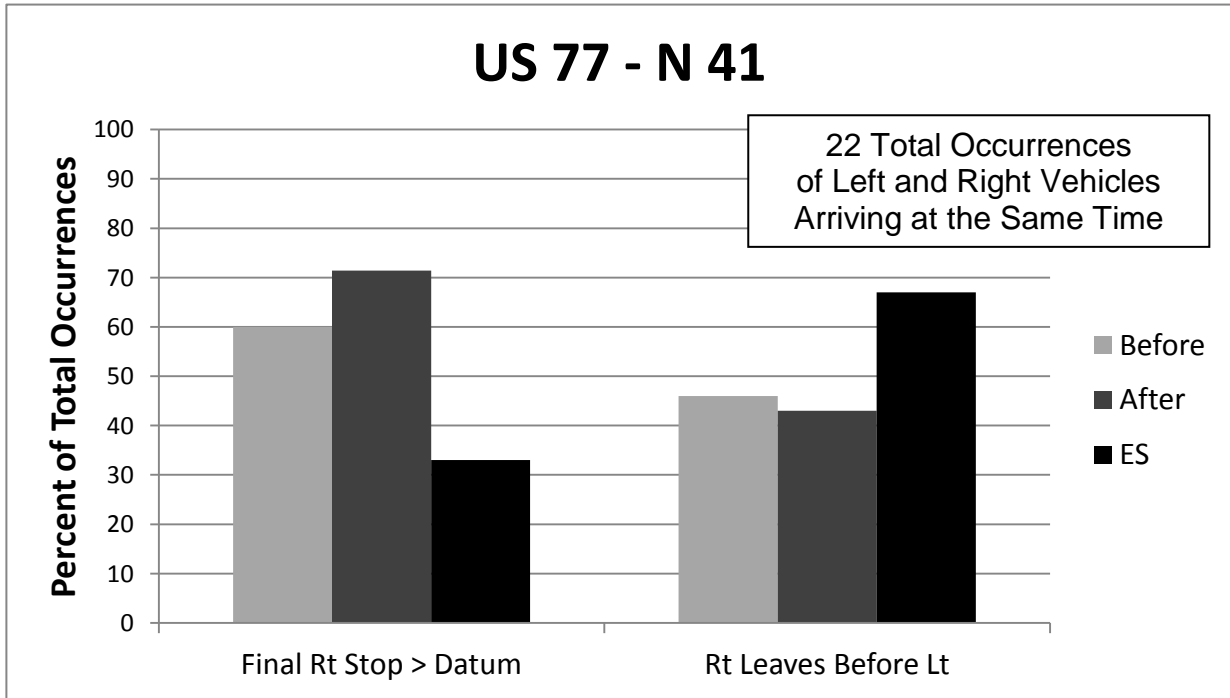
Figure 8.3 Results of Right-Turning Driver Behavior at MLA Type Intersections at Location 1, 148th St and Hwy 2 and Location 2, US Hwy 77 and Hwy N-41

indicates that right-turning drivers pull forward of view-blocking left-turning vehicles and leave before the left-turning drivers the majority of the time.

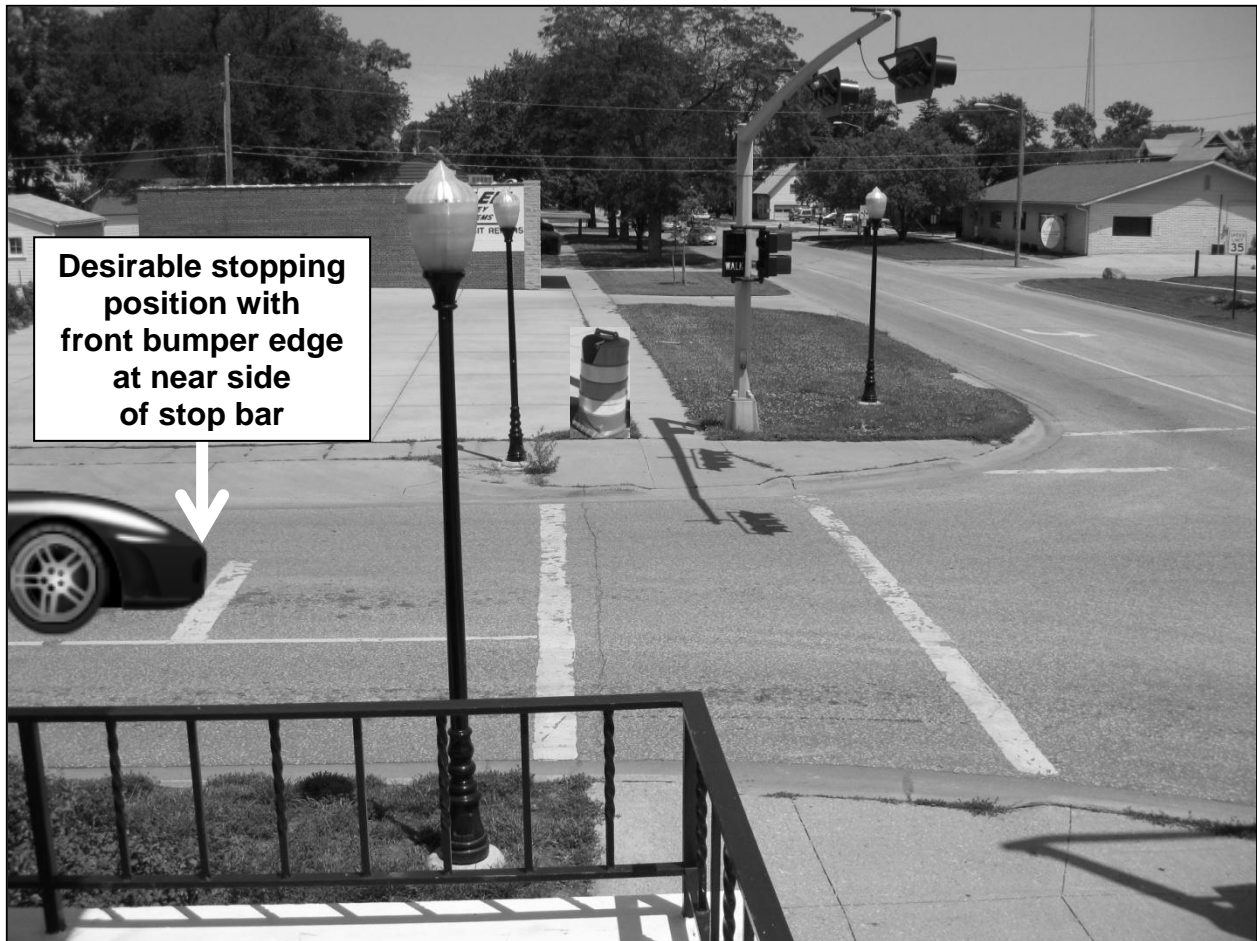
Figure 9.3 View of Staggered Stop Bar on Eastbound Approach to 10th and Charleston Sts, Lincoln, NE

Driver behavior on the eastbound approach was videotaped from a location within the public right-of-way, adjacent to the stop bar. Since the filming location was so close to the drivers being studied, a video camera tripod was set within a plastic construction barrel modified with an opening at the top to allow unobstructed filming and to prevent drivers from modifying their behavior due to video surveillance. A camcorder on the tripod within the barrel was used for filming with power supplied from a deep cycle battery. The battery was connected to a power inverter that was attached to a surge protector. The camera was then powered through the surge protector with an AC power cable. A view of the camera location from the traffic barrel is superimposed in figure 9.3 and shown in more detail in figure 9.4.

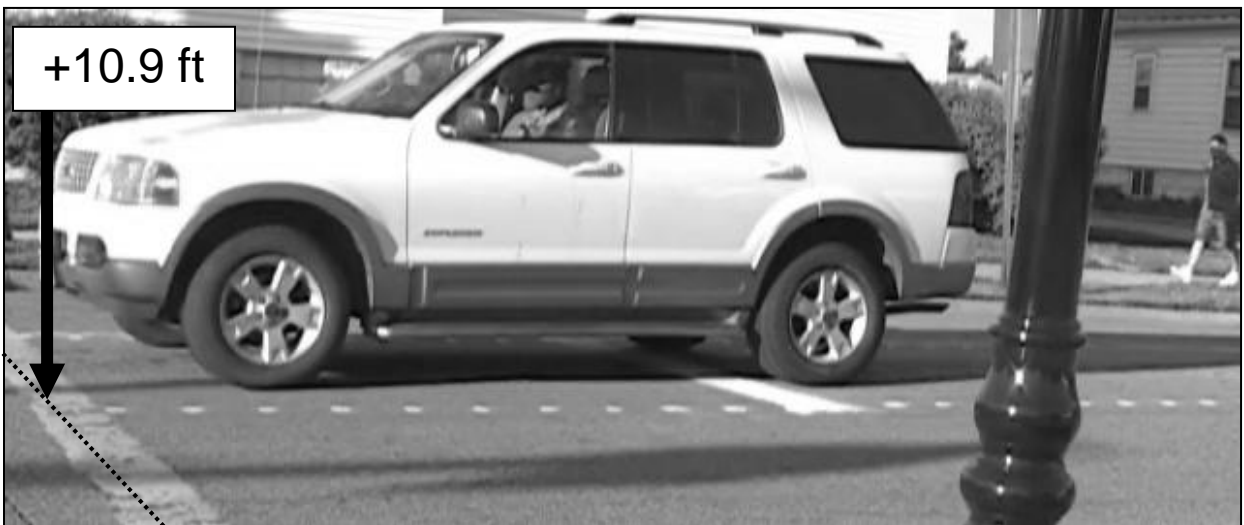
Stops made before the datum line were recorded as negative values, while stops beyond the datum line were recorded as positive values as shown in figure 9.8. The boundaries of the stop positions were 10 ft before the staggered stop line and 12 ft beyond the staggered stop line. These were chosen due to the width of the camera view from its field position. Values outside these limits were recorded as “-10+” and “12+,” respectively. Pictures of vehicles stopped at different points along the studied approach are shown in figure 9.8.

Figure 9.8 Video Screenshots with Stops at 0.0, -3.1, and +10.9 ft from the Datum.

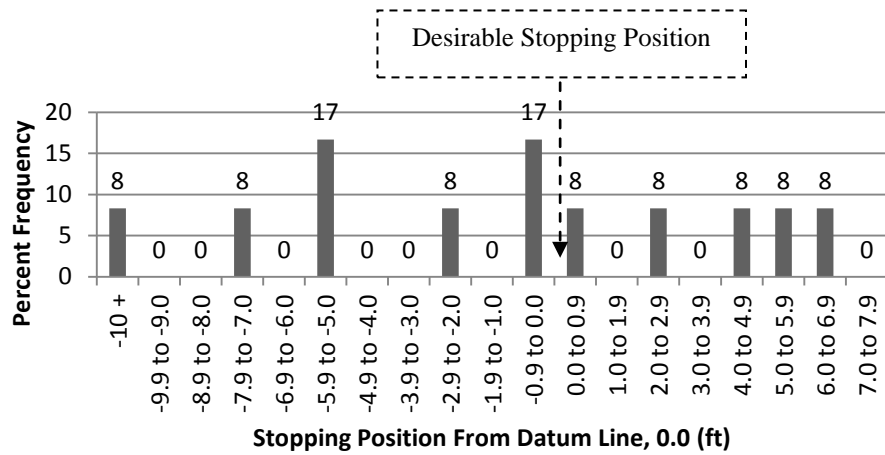
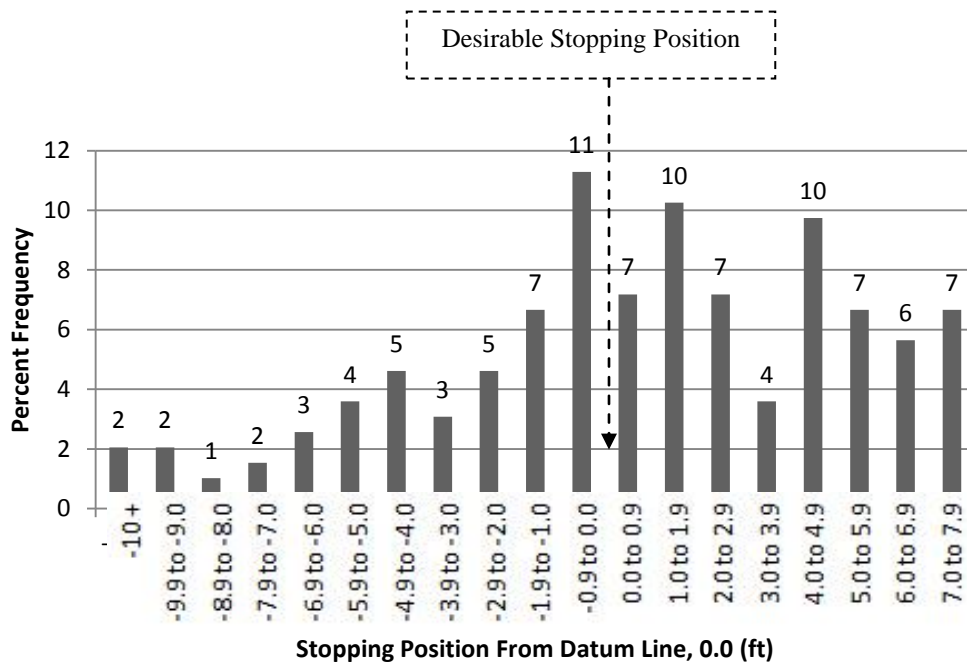
shows the percent occurrence frequency for all conditions combined. Table 9.3 shows a summary of statistics for the data along with sample size error estimates.

Figure 9.10 Percent Frequency of Positioning, Condition 1

Figure 9.11 Percent Frequency of Positioning, Condition 2

Figure 9.12 Percent Frequency of Positioning, Condition 3

Figure 9.13 Percent Frequency of Positioning, Conditions 1, 2, and 3 Combined

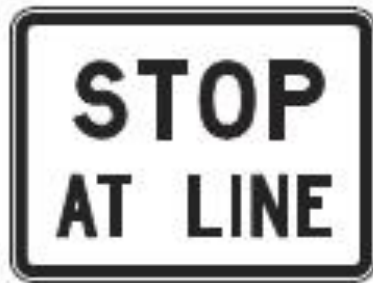
Figure 9.16 Example of NDOR Sign R1-5C-24

The State of Nebraska currently has a special placard designed that can be placed immediately above or below the stop sign at a stop-controlled intersection to encourage drivers to recognize the desirable position for them to stop their vehicles. Figure 9.16 shows an example of the “STOP AT LINE” placard (NDOR Sign R1-5C-24).

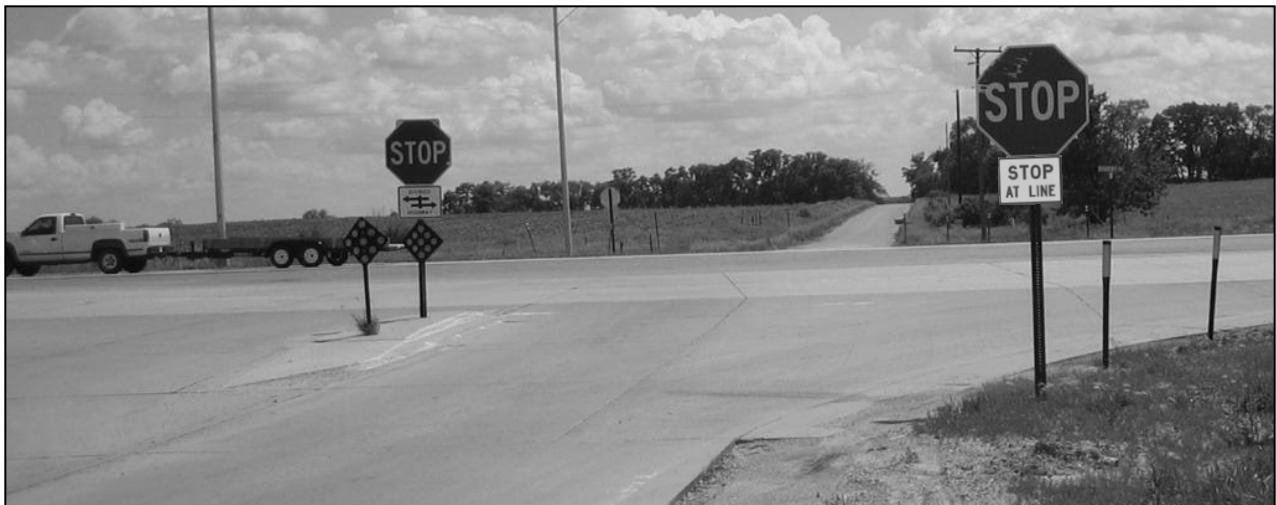
sign was added only to the STOP sign on the right side of the approach, instead of on both STOP signs. This was because the center median STOP sign already had a divided median sign (required) and a diamond-shaped delineator sign (optional) on a single post. NDOR signing authorities felt adding another sign to this existing combination would violate engineering judgment principles based on minimizing the number of sign messages per installation. A photograph of the final study sign installation is shown in Figure 9.18.

Figure 9.18 Example of Placement of STOP AT LINE Sign Only on Right STOP Sign on ORTL Project

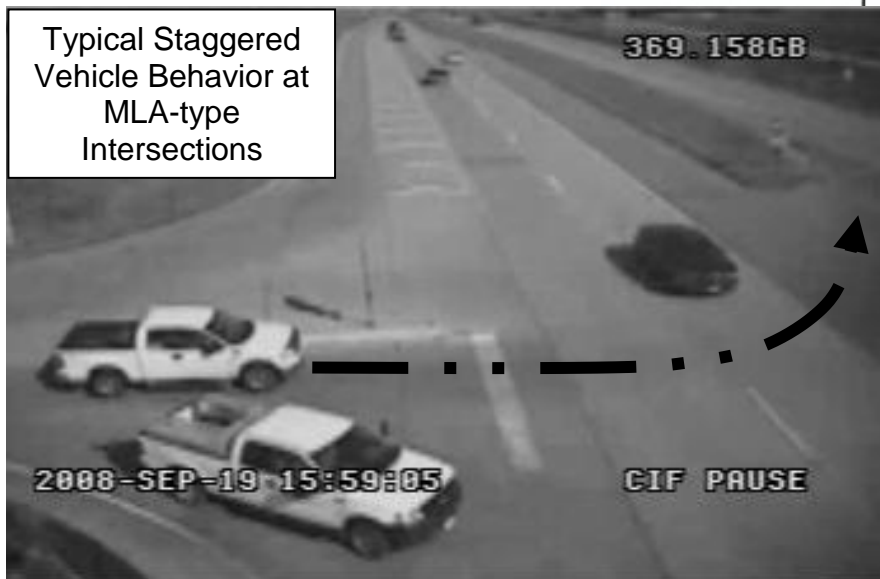
Figure 9.23 Plan View of Proposed Staggered Stop Bar Pavement Marking to Better Fit Driver Behavior at MLA-Type Intersections

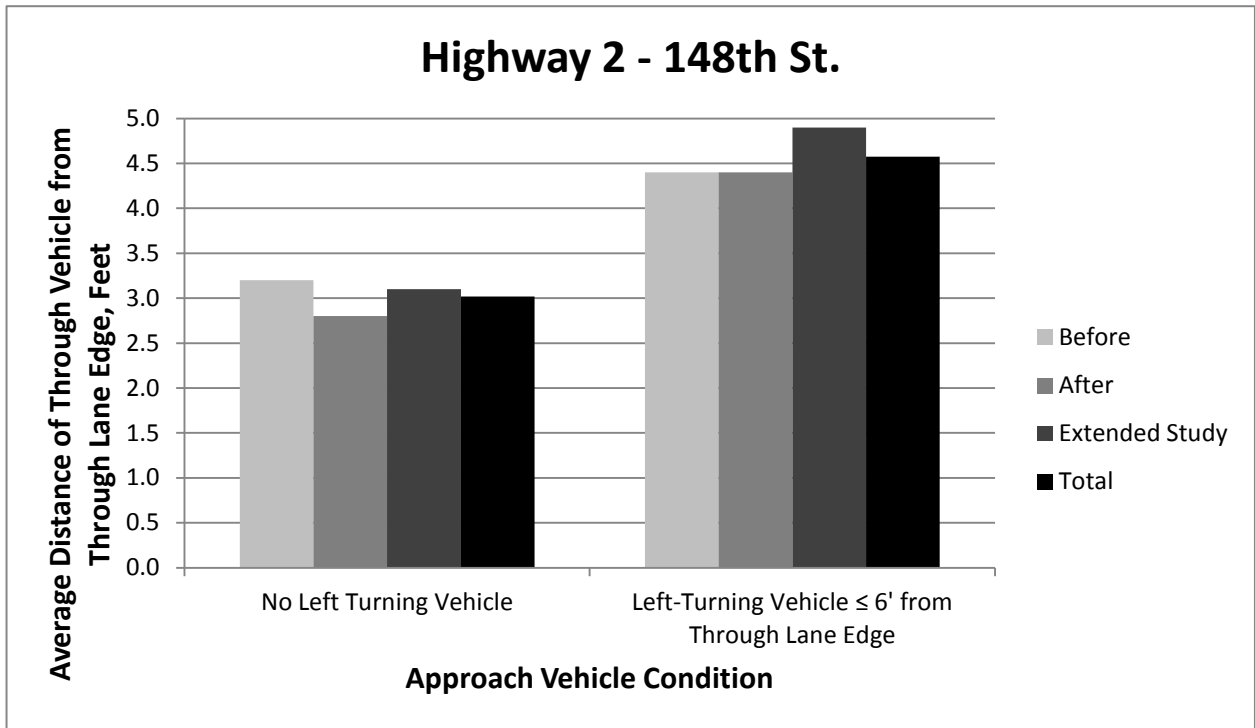
Figure 9.25 Comparison of Through Vehicle Lane Positioning When Stop-Controlled Approach Vehicles At or Within 6 ft of Through Lane Edge and When No Approach Vehicles are Present

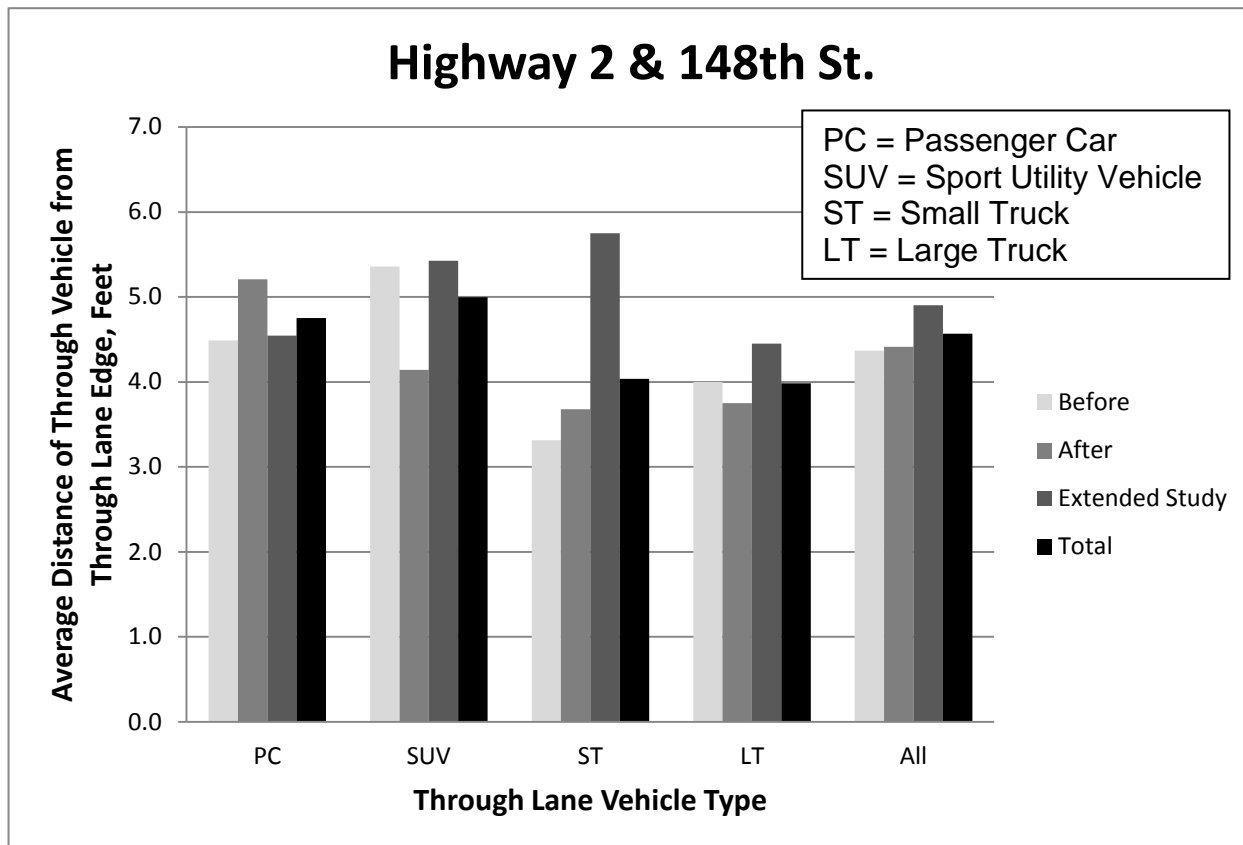
Figure 9.26 Comparison of Through Lane Vehicle Type Positioning When Stop-Controlled Approach Vehicles At or Within 6 ft of Through Lane Edge

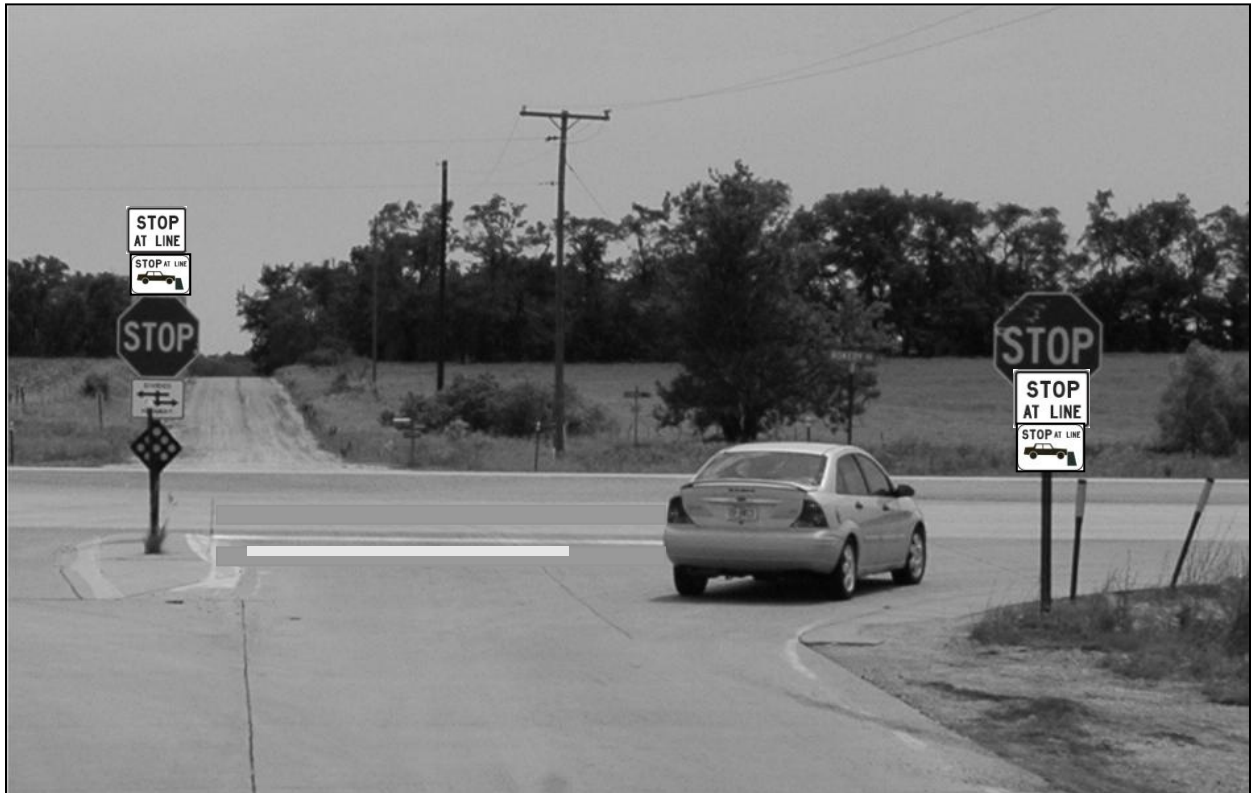
Figure 9.29 Simulation of Proposed Single-Signing Recommendation
