North Carolina Department of Transportation Project No. 2008-13

Final Report

**Field Verification of Undercut Criteria and Alternatives
for Subgrade Stabilization – Coastal Plain**

**Raleigh, North Carolina
June 2012**

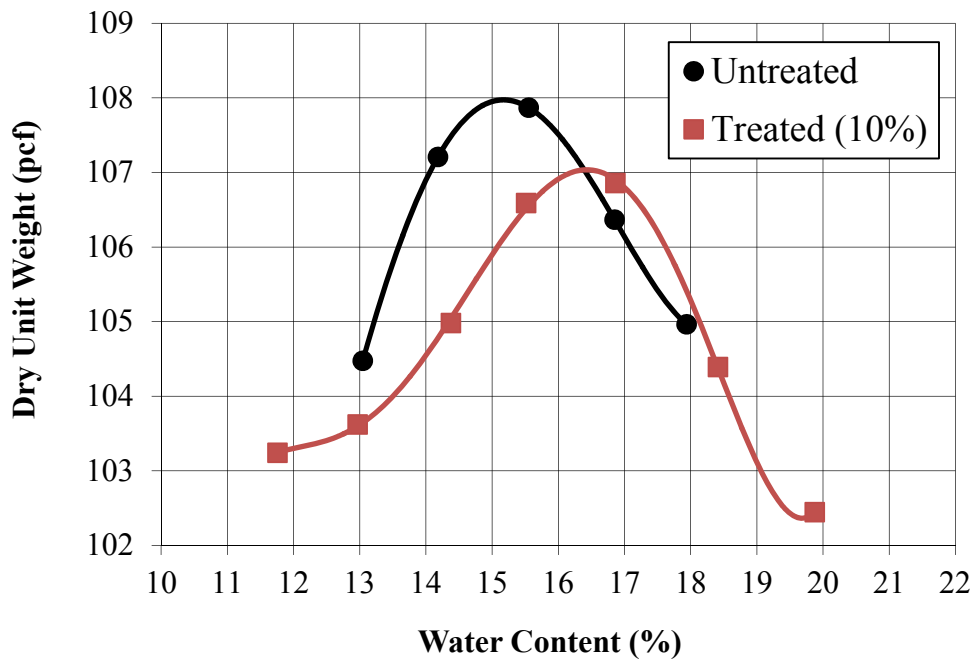
The moisture-density relationship of the soil-cement mixture was determined by performing standard proctor tests according to ASTM D558. Portland cement type I was added to bulk subgrade samples to simulate the construction of cement stabilized subgrade (CSS) in the field. The subgrade samples were taken from the top 12 inches from grade during a preliminary site visit in March, 2011. First, a single set of standard proctor compaction tests were performed on an untreated sample of the subgrade. Based on a measured maximum dry density of 108 pcf, another round of standard proctor compaction tests were performed, this time adding cement at a dosage rate of 10%. After mixing, the soil-cement mixture was immediately compacted at various water contents to assess the moisture content and dry unit weight relationship. The results are presented in Figure 3-16. Compared with the untreated sample the 10% cement treated sample exhibited a slight increase in optimum moisture content and decrease in maximum dry unit weight. This is consistent with the observations made by Sariosseiri and Muhunthan on cement-treated subgrade soils in Washington state (2009).

Figure 3-16: Untreated and cement treated subgrade soil standard proctor compaction test results

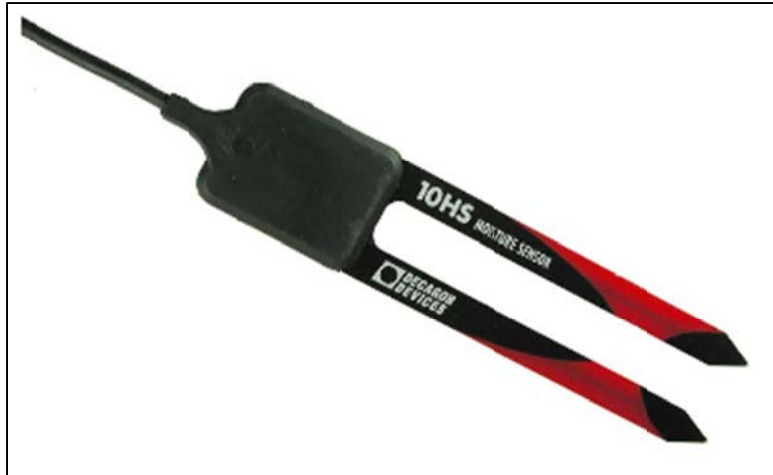
The volumetric water content (VWC) of the subgrade at each test section was measured using two Decagon 10HS Soil Moisture sensors (Figure 3-19). Each sensor was ten centimeters long with an 1100 cubic centimeter volume of influence. When the two probes are inserted into a mass of soil the sensor measures the dielectric permittivity of the soil using capacitance/frequency domain technology (Decagon Devices, Inc., 2010). Based on the dielectric permittivity the VWC can be determined using a manufacture provided calibration equation. However, the manufacturer notes that different soils have different soil properties (Cobos & Chambers, 2010). Thus, for the most precise results the manufacturer recommends calibrating the sensors in the lab using the soil specific to the project. Following their recommendation, the sensors were calibrated in the lab using the subgrade soil obtained from the field. A summary of the lab calibration procedure and the results is provided in Appendix E. A detailed discussion of the soil moisture sensor installation is provided later in this chapter.

Figure 3-19: Decagon 10HS Soil Moisture sensor (Decagon Devices, Inc., 2012)

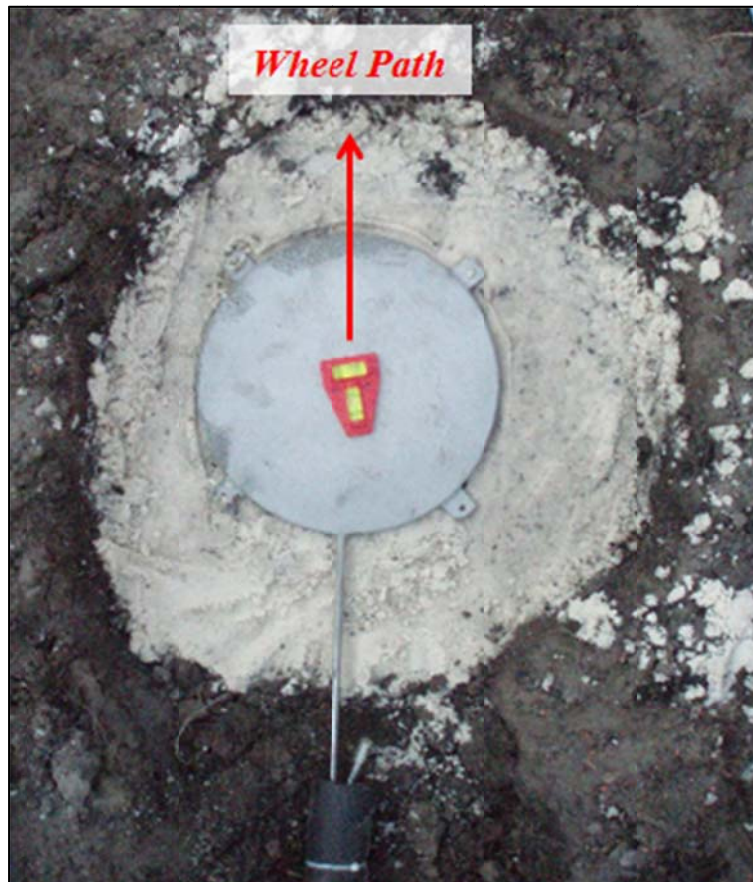
Figure 3-23: EPC installation in Test Section 1

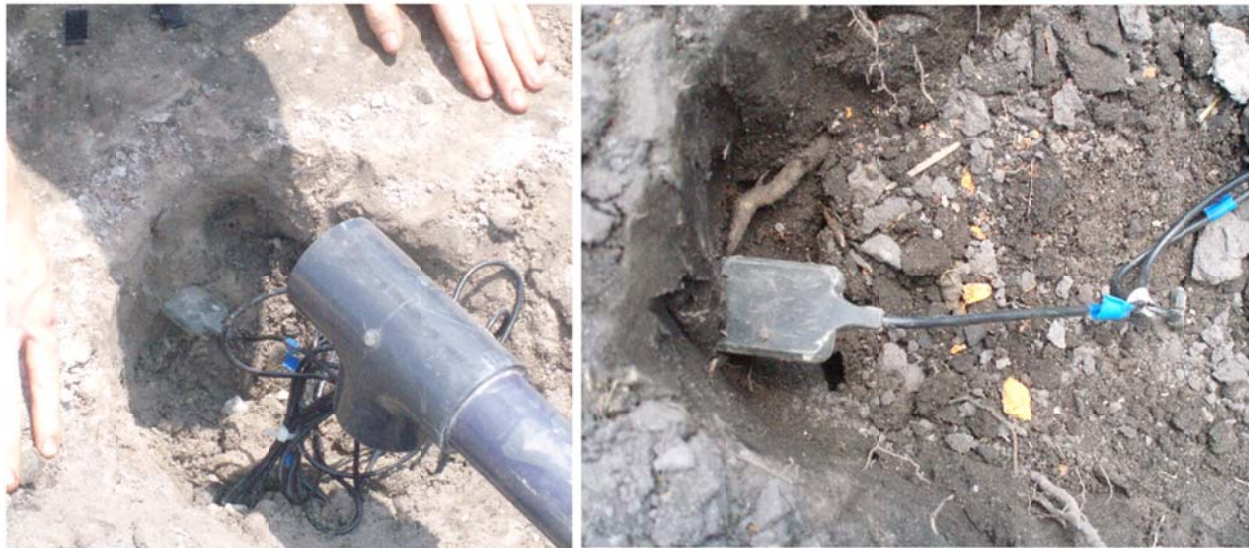
horizontally into the sidewall of the undisturbed subgrade at a depth of three inches below the undercut elevation. The second sensor was installed vertically into the undisturbed subgrade at a depth of six inches below the undercut elevation. Like the EPCs, the moisture sensors in Test Section 4 were installed six inches horizontally and eight inches vertically below the subgrade/base interface out of precaution from damage during the cement stabilized layer construction. Shown in Figure 3-24 is the installation of the soil moisture sensors for Test Sections 1 and 2.

Figure 3-24: Moisture sensors installed (left) in Test Section 1 and (right) in Test Section 2

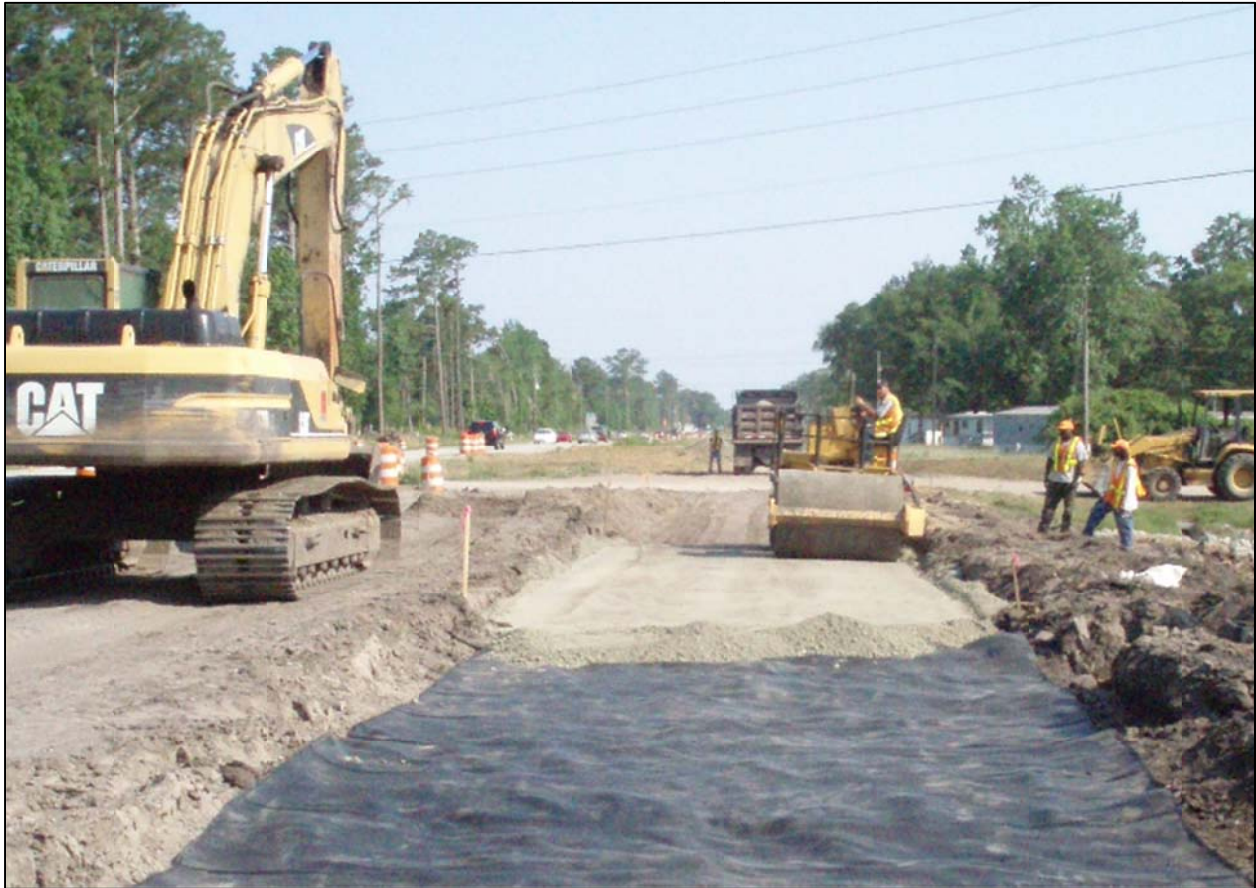
Figure 3-27: Compacting Test Sections 1 and 2 using a steel drum vibratory roller

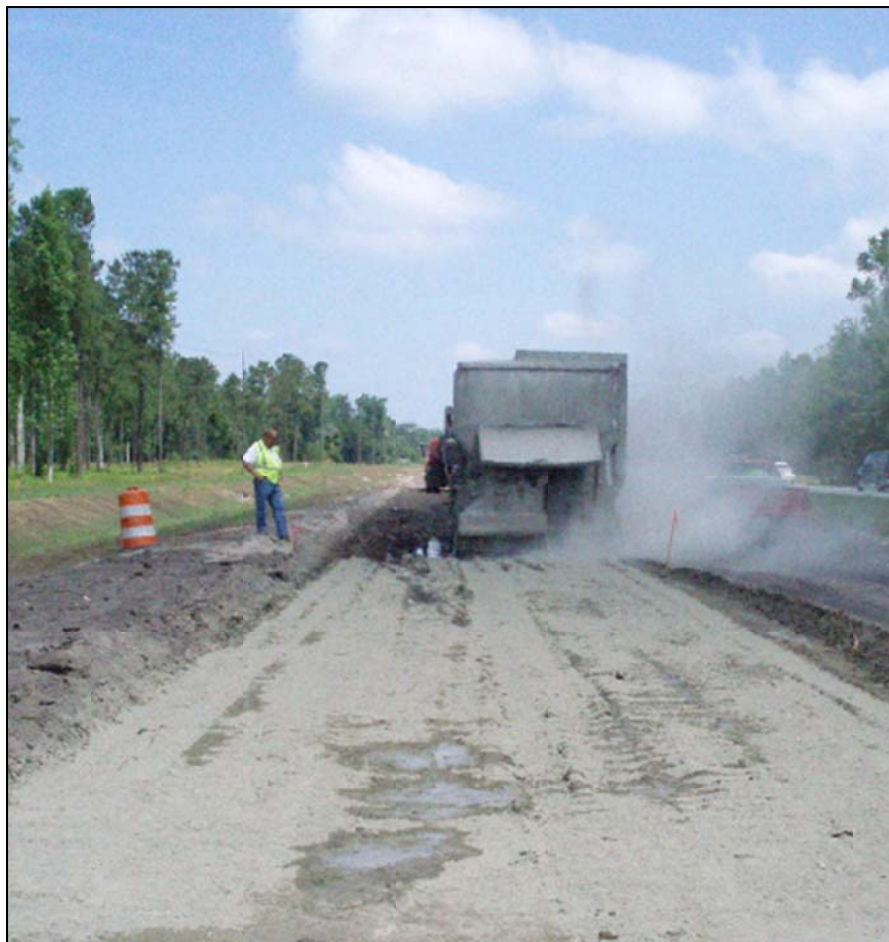
spread using a tanker truck equipped with a deflector that drops the cement out of the back and onto the ground (see Figure 3-28). This method of spreading does not allow the operator to adjust the rate of flow. Consequently, the area of the cement coverage must be pre-determined and monitored in conjunction with emptying the truck in order to verify uniformity. Based on a total cement weight in the tanker of approximately 8100 lbs. it was determined that a coverage area of 946.8 square feet was required to provide a cement content of 12% within the top 8 inches of subgrade soil. Since the test section was 16 feet wide, the cement was spread over 59.2 linear feet of roadway starting at the interface of Test Section 3 and 4 (Station 122+50) and ending 9.2 feet past the designated end of Test Section 4 (Station 123+9.2). In order to spread the cement evenly throughout the test section the operator made two consecutive passes with the first pass running alongside the shoulder of the roadway and the second pass running adjacent to the centerline of the road.

Figure 3-28: Spreading the cement in Test Section 4

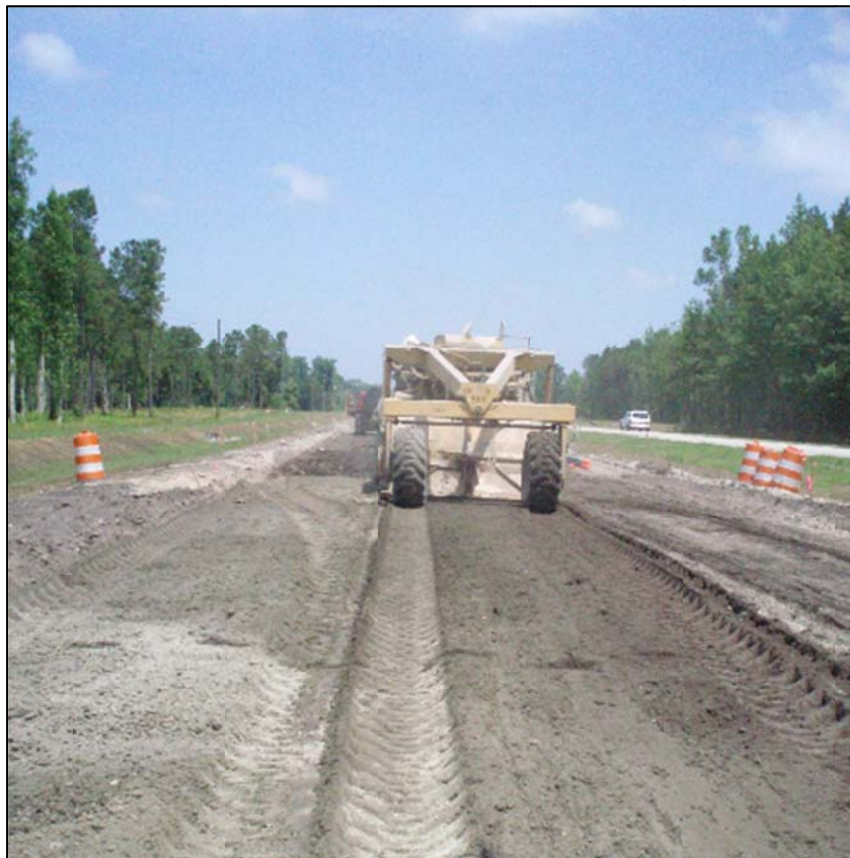
After spreading was complete, the cement was mixed into the top eight inches of subgrade soil using a soil stabilizer shown in Figure 3-29. During this process any roots and debris observed in the soil-cement mixture were removed. Once the NCDOT inspector believed a homogenous and uniform mixture was produced, a sample was obtained to measure the moisture content and to verify it was within plus or minus two percent of optimum. After this was confirmed, the test section was compacted using a vibratory steel drum roller. The entire process took less than two hours from when the cement was spread to final compaction. Once the section was verified to have been compacted to greater than 97% of the maximum dry density using the rubber balloon method (discussed later), the contractor rewet the test pad and covered it with a plastic tarp to allow the soil-cement to cure for seven days. The plastic tarp was used as a replacement of the typical asphalt seal sprayed on top to keep the stabilized layer moist. Periodically during the curing process the contractor removed the tarp and rewetted the sections to prevent the surface from drying out (Simmons, 2011).

Figure 3-29: The soil stabilizer mixing the cement into the top 8 inches of subgrade soil

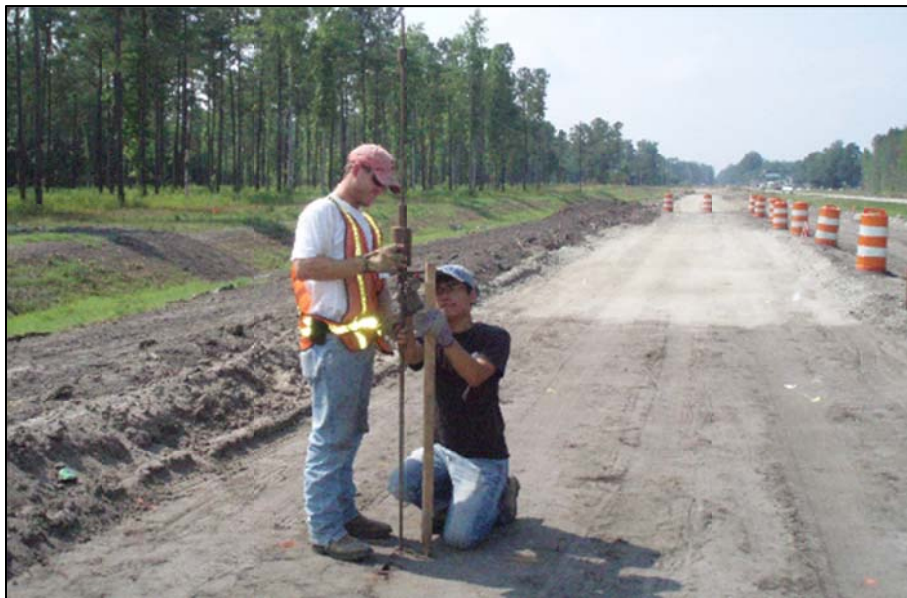
The DCP is used by lifting and releasing a hammer from a standard drop height onto an anvil which drives a cone tipped rod into the ground. Prior to beginning the test a wooden stake is positioned next to the DCP and a mark is made where the stake crosses the DCPs horizontal handle. After each drop of the hammer another mark is made on the wooden stake using the same horizontal handle as the point of reference. After the test is completed the distance between marks can be measured to determine the distance of penetration per blow (mm/blow) or DCP Index (DCPI). Testing was performed according to ASTM D6951 using a hammer weight of 8 kg (17.6 lbs.), a drop height of 576 mm (22.6 inches), a drive rod with a diameter of 16 mm (5/8 inch), and a cone tip angle of 60 degrees. A typical test is shown in Figure 3-31.

Figure 3-31: DCP testing prior to full-scale testing

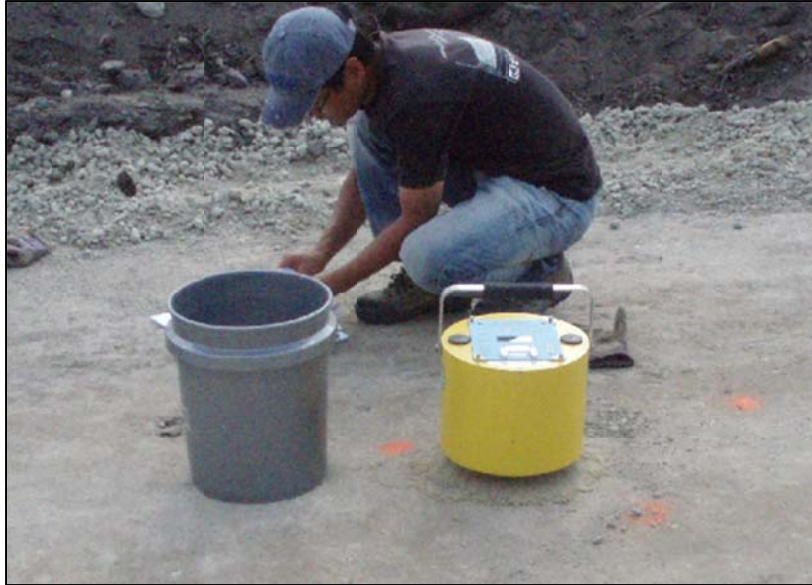
SSG testing was performed within each section at the center of both wheel paths. Prior to performing a test, the base layer surface was swept using a brush to remove any loose material. Next, a small sample of moist ASTM silica sand was placed and patted down to create a thin layer approximately $1/8$ to $1/4$ inch thick. The SSG was then placed on top of the sand and rotated $1/4$ of a revolution, as recommended by the manufacturer (Humboldt Mfg. Co., 2007). To verify precision, three tests were run per test location with the mean stiffness used as the reported value. Shown in Figure 3-32 is a typical SSG test being performed prior to full-scale testing.

Figure 3-32: SSG test being performed prior to full-scale testing

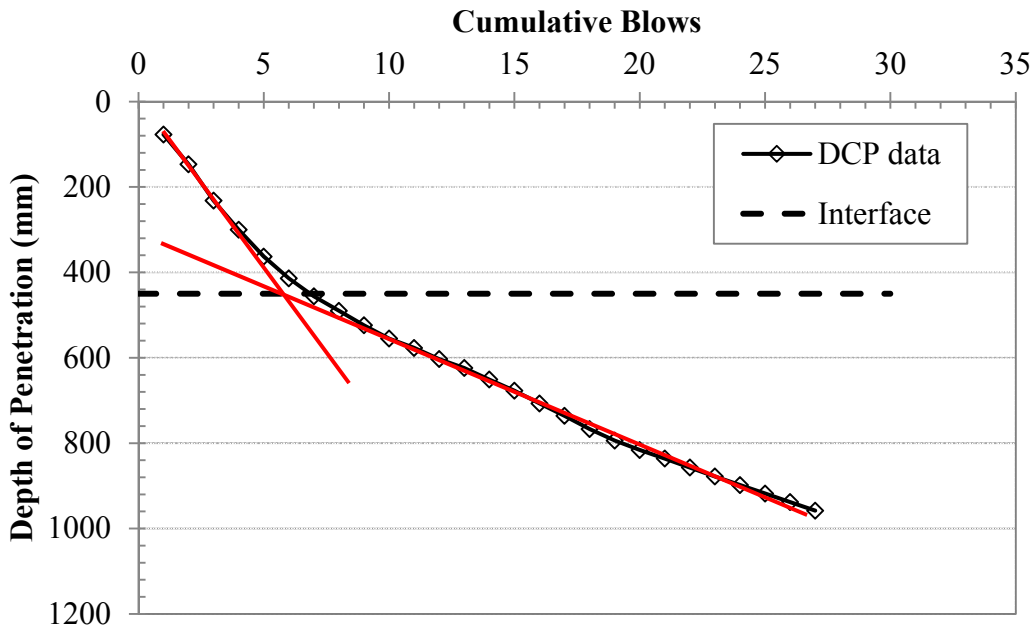
When performing DCP tests on a layered profile there is typically a transition zone between adjacent layers making it difficult to establish the interface location. ASTM D6951 recommends plotting the cumulative blows as a function of depth and drawing lines that represent the average slope within each layer. The depth at which adjacent soil layer lines intersect is then defined as the interface. This approach was followed in this study to determine subgrade layer thicknesses and calculate the weighted average DCPI. As an example, Figure 4-37 demonstrates this process using field data performed on the subgrade at station 121+50 prior to undercutting. Based on the results, there is a layer interface located at approximately 450 mm (18 inches) below the ground surface.

Figure 4-37: An illustration of how the interface of adjacent layers were defined

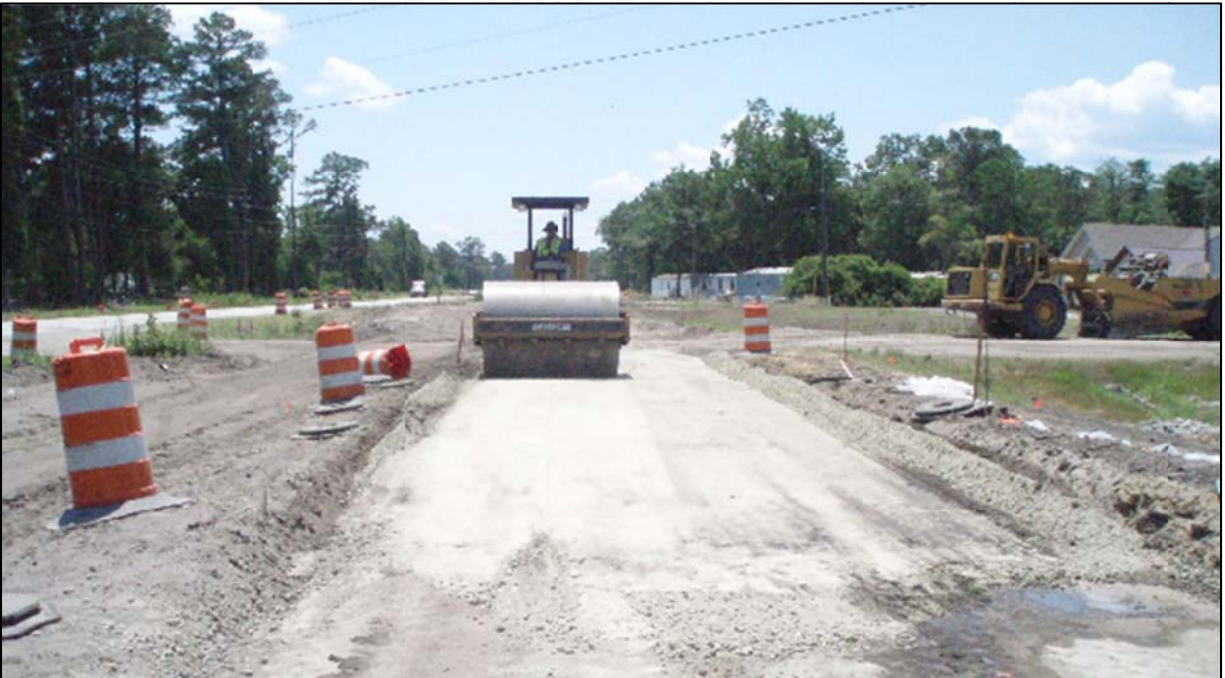
Figure 5-76: Test Section 1 being repaired at 200 truck passes

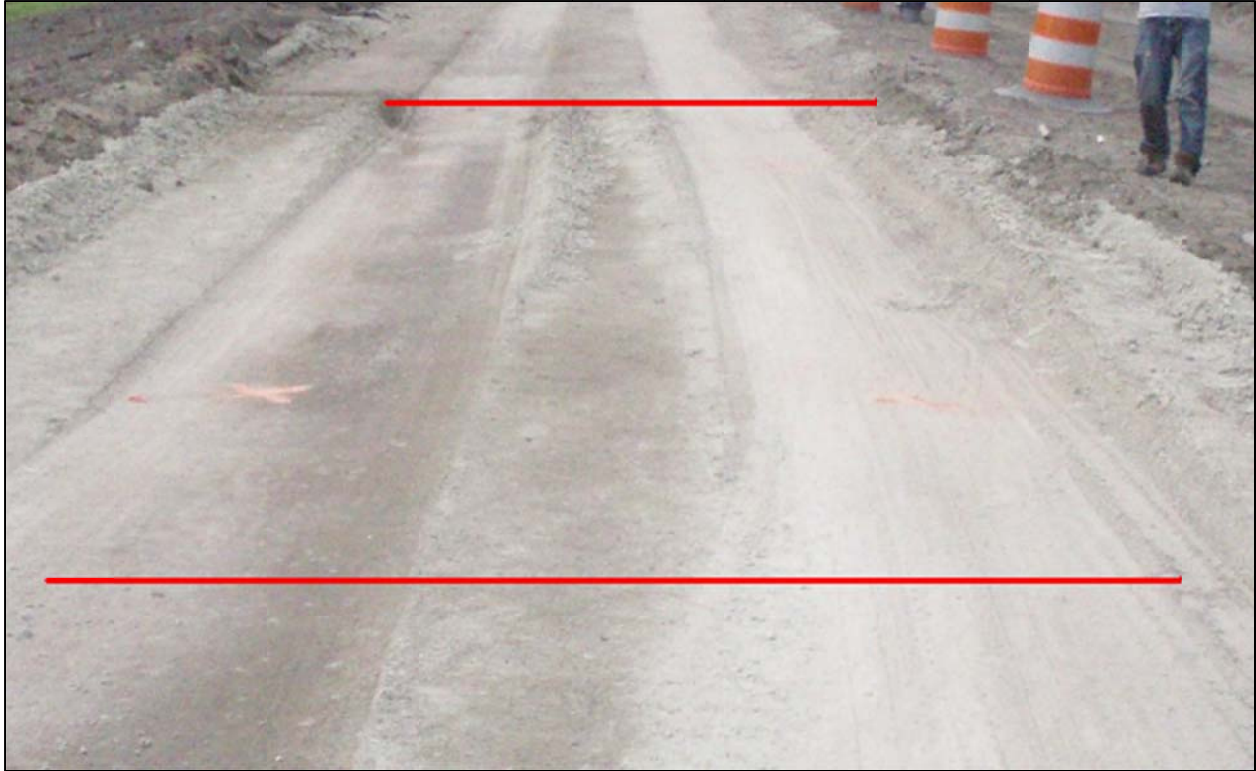
Figure 5-77: Test Section 1 after 1000 truck passes

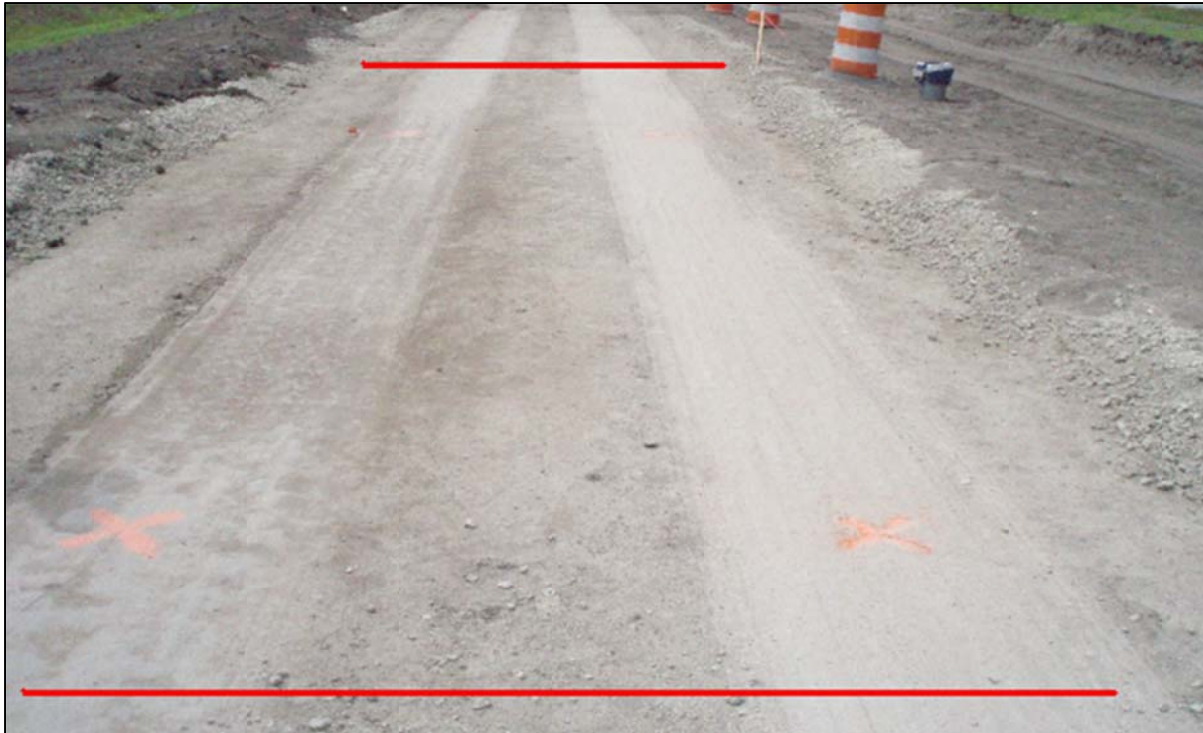
In terms of rutting, Test Sections 2 and 3 performed significantly better than the other two test sections. Shown in Figure 5-78 and Figure 5-79 is an image of Test Sections 2 and 3 after 1000 truck passes. With the exception of periodic wetting for dust control (which was also needed everywhere else at the field site) neither geosynthetically reinforced section required any maintenance or repair during the truck trafficking period. In terms of visible deterioration, alligator cracking, shown Figure 5-80, became prevalent throughout both sections after approximately 100 truck passes. A considerable amount of rutting did develop at the interface of adjacent test sections (Stations 121+50, 122+00, and 122+50); however, these areas were neglected from the analysis due to the overlapping stabilization measures.

Figure 5-78: Test Section 2 after 1000 truck passes

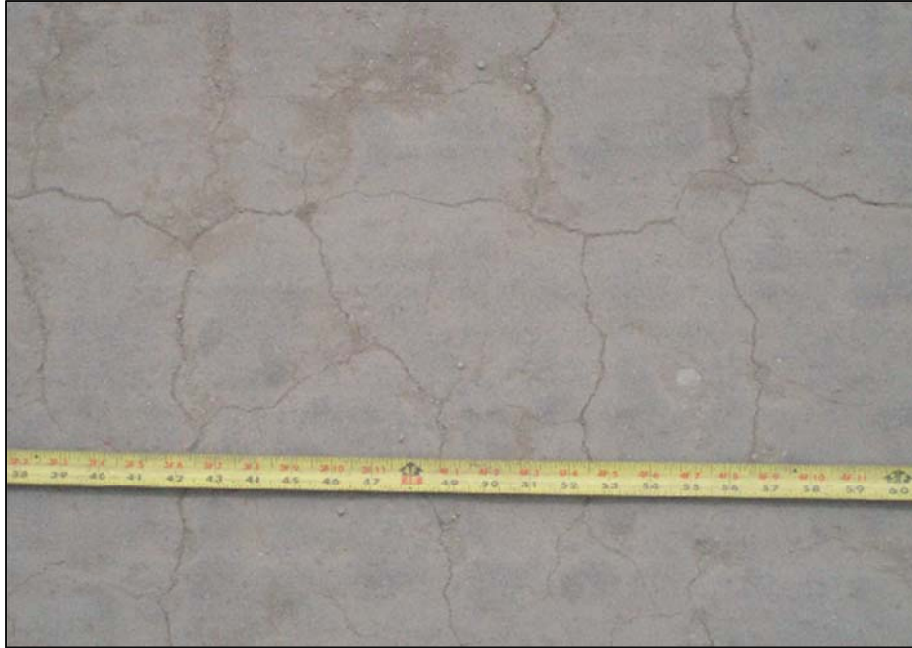
Figure 5-80: Image of the OWP in Test Section 3 after 1000 passes. Note the alligator cracking which was prevalent in Test Sections 2 and 3.

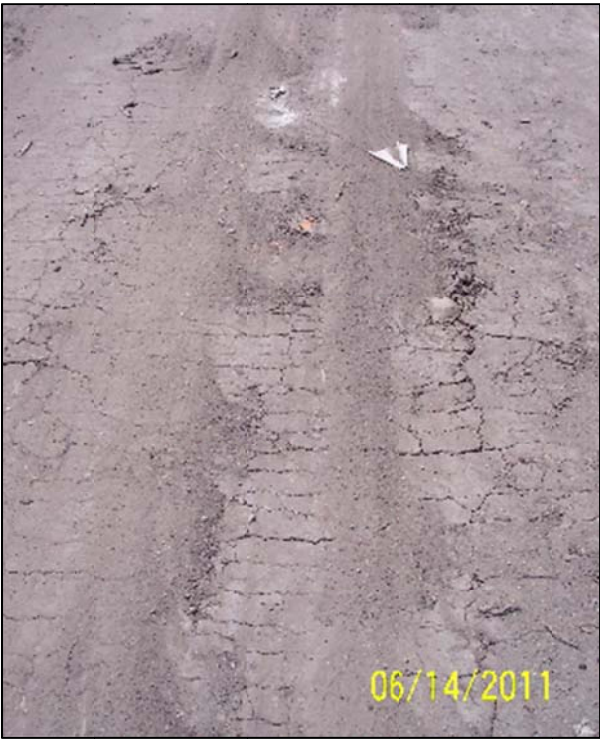
Figure 5-81: Cracks developing along the IWP in Test Section 4 after 10 truck passes

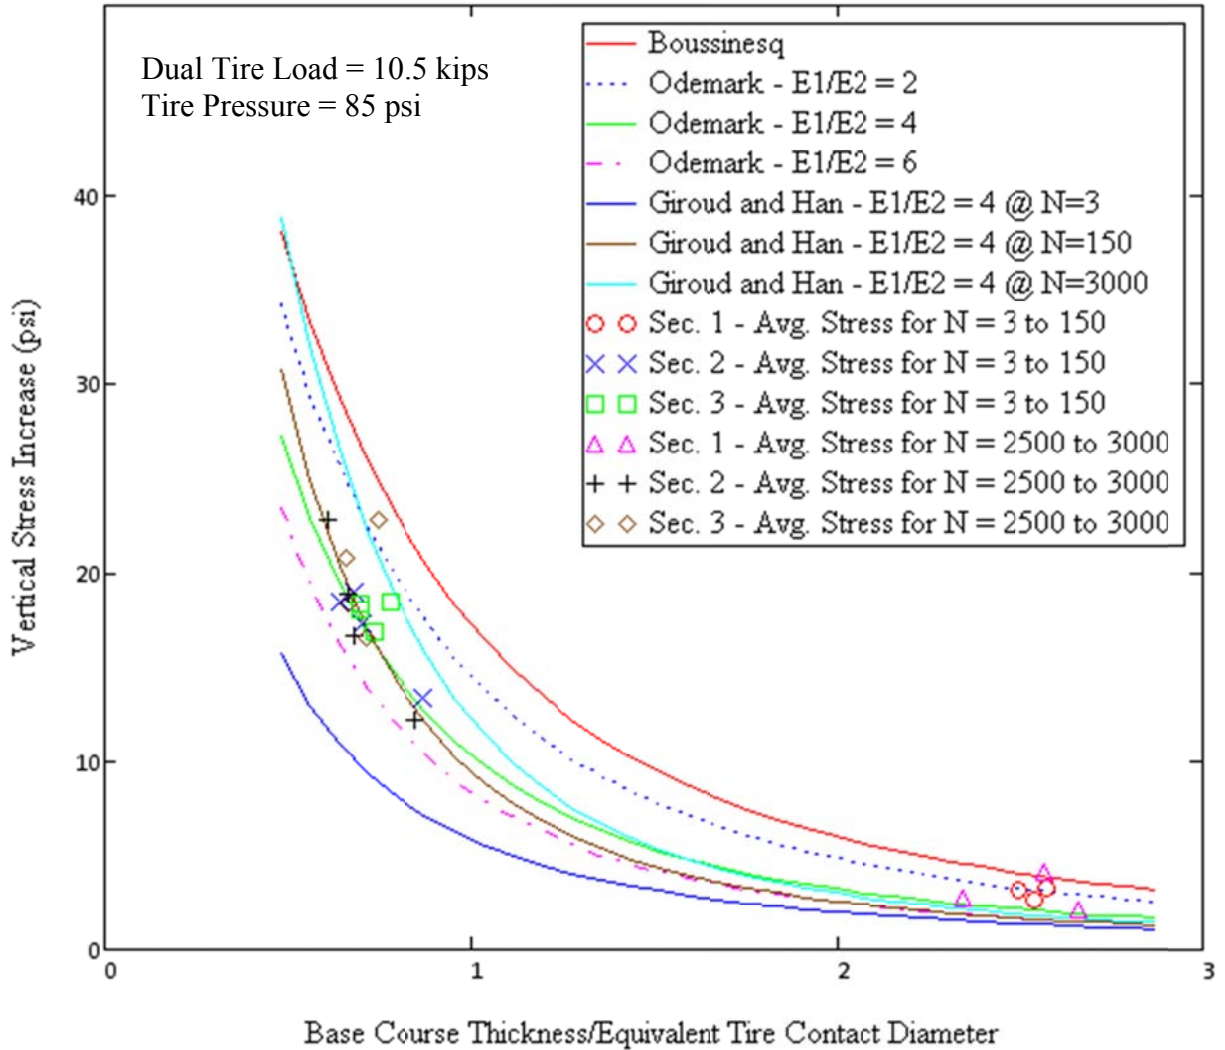
Figure 5-105: Vertical stress increase three inches below the base/subgrade interface

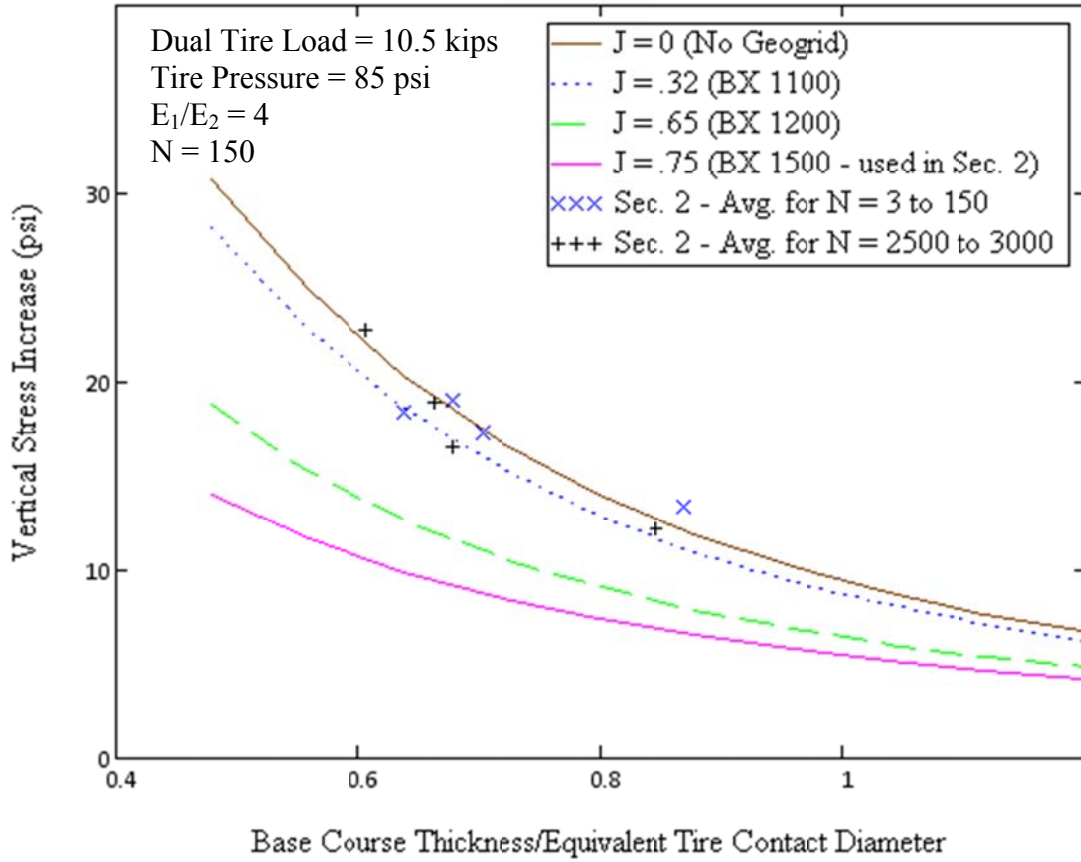
Figure 5-106: Vertical stress increase three inches below the base/subgrade interface for various geogrid aperture stability modulus values

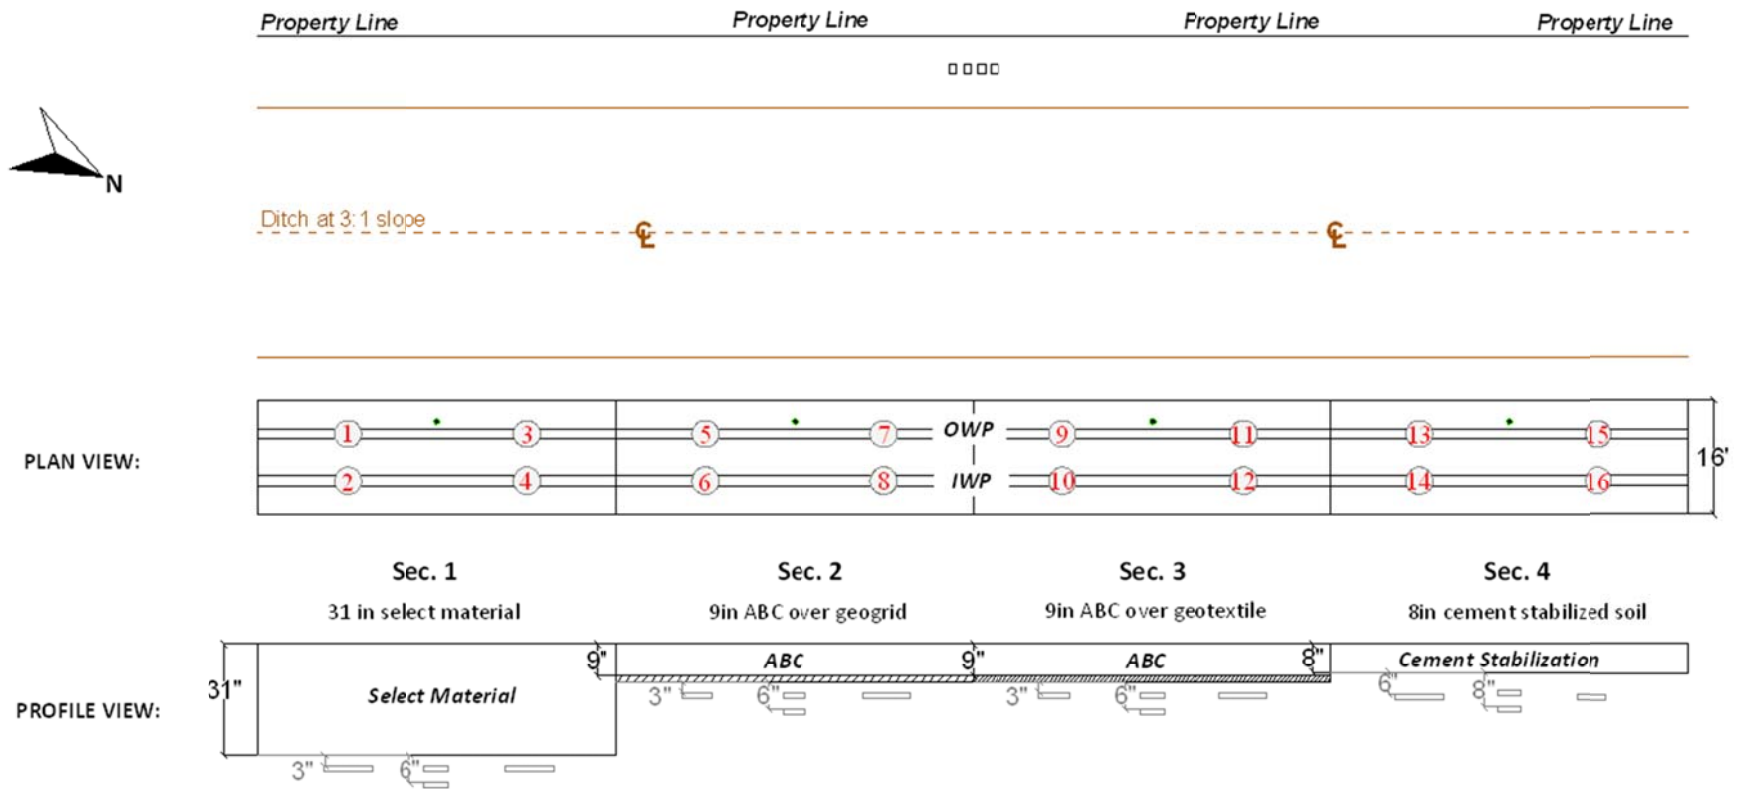
Figure C127: EPC location and identification number

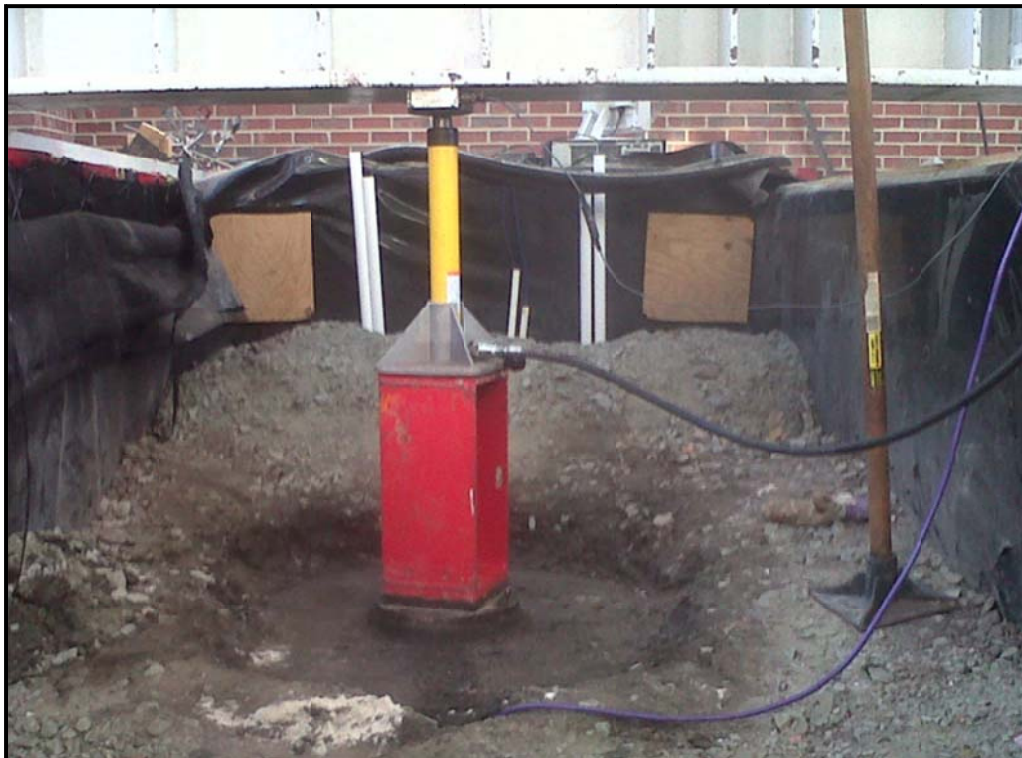
Figure D129: EPC laboratory calibration test setup

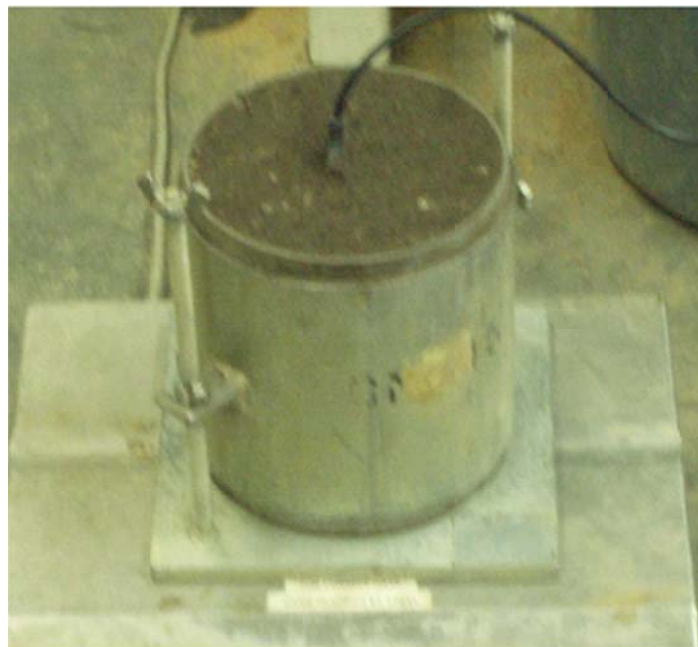
Figure E134: Soil moisture sensor calibration setup
