# FIELD INVESTIGATION OF GEOSYNTHETICS USED FOR SUBGRADE STABILIZATION

FHWA/MT-09-003/8193

*Final Report*

Western Transportation Institute  
Montana State University - Bozeman

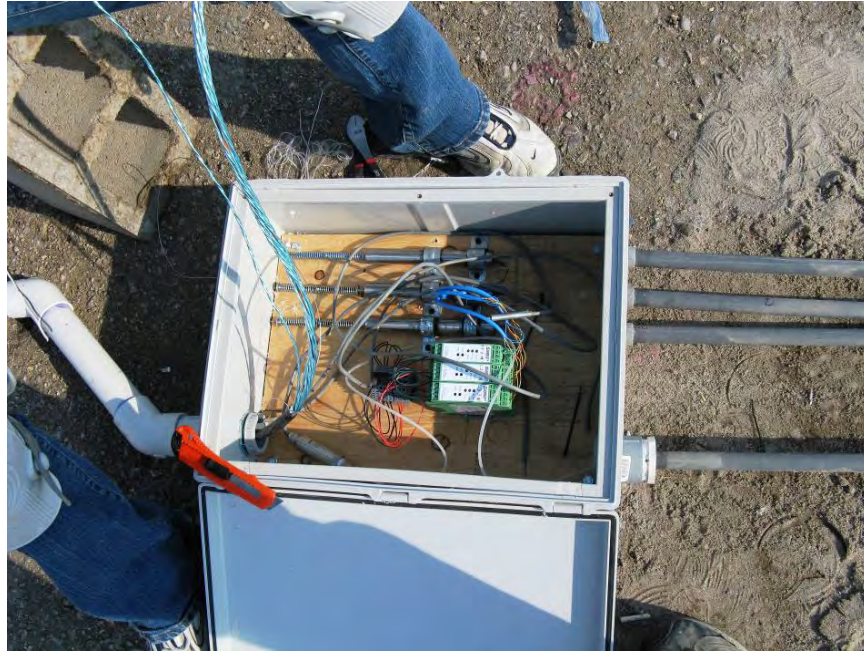
**Figure 8. Installation of sensor box.**

drill bit (not necessary for the geotextiles), 2) threading the 0.4 mm diameter, stainless steel, spring tempered lead wire through the receptacle and securing it, 3) stringing the lead wire through the protective brass tubing, and 4) attaching the lead wire to the LVDT. The protective brass tubing was also run inside small diameter, schedule 80, PVC pipes for two reasons: 1) to provide additional protection of the brass tubes during trafficking and 2) to facilitate plumbing the lead wires into the sensor box. A completed lead wire installation and protective tubing arrangement is provided in Figure 9.

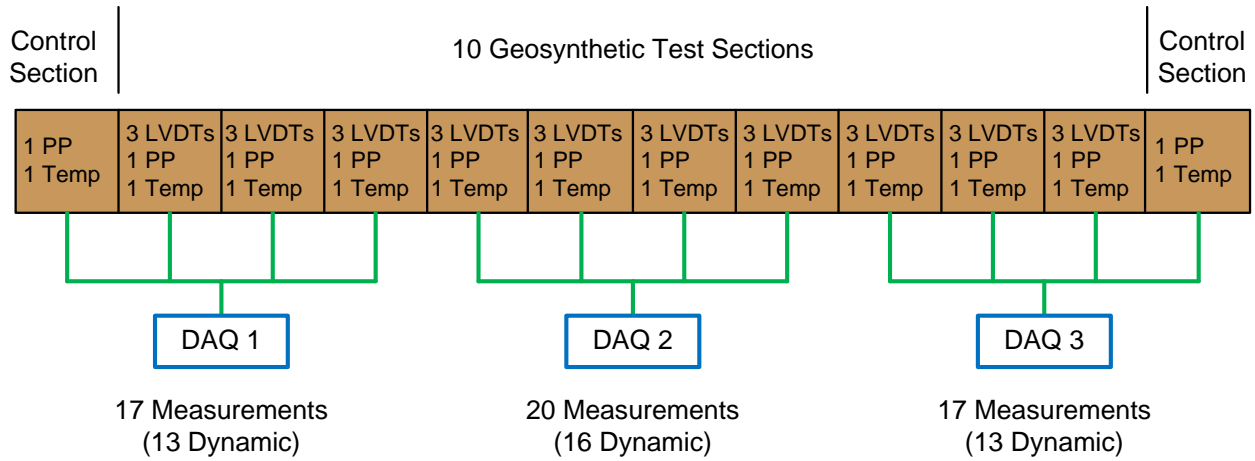
Figure 11. Data acquisition and instrumentation layout.

Three independent data acquisition computers were used to store and transfer data during testing. Each data acquisition computer was connected to the sensors of four test sections, as illustrated in Figure 11. Power to the sensors and data acquisition systems were provided by solar panels and batteries installed adjacent to the testing area (Figure 12). All wires to and from the sensors were run through PVC conduit to one of the three metal cabinets to protect them from damage during construction, as well as water and varmints.

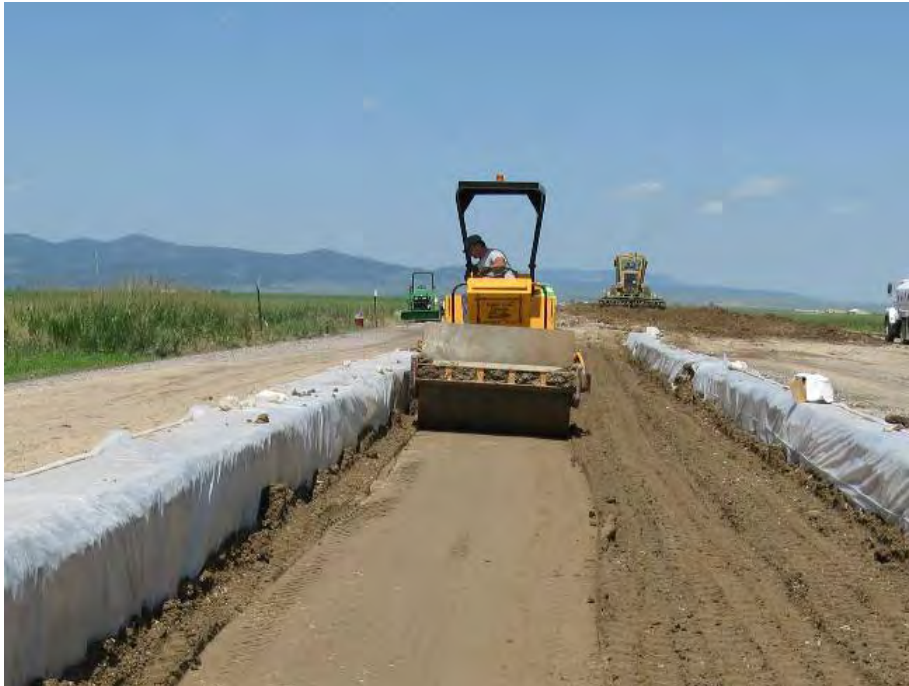
**Figure 17. Compacting subgrade with smooth drum, vibratory roller.**

Compaction was performed with a single cylinder, smooth-drum, vibratory roller (Figure 17). Immediately after compaction, the vane shear device was used to determine in-place shear strength. If the shear strength of the artificial subgrade was not relatively close to the specified limits, two basic remedies were used: 1) shear strength too low—re-till the layer, allow soil to dry, and recompact the soil layer, or 2) shear strength too high—re-till the layer, add water, allow the water to penetrate the tilled soil mass, re-till the soil again, and recompact the soil layer. Altogether, seven layers were necessary to fill the trench (one layer at a time along the entire length of the trench) until the top surface of the subgrade was approximately equal to the original level of the existing pavement. A slight crown was set into the surface of the subgrade so that water from rain or the water truck would not accumulate on the surface.

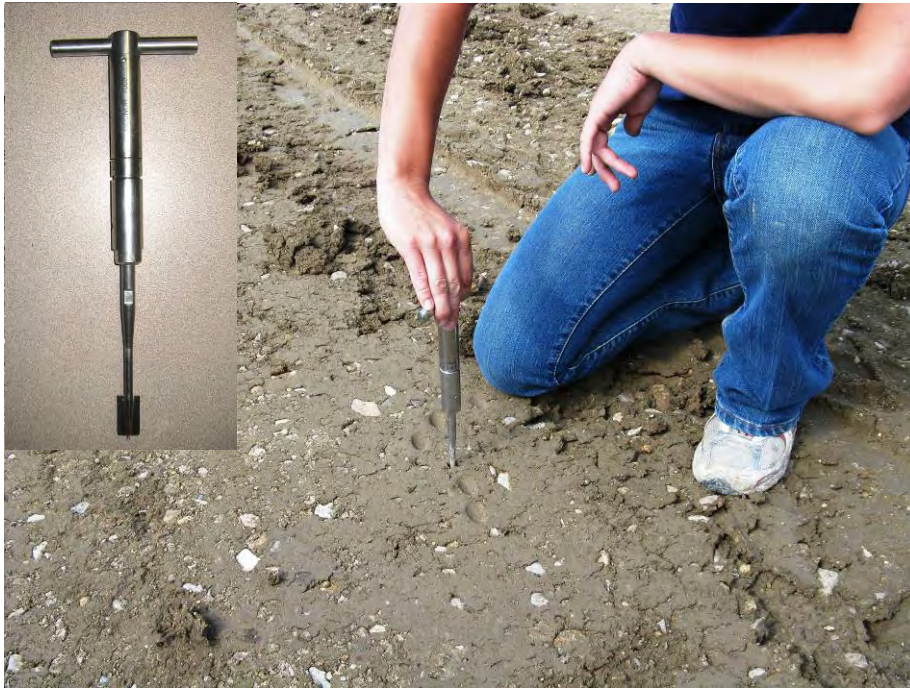
Figure 18. Field measurement of vane shear (inset is close-up of vane shear device).

The quality and consistency of the artificially constructed subgrade was mainly monitored using a hand-held vane shear device and moisture content. Between three and nine strength measurements were randomly taken (average of four) at a particular location along the length of the test pit within each layer during construction using the vane shear device (shown in Figure 18). Data was not always collected in every layer at a particular location due to the many construction activities that were ongoing at the site. Multiple measurements taken at a particular position were averaged together into a single value for that location within that layer. These averaged values are plotted by layer for all the test sections in Figure 19. In general, there was more variability in earlier (i.e., lower) layers of the subgrade and less in the upper layers, so data from layers 2 through 5 were removed to show only results from layers 6 and 7 (Figure 20). Vane shear data from the first layer of subgrade was not taken and was therefore not included in the analysis. Moisture content did not correlate well with the vane shear as seen in the plot of moisture content versus vane for all of the field measurements taken during construction of the subgrade (Figure 21). Therefore, moisture content was mainly used to ensure uniform conditions in the subgrade prior to compaction while vane shear was used to monitor and control subgrade strength after compaction.

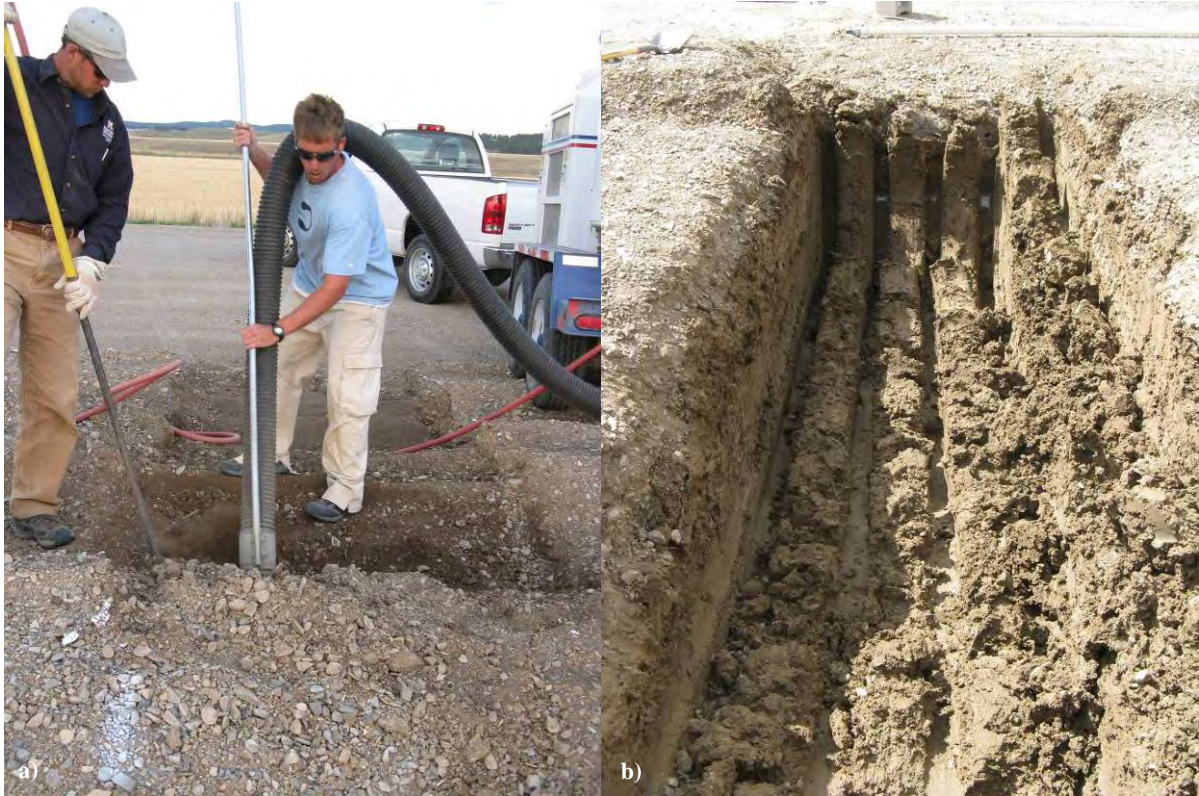
**Figure 34. Forensic investigations: a) air and vacuum removal of base course, b) excavation of subgrade.**

Excavation of the base course was accomplished using a large vacuum truck and a high-flow compressed air nozzle to minimize disturbance and damage of the geosynthetic (Figure 34a). After exposing the entire area of geosynthetics, they were carefully removed to analyze damage to junctions and rib integrity and continuity. Post trafficking DCP measurements were taken in the excavated area prior to removal of the subgrade. The subgrade was then removed from these areas (Figure 34b) to comprehensively evaluate soil mixing between the subgrade and base course in the rutted areas, soil shear strength using the vane shear, soil moisture contents, as well as provide a general evaluation of the rutted area.

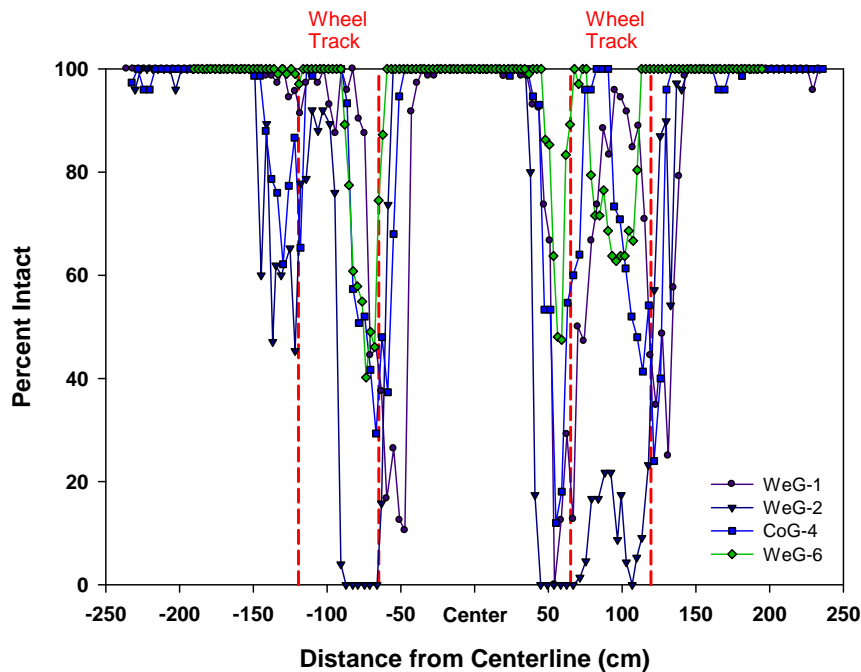
**Figure 35. Junction damage in the cross-machine direction of the welded geogrids.**

The majority of junction damage was near the vicinity of the wheel tracks, as shown in Figure 35. Average values of junction damage were calculated using the entire area of extracted geosynthetic, and are tabulated in Table 8. The WeG-2 and WeG-6 products sustained similar damage, and the CoG-4 and WeG-1 products sustained the most junction damage of the welded geogrids.

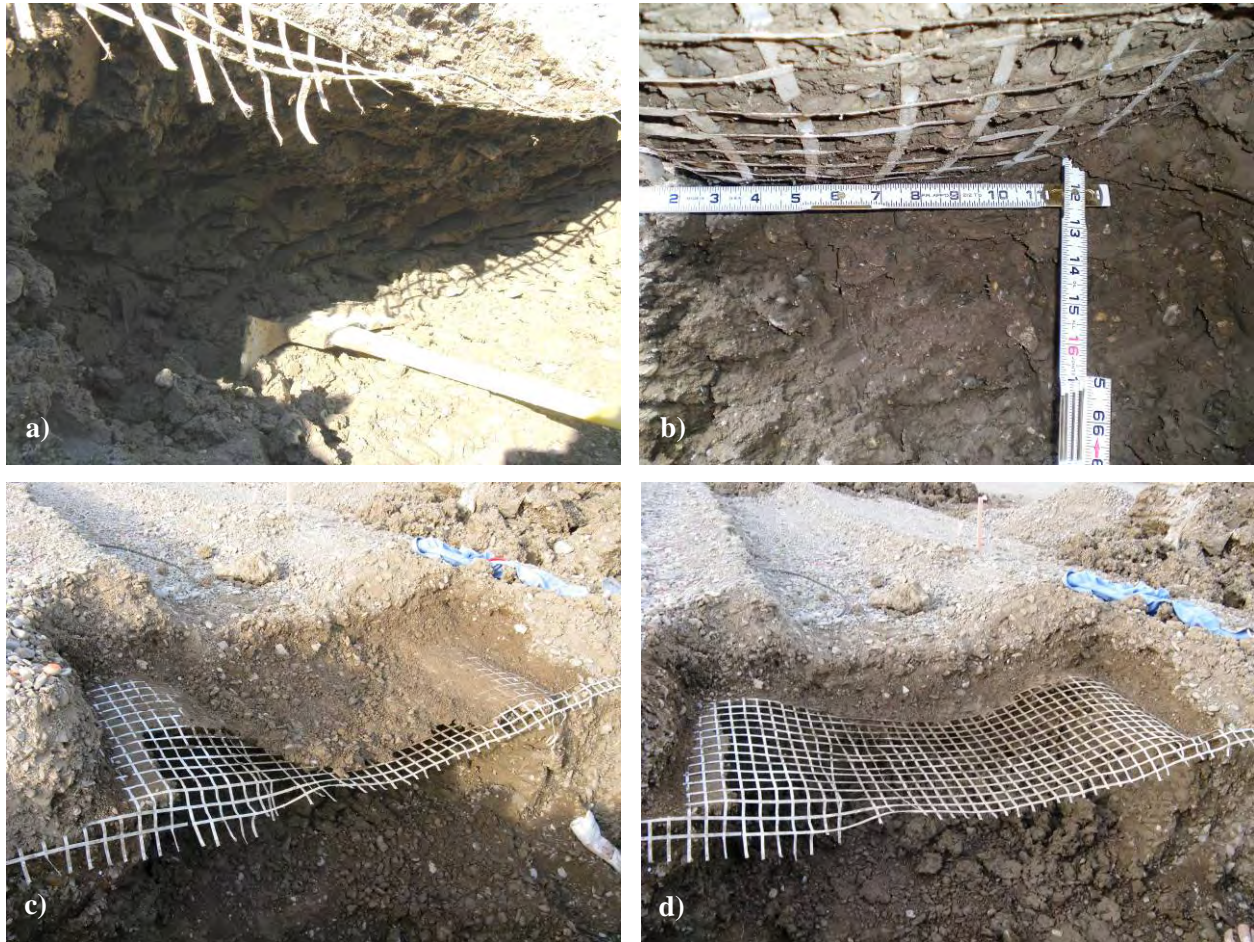
**Figure 36. Pictorial overview of the reverse excavation method: a) excavating underneath the geosynthetic, b) subgrade fully removed and geosynthetic exposed, c) removal of the base from the top and d) fully exposed geosynthetic.**

As previously mentioned, each of the welded geogrid products was excavated from underneath to further minimize damage to the junctions during the excavation process as a way to assess excavation-induced damage. These excavations were done from the side in the trench that was created from the excavator during the forensic investigations. Hand tools were carefully used to remove the subgrade from under the geosynthetics while the base course remained on top (Figure 36a and b). This methodology was intended to keep the junctions from moving relative to one another during the excavation process. After all the supporting subgrade was removed, the base aggregate was carefully removed from the top (Figure 36c) by hand until the entire geosynthetic in the wheel path was freely hanging over the excavated area (Figure 36d). Finally, the geosynthetic was cut free and analyzed for junction and rib damage. Junction damage of the wheel path areas of the reverse excavations are compared to damage within the wheel path areas of the standard excavations (Table 9 and Figure 37). In general, the standard excavation method produced similar results to the reverse excavation method, and differences are thought to be within the accuracy of these assessments.

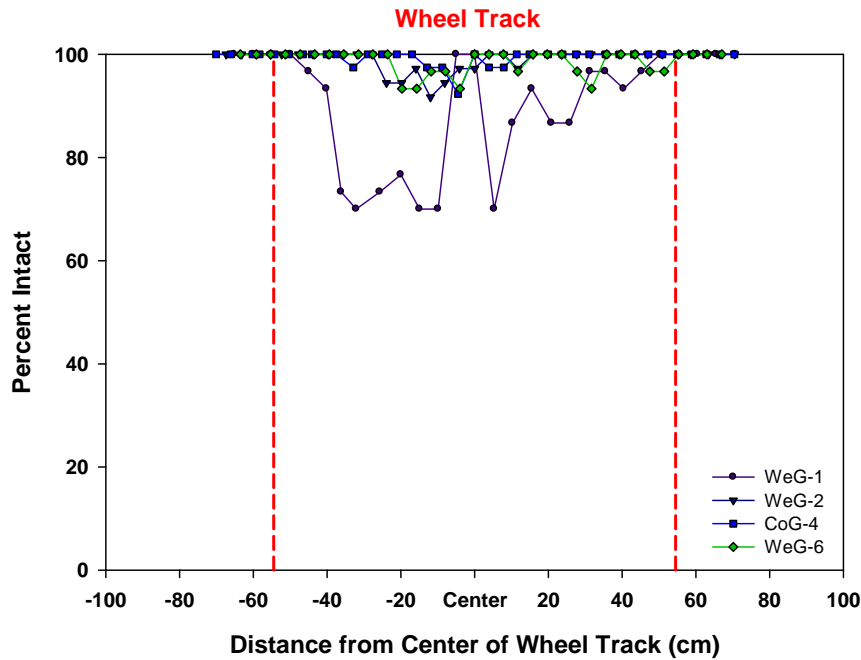
Figure 37. Junction damage in the reverse excavated, welded geogrids.

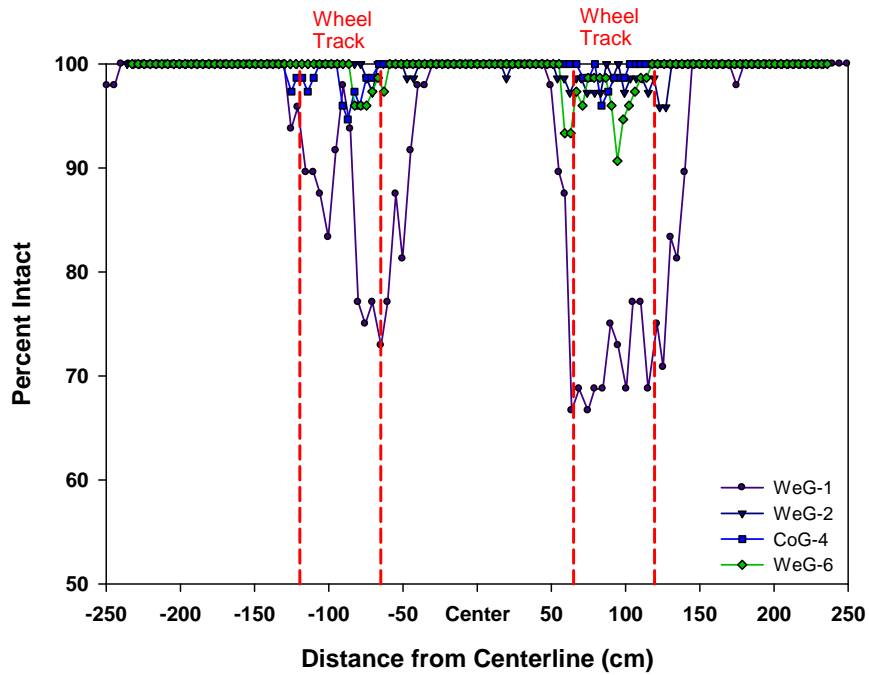
Figure 38. Rib damage in the cross-machine direction of the welded geogrids.

Similar to the junction damage results, the majority of the rib damage was sustained in the wheel track areas, as shown in Figure 38. Average rib damage is tabulated in Table 11. Average rib damage in these products was similar and very low. The WeG-1 geogrid had the highest damage (6.9%), but the majority of the damage was from ribs in the cross-machine direction that were cracked along their length but not broken across their width (scored as a 2), as shown in Figure 39. Outside of the WeG-1 geogrid, the remaining welded geogrids were mostly intact with, again, most of the damage occurring in the wheel paths, and that damage generally occurred randomly.

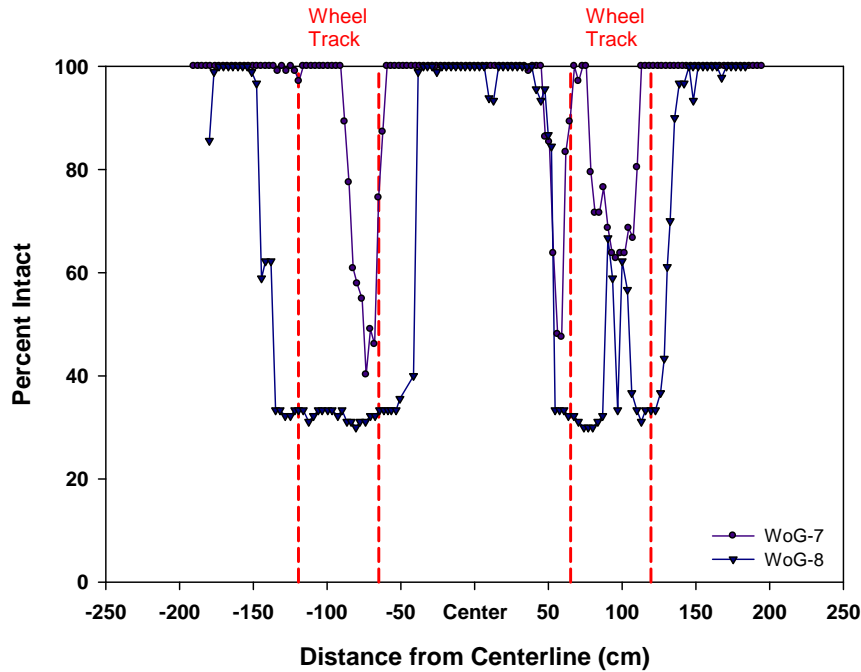
**Figure 40. Junction damage in the cross-machine direction of the woven geogrids.**

Similar to the welded products, the majority of the junction damage was near the vicinity of the wheel paths, as shown in Figure 40. Average values of the junction damage differed significantly between the WoG-7 and WoG-8 geogrids, being 93.2 and 67.6 percent intact, respectively.

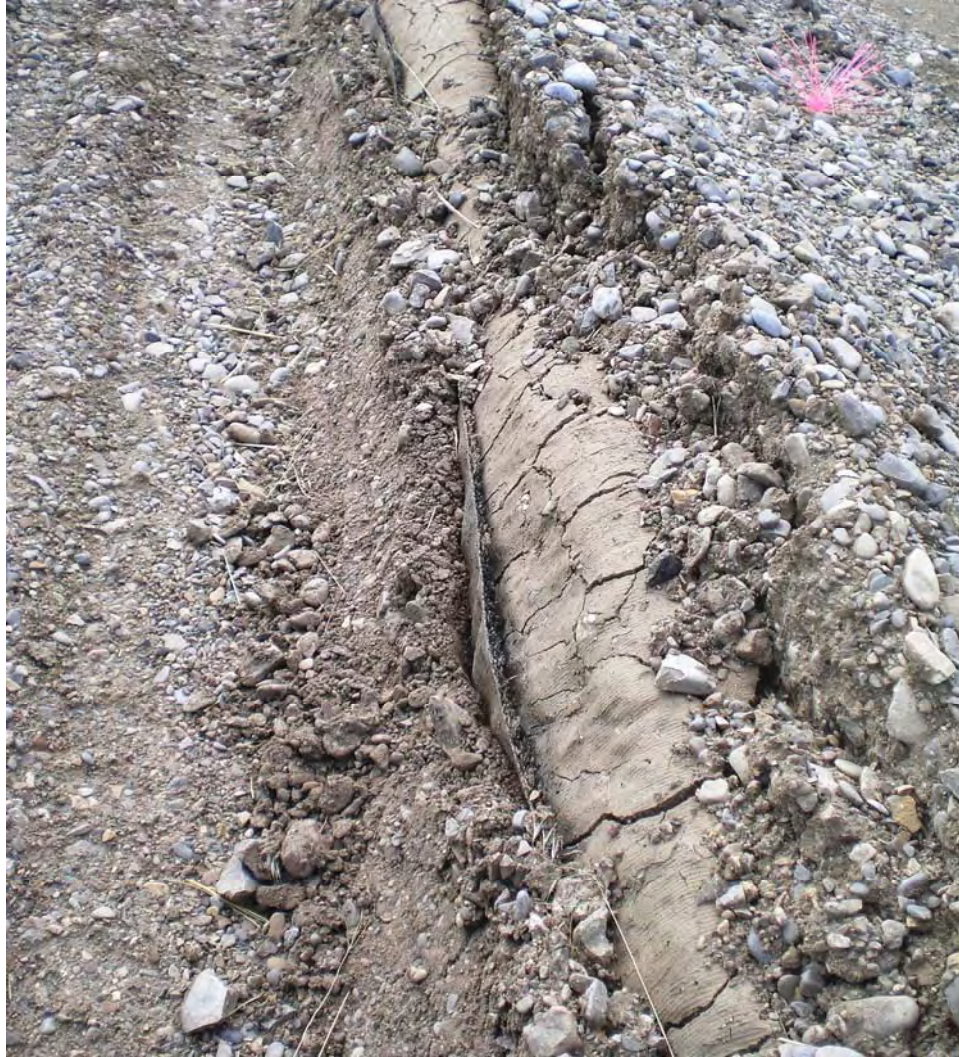
**Figure 42. Pullout failure of the WoT-9 geotextile.**

The two geotextile products sustained very little damage during construction and trafficking, having only minor abrasions. The woven geotextile (WoT-9) was the second narrowest product (3.81 m wide), and it was noticed during trafficking that portions of the textile outside of the rut bowl were pulling out (Figure 42). This pullout failure did not allow the material to mobilize its tensile strength in the cross-machine direction and most likely contributed to reduced performance overall.

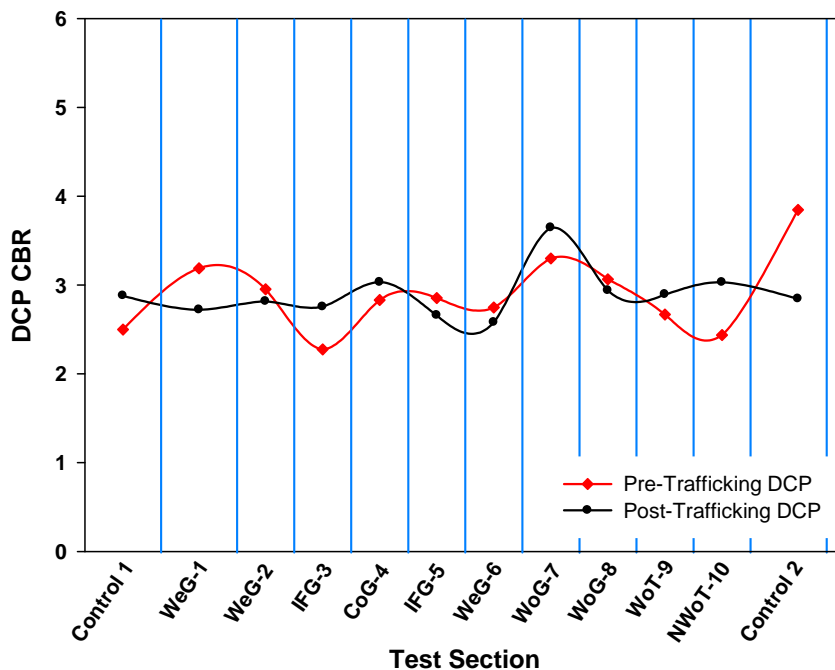
Figure 44. Pre- and post-trafficking, weighted, subgrade strength values from the DCP device.

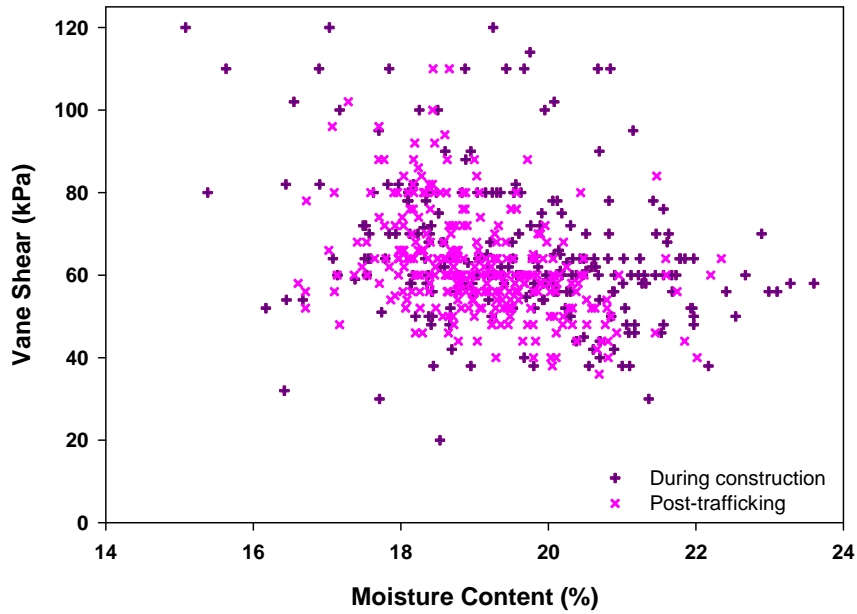
Figure 46. Construction and post-trafficking moisture content vs. vane shear for all test sections.

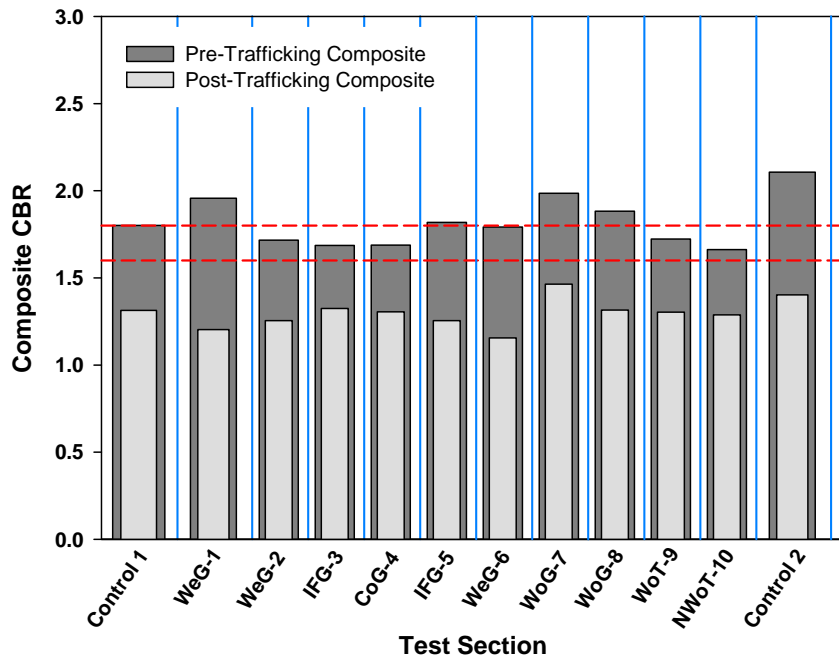
Figure 47. Post-trafficking composite subgrade strength determined from the vane shear and DCP.

As previously noted, the predicted strengths determined using the DCP device were greater than those obtained using the vane shear device. Like before, the data obtained using both of these methodologies were combined together to summarize the overall strength of each of the test sections. A weighting factor of 0.45 was used to adjust the CBR strengths from the DCP device so that it was in the range of values predicted by the vane shear. All subgrade strength values for a particular test section were averaged together to create a composite strength value to generally describe the strength of the artificial subgrade, as shown in Figure 47.

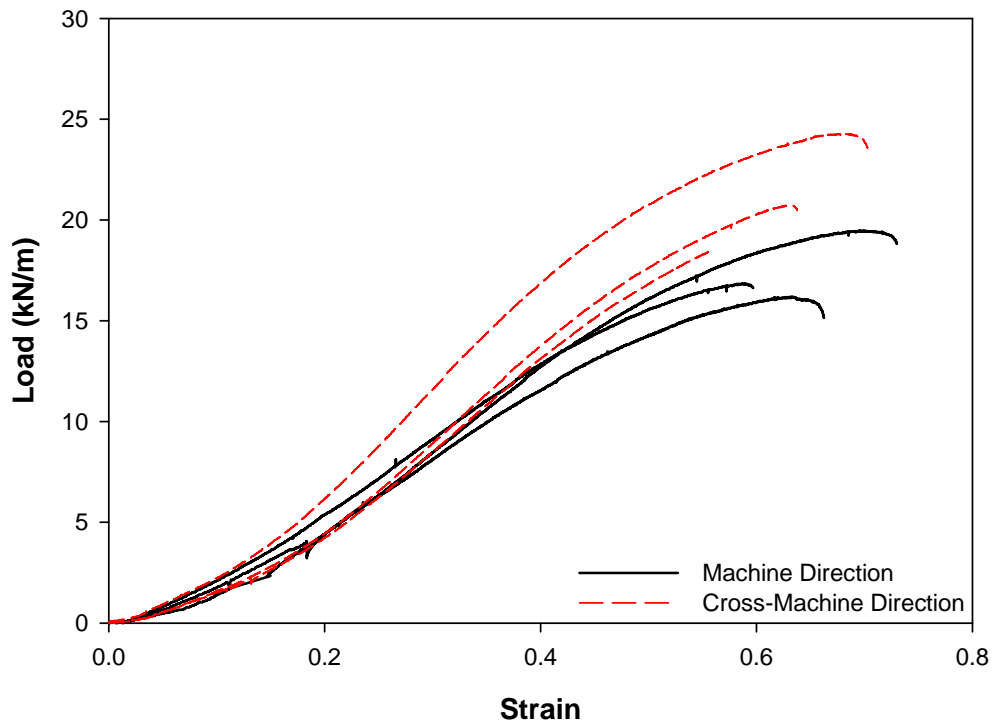
Figure A-10. WTI wide-width tension results for the NWoT-10 geotextile.

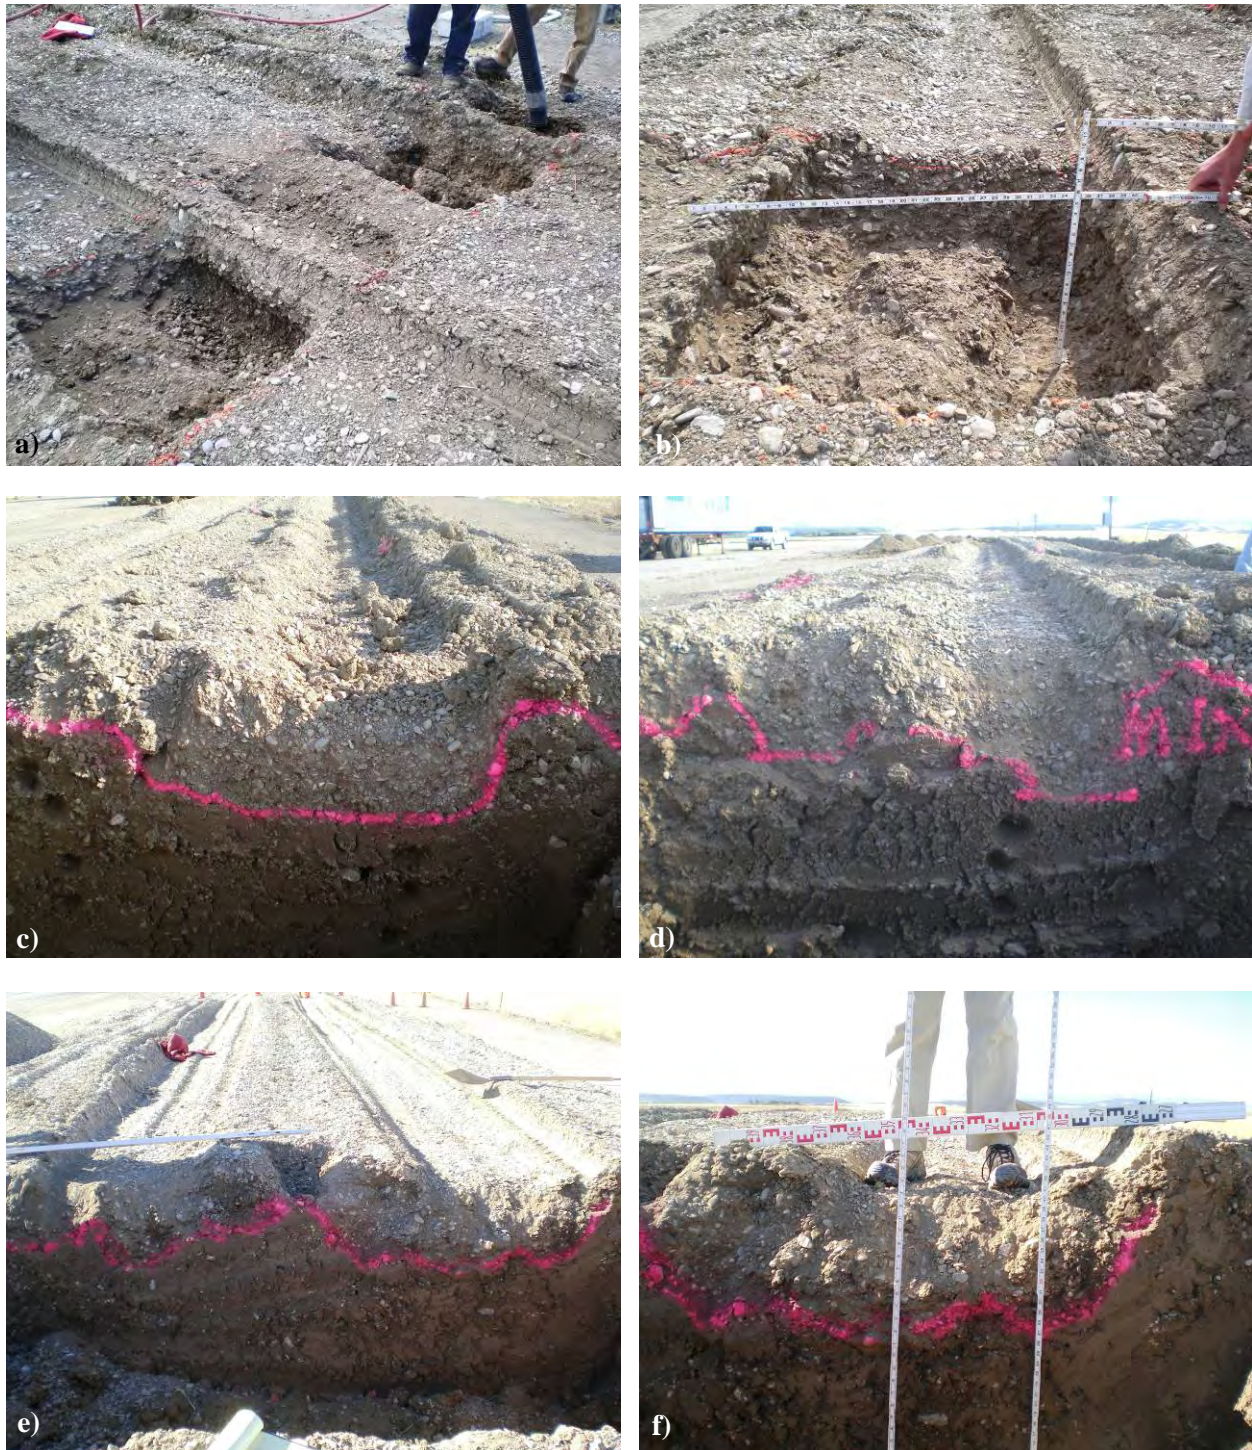
**Figure C-5. Photos of the forensic excavations of the Control sections: a) and b) excavation of Control 1, c) and d) rut profile of Control 1, e) and f) rut profile of Control 2.**

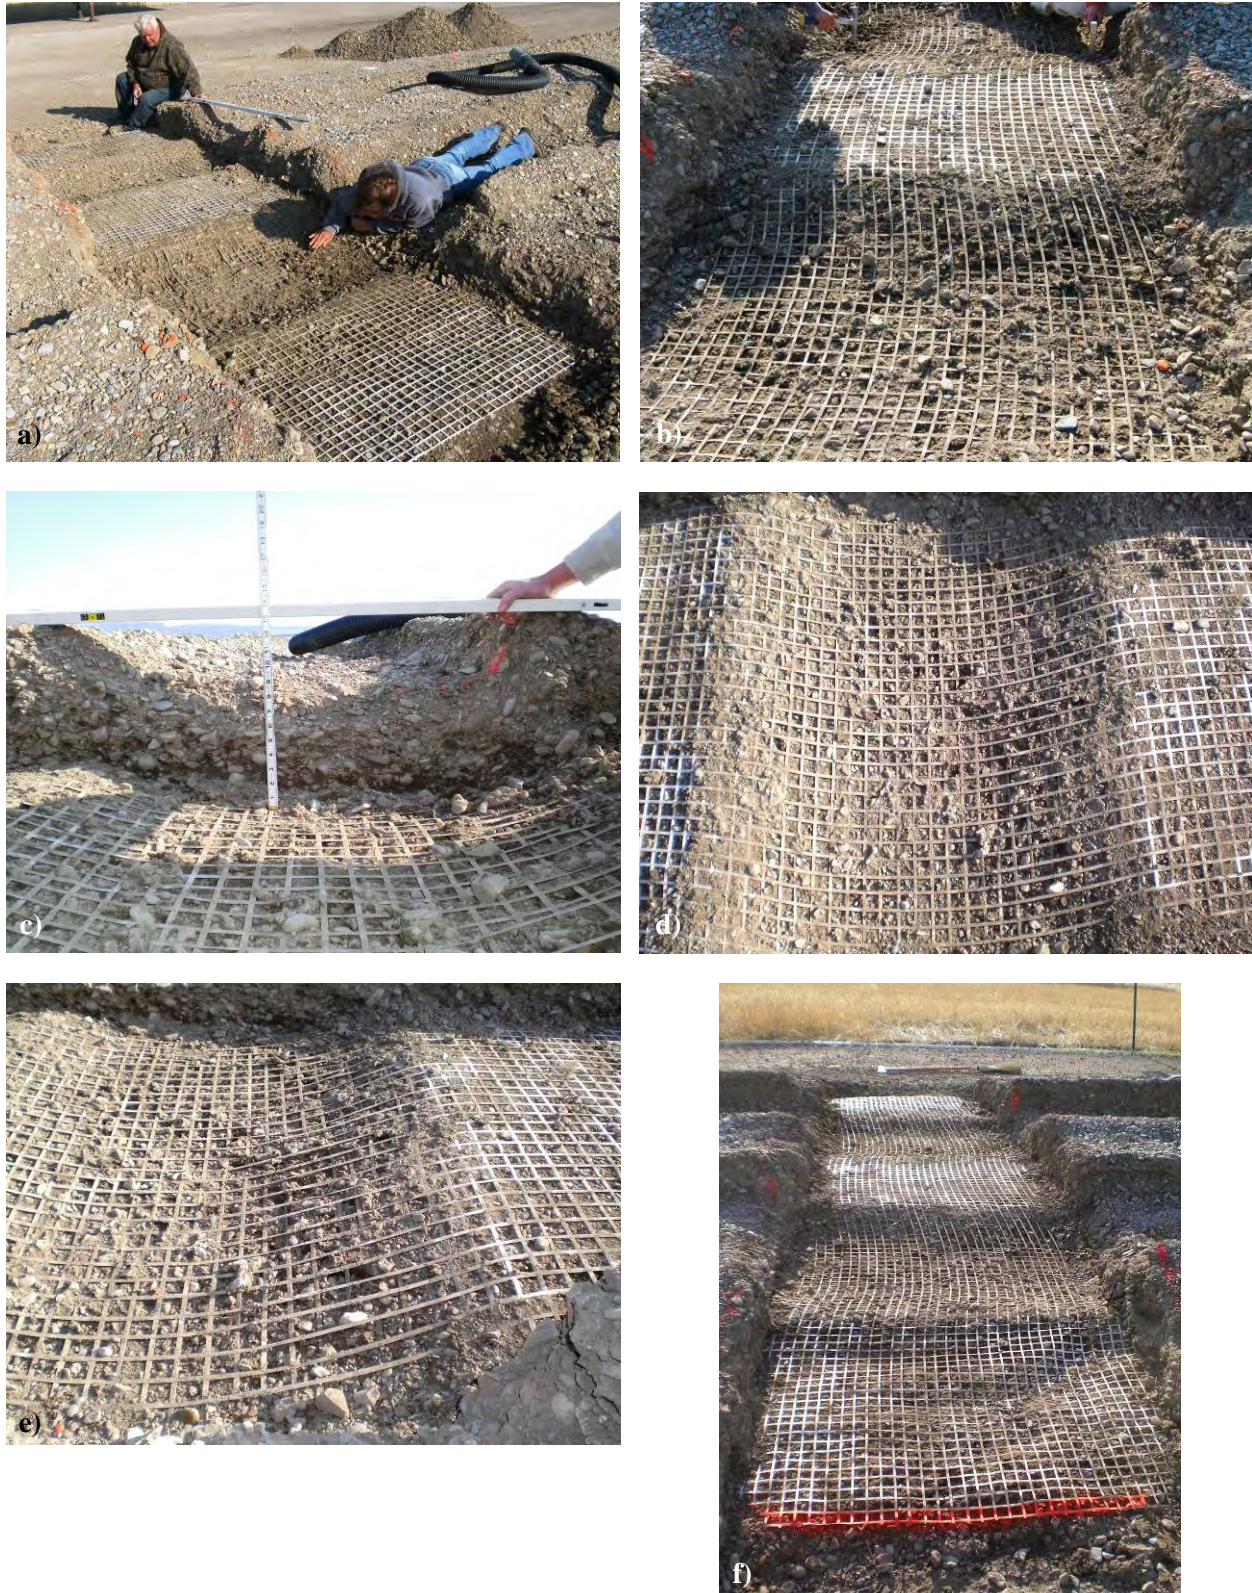
**Figure C-11. Photos of the forensic excavations of the WeG-2 test section: a) looking east, b) rut bowl, c) close-up of rut bowl, d) overhead view of rut, e) close-up of rut, and f) looking west.**

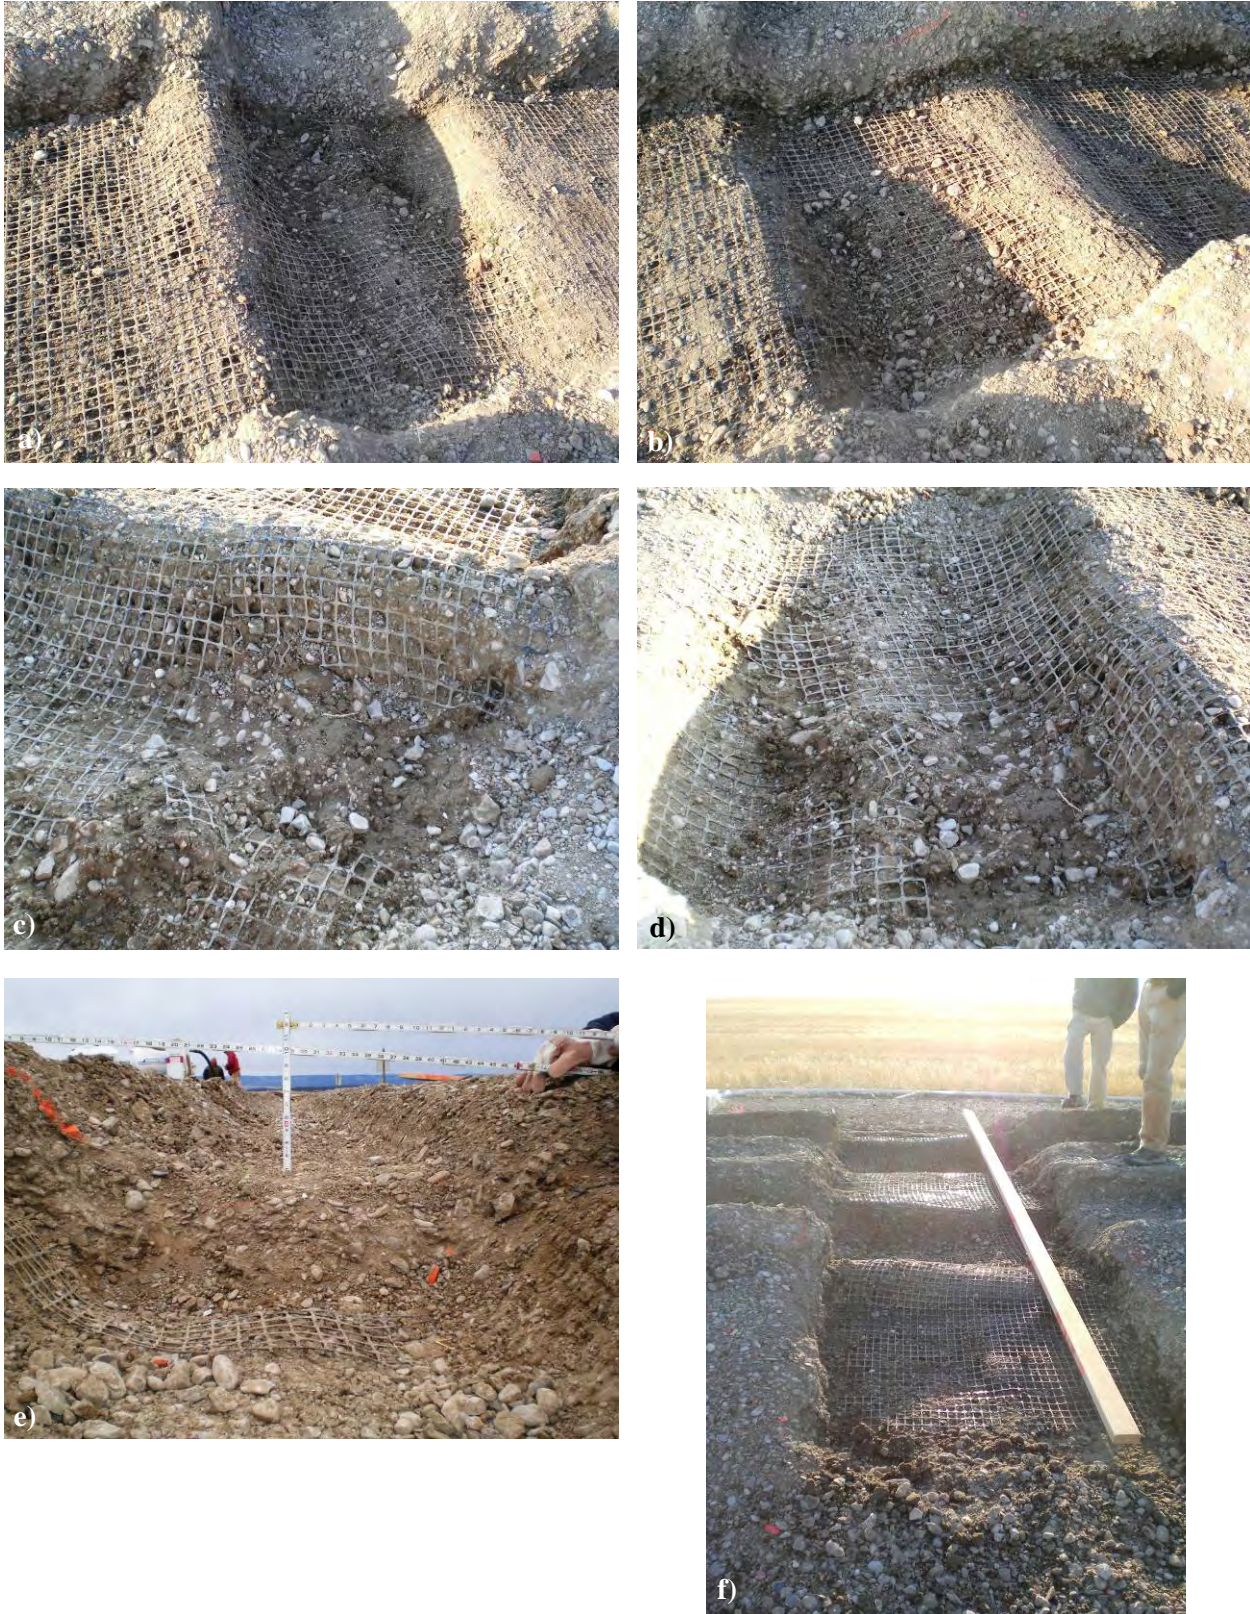
**Figure C-14. Photos of the forensic excavations of the IFG-3 test section: a) rut bowl, b) rut bowl, c) close-up of side of rut bowl, d) close-up of rut, e) rut profile and f) looking west.**

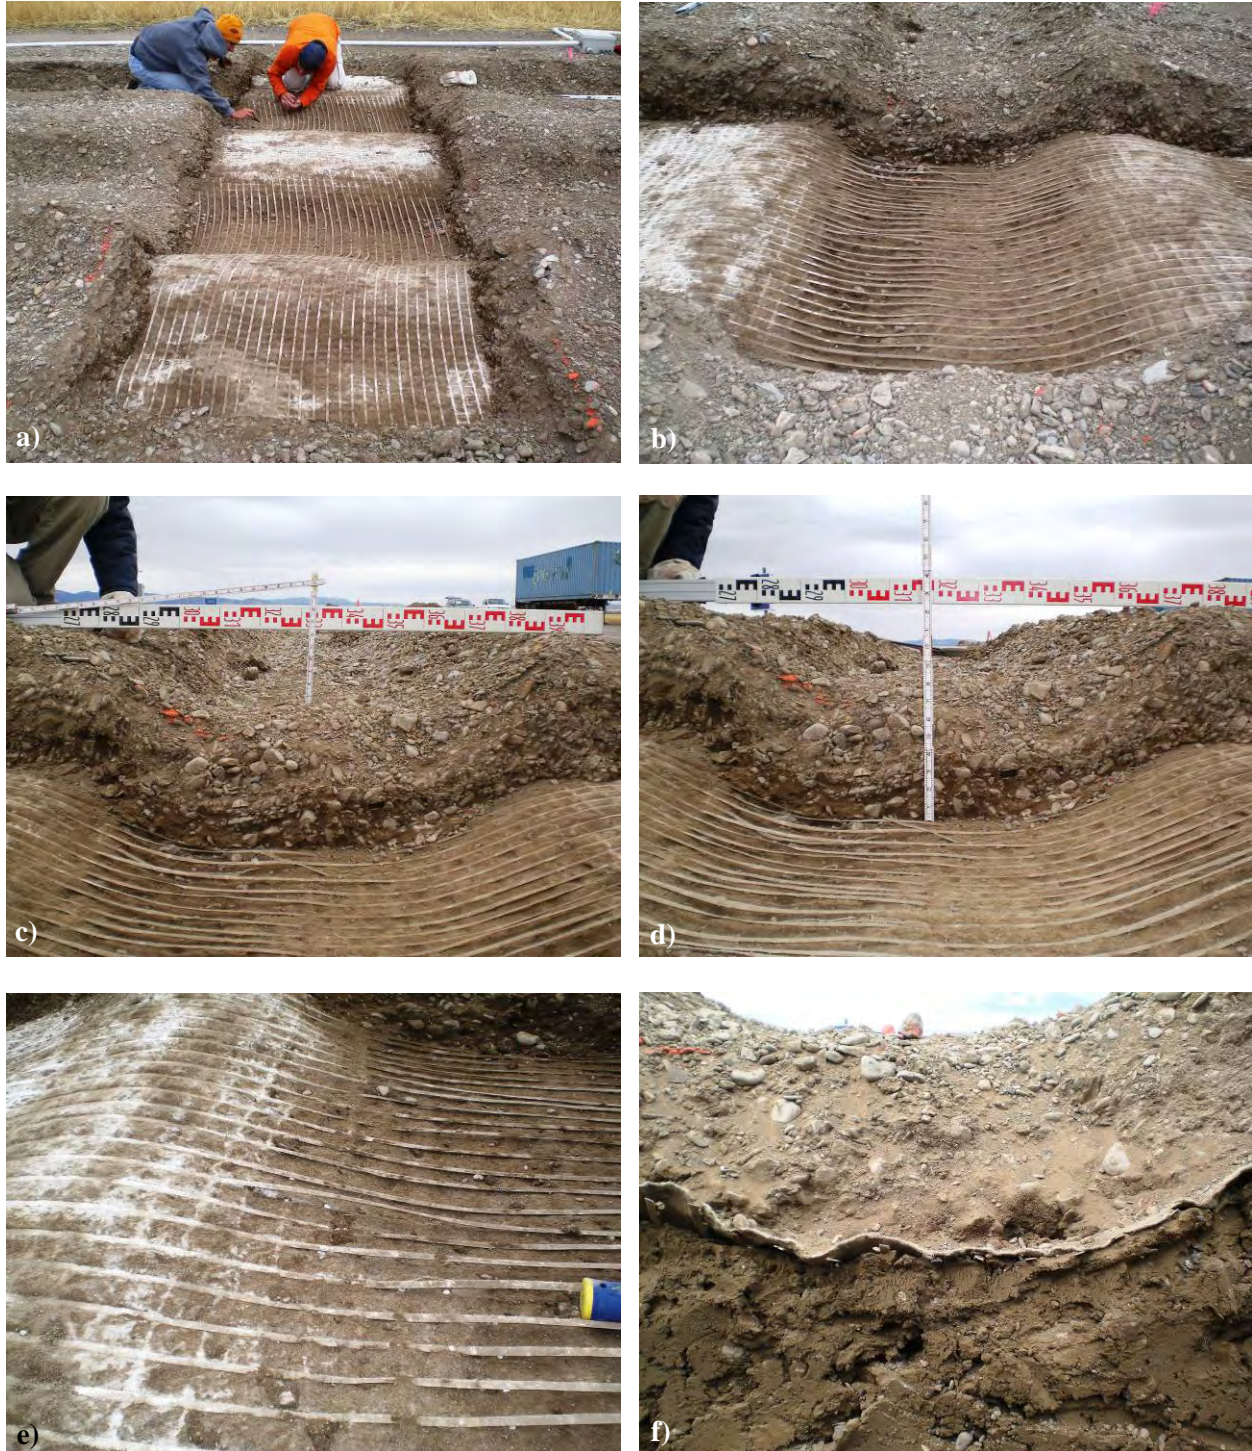
**Figure C-17. Photos of the forensic excavations of the CoG-4 test section: a) looking west, b) rut bowl, c) base rut profile, d) subgrade rut profile, e) close-up of rut and f) layering of base and subgrade.**

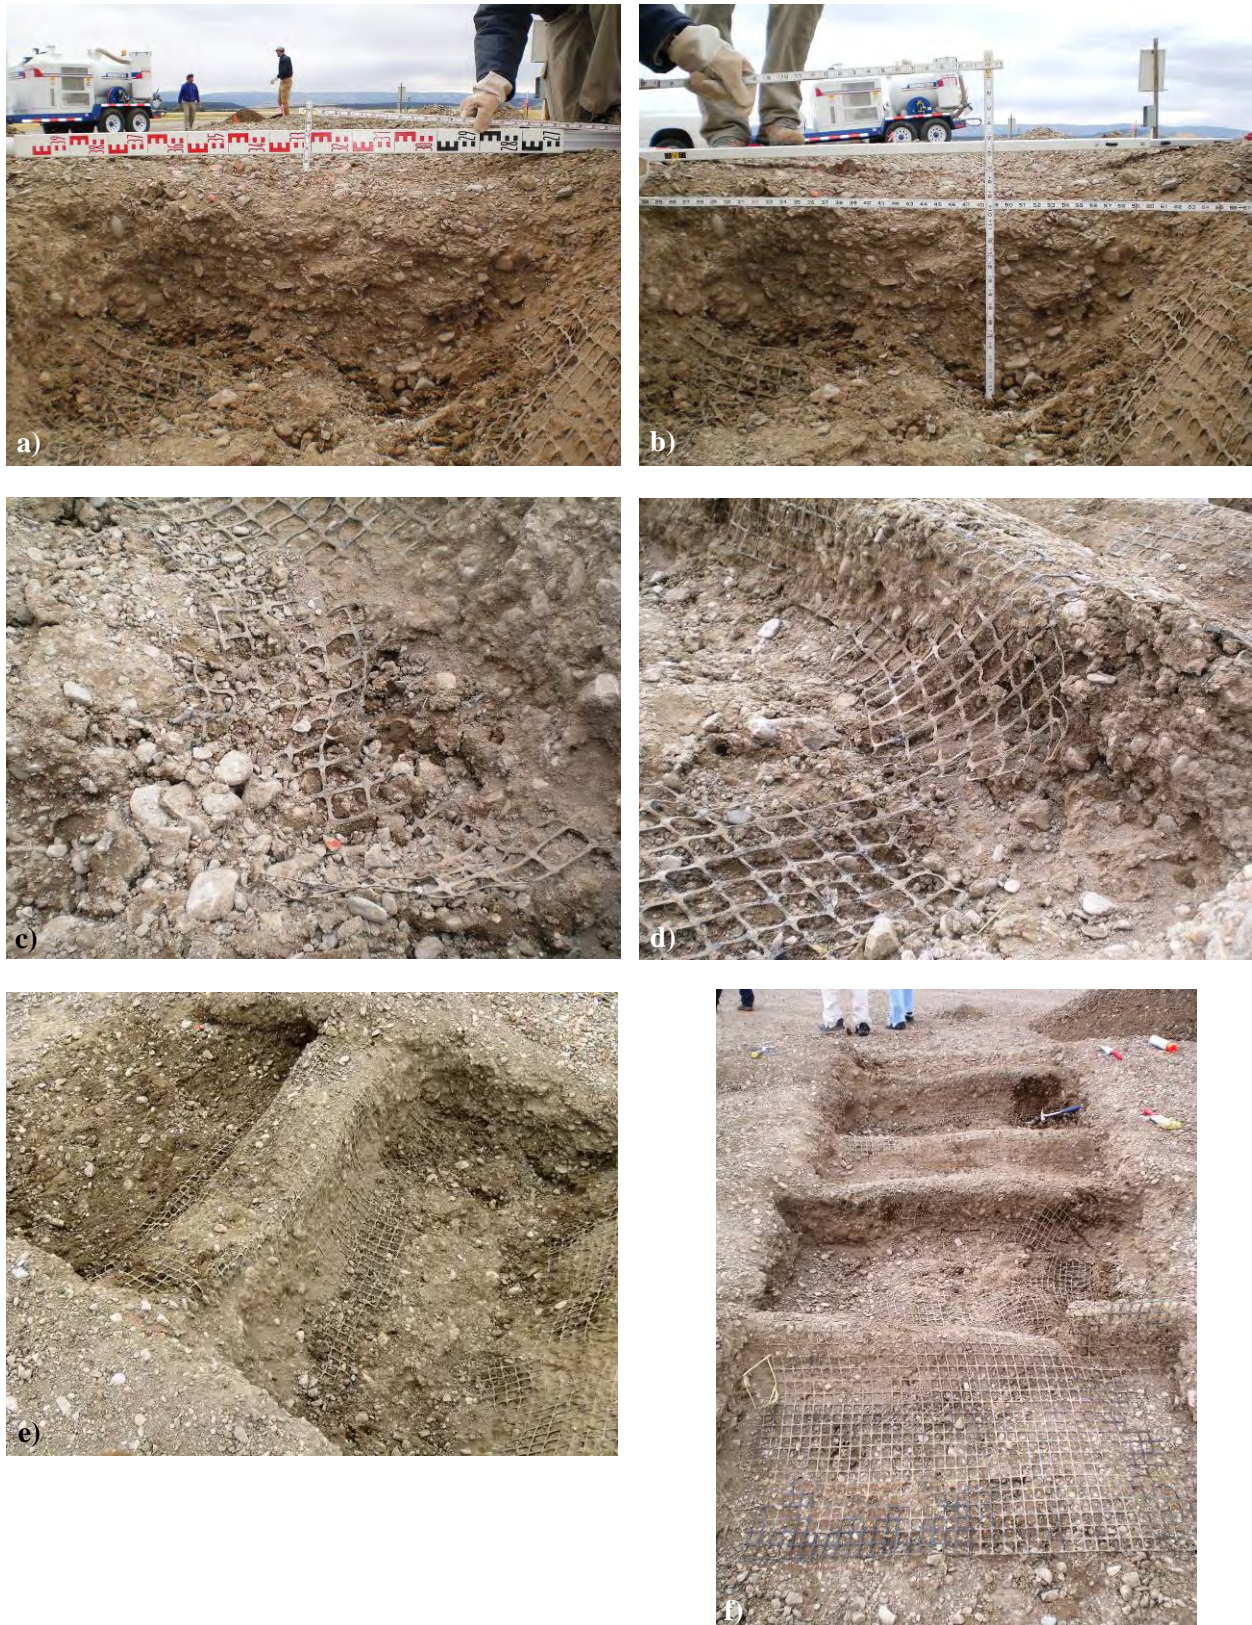
**Figure C-19. Photos of the forensic excavations of the IFG-5 test section: a) base rut profile, b) subgrade rut profile, c) close-up of rut, d) close-up of damage, e) rut bowl and f) looking east.**
