# FIELD INVESTIGATION OF GEOSYNTHETICS USED FOR SUBGRADE STABILIZATION

FHWA/MT-09-003/8193

*Final Report*

Western Transportation Institute  
Montana State University - Bozeman

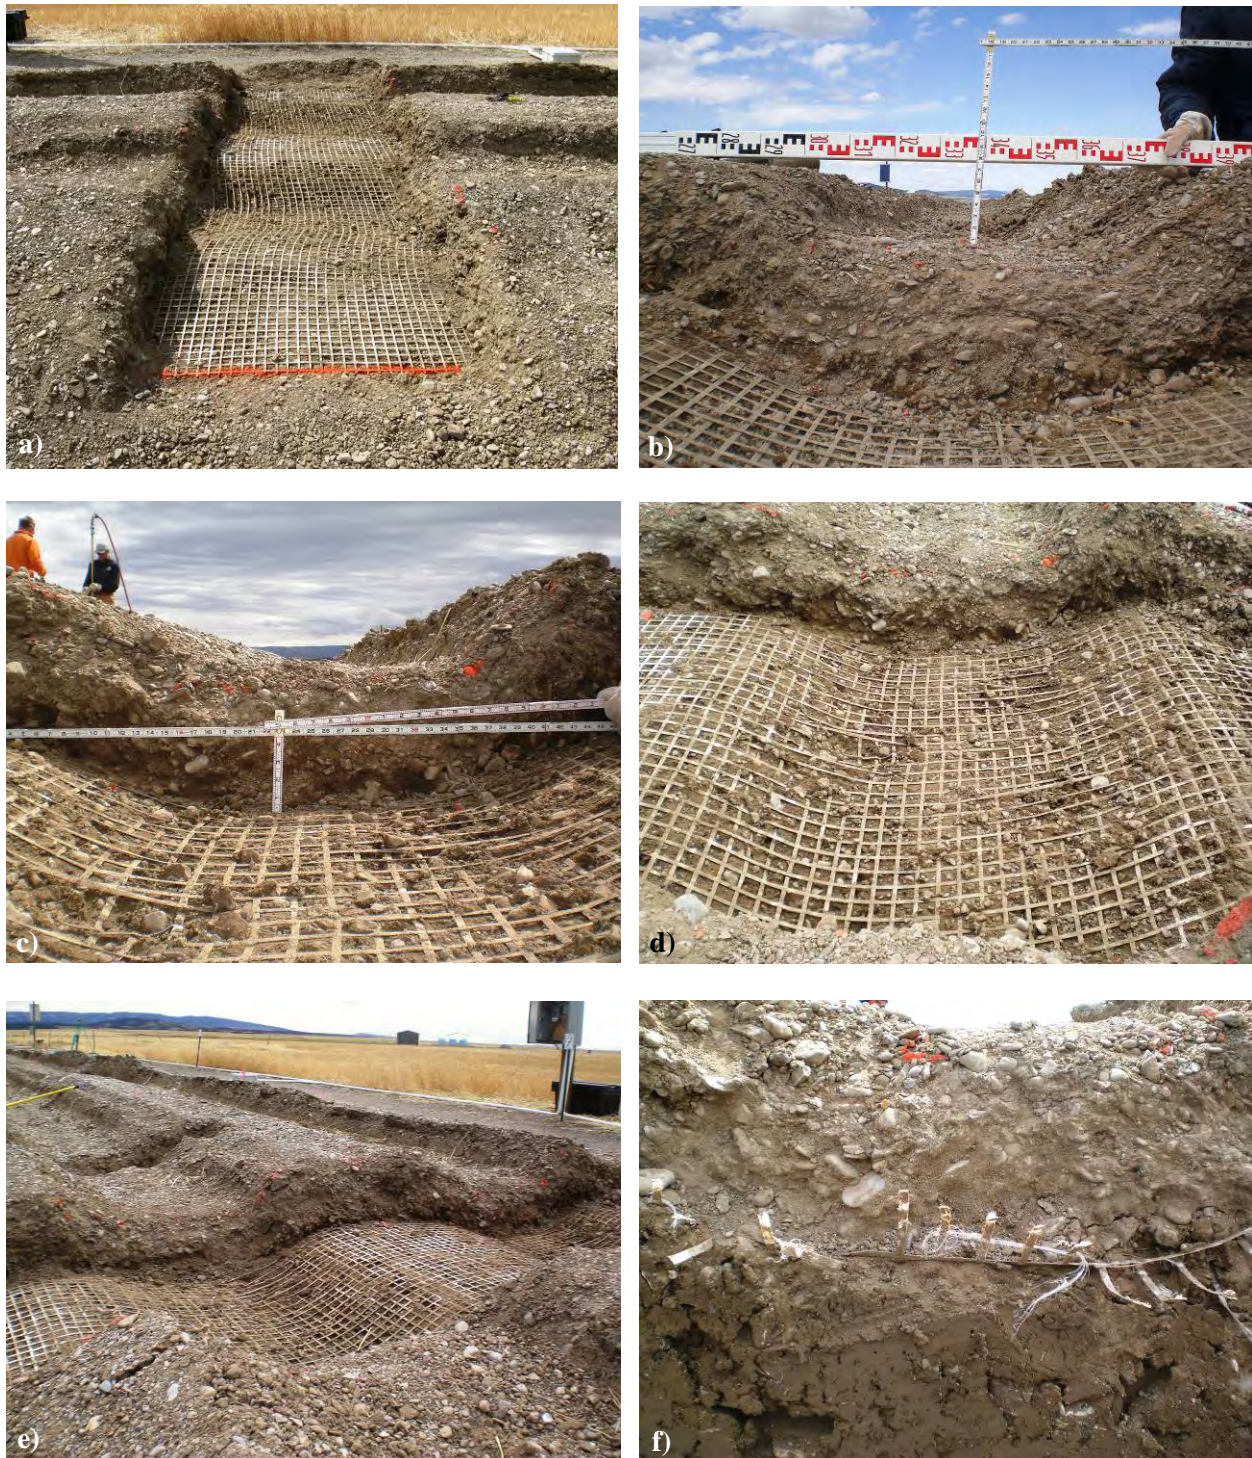
**Figure C-22. Photos of the forensic excavations of the WeG-6 test section: a) looking west, b) base rut profile, c) subgrade rut profile, d) rut bowl, e) view from the side and f) layering of base and subgrade.**

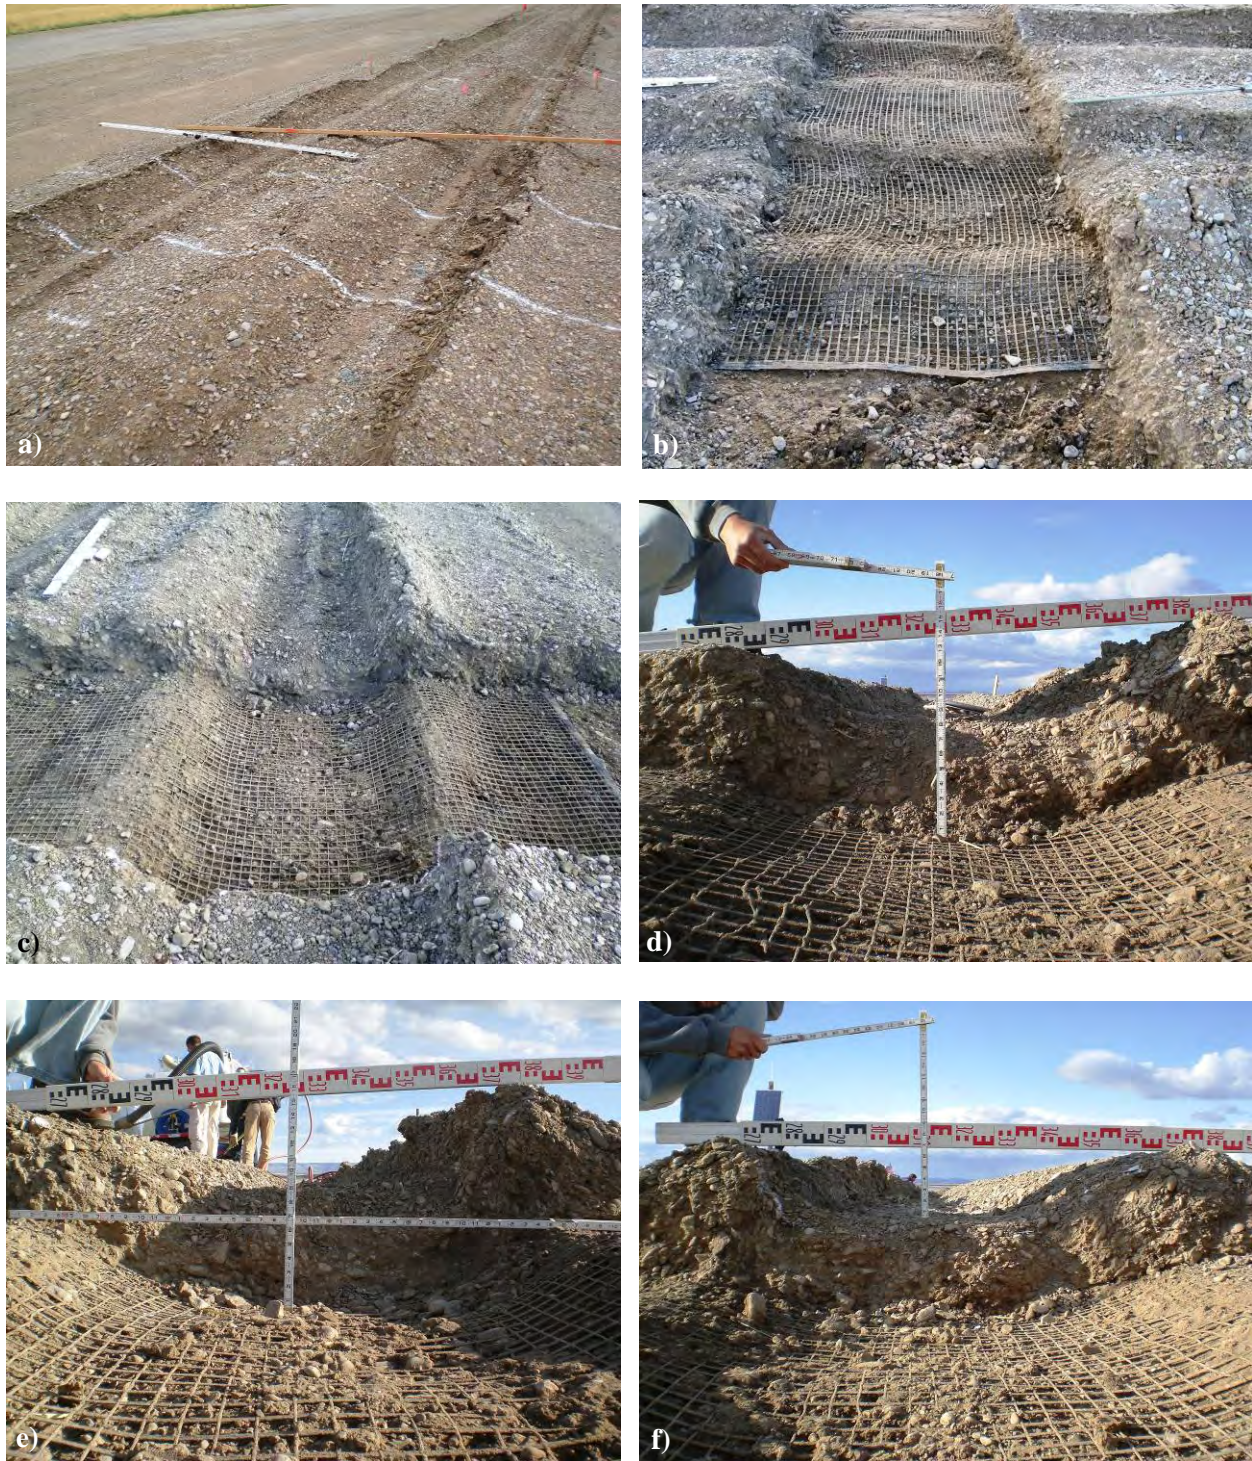
**Figure C-25. Photos of the forensic excavations of the WoG-7 test section: a) excavation area, b) looking west, c) rut bowl, d) subgrade rut profile, e) subgrade rut profile and f) base rut profile.**

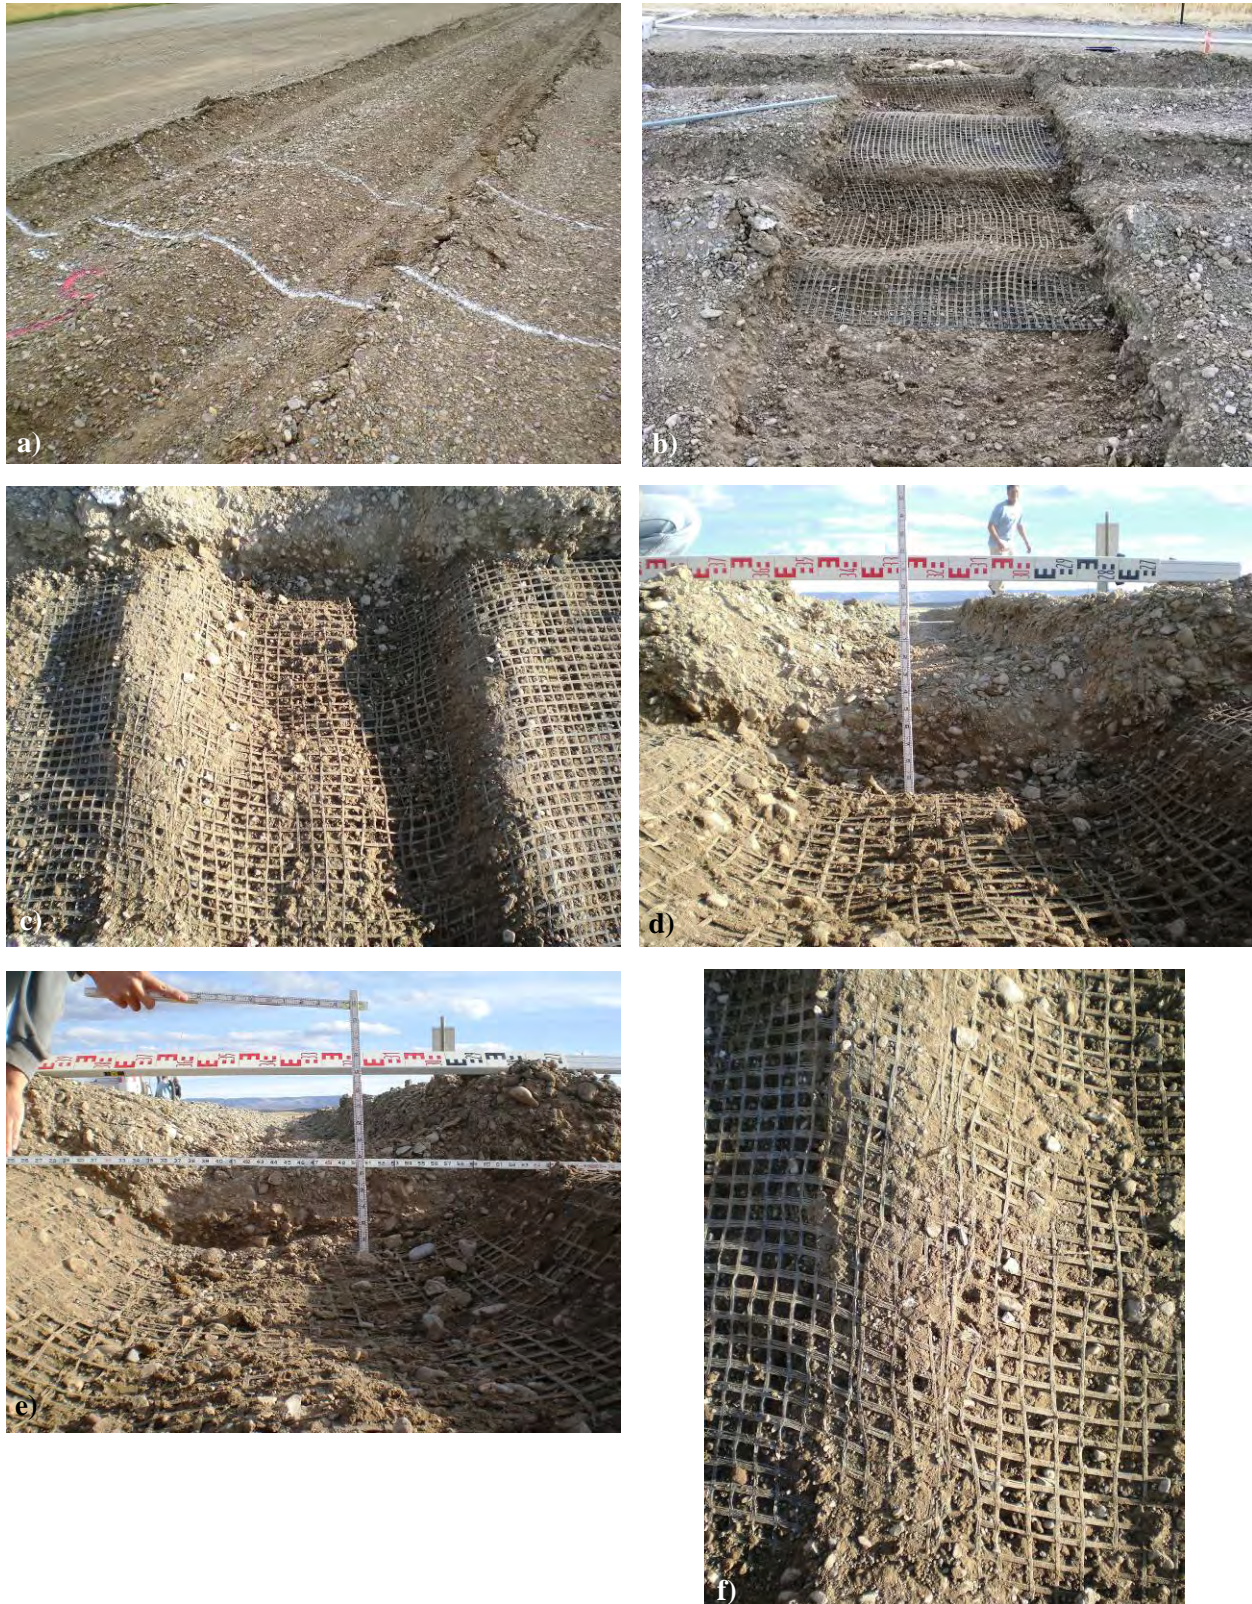
**Figure C-28. Photos of the forensic excavations of the WoG-8 test section: a) excavation area, b) looking west, c) rut bowl, d) base rut profile, e) subgrade rut profile and f) close-up of rut.**

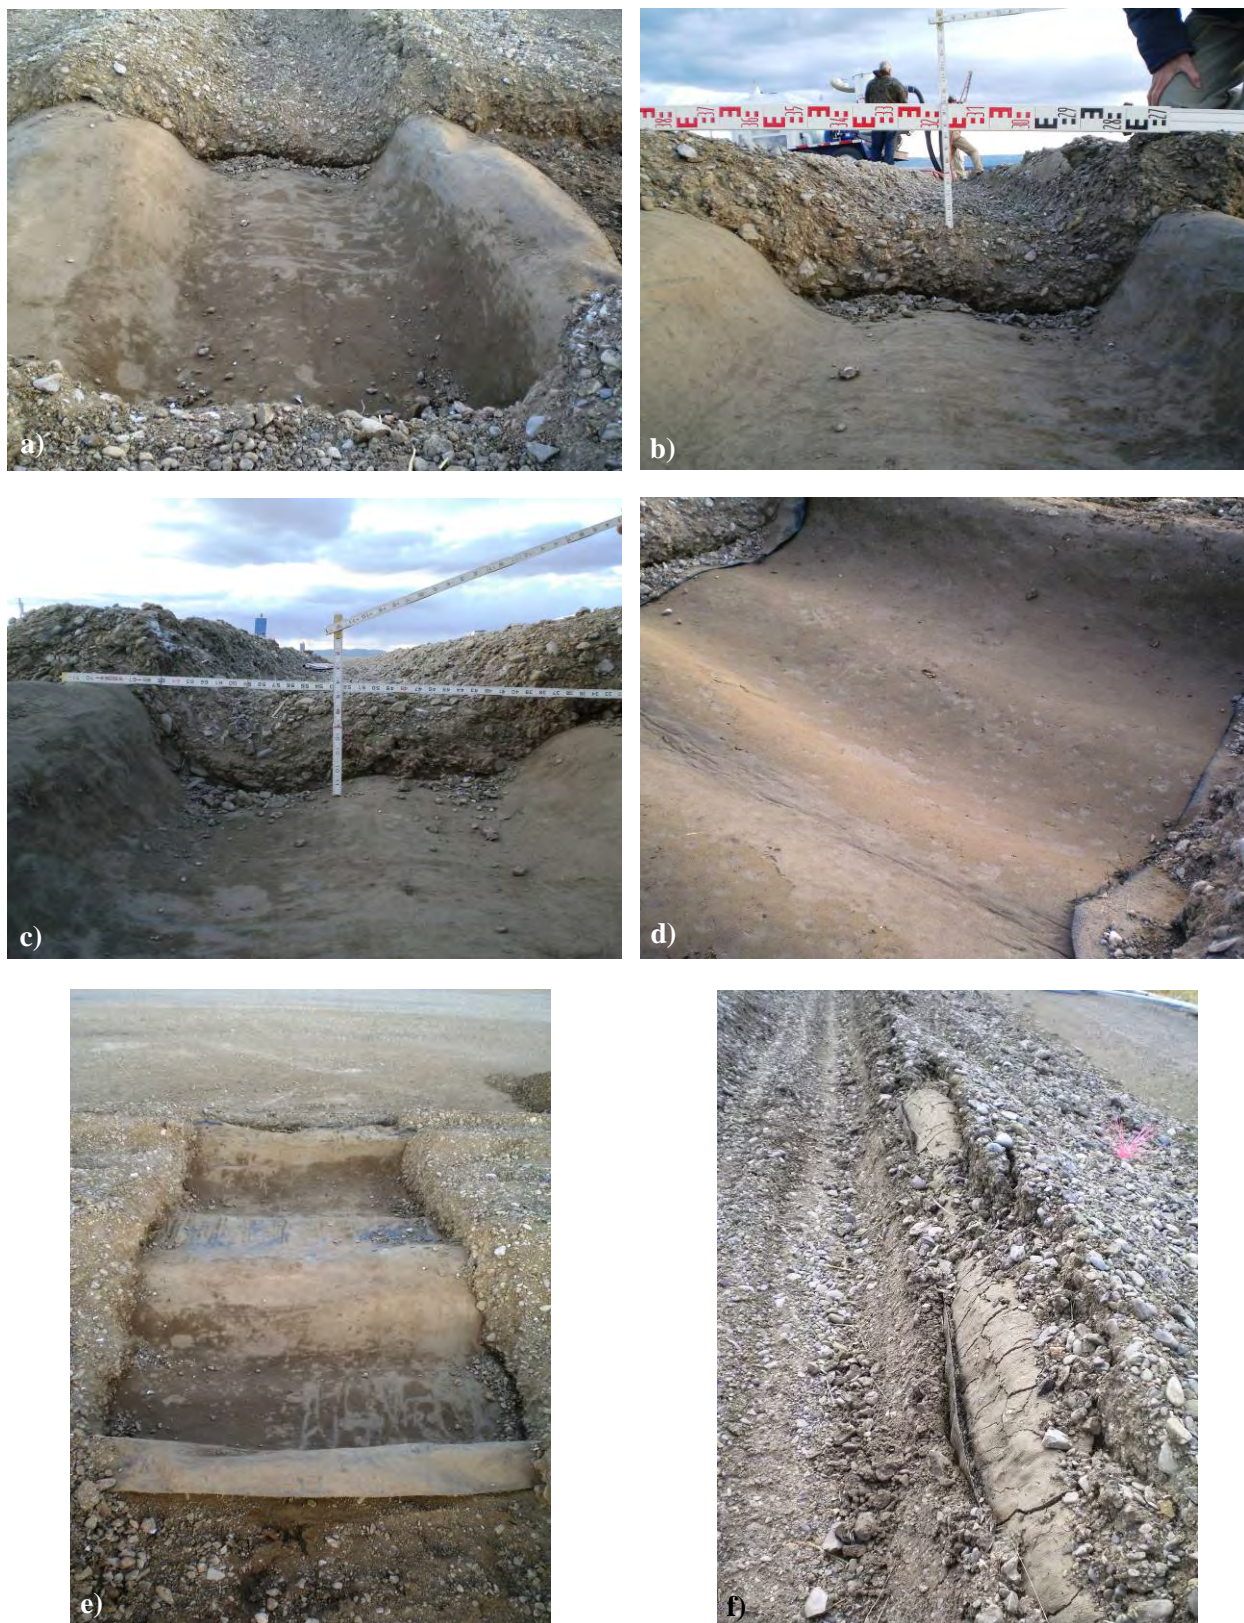
**Figure C-31. Photos of the forensic excavations of the WoT-9 test section: a) rut bowl, b) base rut profile, c) subgrade rut profile, d) subgrade surface, e) looking east and f) pullout failure.**
