# EVALUATING CONCRETE BRIDGE DECK PERFORMANCE

FHWA/MT-06-006/8156-002

*Final Report*

*prepared for*  
THE STATE OF MONTANA  
DEPARTMENT OF TRANSPORTATION

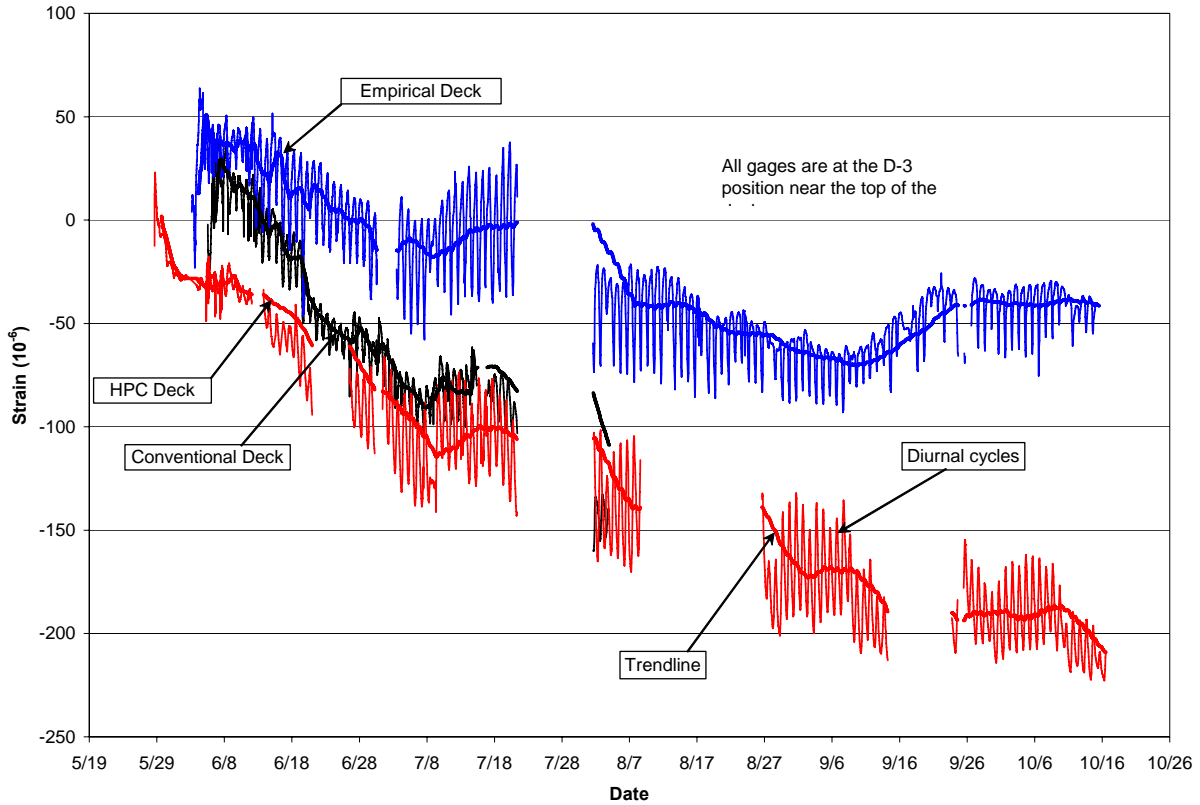
**Figure 94: Long Term Data Illustrating Non-Cracked Portion of the Deck.**

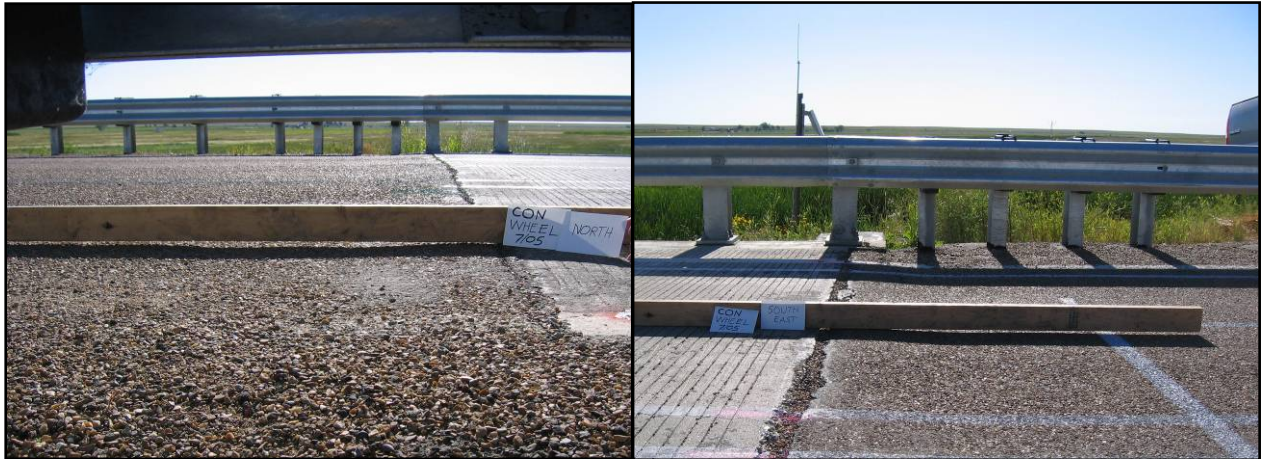
**Figure 114: Paved Approaches of the Conventional Deck (NW-left, SE-right)**

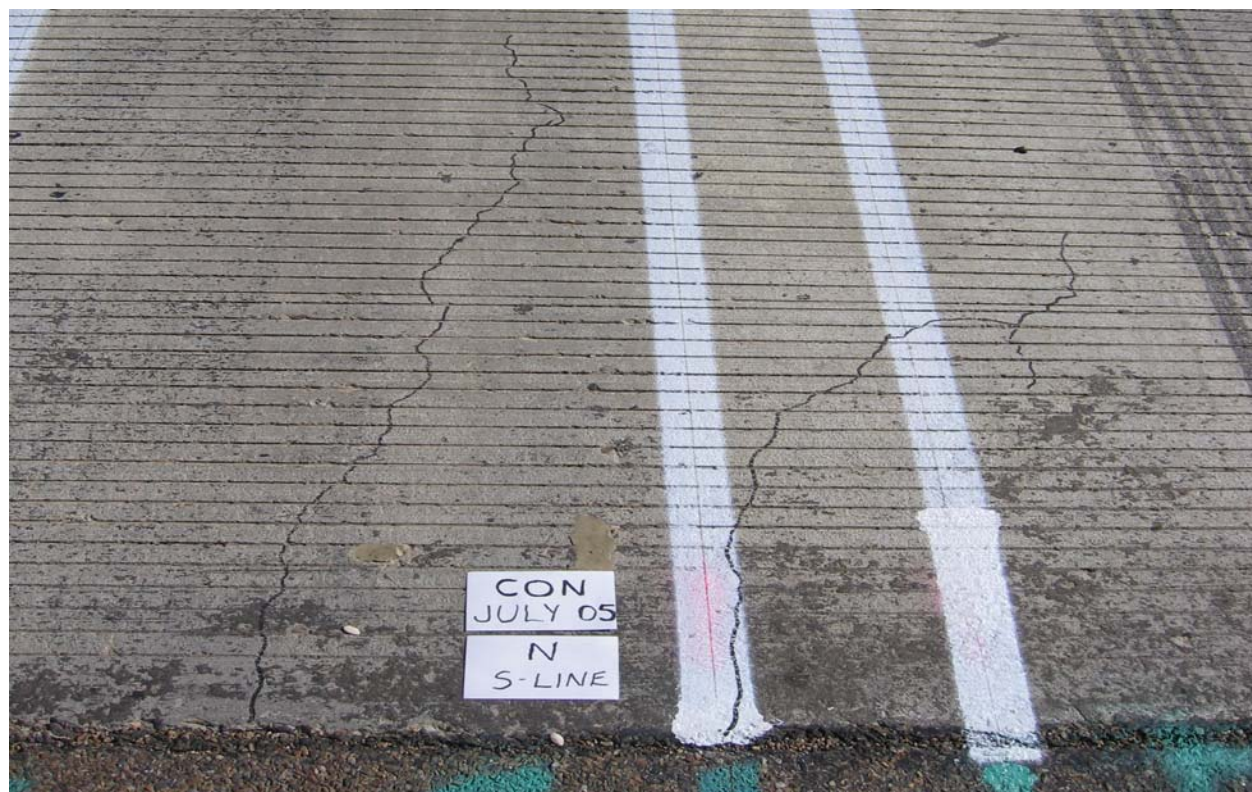
**Figure H -4: Top-Surface Cracking at West Side of North Abutment – Conventional Deck**

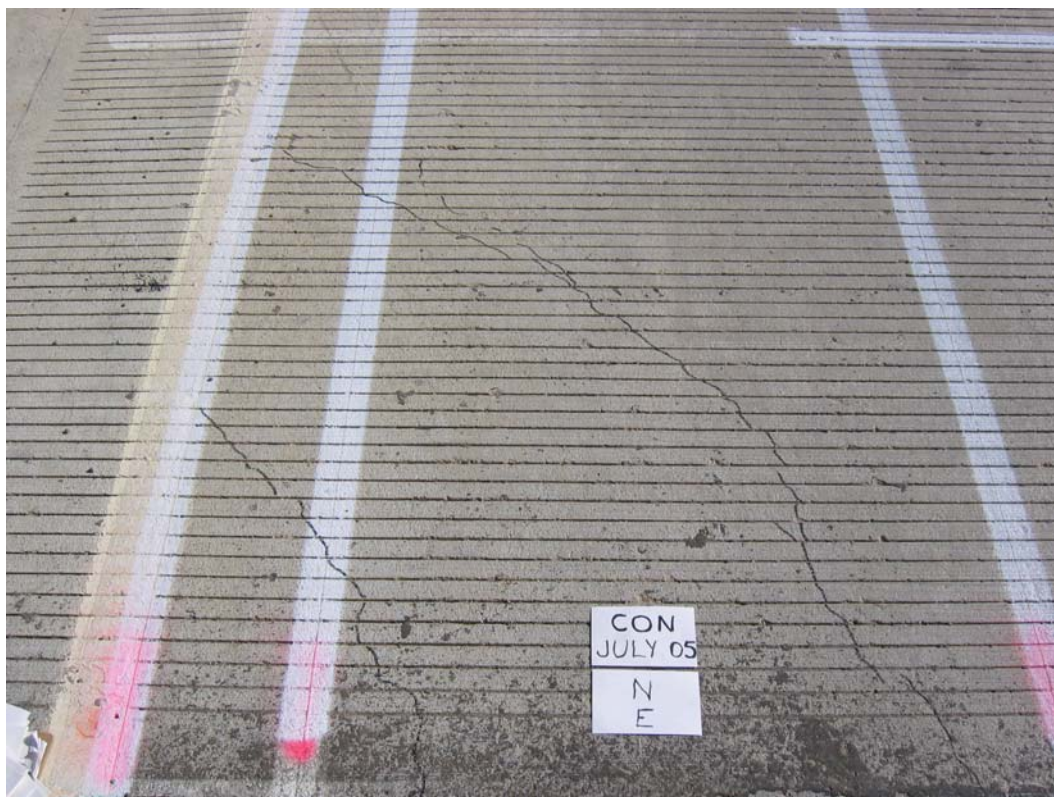
**Figure H -5: Top-Surface Cracking at East Side of North Abutment – Conventional Deck**

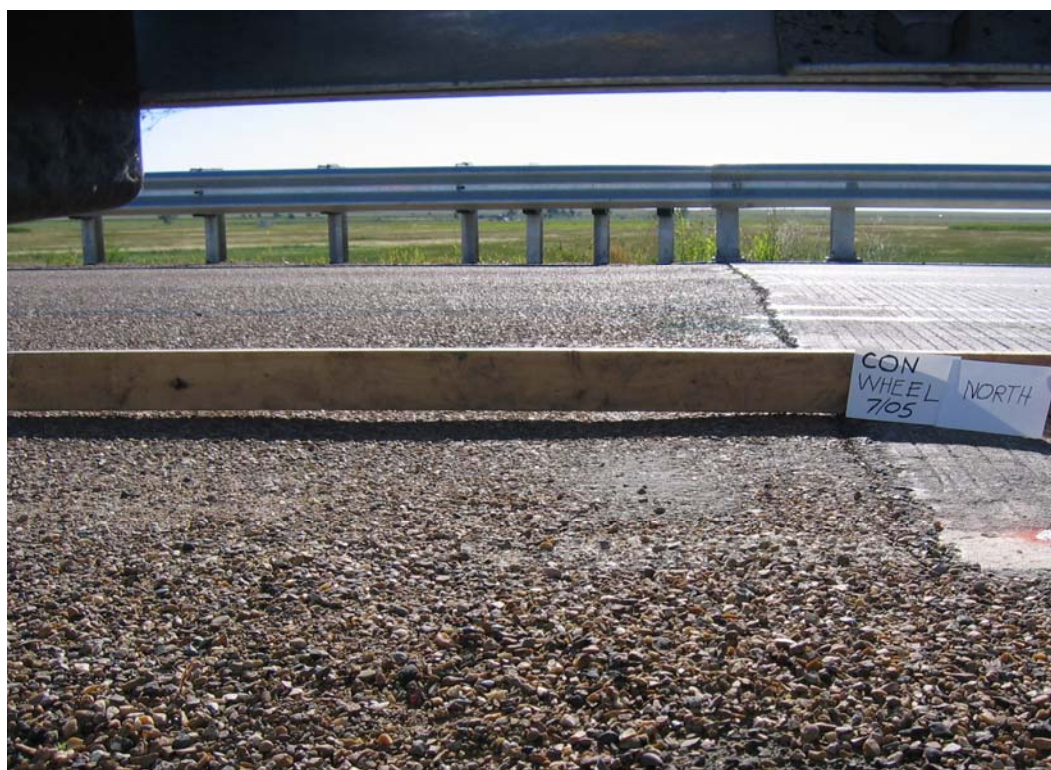
**Figure H -8: Paved Approach – Northwest End of Conventional Deck**

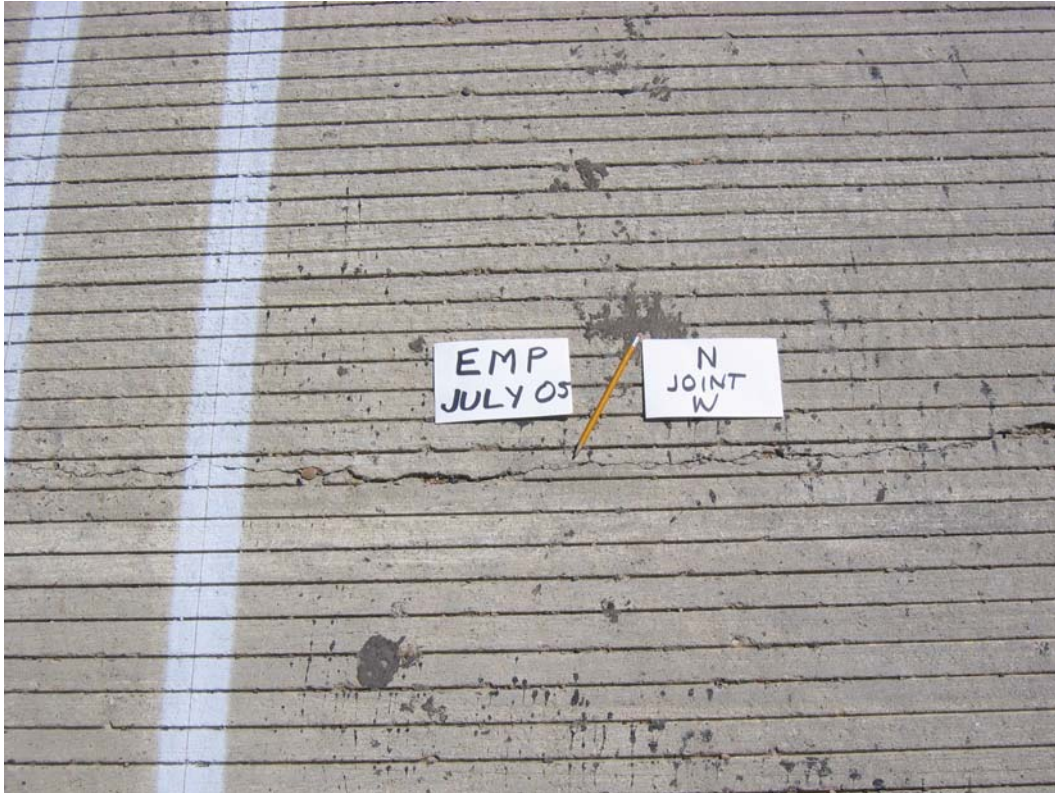
Figure H -12: Full-Depth Transverse Crack at Northern-Most Interior Bent – Empirical Deck

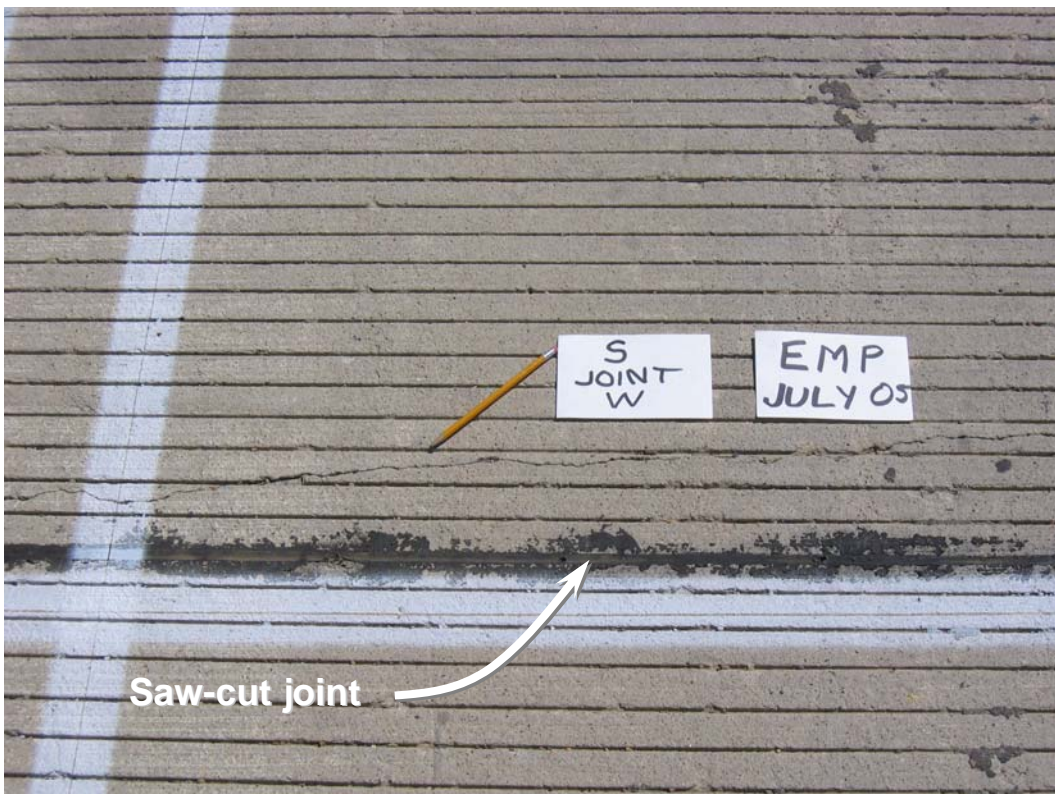
Figure H -13: Full-Depth Transverse Crack at Southern-Most Interior Bent – Empirical Deck

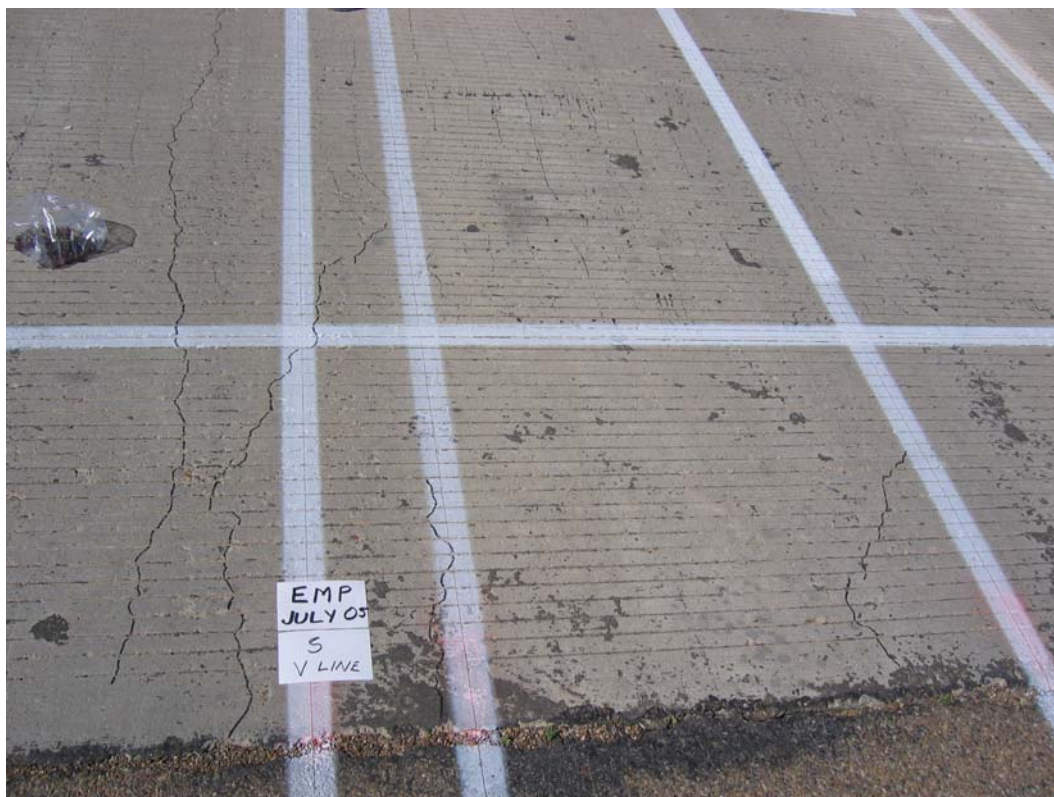
**Figure H -16: Top-Surface Cracking at South Abutment – Empirical Deck**

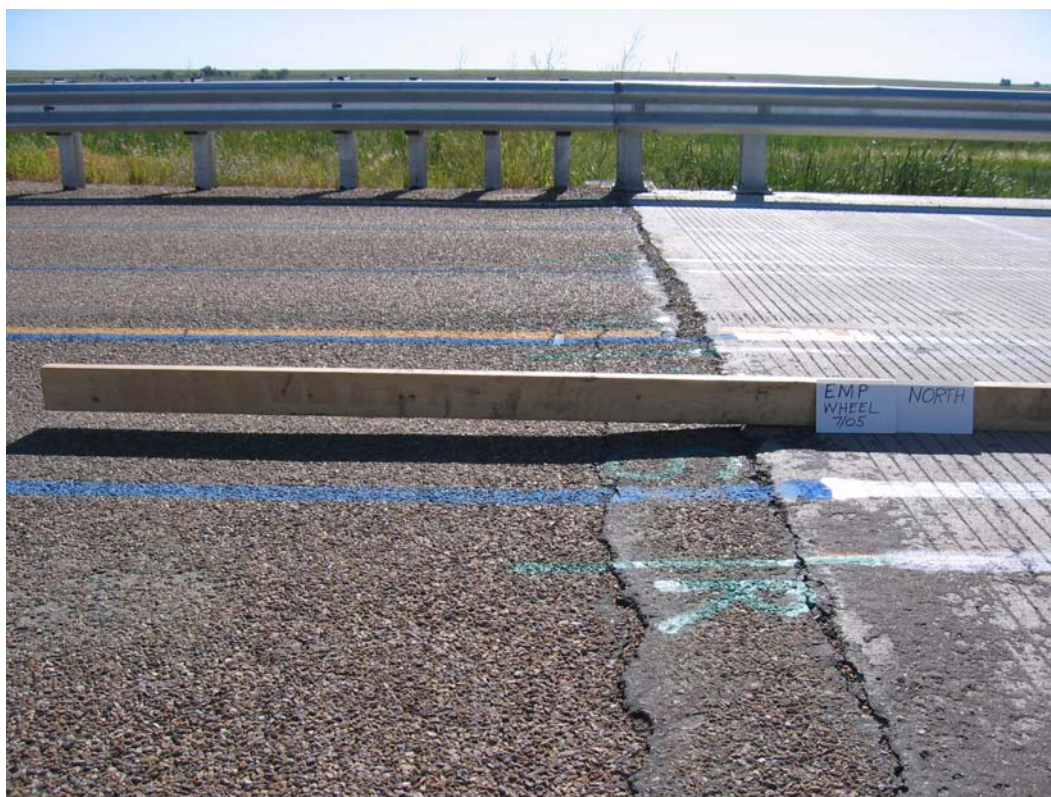
**Figure H -21: Paved Approach – Northwest End of Empirical Deck**

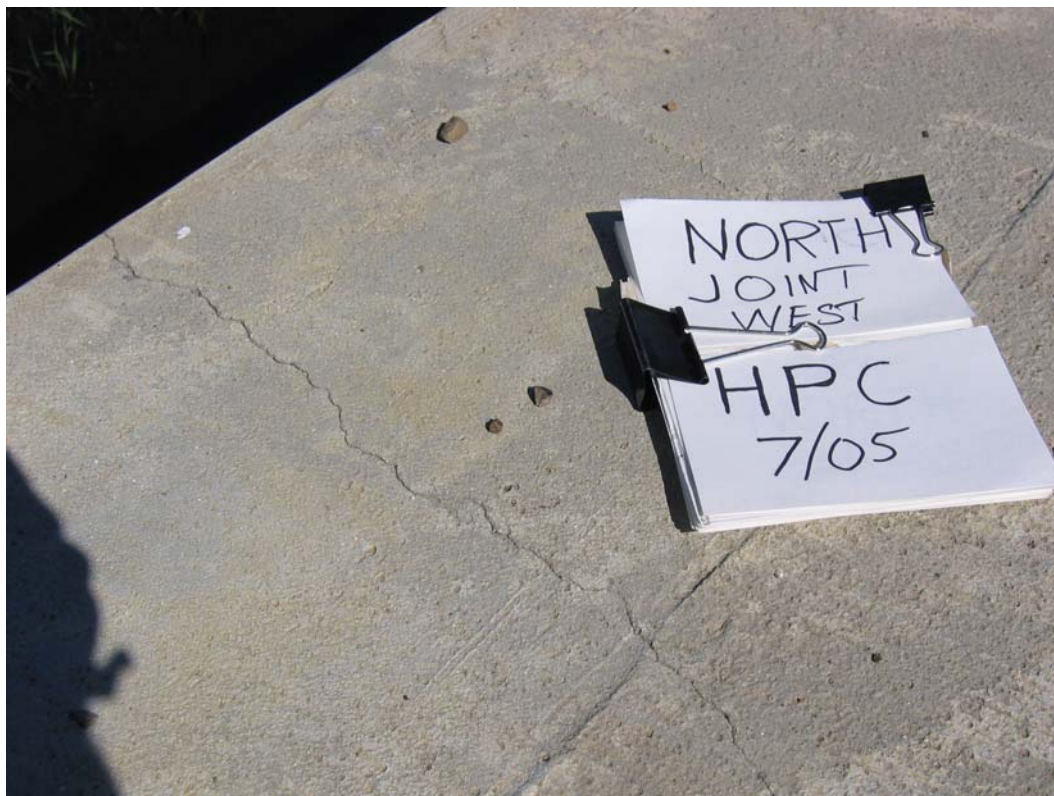
**Figure H -25: Full-Depth Transverse Crack at Northern-Most Interior Bent – West HPC Deck**

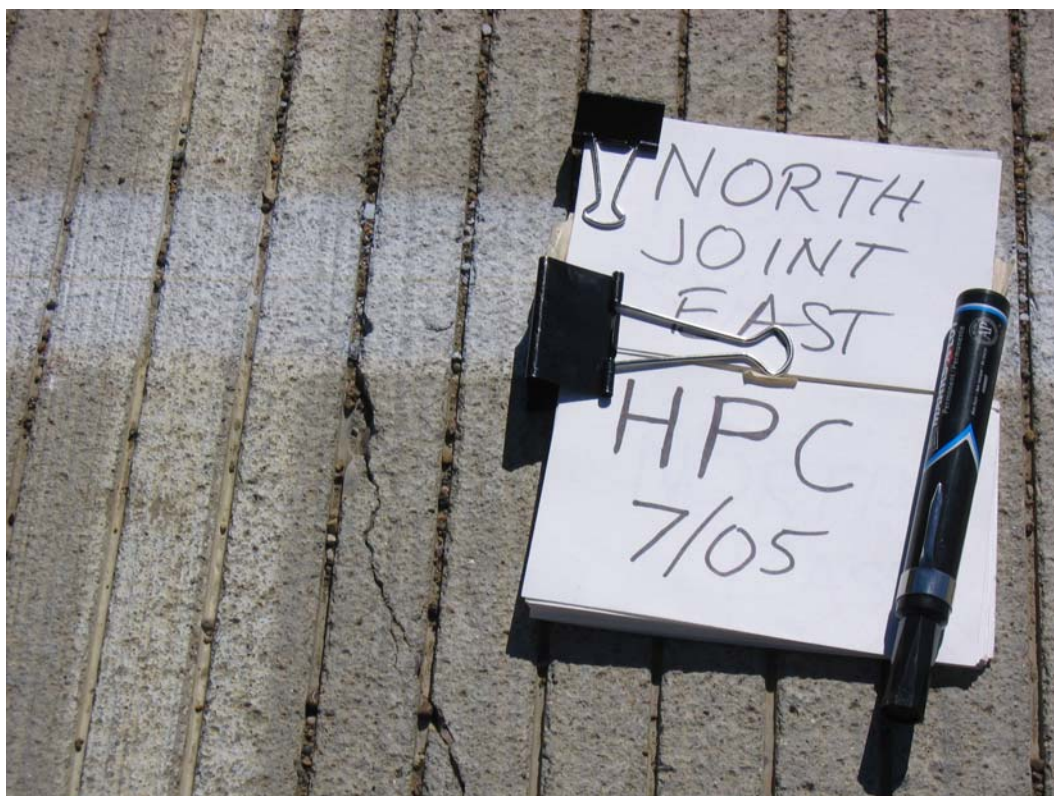
**Figure H -26: Full-Depth Transverse Crack at Northern-Most Interior Bent – East HPC Deck**

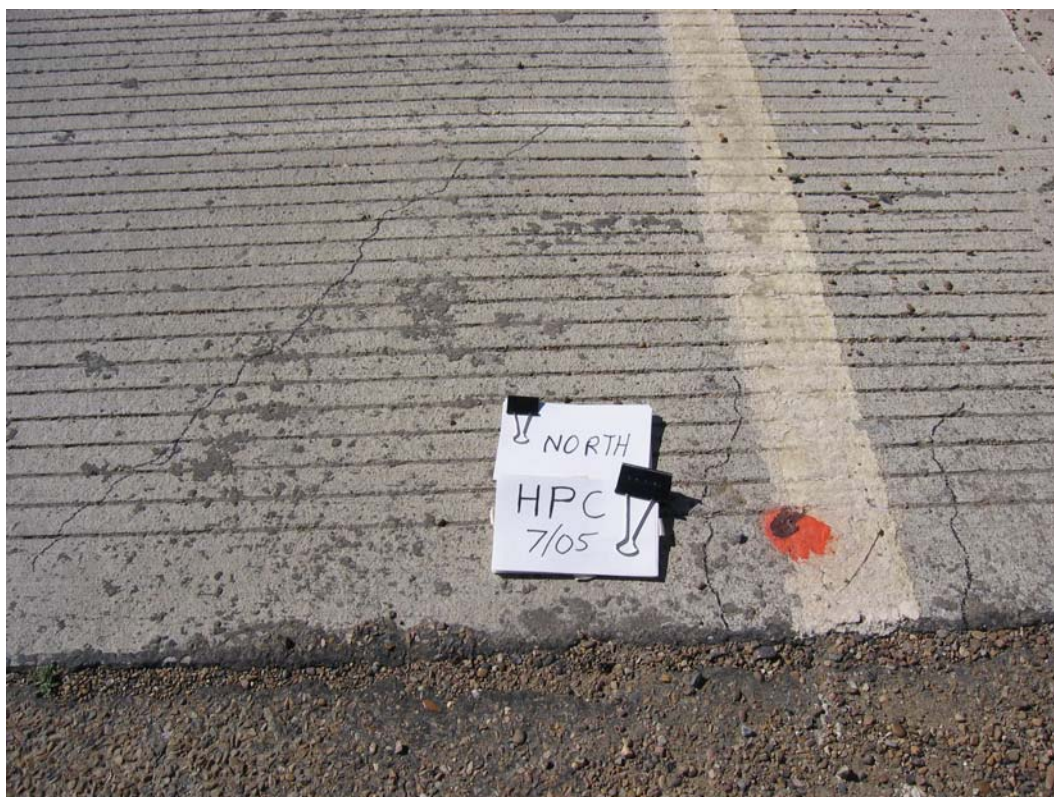
**Figure H -28: Top-Surface Cracking at West Side of North Abutment – HPC Deck**

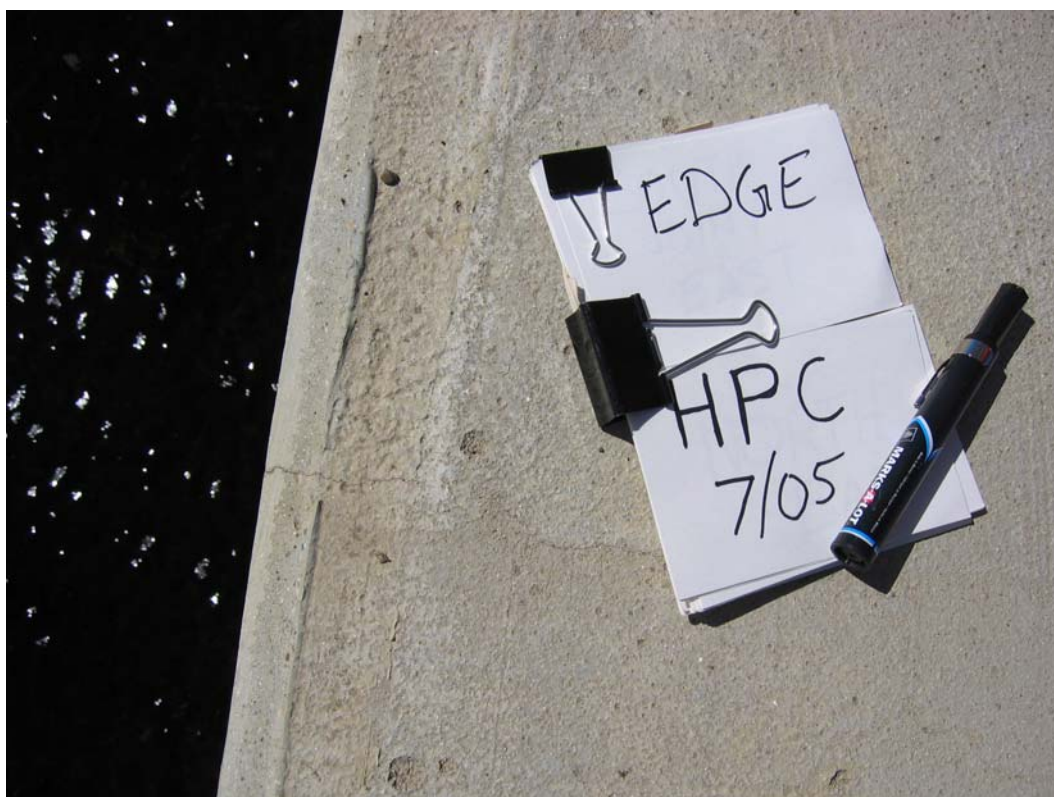
Figure H -30: Edge Cracking on West Side – HPC Deck

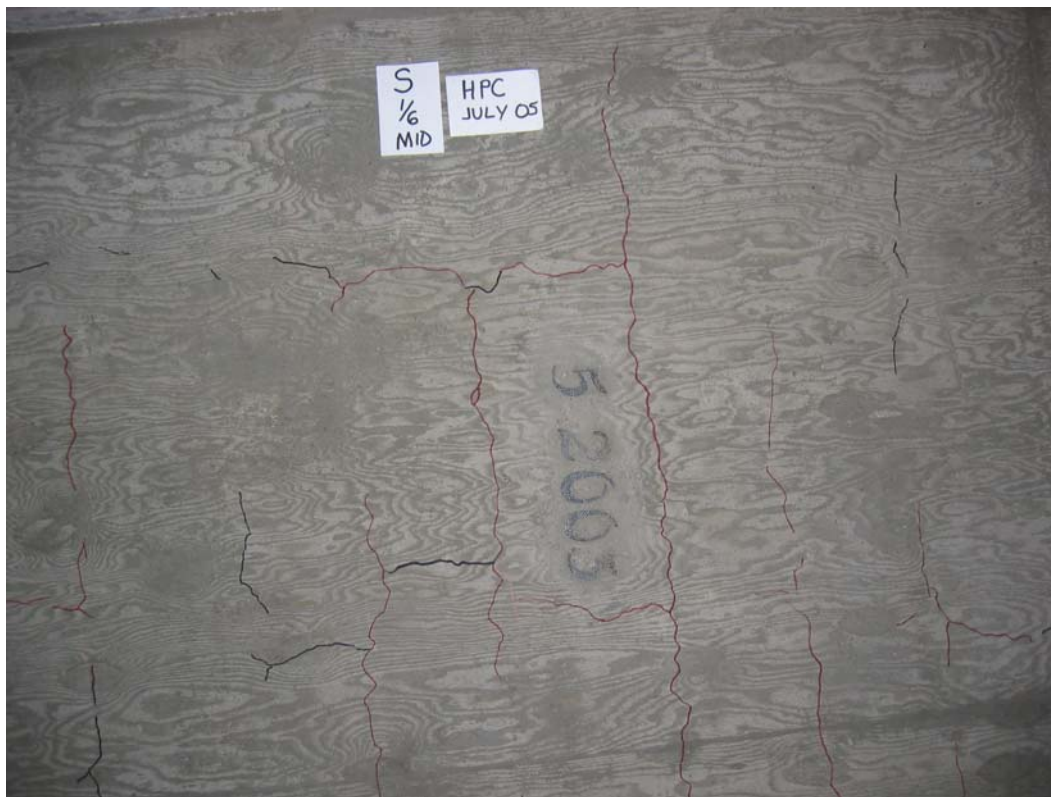
Figure H -31: Hairline Cracking near South Abutment (shown from underside) – HPC Deck

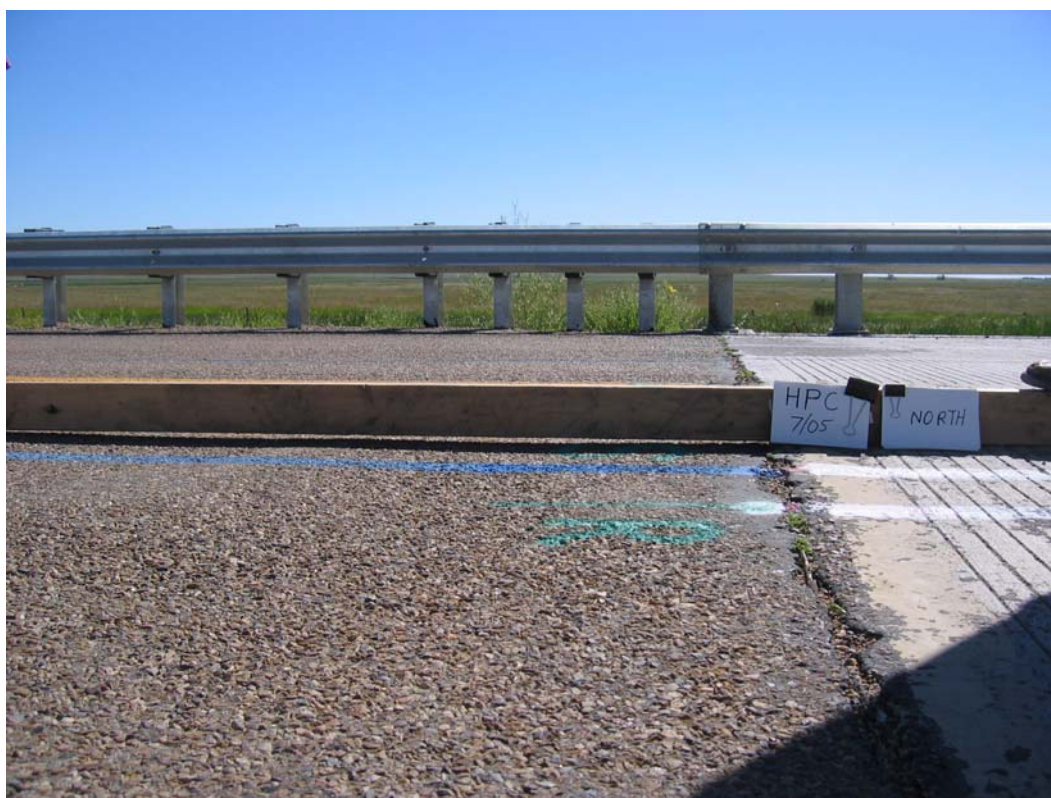
Figure H -32: Paved Approach – Northwest End of HPC Deck
