**InSync Adaptive Traffic Control System  
for the  
Veterans Memorial Hwy Corridor on Long Island, NY**

**THE NEW YORK STATE  
ENERGY RESEARCH AND DEVELOPMENT AUTHORITY**

**Rhythm Engineering**

| 4. Title and Subtitle<br>InSync Adaptive Traffic Control System for the Veterans Memorial Hwy Corridor on Long Island, NY | | | | 5. Report Date<br>August, 2012 | |

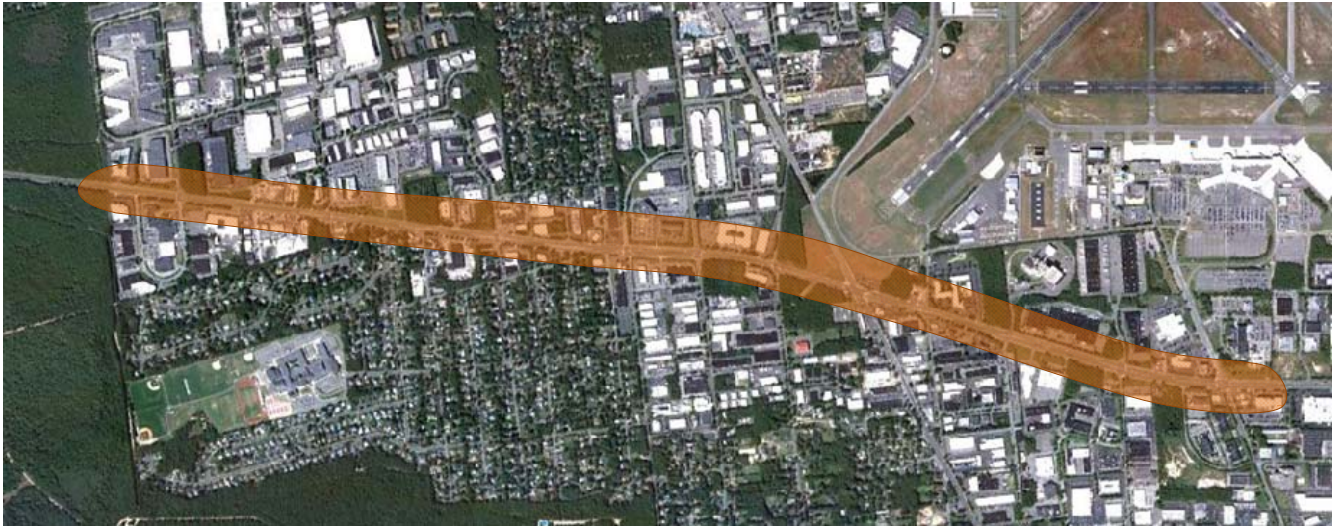
**Figure 2.0.1: Route 454 Study Area Map**

The New York State Department of Transportation (NYSDOT) Region 10 identified the 2.5 mile corridor on NY Route 454 (Veterans Memorial Highway) from 13th Avenue to Johnson Avenue as a critical corridor for congestion relief. The highway serves the Long Island Mac Arthur Airport in the east as well as numerous commercial, government, and residential uses throughout the study area. A little over two miles to the west, Route 454 provides access to I-495 (Long Island Expressway).
