**Report No. CDOT-2012-10  
Final Report**

# **ASSESSMENT OF CONCRETE PAVEMENT TEXTURING METHODOLOGIES IN COLORADO**

**October 2012**

**COLORADO DEPARTMENT OF TRANSPORTATION  
DTD APPLIED RESEARCH AND INNOVATION BRANCH**

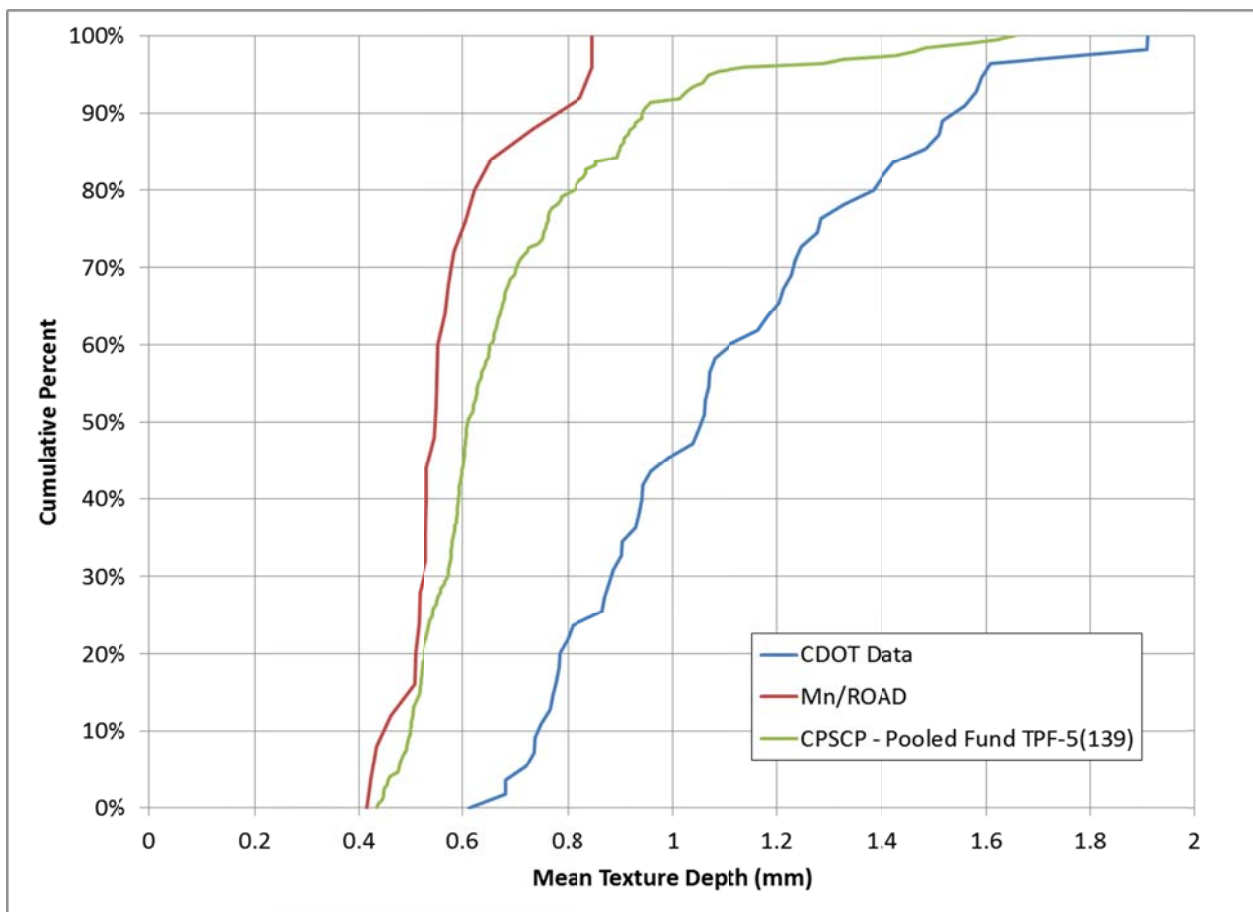
**Figure 9. Cumulative distribution of CDOT texture depth measured following CP 77 compared to PCCP test sites at Mn/ROAD and in the TPF-5(139) pooled fund study measured using ASTM E 965 [note: 1 inch = 25.4 mm, 1 mm = 0.039 inches].**

The difference in glass bead size and roundness between draft CP 77 Method B and ASTM E 965 is significant in that it can lead to a bias in texture depth results. CP 77 Method B specifies glass beads meeting AASHTO M 247 which are about twice as large in diameter as the beads specified in the ASTM E 965 standard. Both procedures specify spreading a known volume of beads on the pavement. However, with larger diameter beads, fewer beads will fill the known volume and spreading these will cover a disproportionately smaller area. The result is larger diameter beads lead to a greater calculated texture depth.

This bias effect is illustrated in Figure 9 which show the cumulative distribution of texture depth for CDOT's test sites along with two other independent data sources; PCCP test sections at the Mn/ROAD test facility and in the TPF-5(139) pooled fund (Concrete Pavements Surface Characteristics Program). The TPF-5(139) pooled fund data includes texture of pavements in Texas, Minnesota, California, New York, Wisconsin, Iowa, and Washington. CDOT's texture data is obtained following the CP 77 standard. Texture from the other studies is obtained following ASTM E 965. In the cumulative distributions, CDOT's 50<sup>th</sup> percentile texture depth is about 0.041 in. (1.05 mm) while the comparators are less, 0.02 to 0.024 in. (0.55 to 0.6 mm).

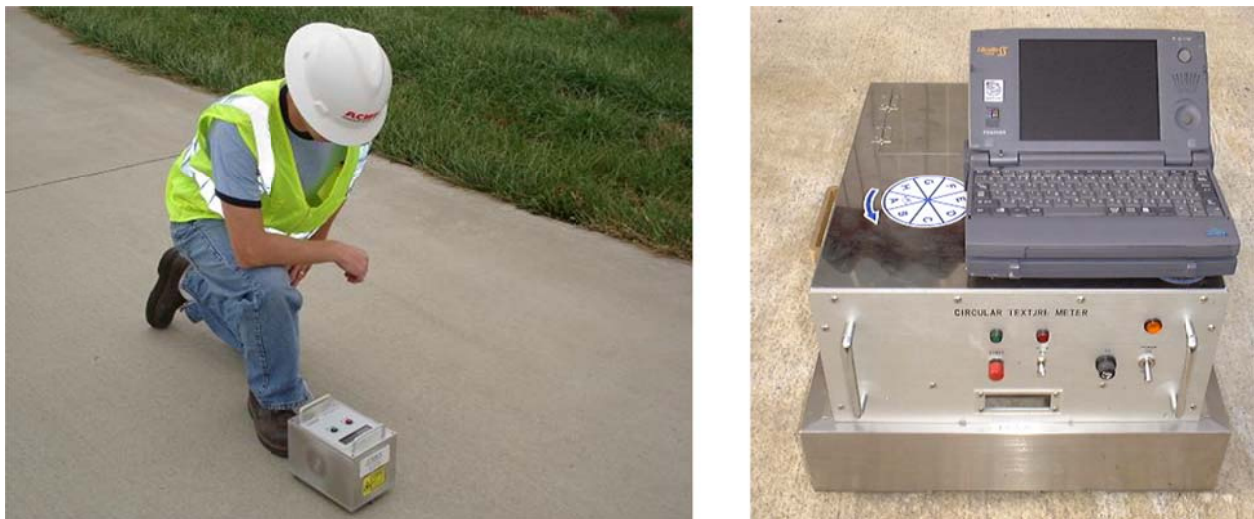
**Figure 11. Commercially available laser based texture profilers. Left: Ames Engineering model 9200 Texture Scanner. Right: Nippo Sangyo Co., Ltd. Circular Track Meter (CTM).**

Consider allowing for Mean Profile Depth (MPD) following ASTM E 1845. This procedure evaluates texture from a profile measurement, typically performed with a laser. The mean texture depth is estimated from the profile results as an Estimated Texture Depth (ETD) which is comparable to the Mean Texture Depth (MTD). Given the unique measurement method in CP 77 Method B, a new mathematical transform would need to be developed. Two commercially available profile measuring devices are shown in Figure 11. Profile based measurement methods have the advantage of less variability over sand patch methods.

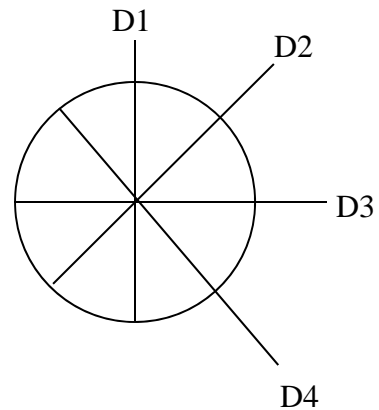
Calculate Macrotexture Depth (in):

Volume of filler (in<sup>3</sup>) divided by area of filler (in<sup>2</sup>).
