**Report #: SPR-PI (08) P309**

**Final Report**

## **Infrared Thermography-Driven Flaw Detection and Evaluation of Hot Mix Asphalt Pavements**

January 2010

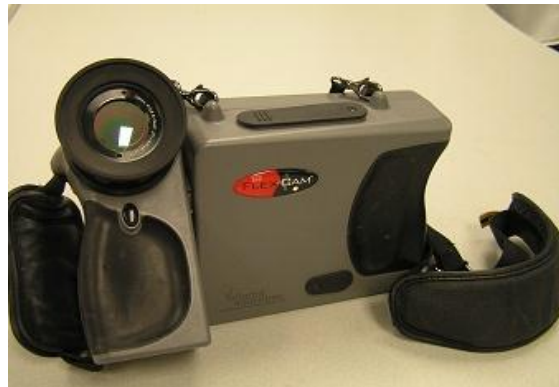
**Figure 3.1** Infrared Camera

For verification of the use of thermal image data in HMA applications, temperature readings were initially taken on the surface of the HMA as well as internally using a temperature probe. The internal and external temperature readings were compared to those obtained by the infrared camera. This was also done to ensure the specific infrared camera used in this study provided an accurate representation of temperature differentials. The accuracy of infrared cameras in general has already been proven in HMA applications by the University of Washington study, which notes that both temperature probes and infrared cameras are adequate tools for proving temperature differentials (Willoughby 2001). Figure 3.1 shows a Flex Cam XR2, the infrared camera used in this research. Figure 3.2 shows infrared images taken from Nebraska paving sites.

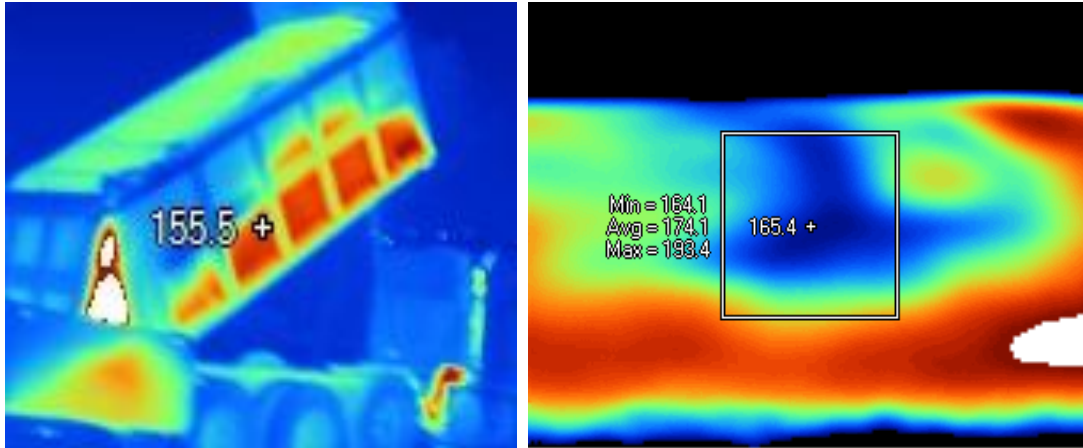
**Figure 3.2** Heat Loss from a Truck (left) and Temperature Differential from an HMA Mat (right) with Temperatures Shown in °F

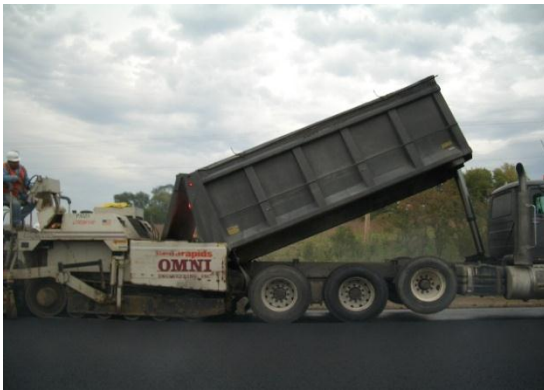
**Figure 4.6** Direct Dump between Truck and Paver

There are two types of material feeding processes from a delivery truck to a paver in Nebraska. Either HMA trucks directly dump delivered HMA into the hopper of a paver (Figure 4.6), or belly dump trucks and live belly dump trucks deposit the material ahead of a pick-up machine that scoops up the HMA and transfers it into the hopper of a paving machine (Figure 4.7). Unlike a material transfer vehicle (MTV), such as Roadtec, Inc.'s, Shuttle Buggy MTV, the pick-up machine does not have a special remixing auger or chute.

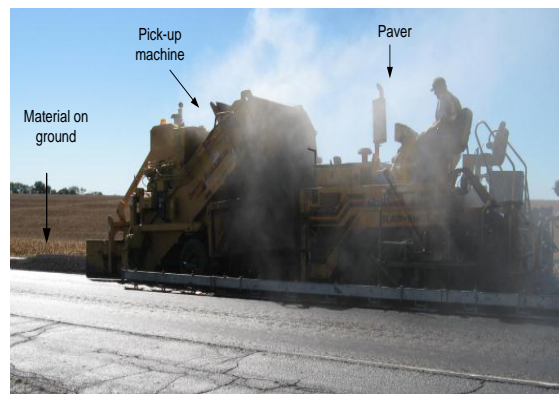
**Figure 4.7** Pick-up Machine with Paver

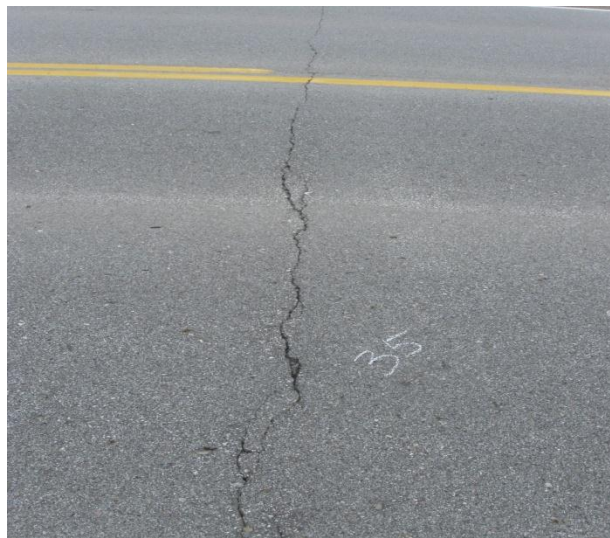
**Figure 5.2** Observed Transverse Crack

The following picture is indicative of a transverse crack (Figure 5.2). Transverse cracks are formed perpendicular to the direction the asphalt paver, and are often the result of asphalt shrinkage. Because areas of different temperature expand and contract at different rates, transverse cracks are of particular interest in this investigation. Cracks of this type also often occur as reflective cracks, which will be discussed later.

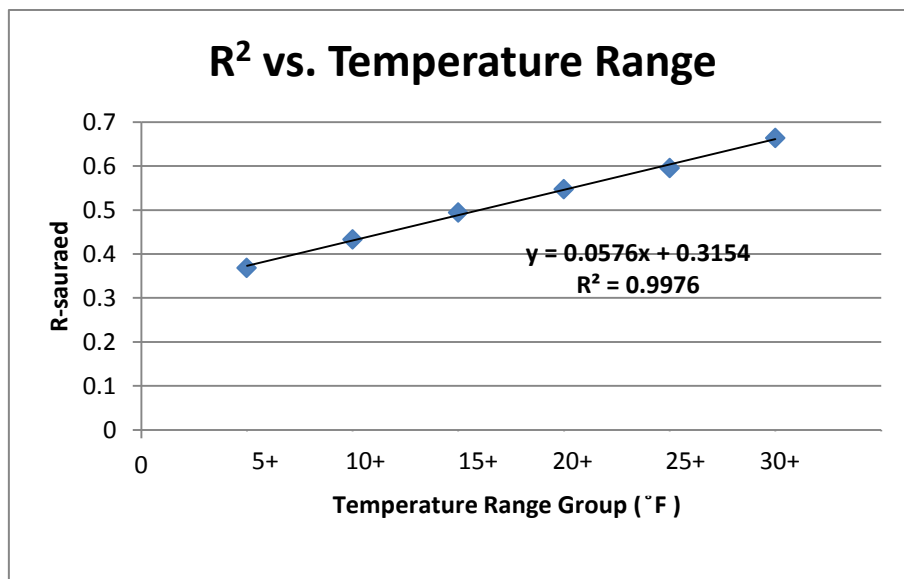
**Figure 5.15** Relationship between the Correlation of TD and DEN for a Given Temperature Range and the Temperature Range Group

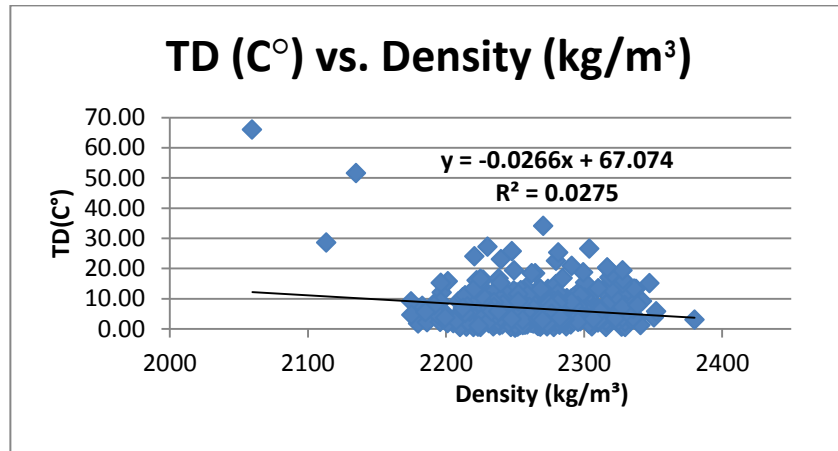
**Figure 4.2** Relationship for All Collected Data between Temperature Differential (TD) and Density (DEN)

Although a negative relationship was found, the general analysis between temperature differentials (TD) after compaction and pavement density (DEN) showed the relationship between the two variables not to be significant (Figure 4.2). This analysis included all 304 density readings obtained throughout the project and charted them against their corresponding temperature differential.

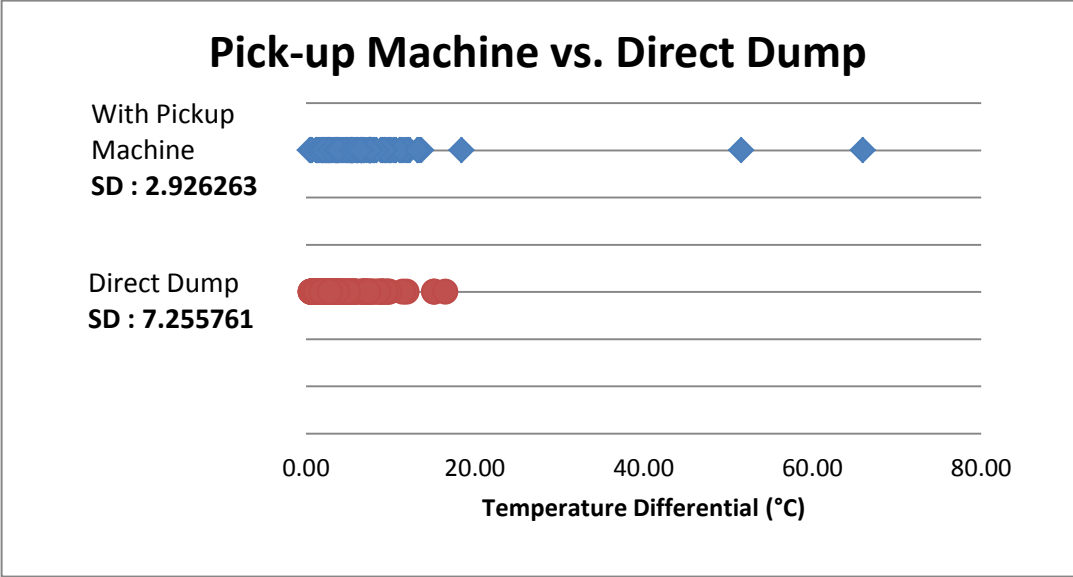
**Figure 4.8** Temperature Differential Based on Feeding Types

demonstrates how a pick-up machine is a very cost-effective solution to reduce temperature differential of delivered HMA without using expensive MTVs.

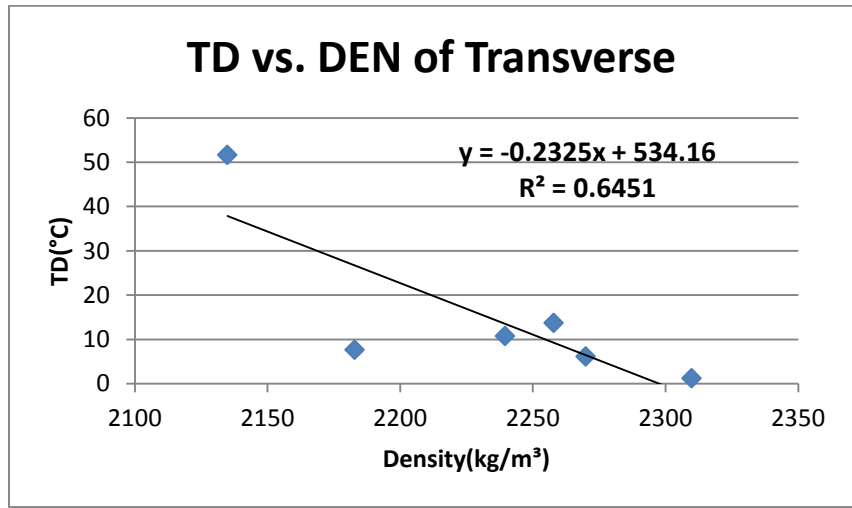
**Figure 5.10** Relationship between Temperature Differentials (TD) and Density (DEN),  
Excluding Reflective Cracks

**Figure 5.10** Relationship between Temperature Differentials (TD) and Density (DEN), Excluding Reflective Cracks

The 14 locations were not further included in data analysis as these locations were almost certainly influenced primarily by the previous pavement underlayments. After excluding the suspected reflective cracks, the remaining six transverse cracks that had developed were found to possess an increased relationship (60.7%) between temperature differentials and density (Figure 5.10).

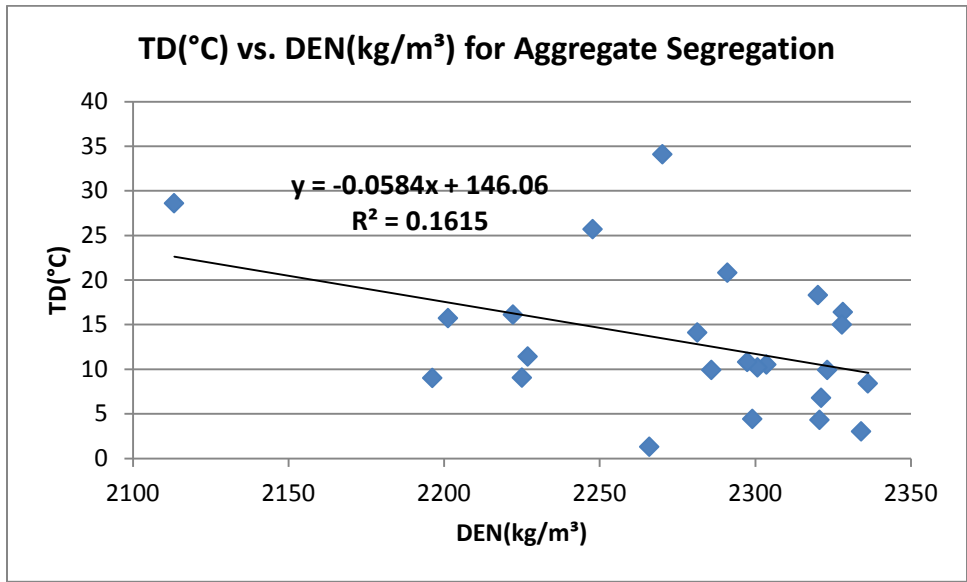
**Figure 5.12** Relationship between Temperature Differentials (TD) among Aggregate Segregation

Of the 24 locations with visible material segregation, a 15% negative relationship was found between temperature differential (TD) and density (DEN).

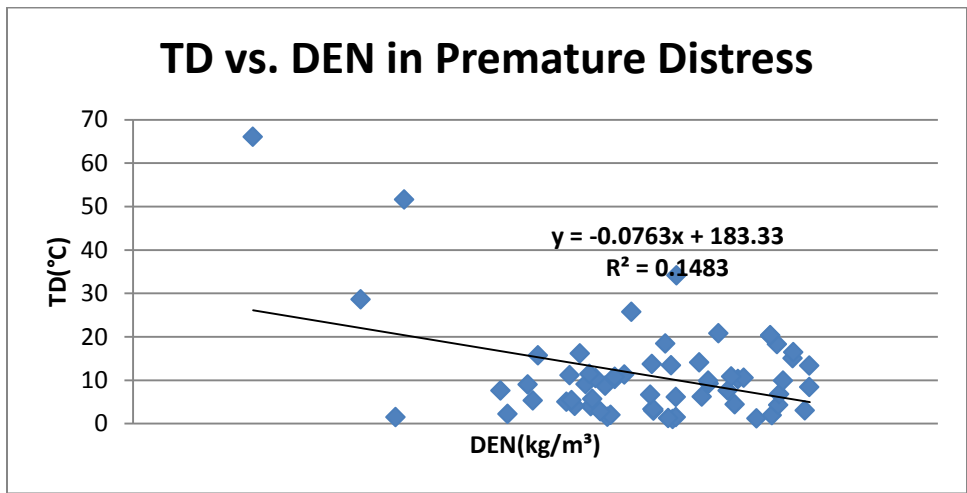
**Figure 5.13** Relationship between Temperature Differentials and Density among Total Instances of Observed Premature Distresses

**Figure 5.13** Relationships between Temperature Differentials and Density among Total Instances of Observed Premature Distresses

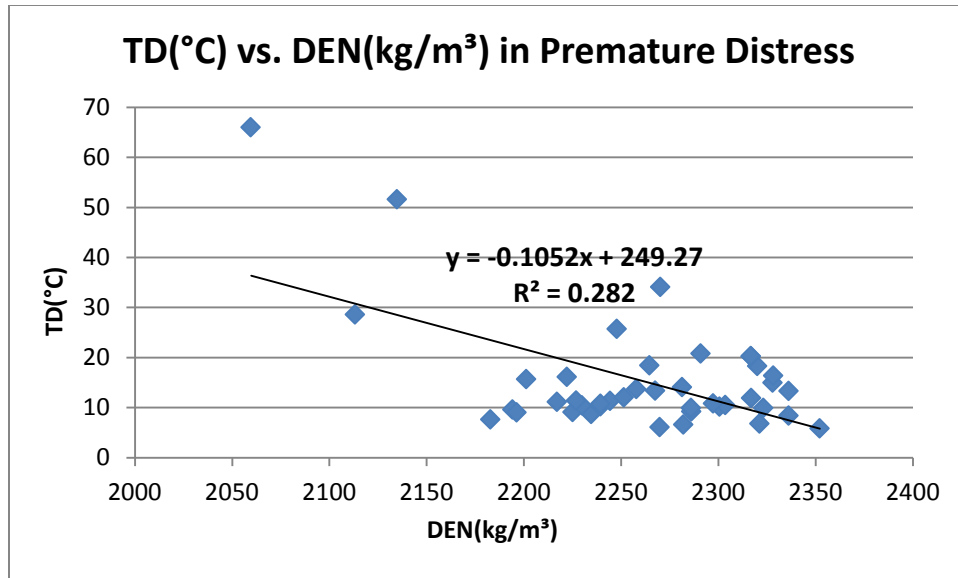
**Figure 5.14** Relationship between Temperature Differentials and Premature Distresses, Excluding Small Surface Voids

Recall, however, that when analyzed individually the pothole type of flaw exhibited a positive relationship between TD and density. Because all other flaw types show signs of being affected by temperature differentials in regard to their corresponding densities, while the locations with small voids do not, they were removed from the data set. The remaining 34 premature distresses or flaw locations were analyzed with regard to TD and density and were found to have a relationship of 37% (Figure 5.14): an improvement of 19% over the inclusion of small voids.

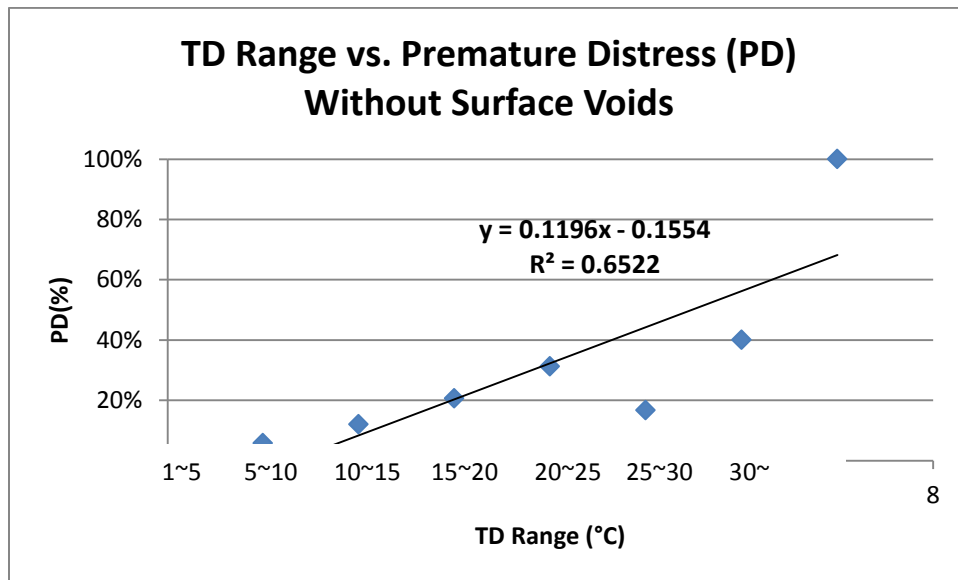
**Figure 5.17** Correlation between the Percentages of Premature Flaws, Excluding Surface Voids, Found within a Specified Temperature Range
