RESEARCH REPORT

THEORETICAL AND FIELD EXPERIMENTAL EVALUATION OF SKEWED MODULAR SLAB BRIDGES

**SP109B4N
FINAL REPORT**

DECEMBER 2012

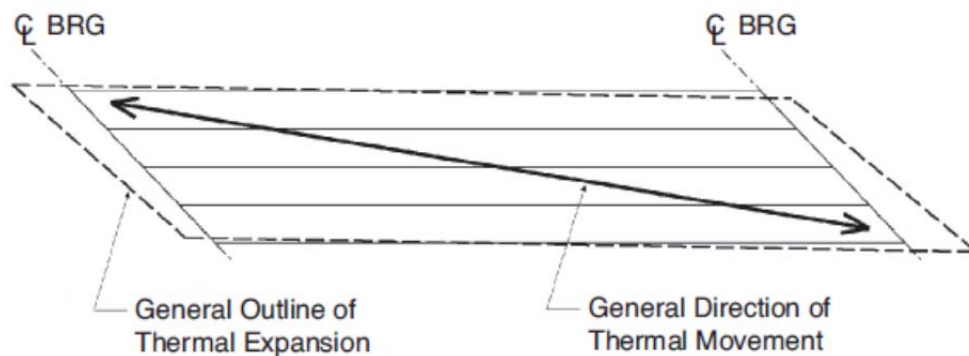
Figure 3-3: General Effect of Thermal Expansion on a Skewed Bridge (CL BRG = Centerline Bearing) (Coletti et al., 2011)

Skewed bridges undergo differential thermal expansion unlike non-skewed bridges because of their geometry and because their precast-concrete slabs are at least partially affixed to the bridge's abutments. The geometry causes the thermal movement of a skewed bridge to be asymmetrical, with the movement centered on a line between the acute corners of the skewed bridge, as shown in Figure 3-3 (Coletti et al., 2011). Thermal contraction and concrete shrinkage produce similar effects (Precast/Prestressed Concrete Institute, 2003).

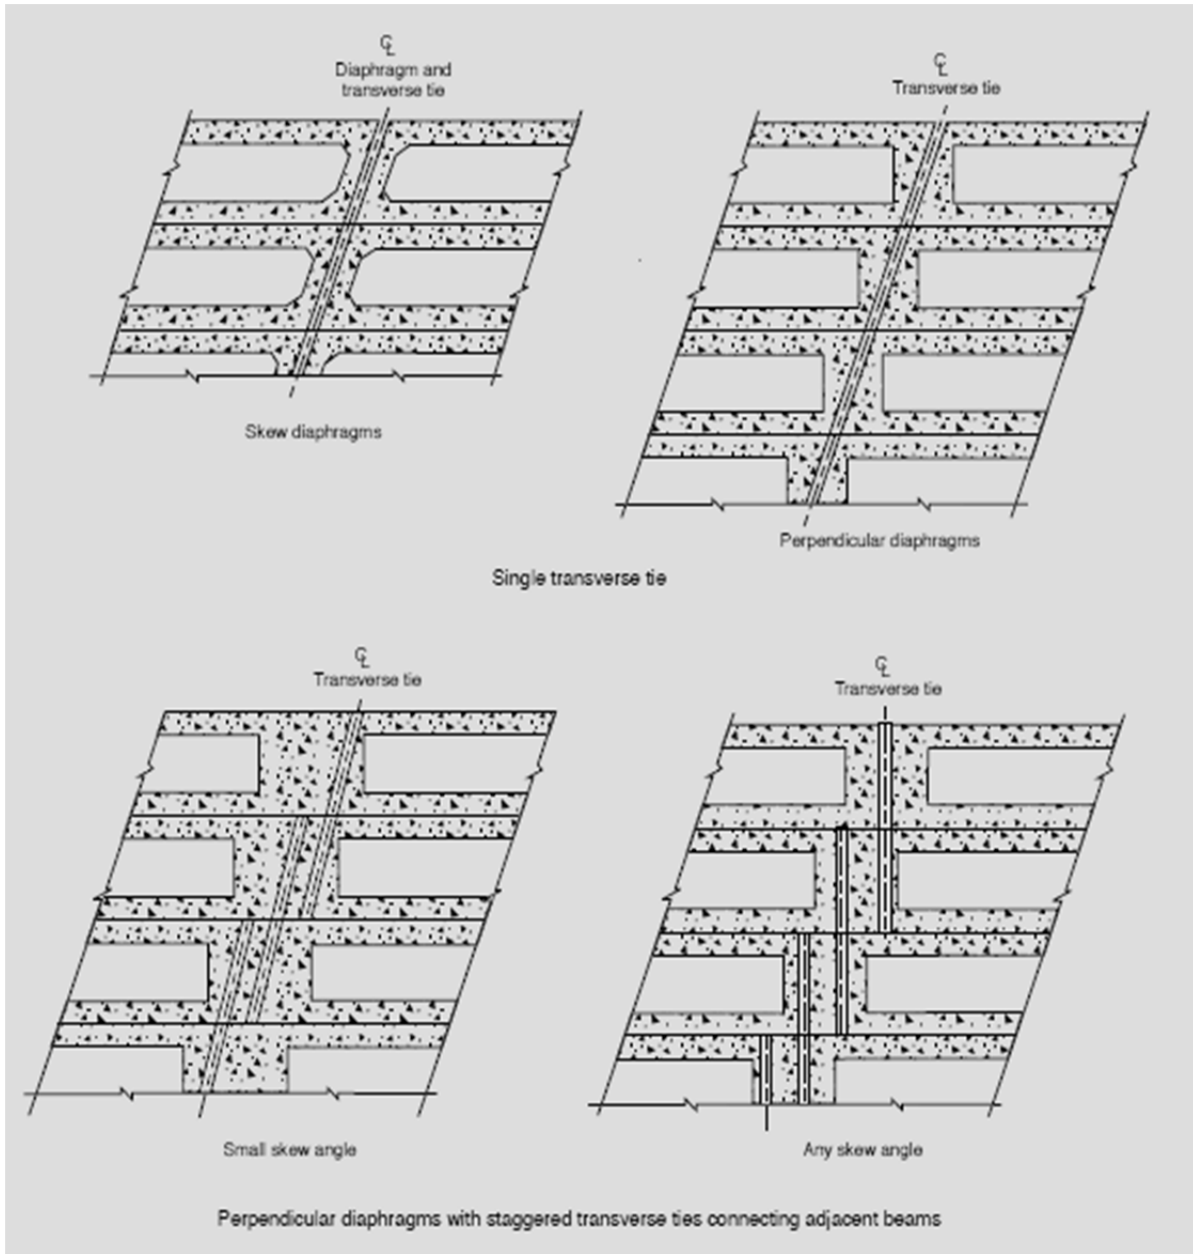
Figure 4-2 Transverse Tendon Orientation and Diaphragm Construction Options (Russell, 2011)

The transverse tendons transfer applied loads to the connected concrete beams in different ways depending on their orientation. The tendons can either remain normal to the beams and staggered throughout the cross-section of a skewed bridge or they can be placed parallel to the bridge's skew angle. A staggered orientation is often easier to install but it connects the beams at different relative distances along the beams. Though more difficult to install, tendons with a skewed orientation connect the beams at their same relative points thus making the skew bridge behave more similarly to a normal bridge. Figure 4-2 shows the possible transverse tendon orientations and the corresponding possible diaphragm construction possibilities for box beams or voided slabs.

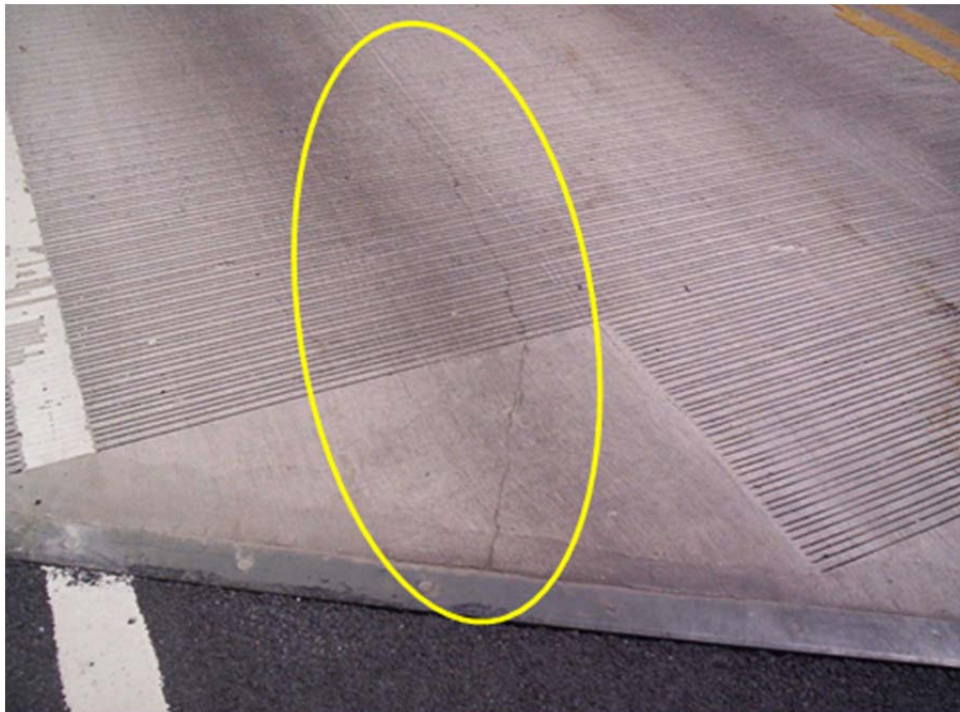
Figure 5-3 Longitudinal Crack on the Top Surface of the Knoxville, MD, Bridge

The longitudinal cracking on the top surface of the Knoxville, MD, are circled in yellow in Figures 5-2 through 5-5. There is a clear pattern: the cracks begin perpendicular to the abutment, travel up to two feet, then reorient to travel parallel to the bridge beams and follow the shear keys between the slabs. Figures 5-6 and 5-7 show that no leakage occurred on the underside of the bridge, which means that the longitudinal reflective cracks on the top surface probably were not yet sufficiently deep to affect the steel reinforcement and post-tensioning in the bridge. All of the relevant Knoxville, MD, bridge plan sheets pertaining to the major structural elements of the bridge superstructure are included in Appendix B.

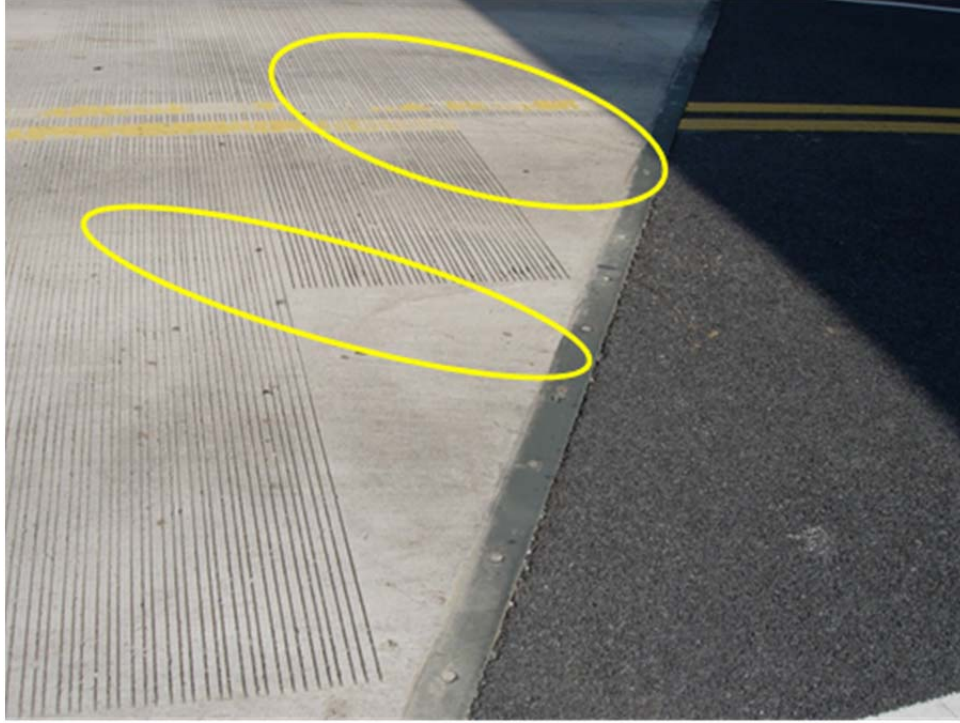
Figure 5-4 Longitudinal Cracks on the Top Surface of the Knoxville, MD, Bridge

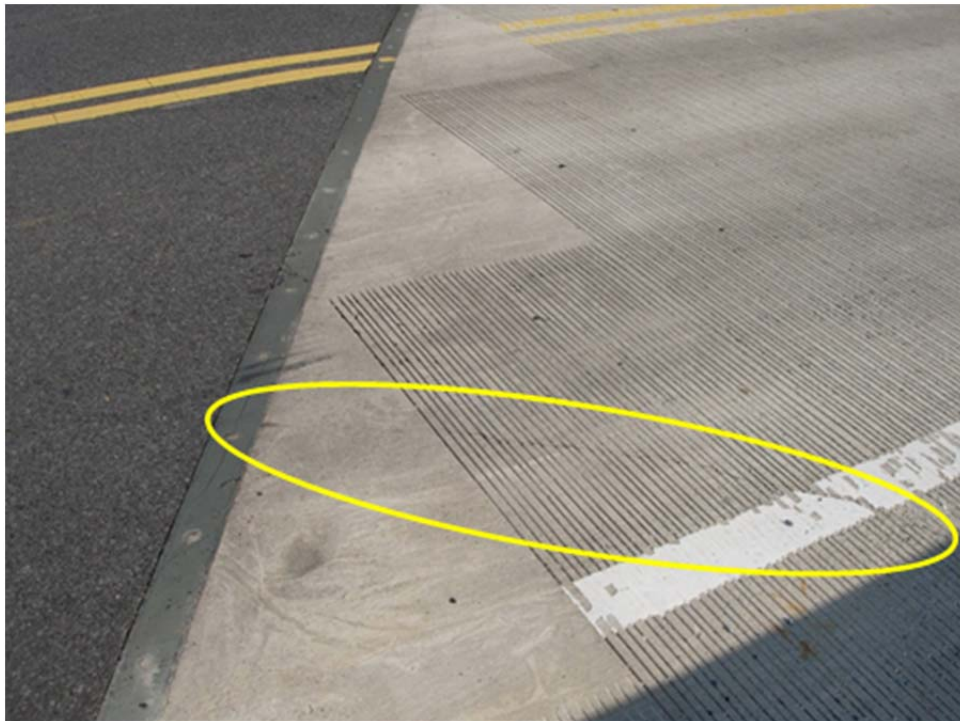
Figure 5-5 Longitudinal Crack on the Top Surface of the Knoxville, MD, Bridge

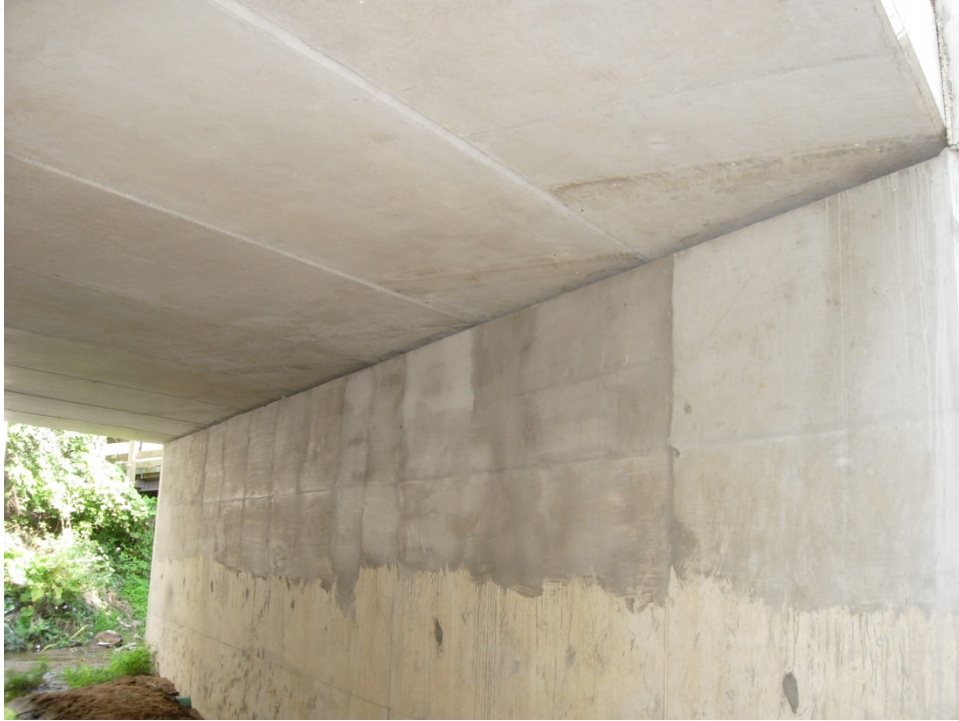
Figure 5-6 View of the Bottom Surface and the East Abutment of the Knoxville, MD, Bridge

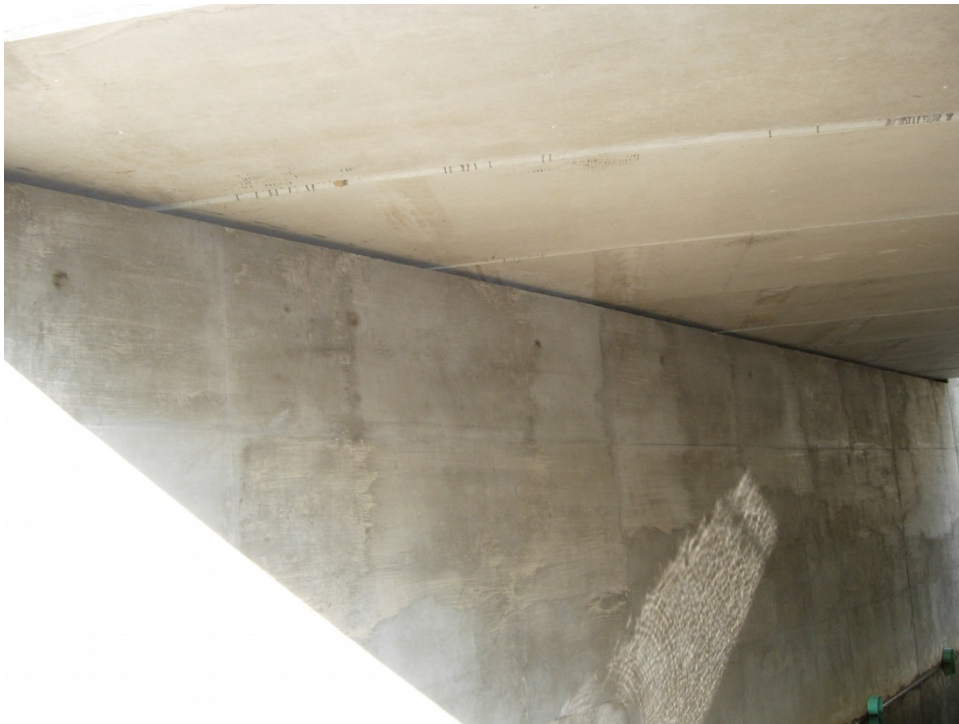
Figure 5-7 View of the Bottom Surface and West Abutment of the Knoxville, MD, Bridge

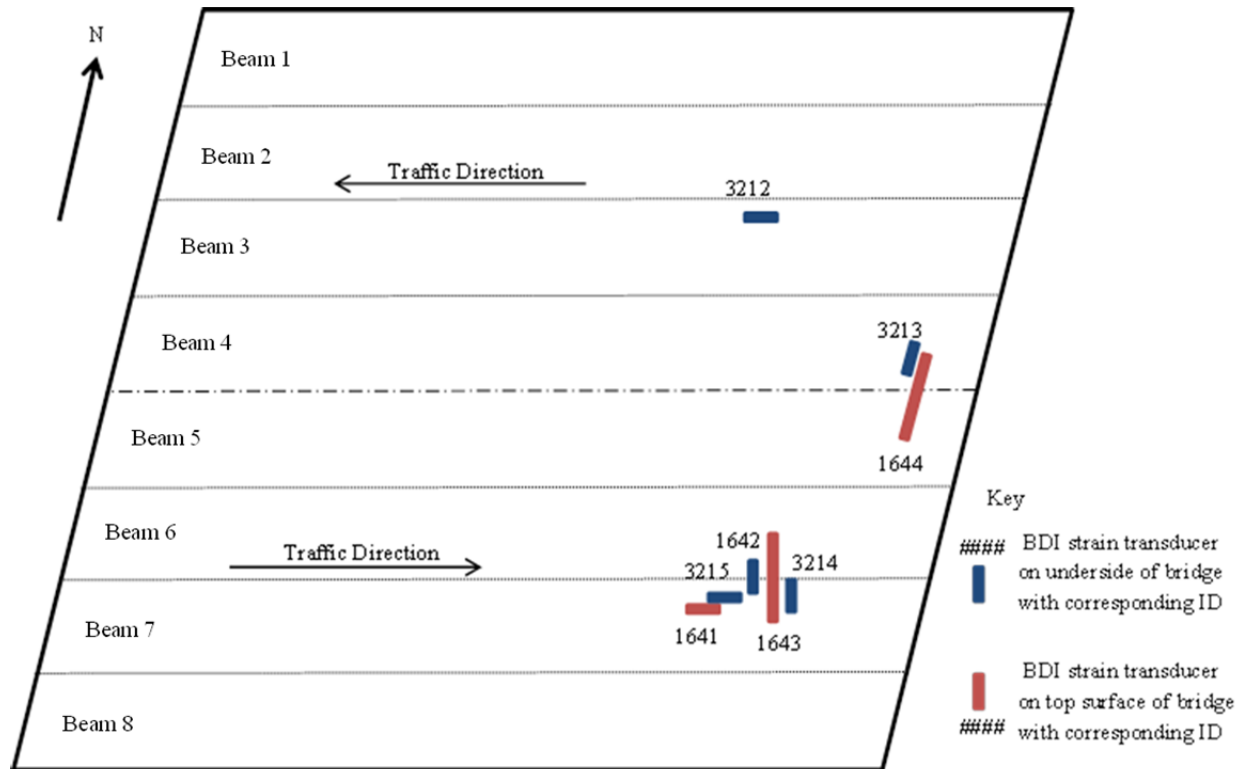
Figure 5-8 Strain Gauge Locations on the Knoxville, MD, Bridge

beams on beam 3. A gauge location schematic and photos of the strain gauges on the bridge are shown in Figures 5-8 to 5-10.

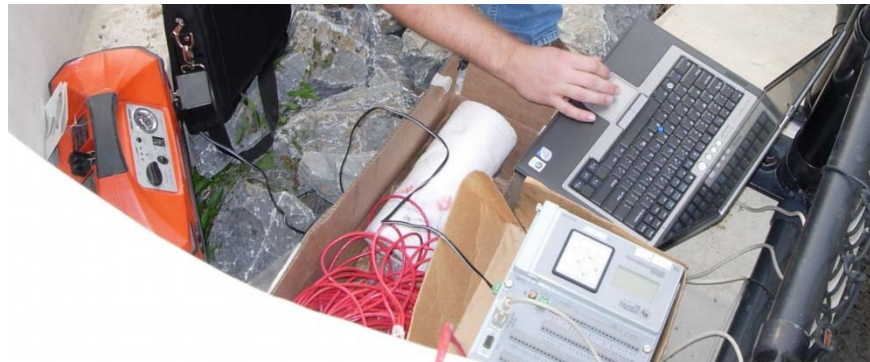
Figure 5-12 Data Acquisition System Monitoring the Strain Gauges During the Live Load Test

The instrumentation set-up for the live-load test had multiple components. Eight prefabricated BDI sensors were connected to the Campbell Scientific CR5000 data logger. The CR5000 was powered by a small generator and connected to a laptop computer which ran the PC9000 software. The connections from the sensors to the data logger were correctly made on the same day as the field test and checked using a multi-meter during preliminary test runs. The data was recorded to the CR5000 and transferred using the PC9000 to the computer. A schematic of the data acquisition network and a photo of in operation are shown in Figures 5-11 and 5-12; further descriptions of each component of the system are provided in the following section.

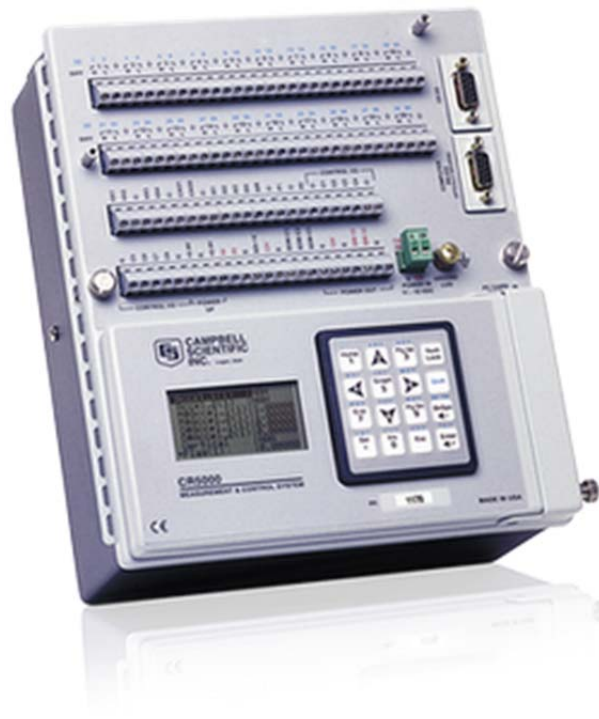
Figure 5-18 Campbell Scientific CR5000 Data Logger

For the live-load field testing, the Campbell Scientific CR5000 Measurement and Control System was used to record the data obtained from the BDI strain transducers. The CR5000 is a

rugged, high-performance data acquisition system that can be used as an excitation source for sensors and can record data at a maximum rate of 5000 Hz (5000 measurements per second). It has twenty differential individually configured inputs that can be used for a variety of different sensor types, including strain gauges. See Figure 5-18 for a photo of the CR5000.

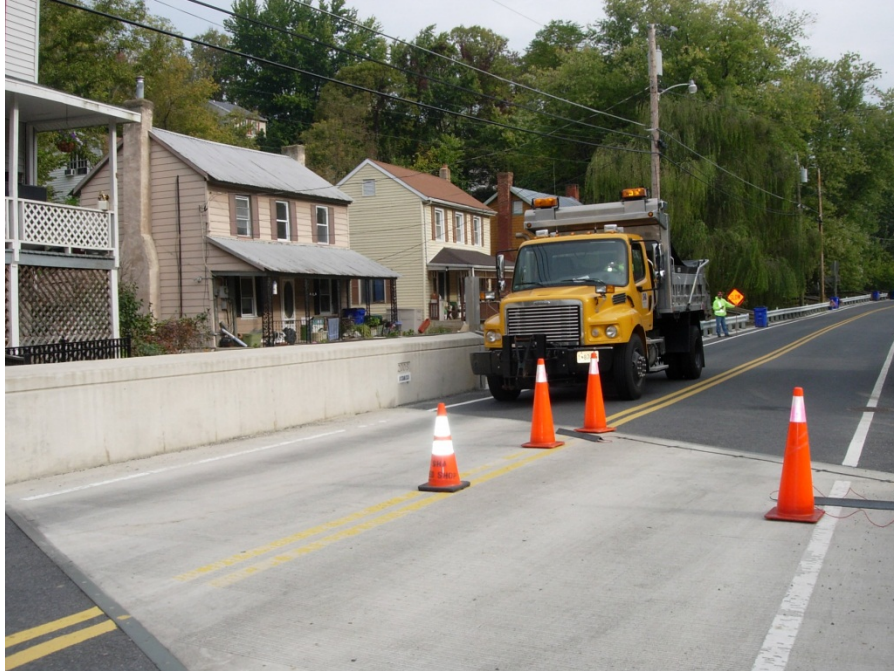
Figure 5-19 Test Vehicle Provided by SHA Traveling Westbound across Knoxville, MD, Bridge

The pre-weighted test vehicle was a two-axle dump truck provided by SHA and weighed 26,420 pounds. It weighed 5,200 pounds in each front wheel and 8,010 pounds in each rear tandem. The driver was instructed to drive across the bridge a total of eight times (four times in each direction) at varying speeds to obtain live-load strain data for the bridge. See Figures 5-19 and 5-20 for photos of the test vehicle.

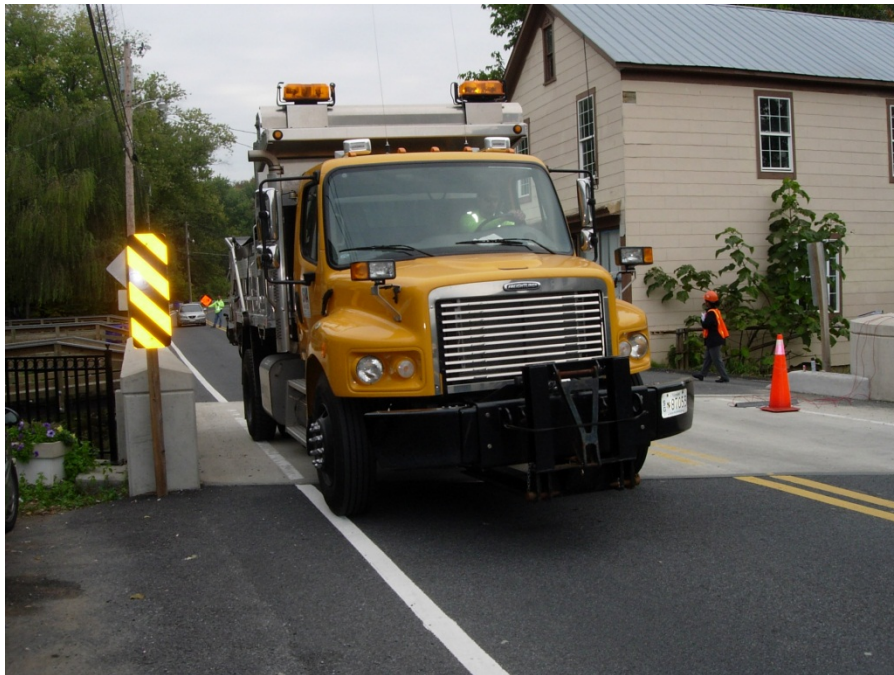
Figure 5-20 Test Vehicle Provided by SHA Traveling Westbound across Knoxville, MD, Bridge

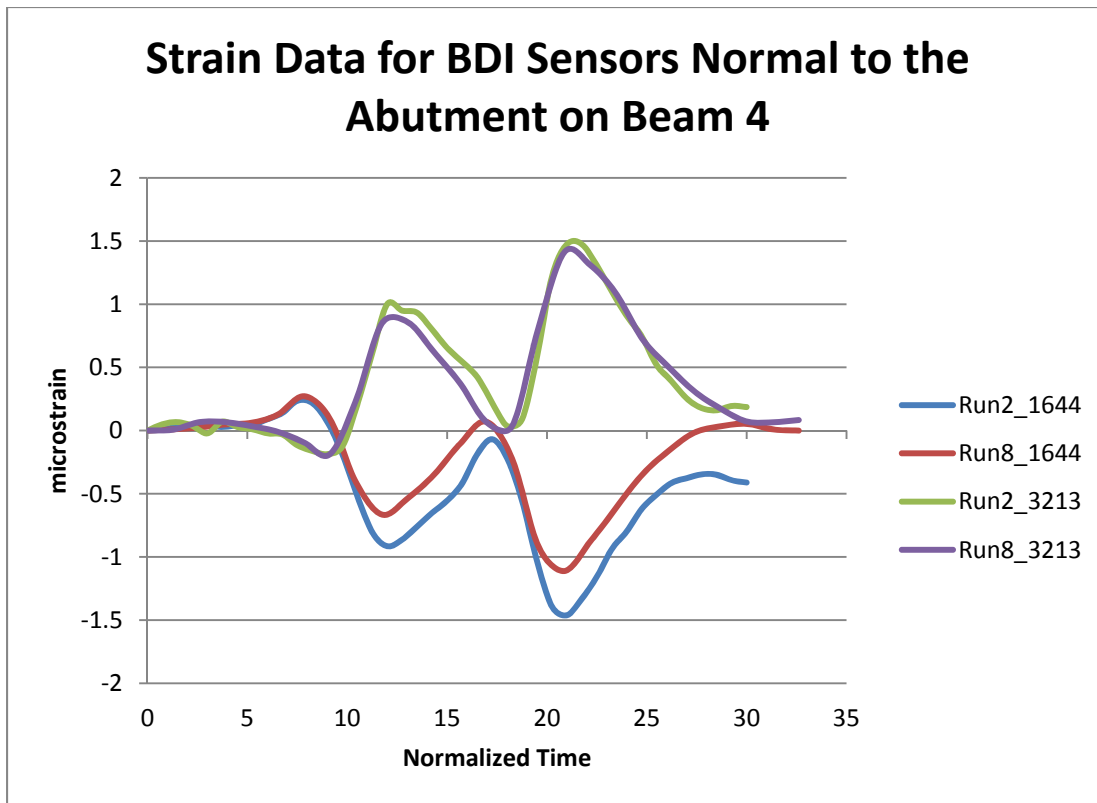
Figure 5-24 Strain Data for BDI Sensor Nos. 1644 and 3213 from Runs Two and Eight

The strain data from BDI sensor Nos. 1644 and 3213, which are located parallel to the abutment on the top and bottom of beam four, respectively, is shown in Figure 5-24. The data from these runs in the same direction show similar shapes and similar magnitudes that are in the same direction as expected.

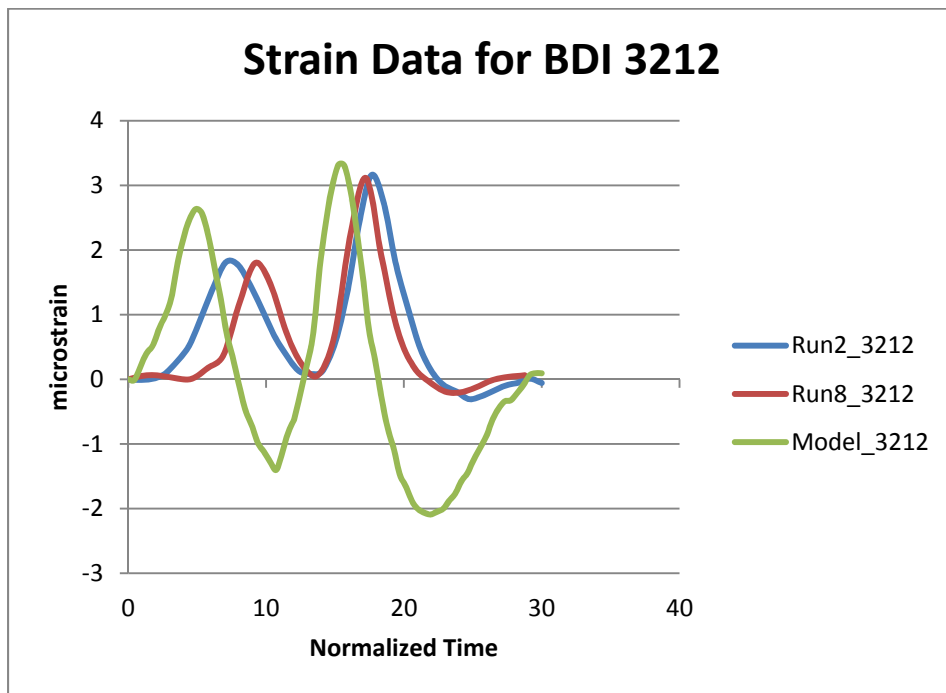
Figure 6-9 Field Test Data Based on BDI Strain Transducer #3212 - Placed Parallel to the Slabs on the Bottom Surface of Beam Three Near the East Side of the Knoxville, MD, Bridge; Model Data Based on an Equivalent Position on Beam Six Near the West Side of the Knoxville, MD, Bridge

of beam seven are similar to the field test data (see Figures 6-6 and 6-7). The data show logical strain directions (tensile on the bottom surface and compressive on the top) and similar trends and maximum values of strain. The bottom surface underwent approximately four microstrain longitudinally and the top surface underwent approximately six microstrain longitudinally. The results for the sensor placed parallel to the slabs on the bottom surface of beam three do not correspond as well with the field test results because of the minimal amount of strain that beam three underwent due to the loading on the opposite side of the bridge. However, the model result does show a similar trend and only differs by approximately 0.3 microstrain (see Figure 6-8). When the corresponding point on the opposite side of the bridge was examined in the model and compared with the data obtained from field runs two and eight (the testing truck traveled westbound on beams two and three), both the trends and the maximum peaks (three microstrain longitudinally in tension) match well, confirming that the FEA model is a reasonably accurate model for the Knoxville, MD, bridge (see Figure 6-9).

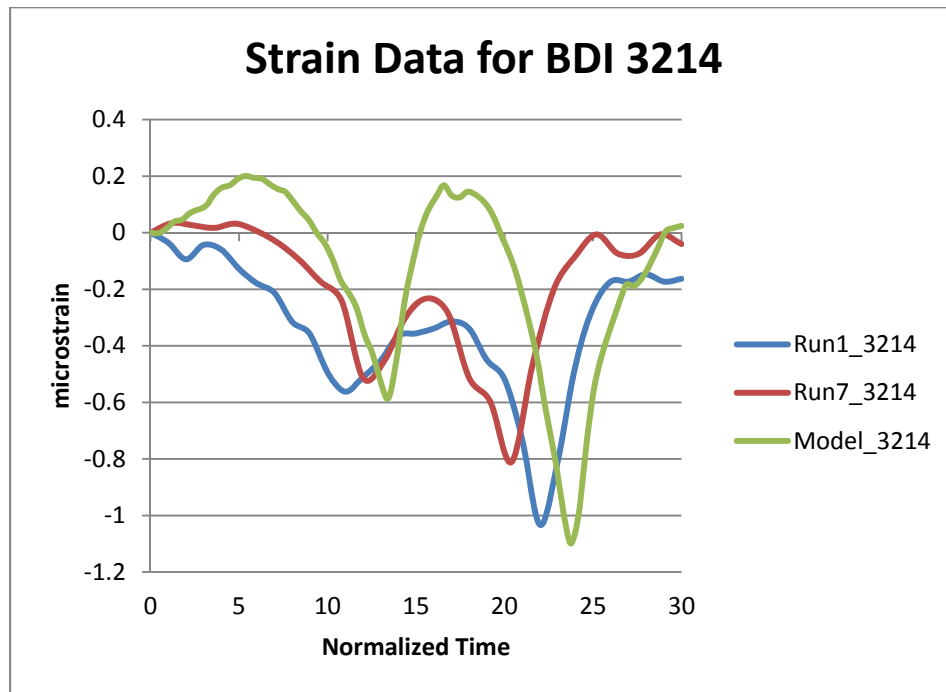
Figure 6-10 BDI Strain Transducer No. 3214 - Placed Normal to the Slabs on the Bottom Surface of Beam Two

Field test strain data obtained from the strain transducers placed normal to the precast-concrete slabs were then compared with the FEA model results. The model results for the strain gauge placed on the bottom surface of beam two (BDI No. 3214) matched well with the field test data, with both a similar trend and peak, with a maximum value of about one microstrain transversely in compression (see Figure 6-10). The model results for BDI No. 1643 which was placed on beams six and seven across a crack between the slabs did not correspond well with the field test results (see Figure 6-11). This poor fit may be because the strain gauge in the field calculated strain across the two beams whereas the model included only one node on beam seven that could be analyzed for strain. Additionally, the model did not include cracking or the consequences of it because of insufficient data about the cracks in the test bridge.
