APT-ALF TESTING AT LTRC IN LOUISIANA

- SUMMARY REPORT -

Lubinda F. Walubita & Tom Scullion
TTI – Texas A&M University System, College Station, TX, USA.

September 2012.

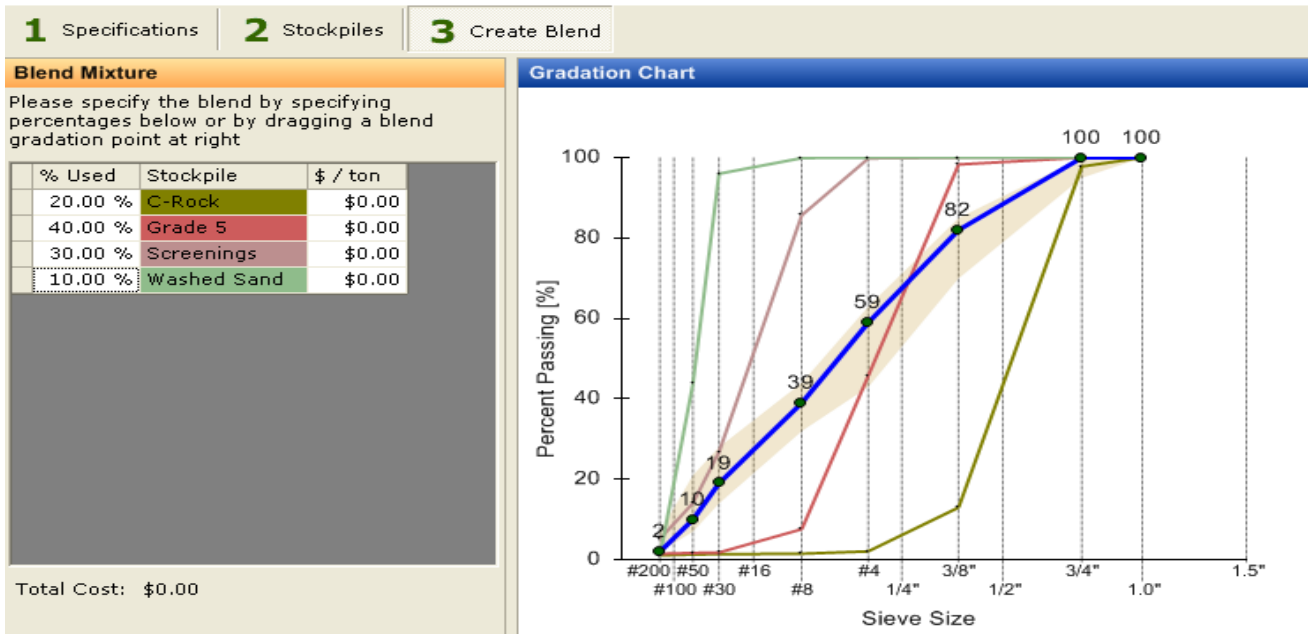
Figure C-1. Aggregate Gradations for the Type C Mix.

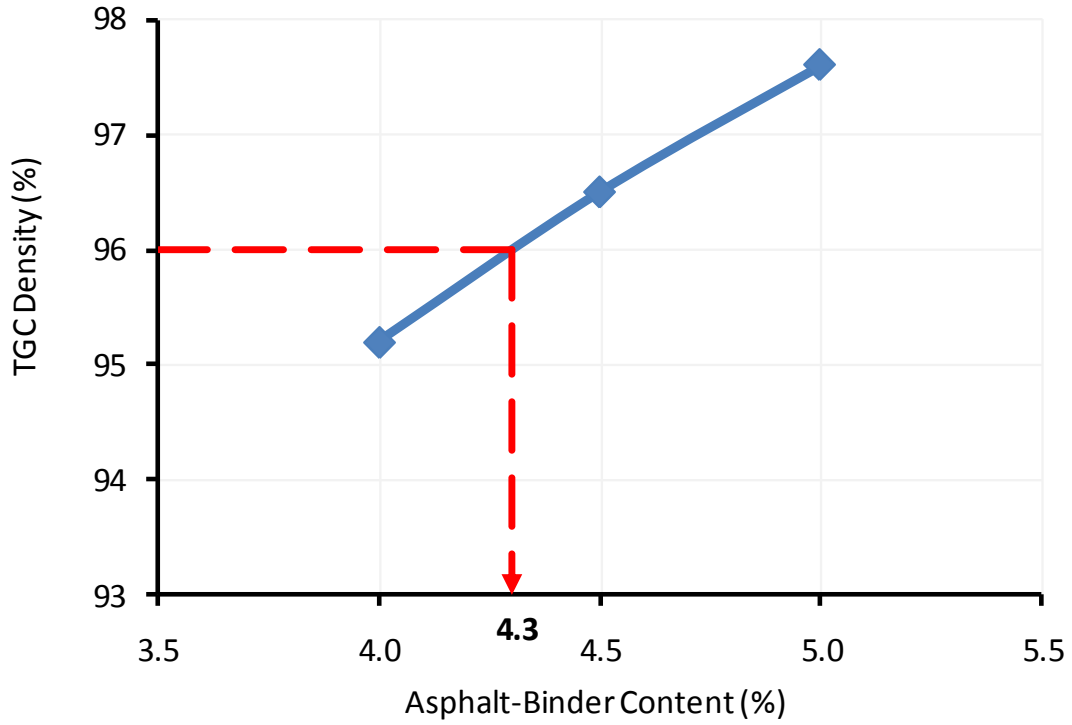
Figure C-2. Design OAC Selection Based on the TGC Method.

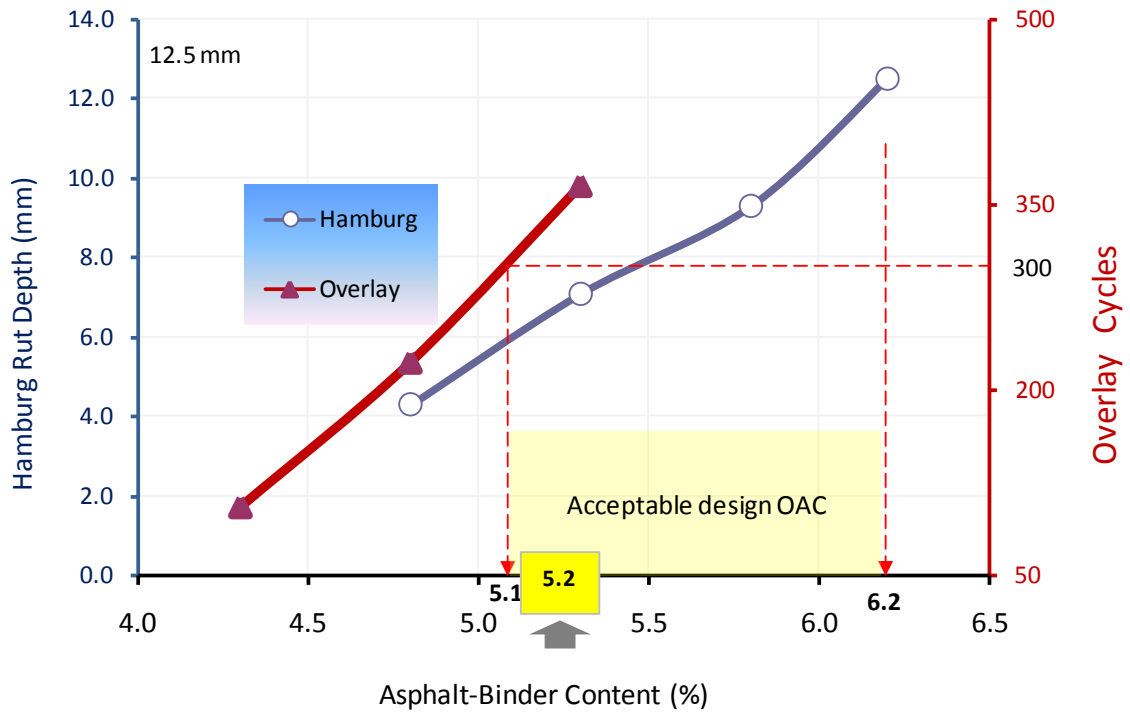
Figure C-3. Design OAC Selection Based on the Balanced (BMD) Method.

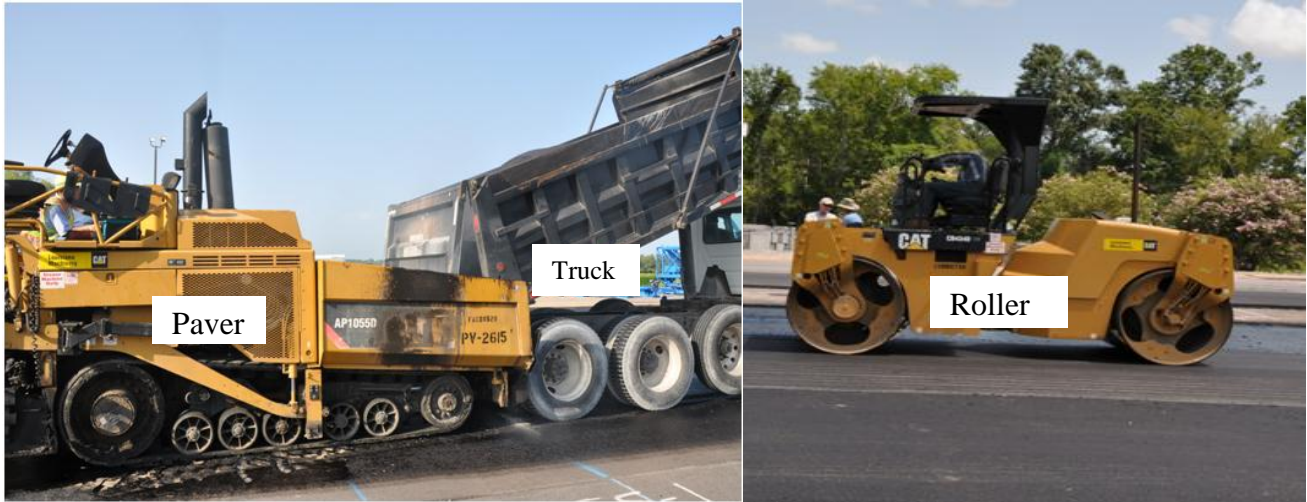
Figure D-3. HMA Placement of the APT Test Sections.

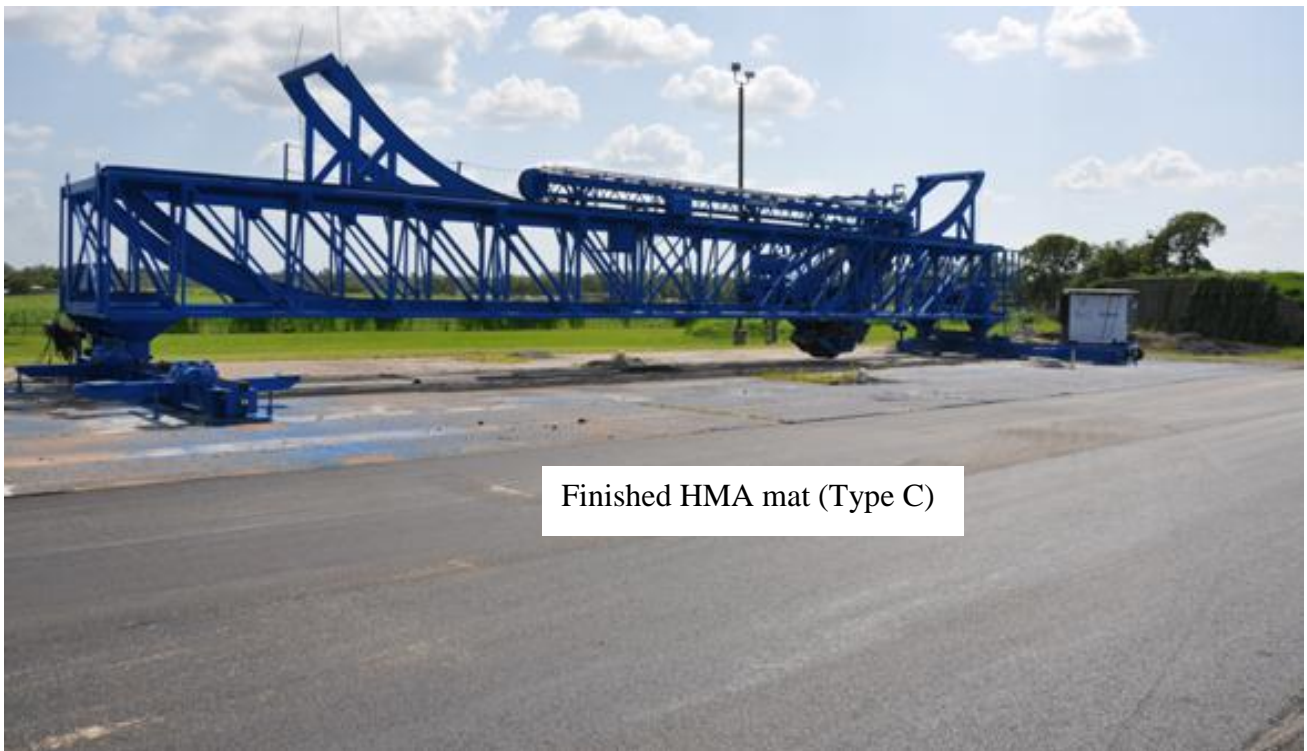
Figure D-4. Finished HMA Mat on the APT Test Sections.

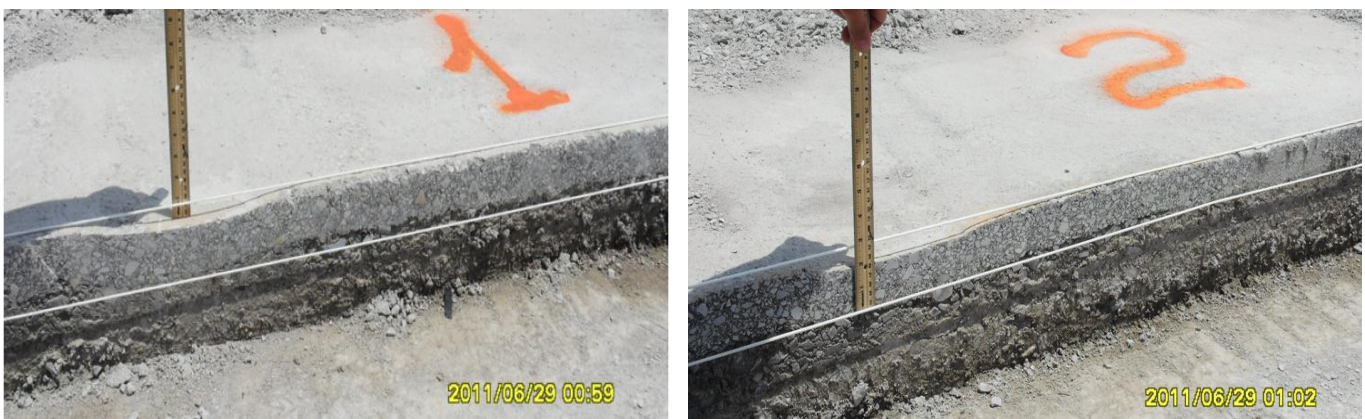
Figure F-2. Trenching and Pictorial Comparison of Rutting.

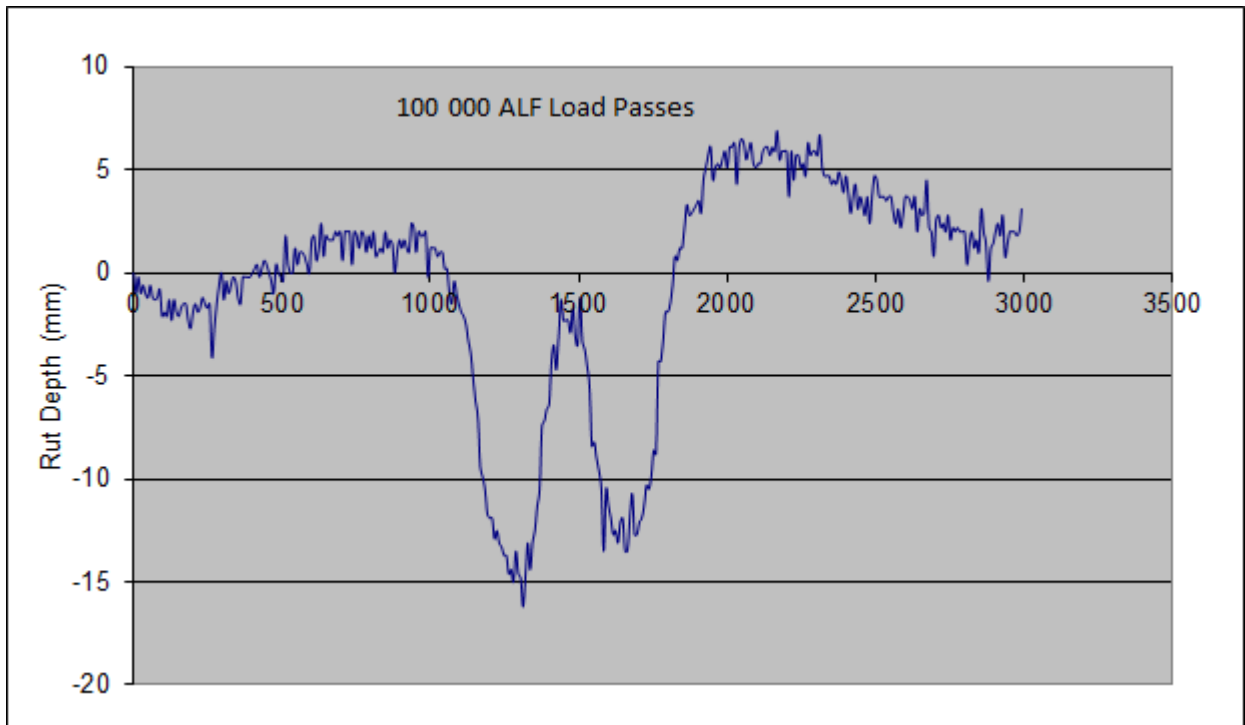
Figure F-4. Transverse Rut Measurements on Modified Section 2.

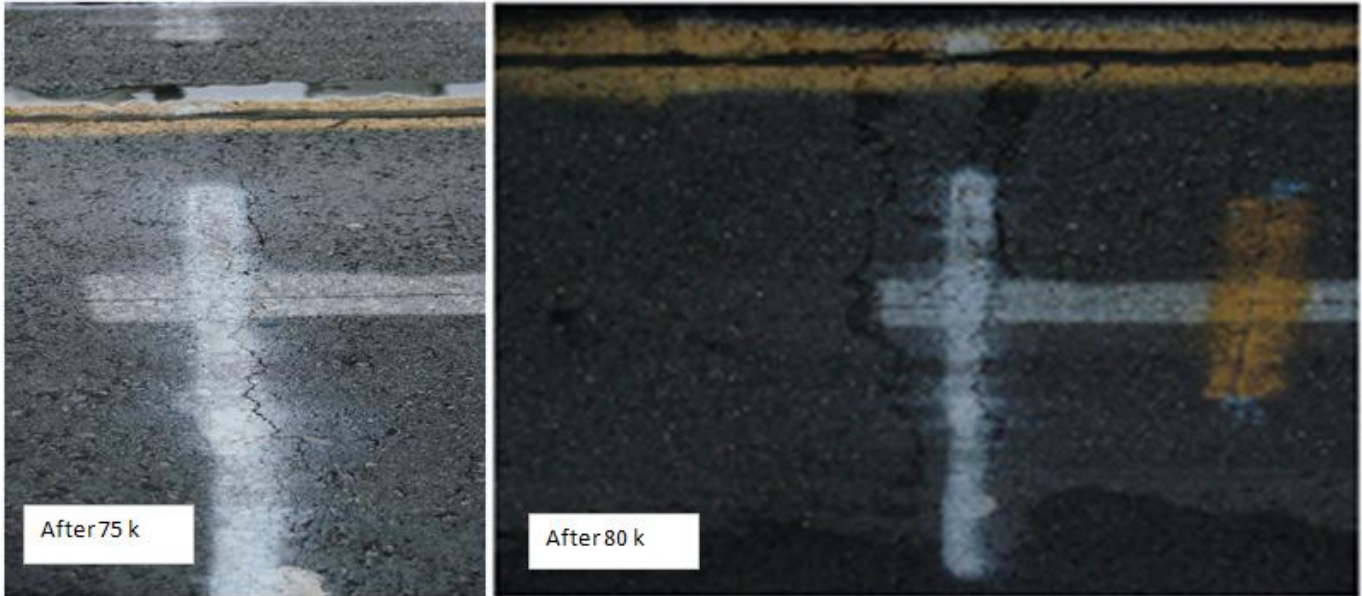
Figure F-5. Reflective Cracking on Control Section 4 (Type C; 4.3% OAC = 50% LTE.
(For Section 3_Control (Type C; 4.3% OAC) = Good LTE; cracks appeared only after 175 k ALF load passes)

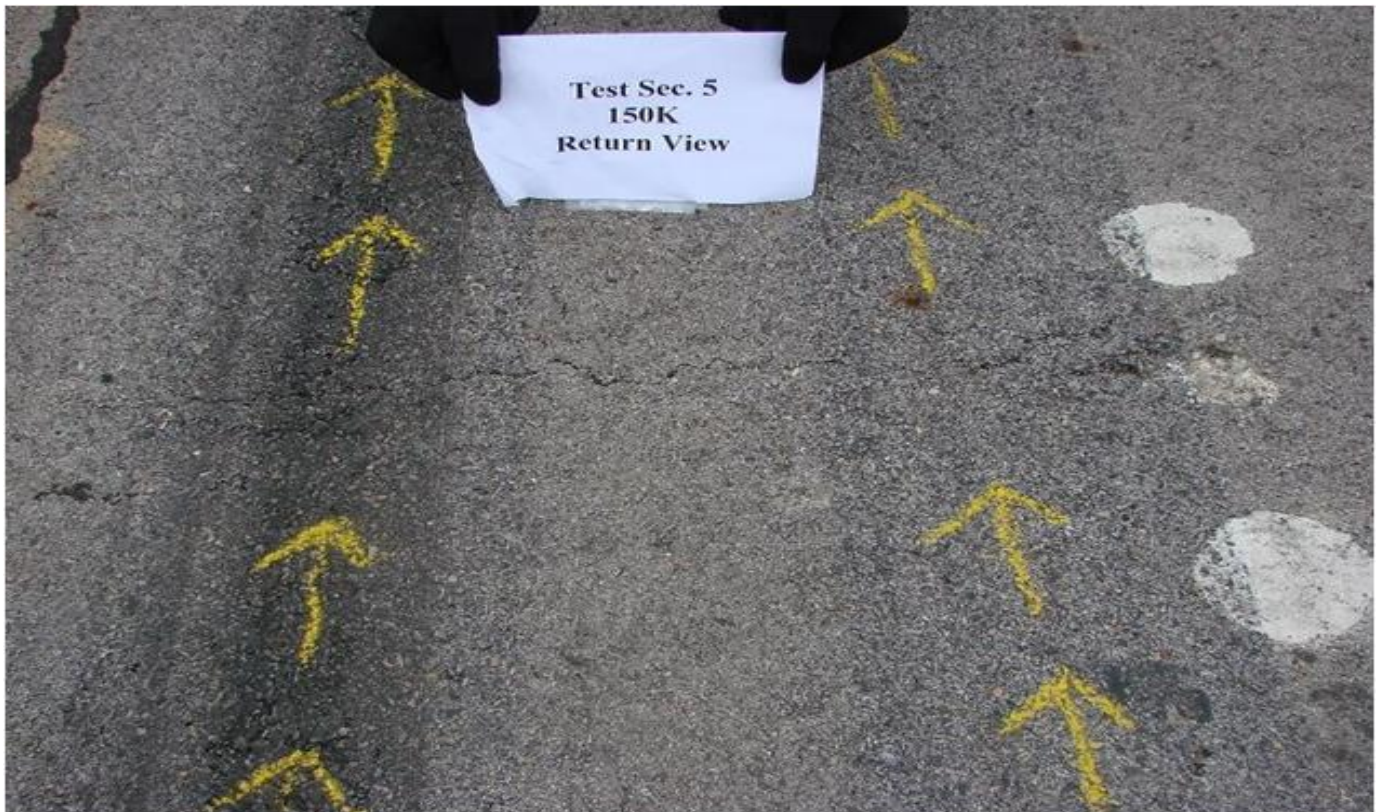
Figure F-6. Section 5 _Modified (Type C; 5.2% OAC) = Good LTE; Cracking at Joint Location Station# 47.5 after 143 k ALF Load Passes

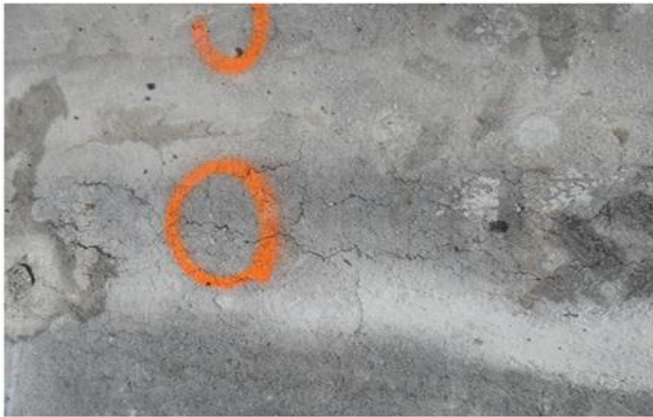
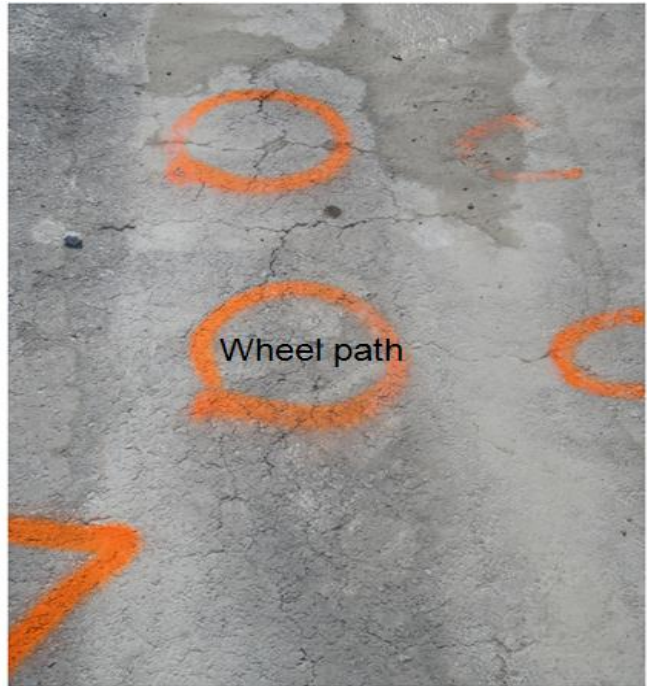
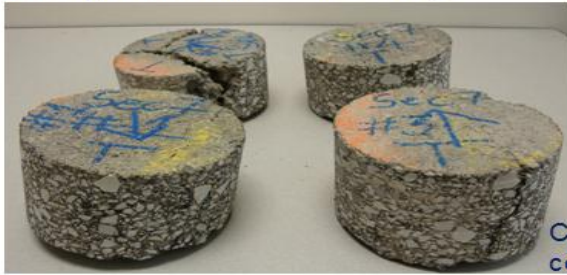
Sec7 (Modified; 5.2% OAC)

Cores from un-cracked wheel path cracked during the coring process; indication of microdamage/microcracks

Figure F-7. Fatigue Cracking on Section 7.

Fatigue Cracking Test Sections: These sections performed unexpectedly; the Modified (high AC) cracked whilst there was none on the Control; see Section F. Also, both sections had accumulated substantially high rutting. As illustrated in Sections F and G, forensic evaluations suggested the following:

- The Control section (4 inches) was thicker than the Modified (3 inches) in terms of the surfacing HMA layer; construction issues.
- The distresses were found to be related to the base and construction problems
- Coring indicated micro-damage and micro-caking on Section 7.
- ALF trafficking on these sections was done towards summer with high temperatures, and hence, the high rutting, particularly on Section 8.

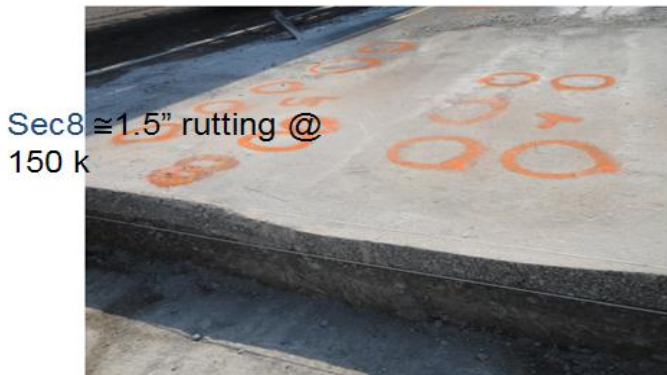
Sec8 \cong 1.5" rutting @ 150 k

Figure F-8. Base Related Rut Failure of Fatigue Crack Sections.

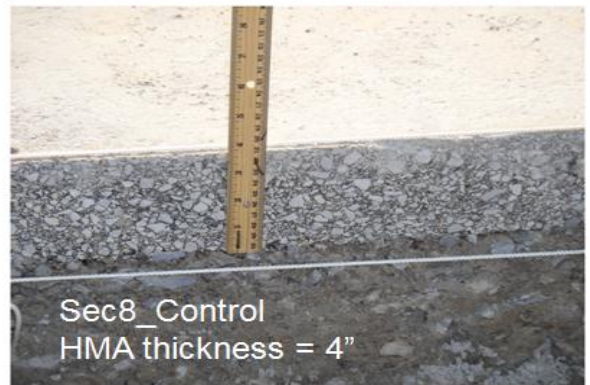
Sec8_Control
HMA thickness = 4"

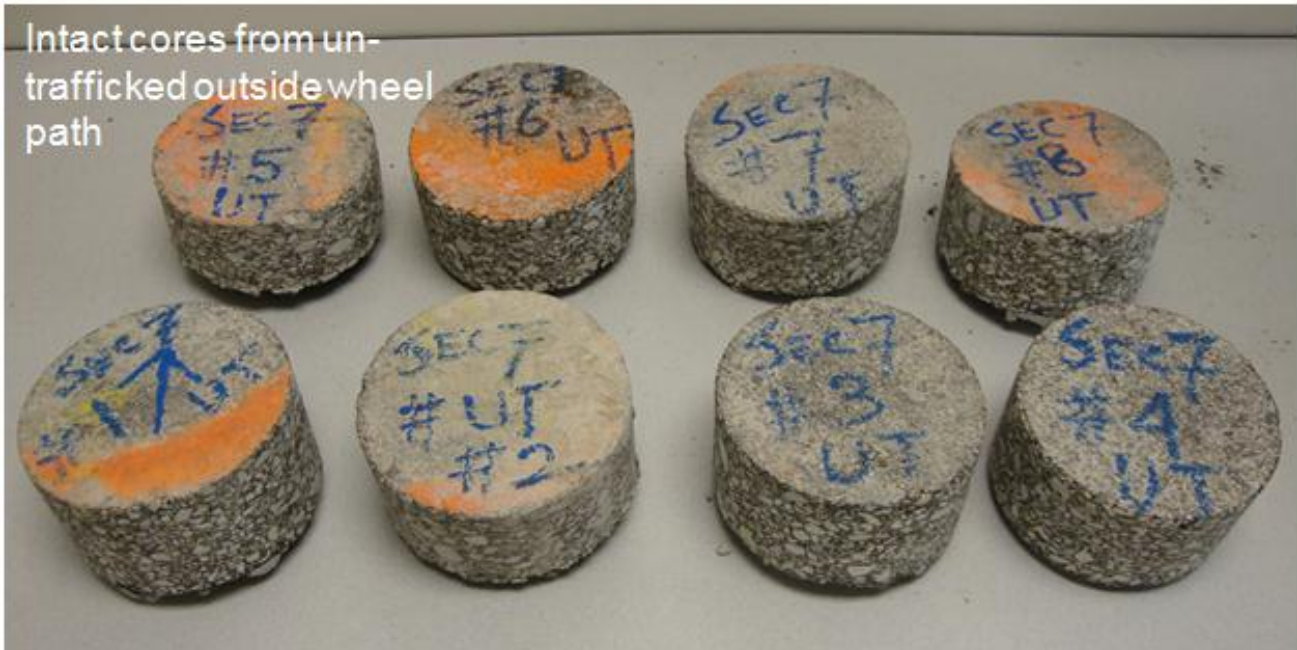
Figure G-1. Cracked and Un-Cracked Cores on Section 7 (5.2% OAC).
