Research Report No. 1 for ALDOT Project 930-601

**DEVELOPMENT OF ACOUSTIC EMISSION
EVALUATION METHOD FOR REPAIRED
PRESTRESSED CONCRETE BRIDGE GIRDERS**

The Alabama Department of Transportation

JUNE 2011

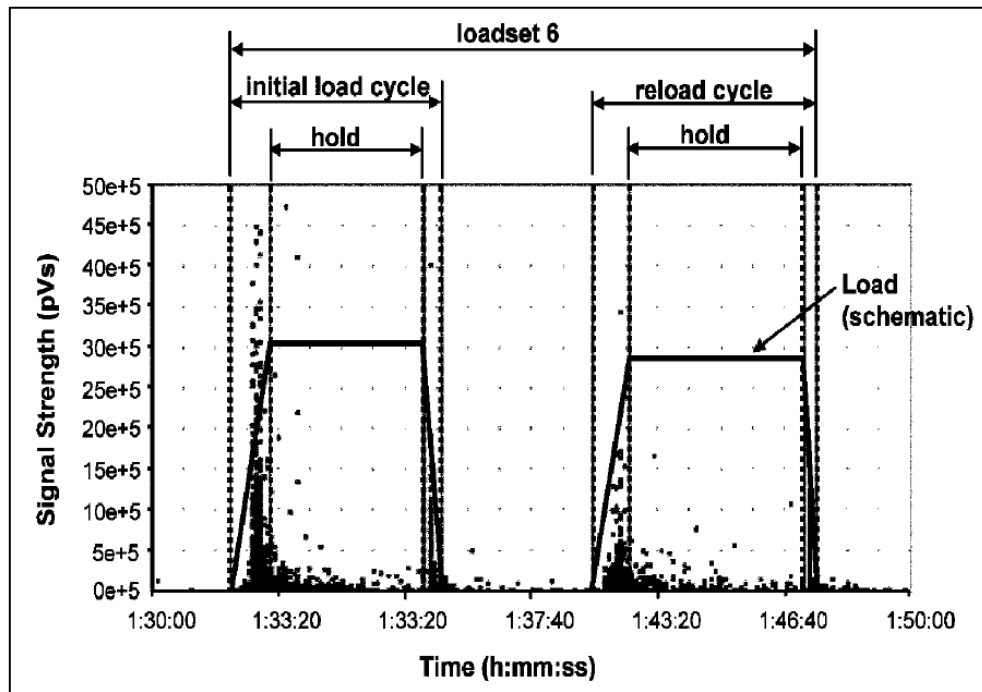
Ridge and Ziehl (2006) proposed an evaluation criterion based on the peak cumulative signal strength (CSS) ratio. This ratio is defined as the peak CSS at the end of the reload hold period divided by the peak CSS at the end of the initial load hold period. A sample loadset can be seen in Figure 3-4.

Figure 3-4: Signal strength versus time (Ridge and Ziehl 2006)

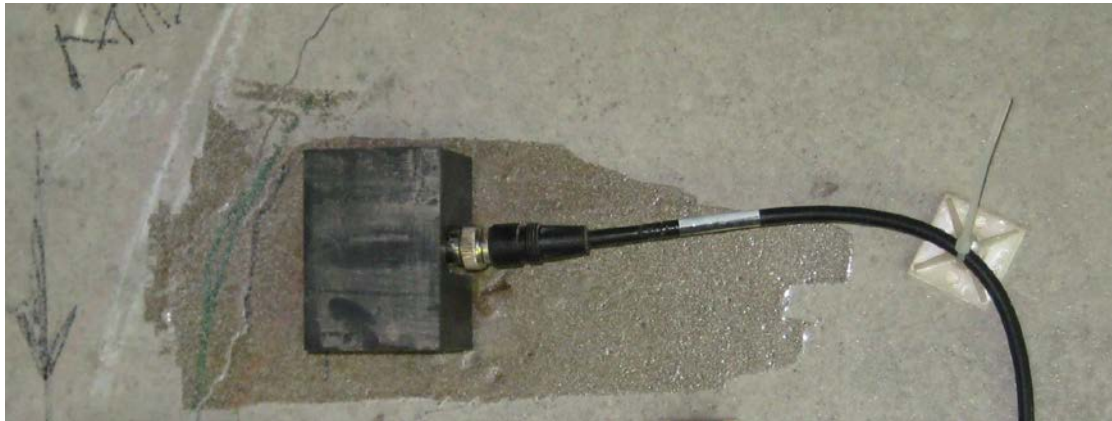
Once the magnetic hold-down device was properly placed over the sensor, the cable was secured using cable ties and mounting pads. This was done to prevent any movement and interference. The sensor was restricted so no movement caused by the weight of the cable occurred. Once the cables were tied down, the sensor installation was complete. The entire sensor setup can be seen in Figure 4-6.

Figure 4-6: Sensor installation

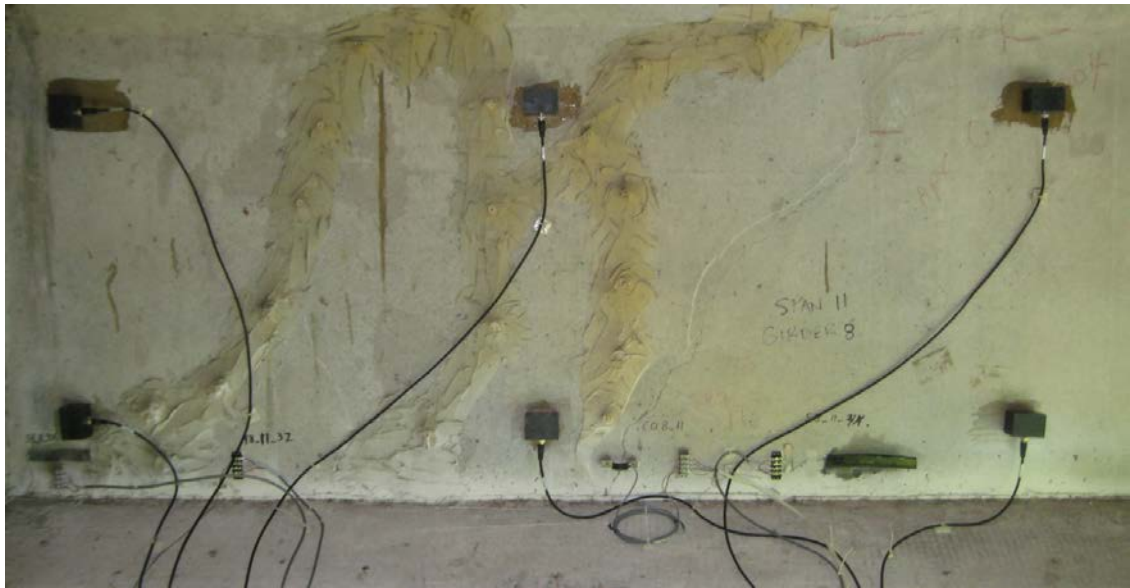
Figure 4-8: Arrangement of Sensors 13-18 on Girder 8

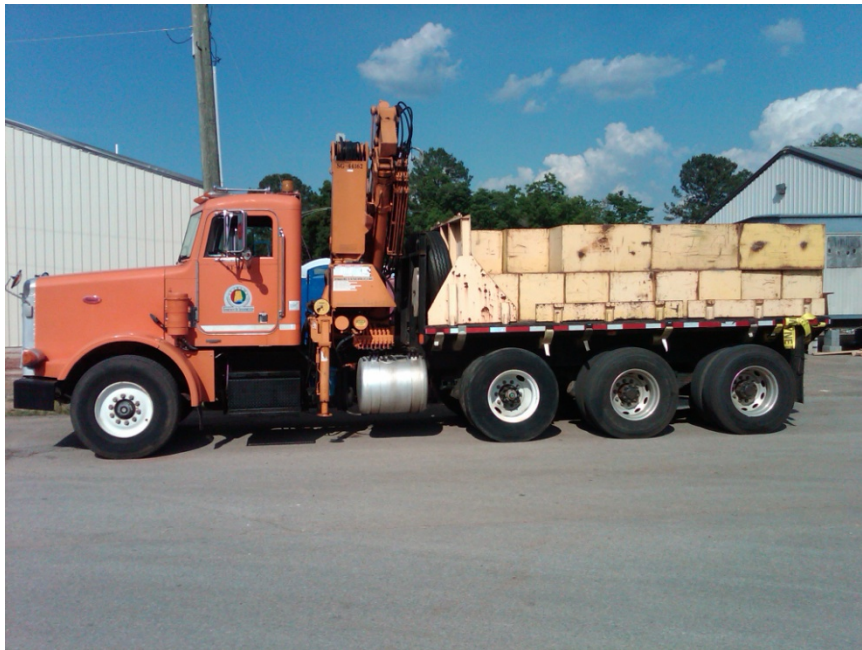
Loading of the bridge girders was performed by moving load trucks onto the bridge. Since the AE testing method is a measure of damage growth, it is dependent on load history. Therefore, loading patterns were designed to produce useful data and utilize the AE method to evaluate the integrity of the concrete girders. Two different load test trucks, provided by the Alabama Department of Transportation (ALDOT), were used for the test. The trucks, ST-6400 and ST-6538, can be seen in Figure 4-11 and Figure 4-12.

Figure 4-11: Standard load truck ST-6400 (pre-repair and post-repair)

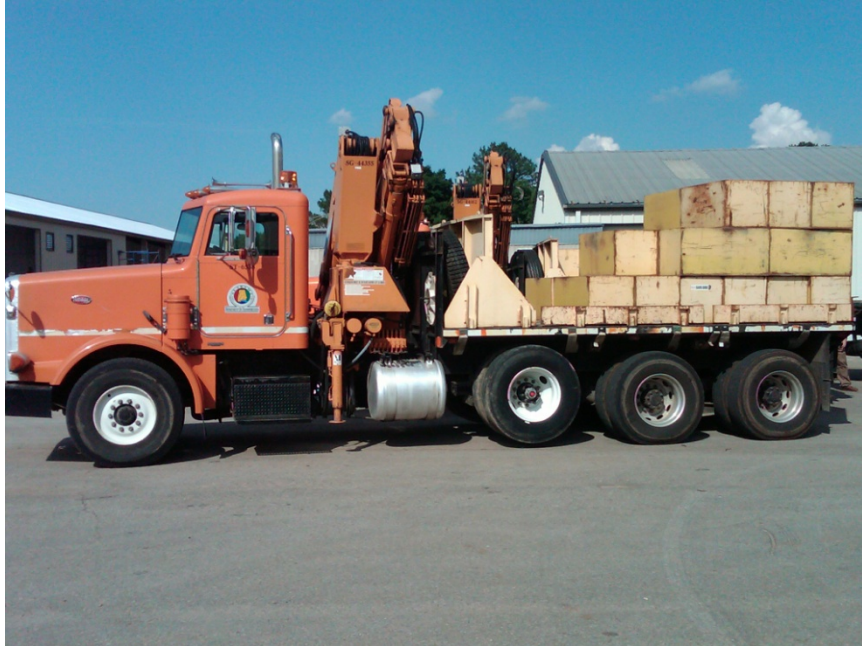
Figure 4-12: Standard load truck ST-6538 (post-repair)

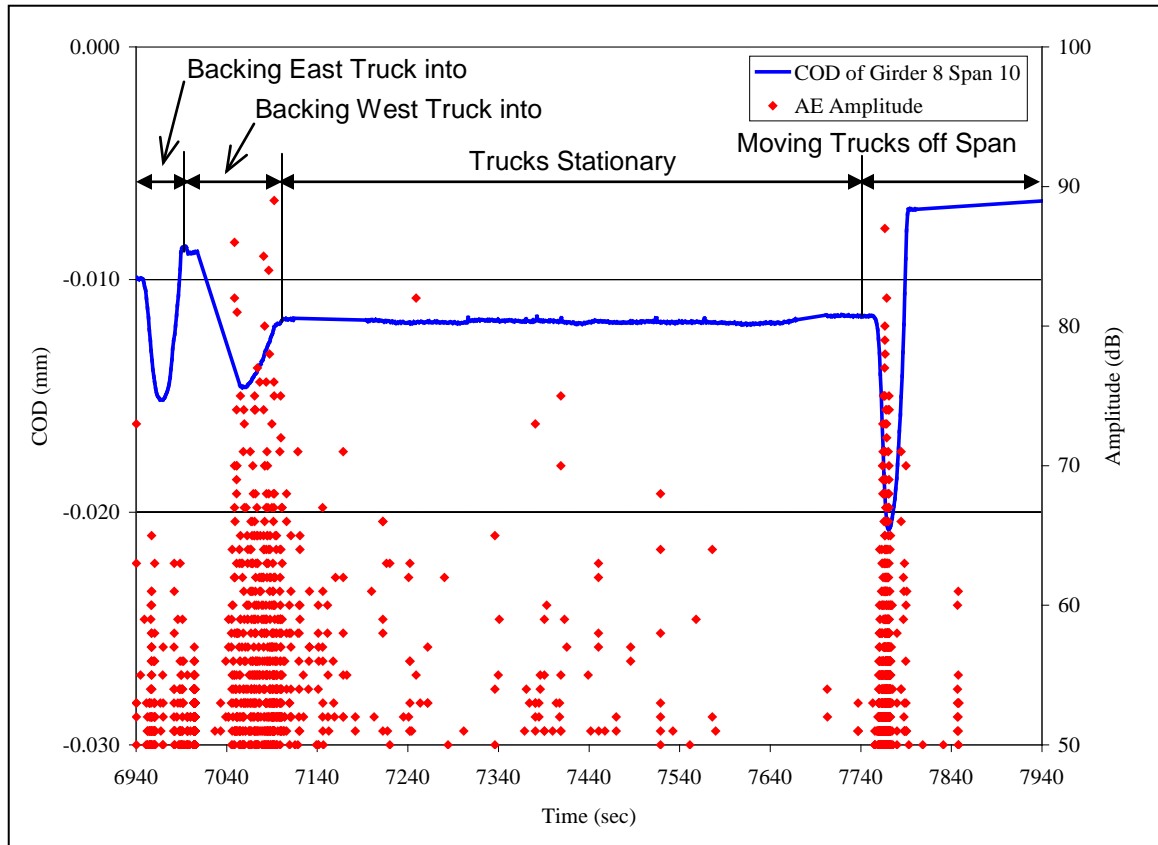
The COD data were also used in relation to the AE activity. Similar to previous findings, it was shown that an increase in AE activity was directly related to a change in COD values. Figure 5-2 shows the AE activity generated from all six sensors on S10G8 on the first night of loading. SP10G8 was chosen to show the general trend that occurred in all four girders. The markers in the figure represent the AE amplitude of an individual hit that occurred during the test. The COD values are also shown on this plot. It can be seen in this plot that most AE activity took place when a large *change* in COD occurred. This shows that the opening and closing of cracks in the concrete girders was associated with a significant increase in AE activity (Xu 2008).

Figure 5-2: COD and AE activity of Span 10 Girder 8 during second night (Xu 2008)

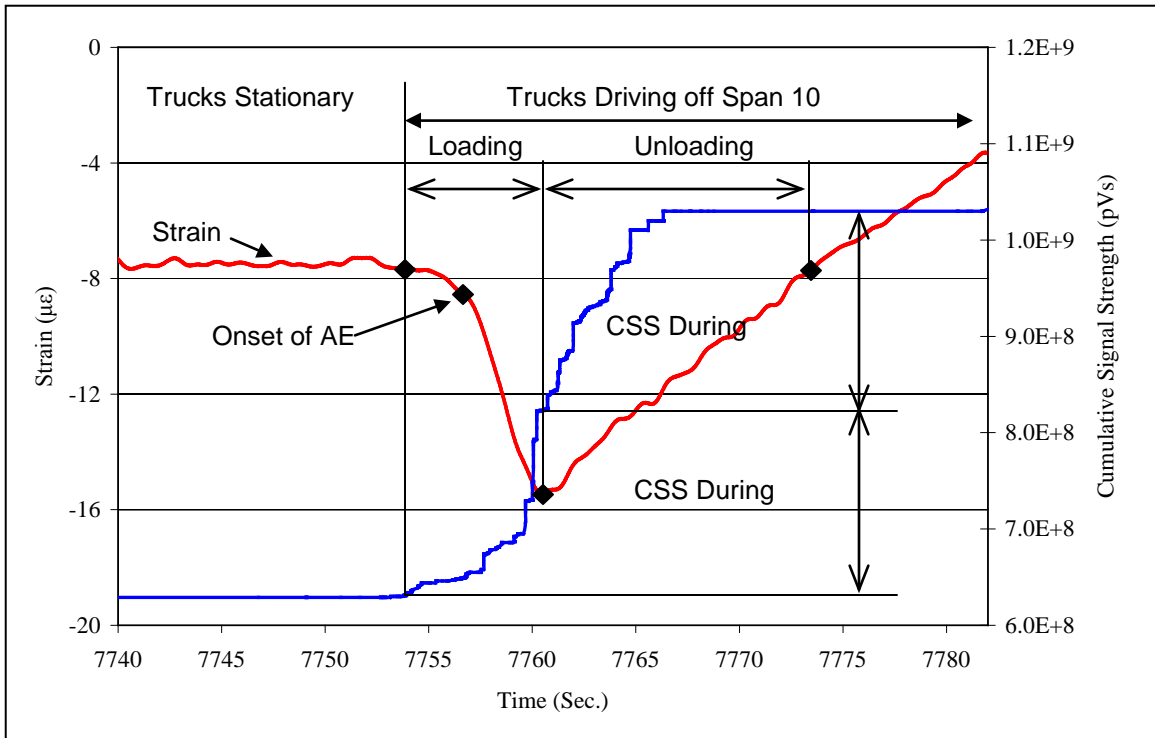
Figure 5-3 is a plot that shows a set of data used to calculate the two ratios for Girder 8 in Span 10. The strain was superimposed on a plot of AE cumulative signal strength (CSS) versus time. The CSS data were generated from all six sensors on Girder 8 of Span 10. As seen in the plot, the compressive strain gradually increased to a maximum value as the trucks drove away from the Span 10 loading position, but while they were still on the span. The strain magnitude then decreased until the trucks were completely off the structure. The “loading” and “unloading” phases of cross sectional effects due to this truck moving operation were identified based on the measured strain change indicated in Figure 5-3. The point labeled “onset of AE” actually indicates the point at which *significant* AE activity occurred during the loading process. The actual onset of AE occurred immediately after the loading began, indicated by the first rise in the CSS data.

Figure 5-3: Plot used in determining strain and calm ratios for Span 10 Girder 8 (Xu 2008)

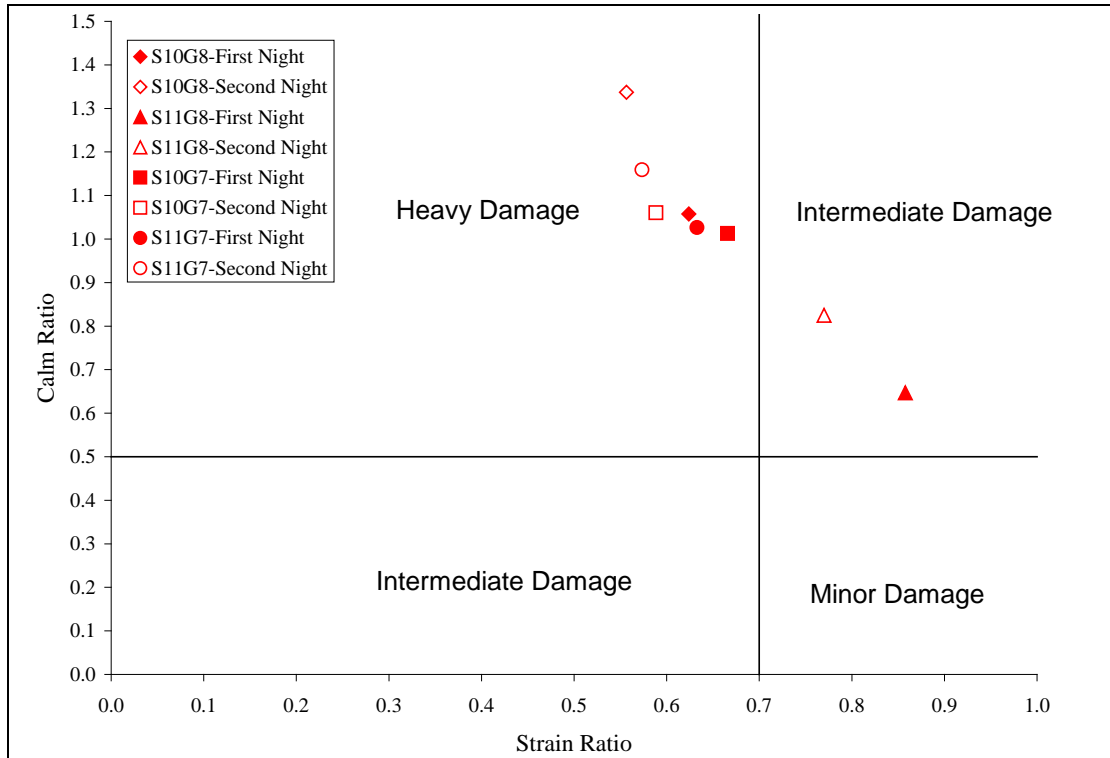
Once the strain and calm ratios were determined based on the data for each girder, the degree of damage of the girders was determined using the NDIS-2421 criterion. These damage levels are plotted in Figure 5-4. The strain and calm ratios are indicated on the horizontal and vertical axes, respectively. The solid markers represent data from the first night, while the hollow markers represent data from the second night. Based on previous laboratory tests of prestressed concrete beams (Xu 2008), the damage classification limits for prestressed concrete were set at 0.7 for the strain ratio and 0.5 for the calm ratio.

Figure 5-4: Damage qualification based on NDIS-2421 method (Xu 2008)

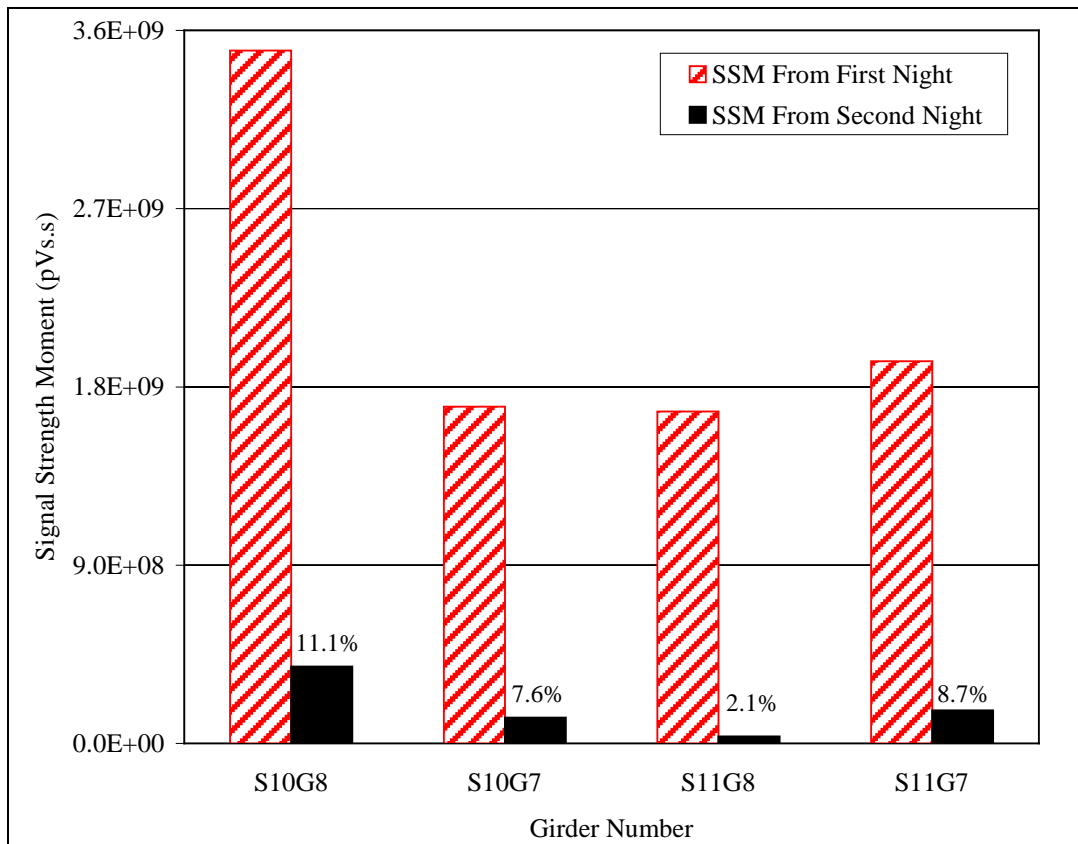
The results of the SSM ratio evaluation are shown in Figure 5-5. The ratio is shown above each second night SSM.

Figure 5-5: Signal strength moment (SSM) ratio during holds (Xu 2008)
