The Effect of Load History on Reinforced Concrete Bridge Column Behavior

August 2012

INE # 12.15

FHWA-AK-RD-12-09

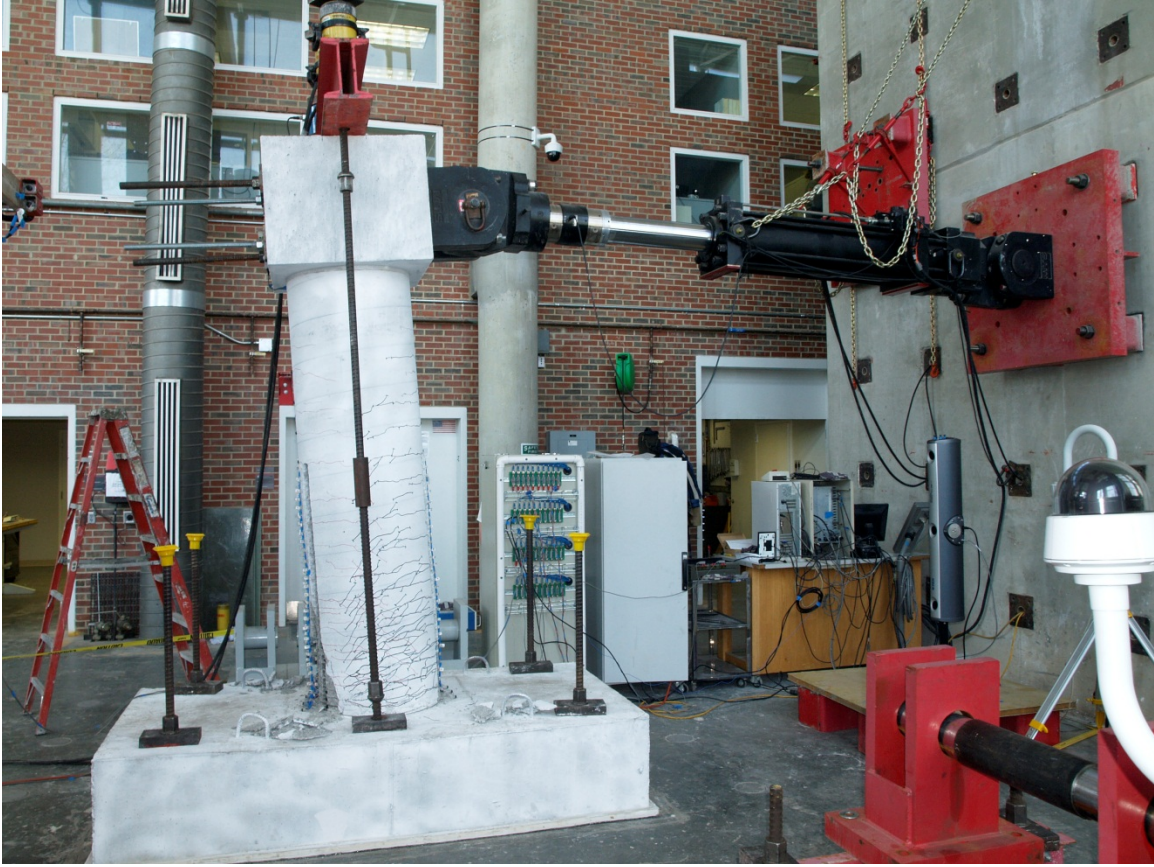
Figure 1-2. Experimental Specimen and Test Setup

The specimen was designed to represent a single degree of freedom bridge column subjected to lateral and axial load, see Figure 1-2. The test specimen consists of a footing, column, and loading cap. The footing is a capacity protected member which secures the specimen to the lab strong floor using post tensioned bars. A 220kip hydraulic actuator, with a 40" stroke capacity, applies lateral load to the loading cap of the specimen. A spreader beam, two hydraulic jacks, and a load cell are placed above the loading cap to apply a constant axial compressive load.

Traditional instrumentation was also utilized within the test setup. The top column displacement was obtained through a string potentiometer placed at the center of the lateral load. The lateral load and stroke of the 220kip hydraulic actuator were measured through an integrated load cell and LVDT. An axial load cell measured the contribution of one hydraulic jack to the total axial load of the column. A self-regulating axial load system was utilized with a third hydraulic jack in a force controlled MTS machine to regulate the pressure, and thus the load, of two jacks on top of the specimen to maintain a constant axial load throughout testing.

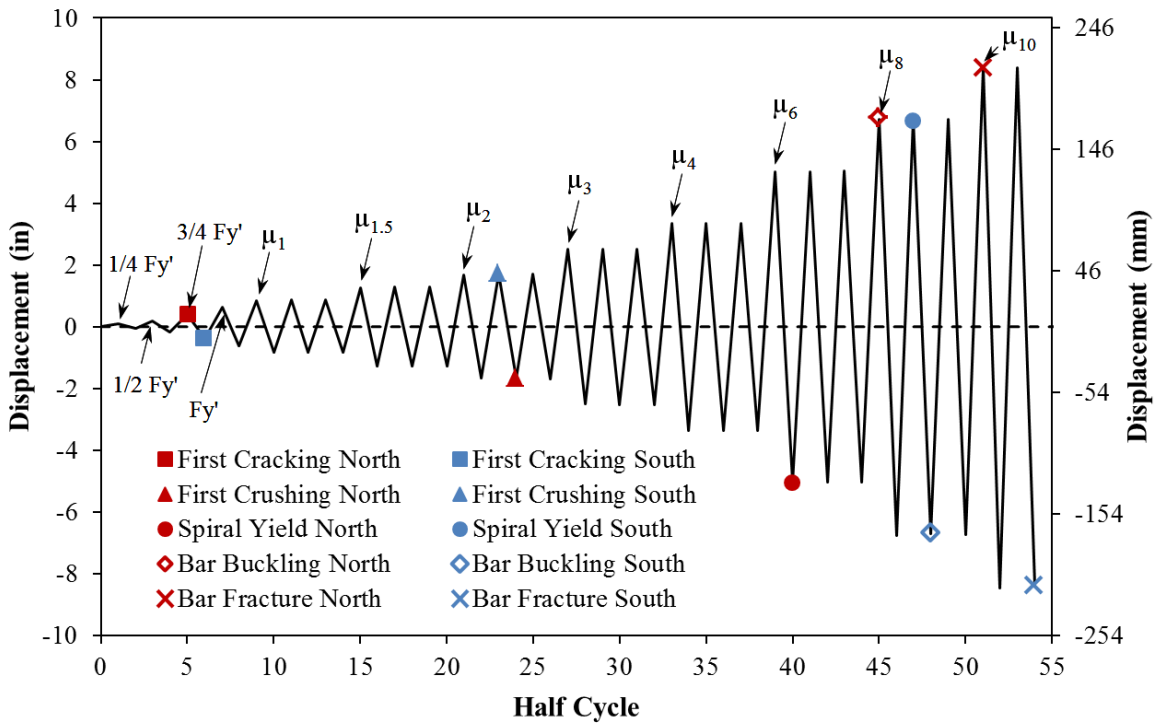
Figure 2-1. Test 9 – Symmetric Three Cycle Set Load History

* $\mu_{10}^{-2} = -8.42"$ represents the second pull cycle of displacement ductility ten which reached a peak displacement of 8.42 inches

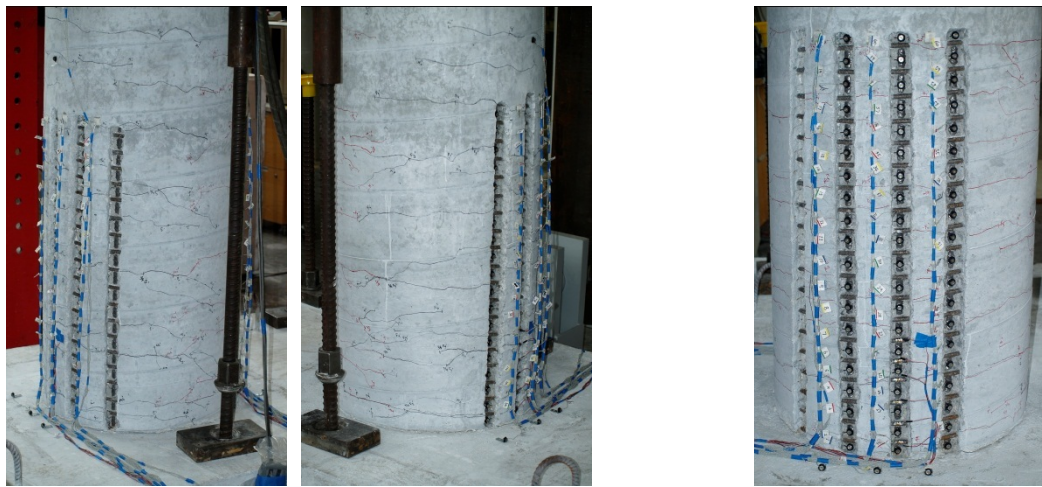
Figure 2-9. Test 9 – (Left) Front and Back of Specimen during ($\mu_2^{+1} = 1.69''$) and (Right) South Crack Pattern during ($\mu_2^{-1} = -1.68''$)

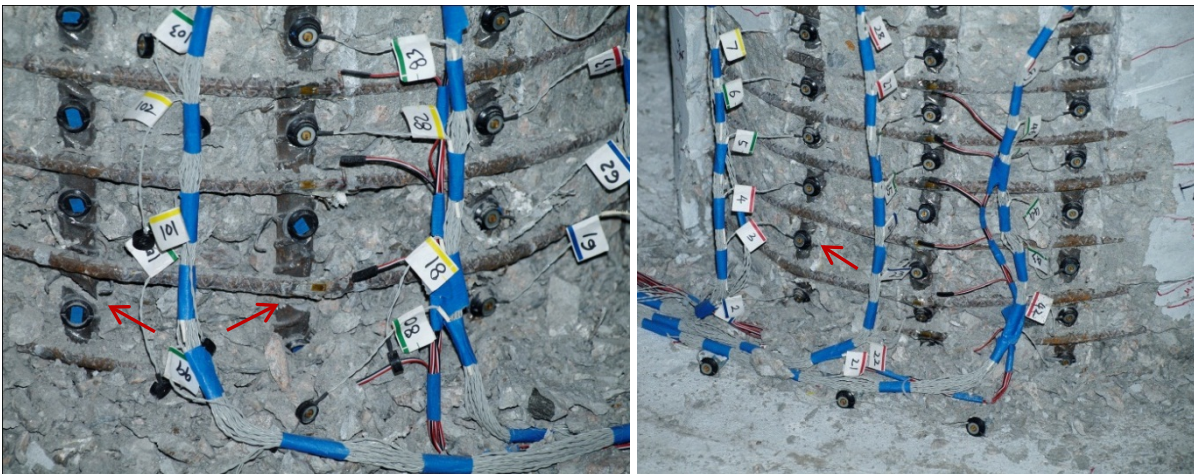
Figure 2-14. Test 9 – Photos during ($\mu_{10}^{+1} = 8.38''$) (Left) Rupture of N4 and N3 and (Right) Buckling of S2 and Additional Deformation in Previously Buckled Bar S3

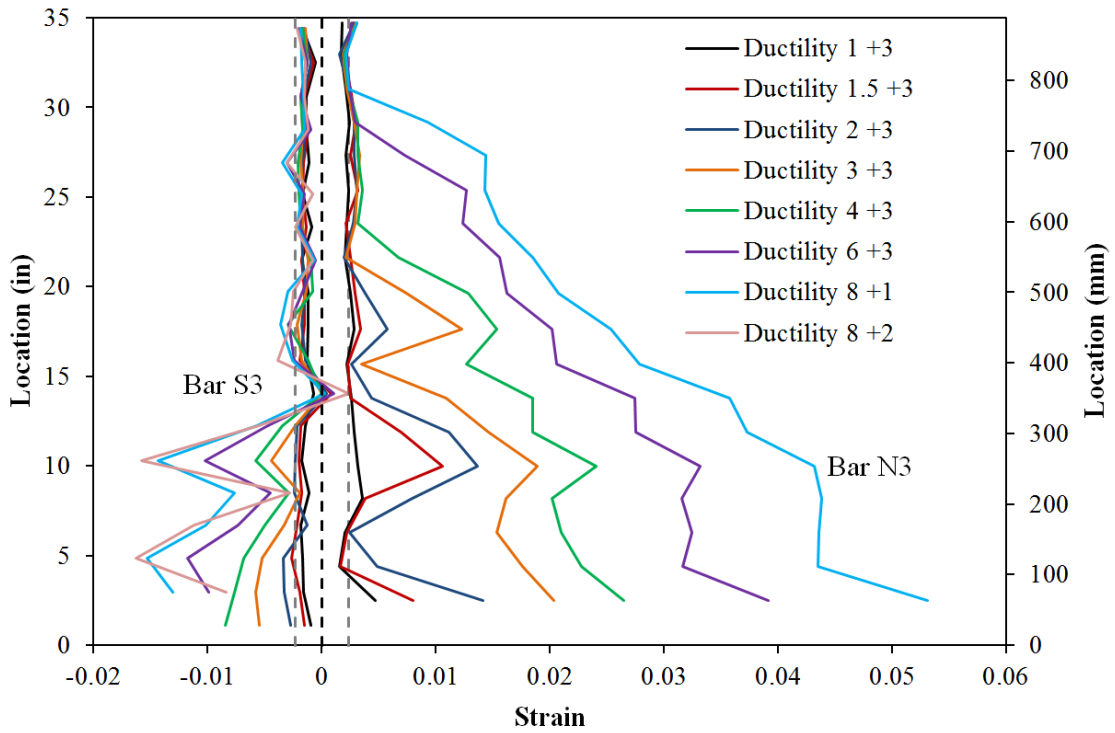
Figure 2-16. Test 9 – Extreme Fiber Vertical Strain Profiles During Push Cycles

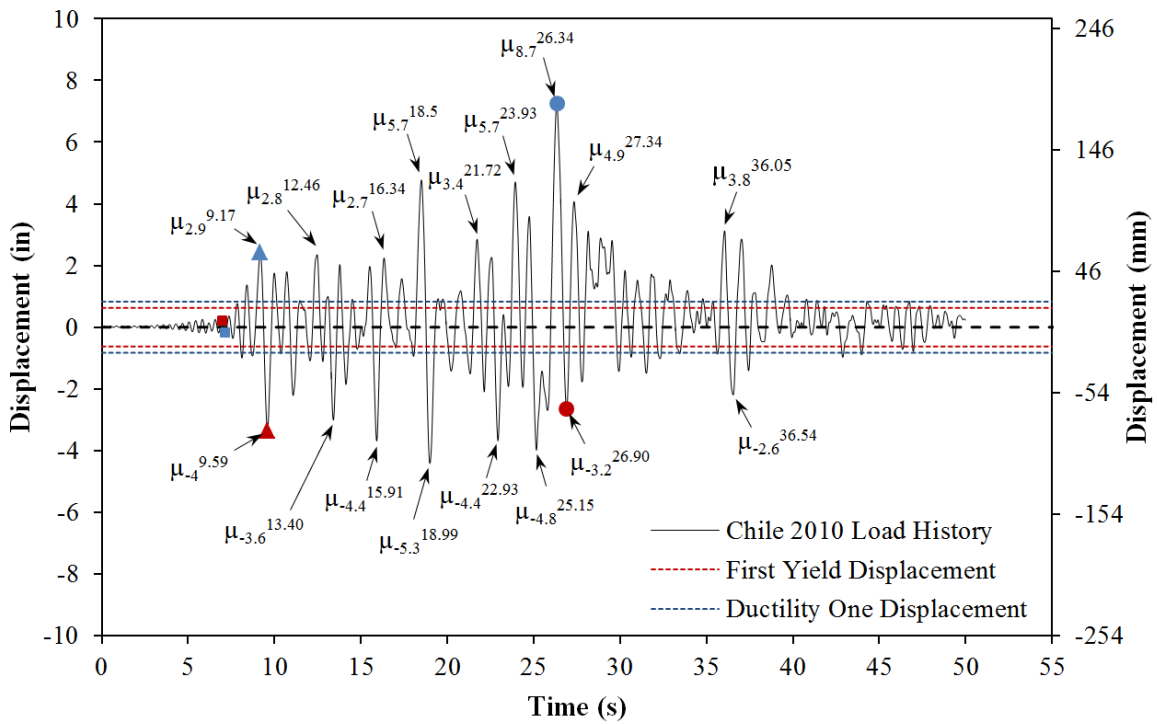
Figure 2-39. Test 8 – Chile 2010 Earthquake Load History

* $\mu_8^{+1} = 6.64"$ represents the first push cycle of displacement ductility eight which reached a peak displacement of 6.64"

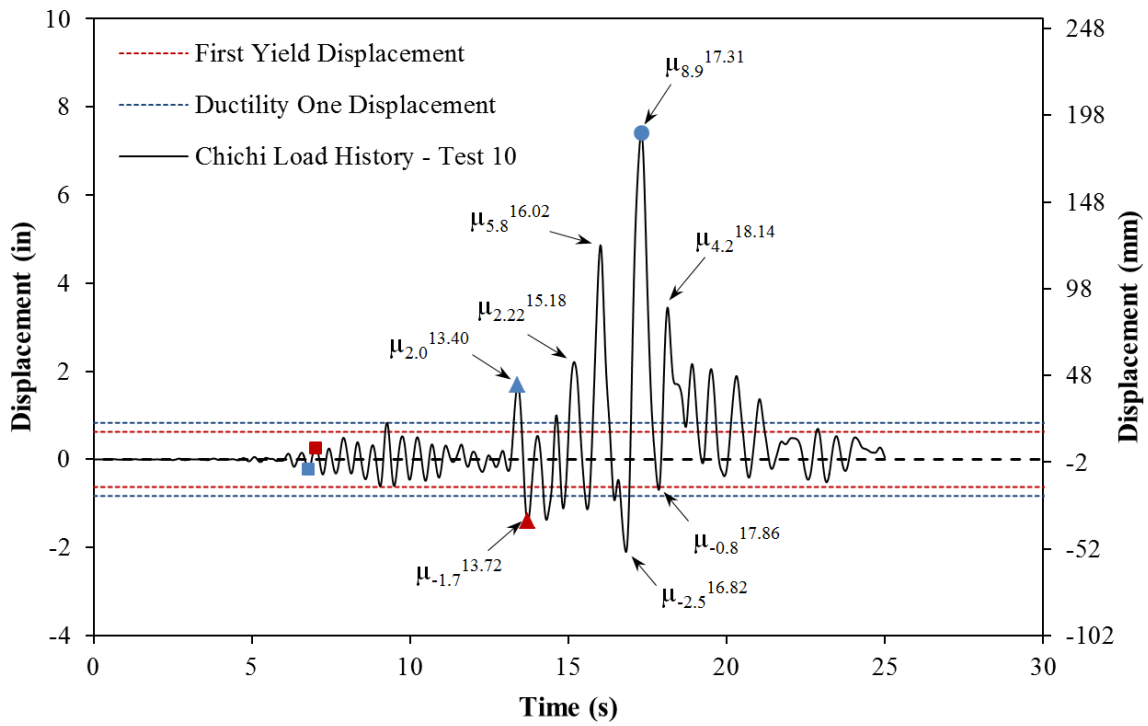
Figure 2-72. Test 10 – Chichi Earthquake Load History

* $\mu_6^{-1} = -5.01''$ represents the first pull cycle of displacement ductility six which reached a peak displacement of -5.01"

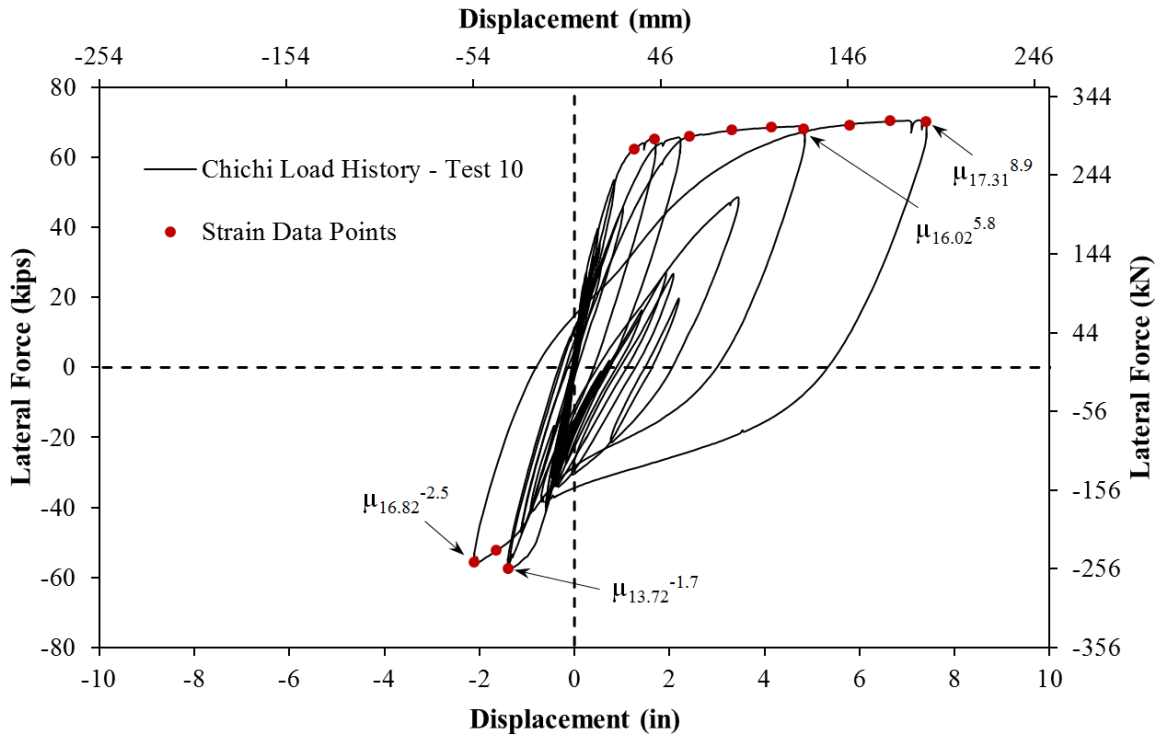
Figure 2-79. Test 10 – Strain Data Observation Points along the Backbone Curve

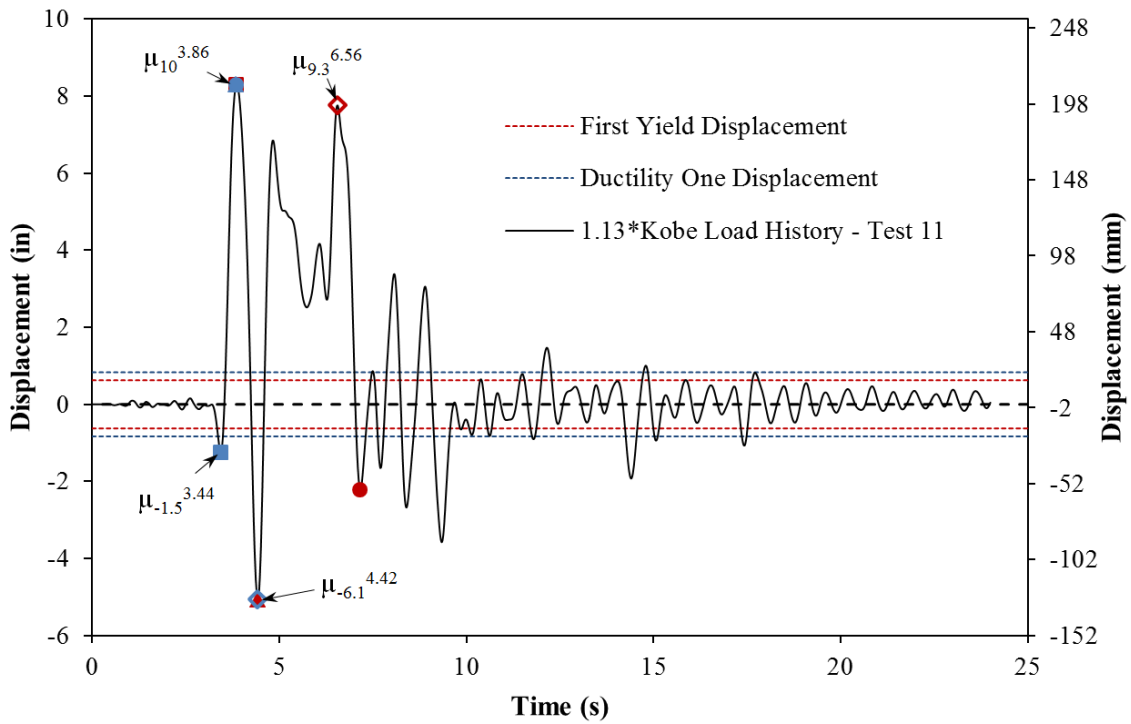
Figure 2-105. Test 11 – Kobe Earthquake Load History

* $\mu_{10}^{3.86sec} = 8.28"$ represents a push cycle 3.86 seconds into the Kobe earthquake record which produced a peak displacement of 8.28" and a displacement ductility of 10

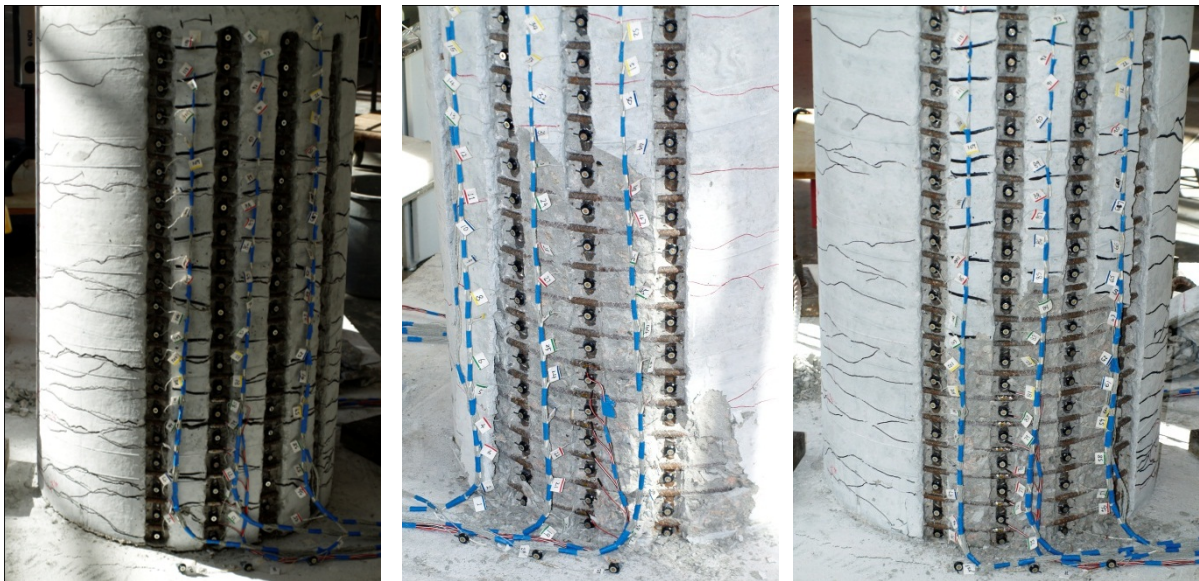
Figure 2-108. Test 11 – (Left and Middle) North and South Sides of Specimen during ($\mu_{10}^{3.86 \text{ sec}} = 8.28''$) and (Right) North Side of the Specimen during ($\mu_{-6.1}^{4.42 \text{ sec}} = -5.08''$)

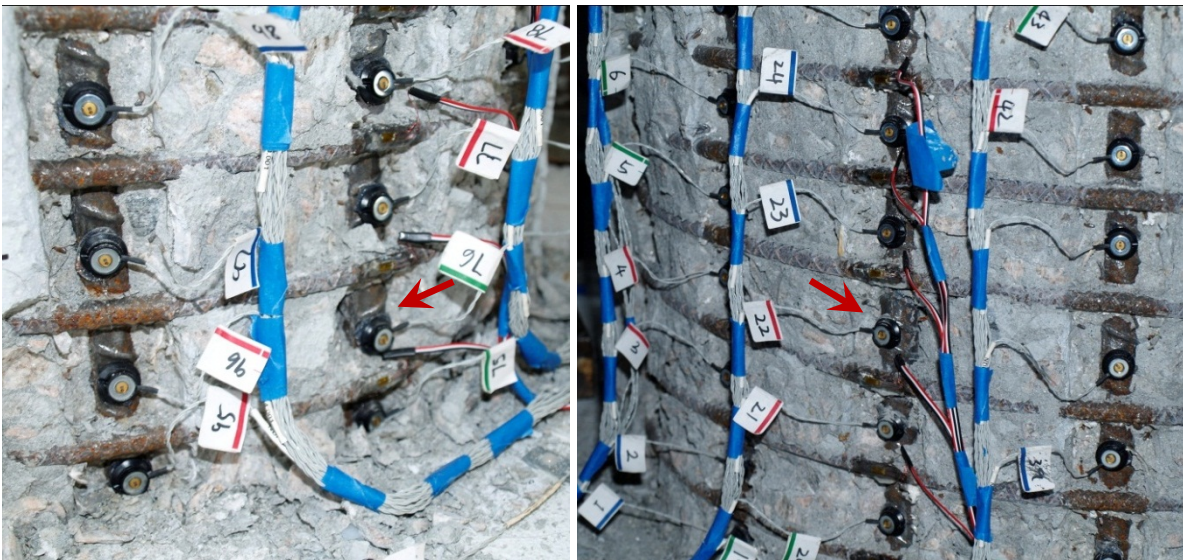
Figure 2-110. Test 11 – (Left) Additional Deformation in North Buckled Region and (Right) Additional Deformation in South Buckled Region

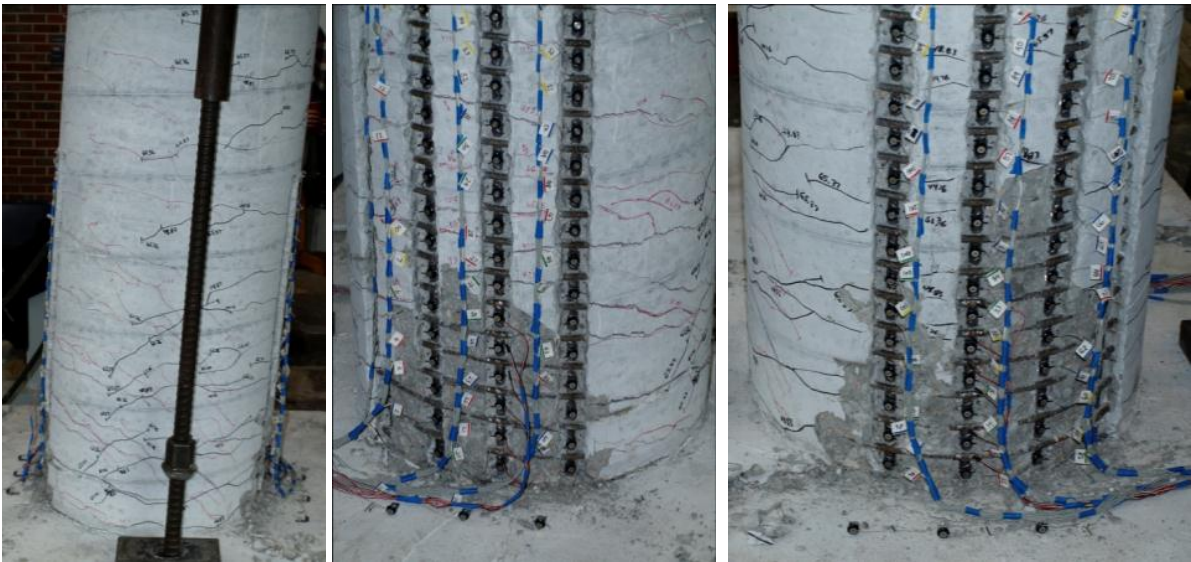
Figure 2-135. Test 12 – Peak Pull Cycle at ($\mu_{-7.9}^{66.88 \text{ sec}} = -6.53''$) – (Left) Back Side of the Specimen, (Middle) South Side, and (Right) North Side

The largest cycle in the pull direction of loading occurred during ($\mu_{-7.9}^{66.88sec} = -6.53''$) with additional crushing on the North side of the specimen, see Figure 2-135. The peak cycle in the push direction at ($\mu_{9.9}^{68.62sec} = -8.22''$) was concluded without visible buckling on the South side of the specimen as shown in Figure 2-136. A peak lateral load of 72.1 kips was recorded during the peak cycle of the Japan 2011 load history. Upon reversal of loading from ($\mu_{9.9}^{68.62sec} = 8.22''$), which placed the North side of the specimen under large tensile strains, the extreme fiber North reinforcing bar N3 buckled on the way to ($\mu_{2.0}^{68.95sec} = 1.68''$) as shown in the left photo of Figure 2-137. Even though the reversal only brought the specimen to a lower ductility in the same direction of loading as the peak cycle, a lateral load of -27.40 kips was recorded due to hysteretic offset from the peak displacement cycle. Therefore, visible buckling was observed while the cracks on the North side of the specimen remained open and the North reinforcement was the sole source of compression zone stability. After a small push cycle to ($\mu_{3.4}^{69.12sec} = 2.80''$), a second reinforcing bar N4 on the North side of the specimen buckled on the way to ($\mu_{-1.4}^{69.41sec} = -1.14''$) as shown in the right photo of

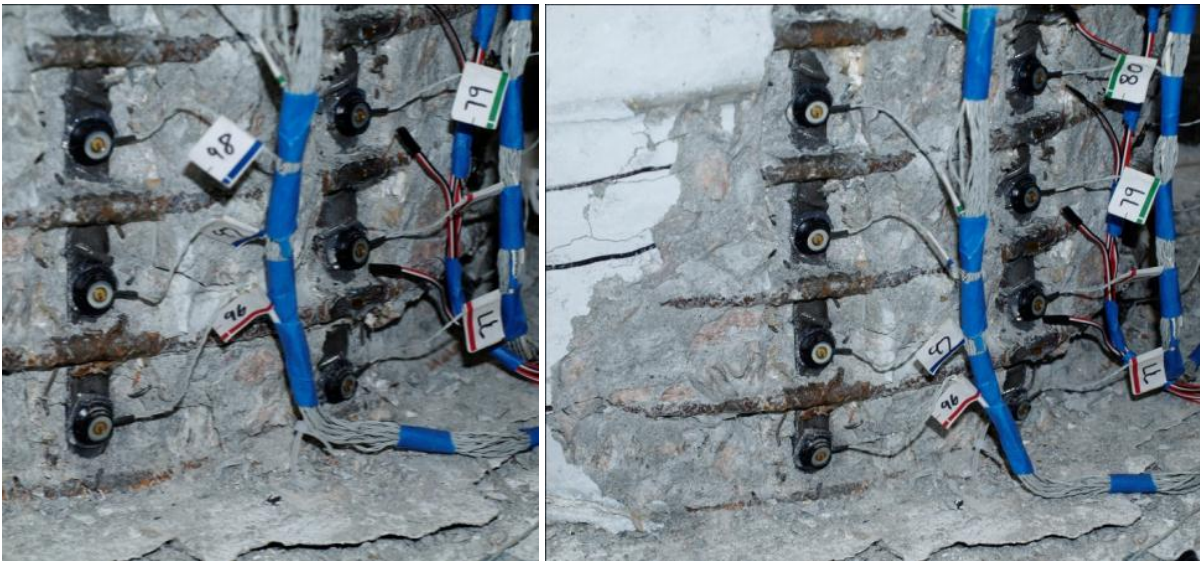
Figure 2-137. Test 12 – (Left) Buckling of Extreme Fiber Bar N3 after Reversal from ($\mu_{9,9}^{68.62sec} = 8.22''$) and (Right) Buckling of Bar N4 at ($\mu_{-1,4}^{69.4sec} = -1.14''$)

Figure 2-137. The rest of the load history progressed without any additional buckled reinforcement or rupture of buckled reinforcement. The deformation in the previously buckled bars increased and the core concrete over the North buckled region began to deteriorate as the load history progressed, see Figure 2-138. Visible buckling of the South reinforcement was never observed, although very slight deformation over the bottom three transverse steel spacing was noticed. This deformation never visibly increased with additional cycles.

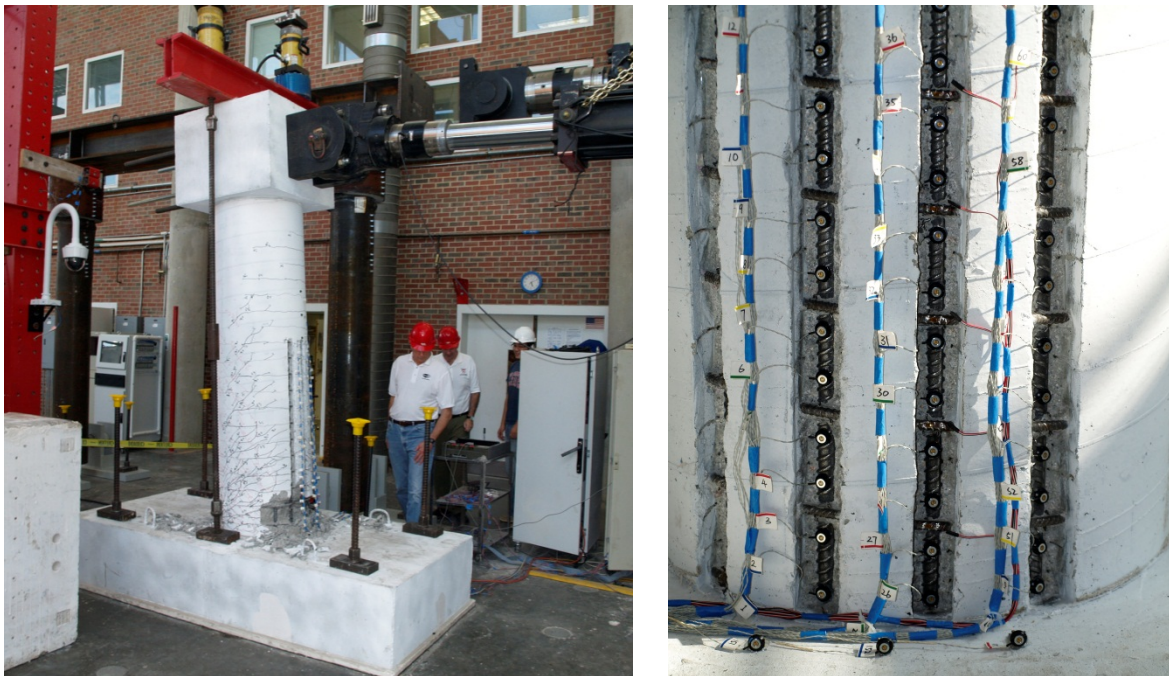
Figure 2-198. Test 14 – (Left) Test Setup and Specimen at ($\mu_8^{+2} = 6.40''$) and (Right) Two Target Markers within Each 4" Transverse Steel Spacing

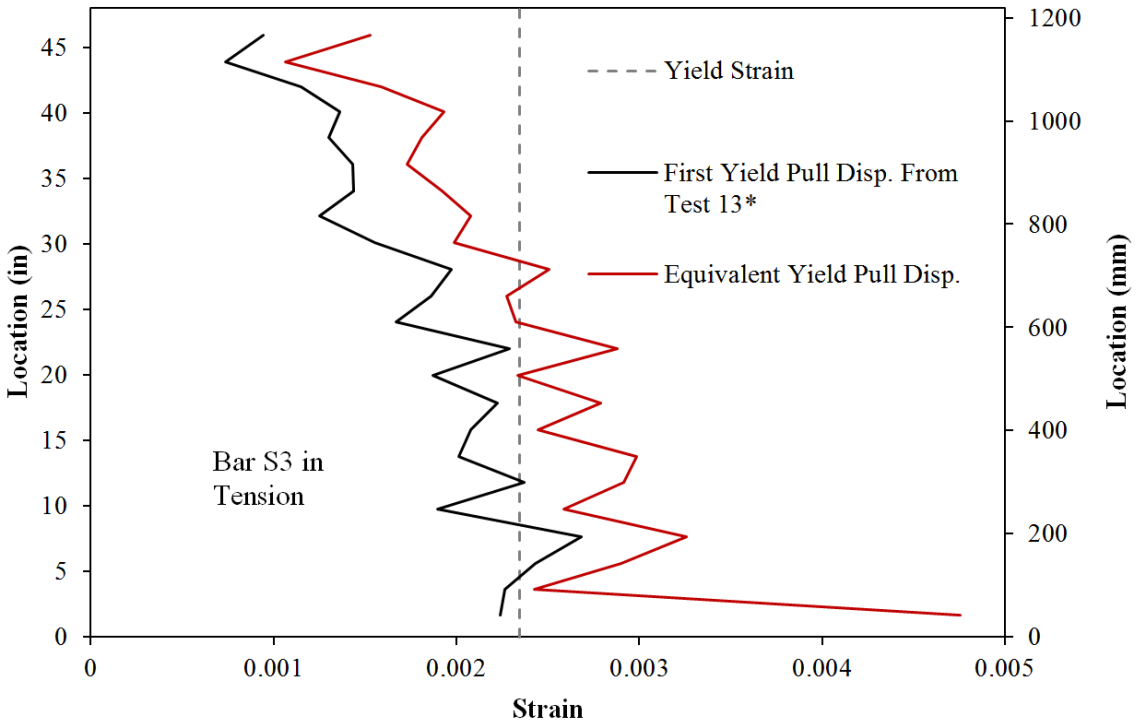
Figure 2-200. Test 14 – Bar S3 Strain Profiles during $-\Delta'_y$ (Test 13) and $-\Delta_y$

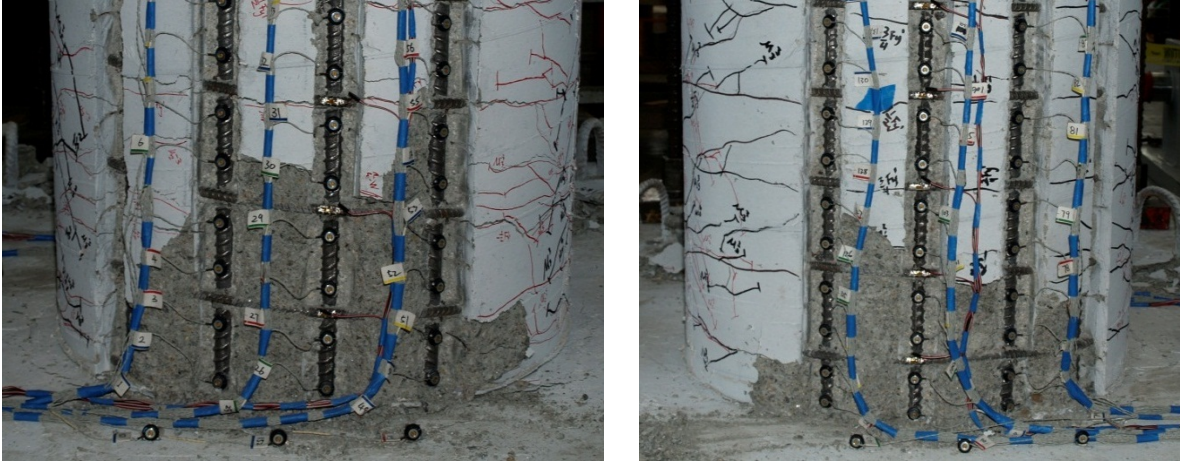
Figure 2-203. Test 14 – (Left) Extent of Crushing on the South Side of the Specimen during ($\mu_4^{+3} = 3.19''$) and (Right) Extent of Crushing on the North Side during ($\mu_4^{-3} = 3.20''$)

The extent of crushing on the North and South sides of the specimen during the third cycle of ductility four is shown in Figure 2-203. Extreme fiber North reinforcing bar N3 buckled after reversal from ($\mu_6^{+1} = 4.80''$), see the left photo of Figure 2-203. All three instrumented bars on the South side of the specimen (S2, S3, and S4) buckled after reversal from ($\mu_6^{-1} = -4.80''$), as shown in the right photo of Figure 2-204. During the reversal from ($\mu_6^{+2} = 4.82''$), additional North reinforcement bars N2 and N4 buckled, see Figure 2-205. North reinforcing bars N1 and N5 buckled during ($\mu_6^{-3} = -4.80''$). At the end of ductility six there was 9% strength loss in the push direction of loading and 12% strength loss in the pull direction due to buckled reinforcing bars and loss of confinement prior to rupture. On the way to ($\mu_8^{+1} = 6.40''$), South reinforcing bar S1 buckled. While the longitudinal steel on the North side of the specimen was in tension, the separation of the deformed spiral in Figure 2-206 highlights the effect of loss of confinement due to buckled bars. During ($\mu_8^{-1} = -6.39''$), previously buckled South reinforcing bars S2, S3, and S4 ruptured causing a 48% loss in strength, see Figure 2-207. On the way to ($\mu_8^{+2} = 6.40''$), previously buckled North reinforcing bars N2 and N3 ruptured causing a 45% loss in strength as shown in the left photo of

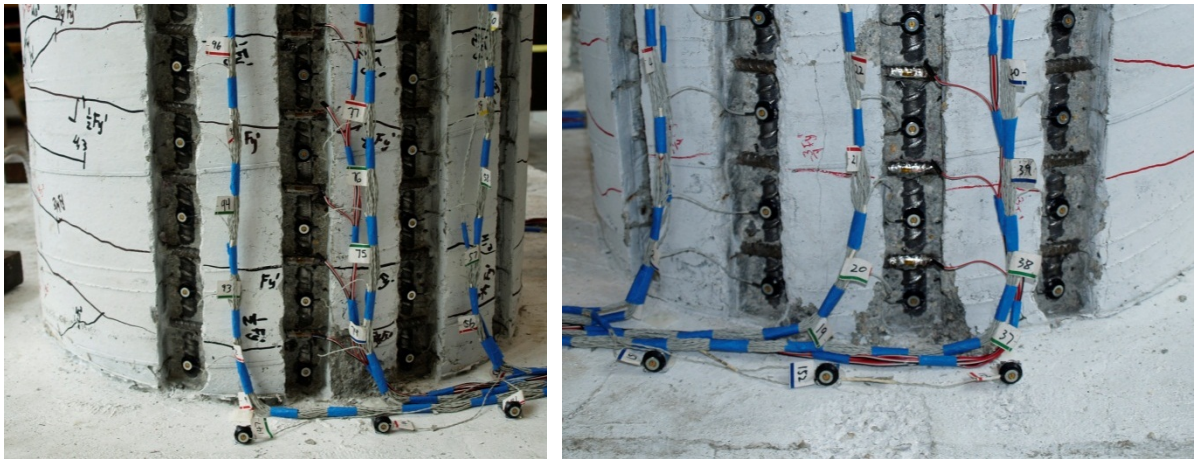
Figure 2-236. Test 15 – (Left) Crushing on the North Side of the Specimen during ($\mu_{1.5}^{-3} = -1.25''$) and (Right) Crushing on the South Side during ($\mu_2^{+1} = 1.68''$)

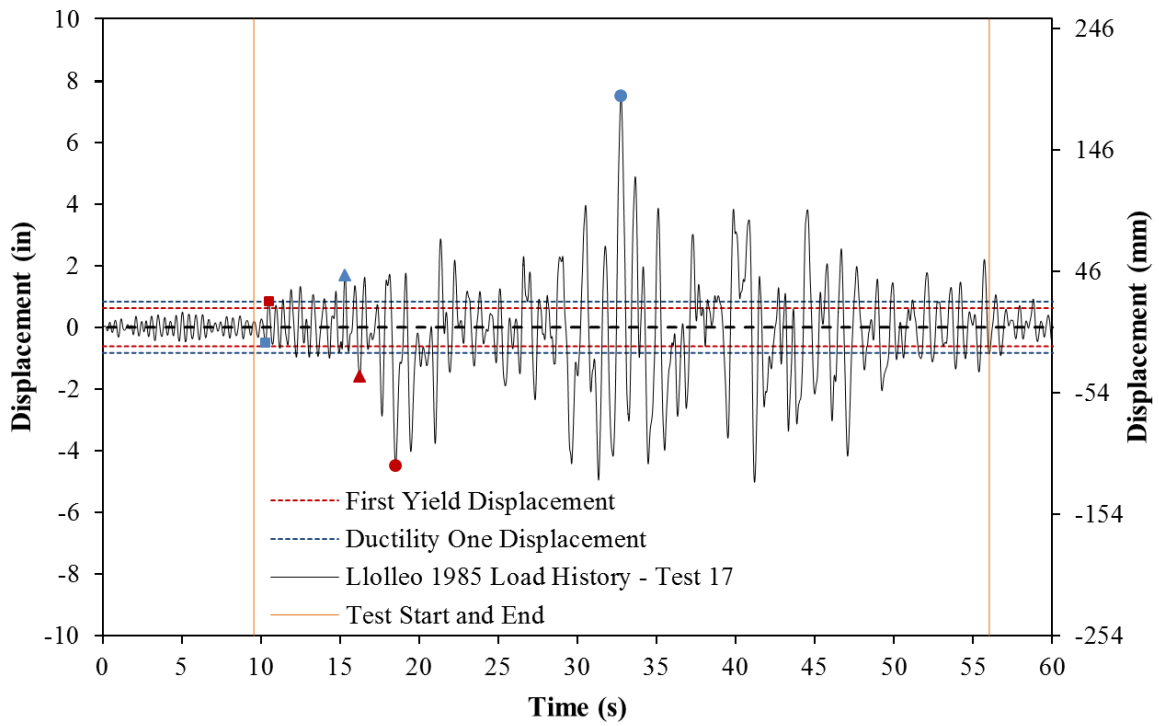
Figure 2-301. Test 17 – Lollole Chile 1985 Earthquake Load History

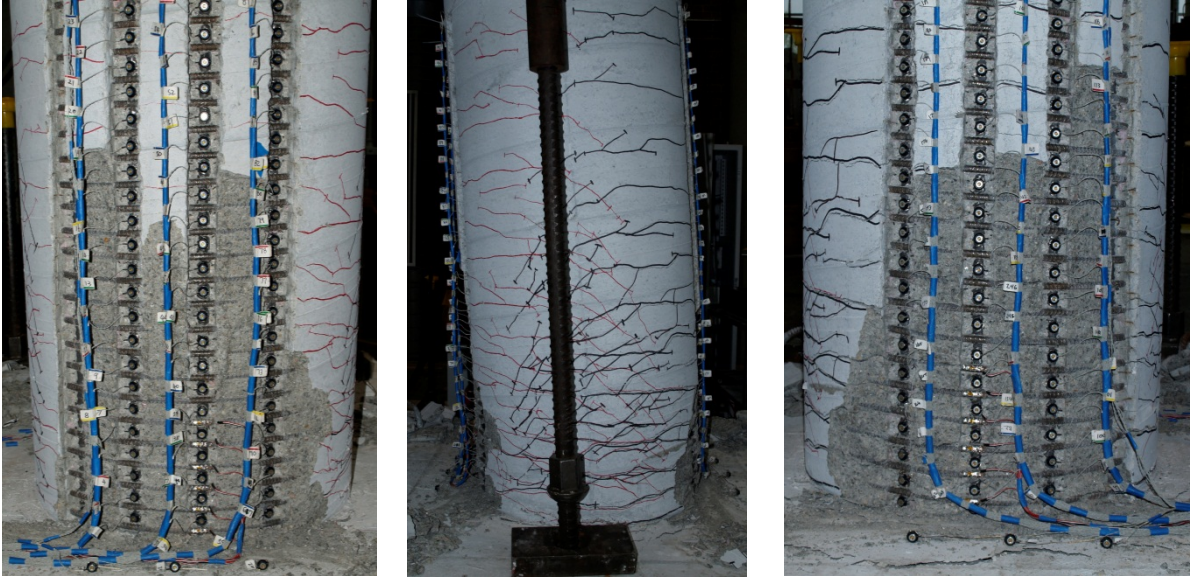
Figure 2-312. Test 17 – (Left, Middle, and Right) South, Back, and North Side of the Specimen during ($\mu_{9,0}^{32.76 \text{ sec}} = 7.49''$) Respectively

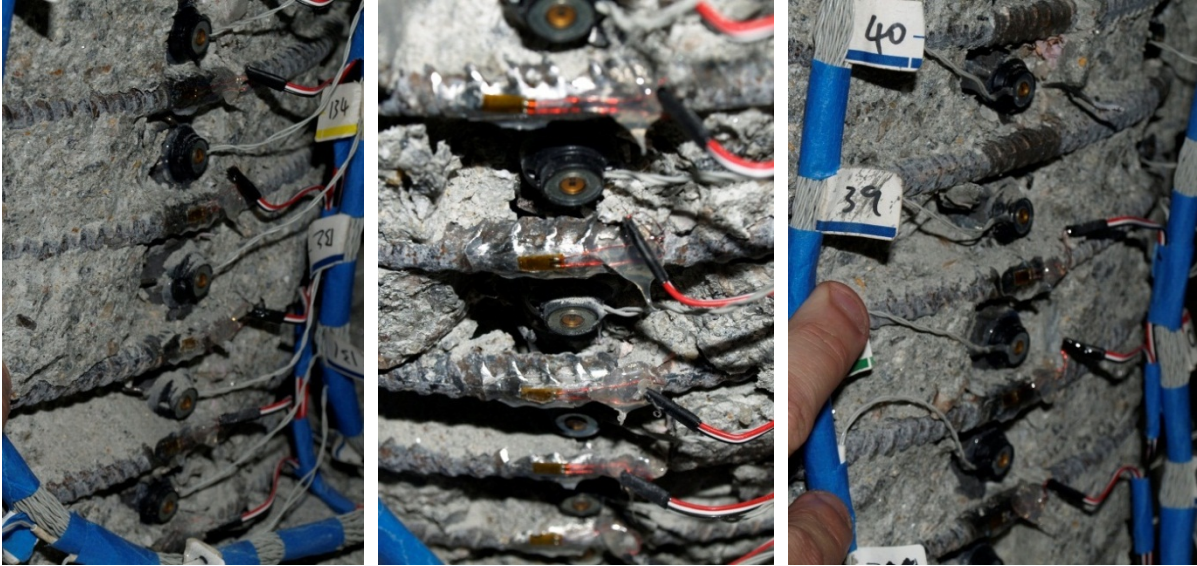
Figure 2-315. Test 17 – (Left) Additional Deformation in Buckled Bar N3 during ($\mu_6^{-3} = -5.00''$), (Middle) Permanent Deformation in Spiral Layers over Buckled Region of Bar N3 during ($\mu_6^{+4} = 5.00''$), and (Right) Additional Deformation in Buckled Bar S3 during ($\mu_6^{+4} = 5.00''$)

During the subsequent push cycle to ($\mu_6^{+3} = 5.00''$), the South extreme fiber bar S3 visibly buckled as shown in Figure 2-314. Outward deformation was observed 8'' above the footing over the highest transverse steel layer instrumented with a strain gage. During the next pull cycle to ($\mu_6^{-3} = -5.00''$), the deformation in buckled bar N3 increased as shown in the left photo of Figure 2-315. Permanent deformation in spiral layers overlaying bar N3 was observed during ($\mu_6^{+4} = 5.00''$), see the middle photo of Figure 2-315. During this cycle, the outward deformation in buckled bar S3 increased as shown in the right photo of Figure 2-315. A fourth cycle at ductility six was conducted to verify that the outward deformation in bar S3 would increase over the same location giving a stronger indication of observable bar buckling during the previous cycle. After this cycle, the test was concluded with buckling of each extreme fiber bar, but without any strength loss or rupture of reinforcement. The specimen was saved as a repair candidate for a separate research project.

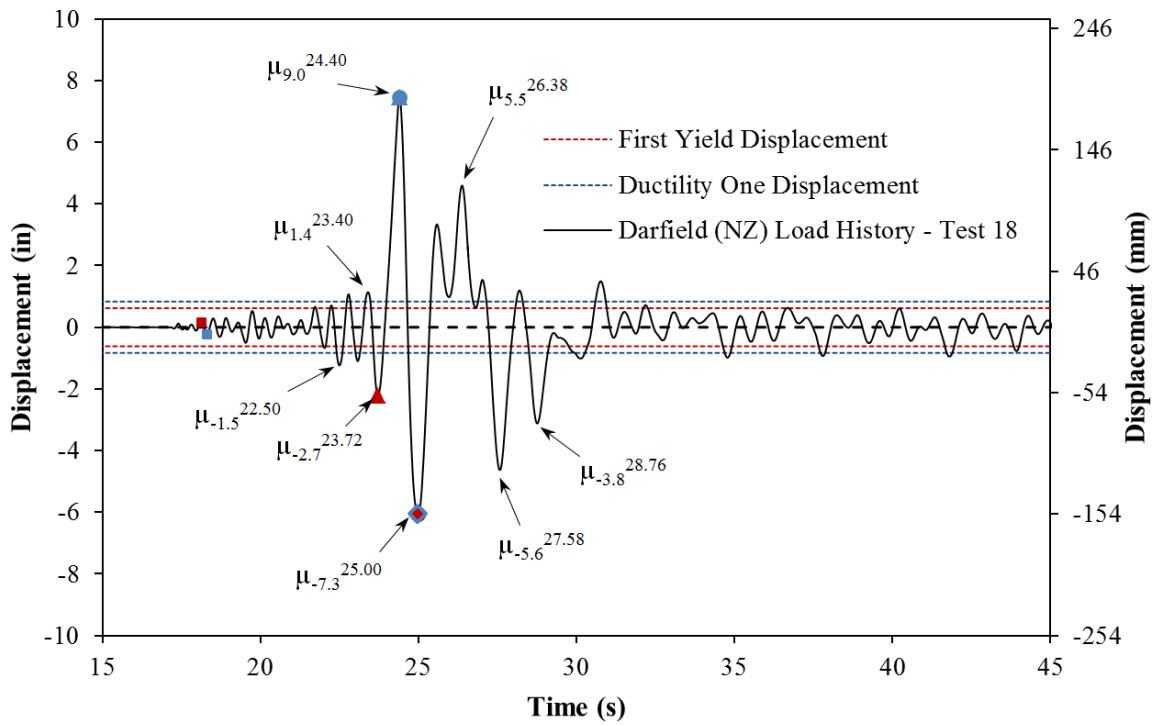
Figure 2-340. Test 18 – Darfield NZ 2010 Earthquake Load History

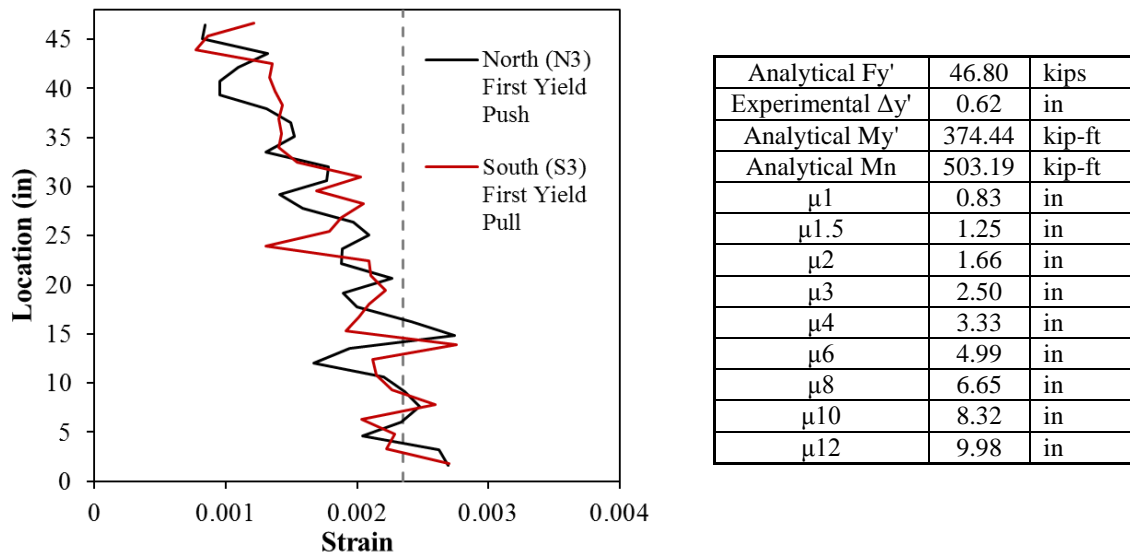
Figure 2-345. Test 18 – (Left) Tensile Vertical Strain Profiles Used to Verify Test 16 First yield Displacement and (Right) Displacement Ductility Levels from Test 16 Which Also Apply for Test 18 due to Identical Detailing, Geometry, and Material Properties

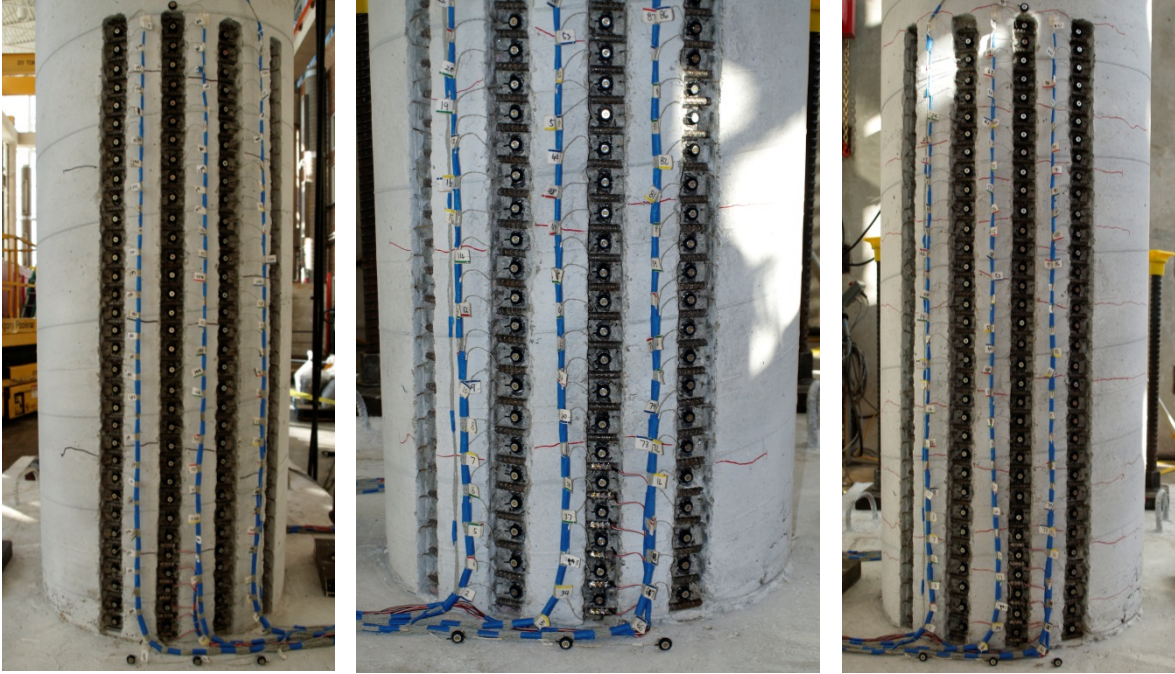
Figure 2-346. Test 18 – (Left) First Cracking on the North Side during ($\mu_{0.2}^{18.12 \text{ sec}} = 0.17''$), (Middle) First Cracking on the South Side during ($\mu_{-0.3}^{18.30 \text{ sec}} = -0.23''$), and (Right) South Crack Distribution during ($\mu_{-0.6}^{19.54 \text{ sec}} = -0.50''$)

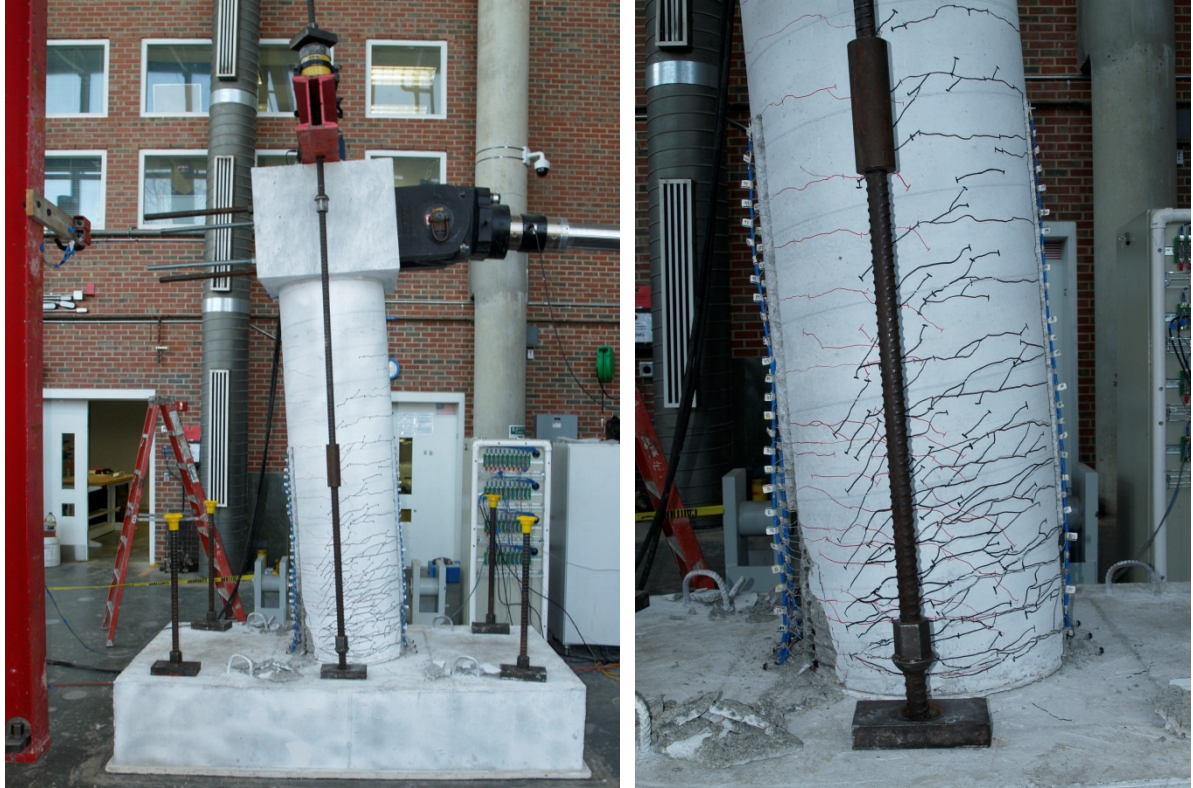
Figure 2-350. Test 18 – Crack Distribution at Peak Displacement ($\mu_{9,0}^{24.40 \text{ sec}} = 7.46''$)

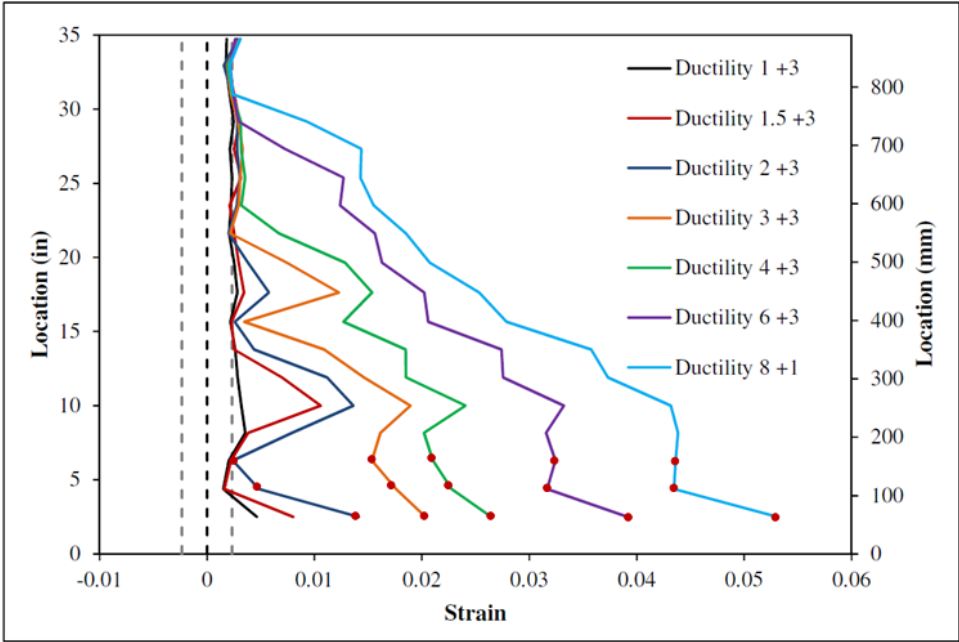
Figure 3-41. Strain Profile of Bar N3 at Tensile Cycles

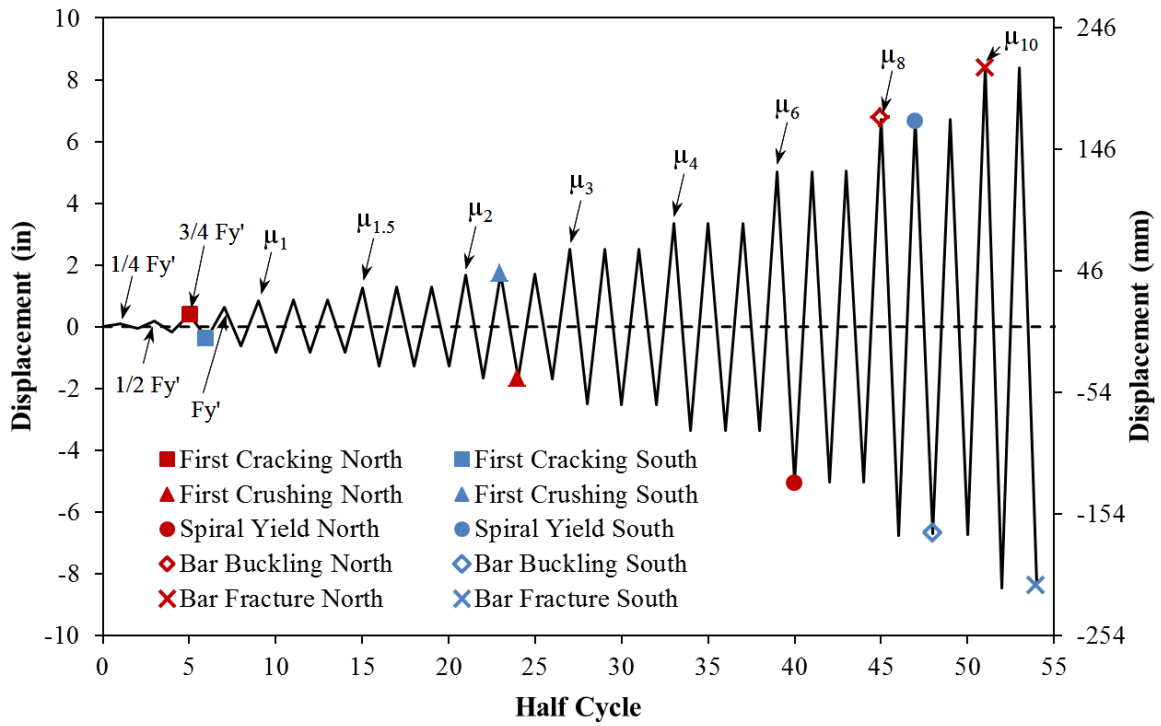
Figure 4-1. Sequence of Damage Observed in the Symmetric Three Cycle Set Load History of Test 9
