## **MASH TL-3 TESTING AND EVALUATION OF THE TXDOT T131RC BRIDGE RAIL TRANSITION**

**Test Report 9-1002-12-4**

**Cooperative Research Program**

Report 9-1002-12-4  
Project 9-1002-12  
Project Title: Roadside Safety Device Crash Testing Program

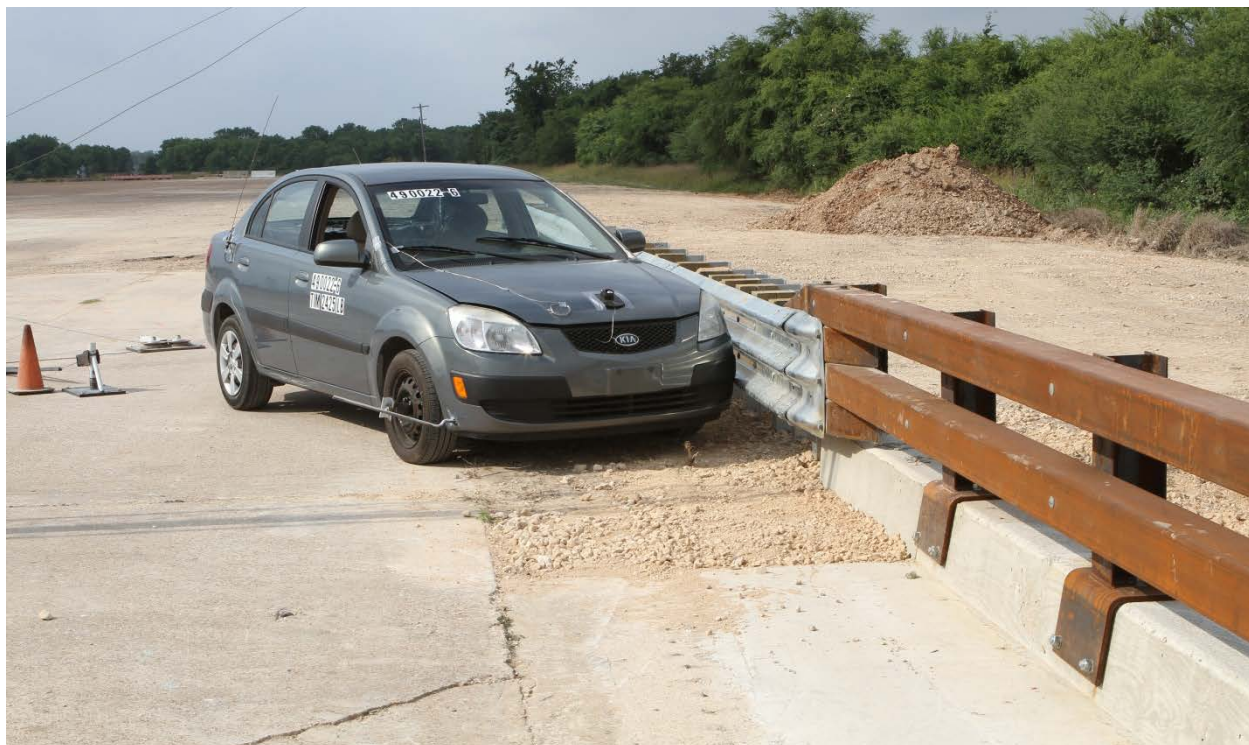
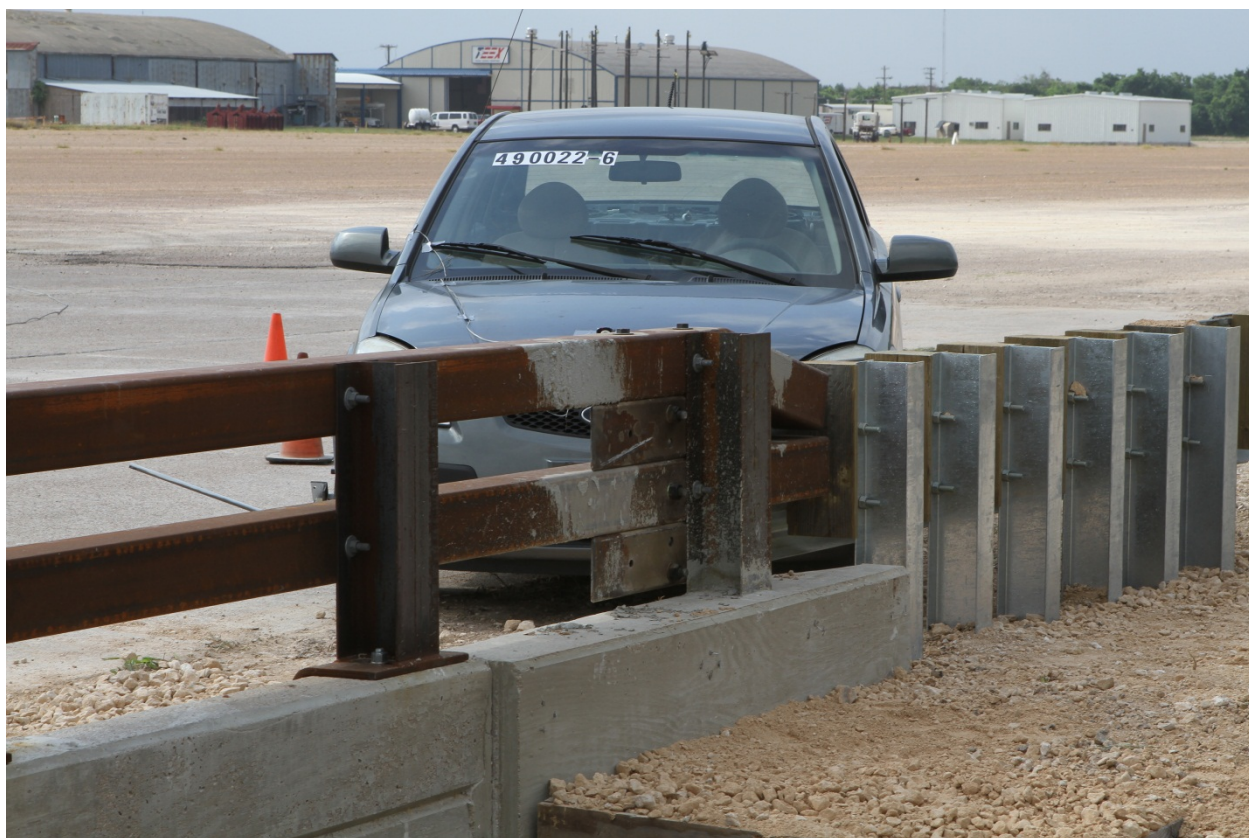
**Figure 5.1. Vehicle/TxDOT T131RC Bridge Rail Transition Geometrics  
for Test No. 490022-6.**

The 2006 Kia Rio, traveling at an impact speed of 61.5 mi/h, impacted the TxDOT T131RC Bridge Rail Transition 60.5 inches upstream of post 20 at an impact angle of 25.6 degrees. At approximately 0.012 s after impact, the thrie beam guardrail began to deflect toward the field side, and at 0.024 s, the vehicle began to redirect. The concrete transition curb began to deflect toward the field side at 0.029 s, and a crack formed in the concrete bridge rail curb downstream of post 21 at 0.053 s. The concrete bridge rail curb under post 21 began to crack at 0.057 s with some of the pieces of concrete spalling off at 0.220 s. At 0.307 s, the vehicle lost contact with the bridge rail traveling at an exit speed and angle of 44.8 mi/h and 4.4 degrees, respectively. Brakes on the vehicle were not applied, and the vehicle came to rest 180 ft downstream of impact and 21 ft toward traffic lanes. Figures D1 and D2 in Appendix D show sequential photographs of the test period.

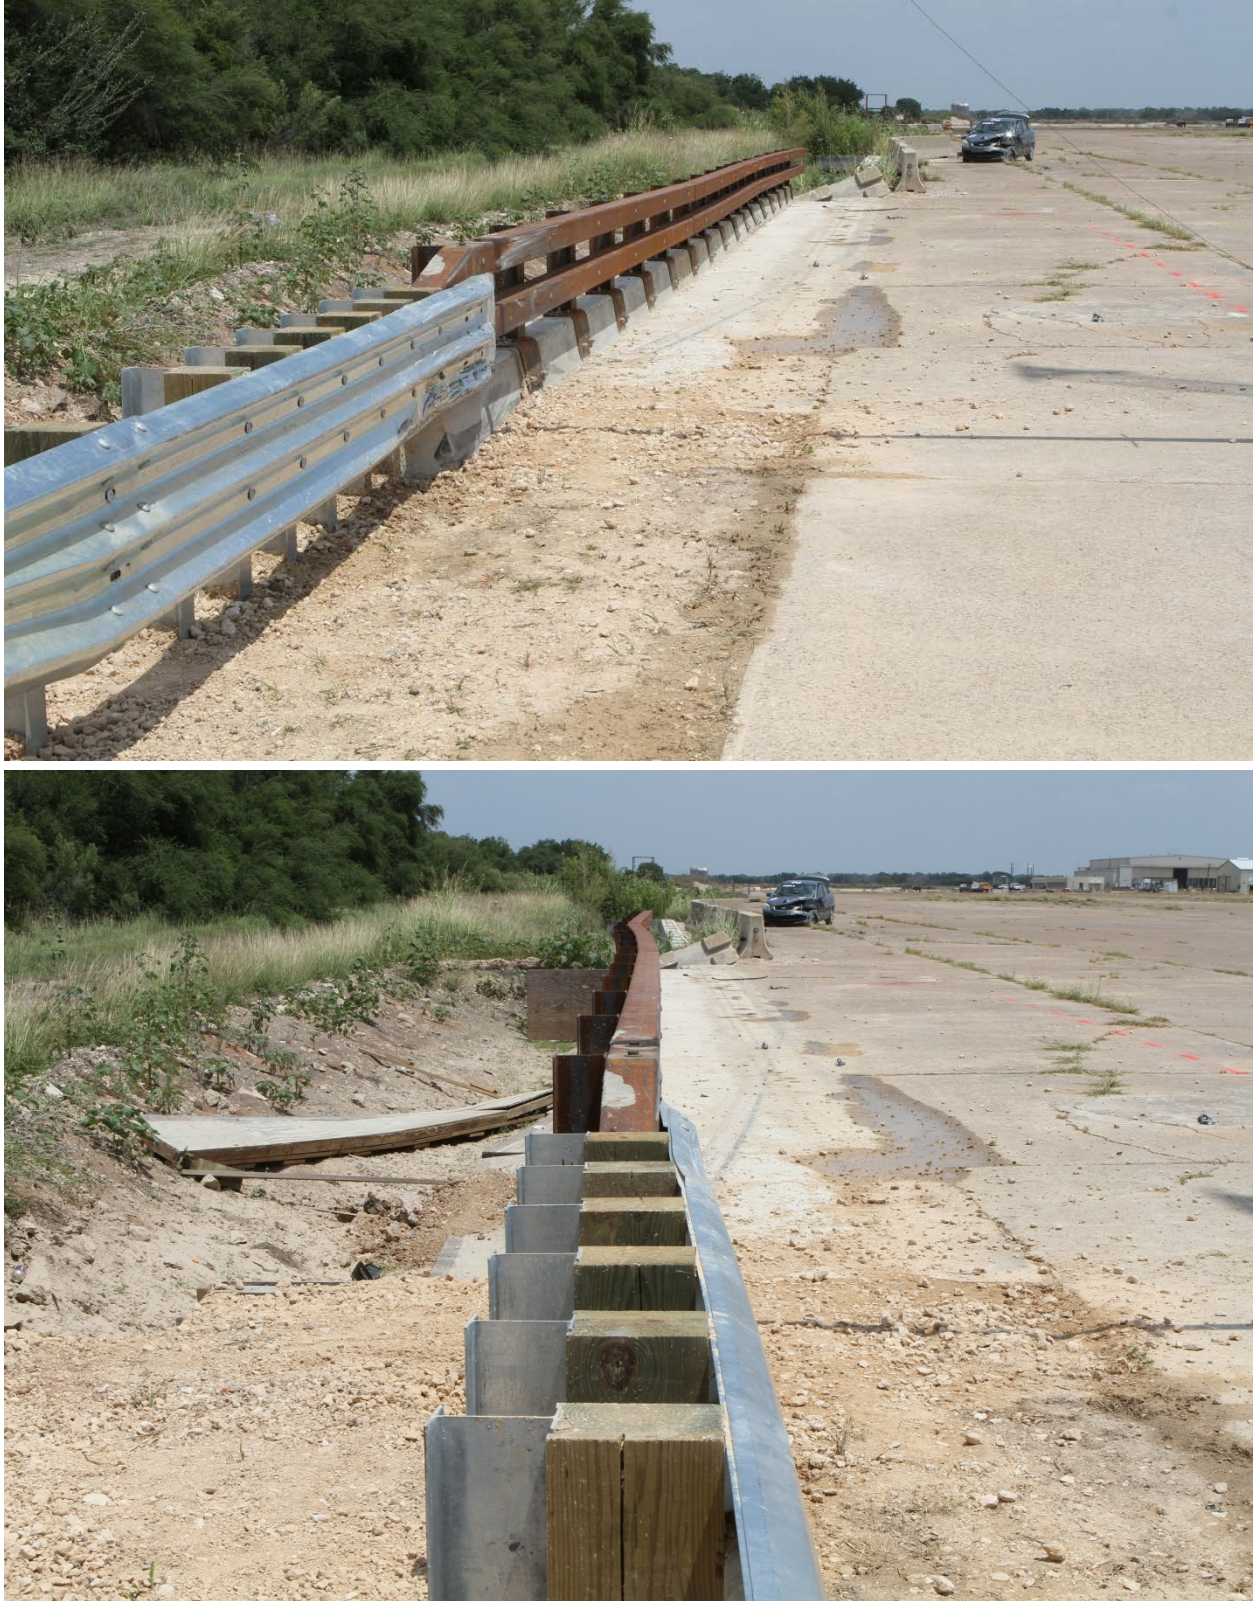
**Figure 5.3. Vehicle/TxDOT T131RC Bridge Rail Transition Positions  
after Test No. 490022-6.**

Figures 5.3 and 5.4 show damage to the T131RC Transition and bridge rail. The transition curb deflected toward the field side 0.5 inch. No cracking of the transition curb was noted. The concrete curb around post 21 was cracked significantly, and there was minor cracking around post 22. The vehicle was in contact with the installation 13.3 ft. Vehicle intrusion (formerly working width) was 7.4 inches. Maximum deflection of the thrie beam guardrail during the test was 7.4 inches, and maximum residual deformation after the test was 1.25 inches.

The TxDOT T131RC Bridge Rail Transition contained and redirected the 1100C vehicle. The vehicle did not penetrate, underide, or override the installation. Maximum dynamic deflection during the test was 7.4 inches. No detached elements, fragments, or other debris were present to penetrate or to show potential for penetrating the occupant compartment, or to present hazard to others. Maximum occupant compartment deformation was 2.5 inches in the left door at occupant hip height. The 1100C vehicle remained upright during and after the collision event. Maximum roll and pitch angles were 5 degrees and 6 degrees, respectively. Occupant risk factors were within the preferred limits specified in *MASH*. The 1100C crossed the exit box 80.1 ft downstream of loss of contact with the installation, which was within the *MASH* recommendation.

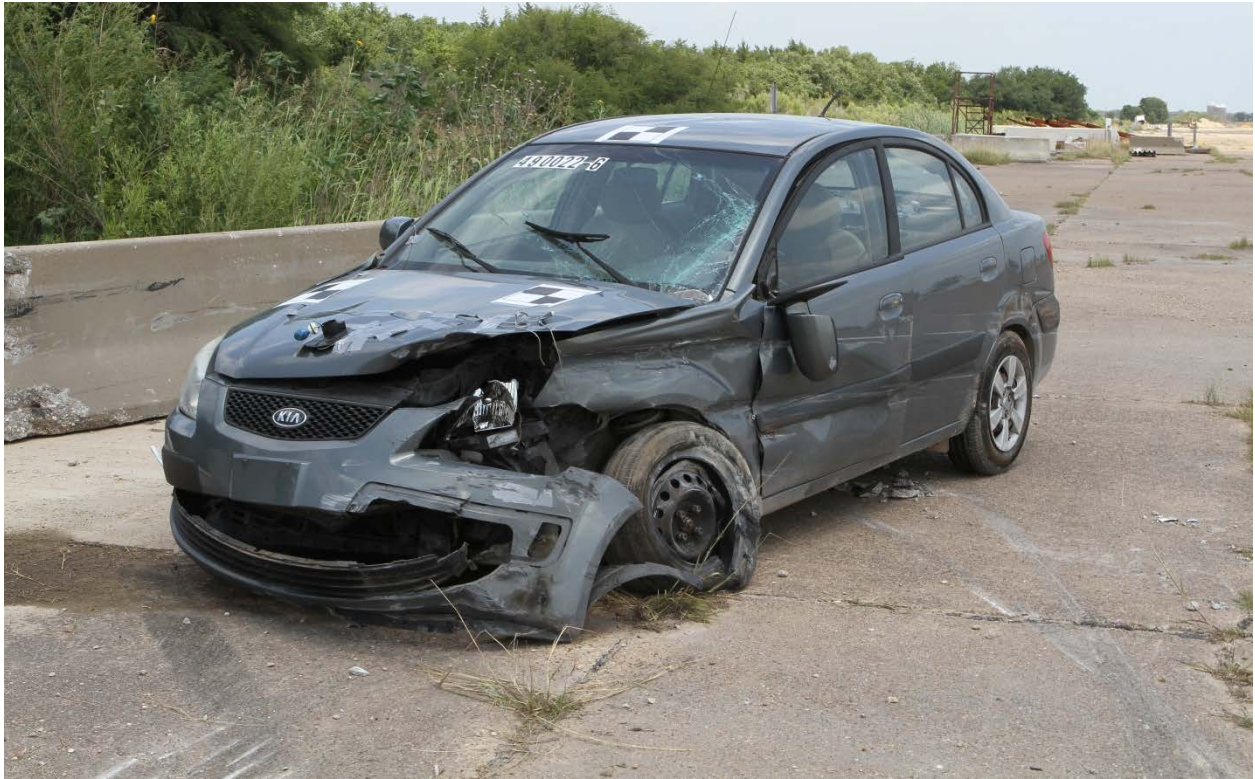
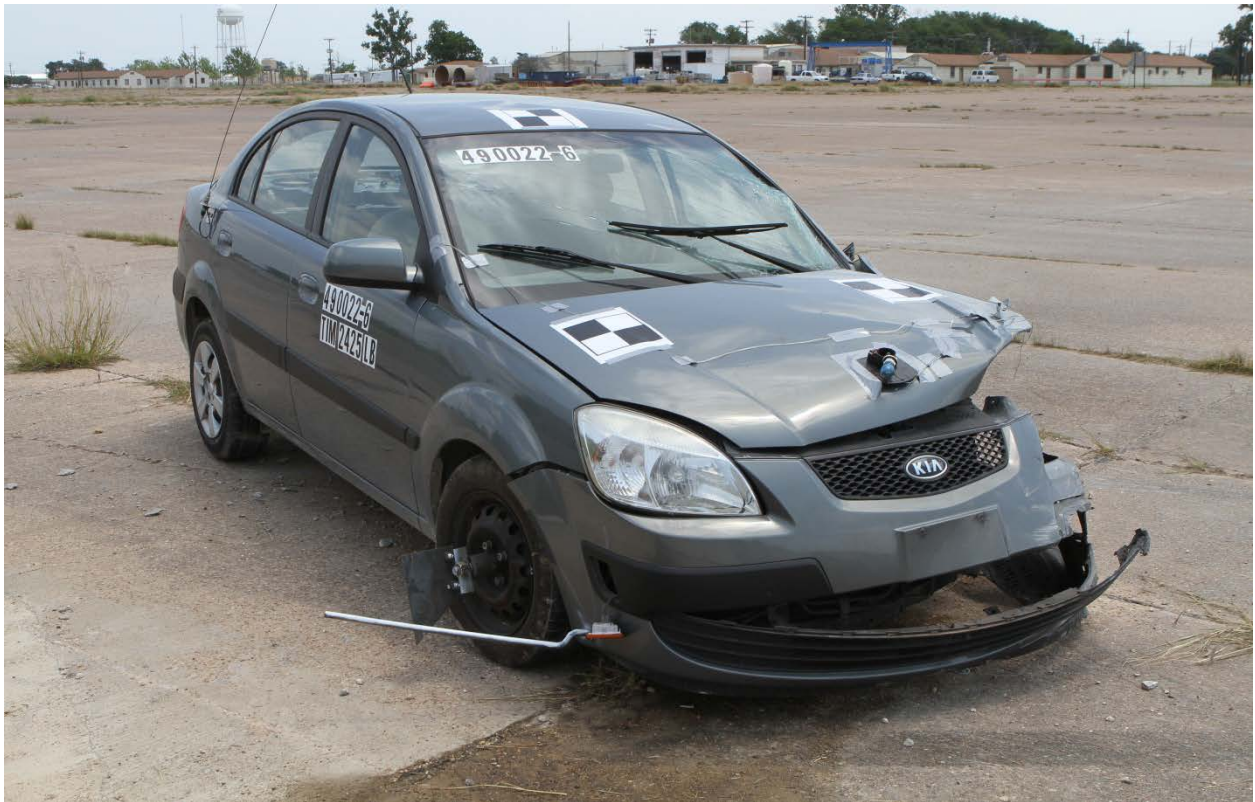
**Figure 5.5. Vehicle after Test No. 490022-6.**

Figure 5.5 presents damage to the 1100C vehicle. The left strut and strut tower were deformed. The front bumper, grill, hood, radiator, radiator support, left front fender, left front tire and wheel rim, left front door, left rear door, left rear quarter panel were deformed. The windshield sustained stress cracks from the left lower corner. Maximum crush to the exterior of the vehicle was 12.0 inches in the front plane in the left front corner at bumper height. Maximum occupant compartment deformation was 2.5 inches in the left front door near occupant hip height. The floor pan and firewall were also deformed. Tables D2 and D3 in Appendix D present the exterior crush profile and occupant compartment deformations.

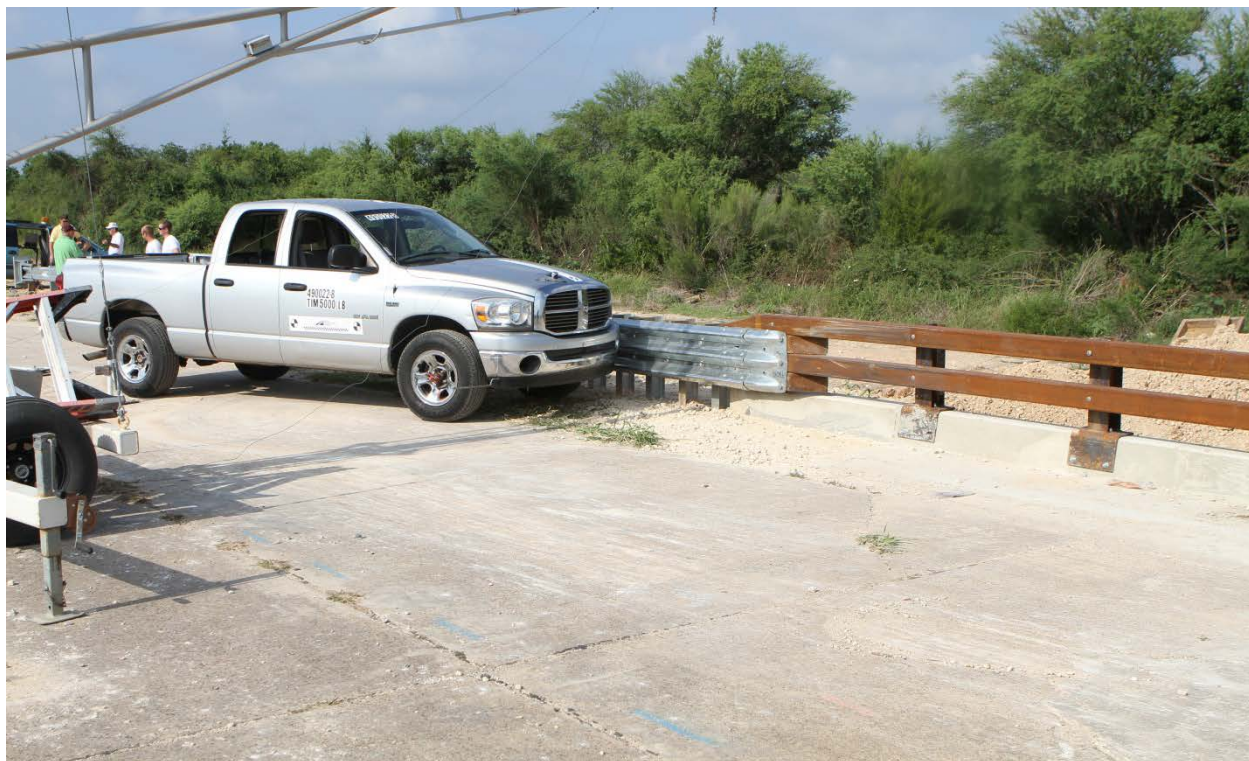
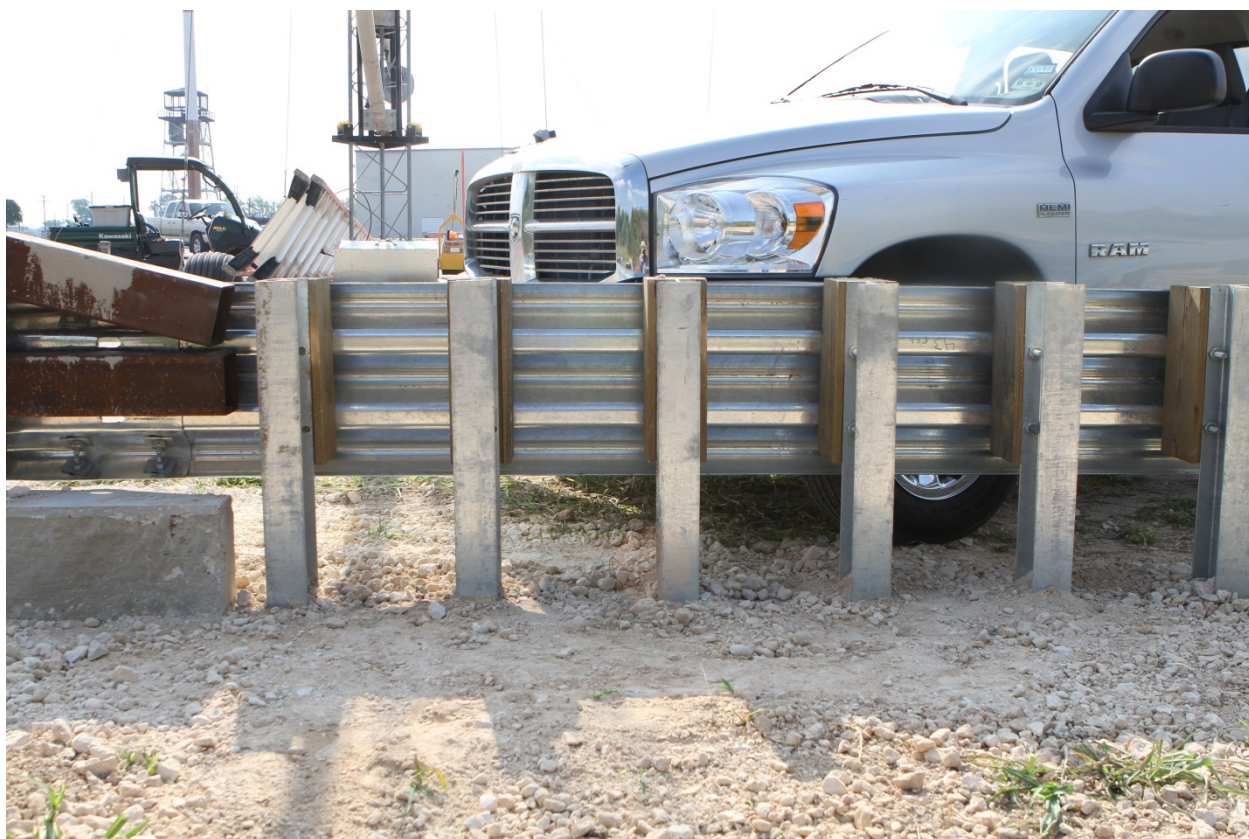
**Figure 6.1. Vehicle/TxDOT T131RC Bridge Rail Transition Geometrics  
for Test No. 490022-8.**

The 2008 Dodge Ram 1500 pickup truck, traveling at an impact speed of 62.7 mi/h, impacted the TxDOT T131RC Bridge Rail Transition 7.2 ft upstream of post 20 at an impact angle of 25.1 degrees. At approximately 0.024 s, the thrie beam guardrail began to deflect toward the field side, and at 0.050 s, the vehicle began to redirect. The transition curb began to deflect toward the field side at 0.127 s, and the rear of the vehicle contacted the transition at 0.209 s. At 0.363 s, the vehicle lost contact with the installation traveling at an exit speed and angle of 47.1 mi/h and 5.6 degrees, respectively. Brakes on the vehicle were applied 1.8 s after impact, and the vehicle subsequently came to rest 202 ft downstream of impact with the left side of the vehicle aligned with the traffic face of the bridge rail. Figures E1 and E2 in Appendix E show sequential photographs of the test period.

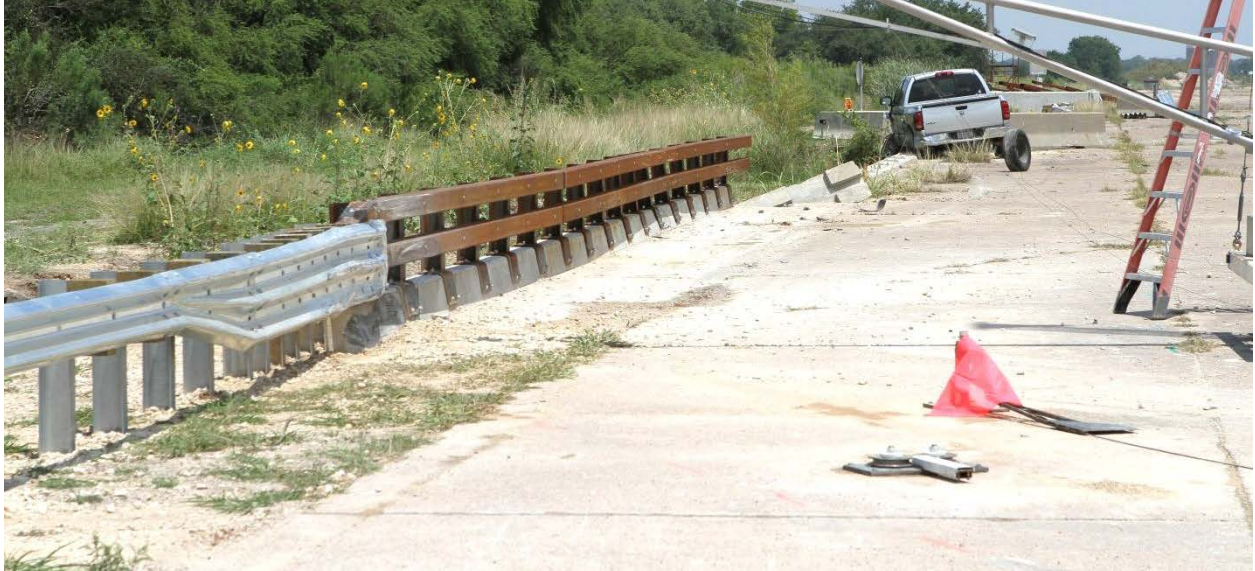
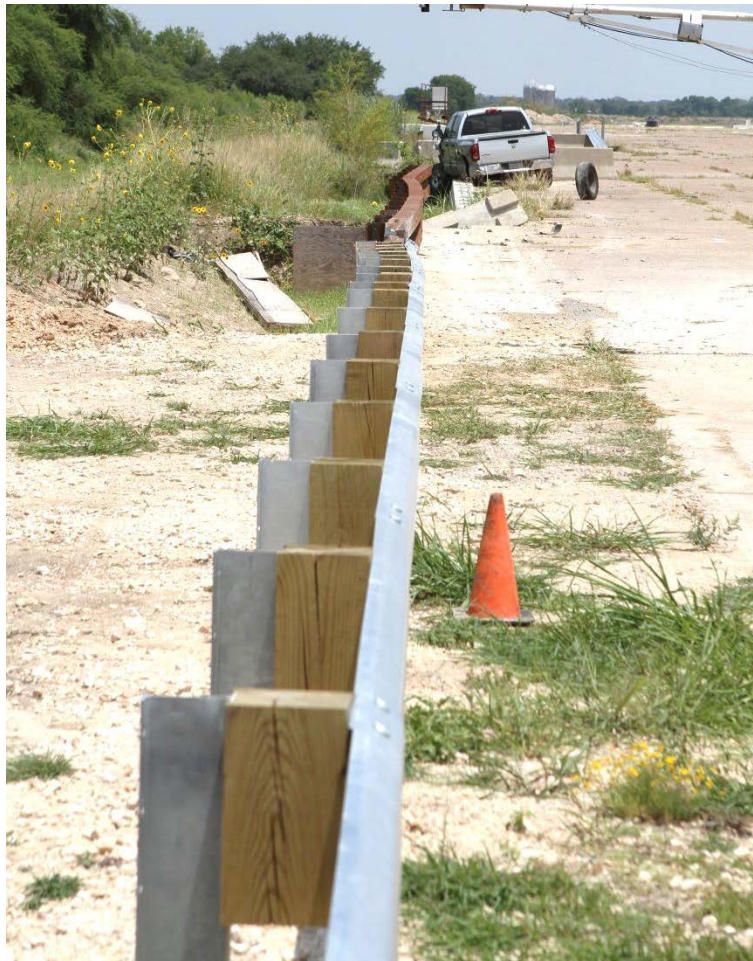
**Figure 6.3. Vehicle/TxDOT T131RC Bridge Rail Transition Positions after Test No. 490022-8.**

Figure 6.3 and 6.4 show damage to the T131RC Transition and the bridge rail. Post 14 was deflected toward the field side 0.25 inch, and post 15 was deflected toward the field side 0.5 inch. The soil around post 16 and 17 was disturbed. Post 18 was deflected toward the field side 1.38 inches, and maximum residual deformation at post 18 was 1.0 inch. The soil around post 19 was disturbed. The transition curb deflected toward the field side 1.5 inches. The transition curb was not cracked, but was marred with tire marks. Significant cracking of the bridge rail curb occurred at post 21 with slight damage at post 22. Length of contact of the vehicle with the installation was 15.3 ft. Vehicle intrusion (formerly working width) was 15.9 inches. Maximum dynamic deflection during the test was 8.37 inches, and maximum permanent residual deformation was 1.0 inch.

The TxDOT T131RC Bridge Rail Transition contained and redirected the 2270P vehicle. The vehicle did not penetrate, underide, or override the installation. Maximum dynamic deflection during the test was 8.4 inches. No detached elements, fragments, or other debris were present to penetrate or to show potential for penetrating the occupant compartment, or to present hazard to others. Maximum occupant compartment deformation was 0.25 inch in the left door at occupant hip height. The 2270P vehicle remained upright during and after the collision event. Maximum roll and pitch angles were 21 degrees and 8 degrees, respectively. Occupant risk factors were within the preferred limits specified in *MASH*. The 2270P vehicle crossed the exit box within the limits specified in *MASH*.

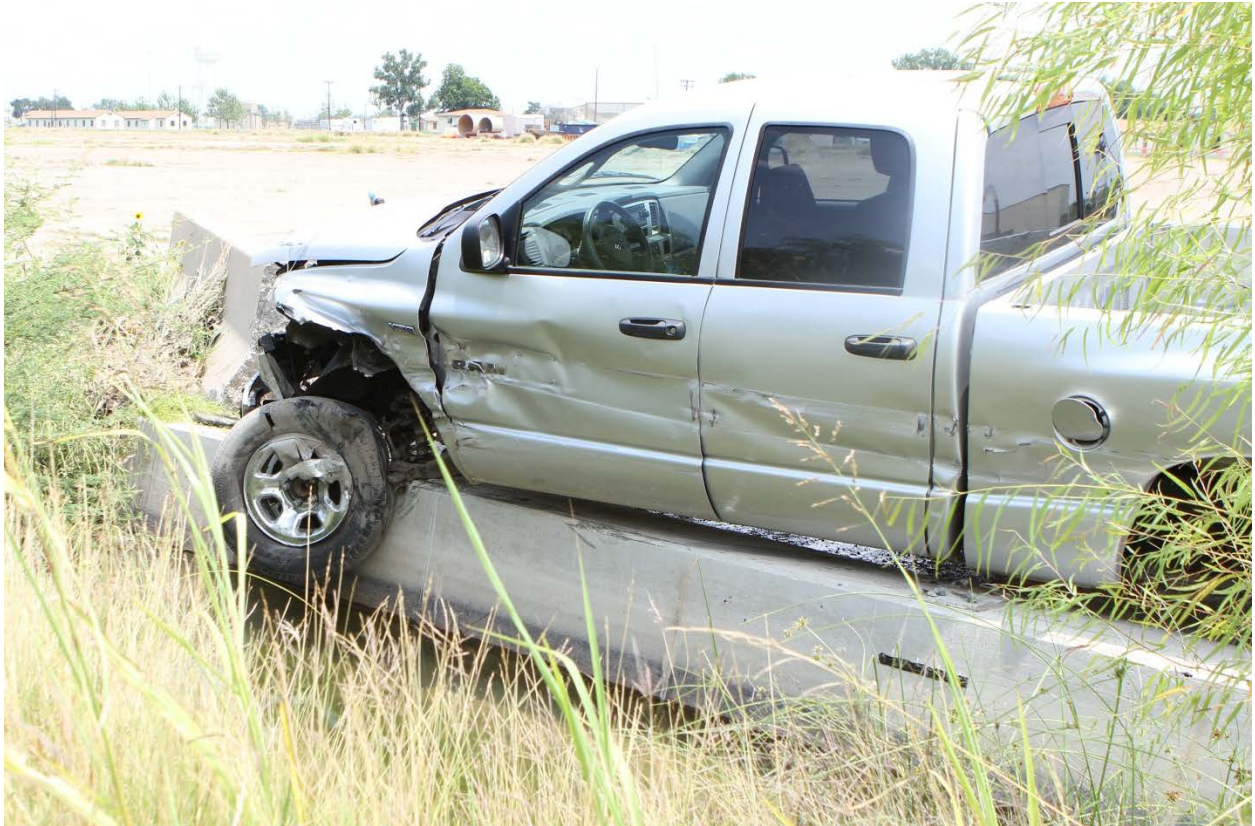
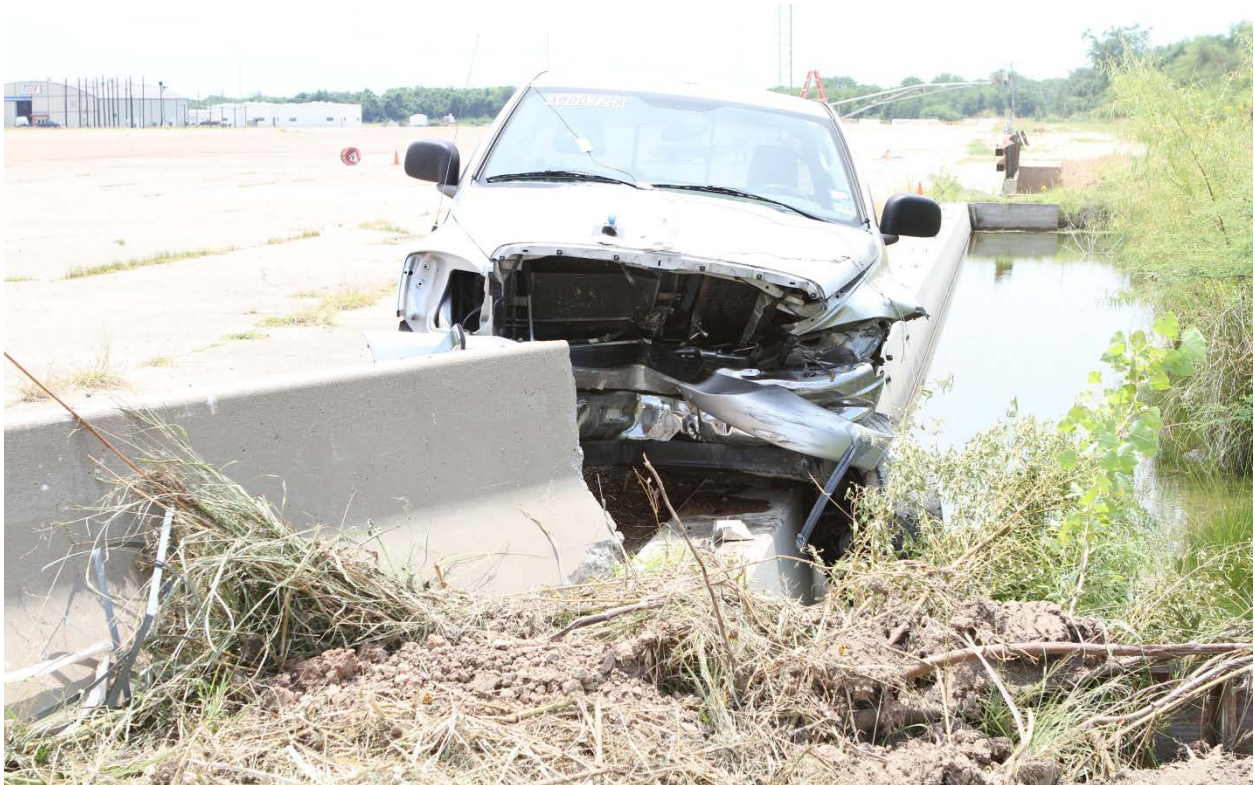
**Figure 6.5. Vehicle after Test No. 490022-8.**

Figure 6.5 presents damage to the 2270P vehicle. The left upper ball joint and left front upper and lower A-arms were deformed and the rear axle was broken. The front bumper, grill, hood, radiator, fan, water pump, left front fender, left front tire and wheel rim, left front door, left rear door, left rear exterior bed, left rear tire and wheel rim and rear bumper were deformed. The windshield sustained stress cracks from the right lower corner due to impact with a secondary barrier. Maximum crush to the exterior of the vehicle was not attainable due to the secondary impact. Maximum occupant compartment deformation was 0.25 inch in the left front door near occupant hip height. The floor pan and firewall were also deformed. Figure 6.6 shows photographs of the interior of the vehicle. Tables E3 and E4 in Appendix E present the exterior crush profile and occupant compartment deformations.

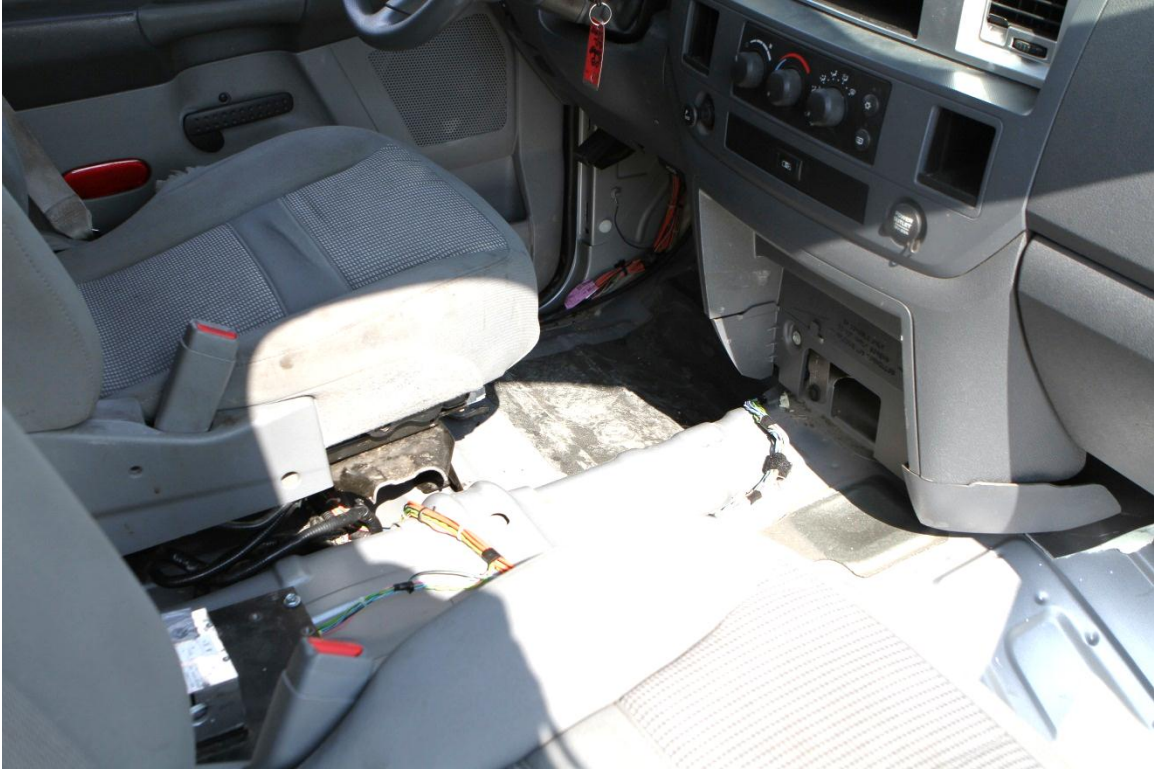
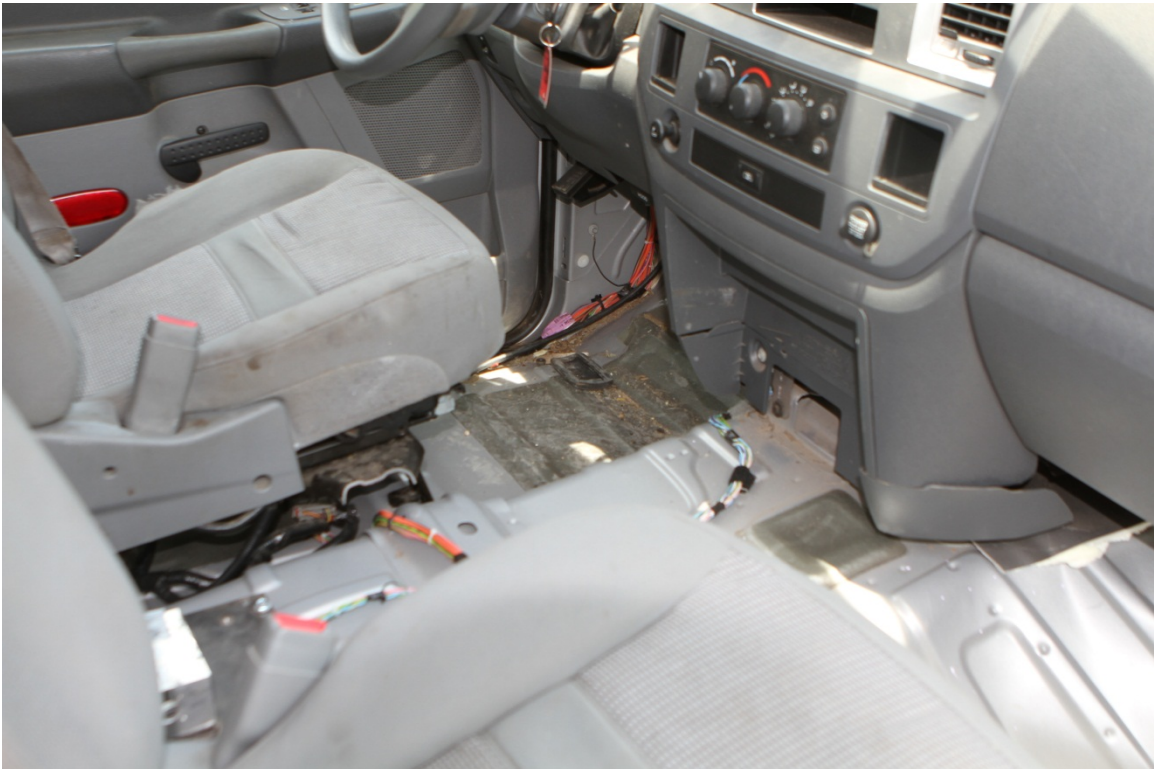
**Figure 6.6. Interior of Vehicle for Test No. 490022-8.**

Results: No detached elements, fragments, or other debris were present to penetrate or to show potential for penetrating the occupant compartment, or to present hazard to others. (PASS)  
Maximum occupant compartment deformation was 0.25 inch in the left door at occupant hip height. (PASS)

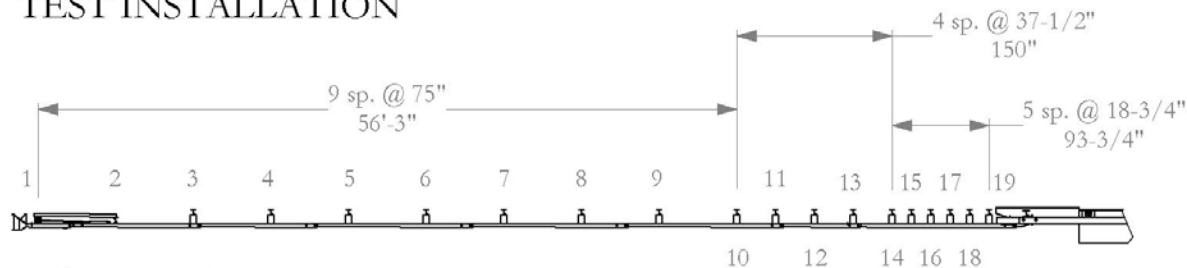
GUARDRAIL  
PLAN VIEW

- 1a. 6" x 8" x 18" routed Wood Blockouts at posts 13 - 19. 6" x 8" x 14" routed wood blockouts at posts 3 - 12. 1-3/4" long Button-head Guardrail Bolts (FBB02) at nested thrie-beam splices. 1-1/4" long Button-head Guardrail Bolts (FBB01) at all other rail splices. 10" long Button-head Guardrail Bolts (FBB03) at rail to post attachments at posts 3 - 19. Recessed Guardrail Nuts (FBB) at all button-head bolts.
- 1b. Place galvanized rectangular washers (FWR03) under Guardrail Nuts at Thrie-beam to Terminal Splice.
- 1c. Only one Rail Bolt is at post 13, at the top slot.
- 1d. Rail terminal is typical ET terminal with CRP Anchor Post.
- 1e. See attached T131-RC drawing for Bridge Deck and Rail details.

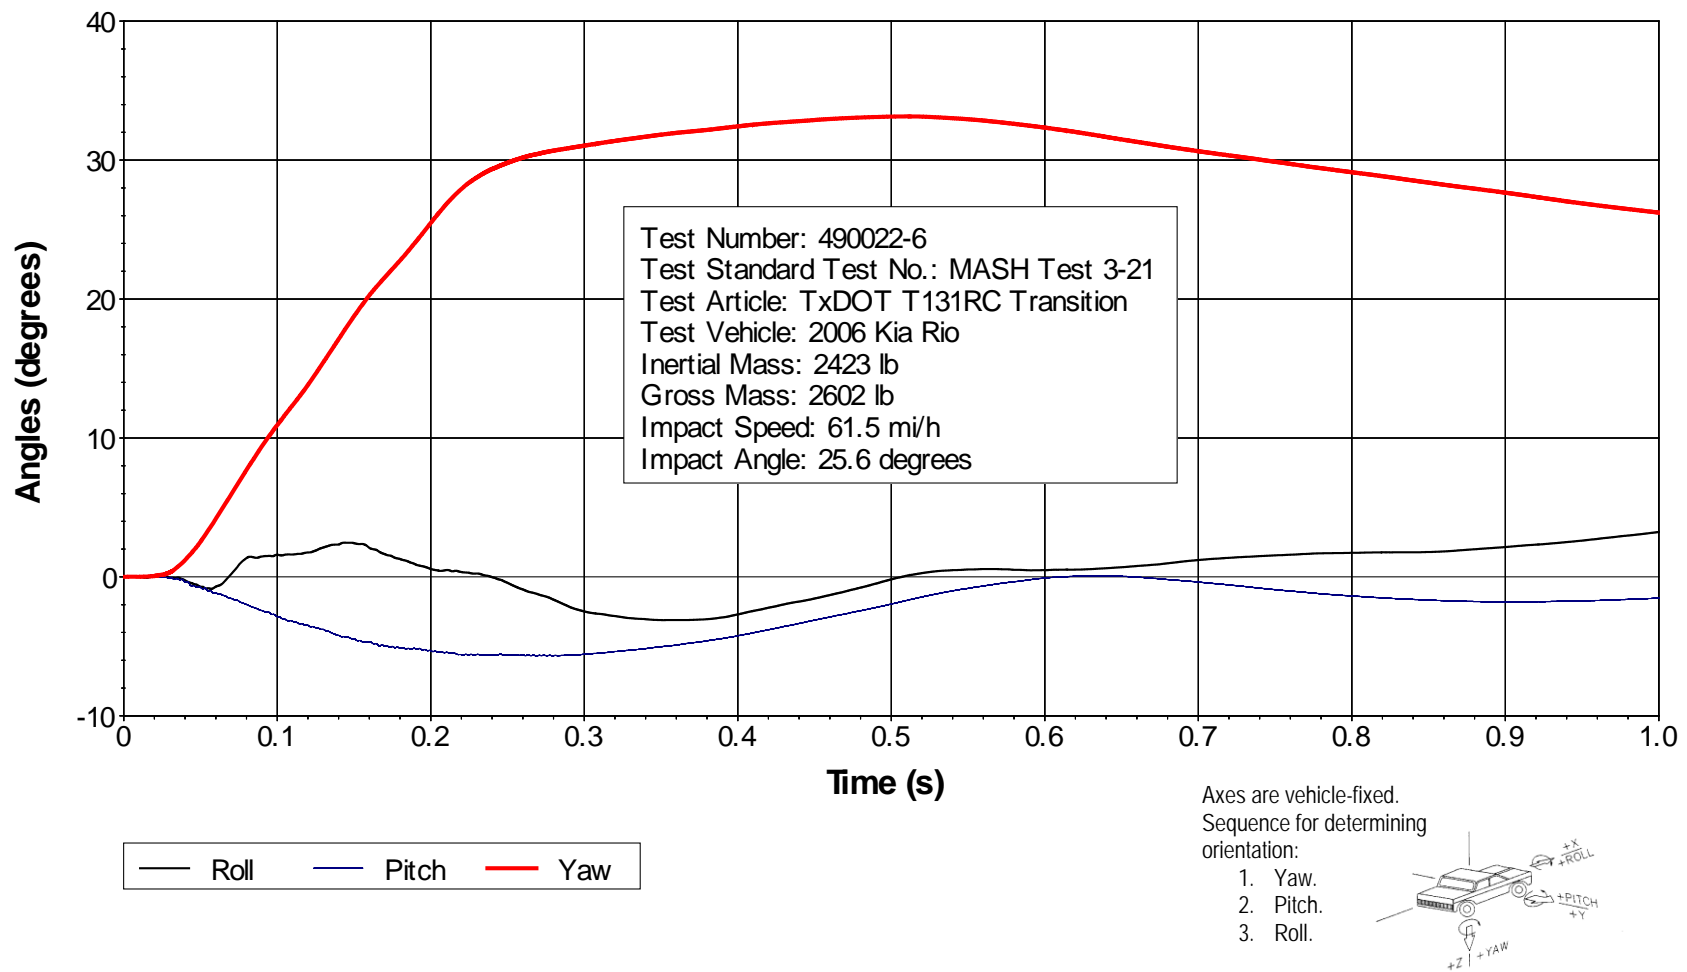
Figure D3. Vehicle Angular Displacements for Test No. 490022-6.

Data from the accelerometer, located at the vehicle center of gravity, were digitized for evaluation of occupant risk. In the longitudinal direction, the occupant impact velocity was 21.0 ft/s at 0.080 s, the highest 0.010-s occupant ridedown acceleration was 6.1 Gs from 0.083 to 0.093 s, and the maximum 0.050-s average acceleration was -10.8 Gs between 0.023 and 0.073 s. In the lateral direction, the occupant impact velocity was 27.6 ft/s at 0.080 s, the highest 0.010-s occupant ridedown acceleration was 6.3 Gs from 0.118 to 0.128 s, and the maximum 0.050-s average was 15.3 Gs between 0.025 and 0.075 s. Theoretical Head Impact Velocity (THIV) was 37.7 km/h or 10.5 m/s at 0.078 s; Post-Impact Head Decelerations (PHD) was 6.9 Gs between 0.117 and 0.127 s; and Acceleration Severity Index (ASI) was 1.92 between 0.025 and 0.075 s. Figure 5.6 summarizes these data and other pertinent information from the test. Vehicle angular displacements and accelerations versus time traces are presented in Appendix D, Figures D3 through D9.

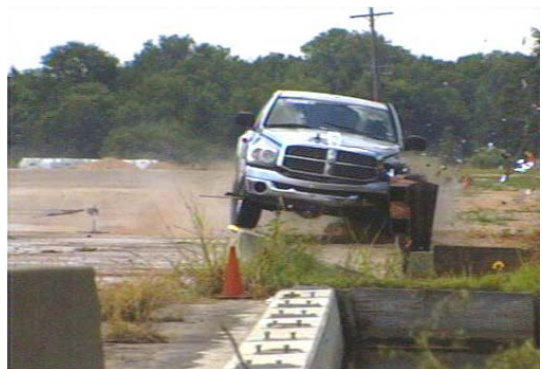
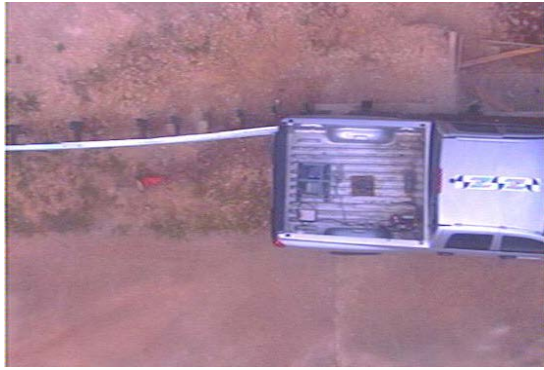
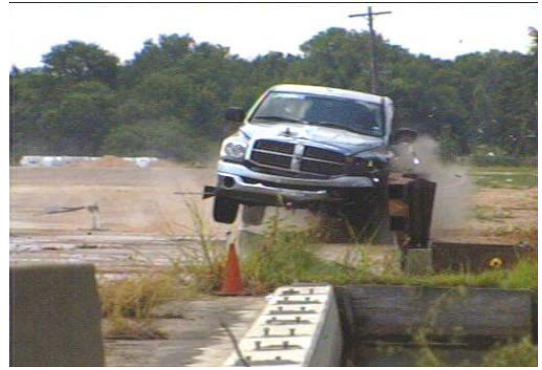
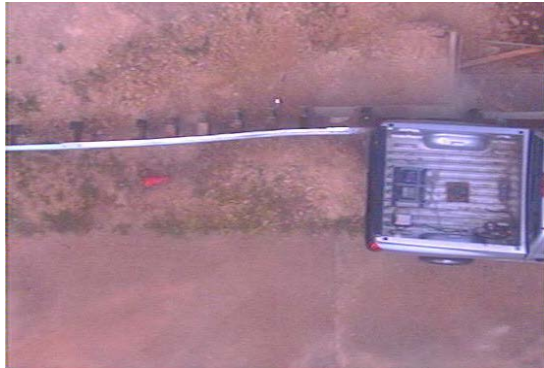
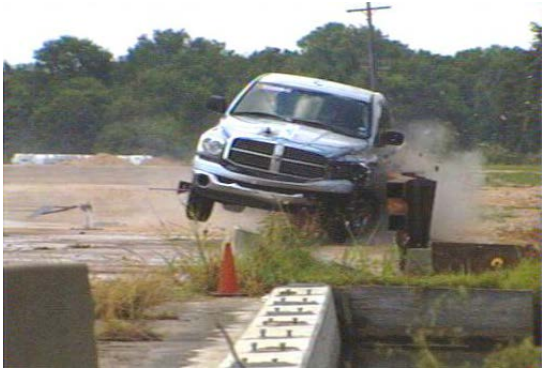
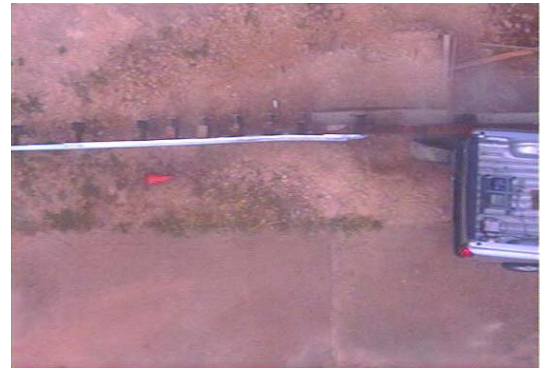
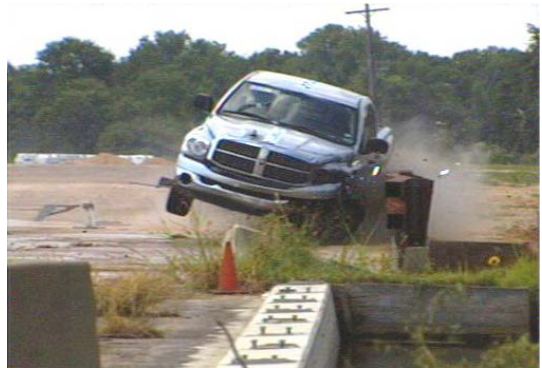
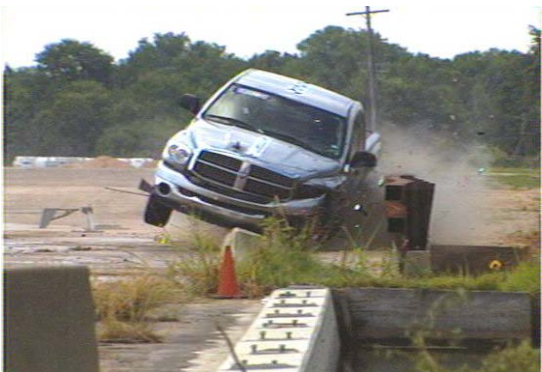
**Figure E1. Sequential Photographs for Test No. 490022-8  
(Overhead and Frontal Views).**

**Figure E1. Sequential Photographs for Test No. 490022-8  
(Overhead and Frontal Views) (continued).**

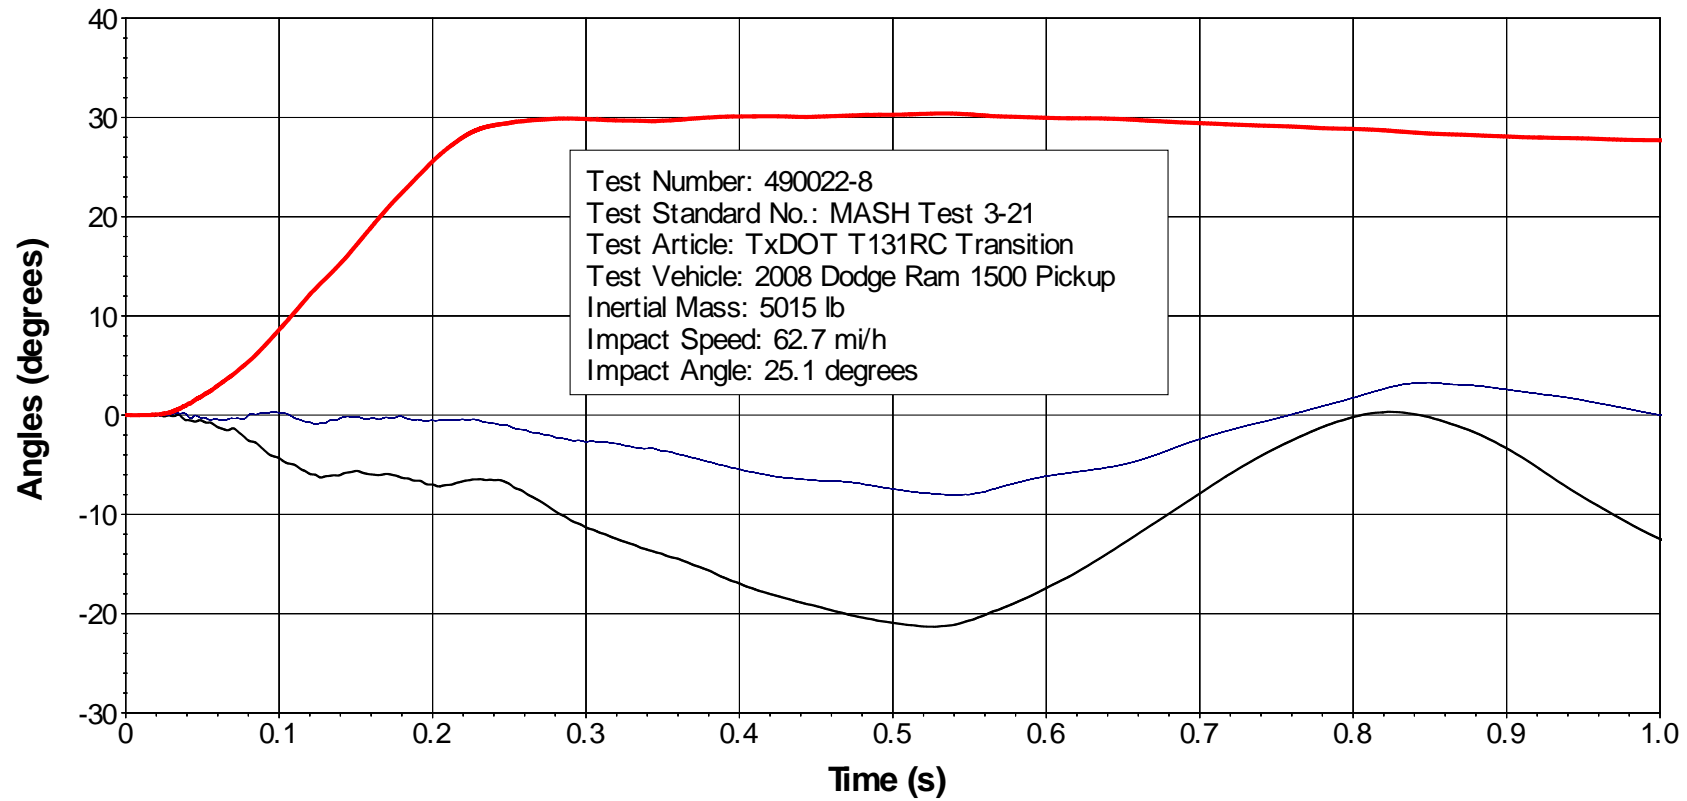
Figure E2. Vehicle Angular Displacements for Test No. 490022-8.

Data from the accelerometer, located at the vehicle center of gravity, were digitized for evaluation of occupant risk. In the longitudinal direction, the occupant impact velocity was 18.4 ft/s at 0.092 s, the highest 0.010-s occupant ridedown acceleration was 6.6 Gs from 0.120 to 0.130 s, and the maximum 0.050-s average acceleration was -8.0 Gs between 0.040 and 0.090 s. In the lateral direction, the occupant impact velocity was 23.6 ft/s at 0.092 s, the highest 0.010-s occupant ridedown acceleration was 9.4 Gs from 0.221 to 0.231 s, and the maximum 0.050-s average was 12.4 Gs between 0.030 and 0.080 s. Theoretical Head Impact Velocity (THIV) was 32.4 km/h or 9.0 m/s at 0.090 s; Post-Impact Head Decelerations (PHD) was 9.5 Gs between 0.221 and 0.231 s; and Acceleration Severity Index (ASI) was 1.52 between 0.030 and 0.080 s. Figure 6.7 summarizes these data and other pertinent information from the test. Vehicle angular displacements and accelerations versus time traces are presented in Appendix E, Figures E2 through E8.
