MID-AMERICA  
TRANSPORTATION CENTER

Report # TRP-03-275-12

## Cable Median Barrier Failure Analysis and Prevention

MwRSF Research Report No. TRP-03-275-12

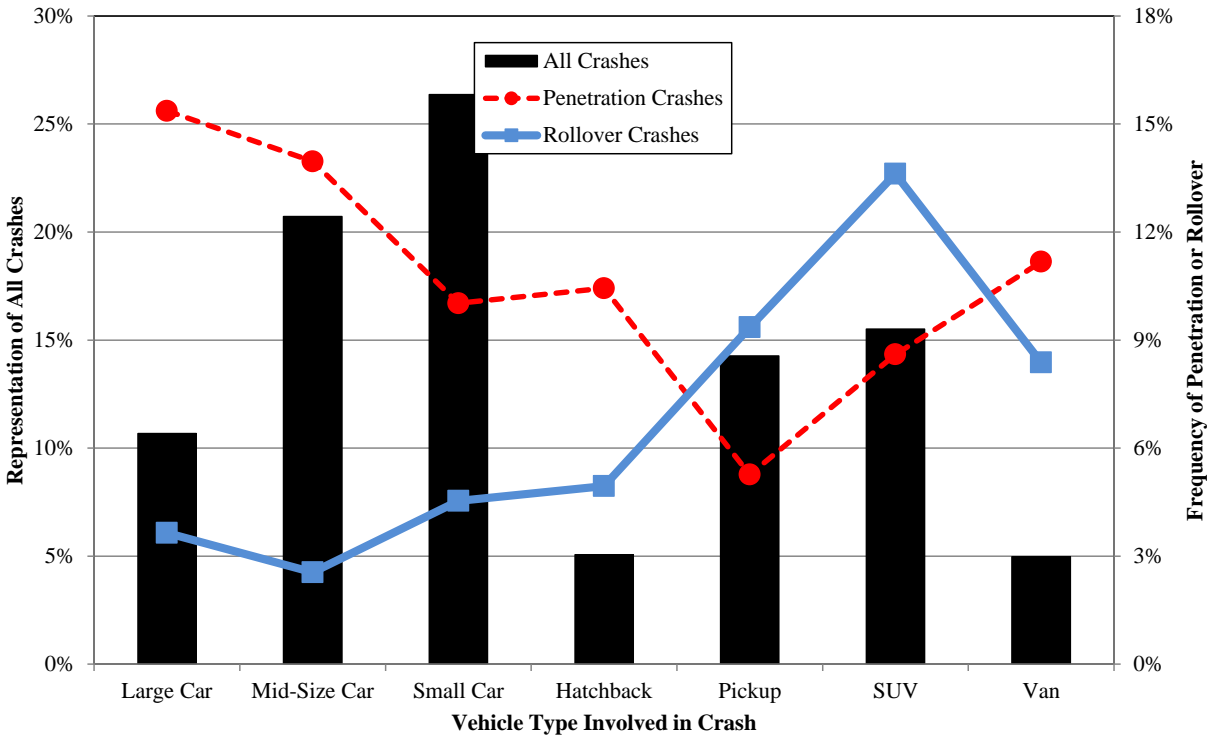
Figure 8. Frequency of Barrier Failure by Vehicle Type

Penetration and rollover occurrence was plotted by vehicle type, and indicated varying susceptibility to certain types of failure mechanisms. For example, mid-size cars had the highest total contribution of penetrations by vehicle type, but mid-size cars penetrated through the barrier less frequently than large cars, on a per-crash basis. Alternatively, large cars represented fewer numbers of penetrations than mid-size or small cars, pickup trucks, or SUVs, but large cars had the highest rates of penetration of any passenger vehicle.

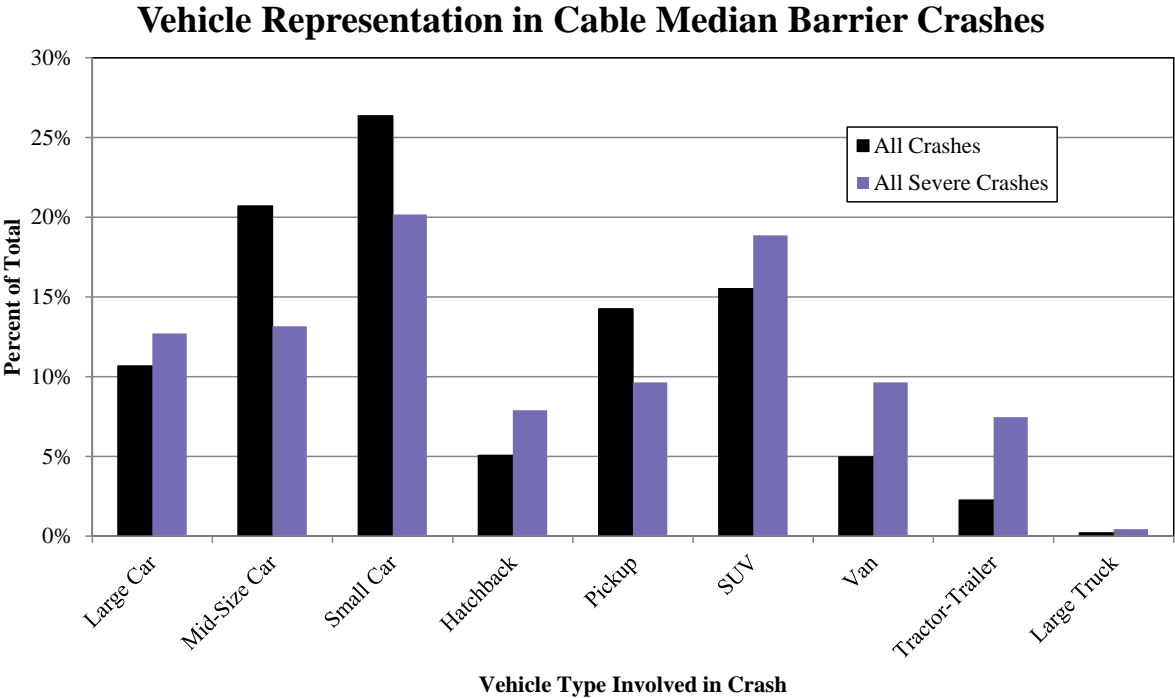
Figure 9. Risk of A+K Crash by Vehicle Type

A comparison of vehicles involved in severe crashes indicated that the serious injury and fatal crashes were distributed between all vehicle classes, as shown in Figure 9. The largest proportionate risk of serious injury or fatality occurred with hatchback or station wagon cars. These vehicles were frequently older vehicles with lower safety ratings than vehicles currently being produced. Also, SUV, van, and large car crashes were generally more severe than mid-size and small car crashes as well as pickup truck crashes. Only tractor-trailer crashes, with a high number of cross-median crashes and rollovers, had higher average severity for modern vehicles.

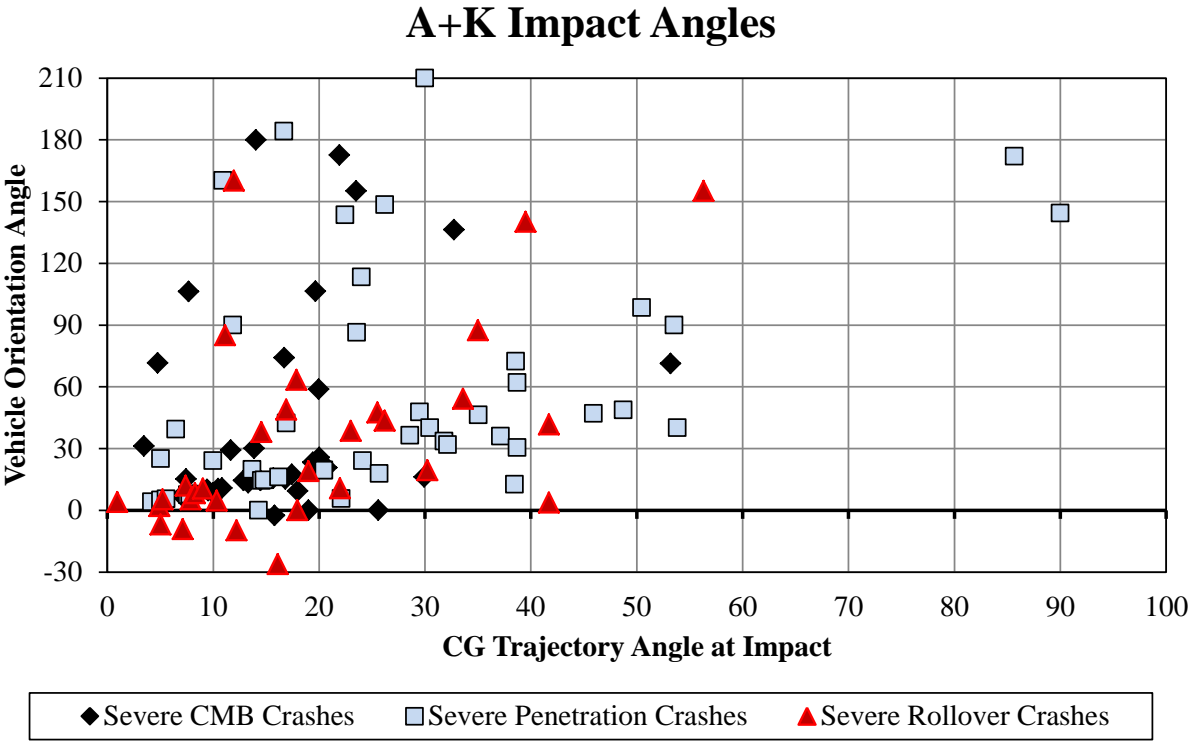
Figure 21. CG Trajectory and Orientation Angles by Crash Result

The CG trajectory and orientation angle plot was segregated by crash result into “Penetration”, “Rollover”, or “Other” categories. The segregated database is shown in Figure 21, and a detail view for vehicle orientation angles greater than -10 degrees is shown in Figure 22.

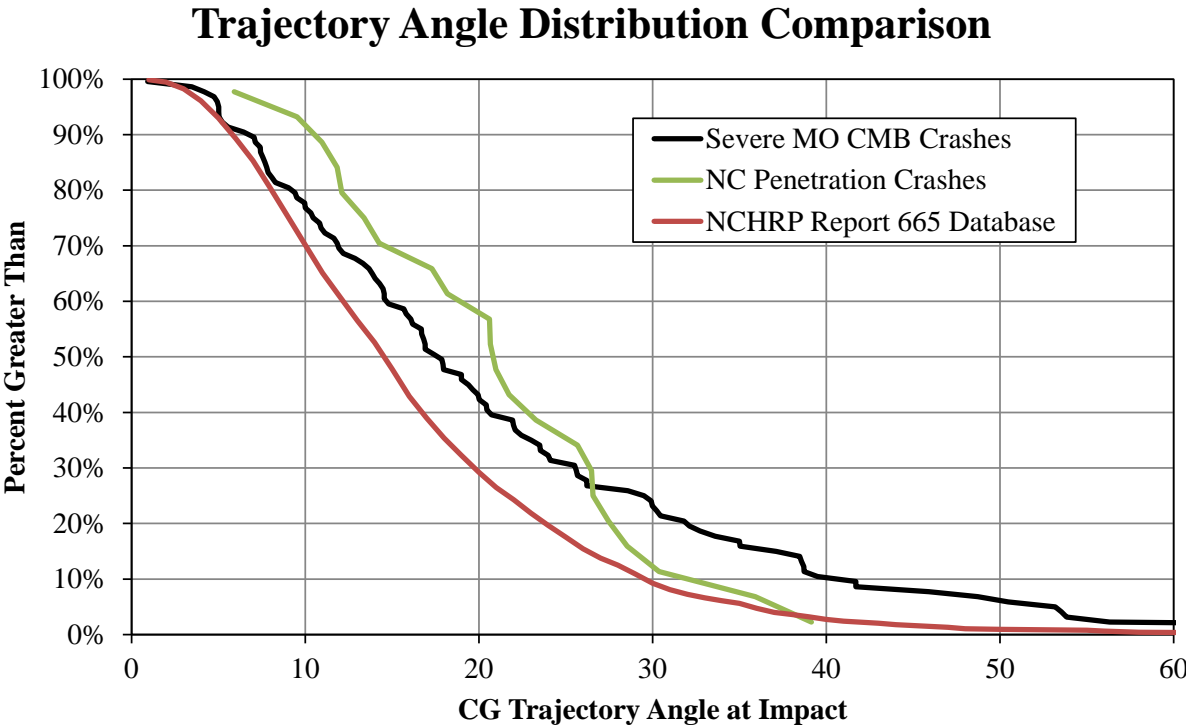
Figure 25. Comparison of North Carolina, Missouri, and NCHRP Crashes

The subset of crashes investigated, totaling 22 in all, were plotted and compared with the severe crashes in Missouri, as shown in Figure 25. The North Carolina sample also tended toward higher angles than the NCHRP 665 crashes, but the sample size was too small to make judgments about the distribution. Preliminary attempts to determine correlations using chi-squared tests were not statistically significant but trended toward significance (i.e., p values between 0.4 and 0.7), and it is likely that the distributions would be similar if additional data were obtained.

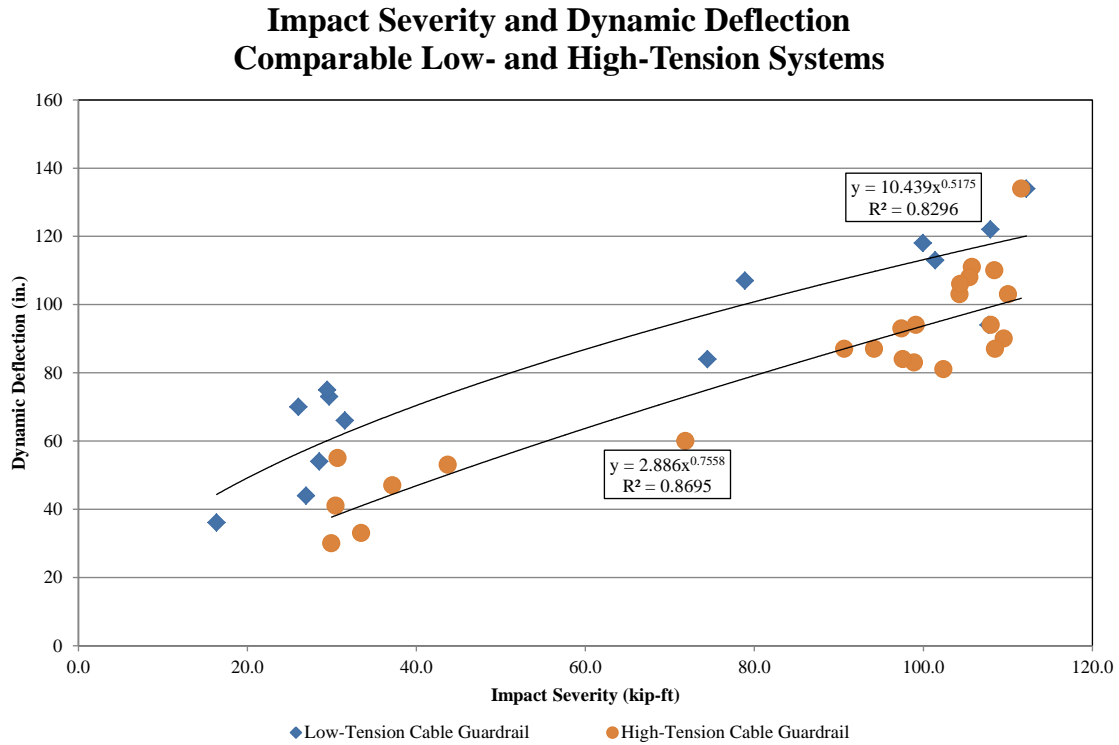
Figure 45. Dynamic Deflection Comparison, Low- and High-Tension Cable Barriers

status for use on the NHS, as well as testing agency reports. Results were included through 2010 and are shown in Figure 45.

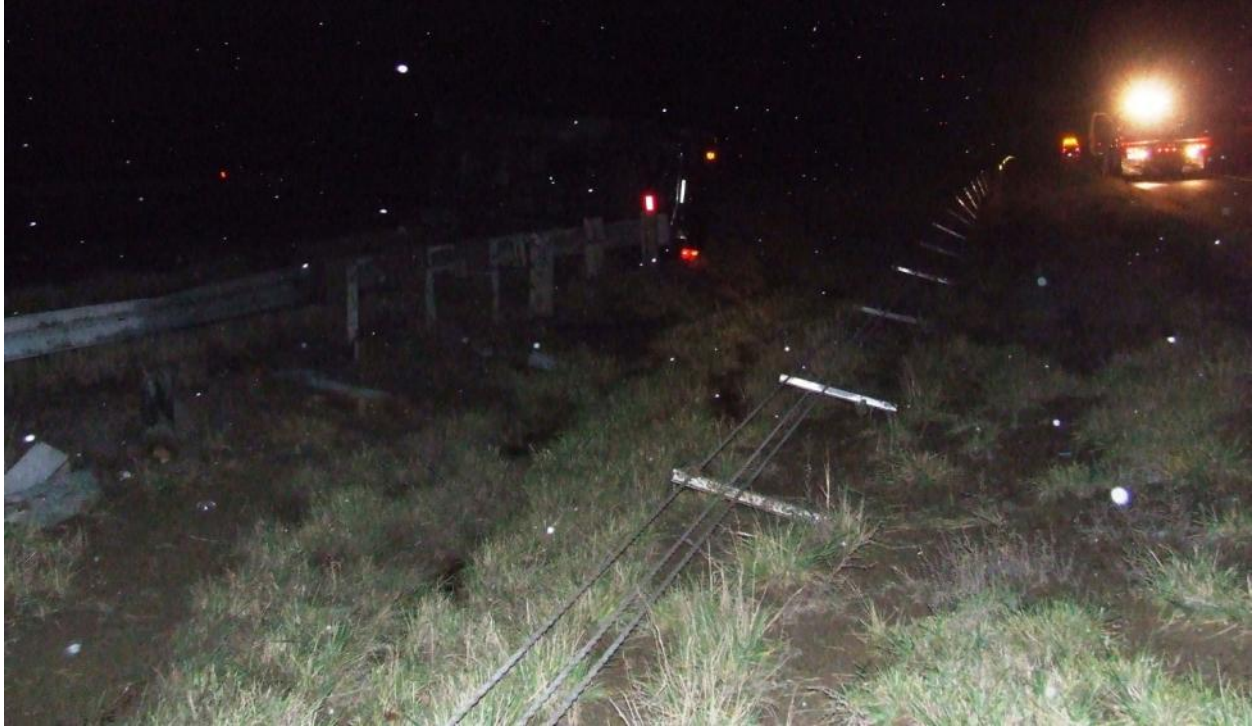
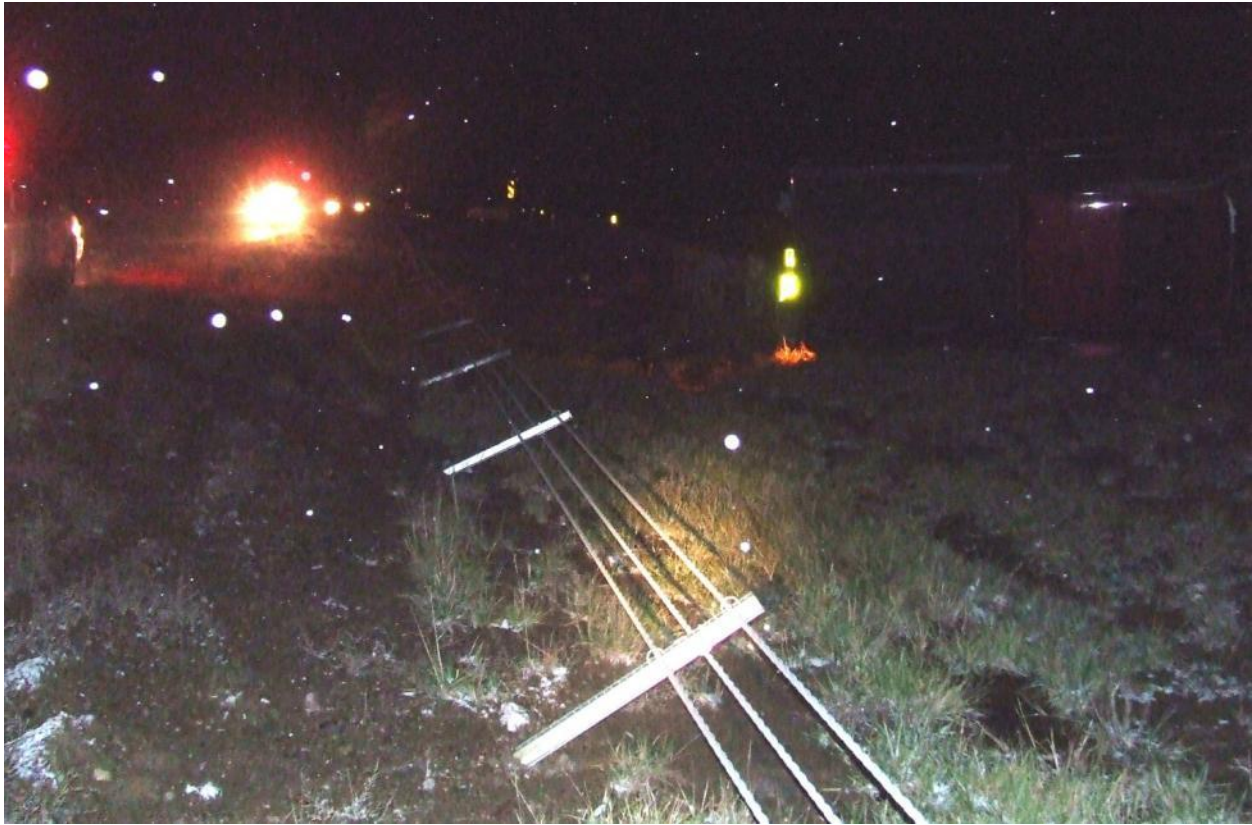
Figure 46. Penetration Crash Caused by Strong Cable-to-Post Attachment

An example of a crash in which the strong cable-to-post attachments contributed to vehicular penetration through the barrier is shown in Figures 46 and 47. In this crash, an impacting pickup lost control due to slick roadways and departed the roadway into the median. The CG trajectory angle was approximately 24 degrees, and the orientation angle of the vehicle at impact was approximately 110 degrees. The vehicle impacted the cables and began to redirect. The first few impacted posts were pulled out of the ground as the pickup was redirecting, and the strength of the cable-to-post attachments retained the posts on the cables. Due to the high orientation angle at impact, the cables did not locally crush the fender at the front of the vehicle. This crush typically fostered proper cable-vehicle interaction and was commonly associated with

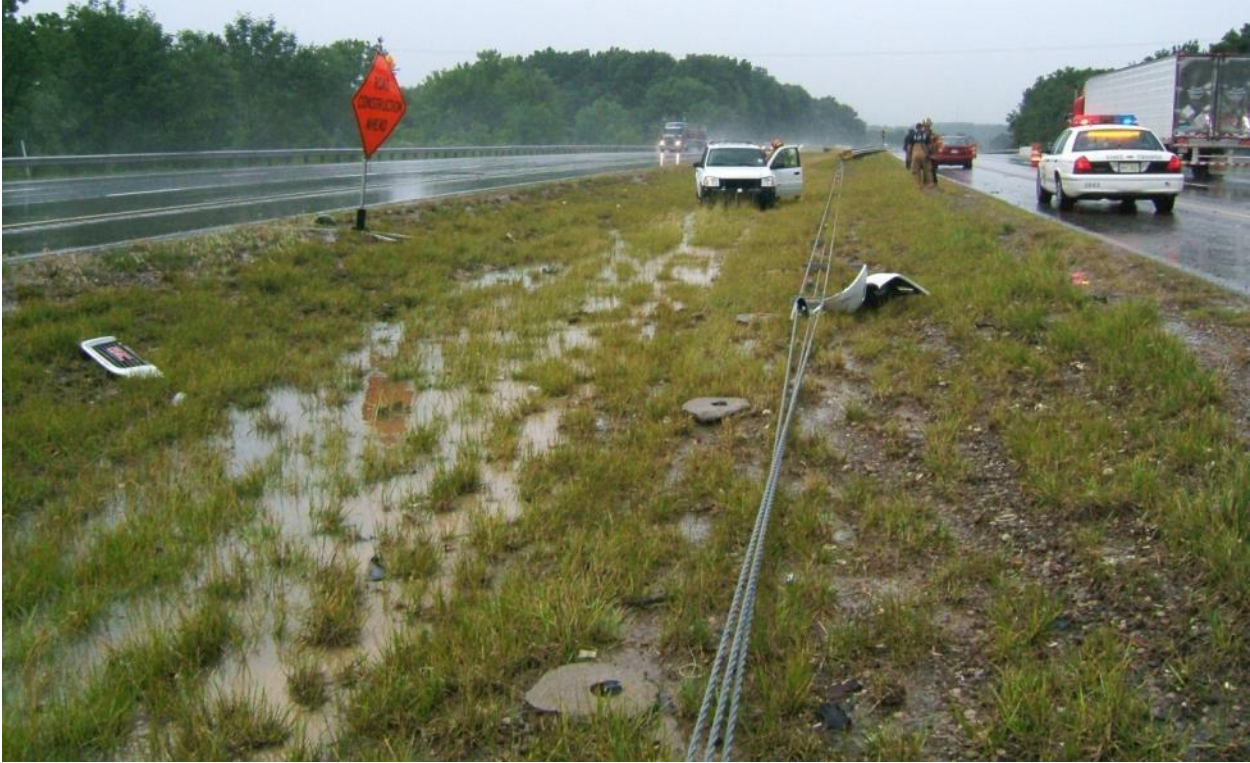
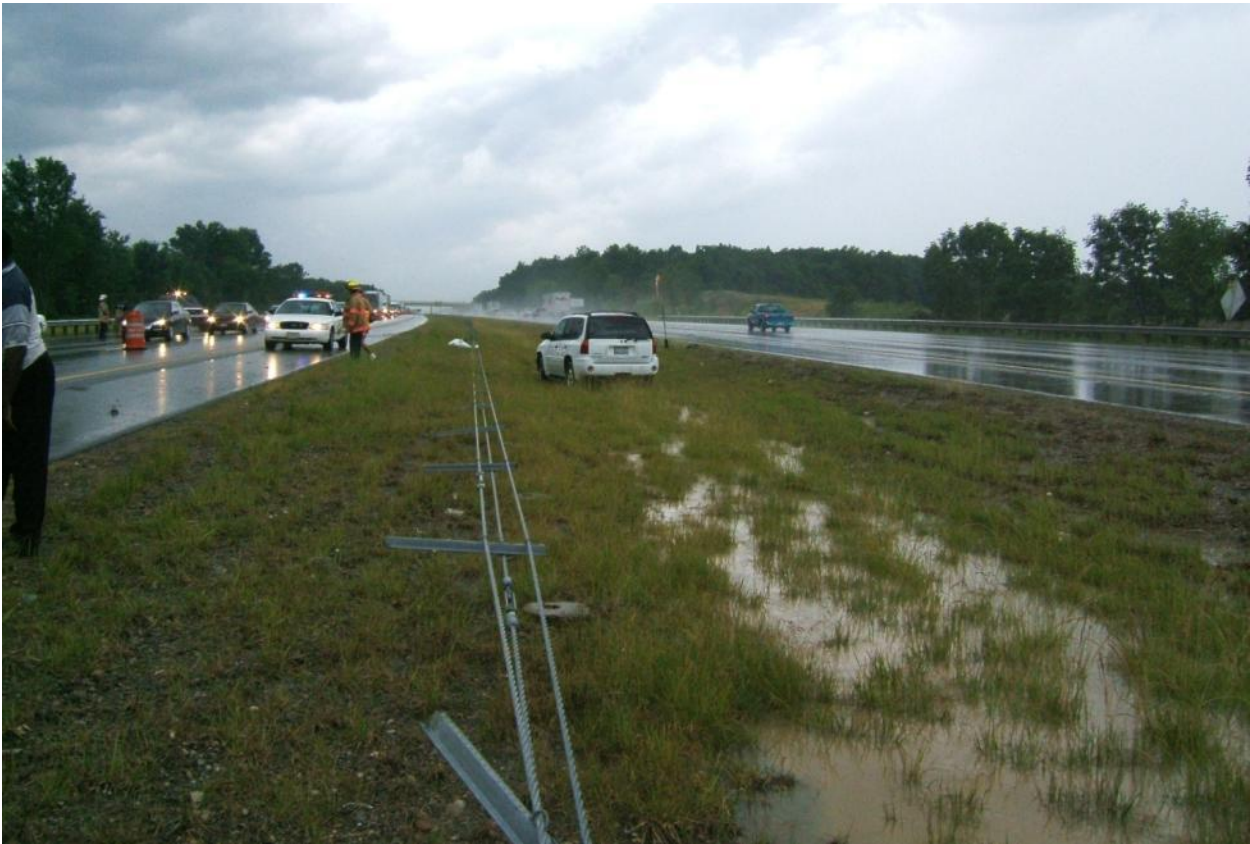
Figure 48. Override Penetration Crash Caused by Strong Cable-to-Post Attachment

The bumper cover separation occurred moments before the vehicle overrode the cable barrier system. The bumper cover was displaced downward, allowing the top cable to engage the expanding gap at the top corner of the bumper cover. The large frictional force generated by the accumulated posts in front of the vehicle pushed the cable downward, slowing the vehicle rapidly. The vehicle overrode the accumulated posts which abruptly stopped the posts from sliding along the cables, and rapidly pulled the cables downward. As the cables dropped, they tore the bumper cover from the vehicle. The vehicle then possibly overran the bumper cover. The

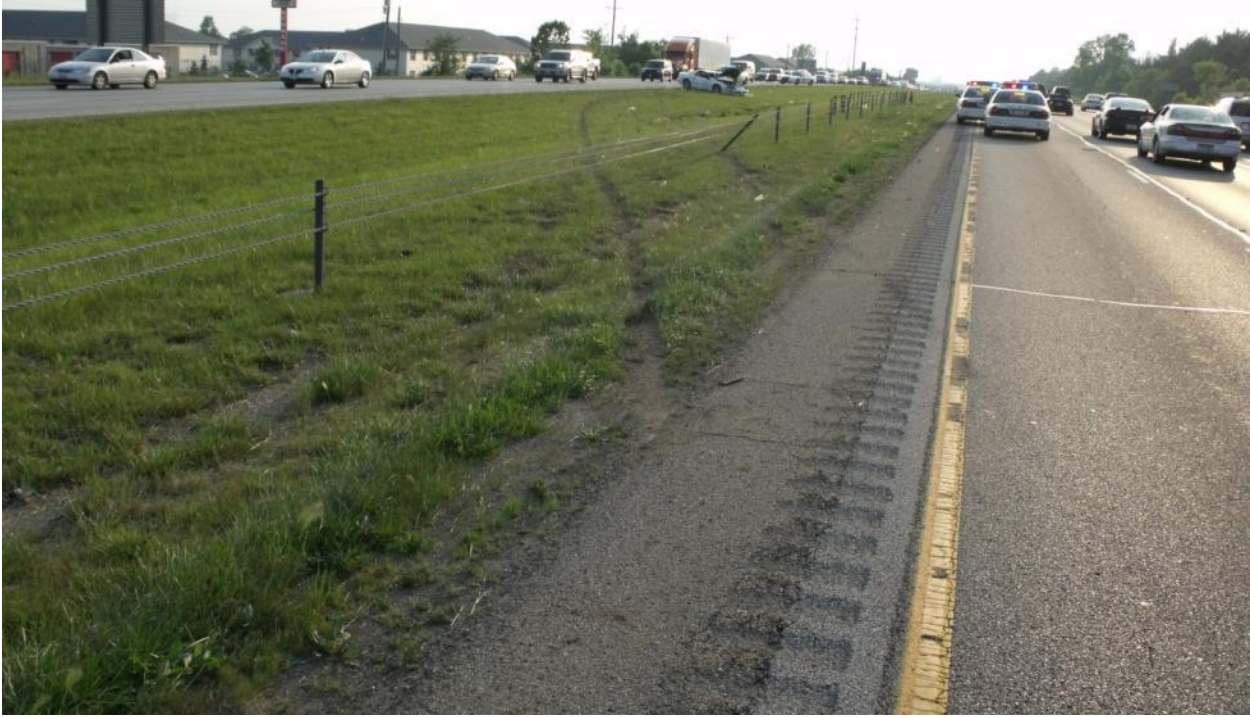
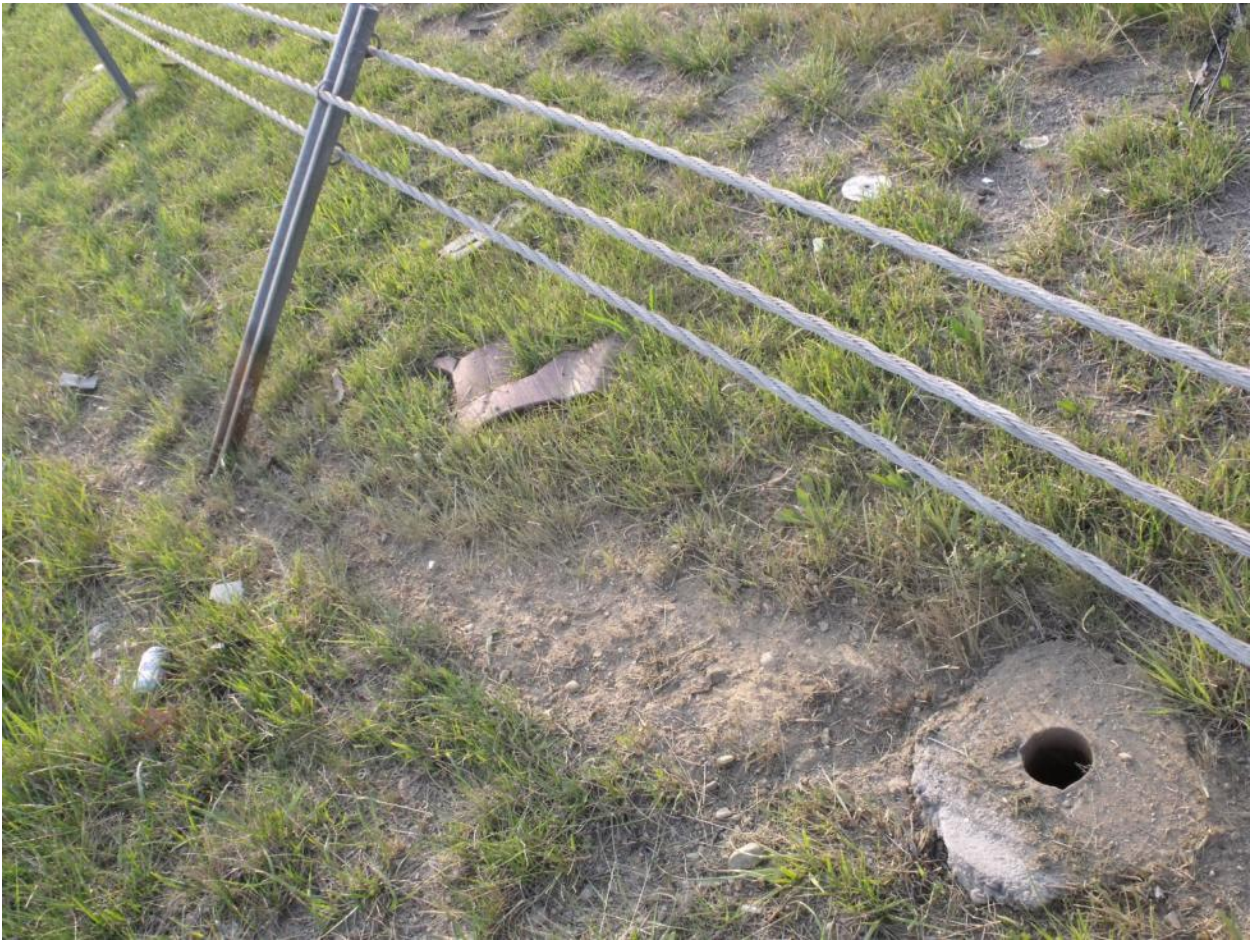
Figure 50. Prying Penetration Crash on Nucor NU-CABLE Barrier

In a second prying case, a 1994 Chevrolet Camaro impacted the Nucor system with a sideslip angle of approximately 90 degrees. The vehicle entered a broad-side skid in an overcorrecting condition, striking a TL-3 3-cable Nucor barrier system with 20 ft (6.1 m) post spacing. The CG trajectory angle at impact was approximately 32 degrees, and the heading angle was approximately 118 degrees. Photos of the impact are shown in Figures 50 and 51.

In this crash, the vehicle oversteered into the median to avoid contact with another vehicle on the road. The high orientation angle of the vehicle did not provide a good engagement of the cables, with the vehicle impacting its right-front corner, and the cables slipped over the bumper and leading hood corner. The pointed front end of the vehicle accentuated vertical prying. The gradual slope of the vehicle permitted the cables to slide up and over the hood and roof, crushing and tearing both the front and rear windshields.

The driver was able to regain control of the vehicle path briefly, but overcorrected in the median and slid to a stop with an orientation angle of approximately 245 degrees. The vehicle

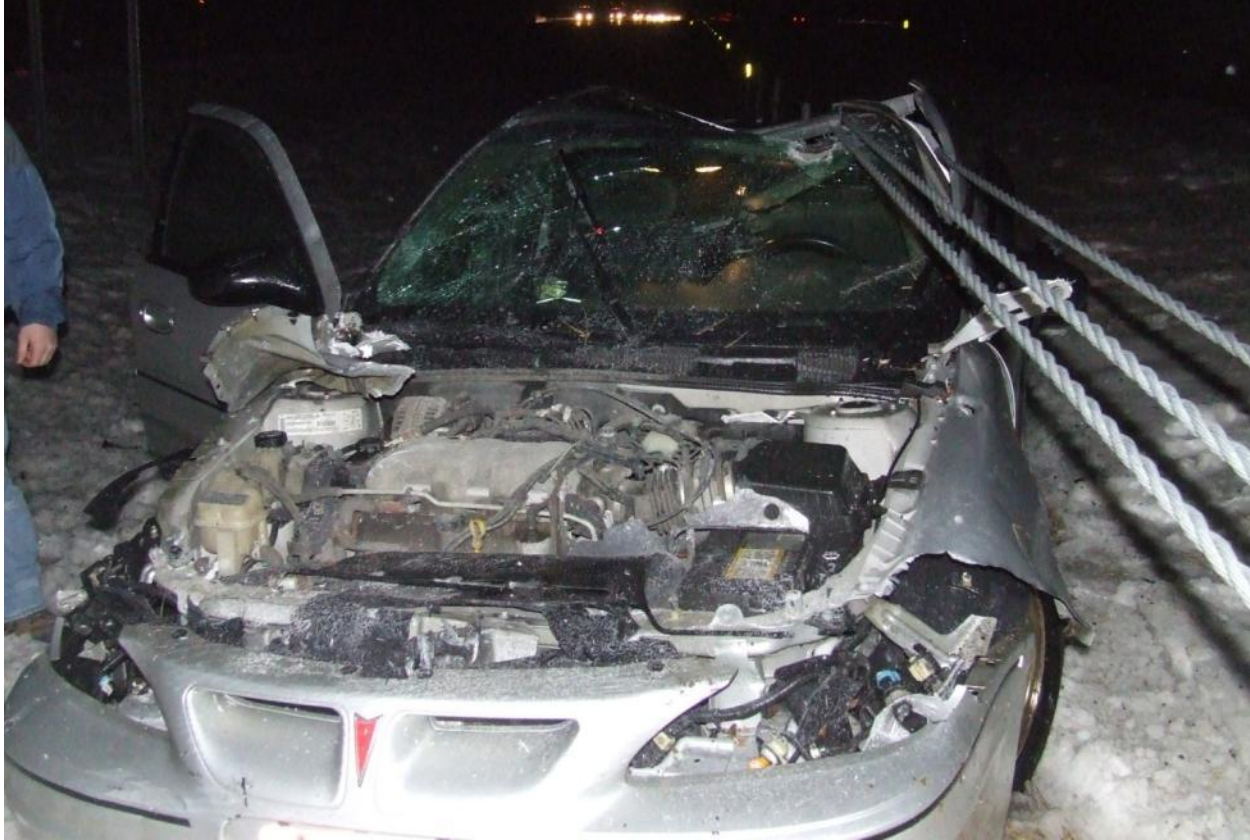
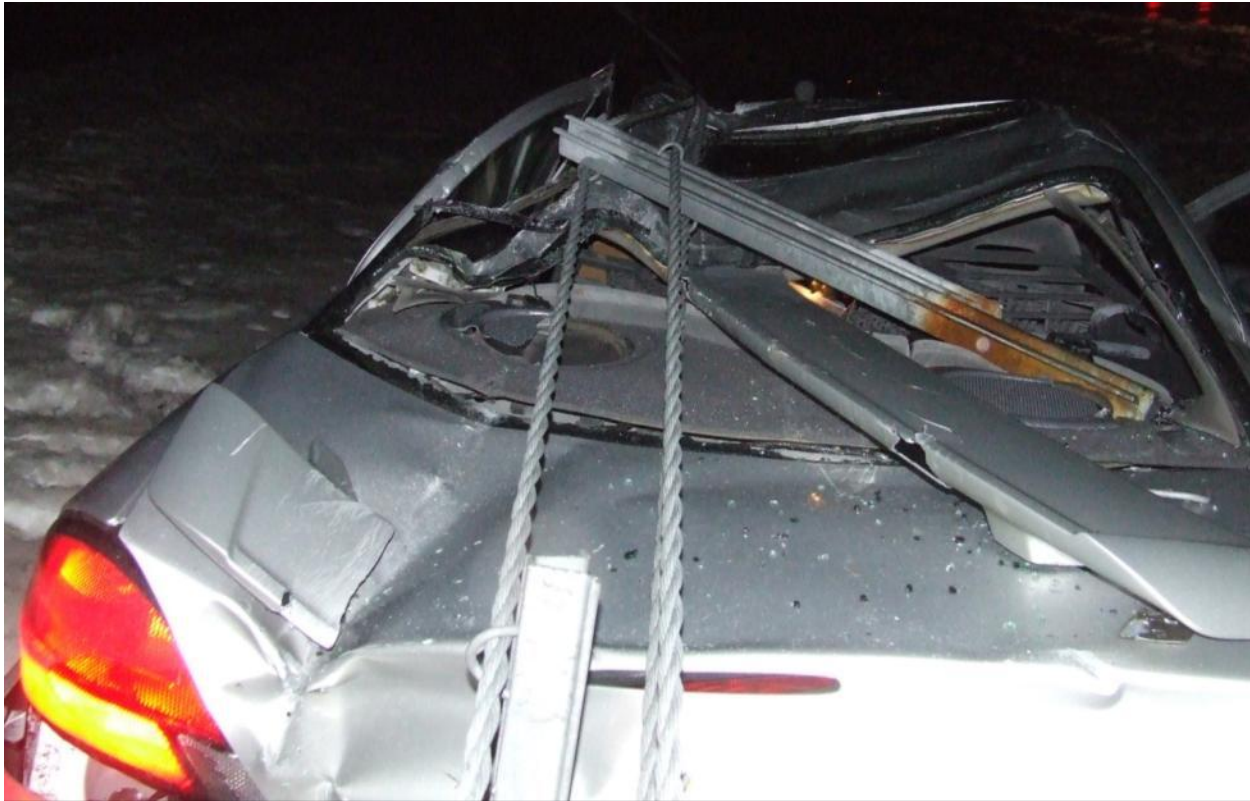
Figure 52. Potential Penetration Crash on Nucor NU-CABLE Barrier

Although the vehicle was brought to a stop in the median, the strong cable-to-post attachment could have seriously injured or killed an occupant in the back seat of the vehicle in this crash because of the retention of the post. Fortunately, no occupants were present in high-risk seat locations, and this crash resulted in only property damage. This crash result further

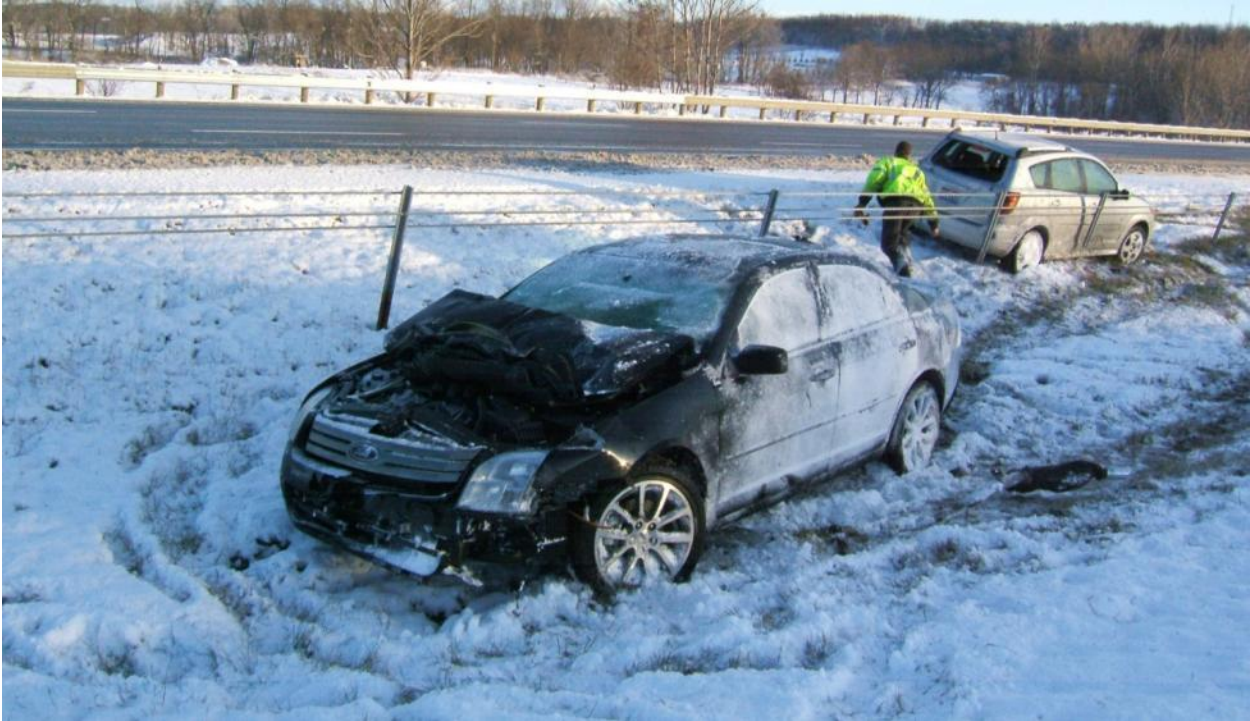
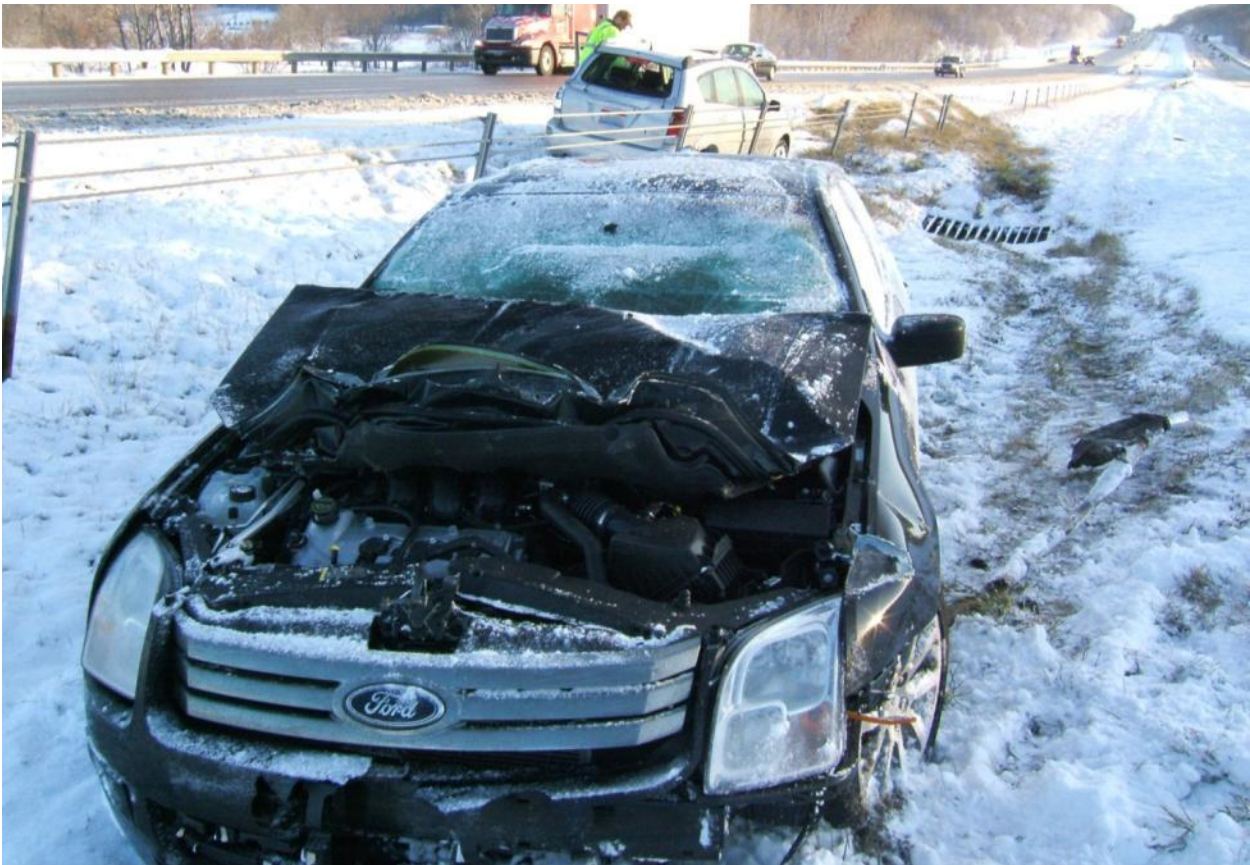
Figure 53. Diving Underride Penetration Crash on Nucor NU-CABLE Barrier

One such diving crash that resulted in a penetration involved a 2009 Ford Fusion. Photographs of the crash are shown in Figure 53. A collision occurred between the Fusion and a second vehicle in an adjacent travel lane, causing the Fusion to veer off of the roadway into the median. The vehicle was oversteering as it entered the median, but due to the approximately 5.2:1 approach slope in the median leading up to the median barrier, the vehicle's front-end suspension compressed, and the vehicle dove beneath the lower cables, forcing the cables upward. Suspension rebound lifted the cables up, crushing and folding the hood toward the windshield before fracturing the windshield. Many posts upstream and downstream from impact were pulled out of the ground due to the underride collision, rendering the system inoperable for subsequent impacts.

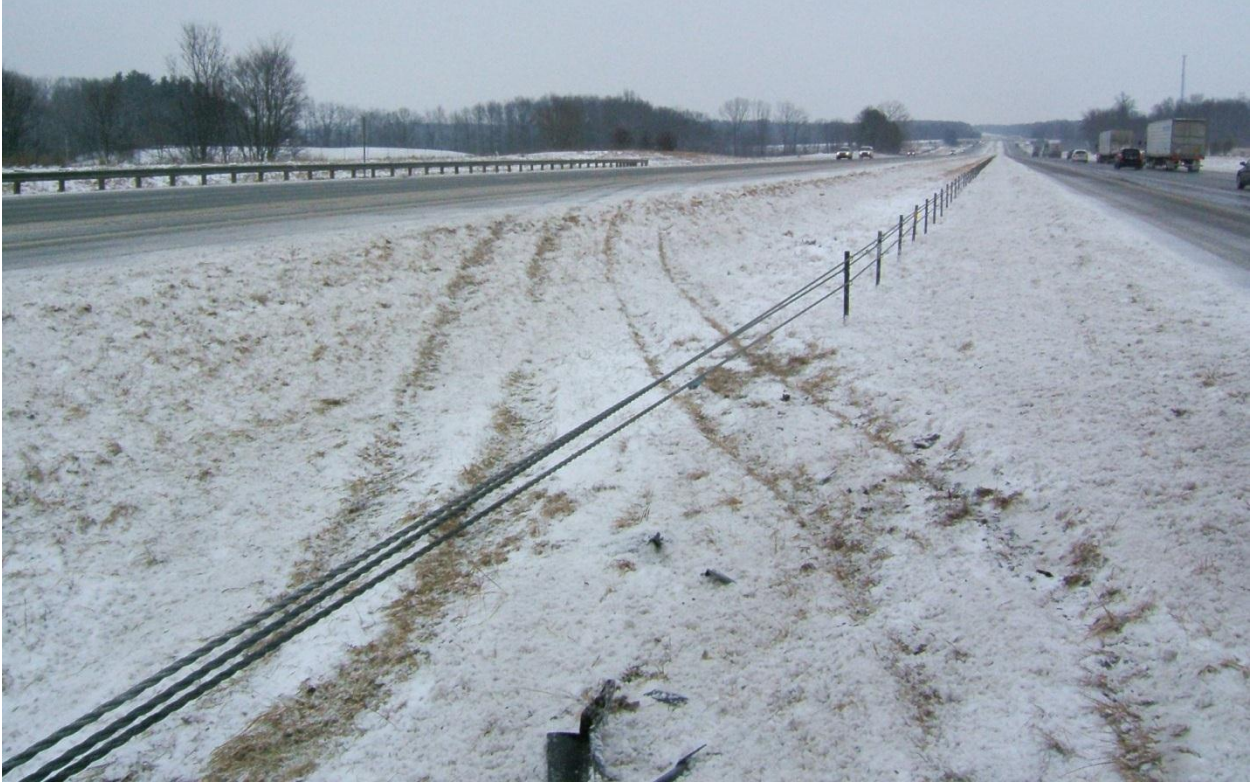
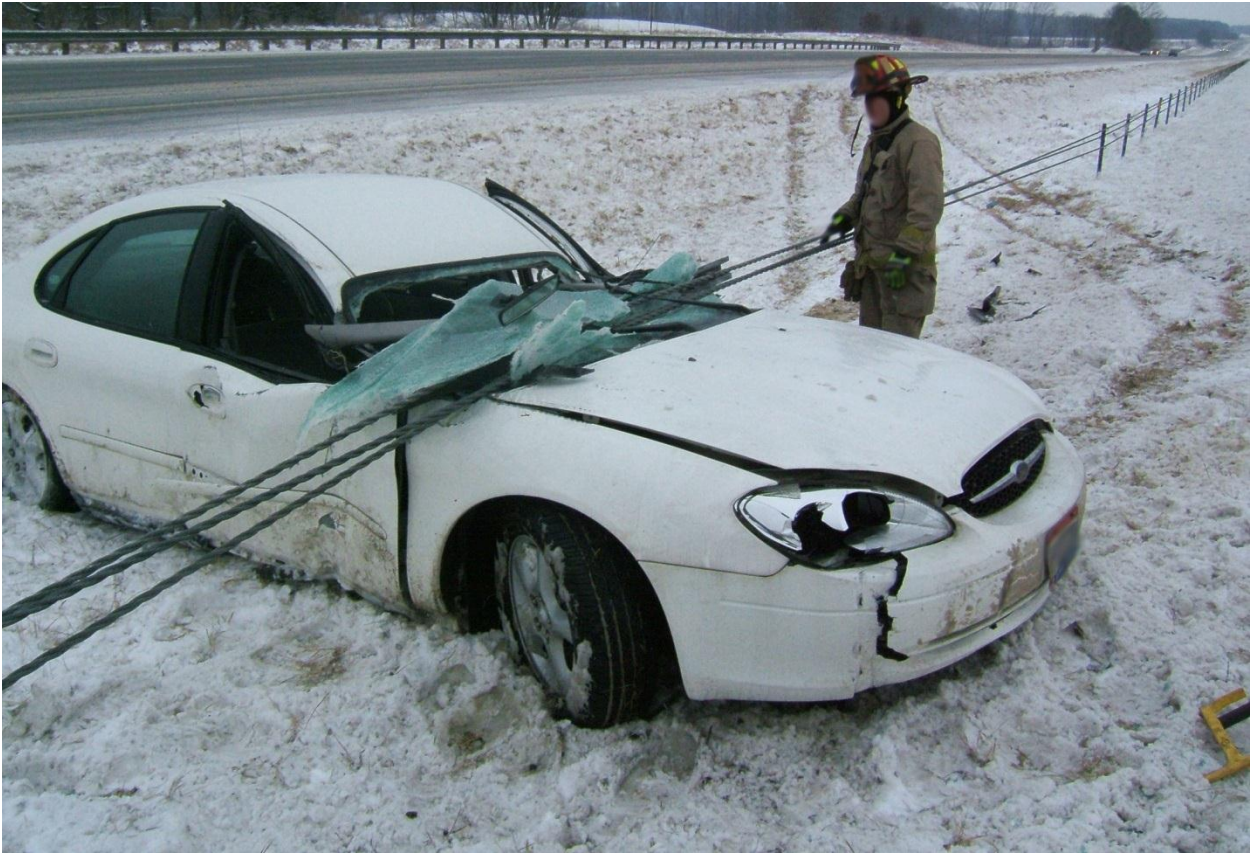
Figure 54. Diving Potential Underride Penetration Crash on Nucor NU-CABLE Barrier

A second example of a diving collision involved a 2003 Ford Taurus. Photographs from the impact are shown in Figure 54. The vehicle entered the median with an orientation angle

greater than 60 degrees and a moderately-high CG trajectory angle of approximately 21 degrees. The vehicle had lost control due to snow and slush on the road.

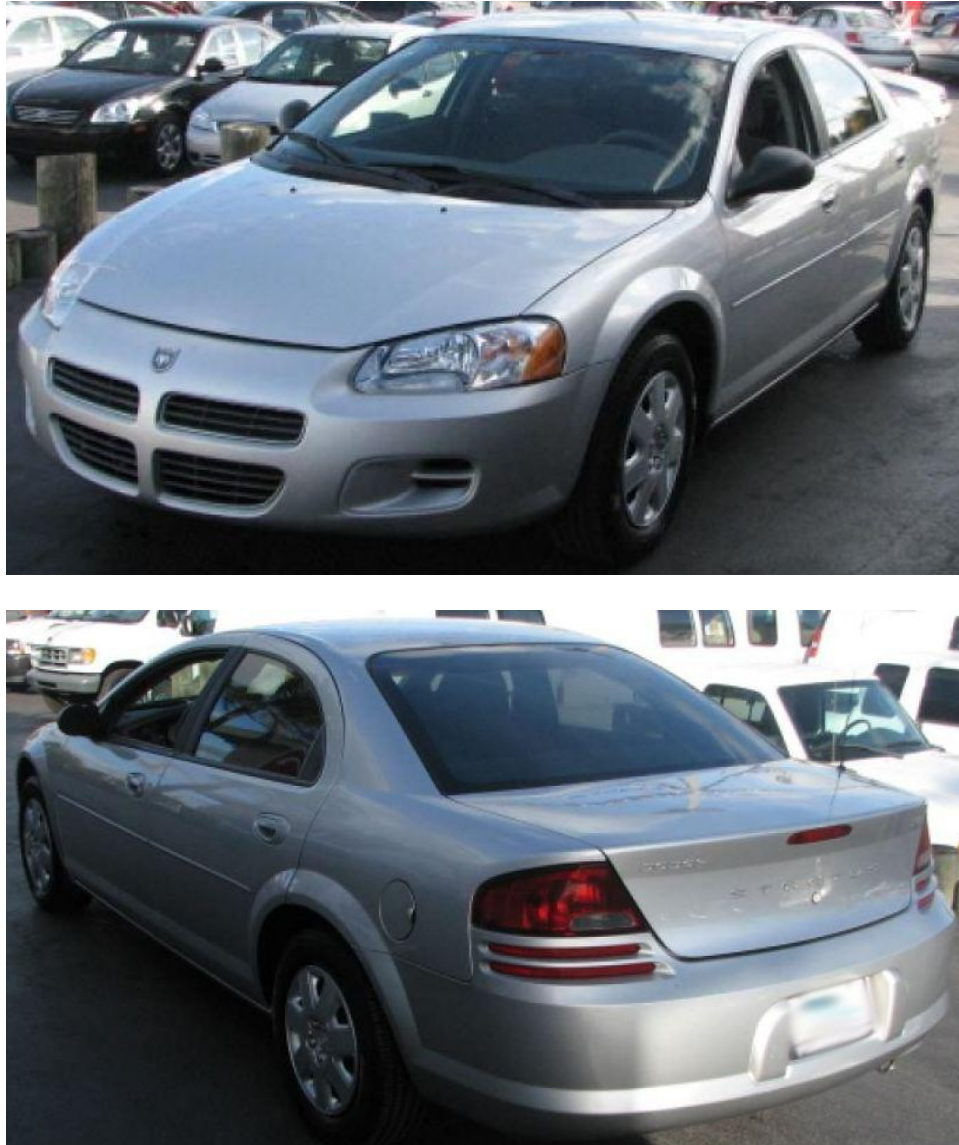
Figure 56. 2002 Dodge Stratus Similar to Vehicle Involved in High-Orientation Angle Penetration Crash [33]

The Dodge Stratus was not typically involved in penetration crashes due to some unique features. The front of the vehicle was both broad and blunt, and the sides of the vehicle were relatively flat. Typical sill heights of the windows exceed 35 in. (890 mm), whereas the ground clearance averages approximately 16 in. (406 mm). Total vehicle height averages were approximately 55 in. (1,397 mm). This height provided a large surface over which vehicle capture was possible, and also required cables to rise substantially to pass over the top of the vehicle. Furthermore, depressions around headlights and taillights improved capture tendency.

Most light to mid-size SUVs and some full-size cars were not typically involved in penetration crashes, since the broad front end combined with large bumper protrusions typically resulted in capture or rollover. One vehicle, which was involved in 21 cable median barrier crashes, but only one penetration crash, was a Dodge Stratus. The scene diagram from the penetration crash involving the 2002 Dodge Stratus is shown in Figure 55. Photographs of a 2002 Dodge Stratus, which was similar to the vehicle involved in the impact, are shown in Figure 56.

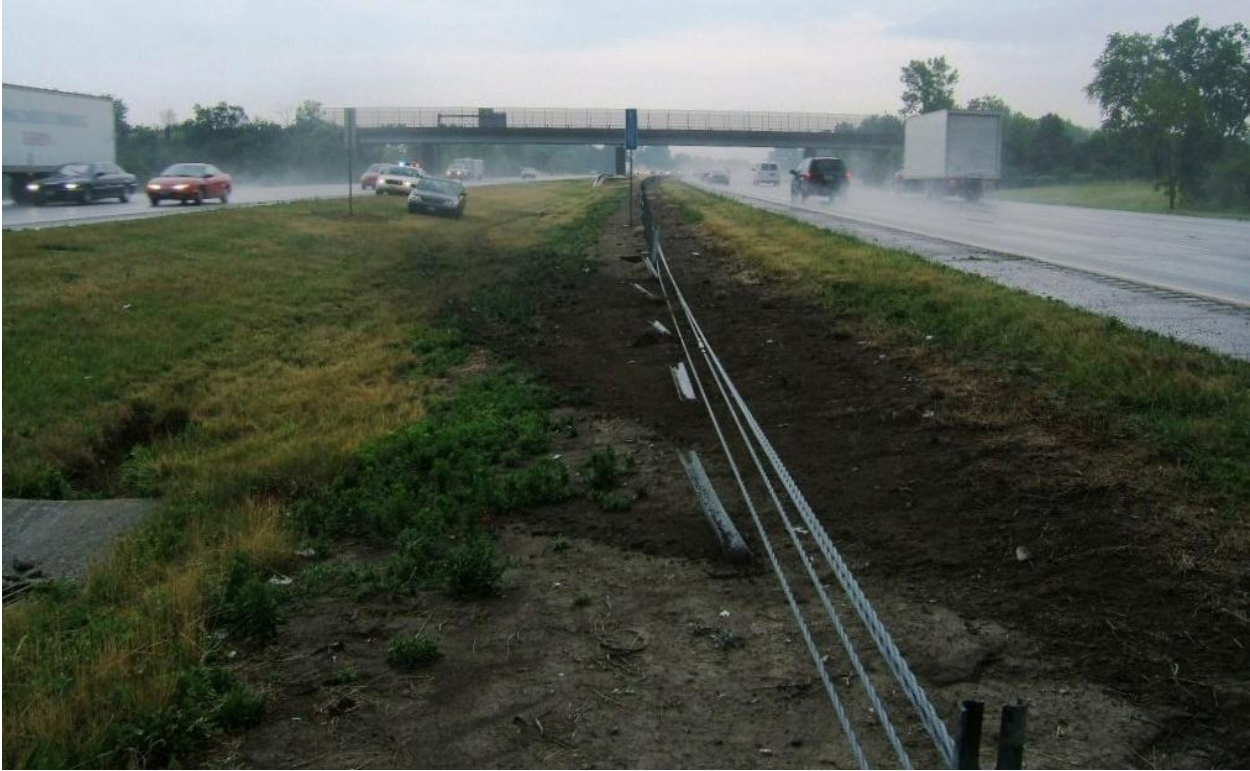
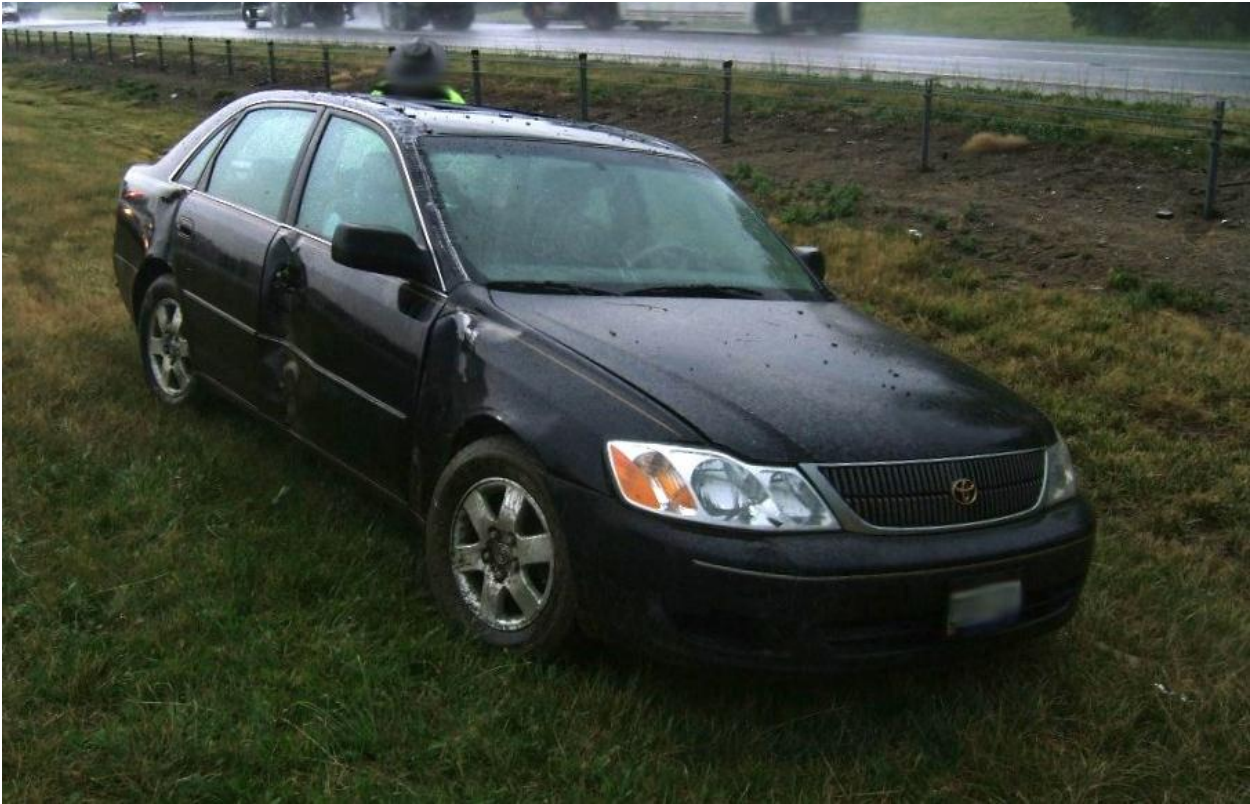
Figure 57. Prying Underride Failure on Brifen WRSF

An example of a Brifen crash which resulted in a prying penetration is shown in Figure 57. With sufficient details to complete a full crash reconstruction, it was determined that the 2000 Toyota Avalon impacted the barrier at approximately 50.7 mph (81.6 km/h) with a 16
