MID-AMERICA  
TRANSPORTATION CENTER

Report # TRP-03-275-12

## Cable Median Barrier Failure Analysis and Prevention

MwRSF Research Report No. TRP-03-275-12

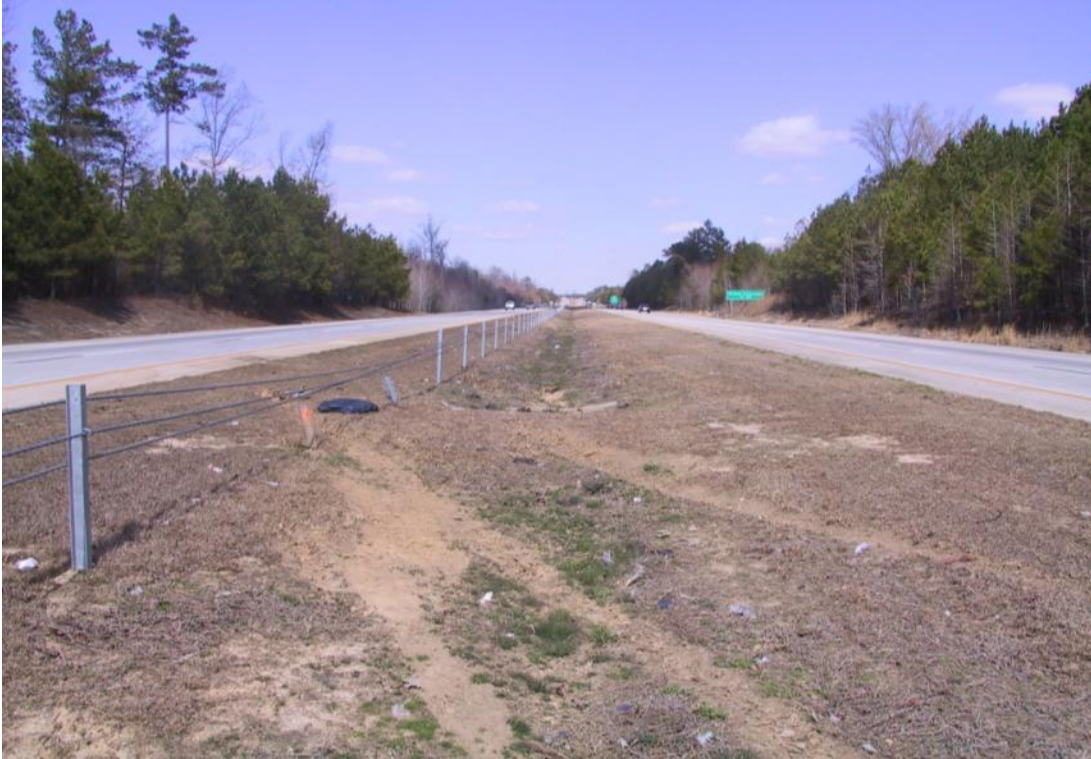
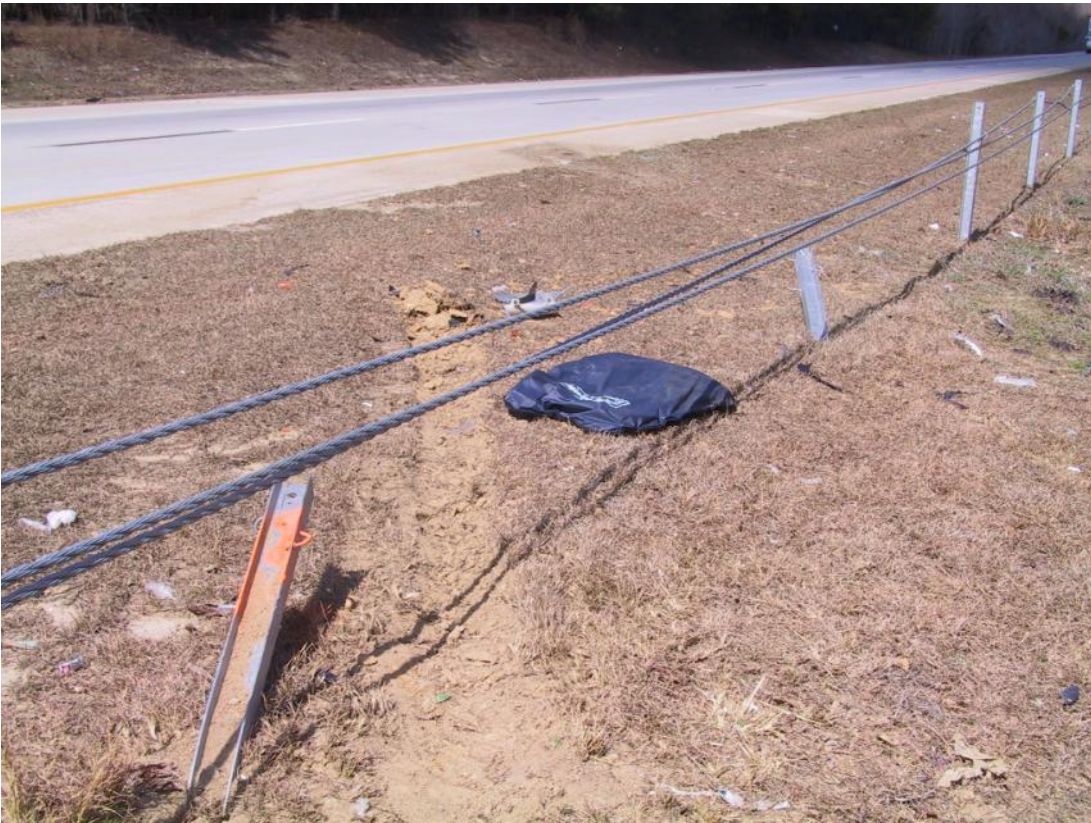
Figure 59. Diving Underride Penetration Crash in North Carolina

Despite the effect of suspension compression on the propensity for vehicle penetration through the barrier, the weak lower cable-to-post attachments strongly increased penetration propensity. The attachments disengaged from the posts at low loads and allowed the cables to slip above or below the vehicle. It was believed that in every recorded diving cable median

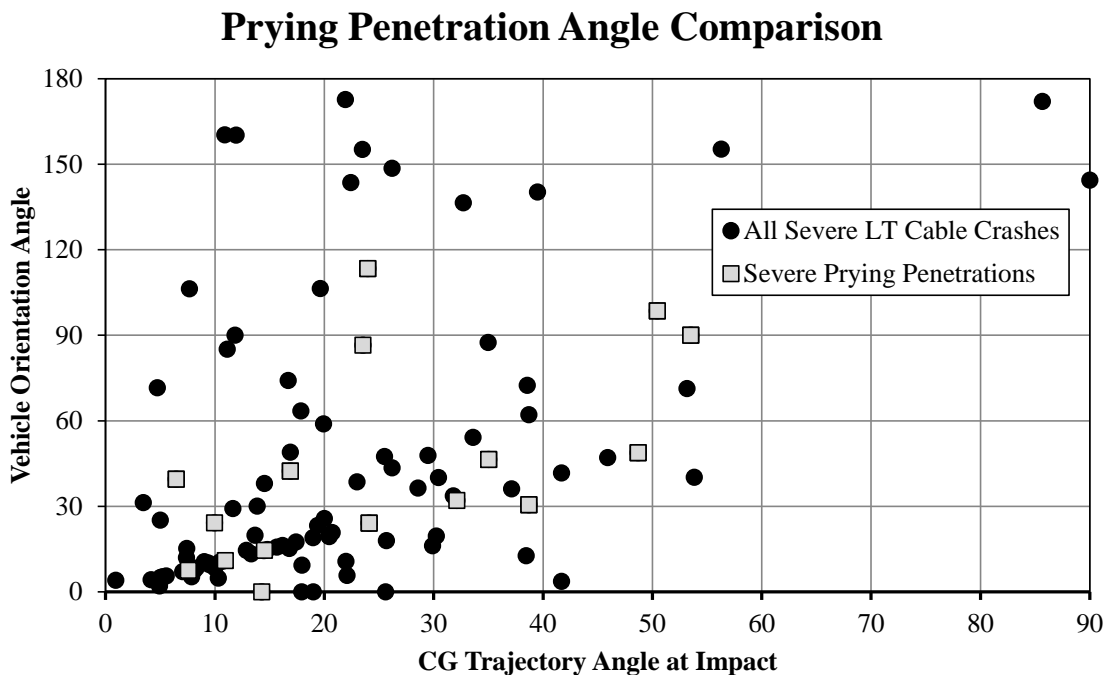
Figure 62. Comparison of Prying Penetration CG Trajectory and Orientation Angles

Frequently, at least two prying risk factors were present in prying penetration crashes. Prying penetrations occurred when cables were lifted or separated and failed to engage the vehicle. As with the high-tension cable median barrier systems, prying penetrations were sensitive to the impacting vehicle orientation angles. These angles were cross-plotted against all severe cable median barrier crashes in Missouri, as shown in Figure 62. No clear distinction could be made between the two crash distribution data sets. Oversteering impacts, in which the vehicle orientation angle was greater than the CG trajectory angle, were 5 times more common for prying penetration crashes.

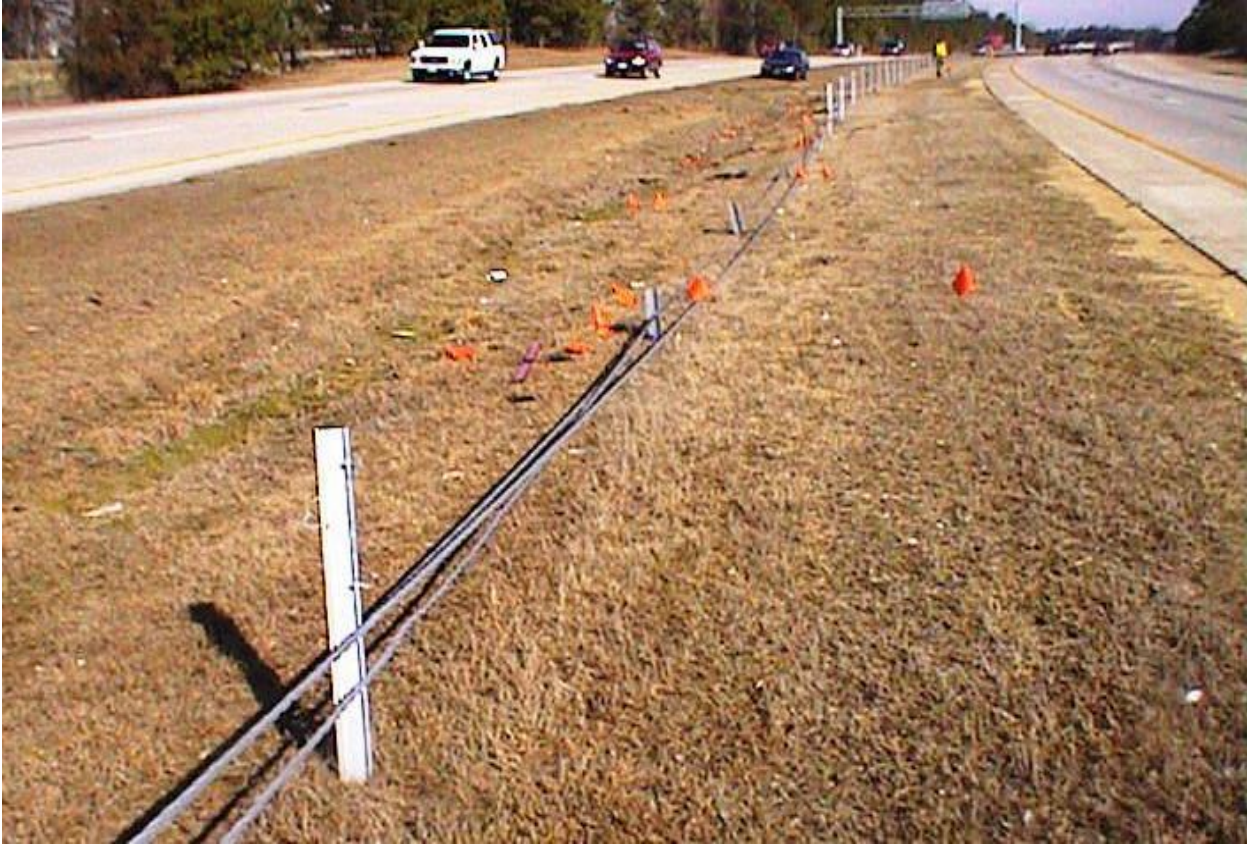
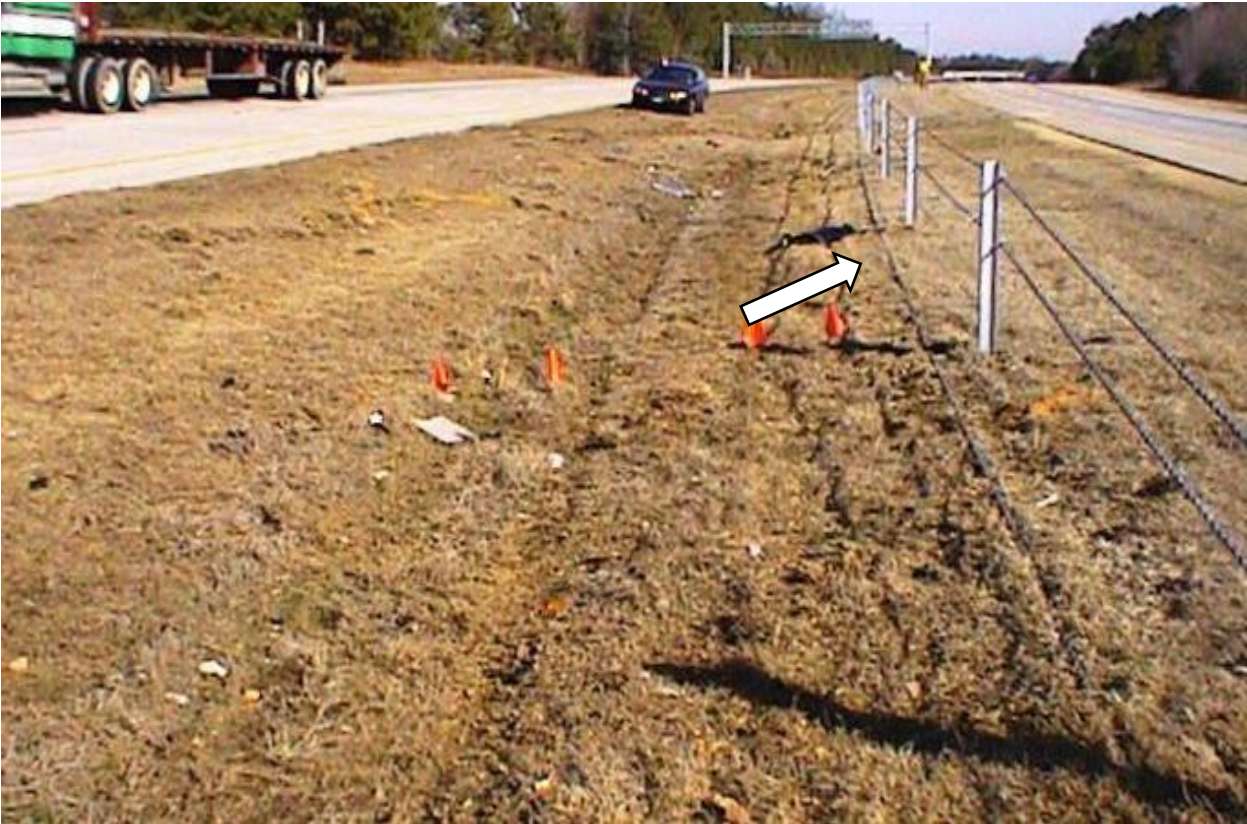
Figure 64. Middle Cable Release from 11 Downstream Posts Resulting in Penetration

causing poor cable-vehicle engagement. Back-side cable release most commonly occurred when other cables failed to adequately engage the vehicle, so the entire redirection load was applied by one back side cable. Examples of penetration crashes in which the impacted back-side cable was removed from more than 10 posts downstream from impact are shown in Figures 63 and 64.

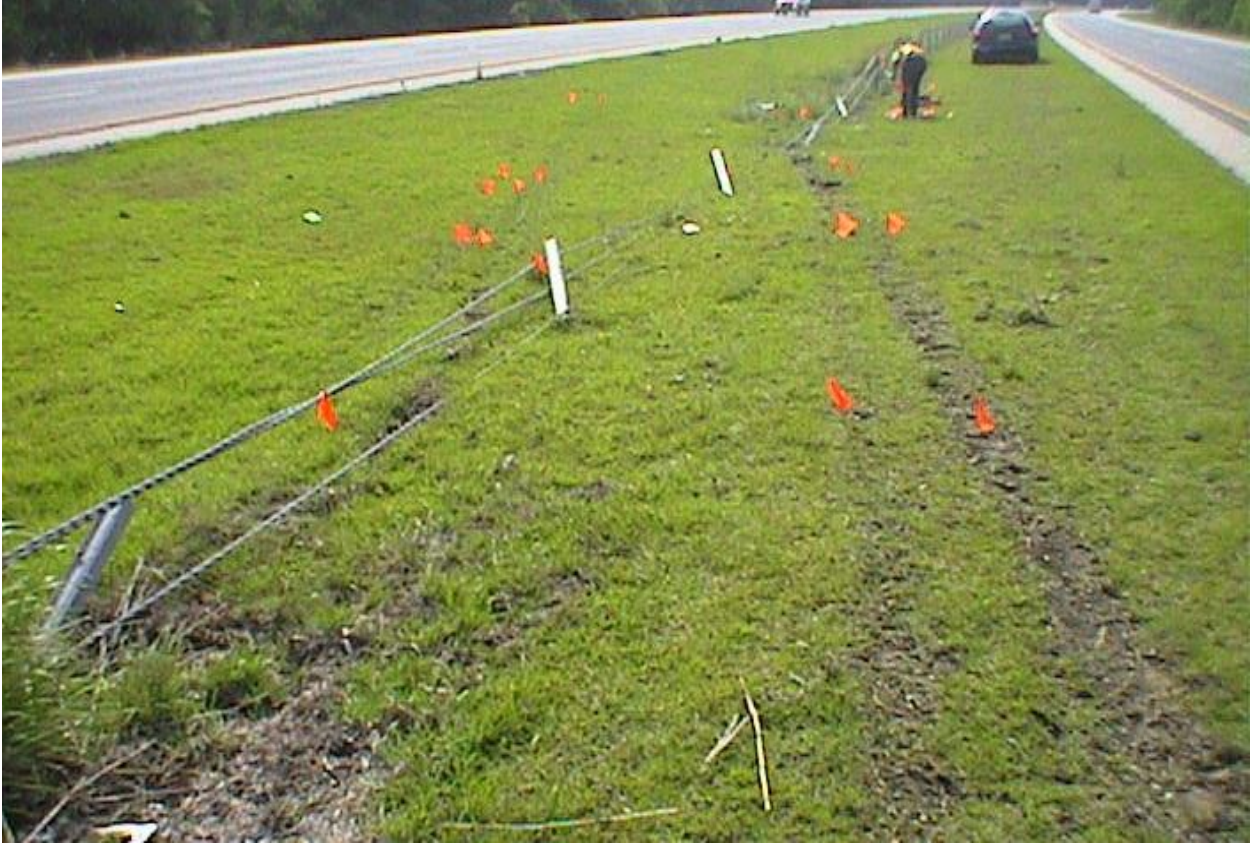
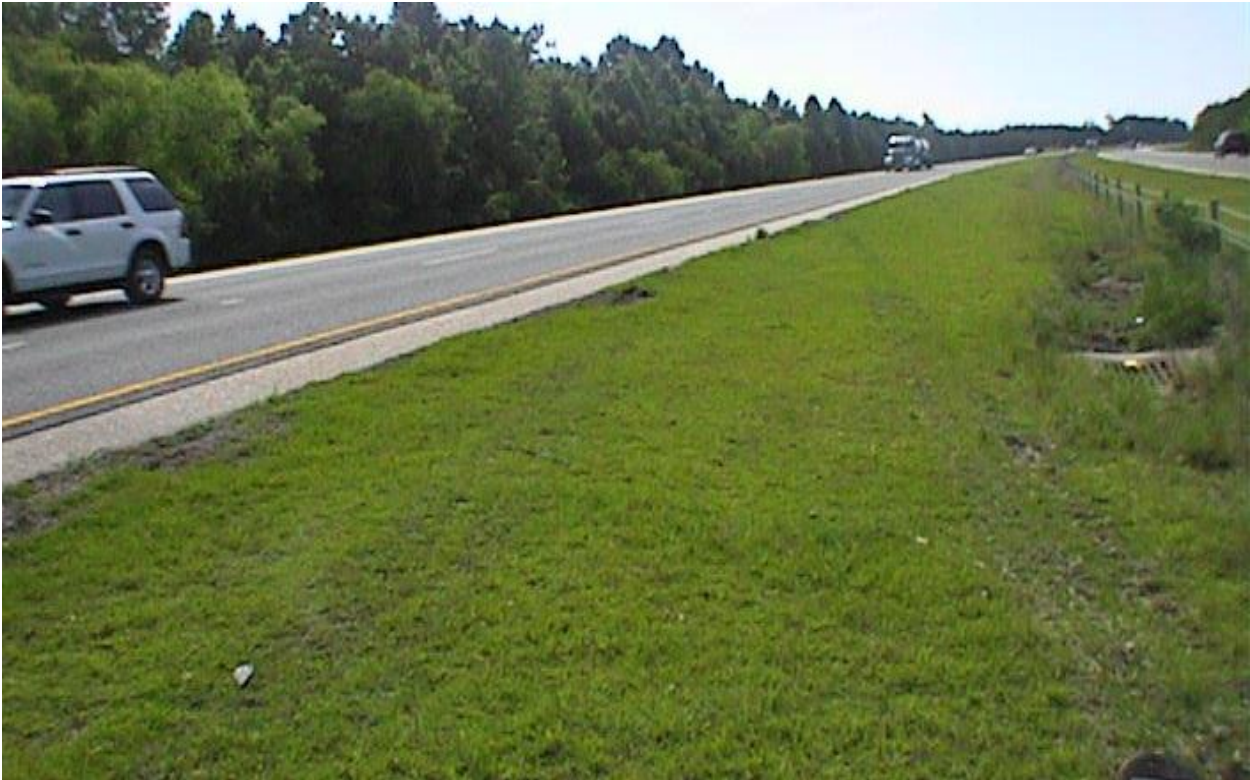
Figure 65. Prying Penetration Failure with SUV Caused by Brush Guard

Such an event was anomalous because very few impacting vehicles were equipped with these guards. However, the effect of the brush guard in this crash was a microcosmic representation of the effect of weak cable-to-post attachments on strong posts. Even large passenger vehicles, which were typically excellent candidates for redirection on cable median barriers, were at an increased risk of prying penetration crashes at high orientation angles. This further supports the conclusion that orientation angles can alter the energetically preferential interaction of vehicles with cable median barriers. If a sufficient contact groove was not made before the impacted cables began to slip on the vehicle, the likelihood of redirection was very low.

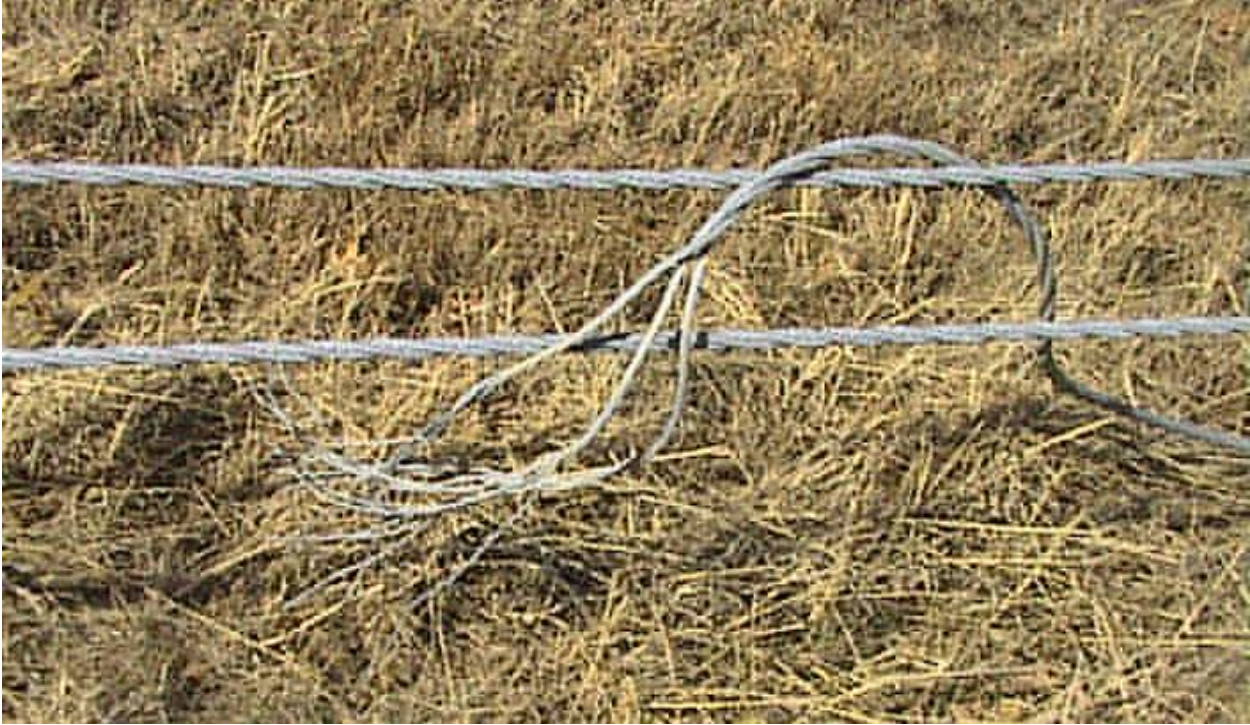
Figure 67. High-Tension Splice Tearout Penetration

Other penetration causes were identified that led to penetrations on low-tension cable median barrier systems, including impacts with large vehicles (i.e., tractor trailers-or single-unit trucks), and bouncing override penetrations due to median slopes. However, as with the high-tension cable median barrier counterparts, bouncing override penetrations were impact condition dependent, and no cable barrier system manufactured had been tested and approved to redirect large vehicles (i.e. tractor-trailers).

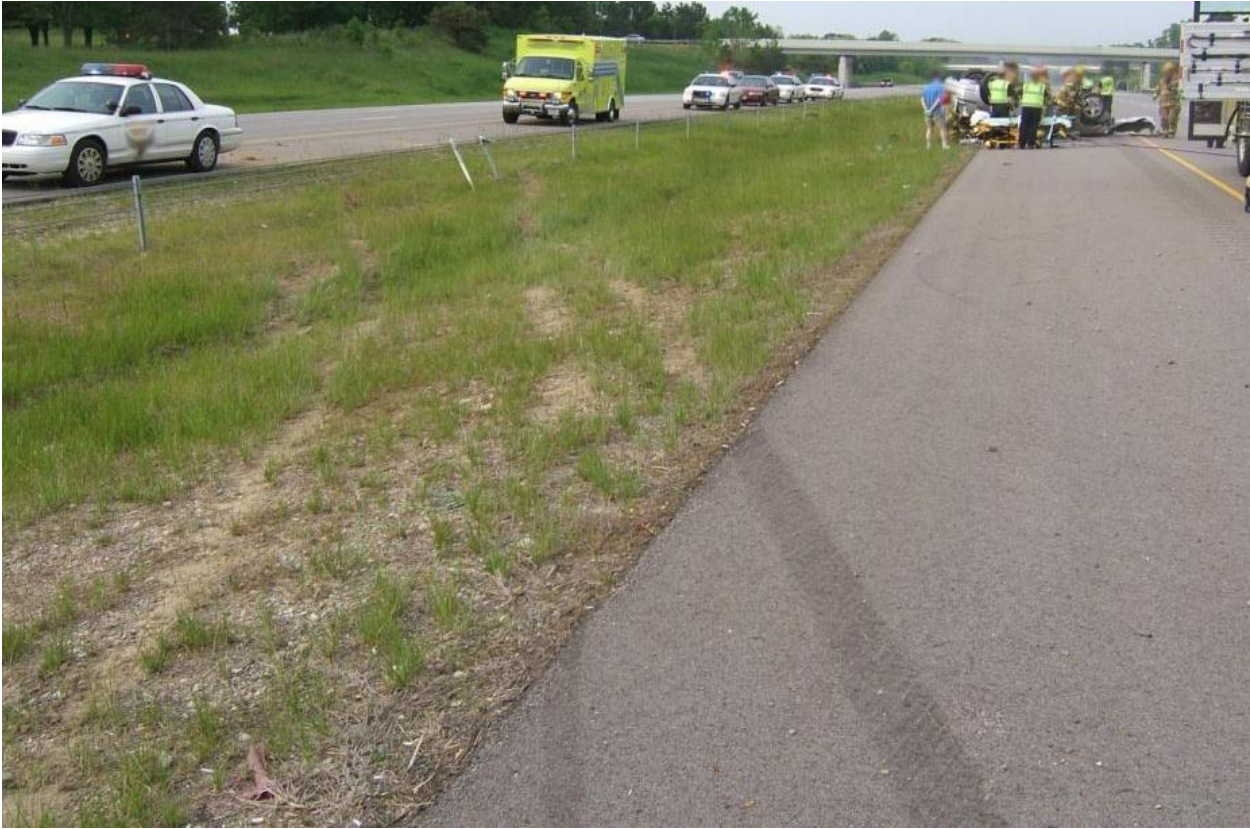
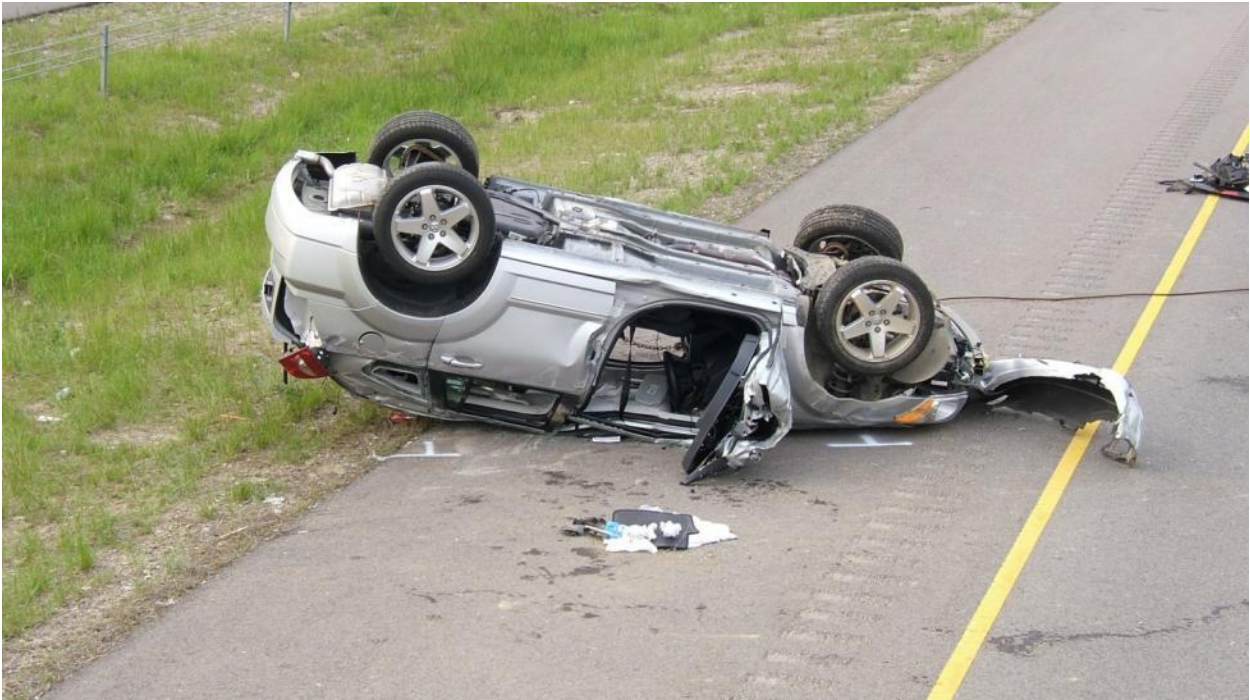
Figure 70. Example Rollover Crash Caused by High Redirection on Back Slope

The third type of median slope rollover was caused when vehicles struck a cable median barrier installed on a V-ditch back slope. After redirection, some vehicles skidded laterally into the median and tripped due to the slope transition in the center of the median. An example of this crash type is shown in Figures 70 and 71. In this crash, a Dodge Caliber struck the cable median barrier with an orientation angle of approximately 110 degrees and a CG trajectory angle of approximately 21 degrees. The vehicle displaced one post and yawed to nearly 180 degrees before being redirected, then rebounded down the back slope and tripped. It is believed that the vehicle made two and a half complete revolutions. Because the median rolled through the center of the V-ditch and back up the approach slope, vehicle damage was extensive.

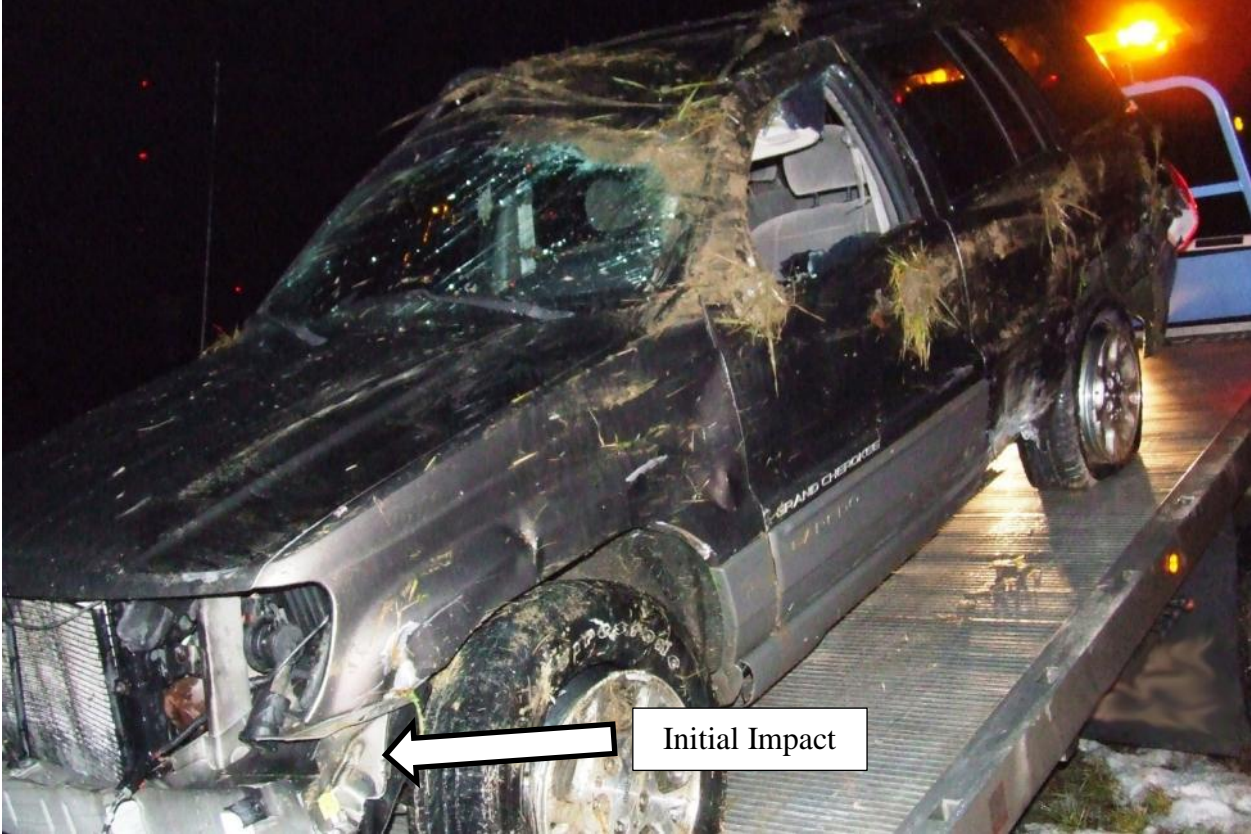
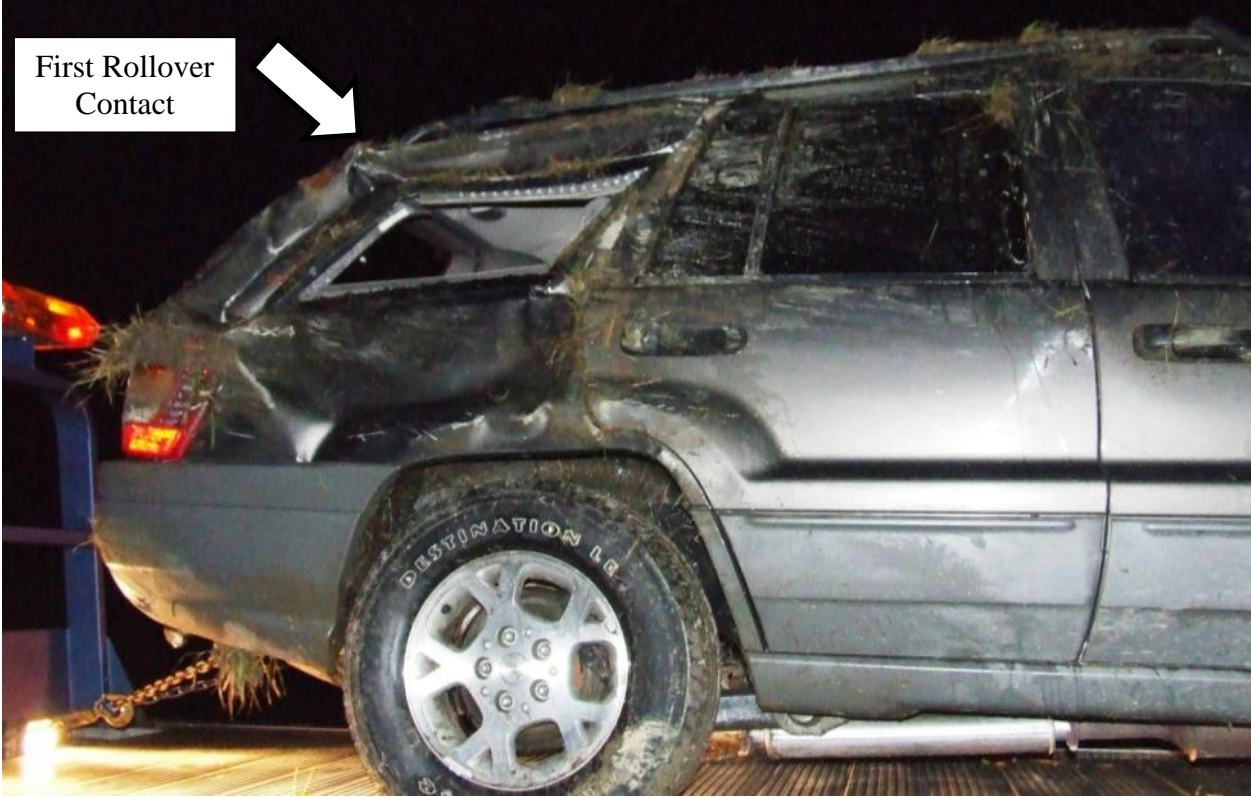
Figure 73. Example Rollover Crash Caused by High Orientation Angle at Impact

One crash involving a Jeep Grand Cherokee is shown in Figure 73. During this crash, the vehicle struck the cable barrier with the left-front corner in an oversteering configuration, yawed around the front end, and tripped as the vehicle approached a 90-degree orientation angle. The right-rear corner made first contact with the ground, shattering the rear windshield and right-rear window. As the vehicle rolled, the roof was crushed, but most of the remaining damage to the vehicle only occurred to the exterior body panels. A similar crash involving a Suzuki Grand Vitara which also yawed around the front end before tripping is shown in Figure 74.

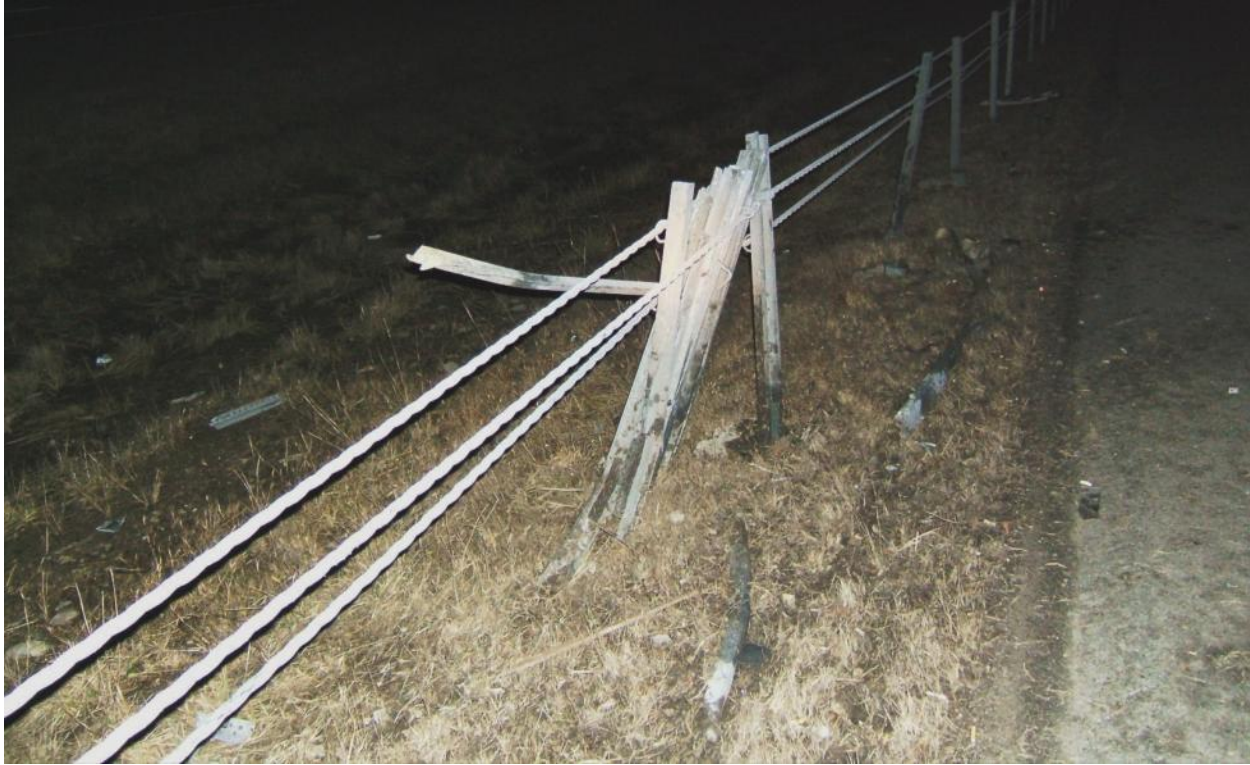
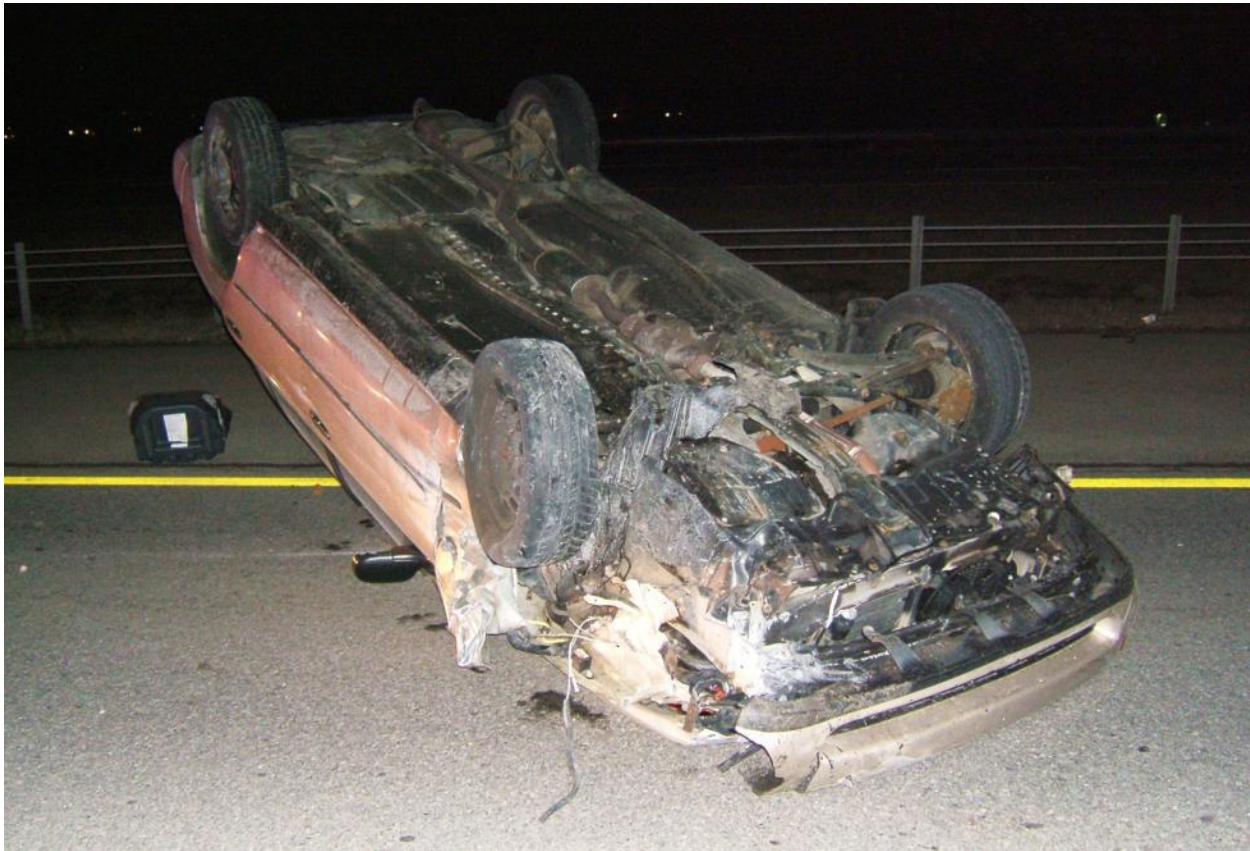
Figure 76. Example of Post Snag Rollover Crash

Contact-with-post rollovers were the most sensitive to the make of cable barrier struck, since post strengths were critical to facilitating rollover. Post shapes and cable tensions are shown in Tables 26 and 27, and several post section shapes are shown in Figure 78.

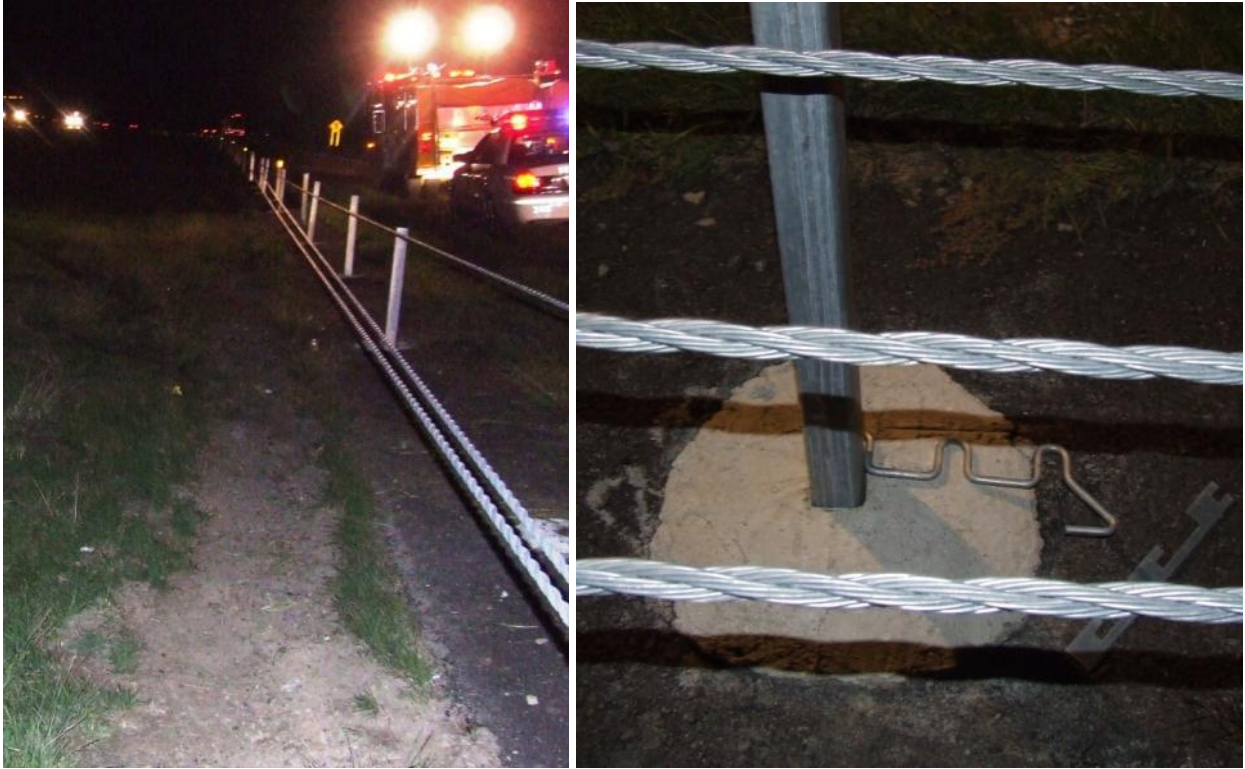
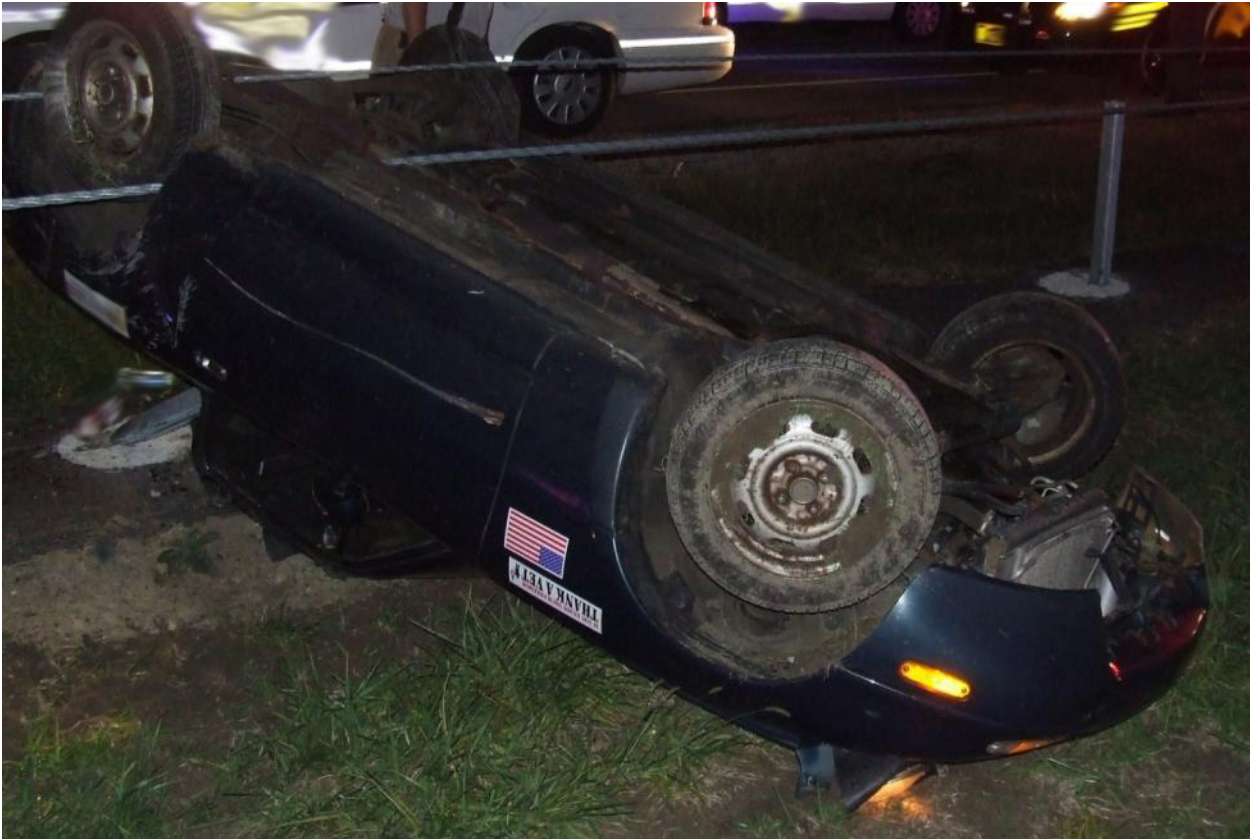
Figure 77. Example of Post Snag Rollover Crash

Rollovers caused by contact with posts were unique because the rollover initiator was wheel snag on a flange or web of the post. Although multiple compounding factors including friction contributed to most rollovers, contact-with-post rollovers also occurred in wet and snowy weather when roadside friction was reduced. The occurrence of these types of rollovers in low-friction conditions indicates that even weak posts can contribute to vehicle instability, which was noted historically [43]. Examples of post snag rollover crashes are shown in Figures 76 and 77.

The Gibraltar cable barrier system, with wide post spacings up to 30 ft (9.1 m) and installed on alternating sides of the cables, may exhibit a higher susceptibility to under-ride penetration crashes. Vehicles impacting at the location of a post on the opposite side of the cables can cause complete post disengagement. Although the hairpin cable-to-post attachment was relatively strong, as shown in Figure 81, upward vertical bracket release could occur during impacts with low-height, sharp-nosed and narrow front-profile vehicles, as shown in Figure 77.
