Appendix D–FIB-54 Tests

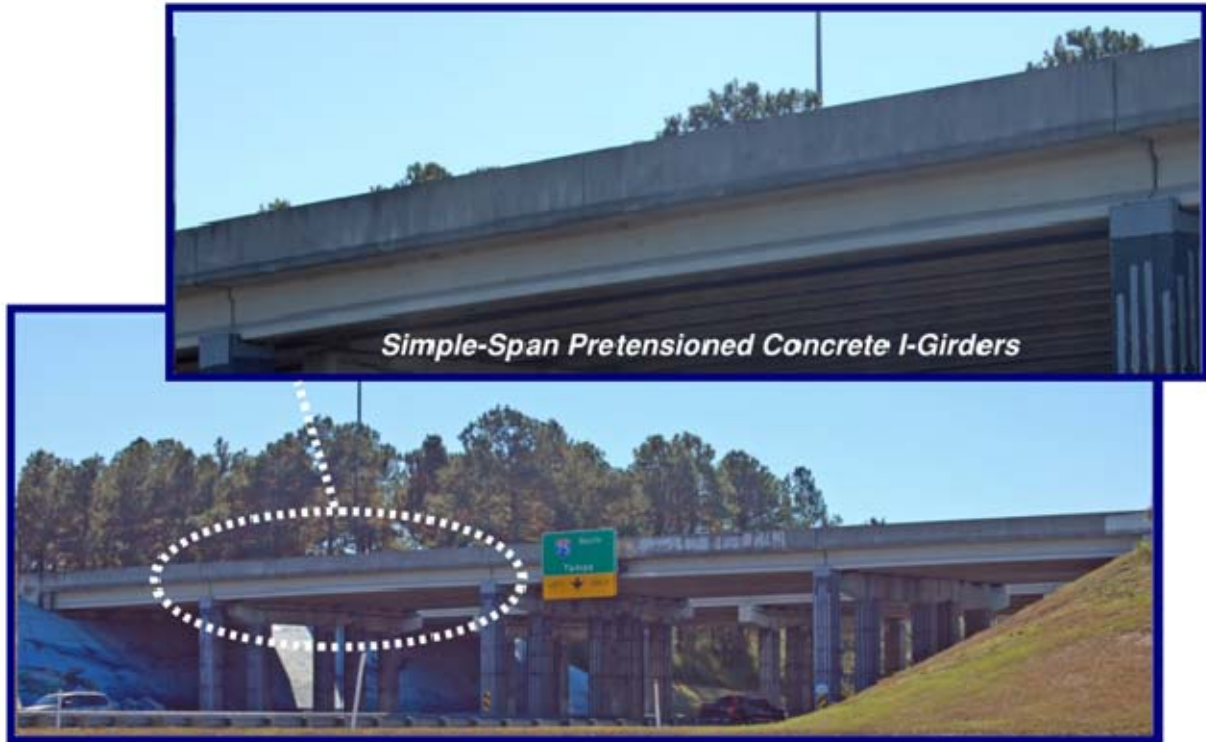
Figure 1–I-Girder highway bridge

Of the almost 12,000 bridges in Florida's public road system, approximately half utilize prestressed concrete as the structural system (FHWA, 2010). Simple-span pretensioned concrete I-girders are the most common type of prestressed concrete structures, and are ubiquitous in Florida's highway system (Figure 1). In 2009, the Florida Department of Transportation (FDOT) introduced the Florida I-Beam (FIB) (Figure 2) for use in highway bridges. The FIB girders "were developed to be more efficient to fabricate, safer to construct, and more cost effect when compared to the [previously] used prestressed beams" (FDOT 2009a).

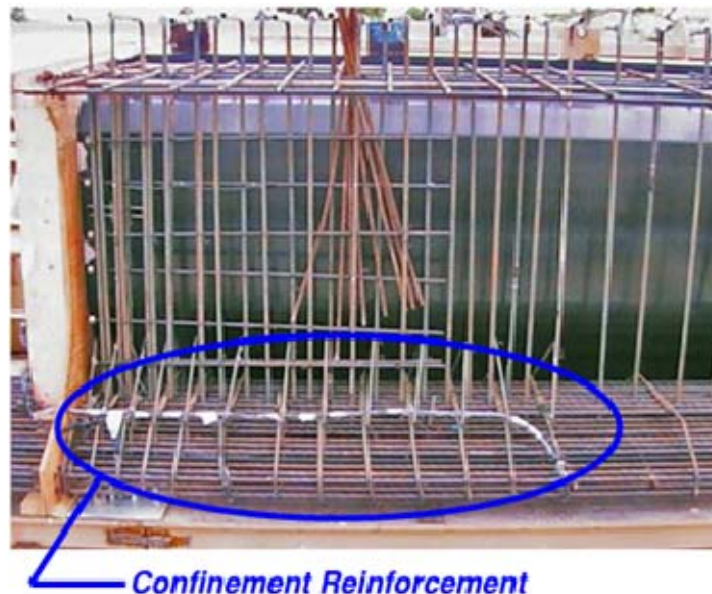
Figure 3–End region reinforcement.

To further improve the efficiency of FIB girders, it is desirable to investigate the feasibility of reducing reinforcement placed in the end region (Figure 3). End region reinforcement is specified by FDOT standard details (Figure 4), which are based on historic FDOT details, code requirements, and constructability considerations (Nolan 2009; Fallaha 2009). There is particular incentive to investigate confinement reinforcement, which is placed in the bottom flange around prestressing strands (Figure 3). The current use of confinement reinforcement is limited by the following:

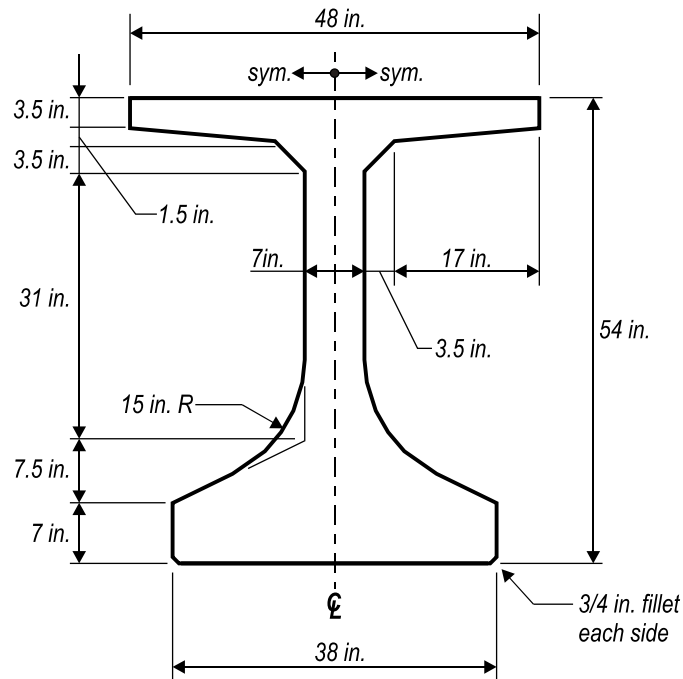
Figure 7–Cross-section of FIB-54

Test girder prototype design was based on girders used in an existing bridge in Clay County, FL, which had the FIB-54 cross-section (Figure 7) and spanned approximately 120 ft. The strand pattern and reinforcement for the prototype girder were designed based on these conditions. Due to laboratory space restrictions, the test girder length was reduced to 49.5 ft. The shorter length, however, still allowed for evaluation of the end region detailing, which was the primary focus of the research program.

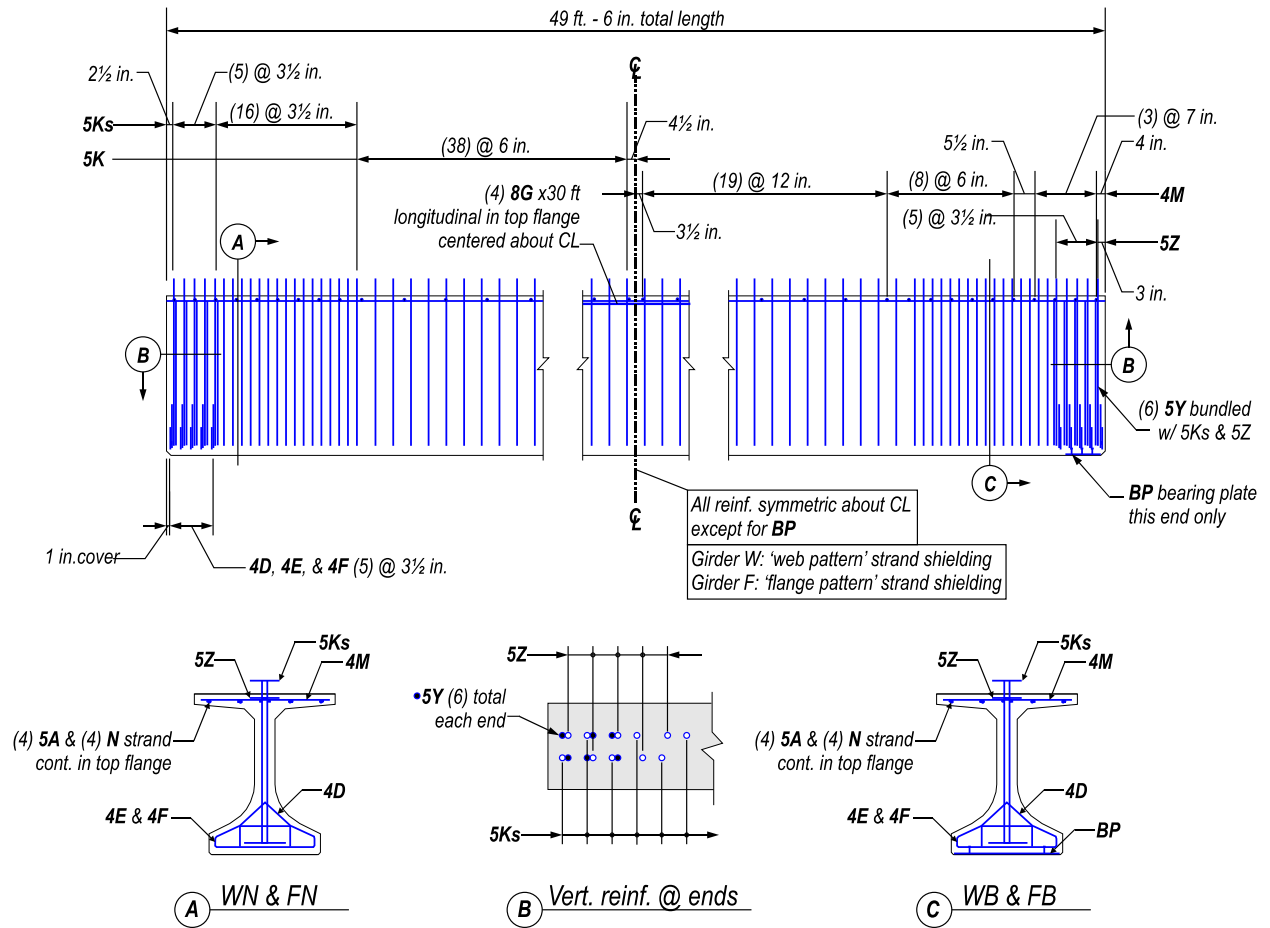
Figure 12—Reinforcement for girders W and F

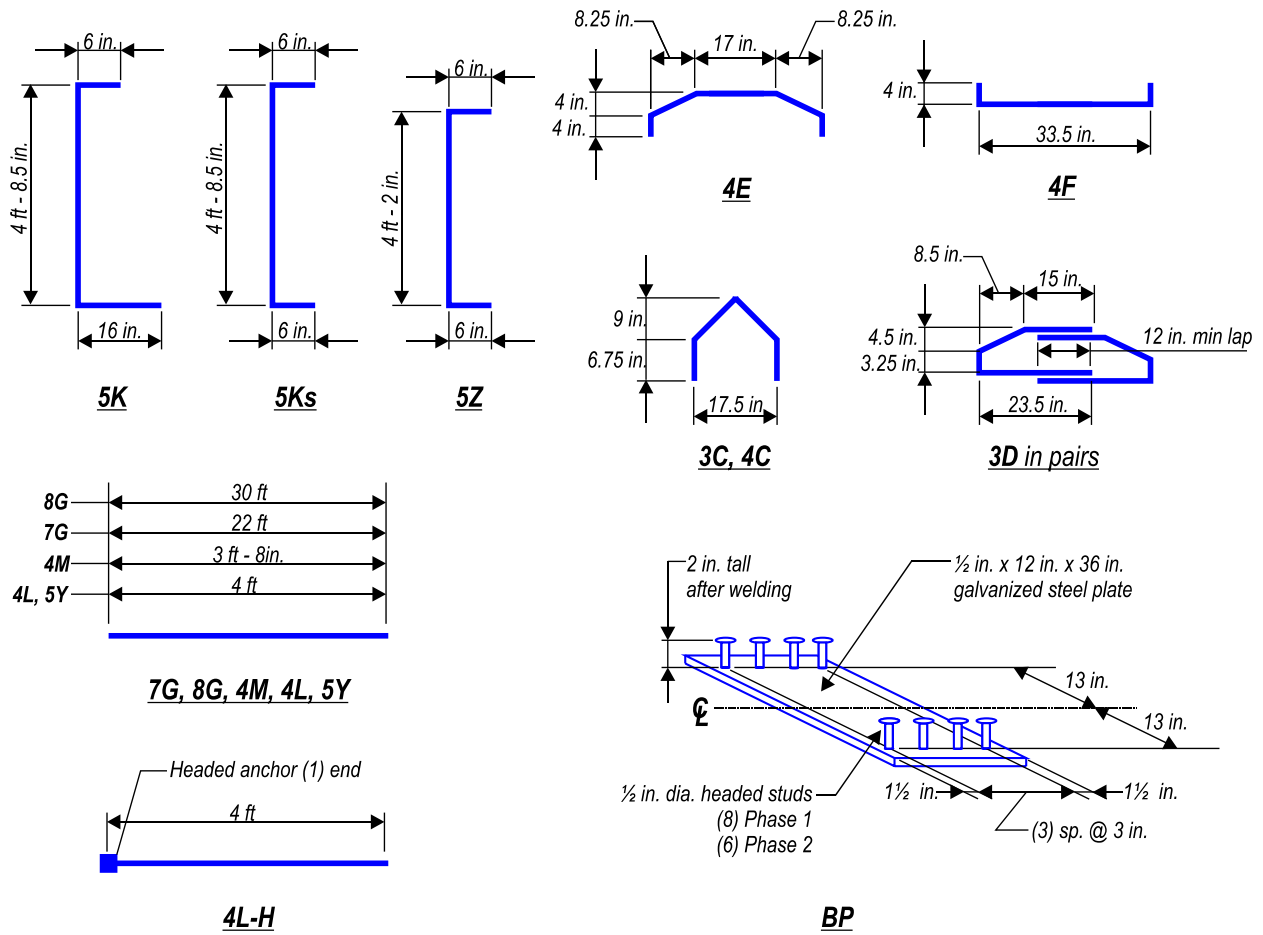
Figure 14–Reinforcement and bearing plate details

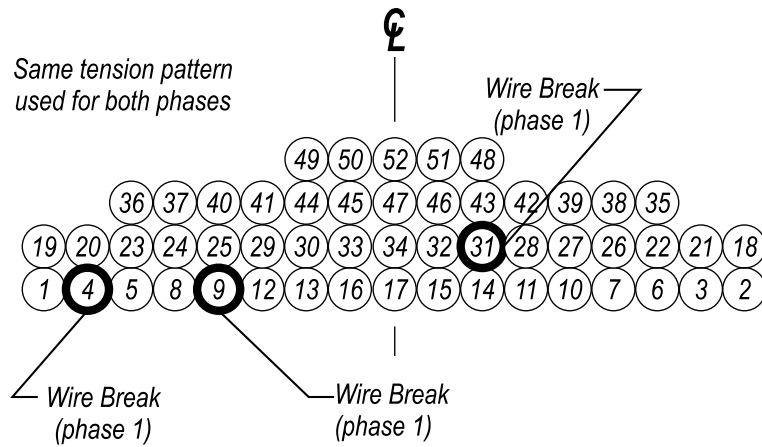
Figure 18–Tension pattern and wire break locations

Wire breaks occurred in three different strands during phase one (Figure 18). The wire breaks did not occur inside the test girders so the strand cross-section within the girders was not compromised. The jacking force of the strands with broken wires could not be checked by the elongation method, however the jacking force as determined by pressure in the hydraulic line was still within the specified range. No wires broke during the second construction phase.

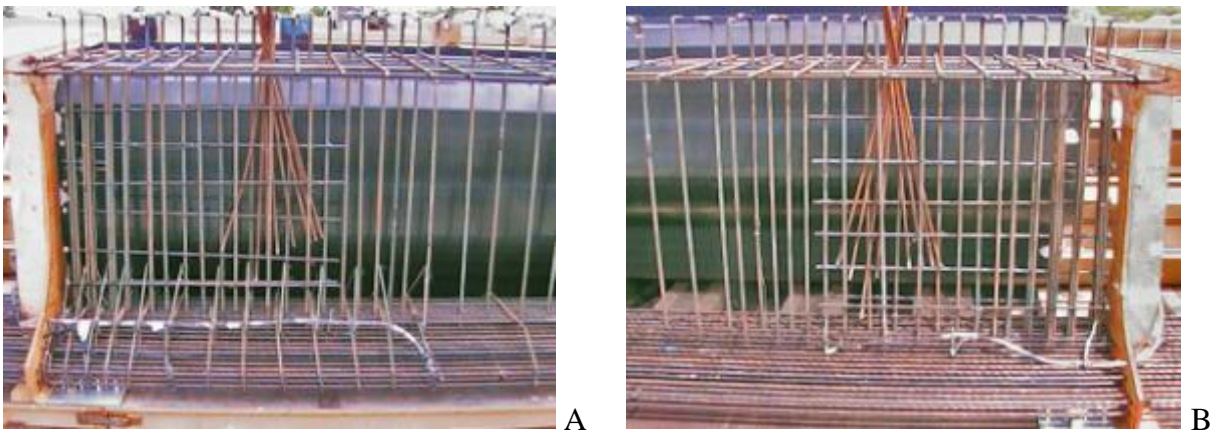
Figure 19–Girder H reinforcement A) Specimen HC and B) Specimen HU

After tensioning, mild steel reinforcement was placed. Select bars were instrumented with strain gages prior to placement in the girders. Figure 19 through Figure 23 show the reinforcement in each specimen.

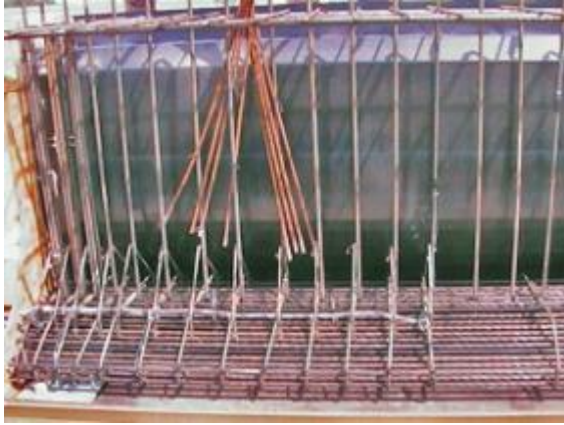
Figure 20–Girder V reinforcement A) Specimen VC and B) Specimen VU

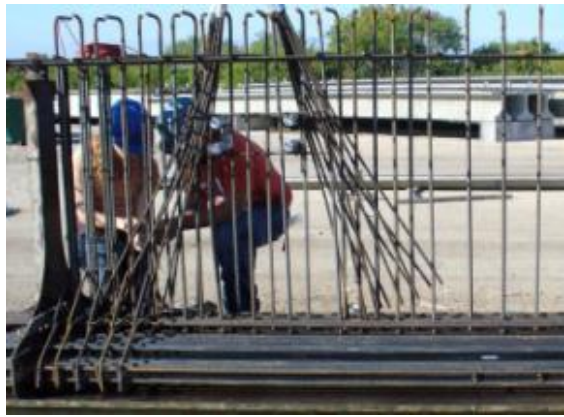
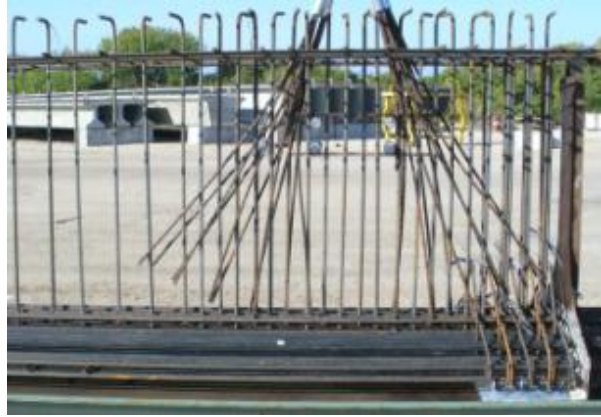
Figure 21–Girder W reinforcement A) Specimen WN and B) Specimen WB

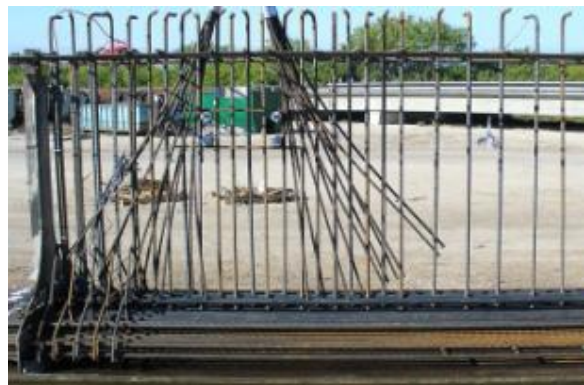
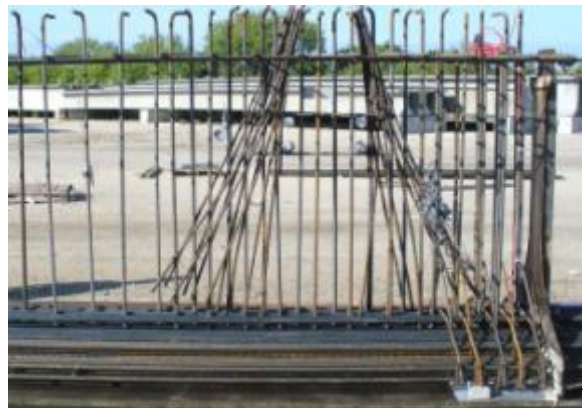
Figure 22–Girder F reinforcement A) Specimen FN and B) Specimen FB

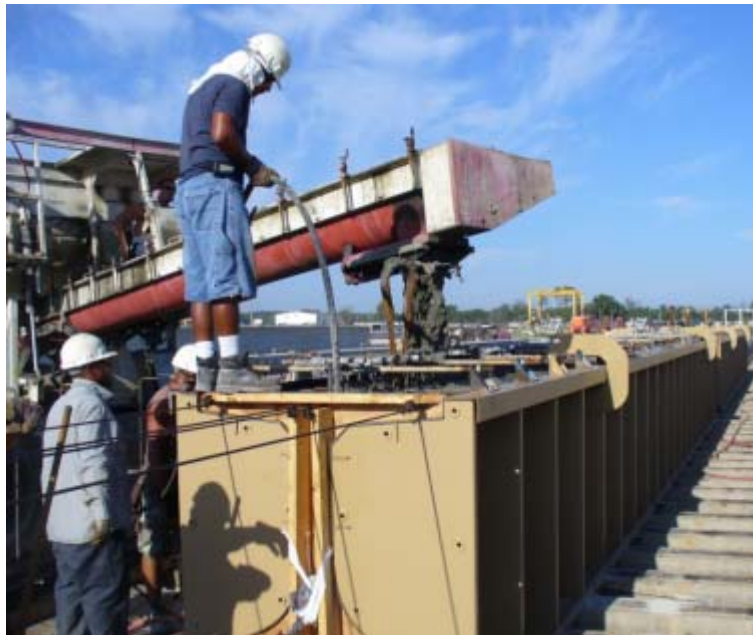
Figure 24–Concrete placement and internal consolidation phase 1

Concrete was mixed at on-site batch plants. For phase one girders, concrete was placed in two lifts and was consolidated with internal and external vibrators after each lift (Figure 24). The internal vibrator was only used on the north side of the web to keep the vibrator away from internal strain gages which were primarily placed on the south side. A self-consolidating concrete mix was used for phase two (Figure 25) and vibration was not necessary. Test cylinders were taken by the fabricators and by the research team from each batch of concrete. The top surface of each girder was raked to intentionally roughen the surface (Figure 26). Girders were covered with heavy tarps during curing (Figure 27).

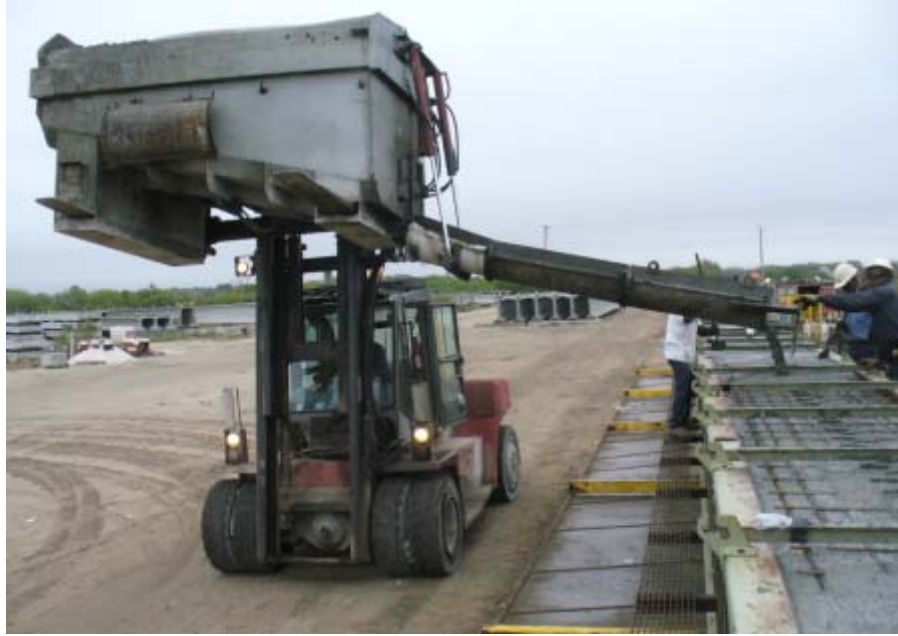
Figure 25–Concrete placement phase 2

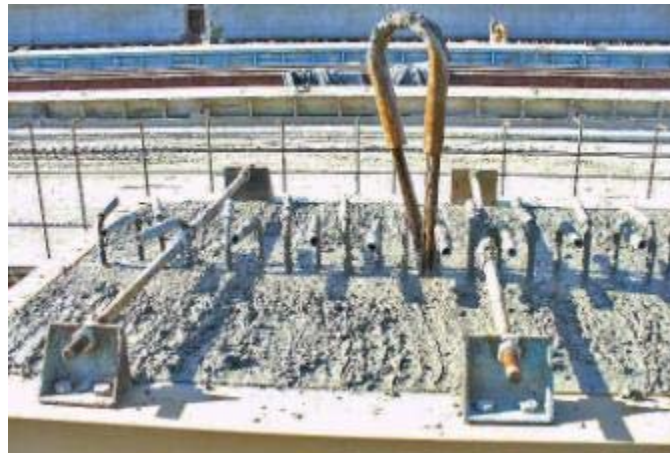
Figure 26–Girder finished surface

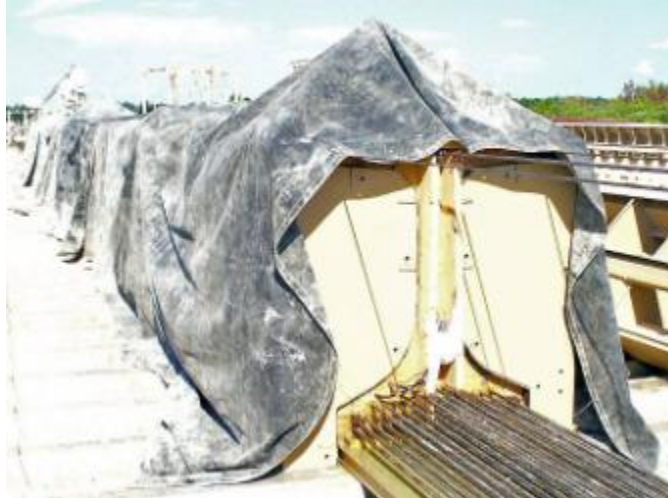
Figure 27–Girders covered with tarps

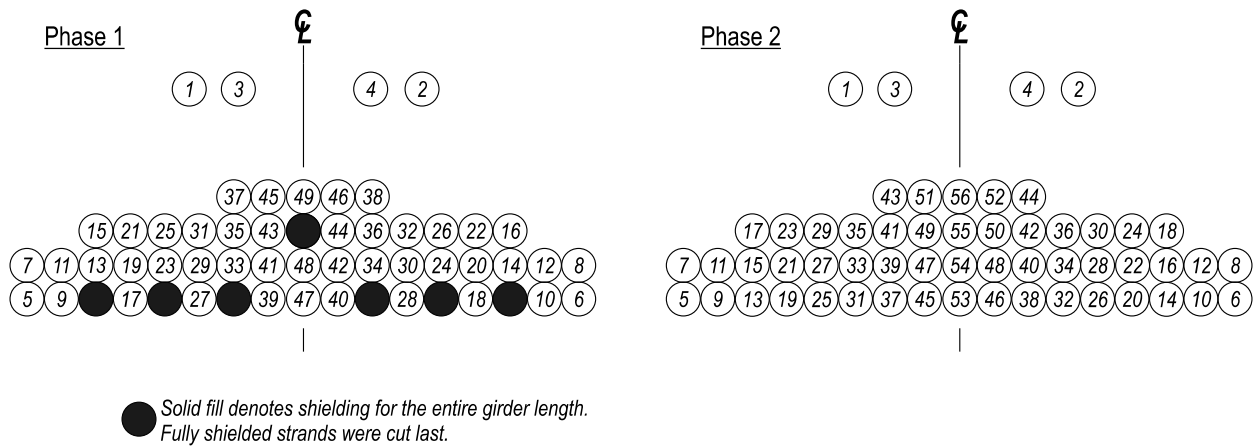
Figure 28—Strand release patterns

Flame cutting was used in both phases to release the prestressing strands. Individual strands were cut simultaneously at points shown in Figure 17. Dormant strands in the top flange were cut first, followed by the bottom strands, which were cut from the outside-in and from bottom-to-top (Figure 28). This release pattern was selected because it is relatively easy to execute and because it is typical of precast girders in Florida. Strand cutting was stopped intermittently at multiple stages to obtain strain readings from the vibrating wire strain gages and to check the girders for cracking.

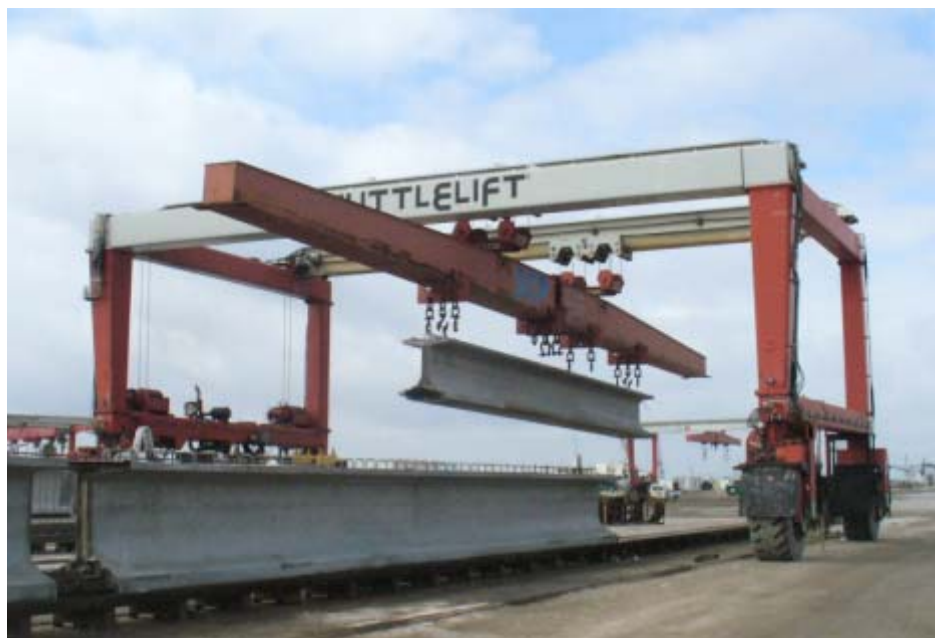
Figure 29–Test girder lifted by crane

To investigate changes in strain due to lifting (Figure 29), girders H and V were lifted by crane immediately after prestress transfer was completed. Girders were supported by the crane momentarily and then placed on dunnage on the stressing beds (Figure 30). Strain data were collected during lifting and as girders were placed on dunnage. After the data were collected, the girders were taken to a storage yard to await shipping. Girders were examined for cracking periodically while in they were held in storage at the prestress fabrication facilities.

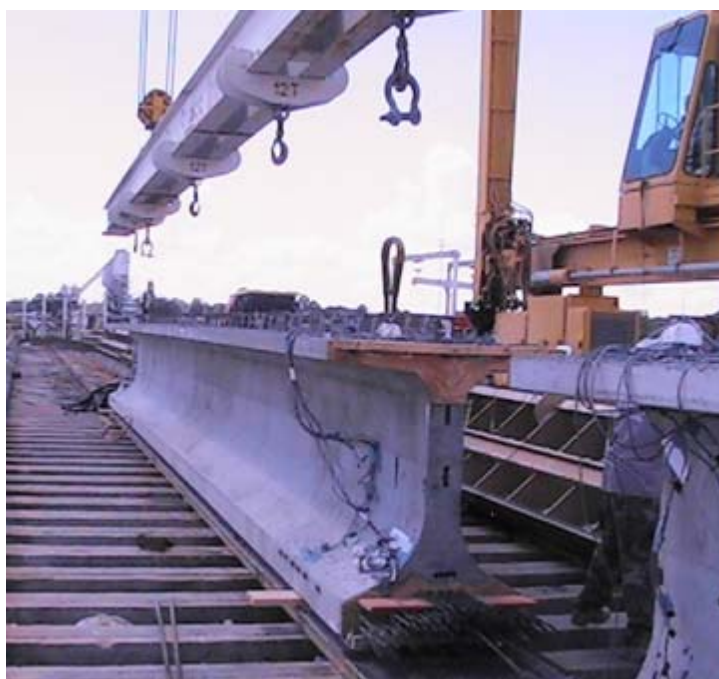
Figure 30–Girder resting on dunnage above stressing bed

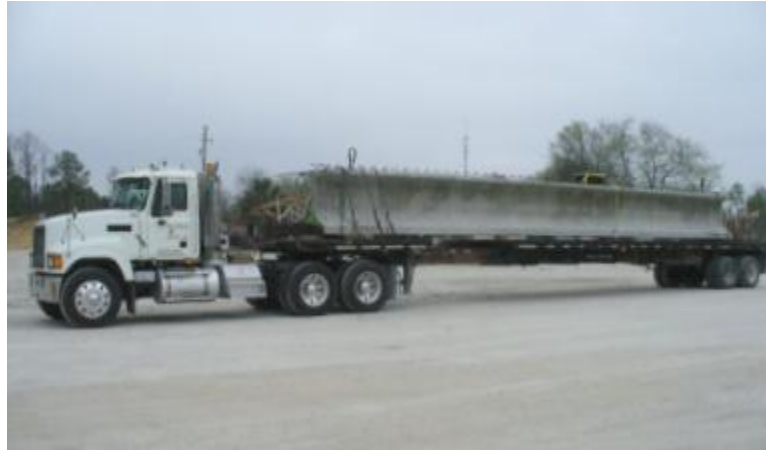
Figure 31–Girder H on truck prior to transit

in girder H (phase one) during transport. Figure 31 shows girder H being transported. The black box on top of the girder in the picture housed the data acquisition system.

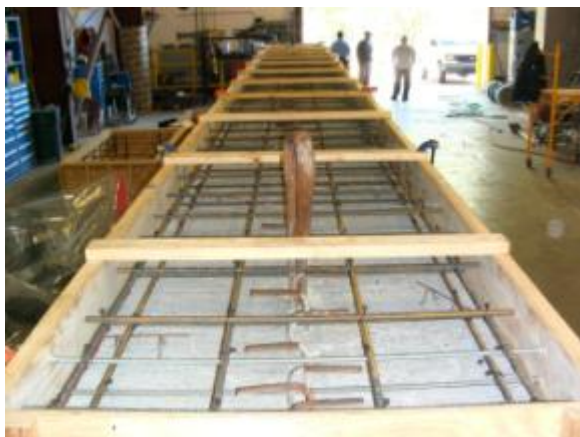
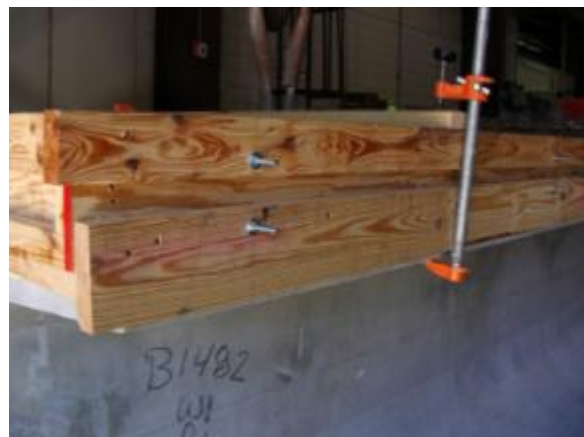
Figure 32–Deck construction A) reinforcement and B) formwork

After unloading of the test girders in Tallahassee, forms were constructed and reinforcement was placed for the concrete deck. Wood forms were affixed to the top flange of the girders using pipe clamps (Figure 32). Concrete was prepared by a local ready mix plant.

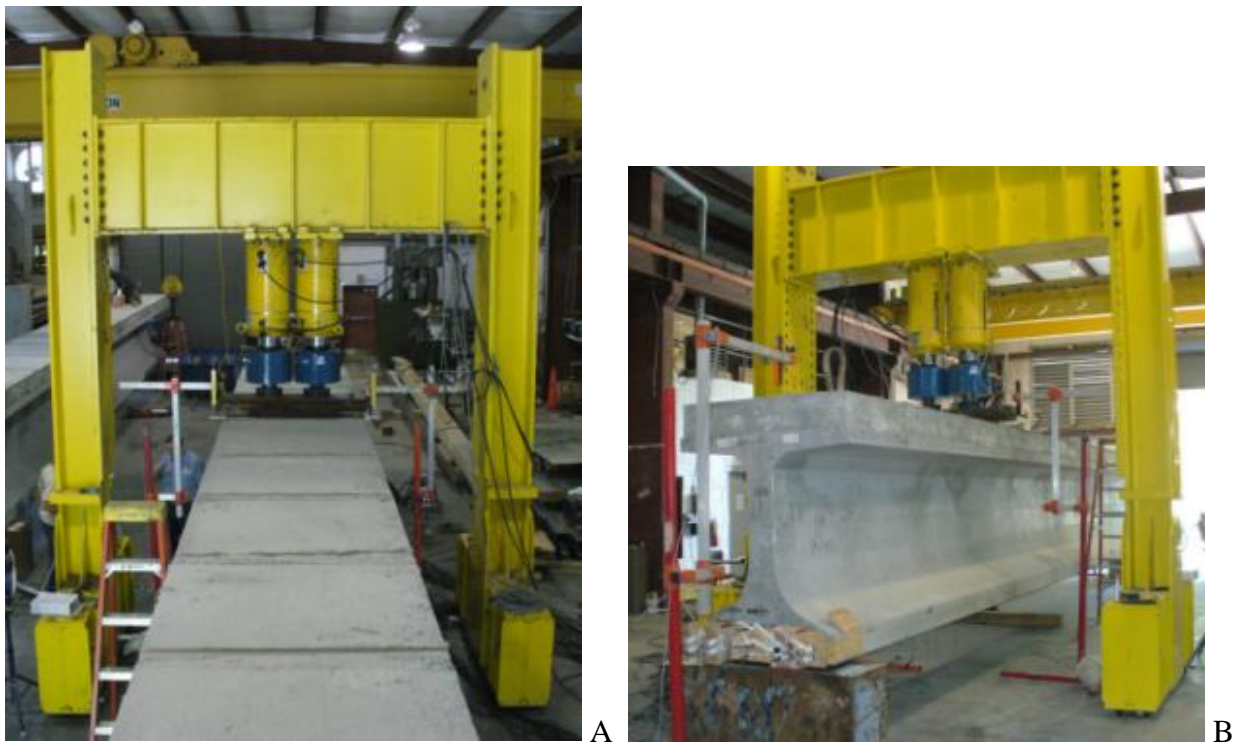
Figure 36–Test specimen and load frame A) top of girder and B) end of girder.

Load and support geometry are shown in Figure 34. Each support consisted of a 10 in. x 32 in. reinforced bearing pad. Pads were “Type E” pads constructed according to FDOT design interim design standards (FDOT 2009d). The bearing pad at the near support was centered below the embedded steel bearing plate (Figure 35). Load was applied to the specimen using side-by-side hydraulic actuators. The load rate was controlled by adjusting a pump that pressurized the hydraulic system. The combined load rate varied from 0.1 kip/sec to 0.6 kip/sec, with the typical rate being approximately 0.4 kip/sec. Load was spread from the actuators to the girders through steel plates and a 10 in. x 30 in. reinforced neoprene bearing pad. A reaction frame was used to transmit load from the actuators to the strong floor (Figure 36).

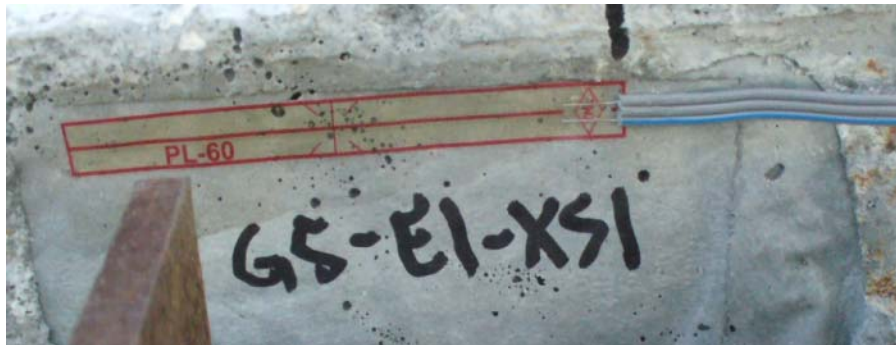
Figure 39–XS gage installation

XS strain gages (Figure 39) were attached to the surface of test girders immediately after formwork was removed. These gages were used to measure concrete strains during prestress transfer, lifting, and trucking. XS gages had a 60mm gage length.

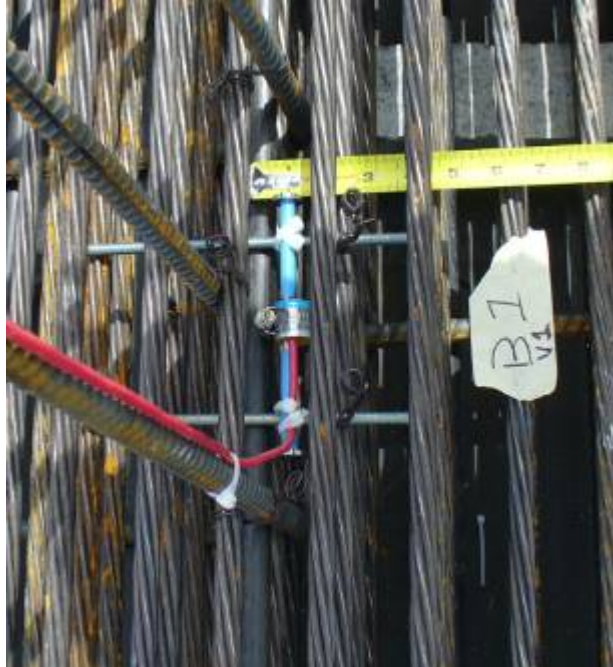
Figure 41–V gage (view from above)

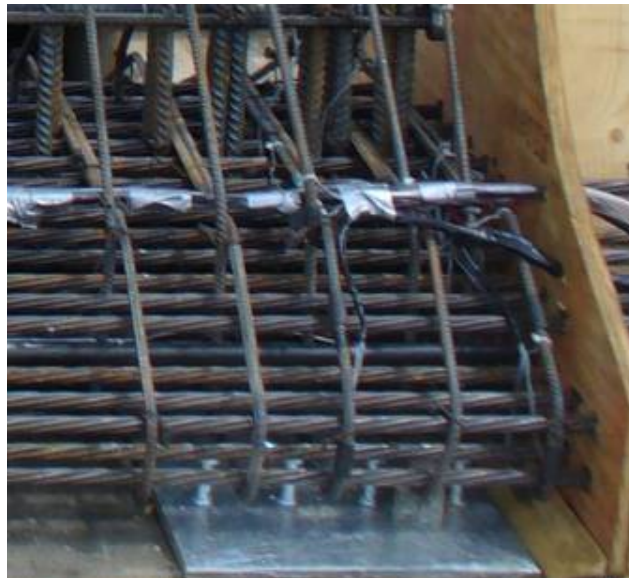
Figure 42–Wire harness and plywood bulkhead

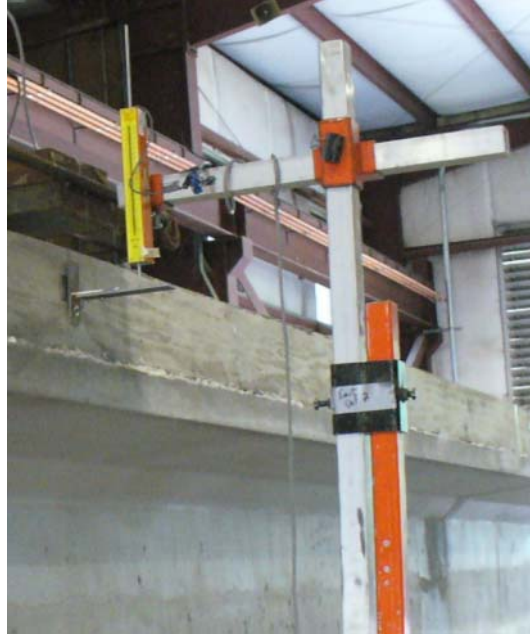
Figure 45–LVDT and support frame

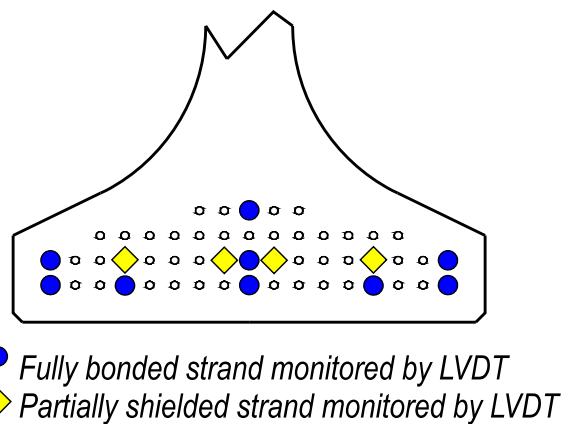
Figure 46–Girder H and V strands monitored by LVDT

LVDTs were also used to monitor strand slip for girders H and V. Monitored strands are shown in Figure 46. LVDTs for monitoring strand slip were mounted to a wooden bracket affixed to the girder end (Figure 47). This setup was unreliable because cracking in the concrete caused the LVDT frame to shift during load testing.

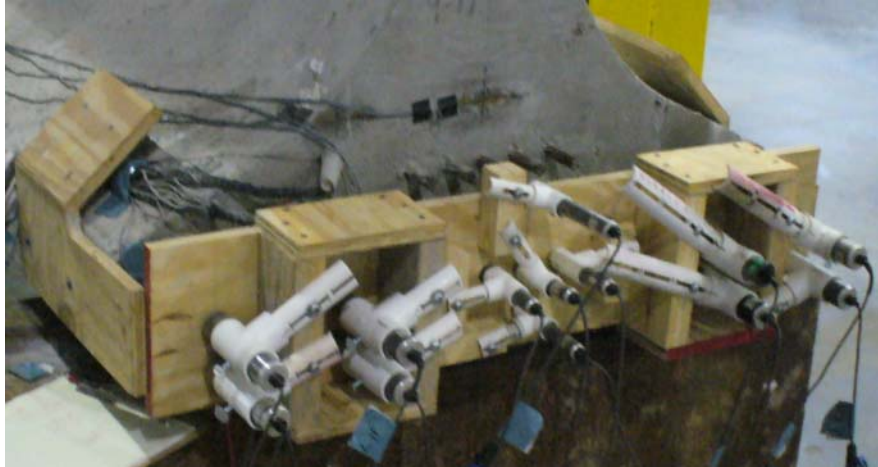
Figure 47–Wood frame and LVDTs

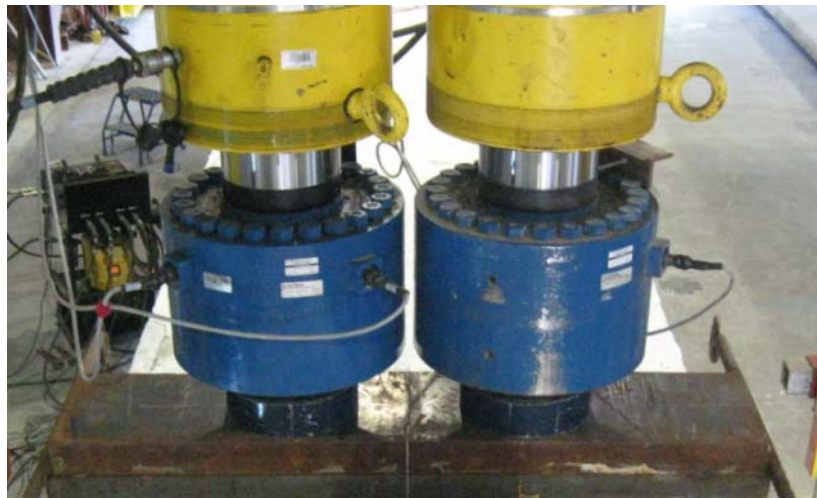
Figure 50–Load cells below hydraulic actuators

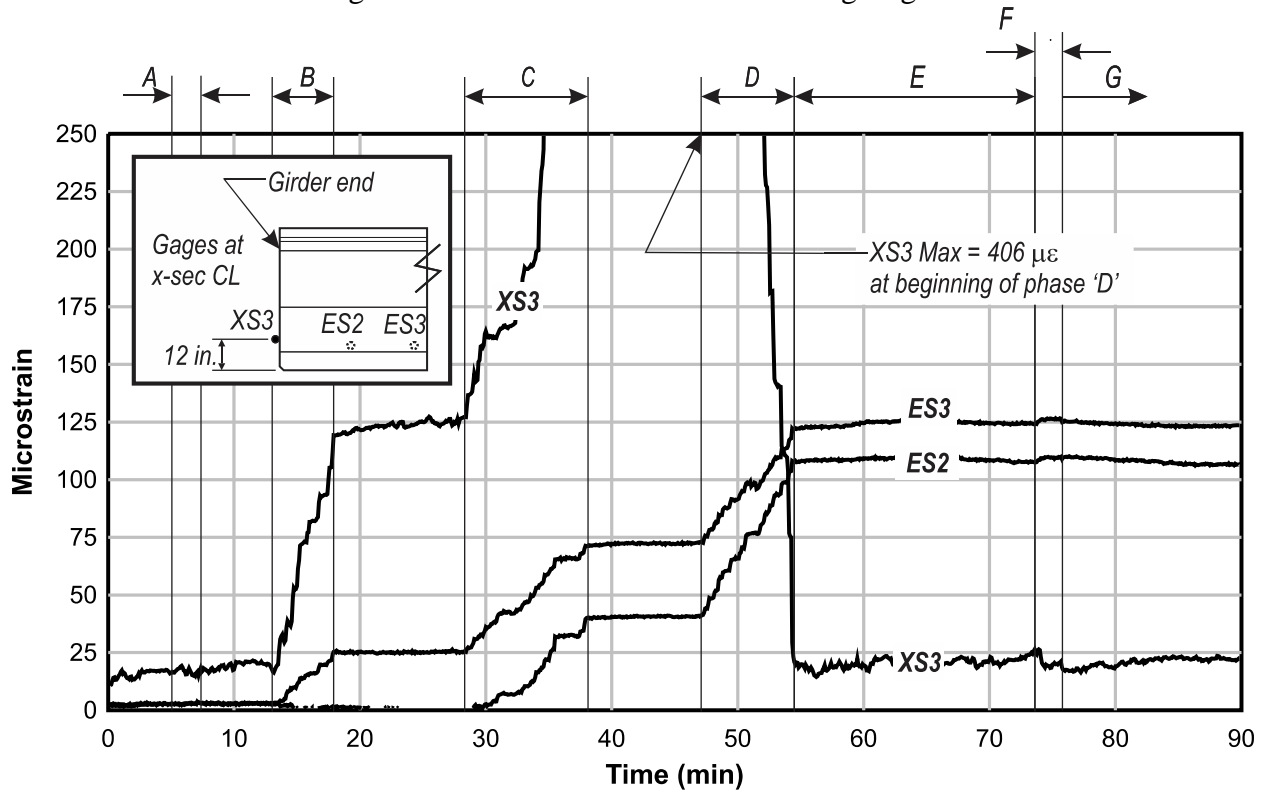
Figure 52–Transverse strain HC

Strands in the top flange were the first to be cut; this stage is denoted A in Figure 52. Data indicate that the transverse strain change was negligible when the top strands were cut. Cutting the bottom strands (stages B, C, and D) had significant impact on transverse tensile strain. The largest measured transverse tensile strain in specimen HC was 406 microstrain reported by gage XS3. This gage was located on the end of the girder, at the cross-section centerline, 3in. above the strands. The maximum strain occurred at the beginning of stage D after all strands in the outer flange had been cut and before any of the strands below the web had been cut. For this chapter, strands in the outer portion of the flange are referred to as “outer strands” and strands below the web are referred to as “inner strands”.

Transverse strain at gage XS3 decreased as inner strands were cut during stage D. The strain-time history from gage XS3 can be understood by considering the strand release pattern (Figure 51) and the resulting deformed shapes (Figure 53). As the outer strands were cut during stage B, the outside edges of the bottom flange deformed as shown in Figure 53. This deformed shape corresponded with the formation of tensile strains at the location of XS3. After the inner strands were cut, deformation of the bottom flange was more uniform and the tensile strain at XS3 was partially relieved. Once all of the strands were cut (stage E), the reported tensile strains at XS3 settled to approximately 25 microstrain.

Stage F on Figure 52 denotes lifting of girder H. Figure 54 shows the supports conditions, loading, shear, and moment diagrams for the girders before, during, and after lifting. The change in support conditions had negligible effect on strain in the end region. None of the gages in the end region of girders H or V reported more than a 25 microstrain change during lifting and placement on dunnage.

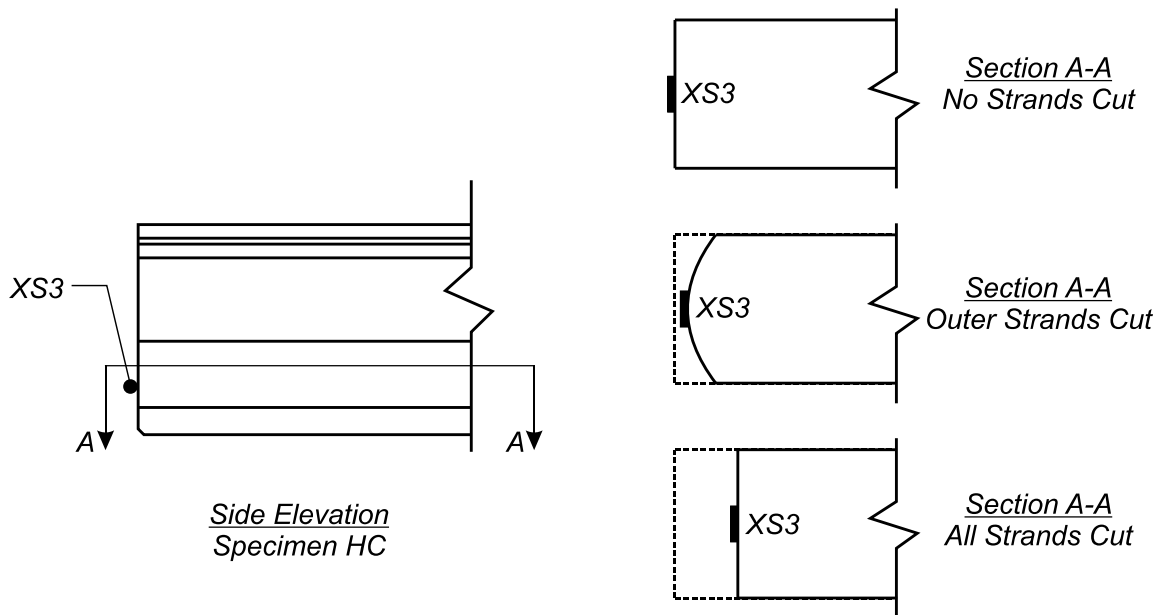
Figure 53–Flange displaced shapes for specimen HC

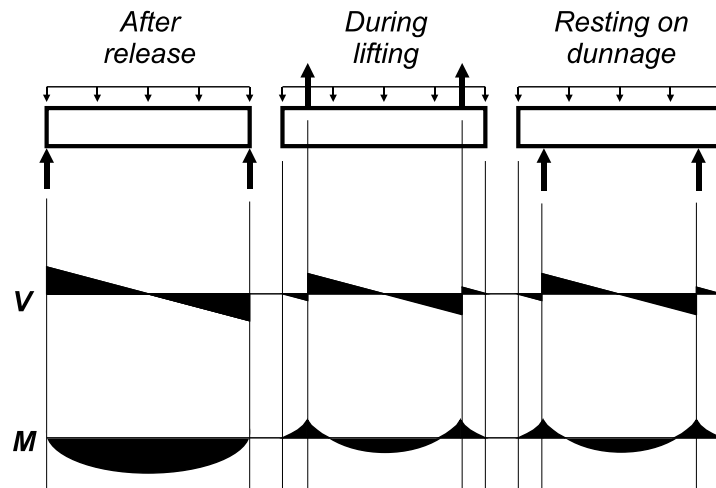
Figure 54–Shear and moment during release, lifting, storage (prestressing not shown)

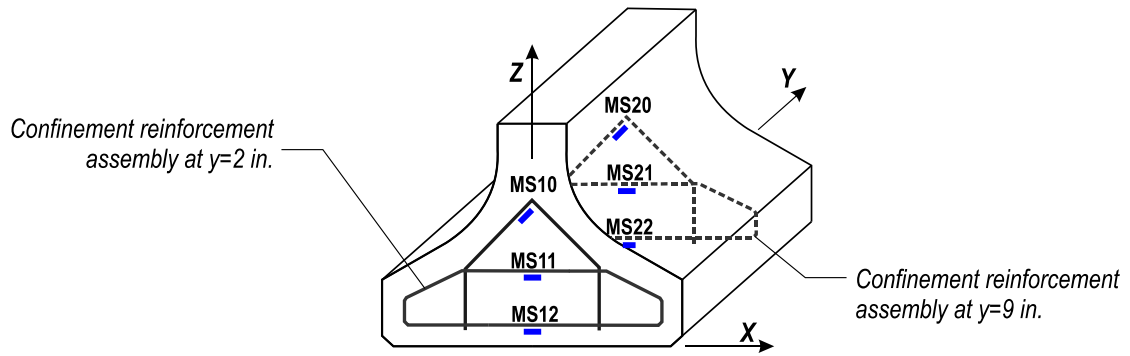
Figure 62–FB confinement reinforcement strain at 2 in. and 9 in. from end of girder

Strain data at the end of stage N (all strands cut) is listed in Table 24 for each specimen. Several observations can be made by averaging the stage N strain data (Figure 64). First, strain was greatest in the bottom layer of reinforcement for each test specimen. On average strain in the bottom layer was 1.4 times greater than the middle layer strain and almost 3 times greater than the top layer strain. Second, the largest confinement reinforcement strain occurred in specimens FN and FB in the confinement assemblies 2 in. from the member ends.

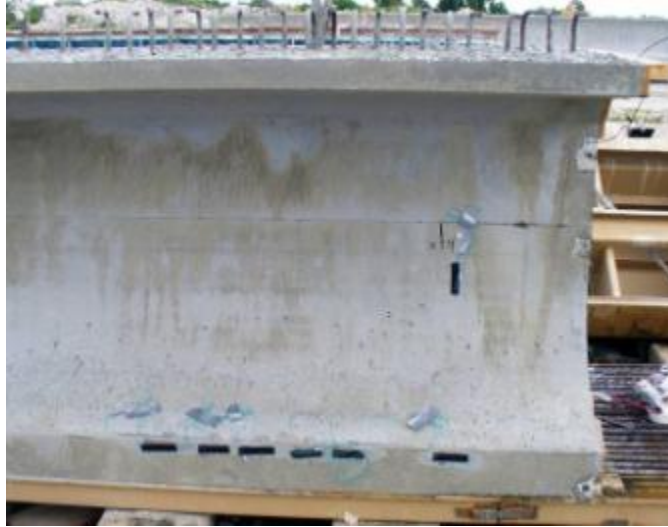
Figure 66–Strain gages for measuring transfer length

Figure 67 presents strain gage data from the bottom flange of girders H and V immediately after prestress transfer. Blue markers on the figure indicate the strain values reported by individual gages. Values reported by the gages were effectively constant (with some experimental scatter) for the monitored positions along the specimen lengths. This indicates that the gages were placed too far from the end of the girder to capture strain in the transfer length. A bilinear curve representing the apparent strain profile is also shown in Figure 67. The apparent profile shows that the strain must be zero at the end of the girder and must increase to the experimental values recorded at 18in. Beyond 18in. the experimental strains and apparent strain were approximately constant. Thus the transition to constant strain occurred prior to 18in. and it is concluded that the transfer length is not greater than 18in. for girders H and V.

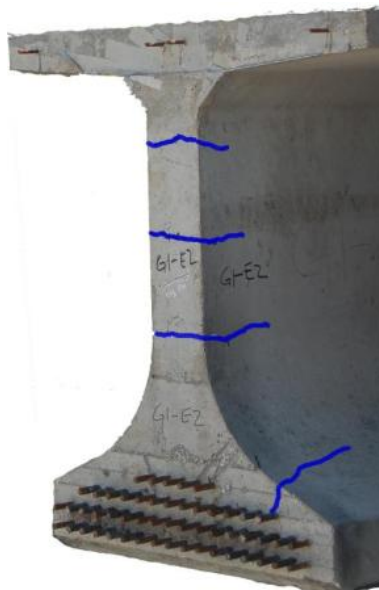
Figure 69–Web splitting and flange splitting cracks

Top flange cracking was due to flexural stresses generated by the vertically eccentric prestressing and is outside the scope of this end region research. Web splitting (Figure 69) cracks were also due to eccentricity of prestressing. Vertical tension stress formed in the web at the end of the specimens as the prestress force was distributed to the cross-section. Flange splitting cracks are of primary interest in the current investigation of confinement reinforcement and were caused by horizontal eccentricity of prestressing, Hoyer expansion of strands, and self-weight reaction of the test girders. Transverse tensile stress formed in the bottom flange as prestressing forces were distributed through the cross-section from eccentric strands in the outer portion of the flange. Additional tensile stresses formed due to the Hoyer effect, in which strand expansion after cutting was restrained by the concrete. Self-weight caused tensile stresses above the support due to Poisson and flange bending effects. Cracks in the top flange, web, and bottom flange occurred when the tensile stresses described above exceeded the concrete strength.

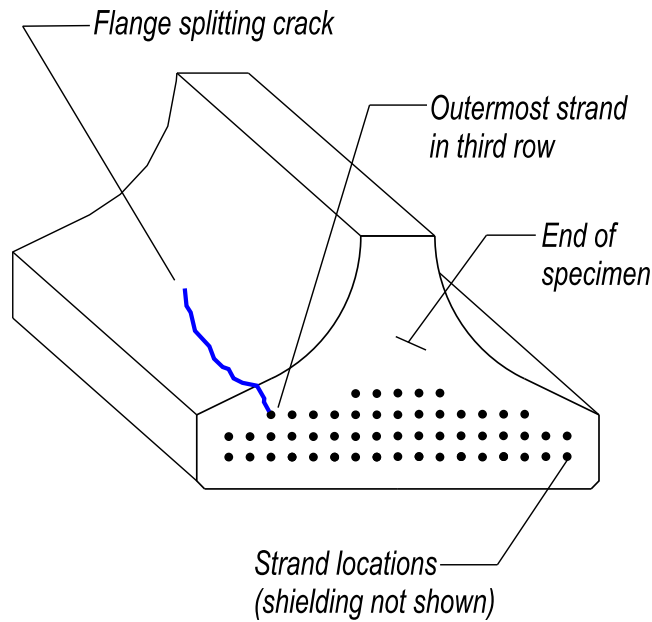
Figure 71–Flange splitting crack intersecting outer strand

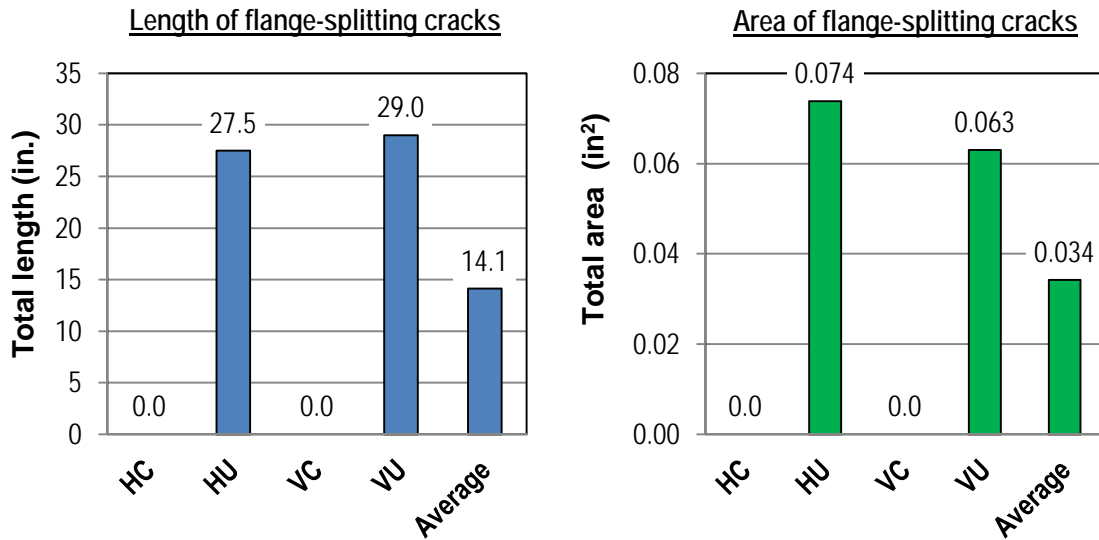
Figure 74—Flange splitting crack data in girders H and V

Flange splitting cracks only occurred in specimens HU and VU, which did not have confinement reinforcement. The total length and area of flange cracks were similar between HU and VU (Figure 74). The maximum width of flange splitting cracks was 0.004 in (Figure 73). Presumably, confinement reinforcement in HC and VC controlled the formation and propagation of flange cracks in those specimens.
