Appendix D–FIB-54 Tests

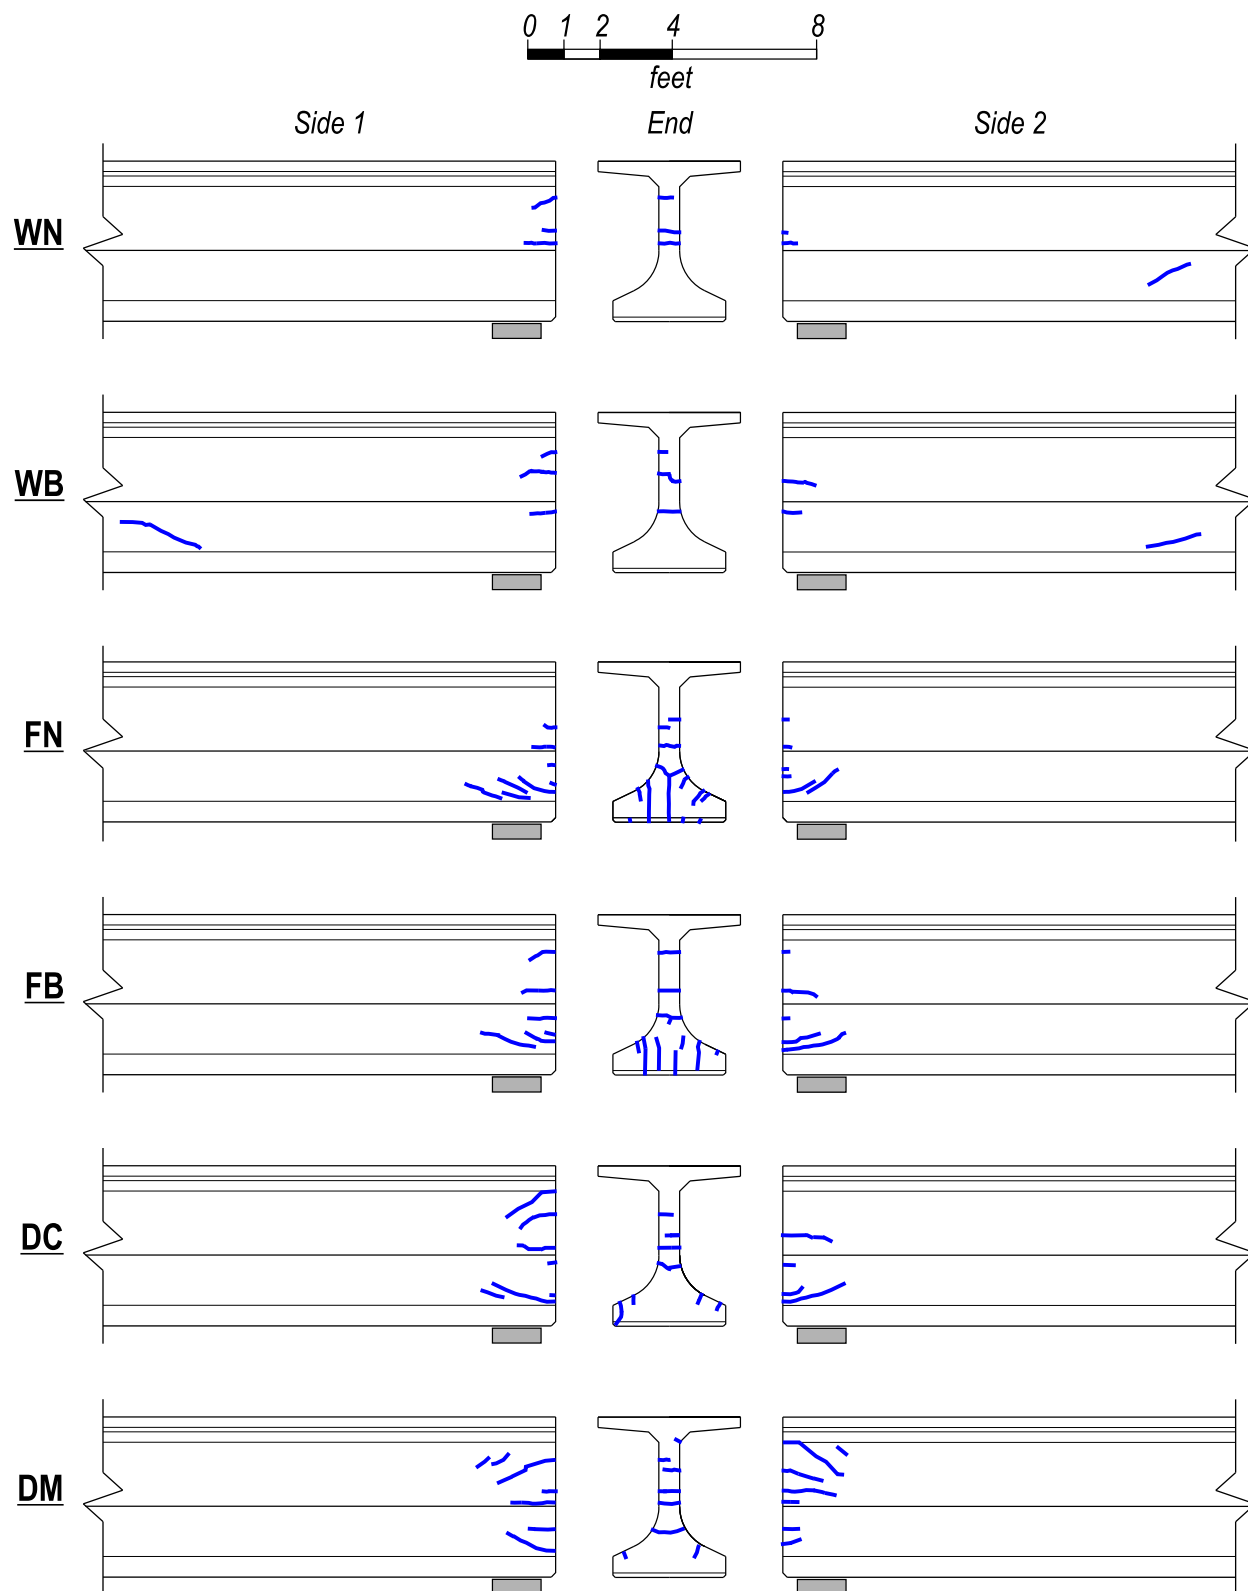
Figure 75–Girders W, F, and D web and flange splitting cracks

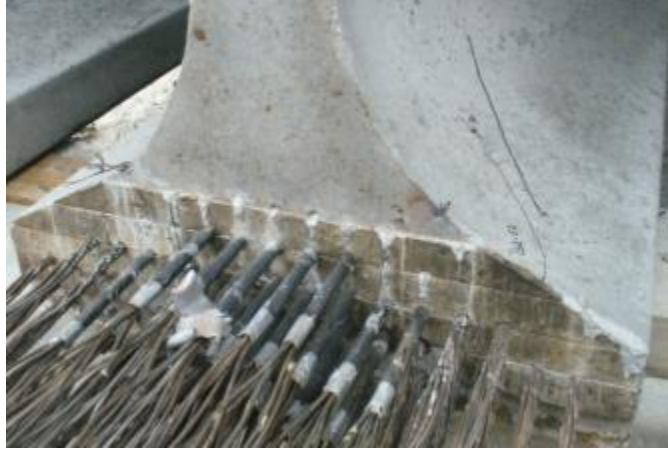
Figure 76–End of bottom flange covered by portion of steel bulkhead

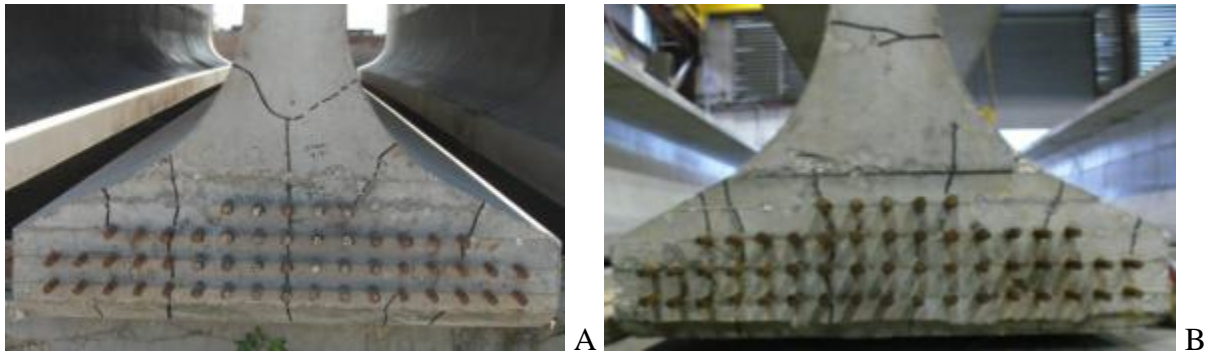
Figure 77–Girder F flange splitting cracks in A) specimen FN and B) specimen FB

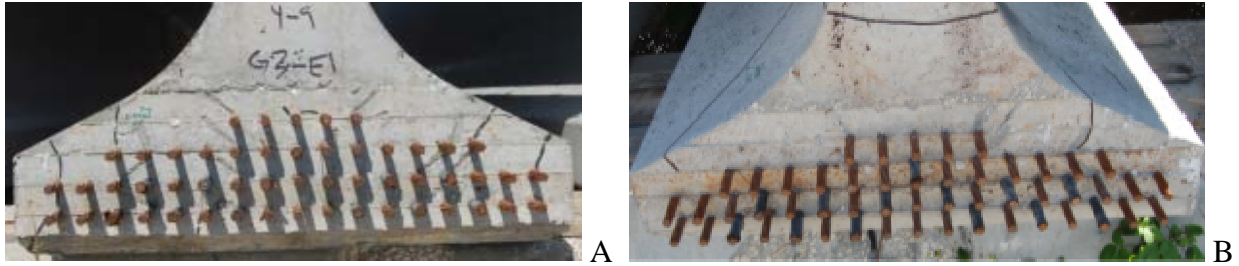
Figure 81–Girder D flange splitting cracks in A) specimen DC and B) specimen DM

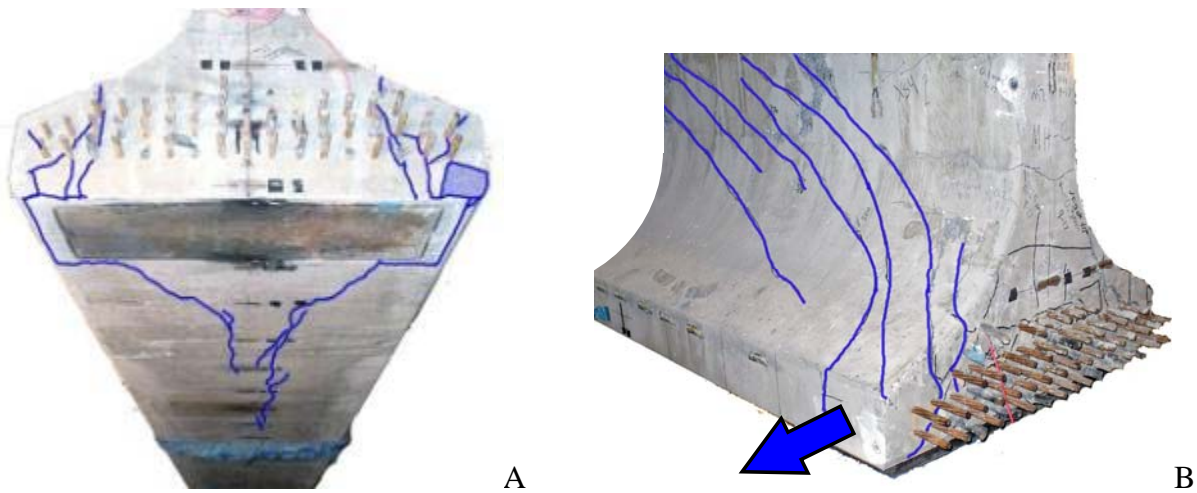
Figure 83–Lateral-splitting failure A) bottom view and B) side-end view

Lateral-splitting failure is characterized by longitudinal cracks in the bottom flange and by peeling (outward) movement at the edges of the bottom flange (Figure 83.) Peeling movement of the bottom flange is caused by eccentricity between prestressing forces in the outer flange and the resultant equal and opposite force centered in the web (Figure 84.) This condition creates a moment which opens bottom flange cracks, and peels the edges of the bottom flange outward. In specimens with sufficient bottom flange confinement, peeling movement and longitudinal cracks are restrained, and peeling failure is mitigated.

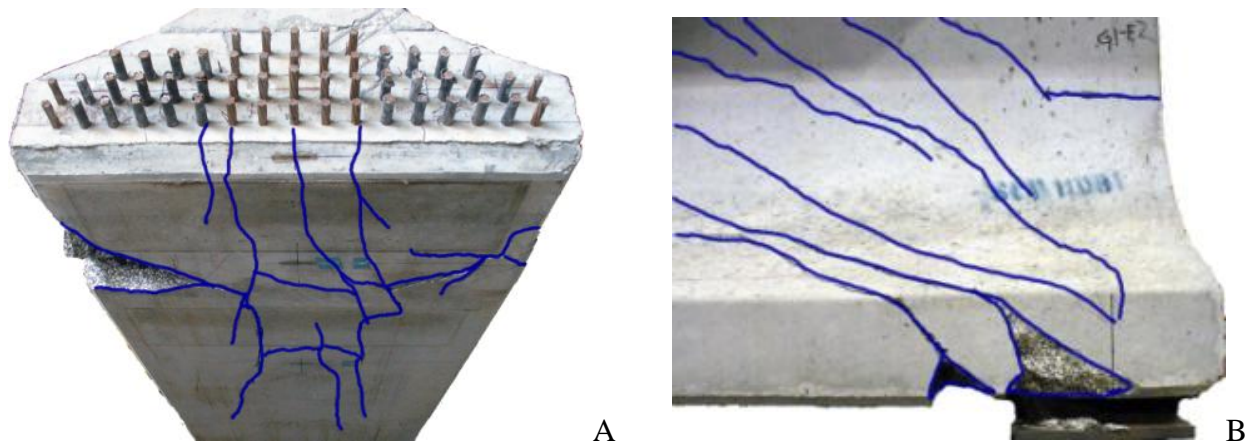
Figure 85–Bond-shear failure A) bottom view and B) side view

Bond-shear failure is characterized by strand-slip at peak load. This type of failure is governed by concrete-strand bond capacity and by specimen propensity for cracking within the strand development length. Cracking in the development length is always a precursor to strand slip (Figure 85). Cracks interrupting strand development reduce the embedment length to the distance between the crack and the girder end. After strands start slipping the cracks opened wider and new cracks form. An abrupt slip event occurs at peak load followed by a subsequent loss of capacity. Longitudinal splitting cracks can also be observed on the bottom of specimens that failure in bond-shear (Figure 85).

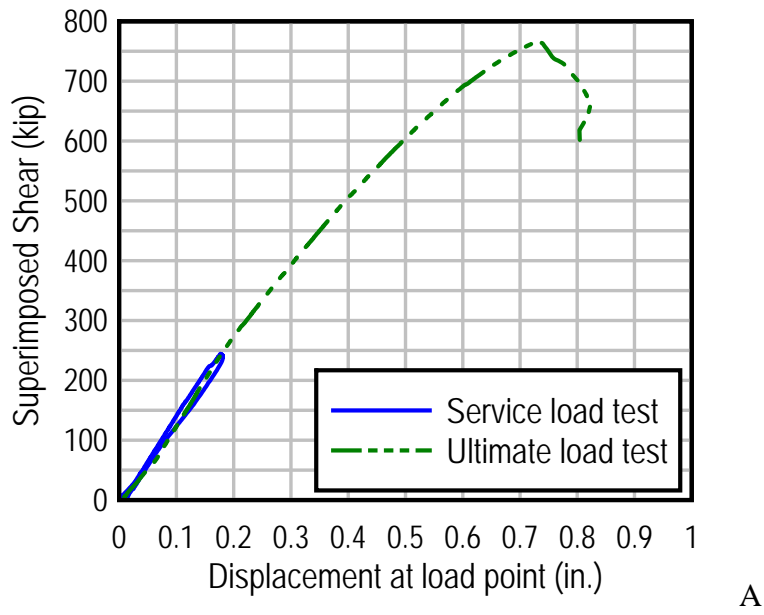
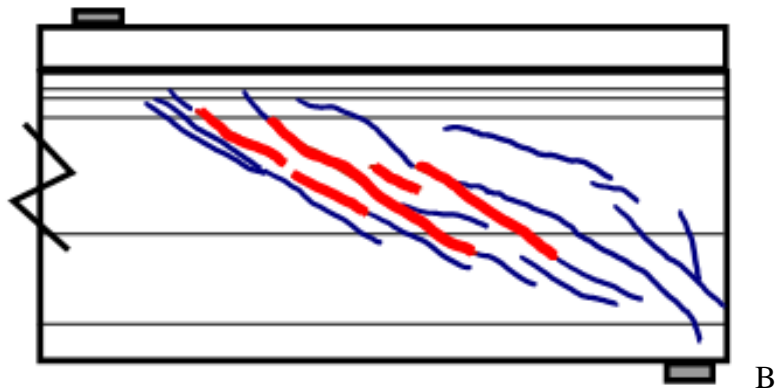
Release cracks not shown.
 Initial cracks shown bold in red
 Final cracks shown blue.

Figure 86–Specimen HC load test summary A) shear-displacement and B) crack pattern

Detailing of specimen HC (Figure 10) was effectively identical to the 2008 FDOT Interim Design Standards (FDOT, 2008). Variables in specimen HC included FDOT specified confinement reinforcement and bearing plate in the bottom flange, horizontal reinforcement in the end region, and the ‘design’ strand bond pattern (Figure 9) which had (39) fully bonded strands. Specimen HC failed in web-shear mode. Shear-displacement and crack pattern are shown in Figure 86.

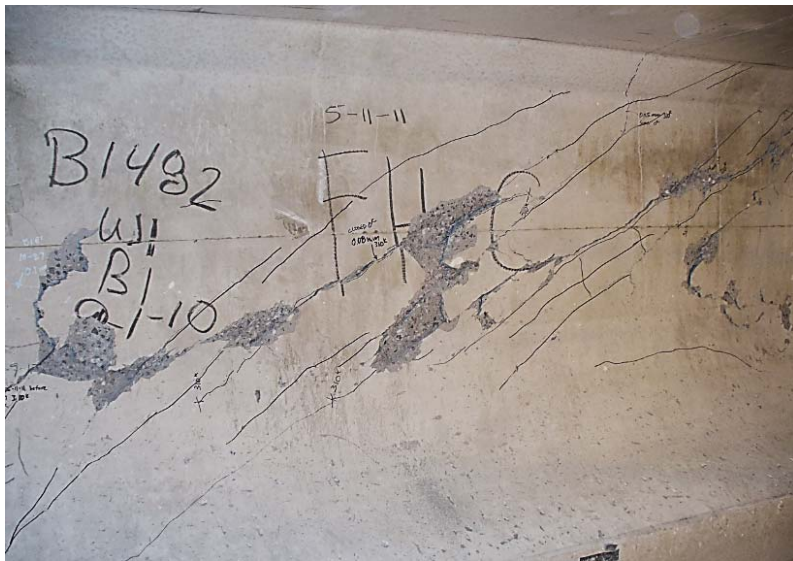
Figure 88–Close-up of web crushing and spalling

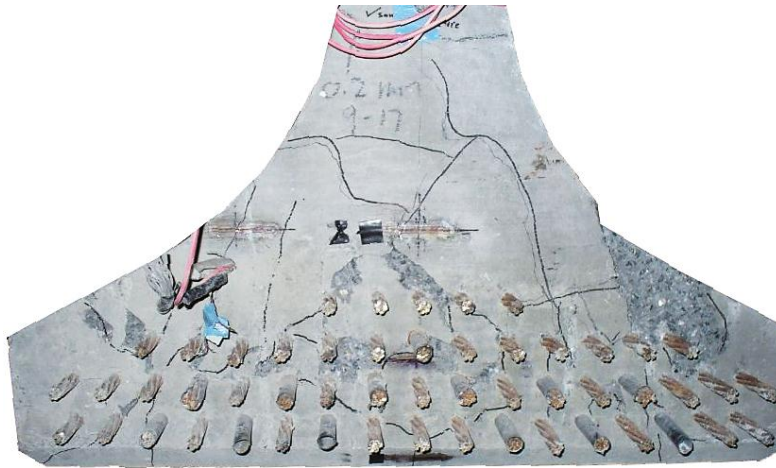
Figure 89–Cracks at end of HC after testing

After the test the wood frame holding the LVDTs was removed, revealing cracks at the end of HC that intersected most of the strands (Figure 89). These cracks are believed to have occurred at or subsequent to the peak load.

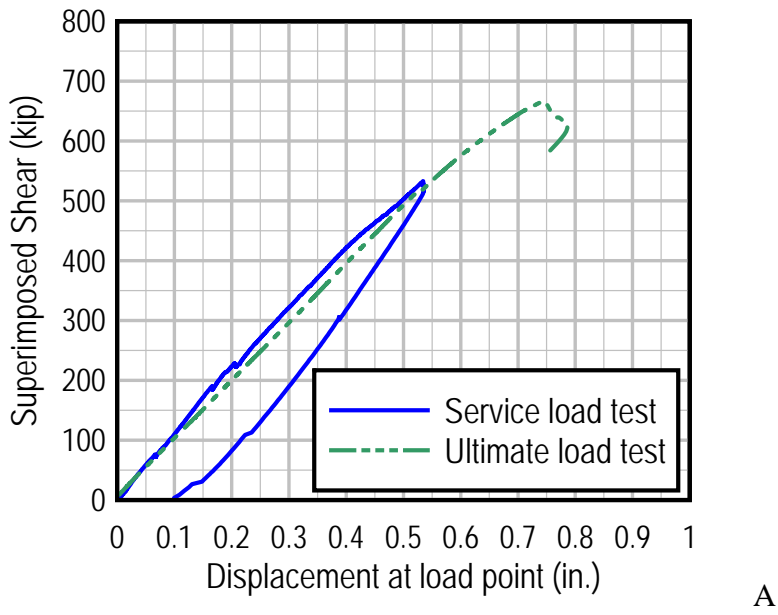
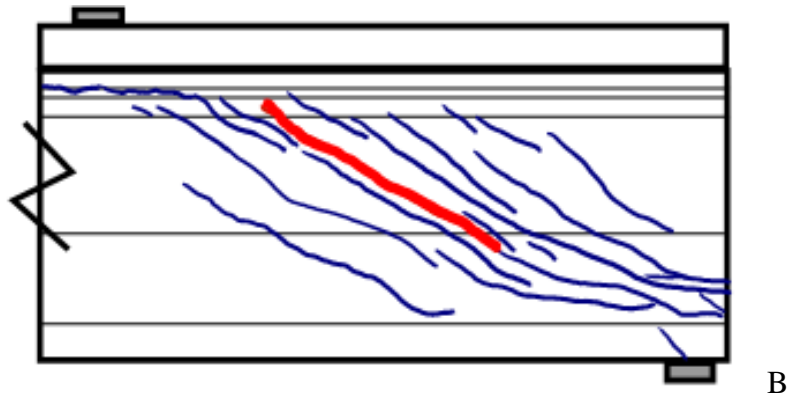
Release cracks not shown.
 Initial crack shown bold in red
 Final cracks shown blue.

Figure 90–Specimen HU load test summary A) shear-displacement and B) crack pattern

Strand slip data are not shown in Figure 90. LVDT data indicate that strand slip was negligible at lower loads. At higher loads cracks caused shifting of the frame holding the LVDTs thereby compromising the strand slip data. Data from specimens with similar strand bond patterns and better instrumentation suggest that strand slip was not a contributing factor to in the failure of in specimens with the ‘design’ strand bond pattern.

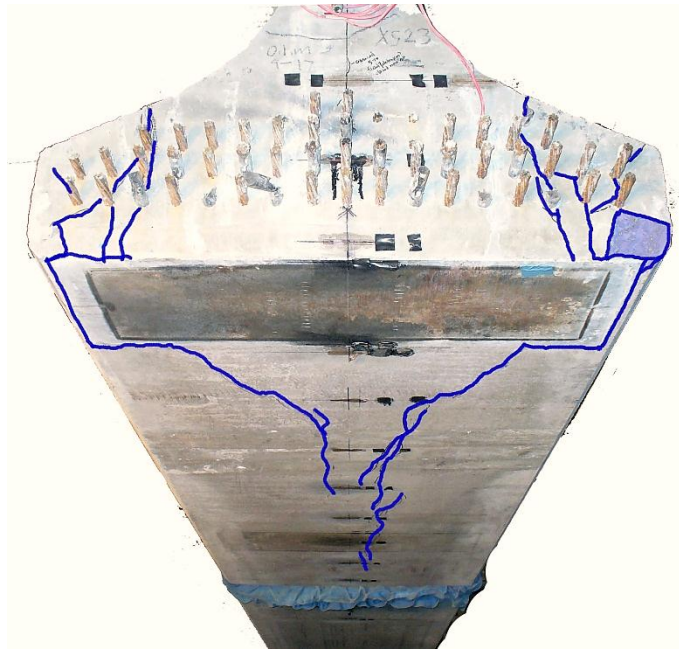
Figure 91–Bottom and end of HU after testing

Peak load in specimen HU corresponded to lateral-splitting failure in the bottom flange, which resulted in an abrupt loss of load (Figure 91, Figure 92). Specimen HU supported a maximum shear of 666 kip.

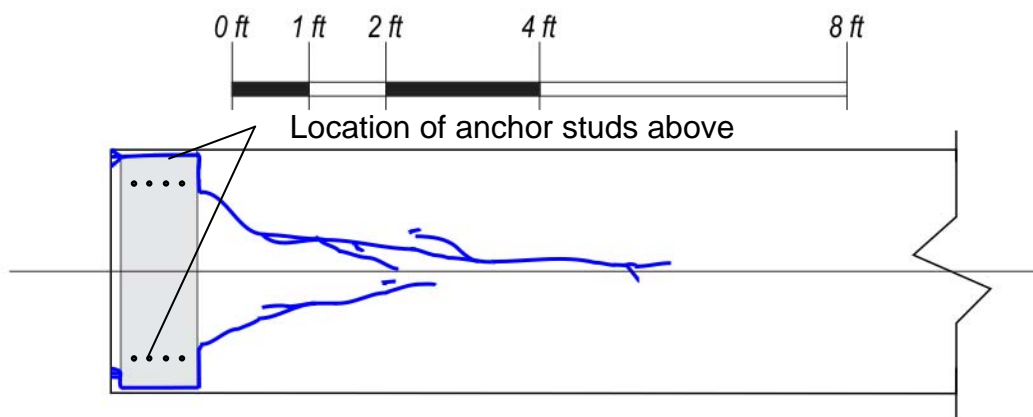
Figure 92–Bottom view of splitting cracks in HU

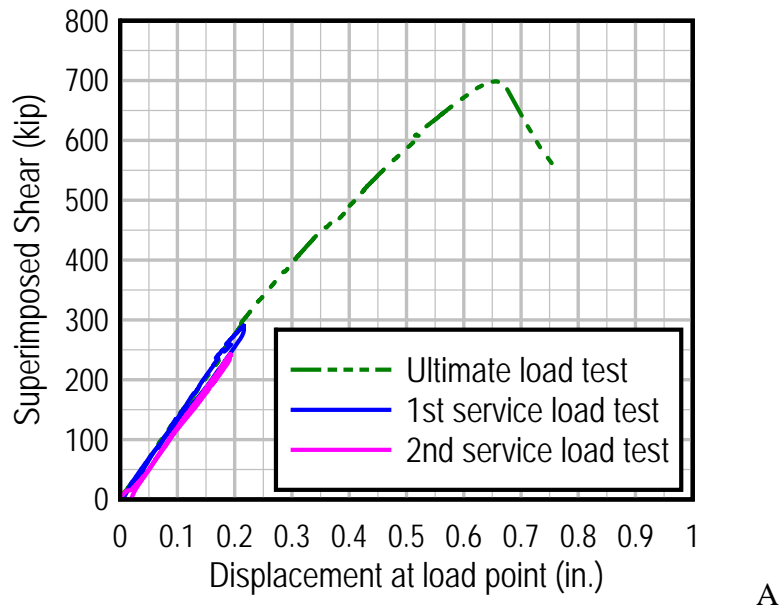
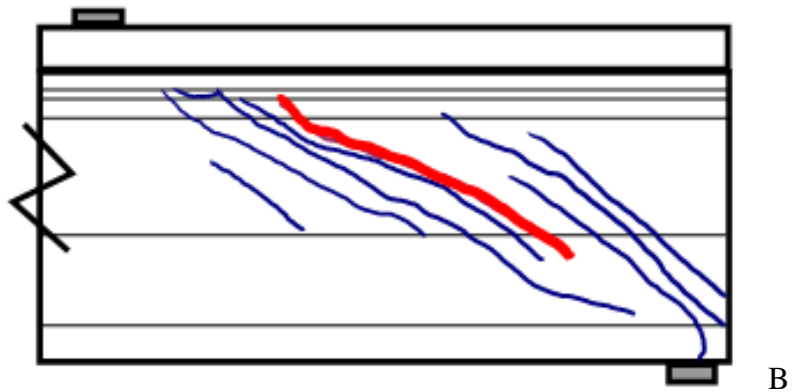
Release cracks not shown.
Initial crack shown bold in red.
Final cracks shown in blue.

Figure 93–Specimen VC load test summary A) shear-displacement and B) crack pattern

pattern (Figure 9) which included (39) fully bonded strands. Specimen VC failed in a web-shear failure mode. Shear-displacement and crack pattern are shown in Figure 93.

Strand slip data are not shown in Figure 93. LVDT data indicate that strand slip was negligible at lower loads. At higher loads cracks caused shifting of the frame holding the LVDTs thereby compromising the strand slip data. Data from specimens with similar strand bond patterns and better instrumentation suggest that strand slip was not a contributing factor to in the failure of in specimens with the 'design' strand bond pattern.

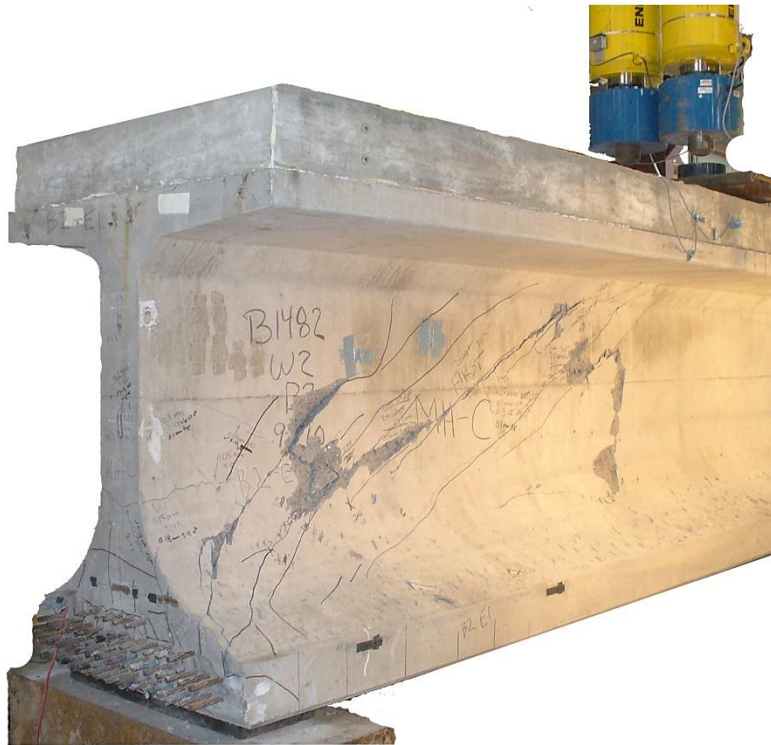
Figure 94–VC after load test

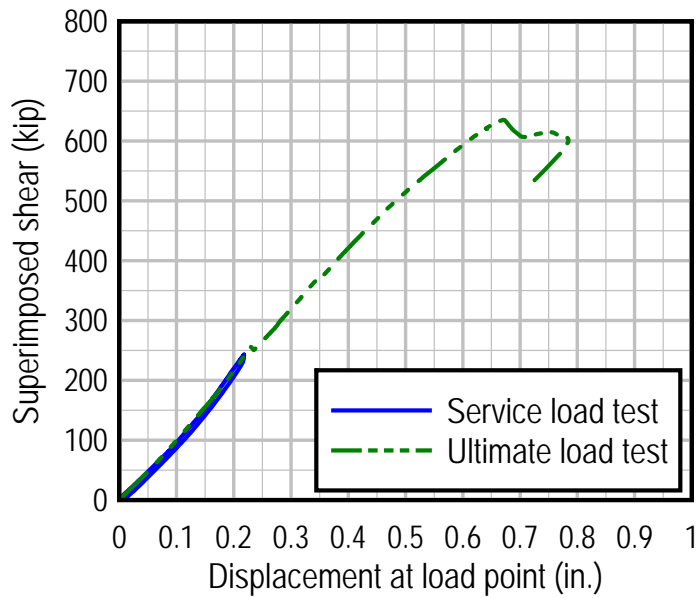
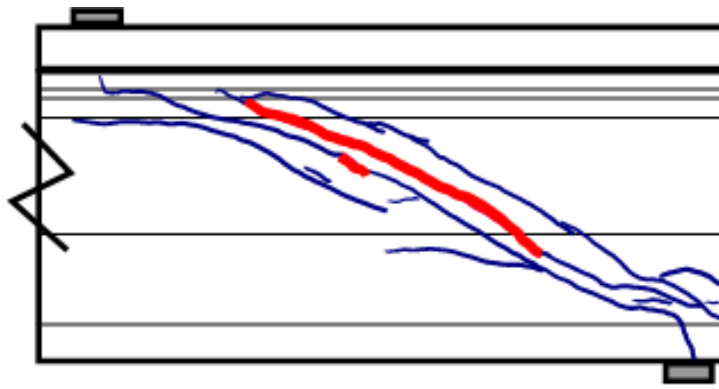
A

Final cracks shown blue.

Specimen VU (Figure 11) had the least amount of reinforcement of any specimen in the test program. Variables in specimen VU included no confinement reinforcement, no horizontal reinforcement and reduced vertical reinforcement in the end region. Specimen VU had a bearing plate in the bottom flange and had the ‘design’ strand bond pattern (Figure 9) which included (39) fully bonded strands. Shear-displacement and crack pattern are shown in Figure 95.

Strand slip data are not shown in Figure 95. LVDT data indicate that strand slip was negligible at lower loads. At higher loads cracks caused shifting of the frame holding the LVDTs thereby compromising the strand slip data. Data from specimens with similar strand bond patterns and better instrumentation suggest that strand slip was not a contributing factor to in the failure of in specimens with the ‘design’ strand bond pattern.

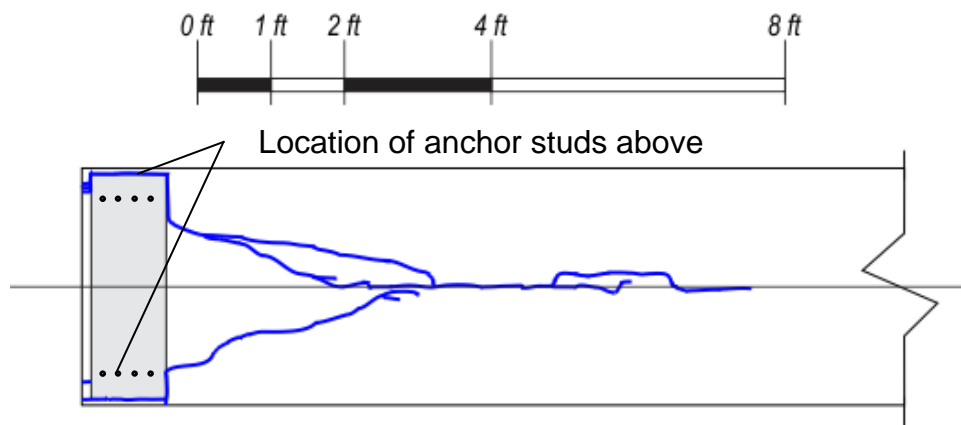
Figure 96–Bottom view of splitting cracks in VU

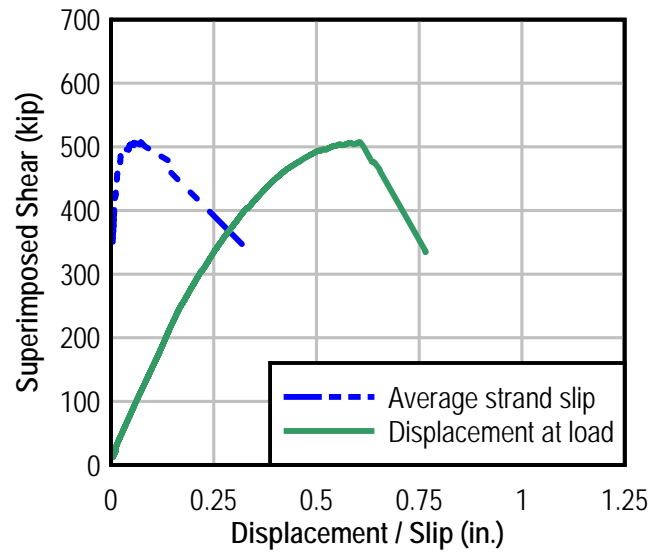
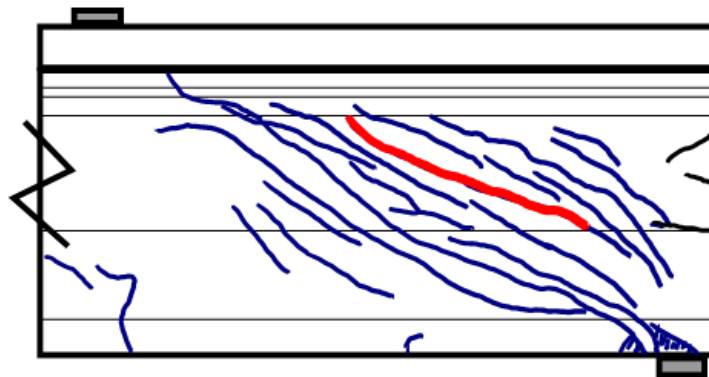
A

Final cracks shown blue.

The primary features of specimen WN (Figure 21) were the lack of an embedded bearing plate and the ‘web’ strand bond pattern (Figure 9) that placed (20) fully bonded strands below the web. Four additional strands were fully bonded at the edges of the flange, resulting in a total of (24) fully bonded strands. Other variables in WN included no horizontal bars in the end region and modified confinement reinforcement. The modified confinement scheme had fewer, but larger, bars than specified by the FDOT. Shear-displacement, shear-slip and crack pattern results for specimen WN are shown in Figure 97.

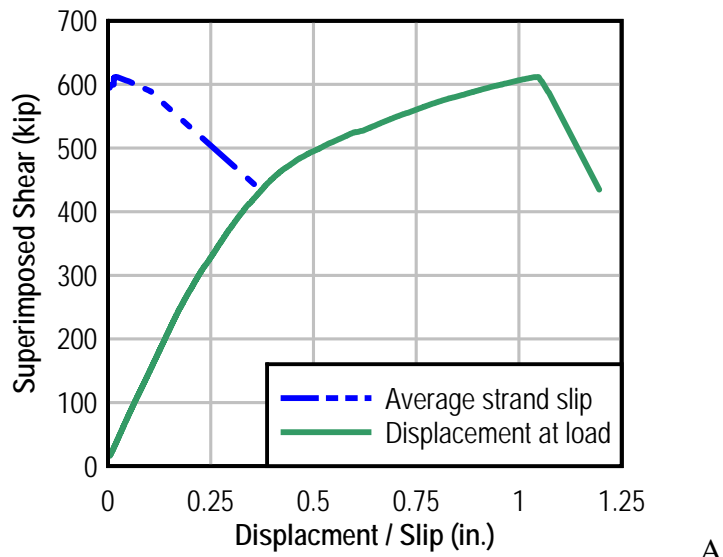
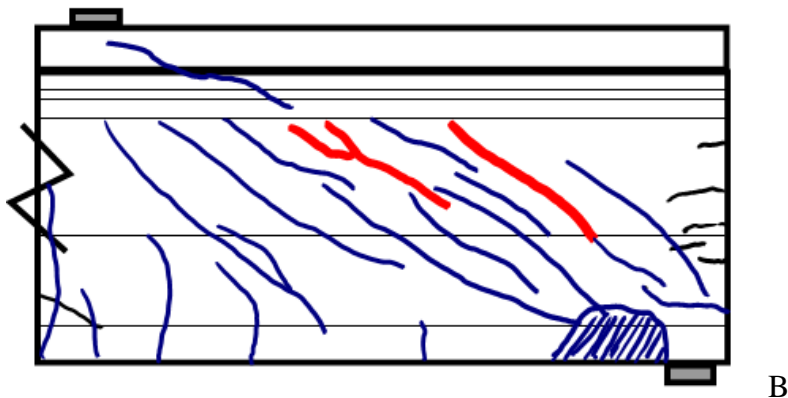
Release cracks shown black.
 Initial crack shown bold in red.
 Final cracks shown blue.

Figure 98–Specimen WB load test summary A) shear-displacement/slip and B) Crack pattern

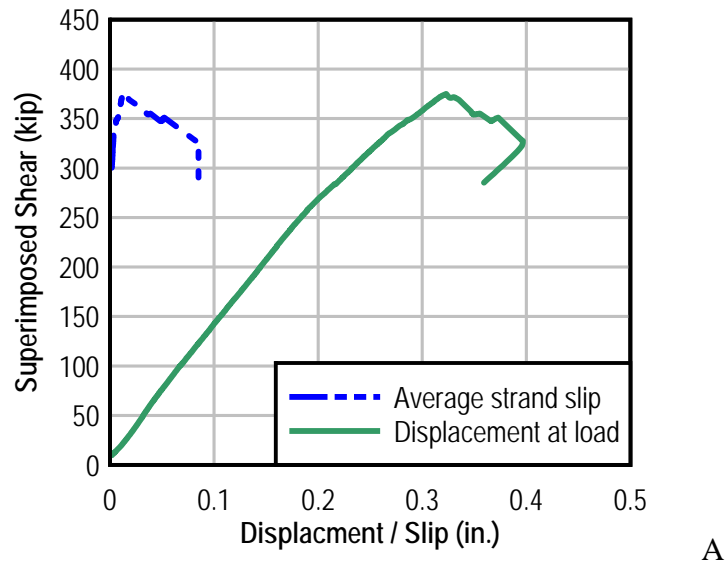
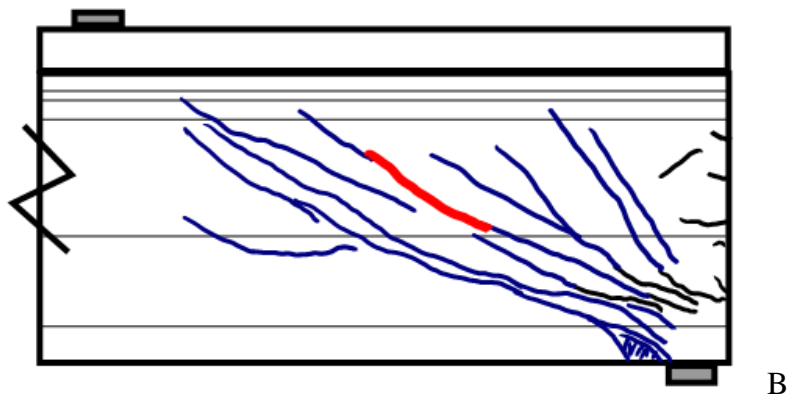
Release cracks shown black.
 Initial crack shown bold in red.
 Final cracks shown blue.

Figure 99–Specimen FN load test summary A) shear-displacement/slip and B) crack pattern

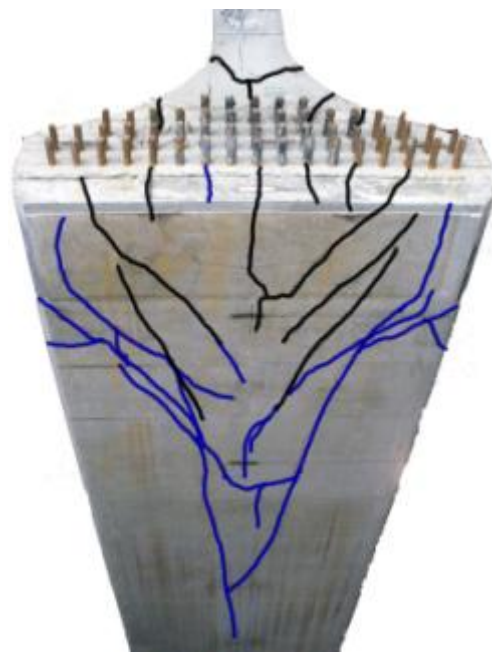
Figure 101–Longitudinal splitting cracks on bottom of specimen FN (release cracks shown black; final cracks shown blue)

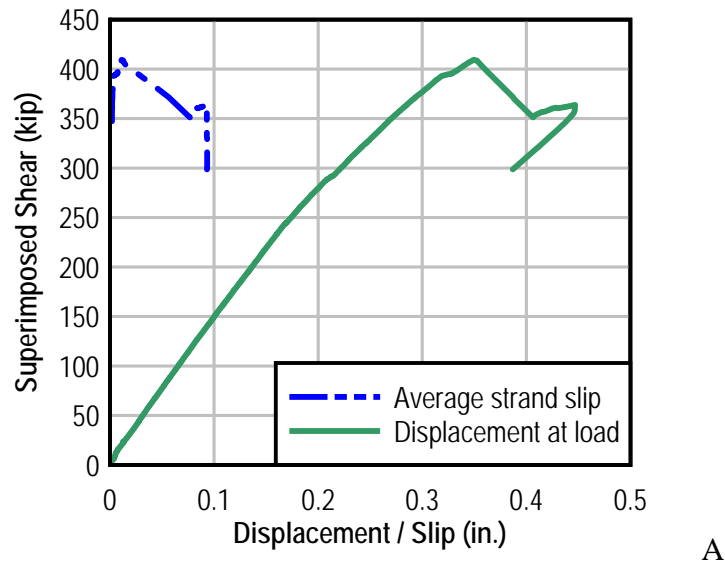
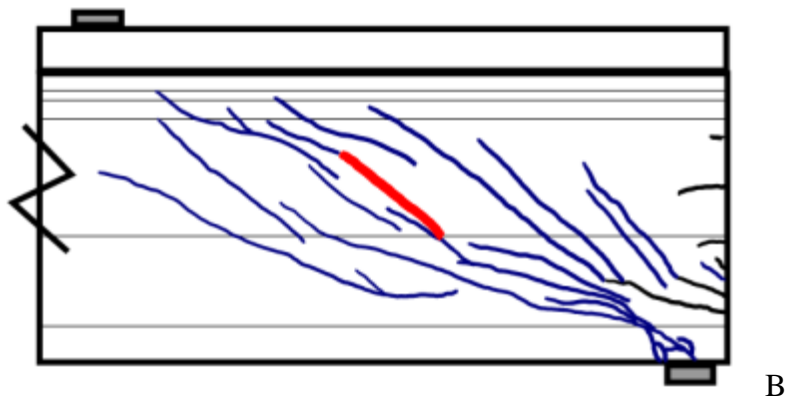
Release cracks shown black.
 Initial crack shown bold in red.
 Final cracks shown blue.

Figure 103–Specimen FB load test summary A) shear-displacement/slip and B) crack pattern

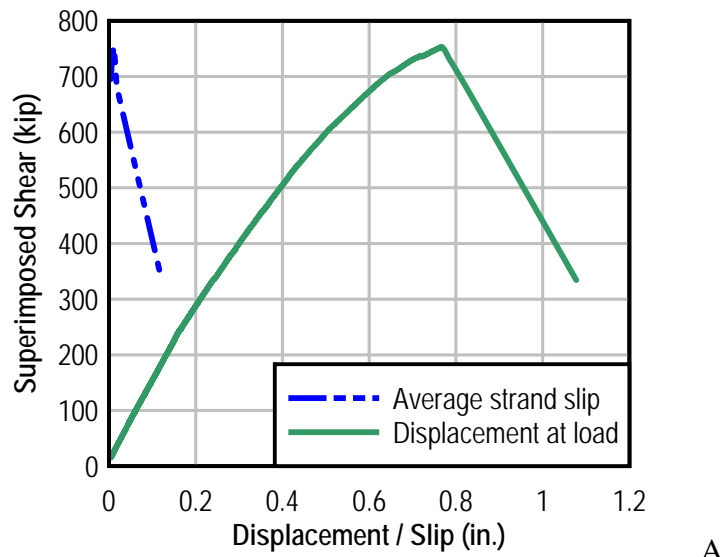
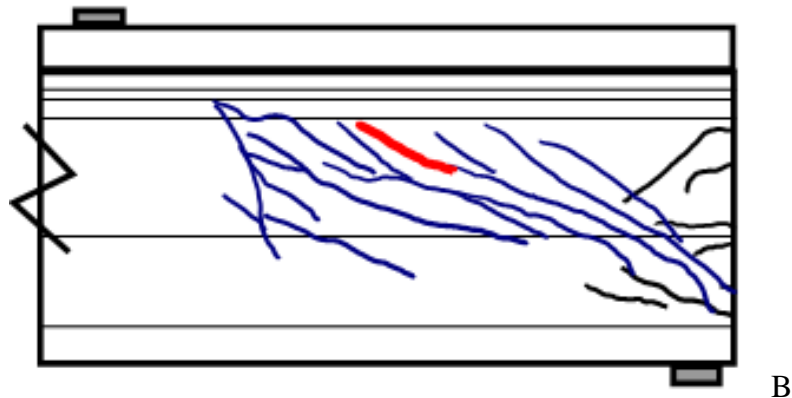
Release cracks shown black.
 Initial crack shown bold in red.
 Final cracks shown blue.

Figure 104–Specimen DC load test summary A) shear-displacement/slip and B) crack pattern

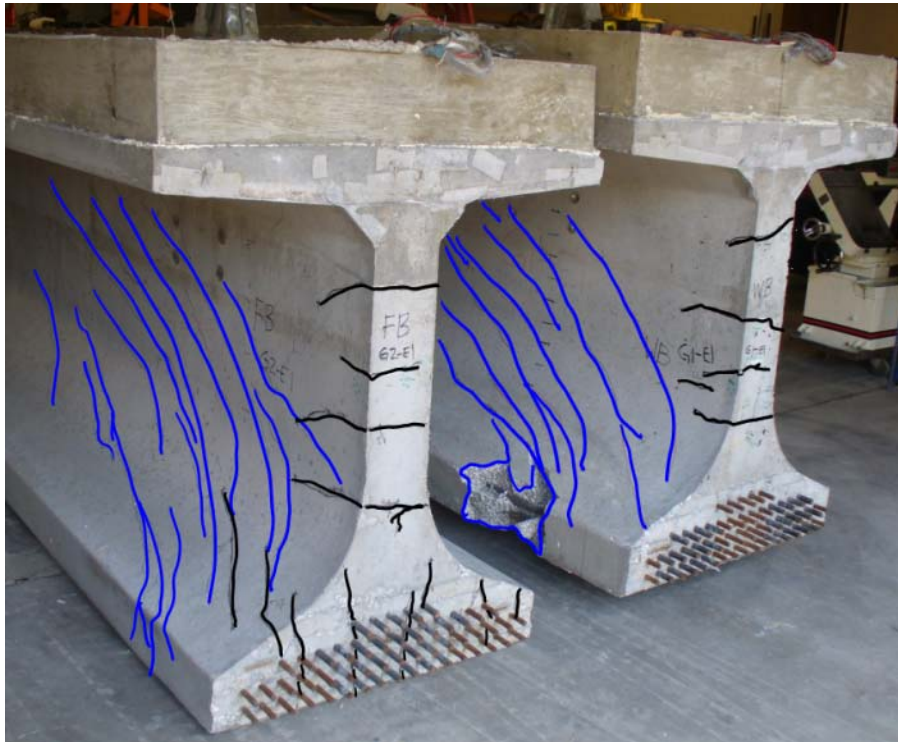
Figure 119–Comparison of FB (left) and WB (right)
(release cracks shown black; final cracks shown blue)
