Appendix E–FIB-63 Tests

1 Introduction

2.2 Design

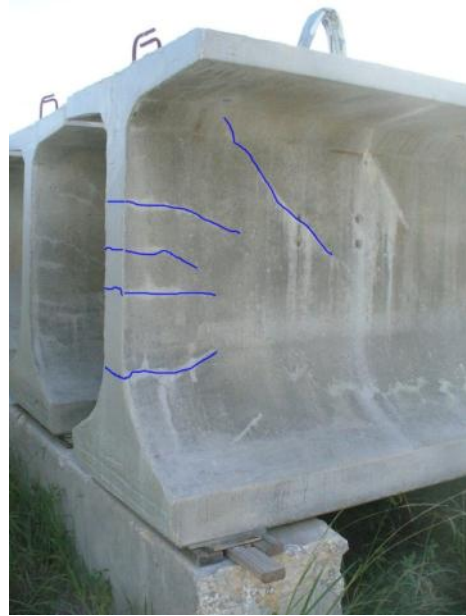
Figure 1–Web splitting cracks (enhanced in blue)

Web splitting cracks (Figure 1) typically form during prestress transfer, or in the days and weeks following transfer. They occur due to tensile stresses that are induced as prestressing forces in the bottom flange are distributed through the cross-section (Figure 2).

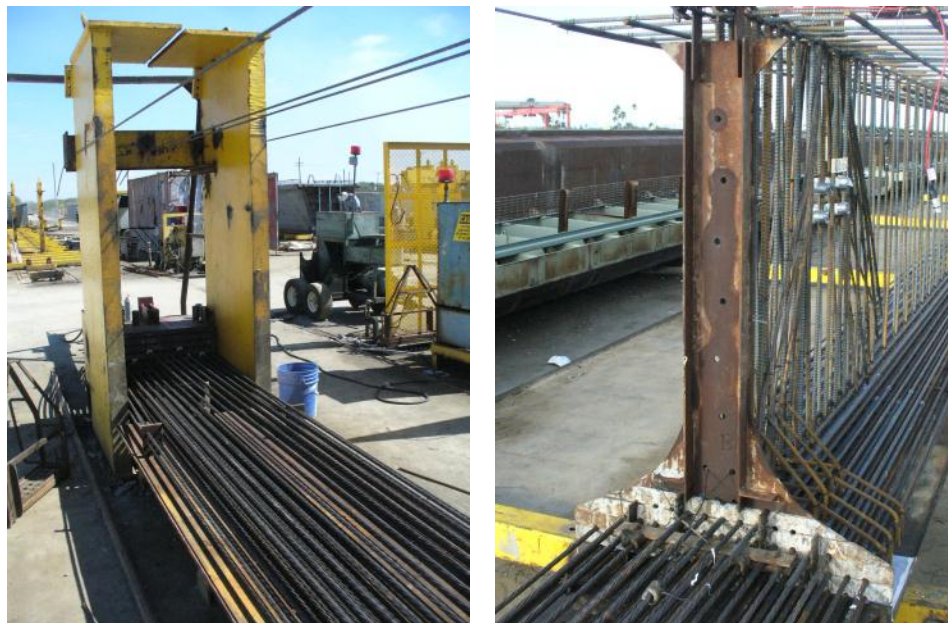
Figure 12–Jacking frame (left), and steel bulkhead (right).

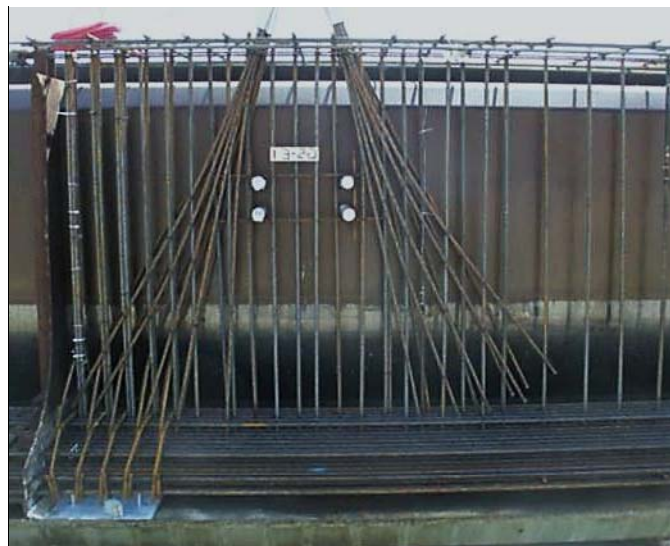
Figure 14–Specimen CT reinforcement

After tensioning, mild steel reinforcement was placed in each specimen. Select bars were instrumented with strain gages prior to placement in the girders. Figure 14 to Figure 17 show the reinforcement in each specimen. Diagonal strands shown in the web in the pictures are from the lifting loops. Close-ups of the post-tensioning system used in specimen PT are shown in Figure 18. As shown in Figure 18 pipes were placed at the top of two rods to act as spacers for load cells. Close-ups of the 1-in. diameter vertical bars in specimen LB are shown in Figure 19.

5T. Bars bundled with 5Rs bars at girder ends. These bars were used to control web splitting cracks.

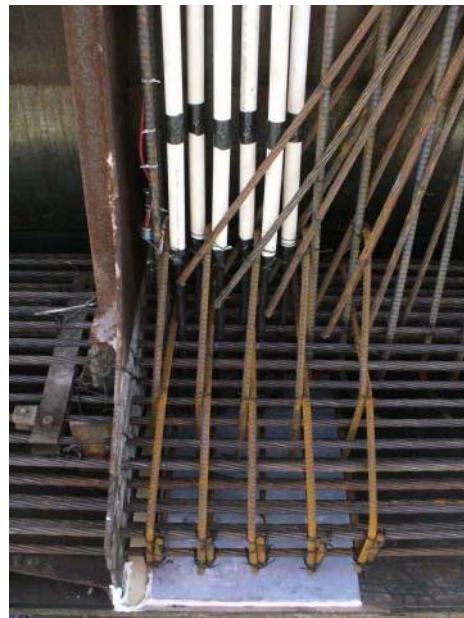
Figure 18—Top (left) and bottom (right) of post-tension rods in specimen PT

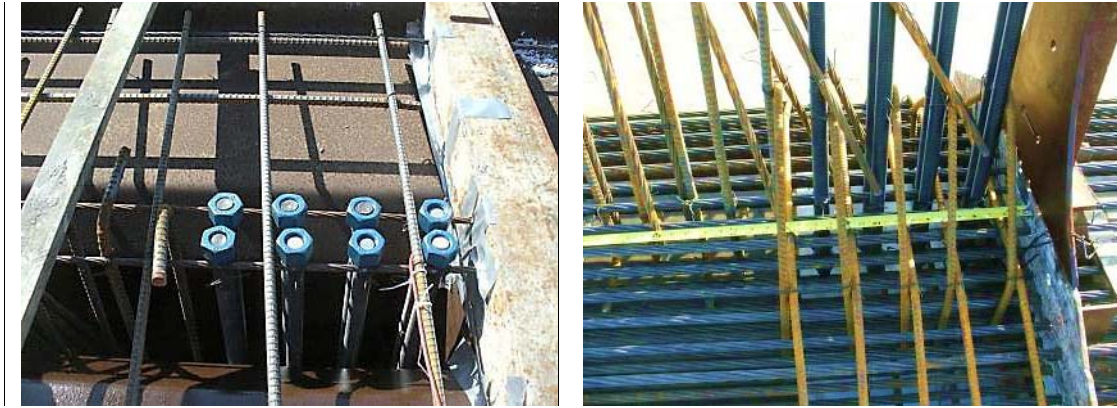
Figure 19–Top (left) and bottom (right) of all-thread rods in specimen LB

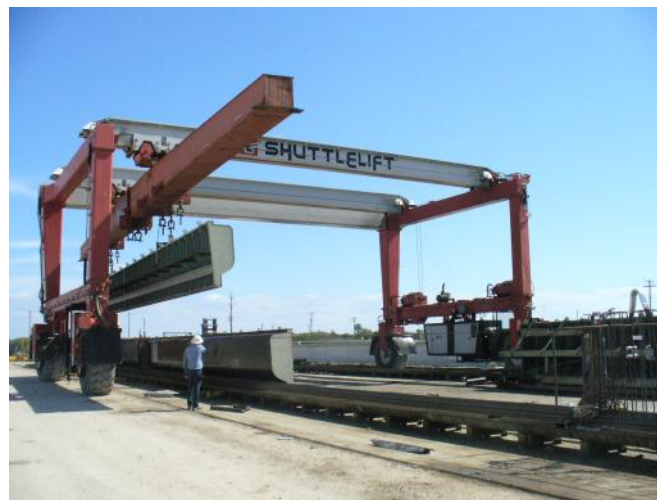
Figure 20–Form placement

Once reinforcement and internal instrumentation were installed and checked, steel forms were oiled, placed, and squared (Figure 20 and Figure 21). Concrete was mixed at an on-site batch plant and was transported and poured using the fabricator’s mix truck and delivery equipment (Figure 22). A self-consolidating concrete mix was used and vibration was not necessary. One batch of concrete was used for both FIB-63 test girders. Concrete test cylinders were taken by the fabricators and by the research team. The top surface of each FIB-63 girder was trowel smooth (Figure 23). Girders were covered with heavy tarps during curing (Figure 23).

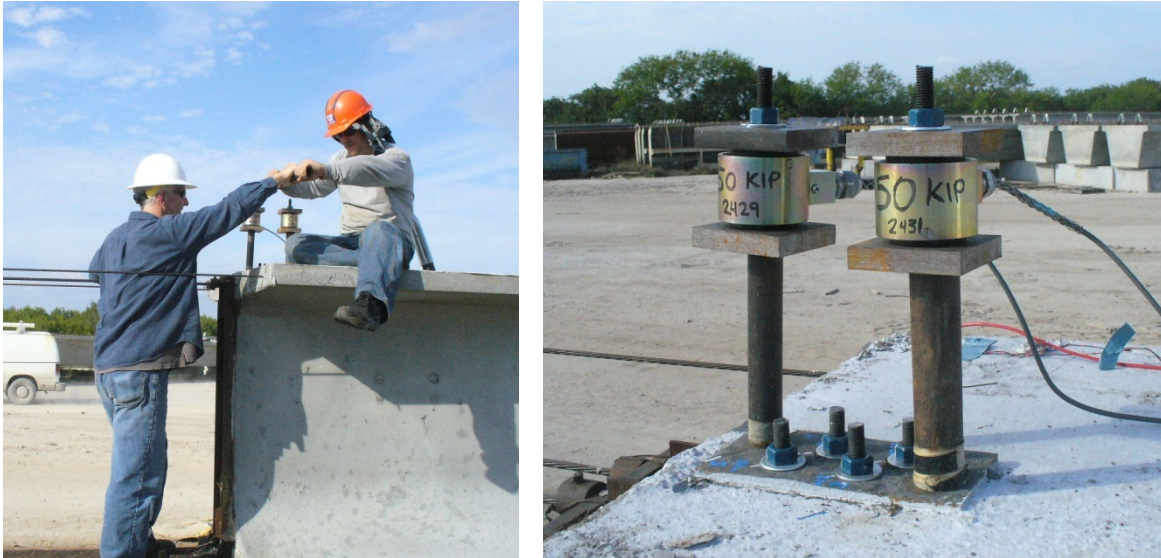
Figure 24–Post-tensioning specimen PT (left) and load cells and anchor plate (right)

Forces in the individual rods were influenced by the relative difficulty of the post-tensioning process. In spite of these difficulties a total post-tensioning force of 77.9 kip was obtained. This value is within the acceptable range as determined from preliminary analysis conducted prior to fabrication. The total applied post-tension force was approximately 3.4% of the initial pretension forces.

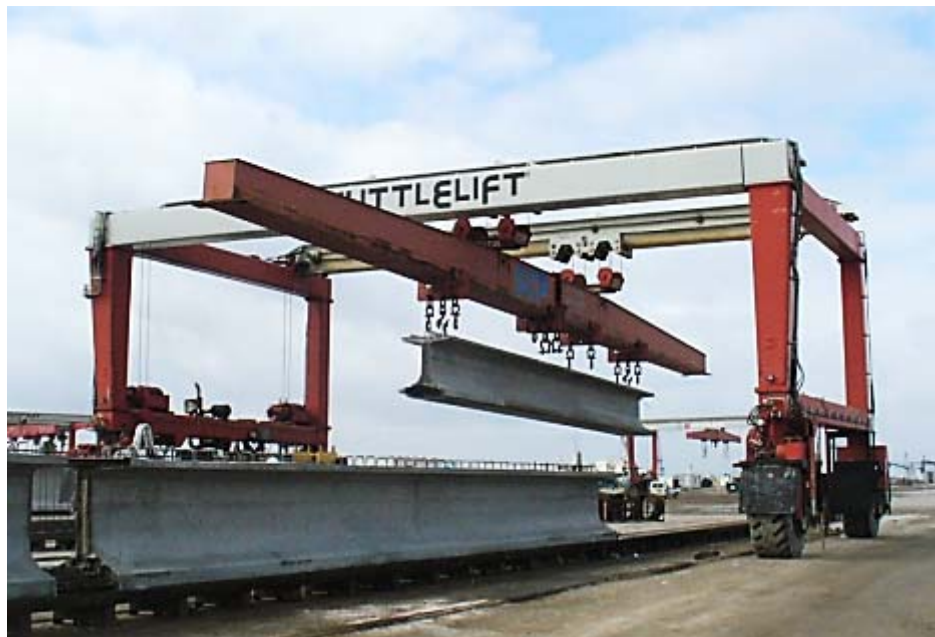
Figure 26–Girder lifted by crane

Girders were moved from the stressing bed to storage yard the day after prestress was transfer (Figure 26). While in storage the girders were examined periodically for cracking. After three months in storage girders were trucked (Figure 27) to the Marcus H. Ansely FDOT structures laboratory in Tallahassee, FL for load testing.

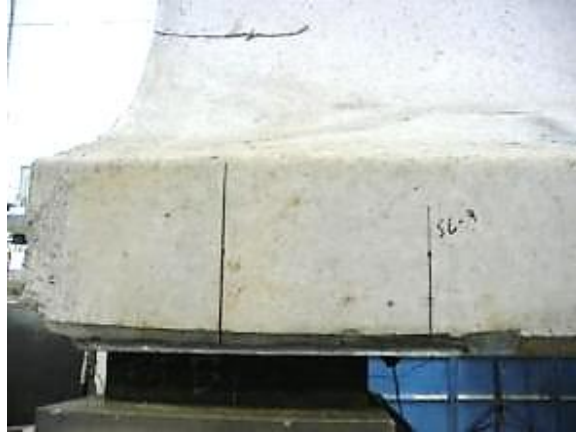
Figure 29–Support conditions at bearing

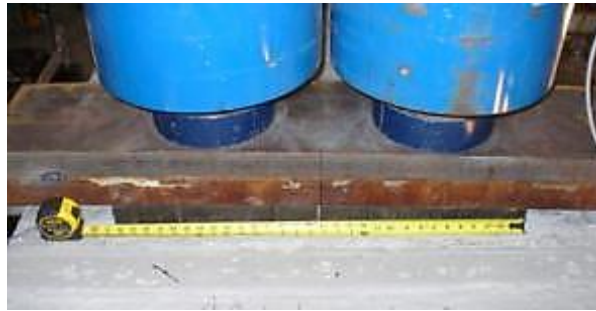
Figure 30–Support conditions at load point for specimen LB

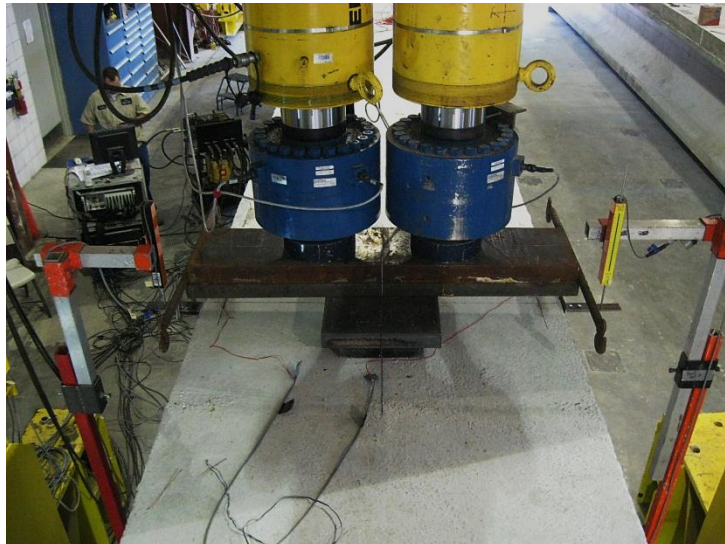
Figure 31–Support conditions at load point for specimens CT, SL, and PT

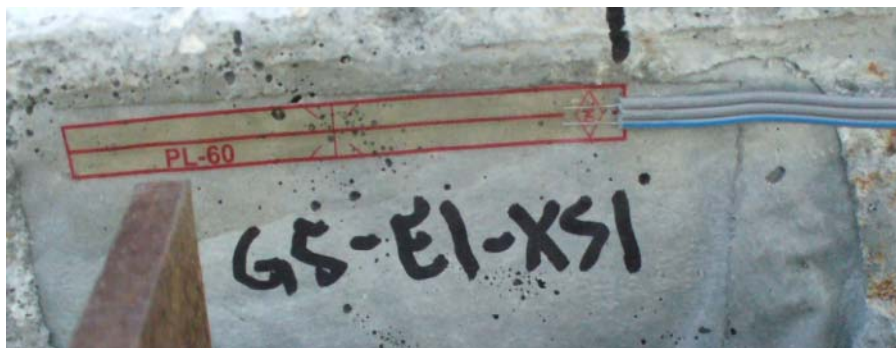
XS strain gages (Figure 35) were attached to the surface of test girders immediately after formwork was removed. These gages were used to measure concrete strains during prestress transfer. XS gages had a 60mm gage length.

Figure 35–XS gage installation

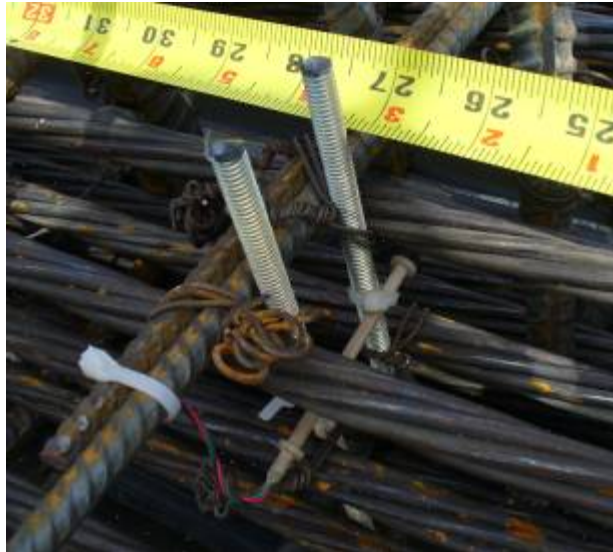
Figure 36–ES gage installation

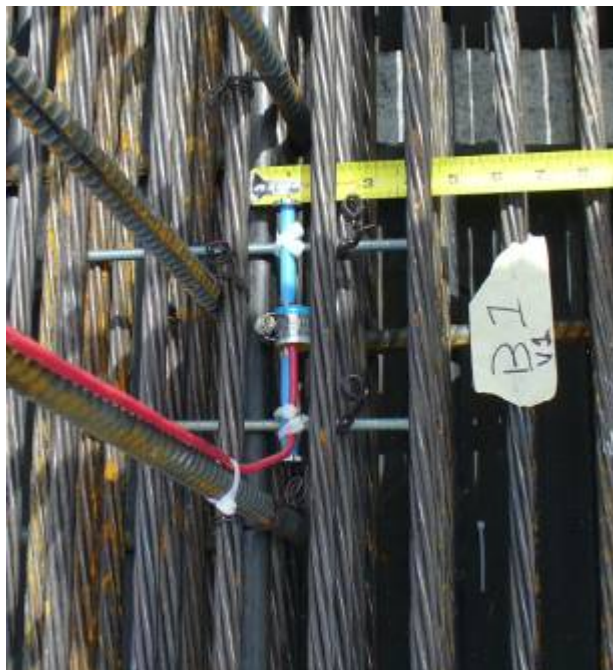
V series gages were vibrating wire strain gages which were embedded in the test girders. These gages had a gage length of 152mm and were used to measure concrete strain during all phases of fabrication and load testing. Figure 37 shows a V series gage installation prior to concrete placement. Because vibrating wire gages do not experience electronic drift over time, they were particularly useful in monitoring prestress losses.

Figure 37–V gage installation (view from above)

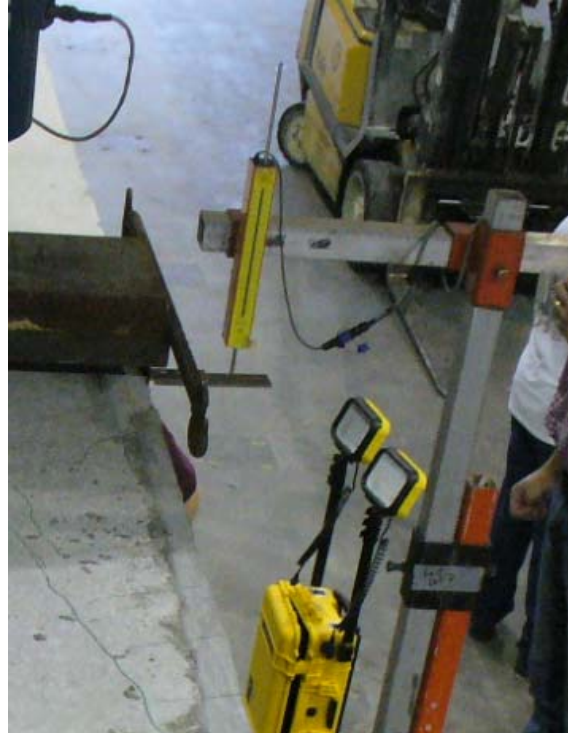
Figure 40–LVDT and support frame

L series instruments were LVDTs used to monitor vertical displacement during load tests. Labels and locations of the LVDTs measuring vertical displacement are shown in Figure 39. LVDTs were mounted to fixed support structures as shown in Figure 40.

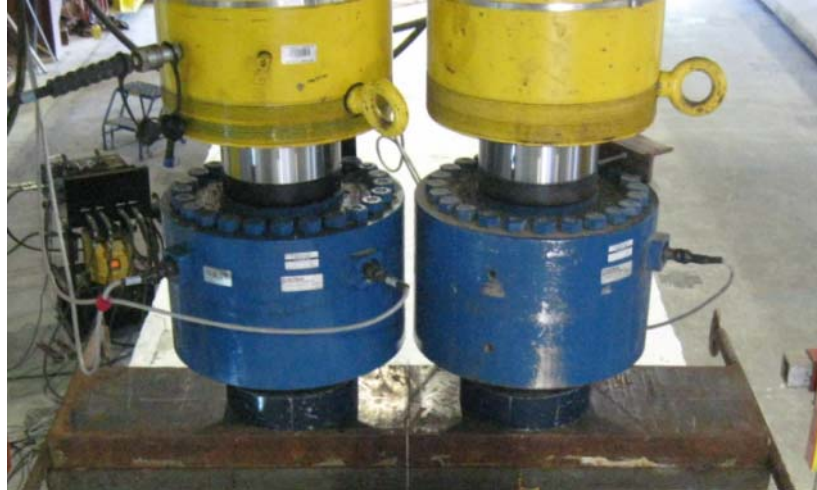
Figure 43–Load cells below hydraulic actuators

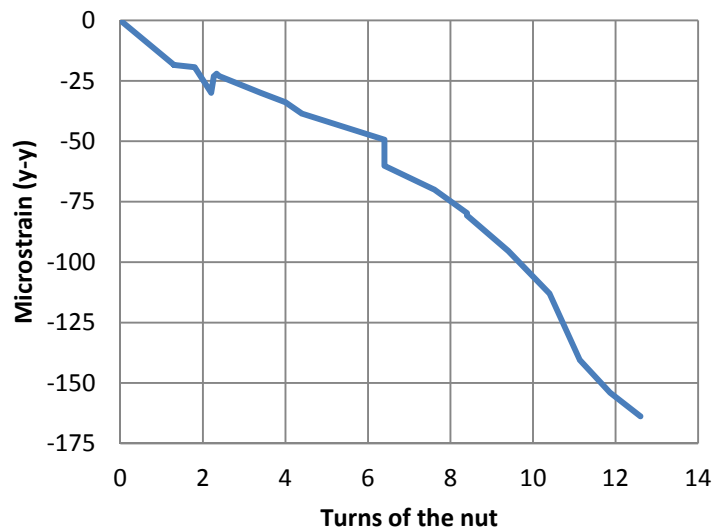
Strain effects from each turn-of-the nut are plotted in Figure 45. Strain in Figure 45 is from the vibrating wire gage placed vertically in the bottom flange (Figure 46). Strain at this location increased as the cumulative number of turns increased throughout the post-tensioning process. Abrupt jumps in the data at 2.2 turns and at 6.5 turns occurred during pauses in the post-tensioning. The strain-per-turn rate increased towards the end of the process as rods closer to the vibrating wire gage were tensioned.

Figure 45–Strain measured by V1 gage during the post-tensioning process

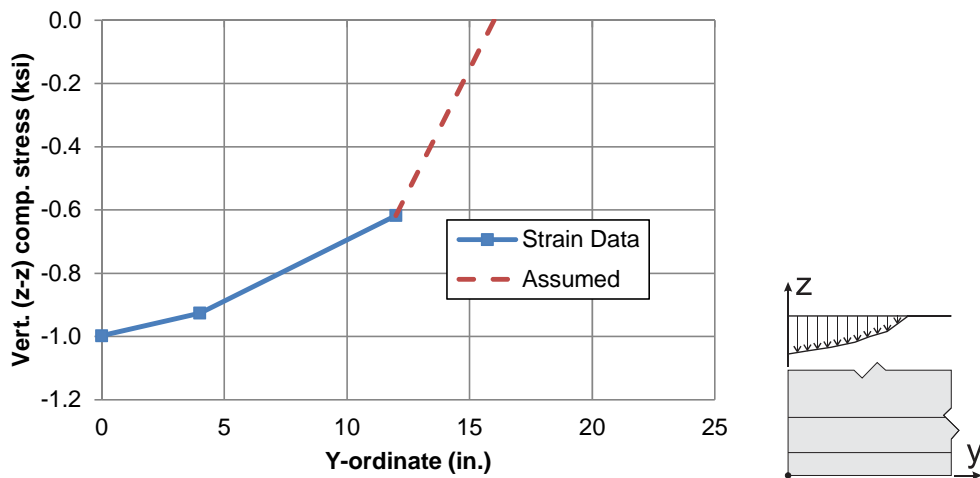
Figure 48–Estimated stress profile in web due to post-tensioning (tension positive)

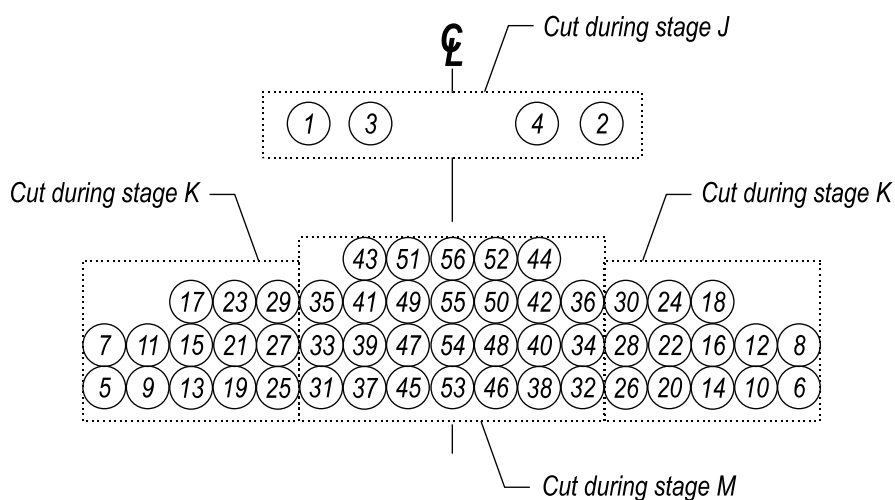
Stage	Event
J	strands 1-4 cut
K	strands 5-30 cut
L	Pause
M	strands 30-56 cut
N	all strands cut

Figure 49–Strand cutting pattern groups

Strain and crack data were collected during prestress transfer. To facilitate discussion of strain data, strand cutting events were broken into the stages listed in Table 15. Strand cutting events listed in Table 15 are keyed to the strand cutting pattern shown in Figure 49.

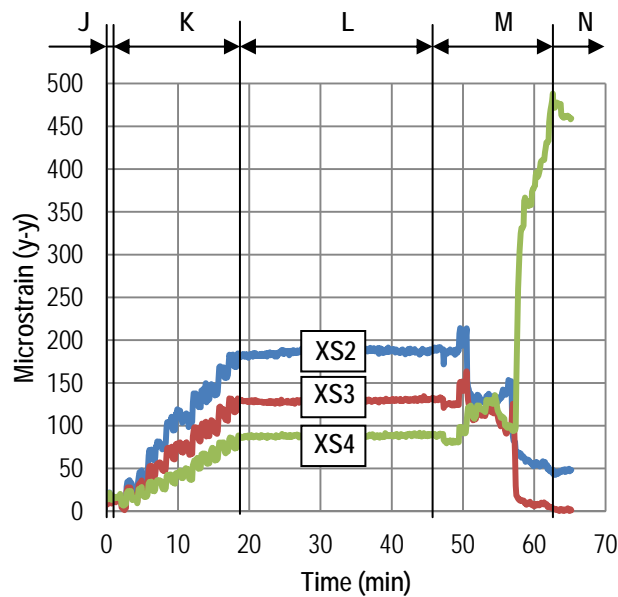
Figure 50–Concrete strain in specimen CT during prestress transfer

Vertical strain in the web became increasingly tensile in each specimen as prestress force was transferred to the girders (Figure 50 through Figure 53). Data indicate that strain was typically largest at the end of the girder (XS2) and smaller away from the end (XS4). For example, vertical strain in specimens CT at gage XS2 was 190 microstrain during stage L and only 90 microstrain at XS4.

Cracks were visually observed in specimen CT immediately after prestress transfer (Figure 54). Abrupt changes in strain behavior at approximately 57 minutes suggest that the cracks formed during stage M (Figure 50).

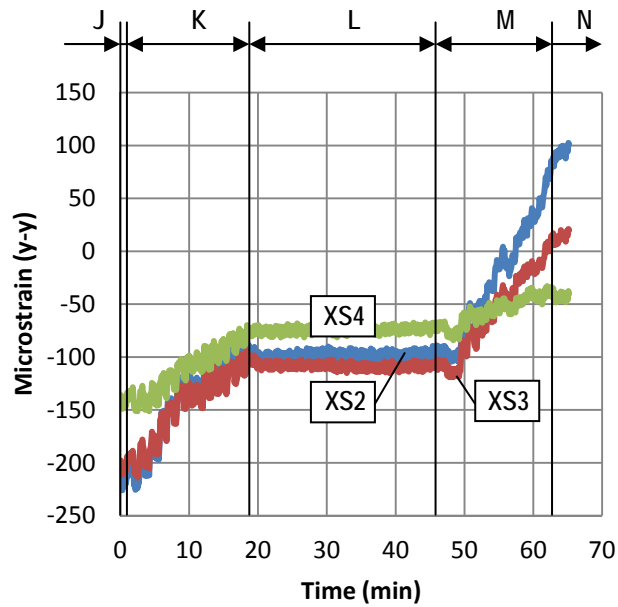
Figure 52–Concrete strain in specimen PT during prestress transfer

For specimen PT, vertical strain at the beginning of transfer was initially compressive (Figure 52) due to the post-tension force discussed in the previous section. Strain reported by gages XS2 and XS3 became tensile as the outer strands were cut during stage M. Multiplying the final strain during stage N by an elastic modulus of 4750 ksi gives an estimated stress profile in the web (Figure 55). Integrating the tensile stress portion over the web area results in an estimated net tension force of 9.2kip.

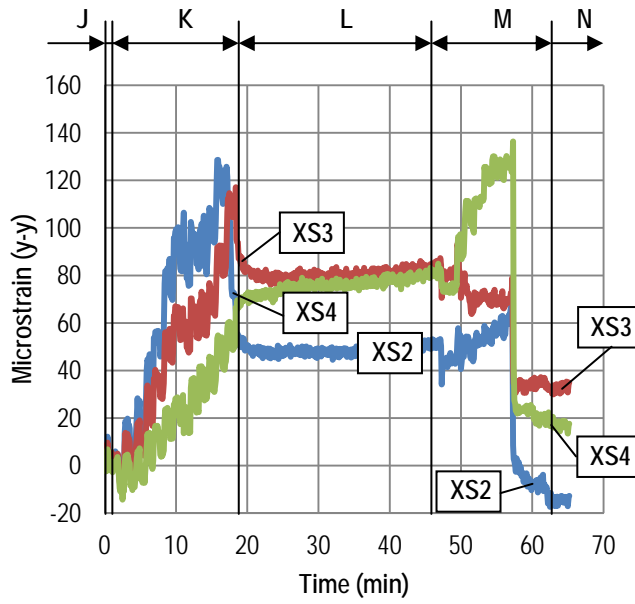
Figure 53–Concrete strain in specimen LB during prestress transfer

Cracks were also observed immediately after transfer in specimen LB (Figure 54). As with specimen CT, abrupt changes in strain behavior at approximately 57 minutes suggest that

the cracks formed during stage M (Figure 53). Cracking may have initiated during stage K as suggested by the abrupt changes at approximately 18 min.

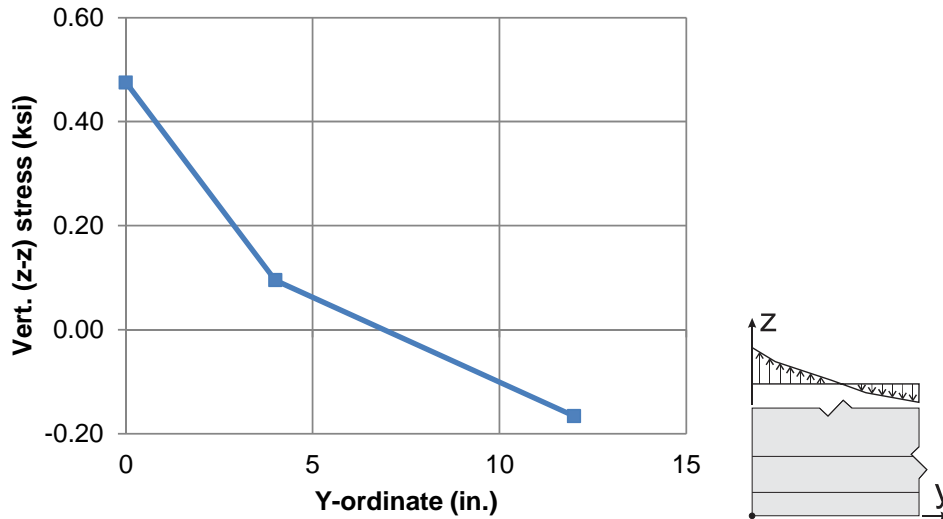
Figure 55–Estimated stress profile in web of specimen PT after transfer (tension positive)

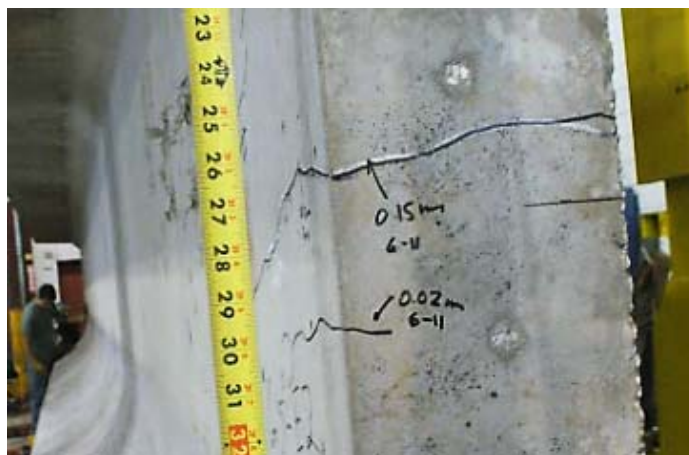
Figure 63–Web crack measurements (view from end of specimen)

Representative widths used to calculate crack area were derived from width measurements taken by microscope. The means of determining the representative width was different depending on the crack location. For the portion of a crack on the end face of a specimen, the representative width was taken as the measured width (Figure 63). Where multiple measurements were taken for the same crack on the end face, the representative width was taken as the average of the measurements. For the portion of a crack on the side of a specimen (Figure 64) the representative width was taken as the average of all widths measured along the crack. Only a single measurement was taken for some cracks on the specimen sides. The single measurements typically occurred near the end face where cracks had their greatest width. In these cases, the representative width was taken as one-half of the measured width.

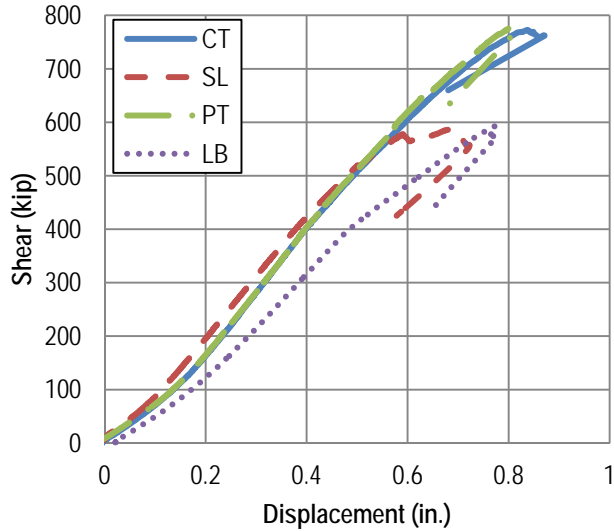
Figure 67–Ultimate load test shear-displacement for all specimens

Each specimen was loaded twice. The first test mimicked service loading and the second test determined ultimate capacity. Maximum shear force in the service load test was 390kip. Shear-displacement data from the ultimate load tests are presented in Figure 67, and shear-strand slip data are presented in Figure 68. Slip data is presented as the average slip of all monitored fully bonded strands. Specimen LB was excluded from Figure 68 due to minimal slip.

After reaching the maximum load, SL continued to carry load with a stick-slip behavior controlled by strand slip. Load was removed after it had become apparent from the load-displacement curve that peak load had been reached. Because of the stick-slip behavior, failure of SL was slightly more ductile than the other specimens (Figure 67).

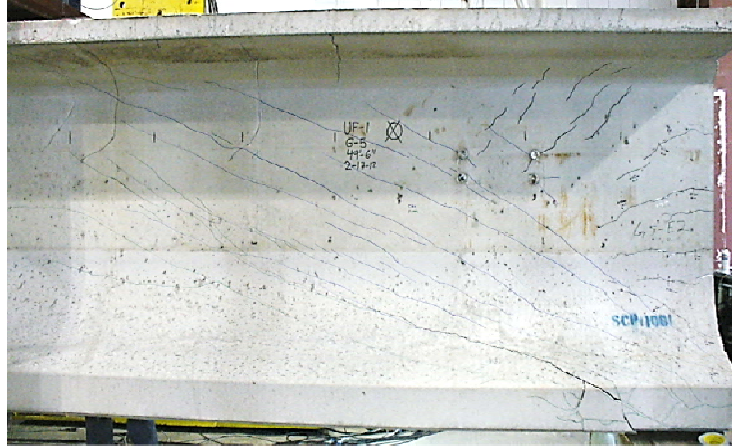
Figure 72–Bond shear failure of specimen SL

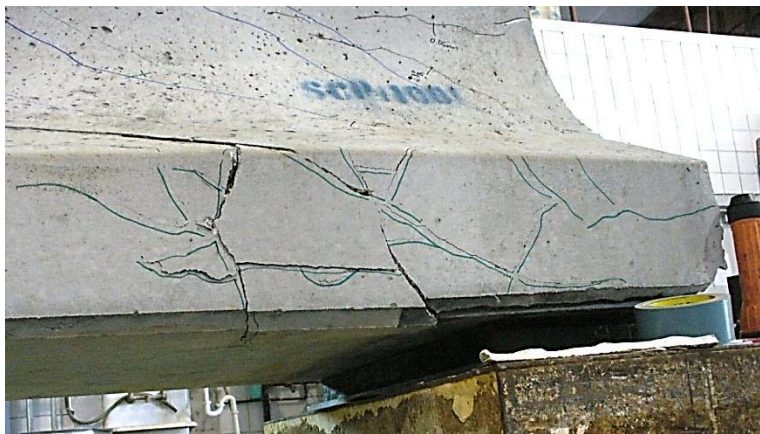
Figure 73–Bottom flange cracking at SL bearing.

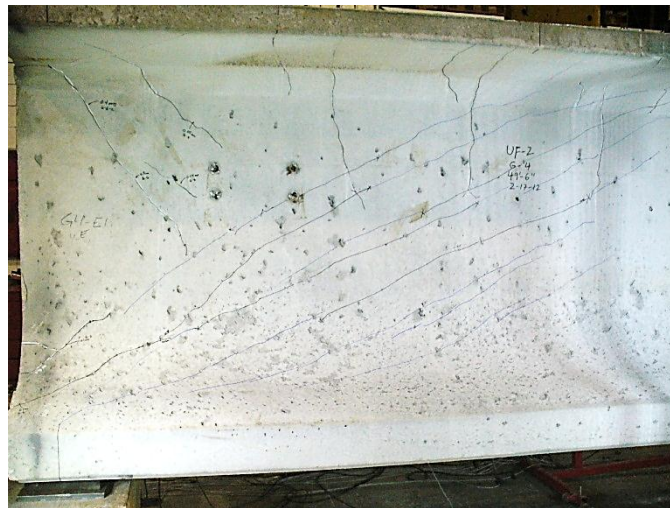
Specimen PT did not fail before reaching the capacity of the test apparatus and failure behavior could not be determined. Specimen PT was loaded to 782kip in shear, which was the greatest of any specimen. This result suggests that the post-tensioning had no adverse effect on the ultimate capacity. Multiple web cracks had formed in the web prior to peak load (Figure 74). Some of these cracks had propagated to the end of the specimen.

Figure 74—Cracking specimen PT

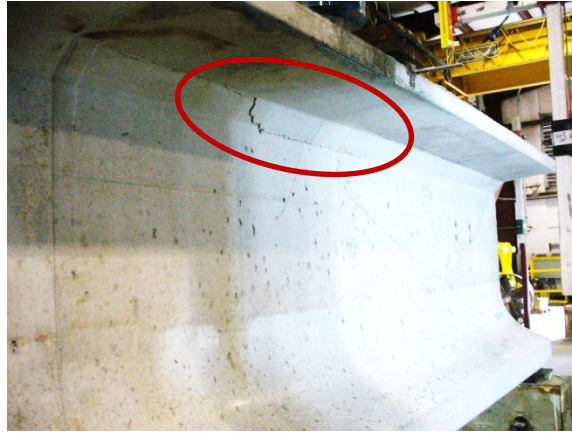
Figure 76–Punching shear failure in specimen SL

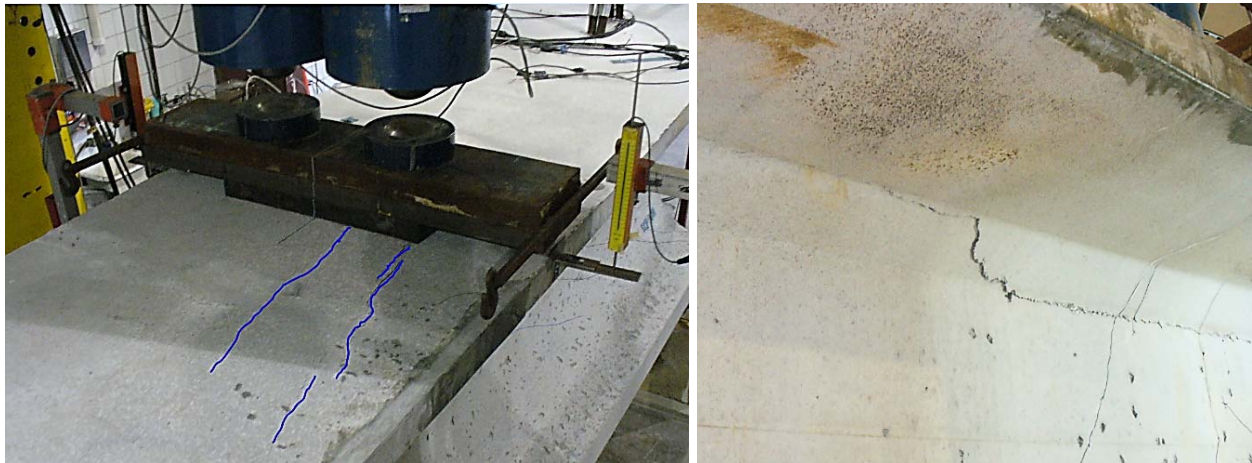
Figure 77–Punching failure from above (left) and below (right)

Specimen LB failed in the top flange due to punching failure (Figure 75). Punching failure occurred because load was applied across the width of the relatively thin top flange. Cracking associated with punching failure is shown in the photos in Figure 76 and Figure 77.
