Appendix H–Support Data

H.1 SR-72 Support Data

H.2 FIB-54 Support Data

H.3 FIB-63 Support Data

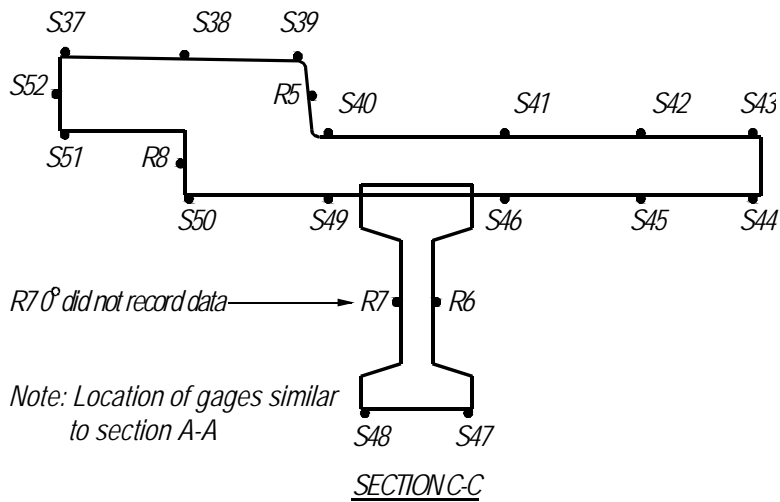
Figure 4-X7 instrumentation at plane C-C (centerline of span)

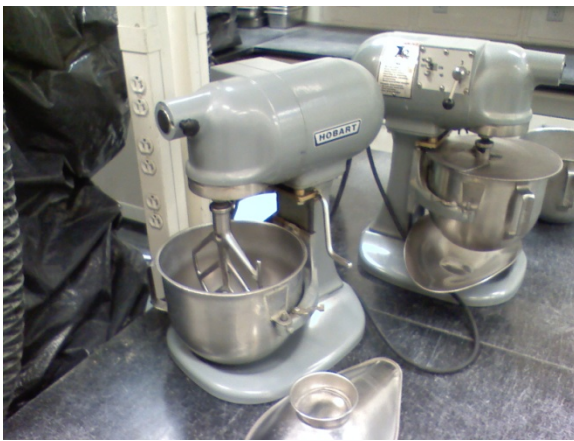
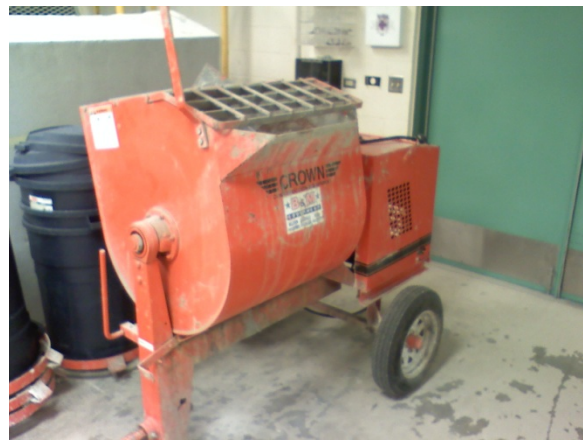
Figure 27–Mixer for small batches (left), large batches (right)

In preparation for the NASP tests, numerous small and full size grout mixes were tested. Table 3 lists the proportions, flows, and strengths for each test mix. Small batches had a total mix weight of approximately 7 lb. Full batches had a total mix weight of approximately 225 lb. Prior to mixing the full batches, the mixer was “buttered” using a batch having a total weight of approximately 35 lb. The butter was discarded prior to mixing the grout batch. Mixers for the small and full batches are shown in Figure 27. All grout mixing and testing was conducted at the FDOT State Materials Office in Gainesville, FL.

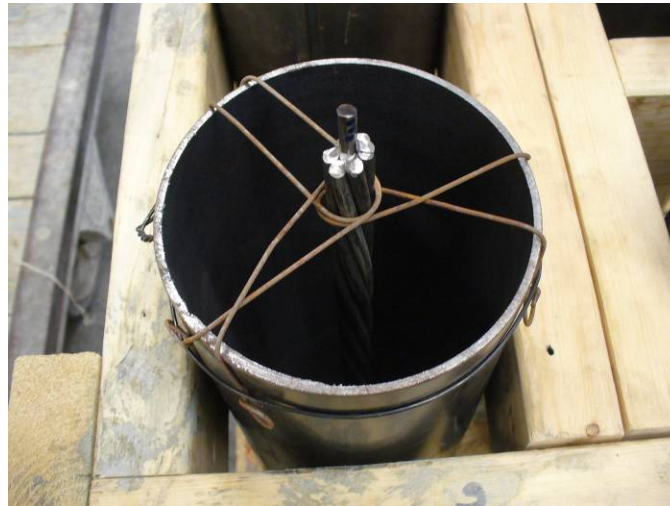
Figure 29–Stand lateral support at top of tube

Test samples were placed in a wood support frame to secure the strands and tubes during grout pouring and curing (Figure 28). Grout was placed in (3) lifts as specified by the test method. Grout was consolidated after each lift using a mechanical vibrator. Strands were supported vertically and laterally at the base of the wood frame. Additional lateral support was provided at the base and top (Figure 29) of the tube structure. Prior to placement in the tubes, the outer wires were cut shorter than the center wire (Figure 29). This was done to facilitate measurement of slip of the center wire, as required by the test method. Care was taken to maintain the surface condition of the strands from the time of collection in the prestressing yard, until they were embedded in grout.
