THE MARKED TREE SITE: EVALUATION OF GEOSYNTHETIC  
REINFORCEMENTS IN FLEXIBLE PAVEMENTS

Final Report for project TRC 0903:  
Evaluation of Basal Reinforcement of Flexible Pavements with Geosynthetics

December 2011  
University of Arkansas

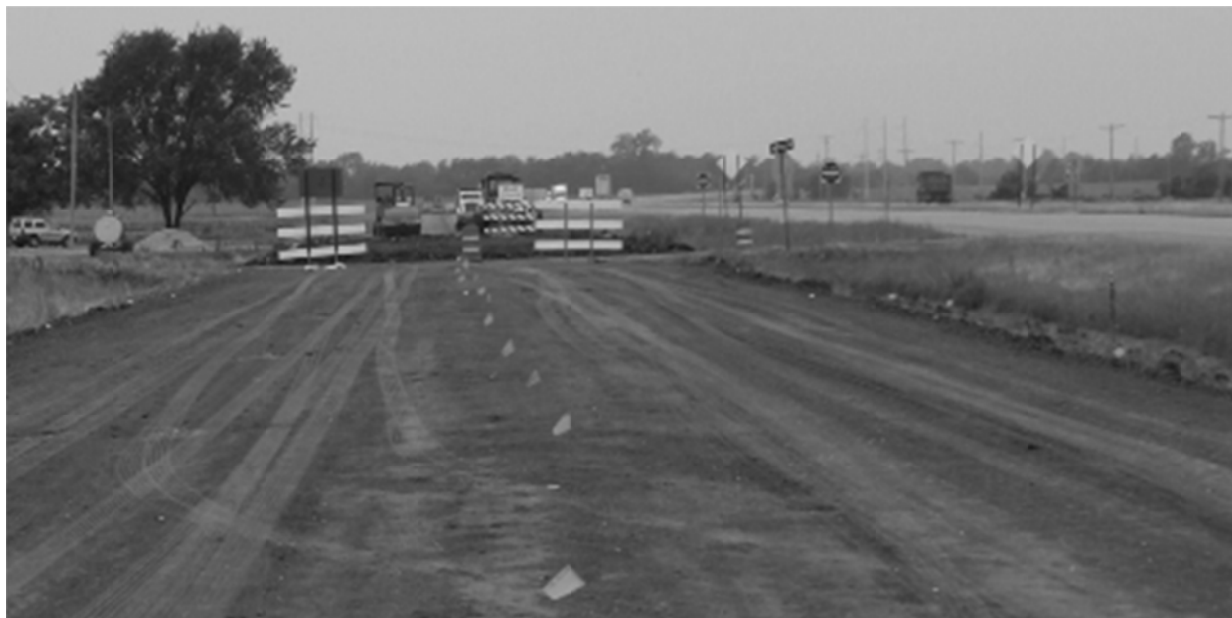
Figure 3.10. Finished cut subgrade (Howard 2006).

material in its place (Howard 2006). A picture of the finished subgrade can be found in Figure 3.10. There were no new proctor tests conducted to discover the maximum dry density or optimum moisture content of the new fill material that was placed on top of the reworked subgrade. However, it was assumed that the new fill material was equivalent to the original subgrade fill material, so it could be assumed that the maximum dry density was considered to be 106 pcf ( $1697 \text{ kg/m}^3$ ) with an optimum moisture content of 16.8%. It should be noted that in the October 2004 construction, Sections 5, 6, 7, 9, 10, 11, and 12 were not compacted to at least 95% of the maximum dry density, while the average moisture content of each section was approximately 4.4% dry of the 16.8% optimum moisture content.. The few centimeters of reworked subgrade were compacted to an average dry density of 112 pcf ( $1789 \text{ kg/m}^3$ ). The moisture content of the reworked subgrade was on average approximately 2.1% dry of optimum, while a few sections (Sections 4, 5, and 6) had moisture content values wet of optimum. The density values used for comparison are from an average of three nuclear density gage readings at

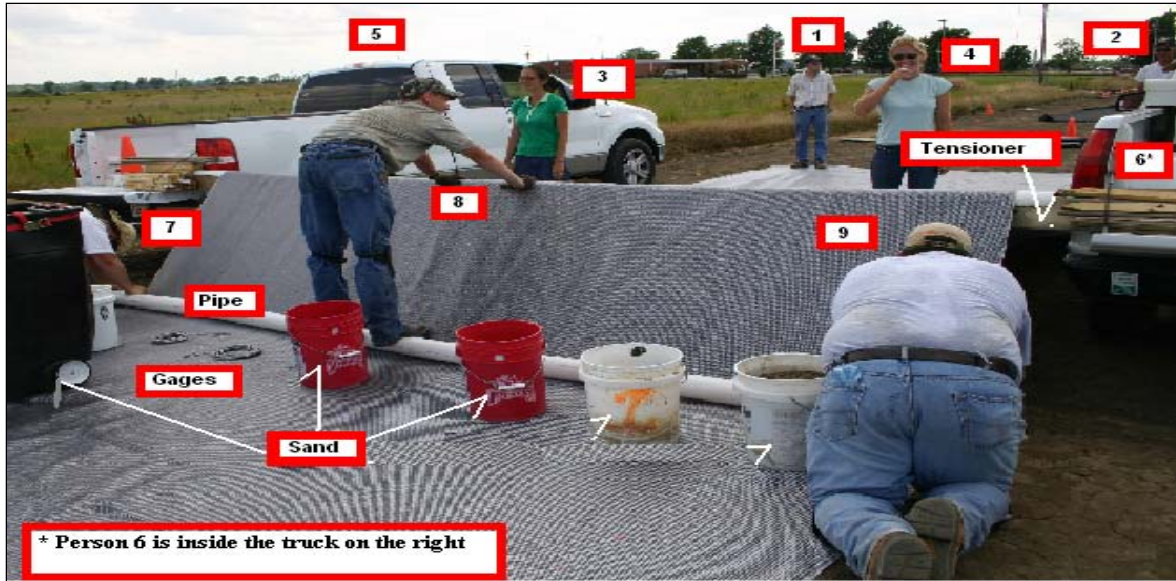
Figure 3.12. Geosynthetic tensioning technique (Howard 2006).

- 10) Once tension is applied, person 8 directs the trucks to pull forward very slowly and persons 7 and 9 roll the pipe forward at the same rate that the trucks move forward. During the lay down process, person 8 is ensuring adequate tension is maintained by adjusting the position of persons 3 and 4, controlling the rate of the trucks and pipe personnel to keep the geosynthetic straight and going under the pipe at an angle of approximately  $45^{\circ}$ , and removing wrinkles from the geosynthetic as it traverses over the tensioner.

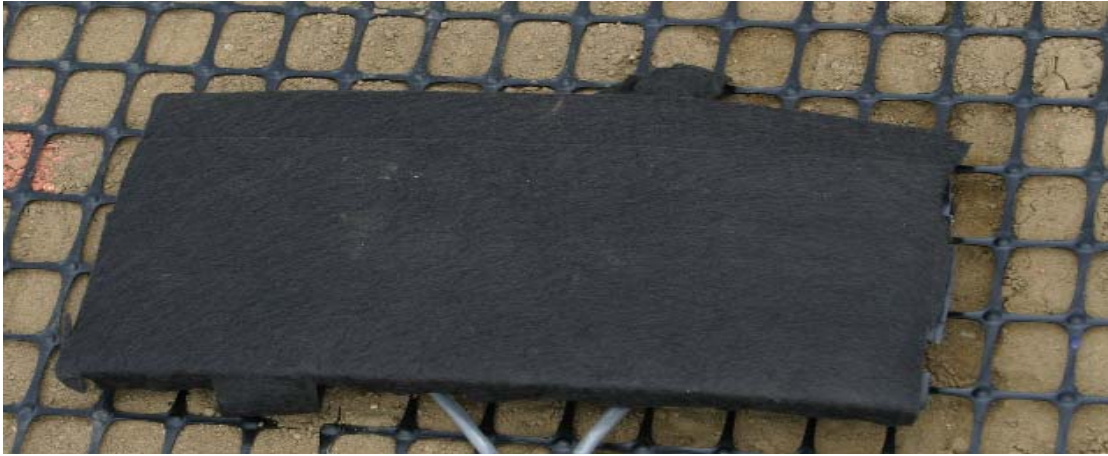
Figure 3.13. Geogrid strain gage protection, strip drain (Howard 2006).

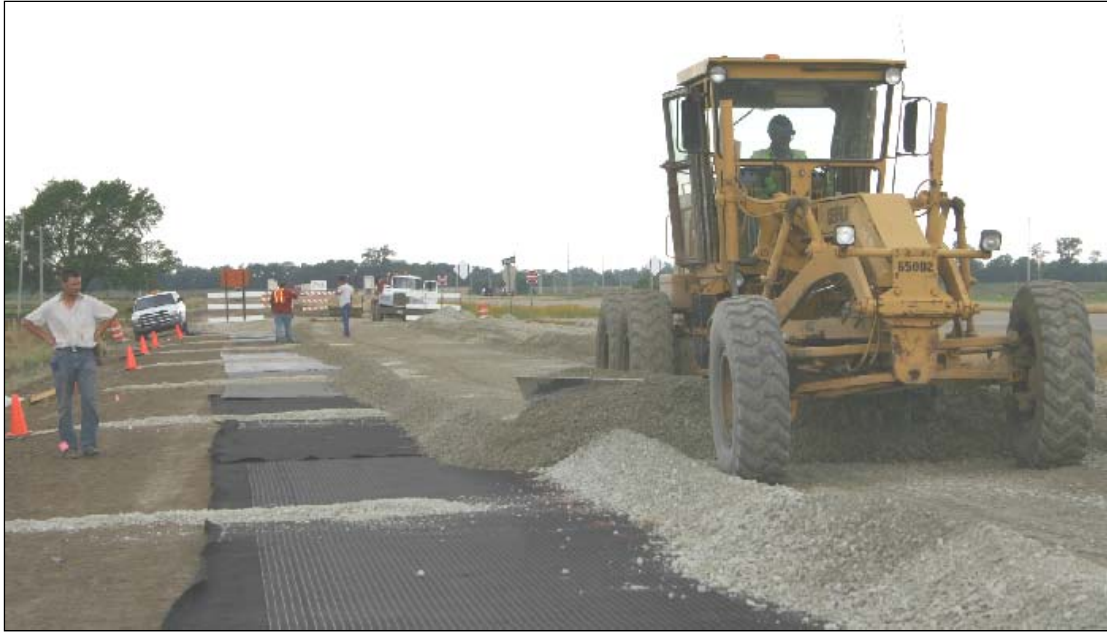
Figure 3.18. Lateral placement of crushed limestone on geosynthetics (Howard 2006).

and/or traffic cones. This process was carefully observed and no movement of the geosynthetics occurred. After compaction of the first lift of crushed stone, the contractor proceeded as normal to bring the entire test section to the appropriate grade and density (Howard 2006).

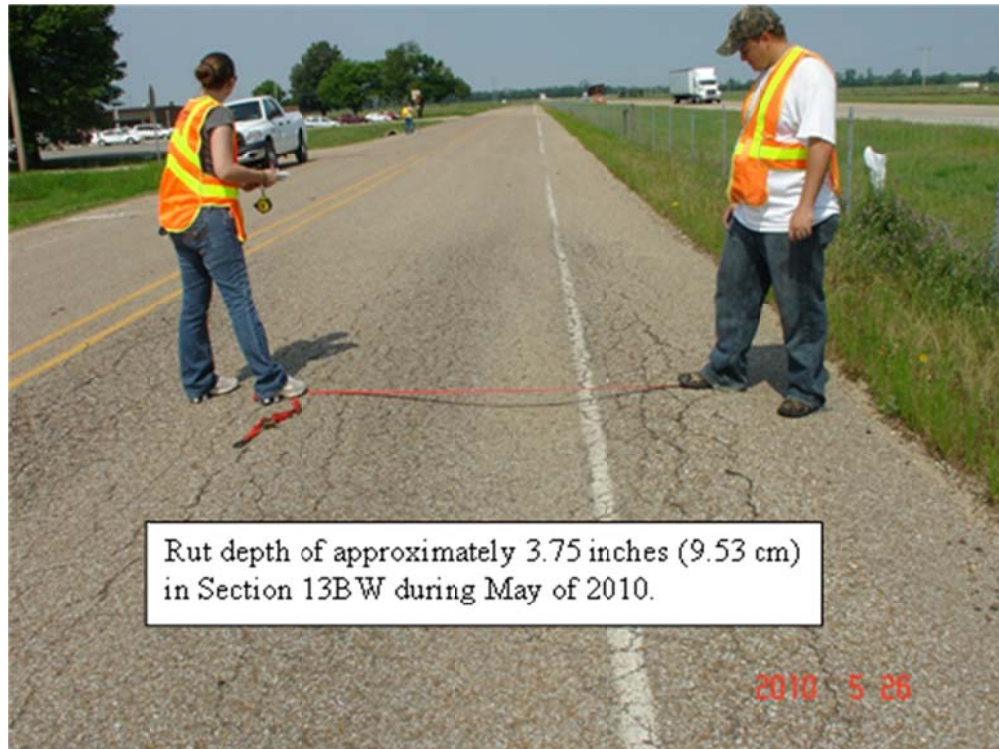
Figure 6.1. Rut depth exceeding 3 inches (7.6 cm) in Section 13BW during May 2010.

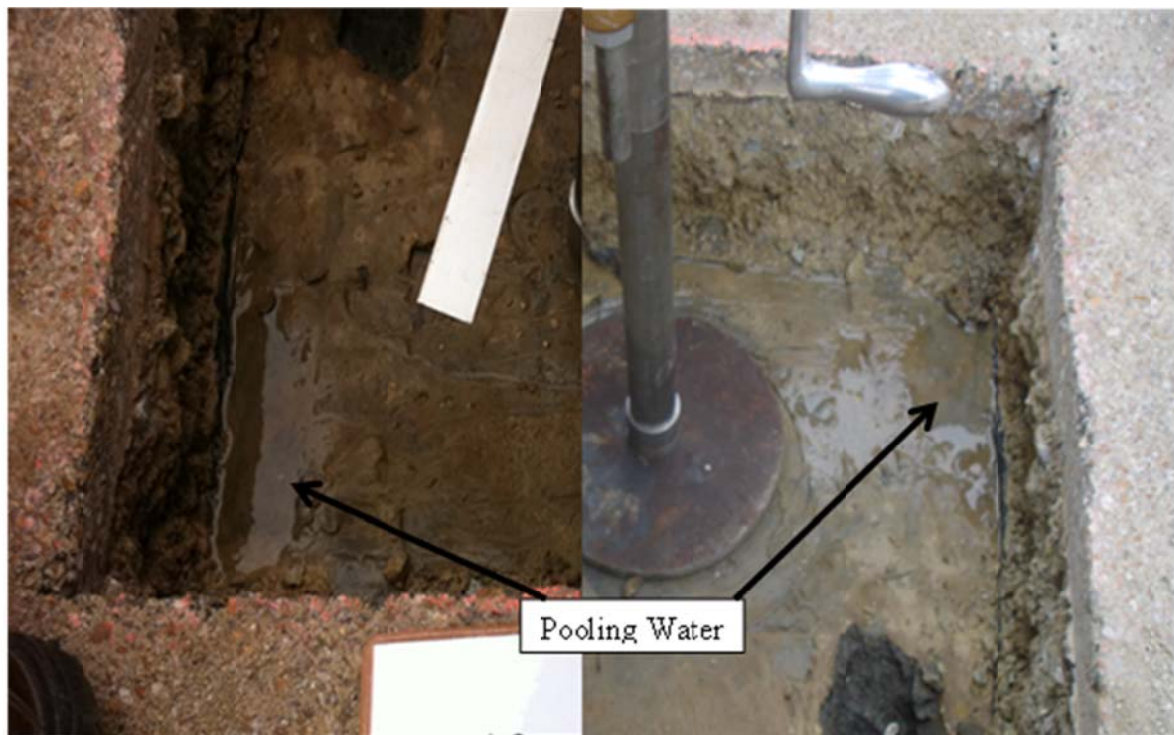
Figure 6.15. Pooling water on subgrade of Section 13W in October 2010.
