| 4. Title and Subtitle<br><b>GUIDANCE FOR EFFECTIVE USE OF PYLONS FOR LANE SEPARATION ON PREFERENTIAL LANES AND FREEWAY RAMPS</b> | | | | 5. Report Date<br><b>Published: May 2013</b> | |
| 7. Author(s)<br><b>Shamanth P. Kuchangi, Robert J. Benz, Alicia A. Nelson, Anthony P. Voigt, Roma G. Stevens, John P. Wikander, and LuAnn Theiss</b> | | | | 8. Performing Organization Report No.<br><b>Report 0-6643-1</b> | |
| 9. Performing Organization Name and Address<br><b>Texas A&amp;M Transportation Institute<br/>College Station, Texas 77843-3135</b> | | | | 10. Work Unit No. (TRAIS) | |

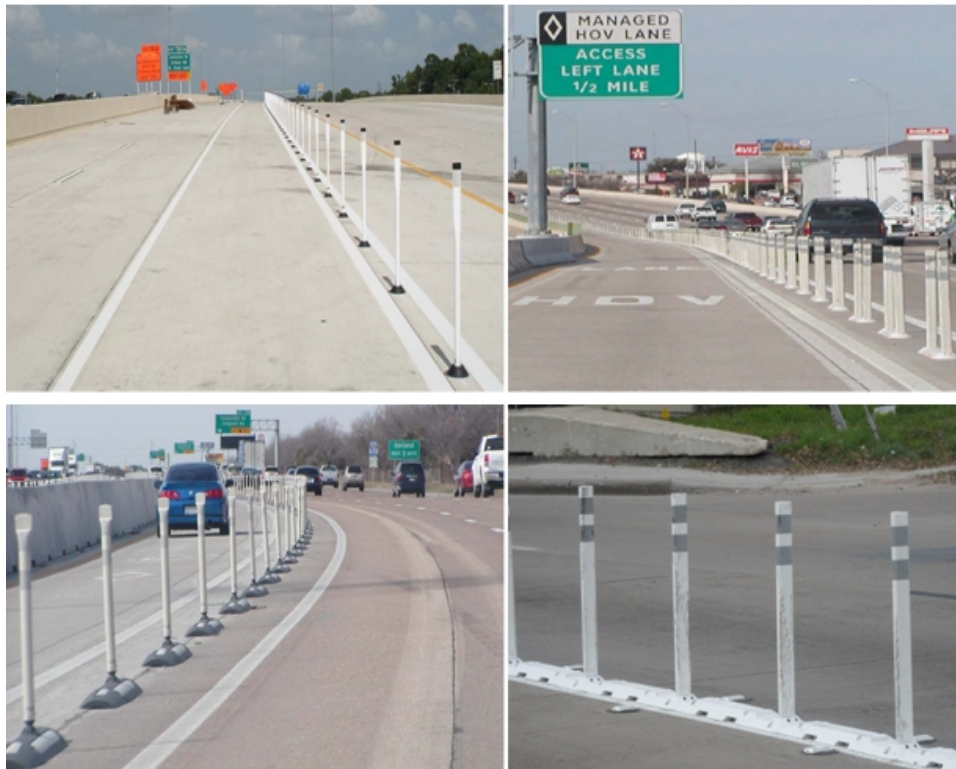
**Figure 1. Examples of Pylon Devices.**

Over the past decade, flexible pylons have been increasingly used on Texas roadways for the purposes of lane delineation and separation. Numerous terms have been used to describe the devices herein referred to as pylons, including *flexible pylons*, *delineator posts*, *candle sticks*, *tubular markers*, and *channelizing posts*. Figure 1 shows examples of pylon traffic control devices.

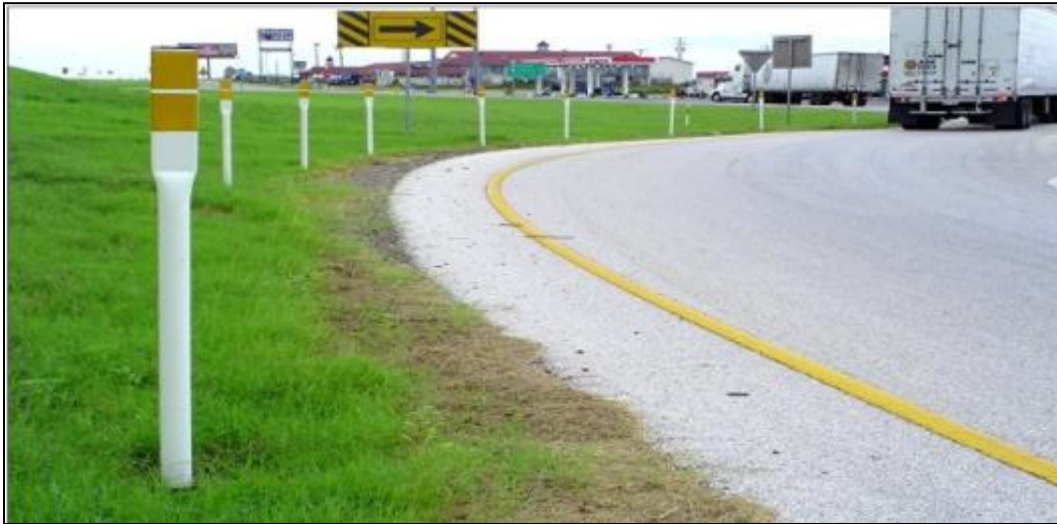
**Figure 5. Example of Pylons Used for Curve Delineation (11).**

Flexible pylons have been used in various roadway applications. One of the early uses of flexible pylons was as a replacement for steel delineator posts for delineation of horizontal curves. Figure 5 shows an example of flexible pylons used in the delineation of a freeway exit ramp. Embedded (soil-driven) pylons near the roadside (not mounted directly on the pavement surface) are commonly used in the curve delineation applications. Flexible pylons can take more hits compared to steel posts resulting in less frequent replacement. Flexible pylons also cause less damage to vehicles when hit as compared to steel delineator posts. Given these benefits, flexible pylons are now widely preferred for horizontal curve delineation. However, one study

reported that replacement of broken pylons is more tedious than replacing the steel posts due to the accumulated debris at the base of the pylons that makes pylon replacement difficult (12).

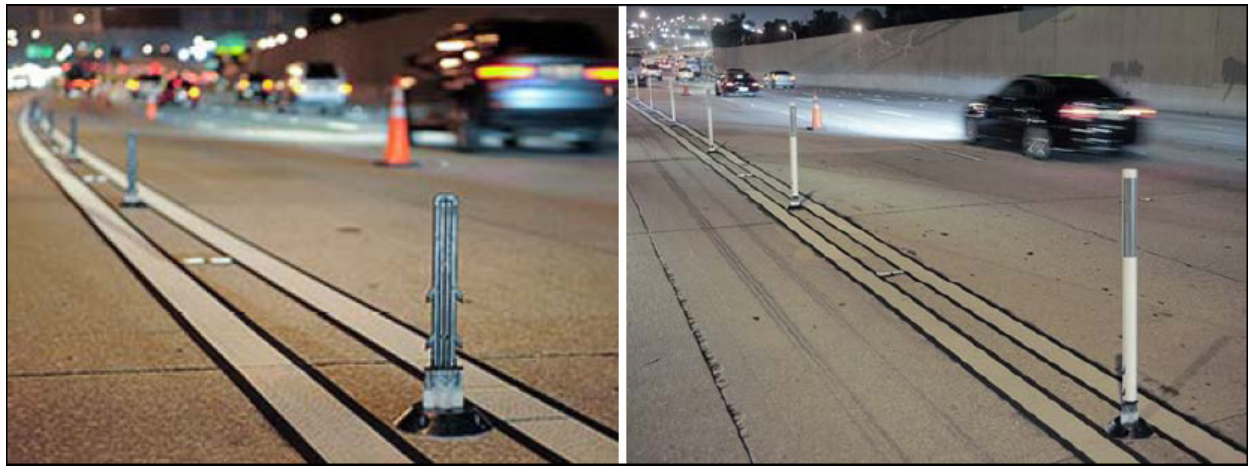
**Figure 19. Pylons Used on IH 95 Express Lanes in Miami, Florida (6).**

Surface mounted pylons separate the express lanes from the general purpose lanes. As shown in Figure 19, several different types of pylons were deployed as an experiment on this facility (6). FHWA specified 20 ft. as the minimum pylon spacing; therefore an initial pylon spacing of 20 ft. was used. However, there was frequent weaving between the pylons with the 20 ft. spacing. In response, the pylon spacing was reduced to 10 ft. (6). After initial use of white colored pylons, the initial 500 ft. of an access point were replaced with yellow pylons to increase visibility in contrast to the white concrete pavement, as seen in Figure 20 (6). The pylon implementation on the IH 95 Express Lanes has a buffer width of 2 ft.

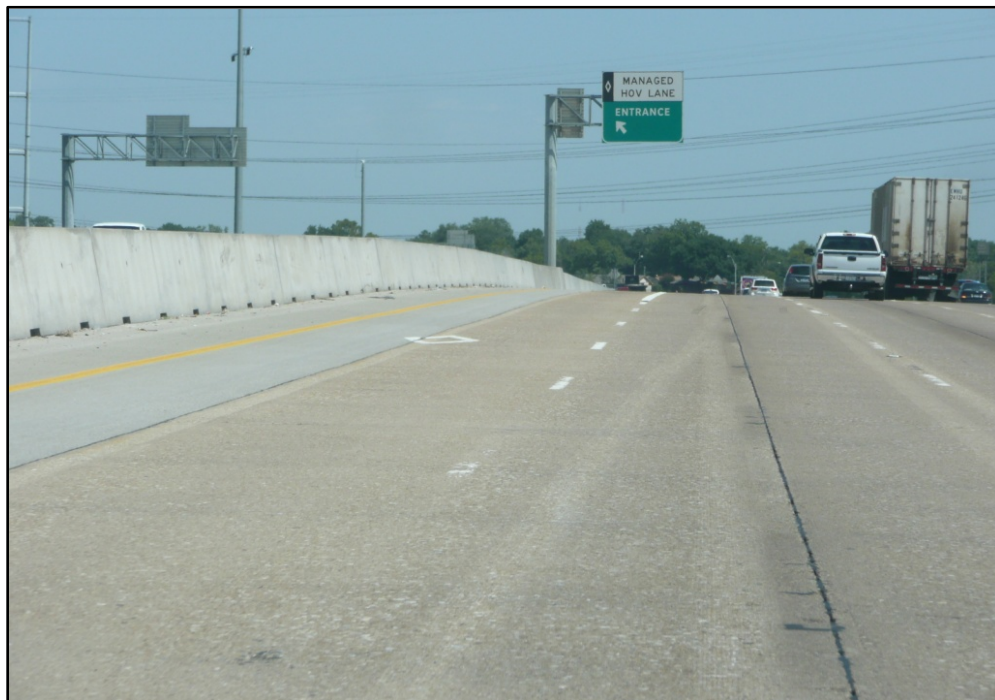
**Figure 40. Vertical Curvature on Approach to the HOV Lane Entry at IH 635 Northbound at Oates Road Study Site, Mesquite, Texas.**
