*Research Project Number TPF-5(193) Supplement #130*

# **ENERGY ANALYSIS OF VEHICLE-TO- CABLE BARRIER IMPACTS**

## **NEW YORK STATE DEPARTMENT OF TRANSPORTATION**

MwRSF Research Report No. TRP-03-283-13

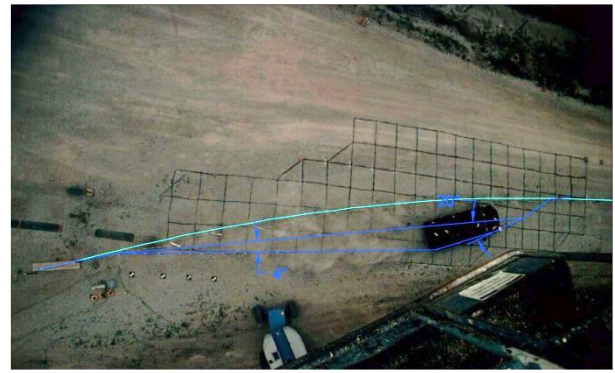
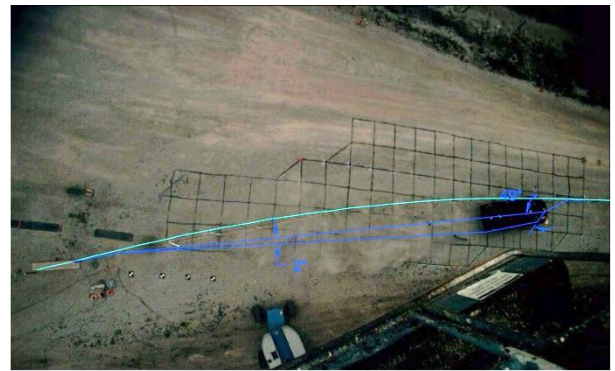
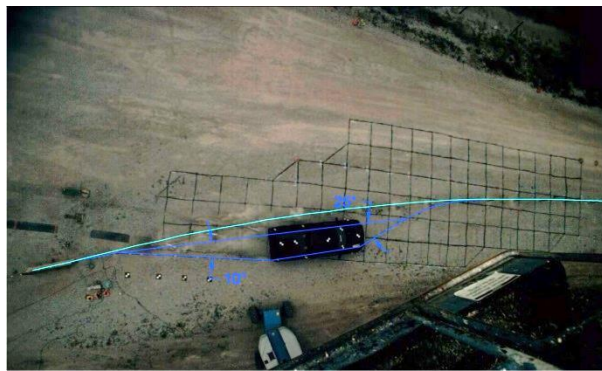
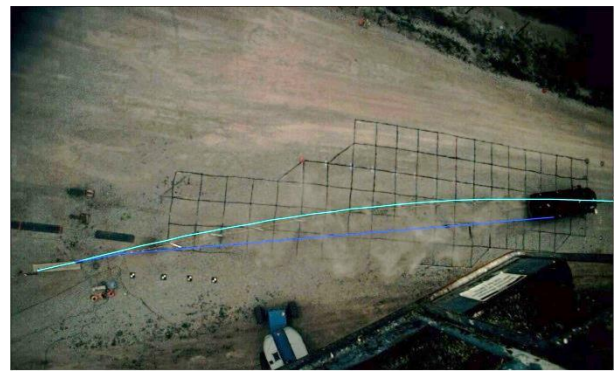
Figure 33. Cable Position and Vehicle Trajectory – Test No. NYCC-3

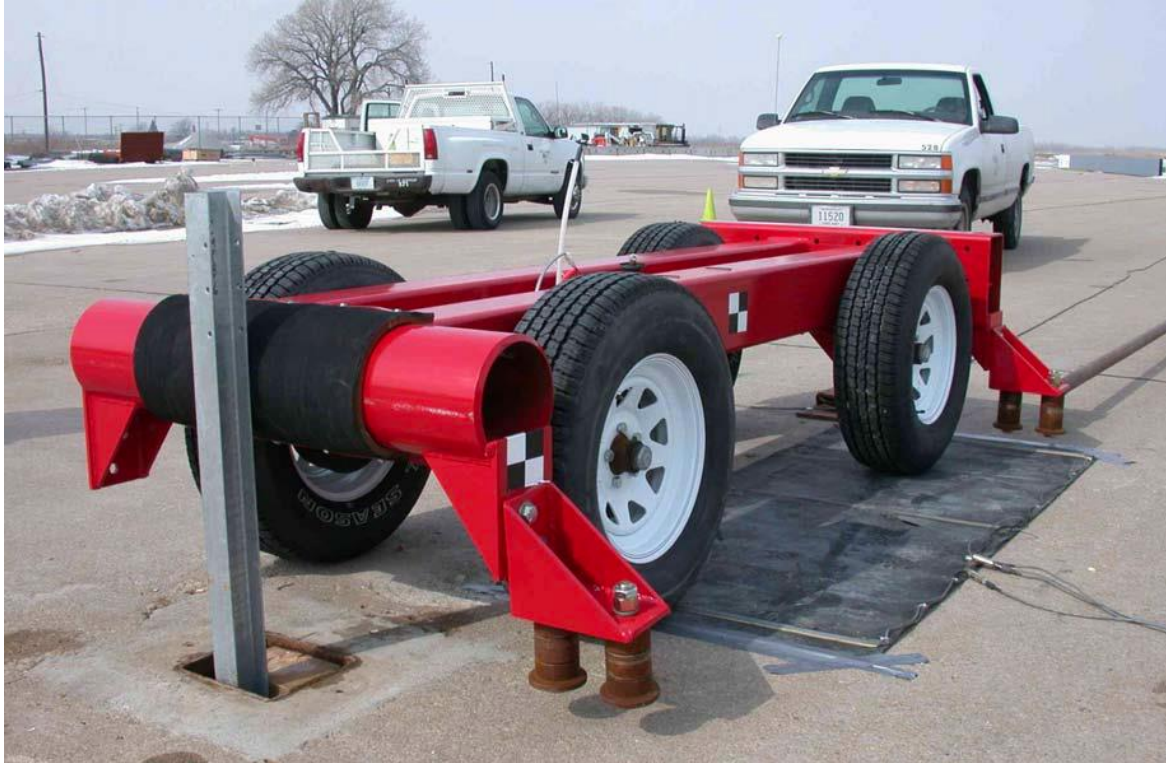
A rigid frame bogie was used to impact the posts. An impact head, made of an 8 in. (203 mm) standard steel pipe, was mounted to the bogie at the height of 21.65 in. (550 mm) above the ground. Neoprene belting, 3/4 in. (19 mm) thick, was attached to the steel pipe to minimize the local damage to the post from the impact. The bogie weight was 1,353 lb (613.7 kg) in the CMPB and CCP test series, and the bogie is shown in Figure A-1. The bogie weight was 2,237 lb (1,014 kg) in the CPB test series, and the bogie is shown in Figure A-2.

Figure A-1. Bogie and Test Setup – CMBP and CCP Test Series

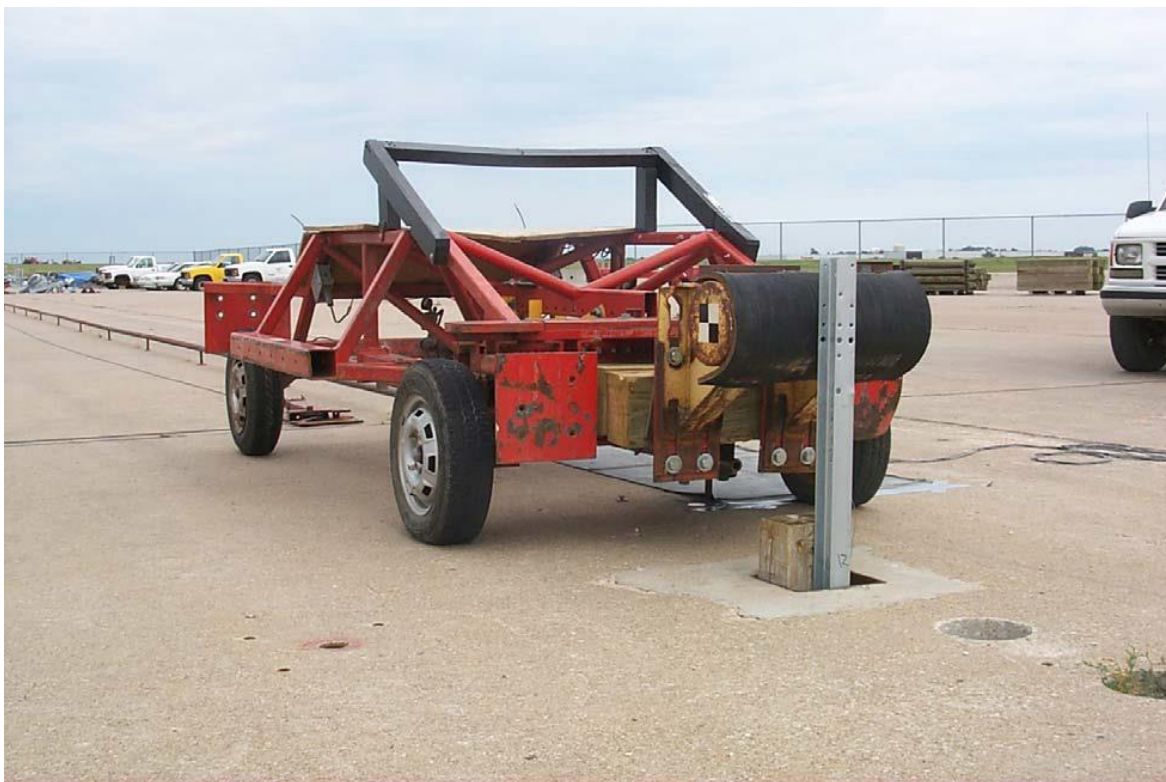
Figure A-2. Bogie and Test Setup – CPB Series

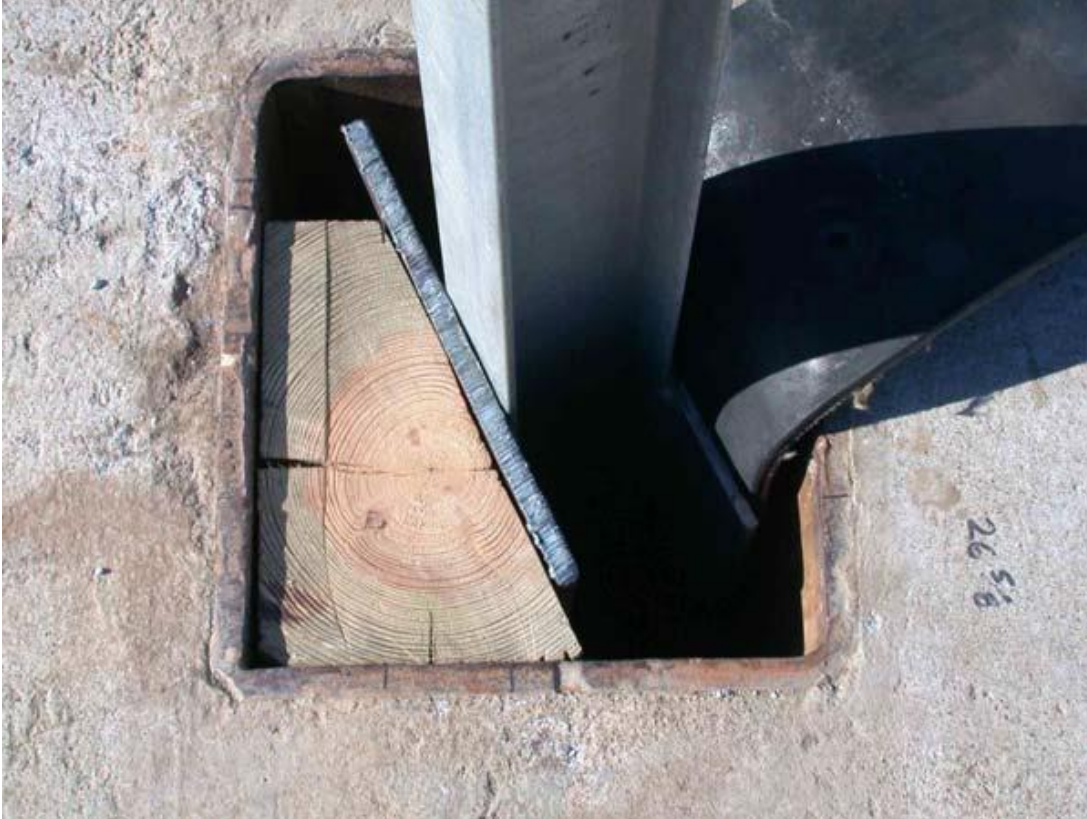
For tests CMPB-4, CMPB-5, CMPB-6, and CCP-5, a rectangular hole was cut out in the tarmac to house the post. The hole was lined with a mild steel tube, approximately 10.0 in. x 8.75 in. (254 mm x 222.25 mm) and 10 mm (0.394 in.) thick, to prevent spalling of the concrete around the hole. The post was fitted into the steel lined hole with a block of wood to keep it upright and rigidly hold the post against the casing. A soil plate was attached to the S3x5.7 (S76x8.5) posts and was flush with the wood blocks. An effort was also made to minimize the slop in the posts by inserting an additional steel plate or a piece of plywood to fill the gaps. Neoprene was also added between the post and casing to prevent damage from the impact that may have affected the post properties subsequently determined. The installation setup for test no. CMPB-4 is shown in Figure A-4. The other tests had the same setup only with the wood oriented at different angles.

Figure A-5. Typical Post and Wood Block Setup
