# **SELF-CONSOLIDATING CONCRETE REPAIRS ON INTERSTATE 25 BRIDGE ABUTMENTS NORTH OF MEAD**

**July 2013**

**COLORADO DEPARTMENT OF TRANSPORTATION**  
**DTD APPLIED RESEARCH AND INNOVATION BRANCH**

Report No. CDOT-2013-1

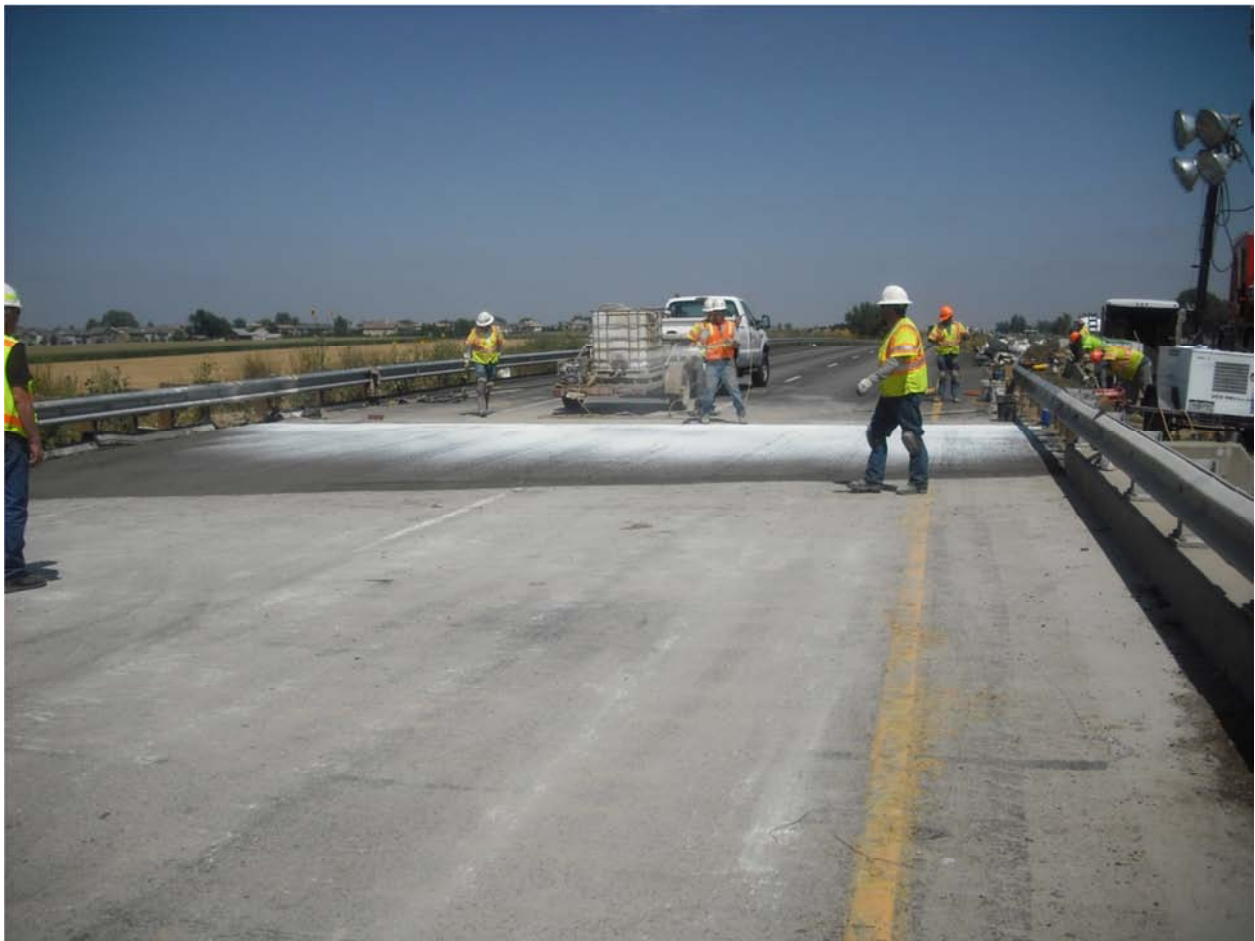
Aggregate Industries, Inc. provided the SCC concrete for the repair work. For the repair, the contractor used two separate operations to encase the ends of the steel bridge girders in order to “lock” their end rotations. In the first operation, normal concrete was used to encase the ends of the bridge girders on the north abutment, where the expansion joint needed replacement. As shown in Figure 1, approximately ten feet of the concrete deck and approach slab were removed, followed by placement of normal concrete into the voids between the girders up to the deck profile elevation. This operation eliminated the expansion joint and integrated the abutment, girders and approach pavement. Normal concrete was used because the removal of the expansion joint allowed workers to access area with vibrators and the normal concrete was deemed to be a more cost effective alternative.

**Figure 1: Southbound Bridge, North Abutment**

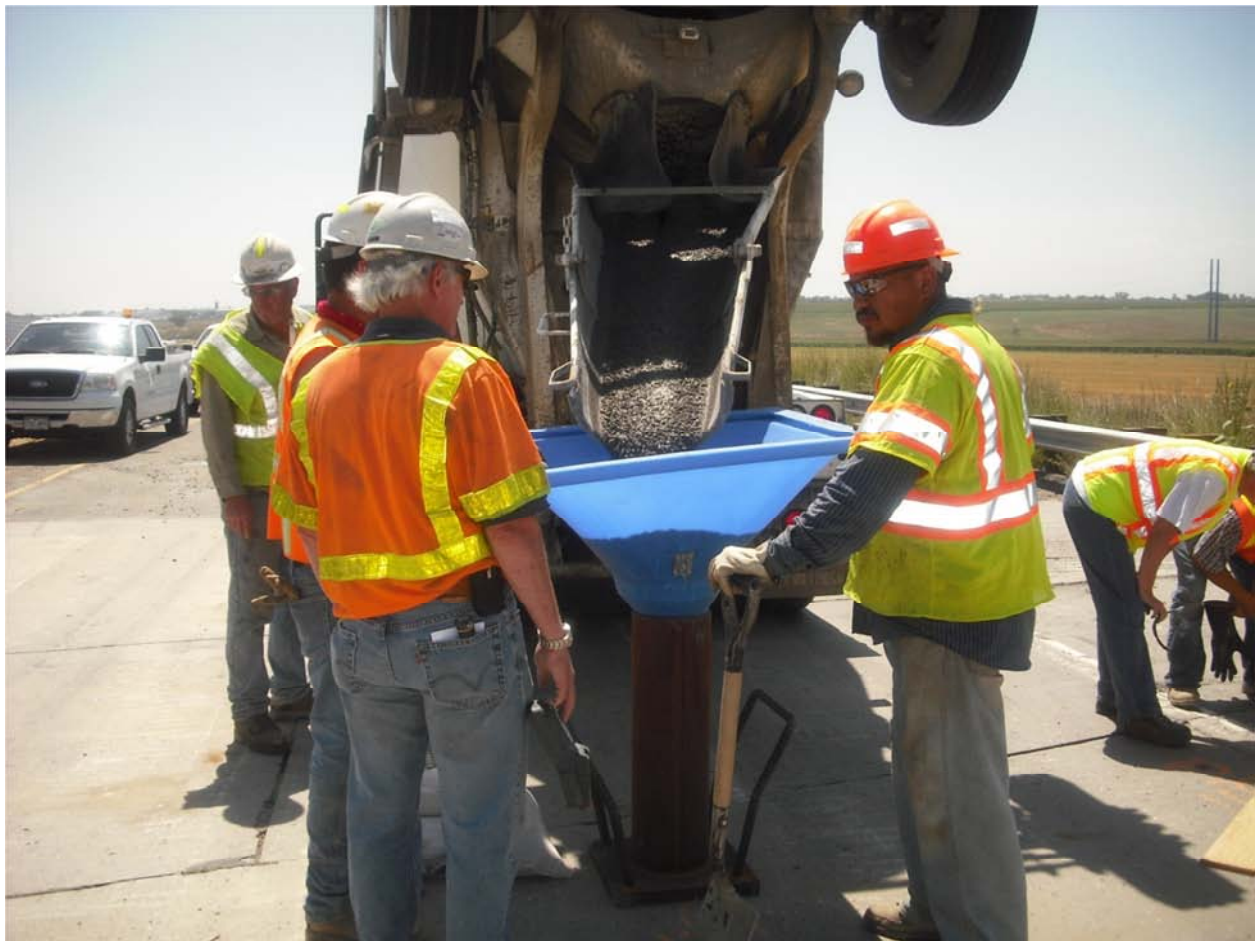
The second repair operation aimed, similarly, to encase the girder ends in the southern abutment. This task was accomplished by placing SCC through the existing deck, and filling the abutment area between the girders. Holes were cored through the deck into each of the bays between the girders and above the overhangs. SCC was then poured from the trucks down into the holes, through the funnel system shown in Figure 2, filling up all bays with SCC.

**Figure 2: SCC Placement Funnel**

Due to the cross slope of the deck and abutment, it was decided to begin placing the SCC near the transverse center of the bridge, allowing it to flow outwards in both directions. The east-side holes were at slightly higher elevation. Placing the SCC at the eastern-most hole and allow gravity and the concrete flowability to fill up all space was considered. However, it was decided to start the placement of the SCC at the central hole to reduce flow travel and avoid potential segregation. At the early stages, the SCC flowed both towards the lower end, as well as the

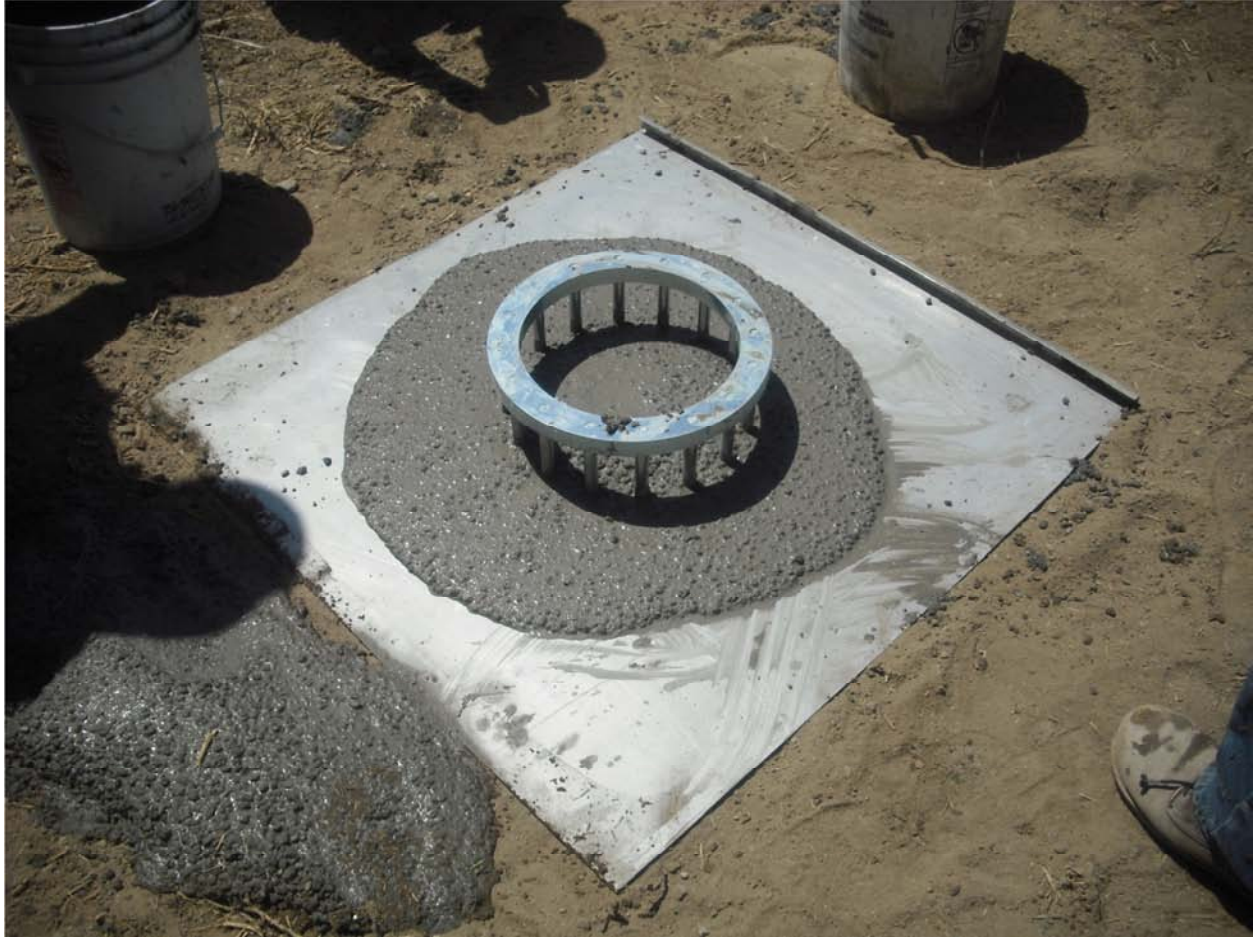
This slump flow test is used to monitor the consistency of fresh, unhardened self-consolidating concrete and its unconfined flow potential. The slump flow test through the J-Ring (Figure 3) gives an indication of the SCC's ability to flow through confined spaces while maintaining its required flow circumference. The J-Ring tests of SCC typically should not show excessive amounts of aggregate trapped behind the vertical bars, which is an indication of the SCC being susceptible to segregation. The SCC tested on the Mead Bridge repair showed minor amounts of aggregate being left behind the J-Ring bars, as demonstrated in Figure 4. However, it was judged that the amount remaining behind did not indicate that the SCC delivered would not perform as intended.

**Figure 3: SCC Slump Flow Test with J-Ring**

The average slump flow of the SCC measured without a J-Ring was 27 inches, while the slump flow with J-Ring measured on average 26 inches, both of which were acceptable under the project specification minimum of 24 inches. The small difference of slump flow between the unobstructed and obstructed conditions (27 inches vs 26 inches) is a reliable indicator that the flow of SCC through bars will not result in significant segregation.

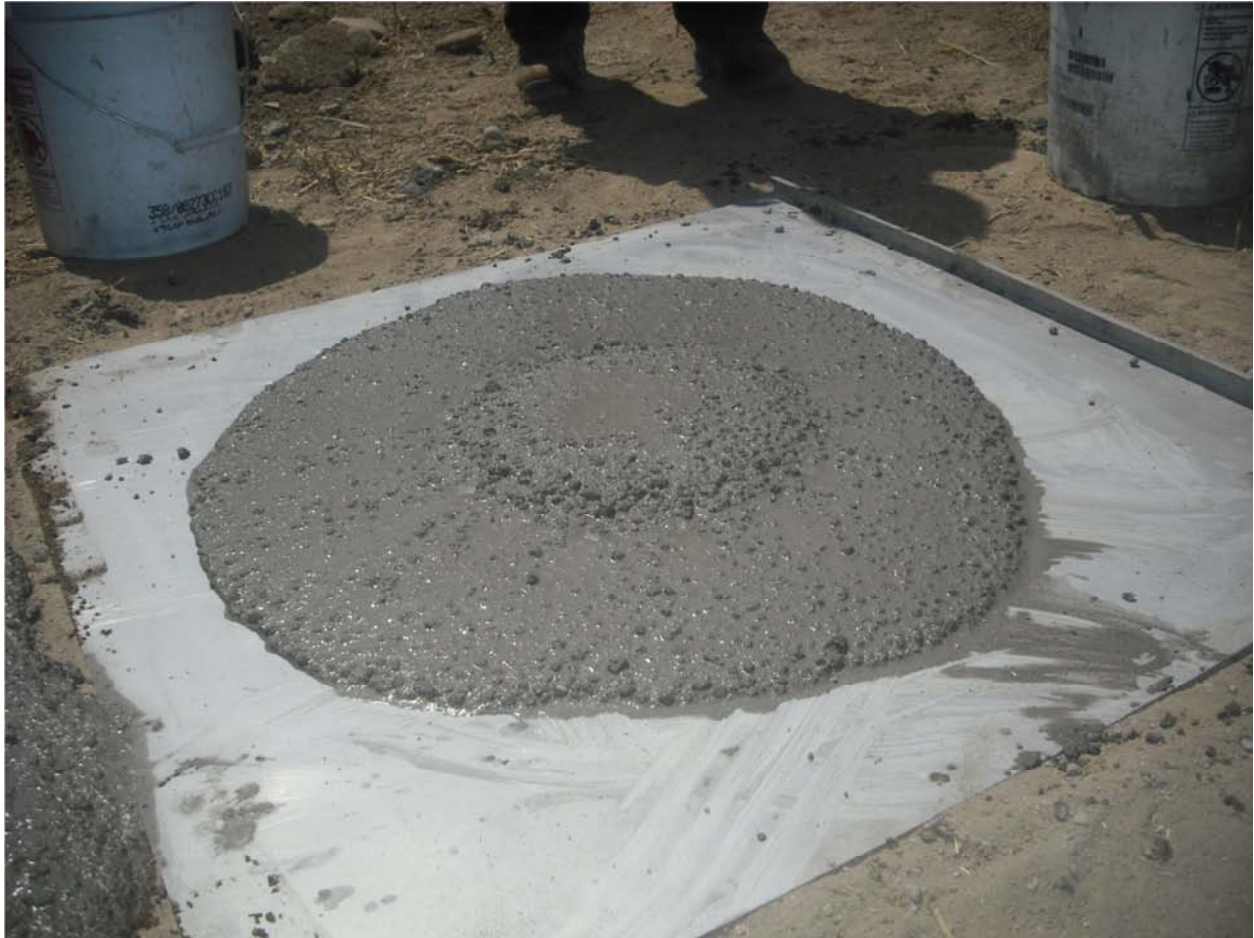
**Figure 4: SCC J-Ring Aggregate Left Inside the Ring**

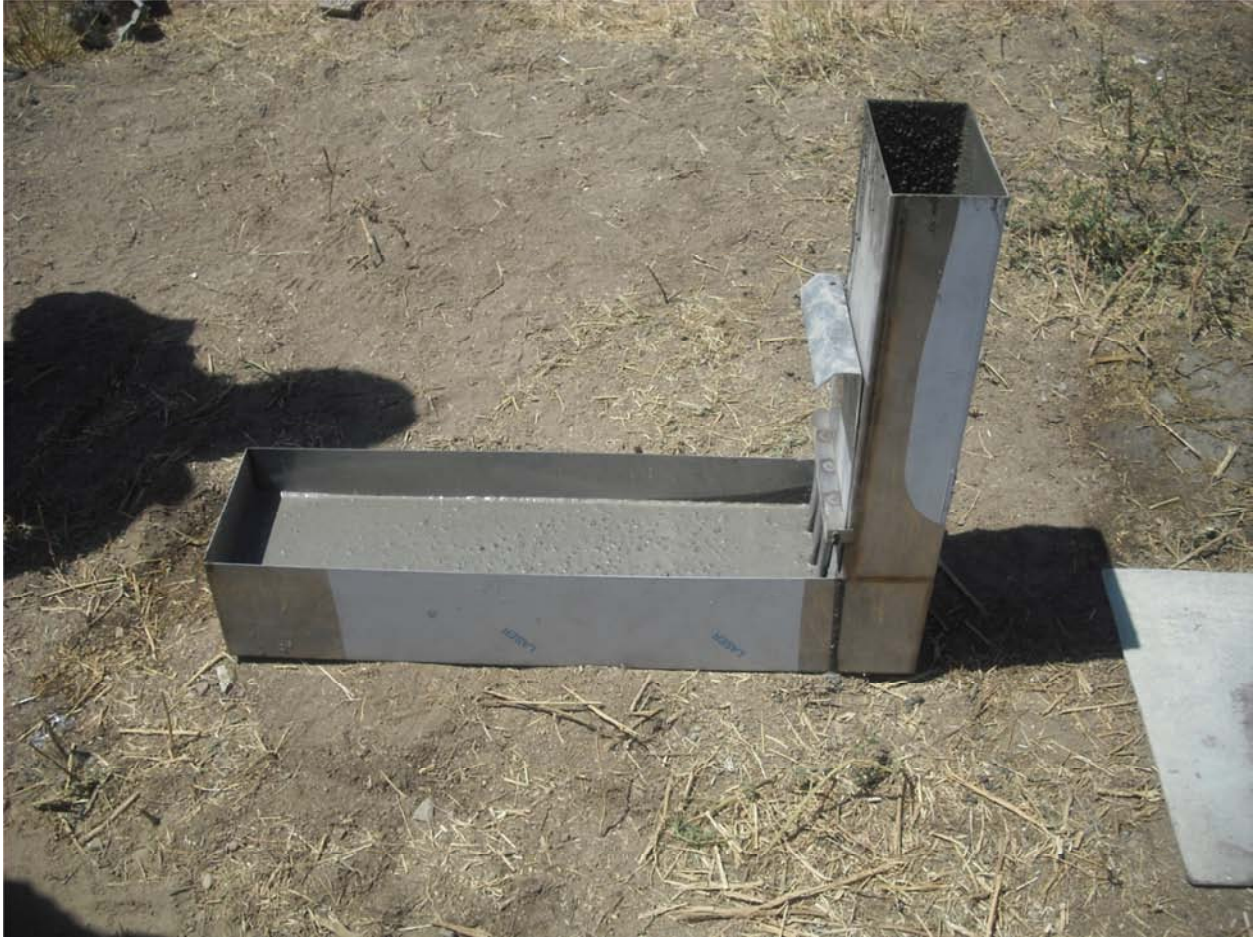
The L-Box test is used as another indication of SCC ability to pass through tight spaces and retain its self leveling attributes. As demonstrated in Figure 5, the SCC delivered for the project did not show any indication of being restricted in the L-box test and was approved on-site.

**Figure 5: SCC L-Box Test**

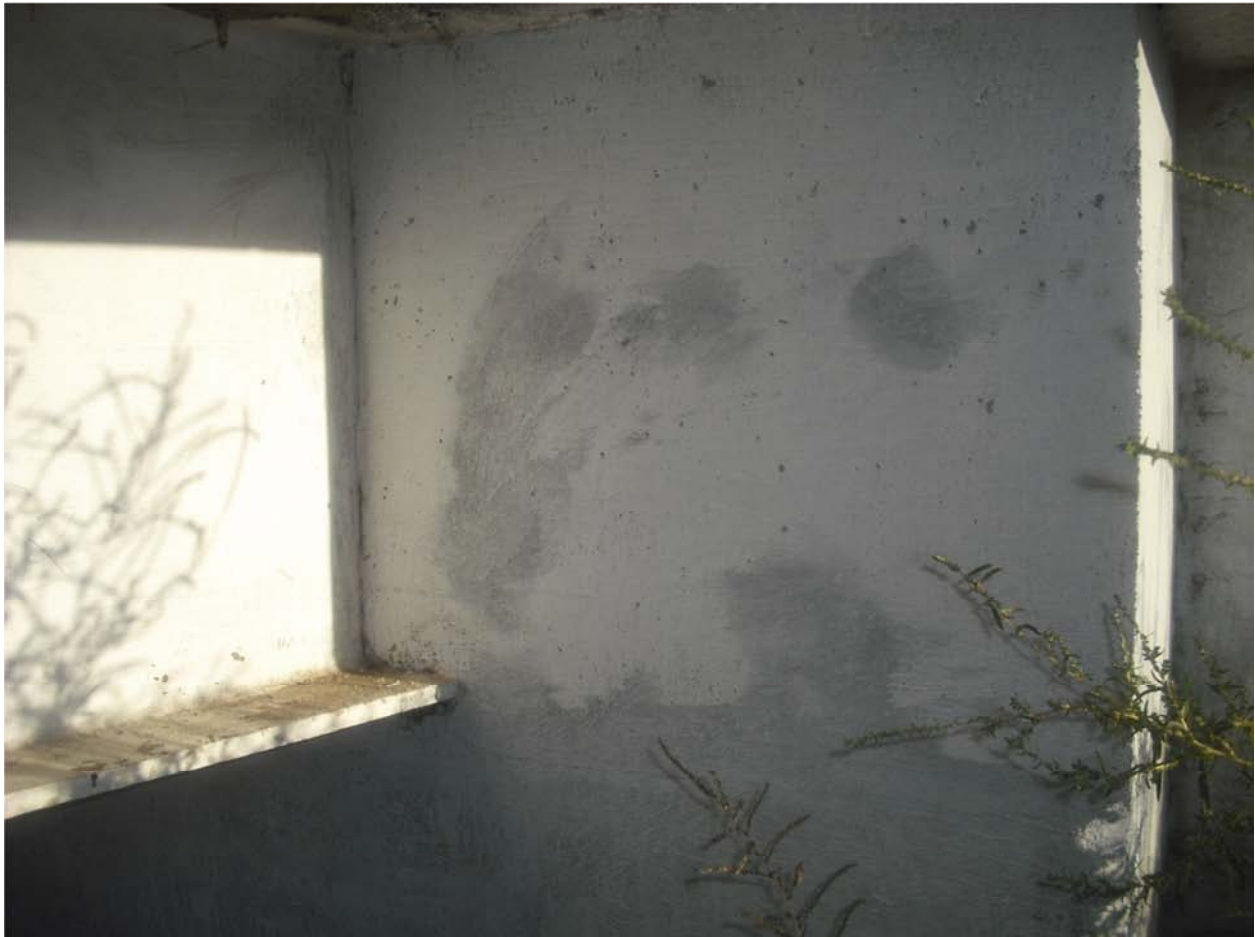
The surfaces of the repaired abutments were coated in a white wash. There are a few areas beneath the bottom flanges of the steel girders where minor cracking was observed. Figure 6, taken at the deck overhang area, shows the typical surface finish of the SCC on the south abutment of the northbound bridge.

**Figure 6: South Abutment of NB Bridge with SCC**

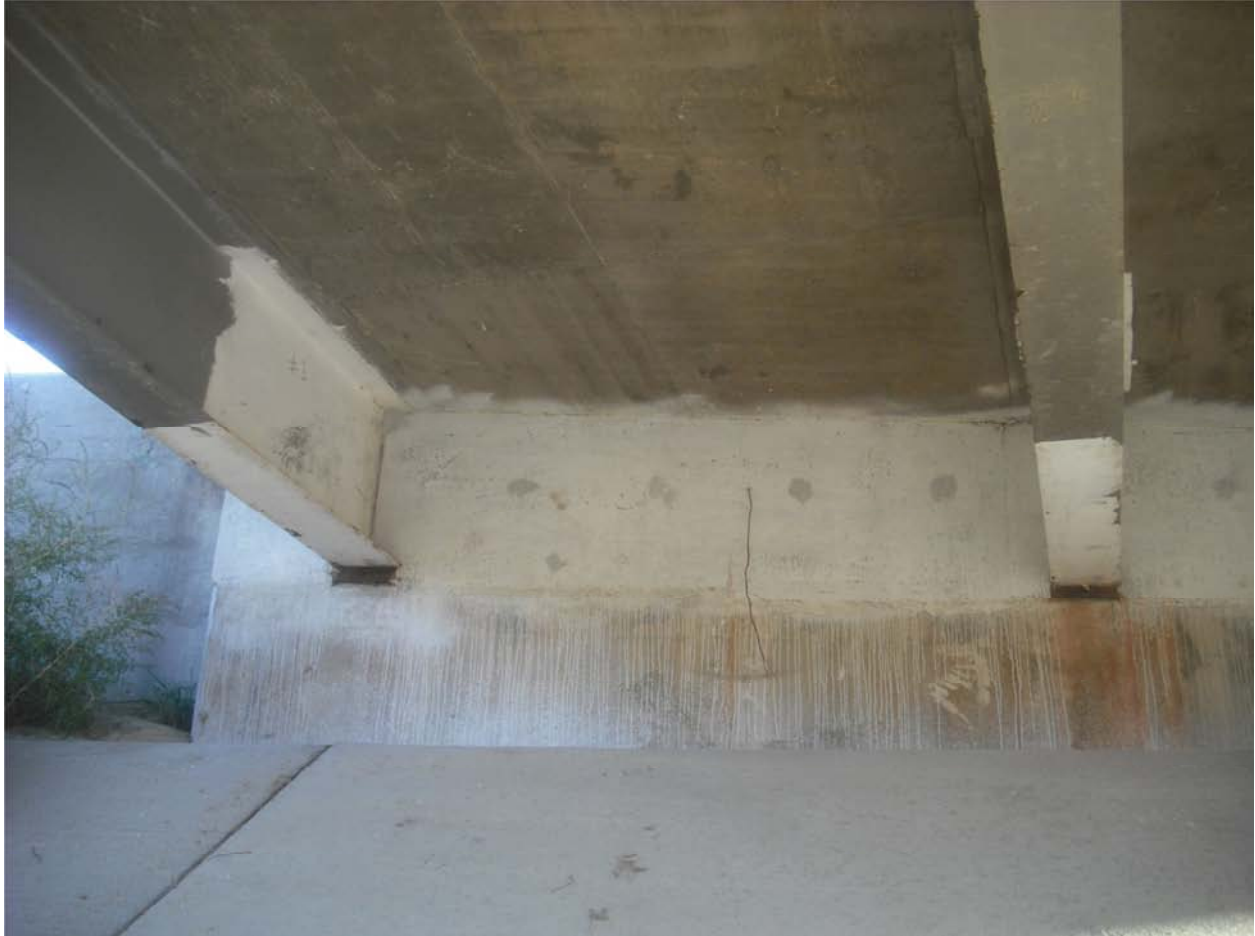
Figure 7 shows the typical surface finish of the SCC on the Southbound Bridge between the girders. Note that the thermocouple used during construction to monitor the strength gain during the repair is still in place in this photograph.

**Figure 7: SB Abutment Typical SCC Finish**

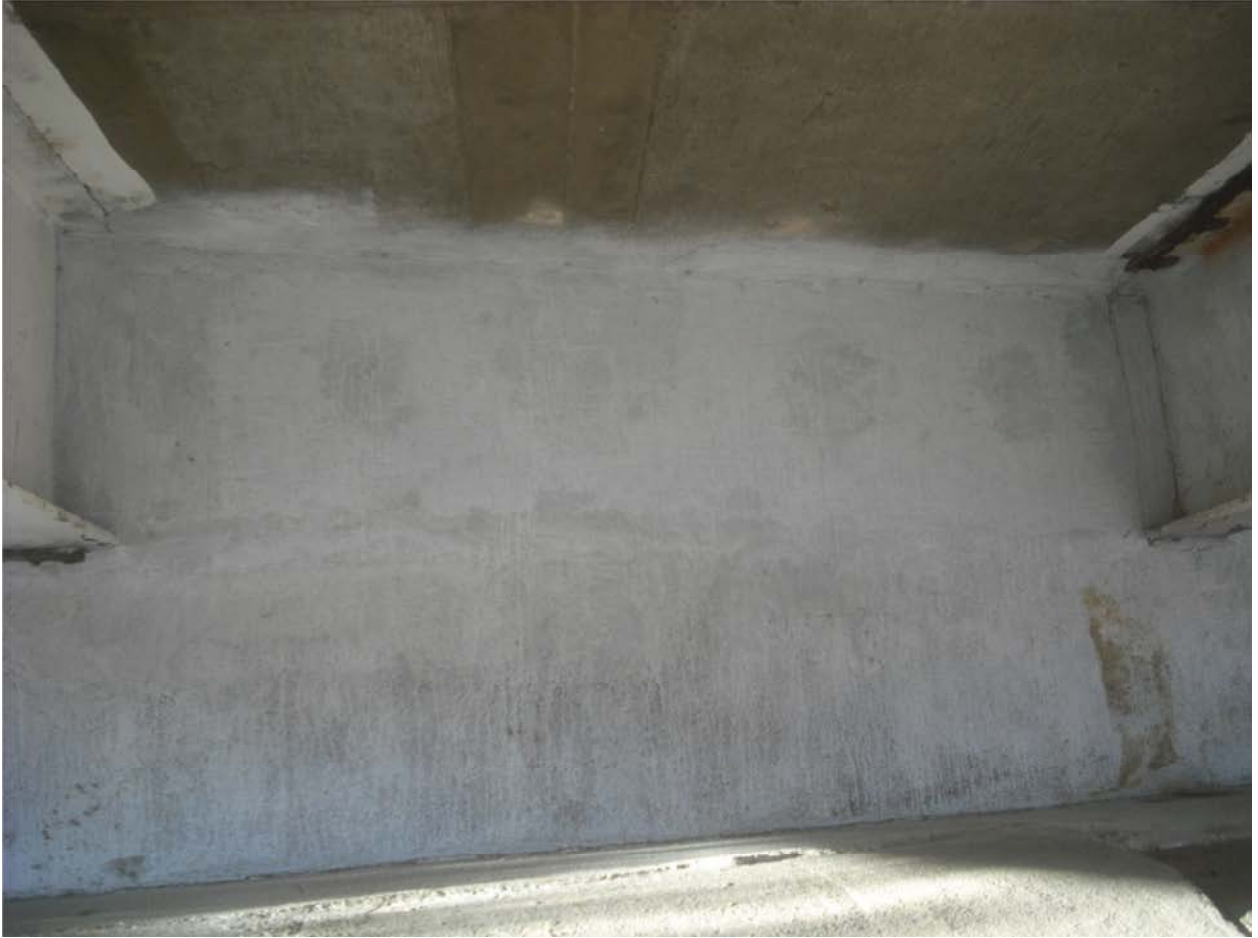
The northern abutments of both bridges, cast in normal concrete, also appeared to be performing satisfactorily in the service conditions. No significant cracking was observed near the girders or in the bays between the girders. Figure 8 shows the typical surface finish and performance of the normal concrete used.

**Figure 8: Typical Surface Finish of Normal Concrete**
