Feasibility Study for Detection and Quantification of Corrosion in Bridge Barrier Rails

Final Report
April 2013

Sponsored by
Federal Highway Administration
Iowa Department of Transportation
(InTrans Project 11-413)

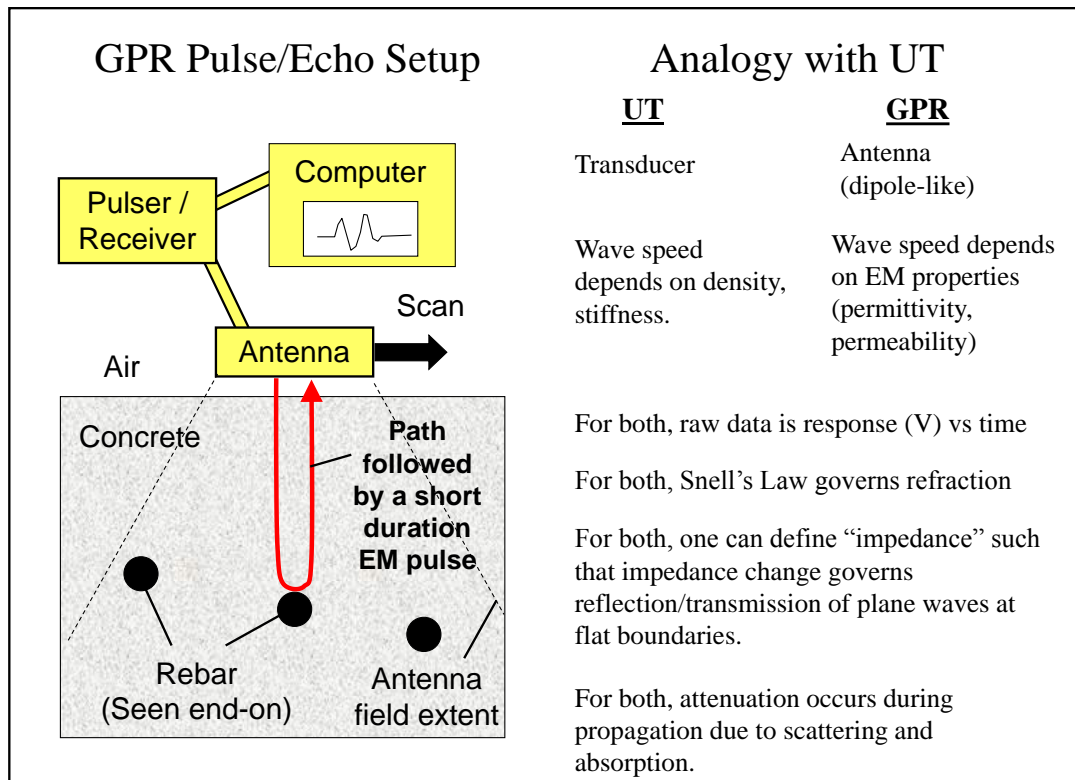
Figure 8. GPR pulse/echo inspection of reinforcing steel and analogy with ultrasonic inspection

As indicated in Figure 8, the GPR inspection process is analogous to that used in pulse/echo ultrasonic inspection, and tools developed on the ultrasonic side for analyzing data and modeling inspections can be adapted readily to GPR.

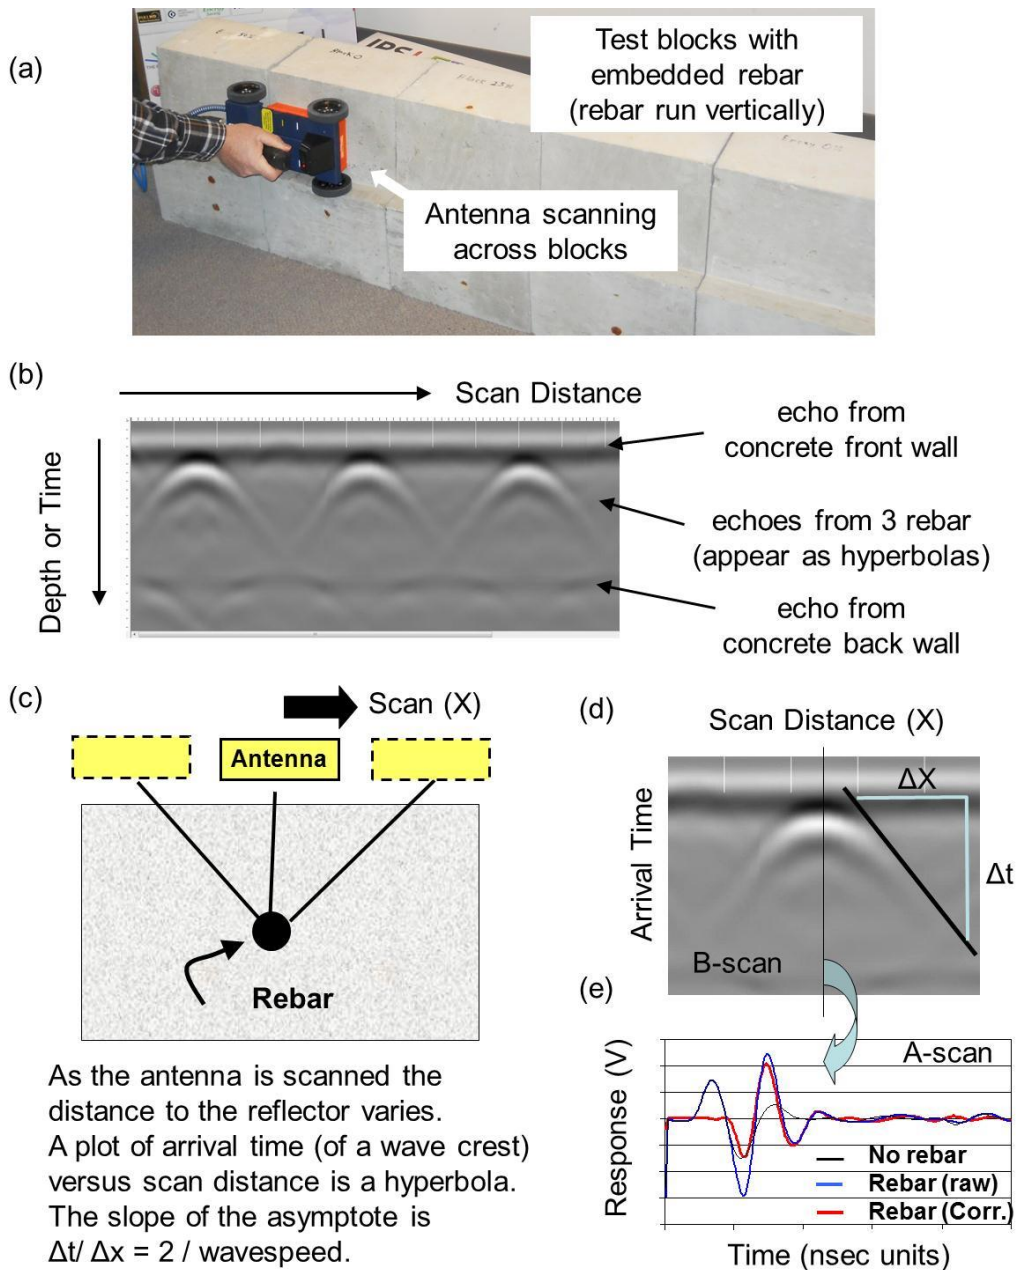
Figure 9. Scan of the GPR antenna, the resulting B-scan image, why B-scan responses have a hyperbola shape, and A-scan plot of output voltage versus time for the antenna position

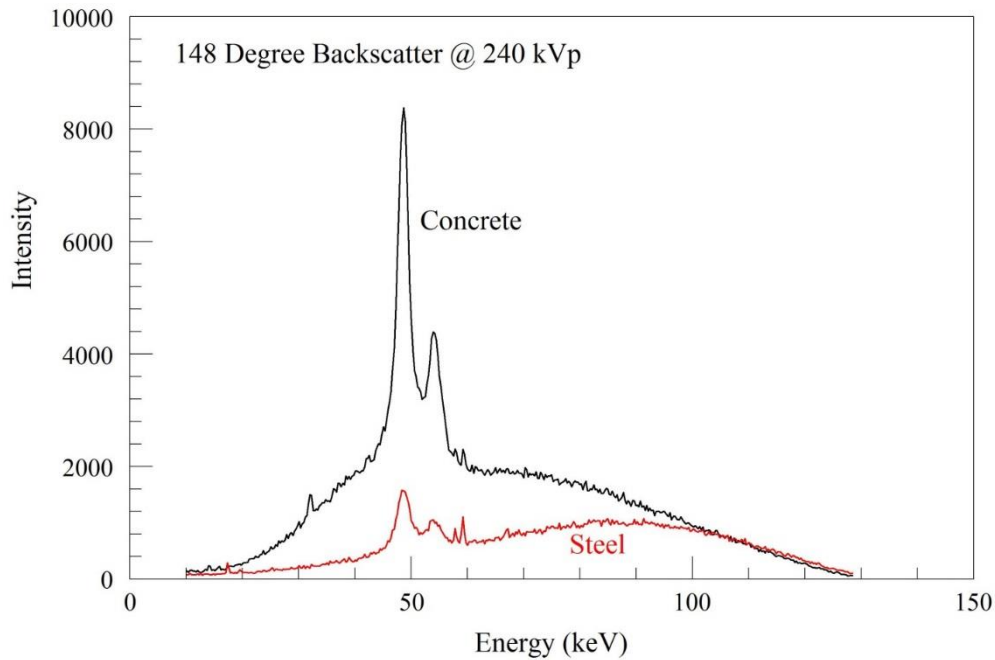
Figure 20. Backscatter spectra observed for concrete and steel samples

Some very preliminary studies of x-ray backscatter were carried out using the configuration shown earlier in Figure 5. Comparison of the x-ray spectra observed for scattering from concrete and steel is shown in Figure 20.

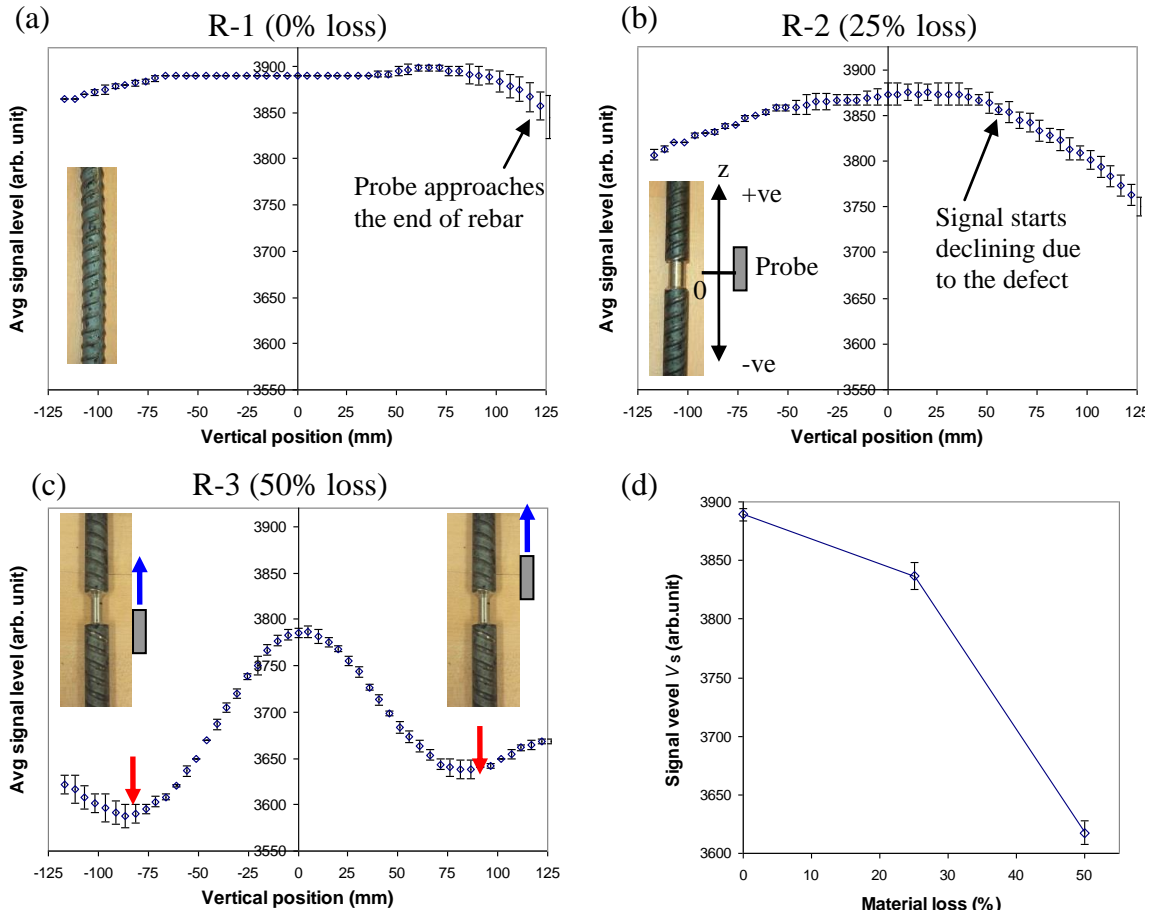
Figure 27. (a-c) EC signal levels (in arbitrary unit) versus vertical position of the sensor probe and (d) dependence of the averaged EC signal level detected at 3 in. from the defect on the amount of material loss

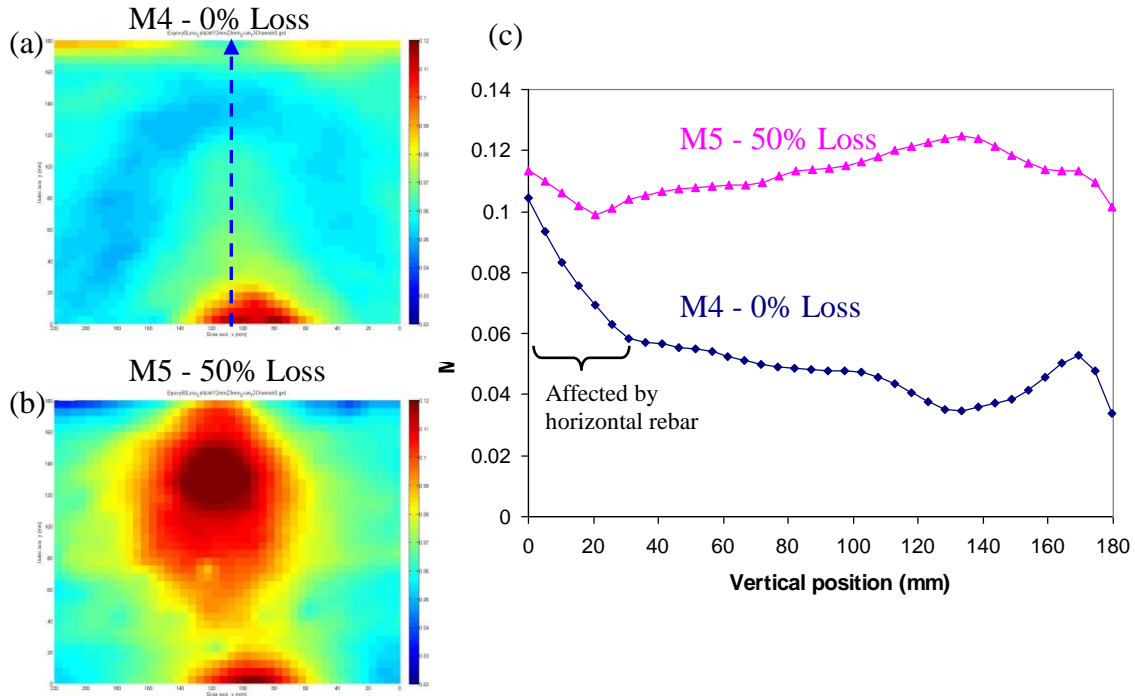
Figure 36. C-scan images of the test specimens and comparison of signal levels

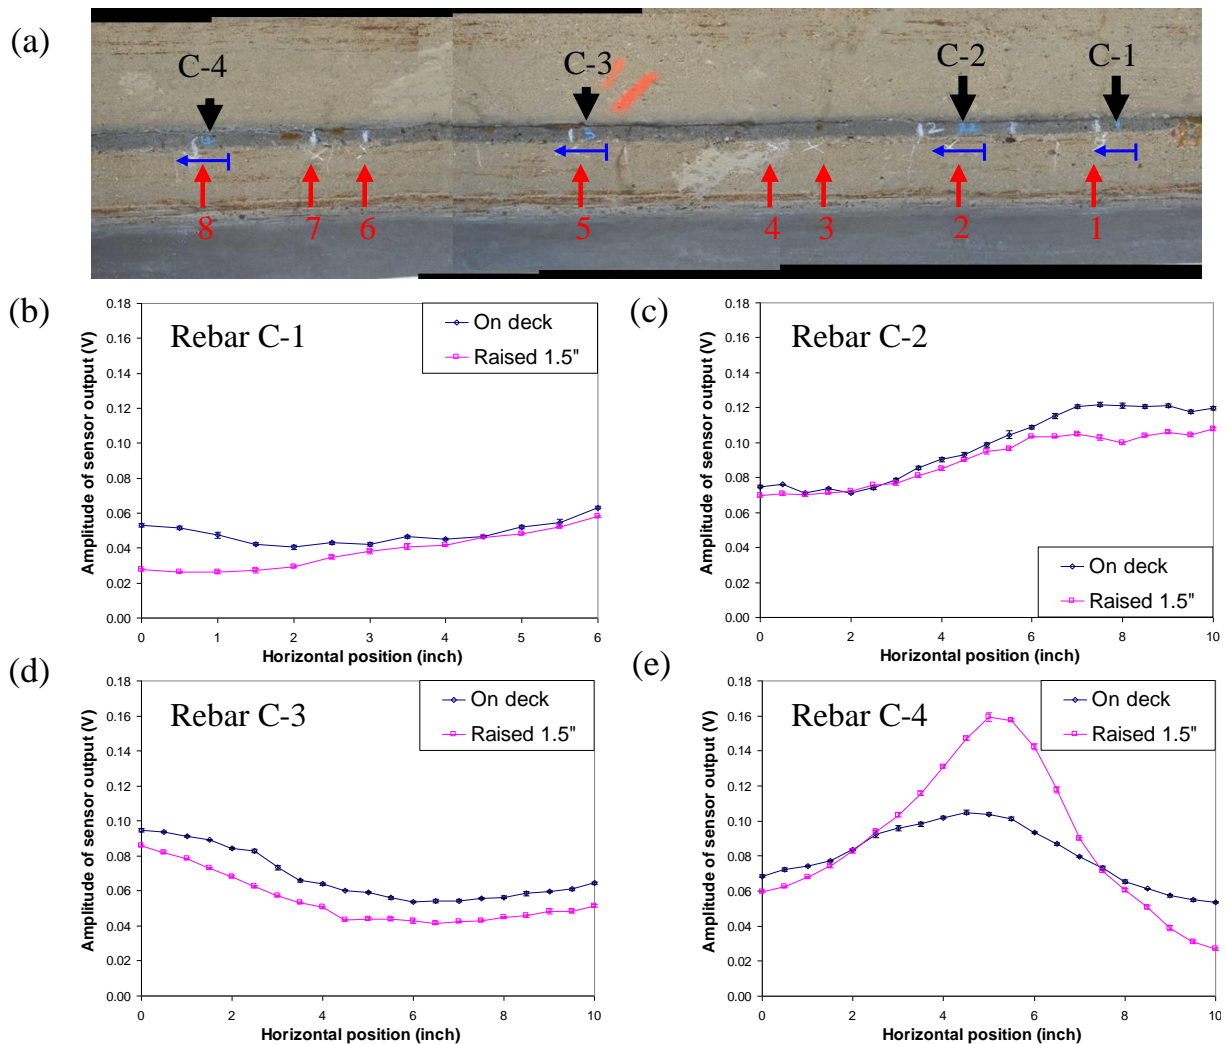
Figure 38. Crown section of the Highway 210 Bridge barrier rail

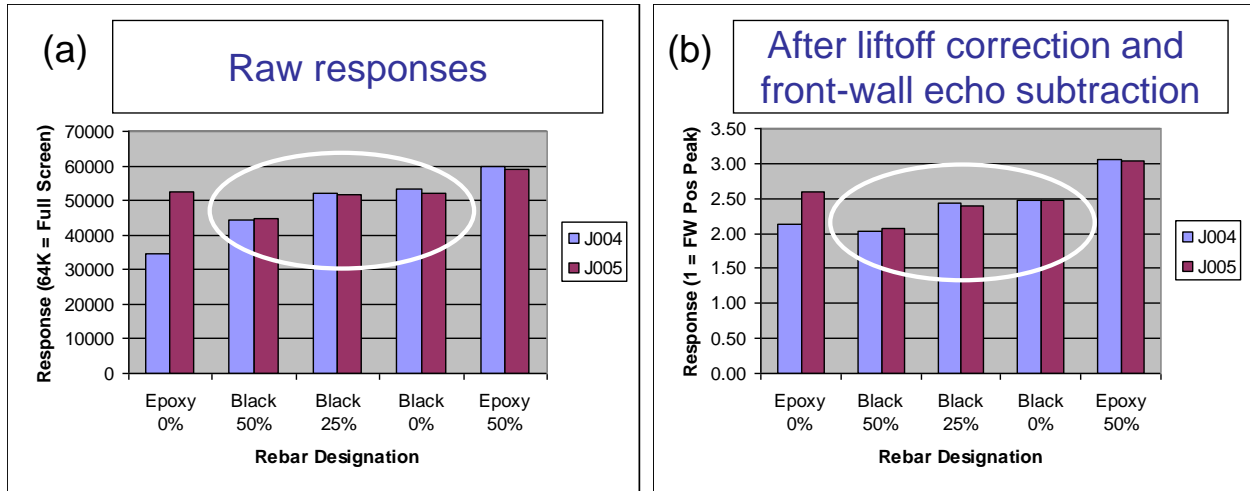
Figure 47. As-measured (a) and corrected (b) peak-to-peak responses for the vertical reinforcing steel in the five test specimens for right-to-left (J004) and left-to-right (J005) measurements

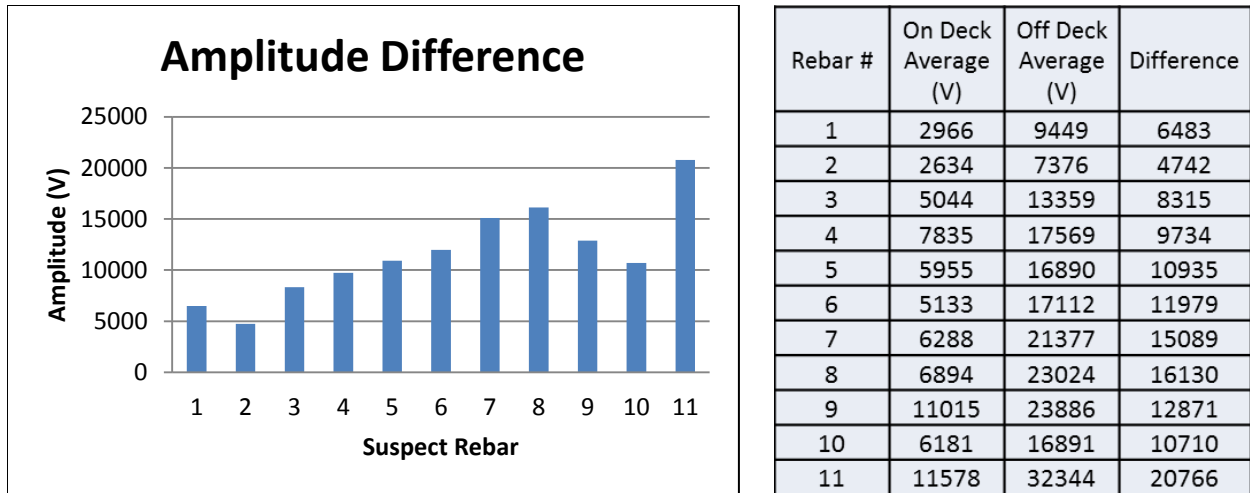
Figure 55. Amplitude difference data for the 11 suspect reinforcing bars

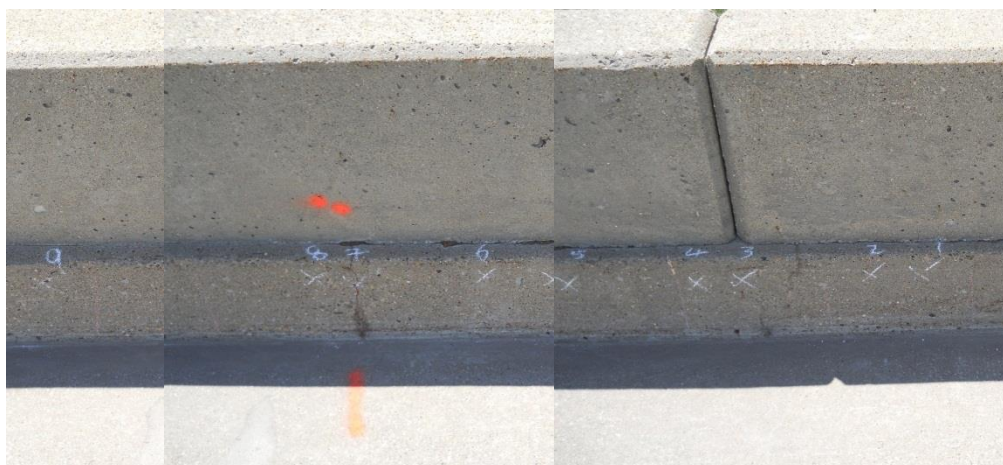
Figure 57. Suspect locations on the east end of the bridge

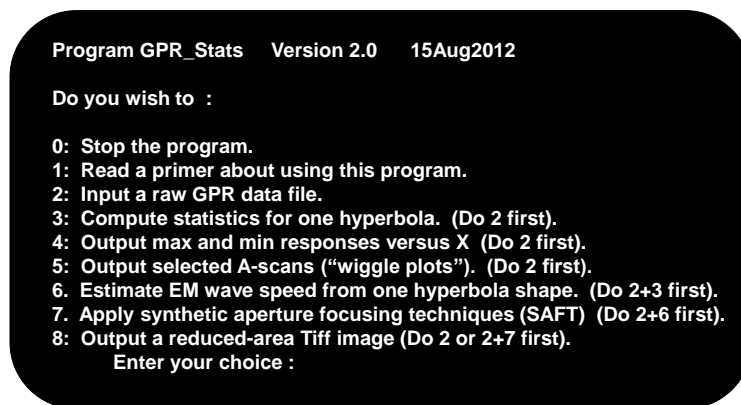
Figure 60. Data analysis operations available in the special-purpose software written to analyze GPR data collected and stored by the GSSI instrument

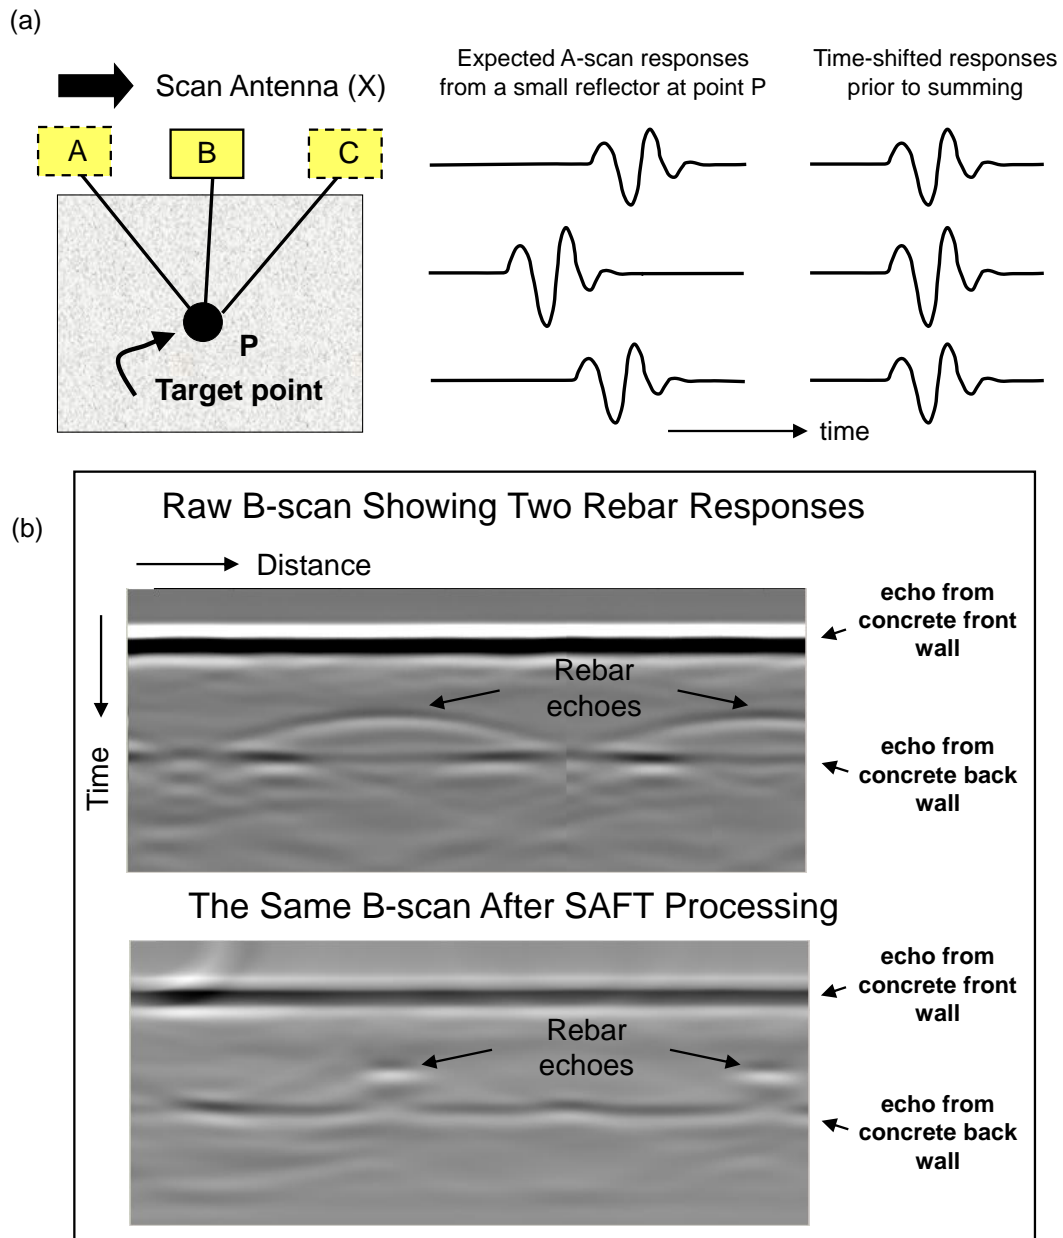
Figure 62. (a) Principle underlying SAFT processing and (b) application of SAFT to a scan over abutting concrete test specimens containing two reinforcing steel targets

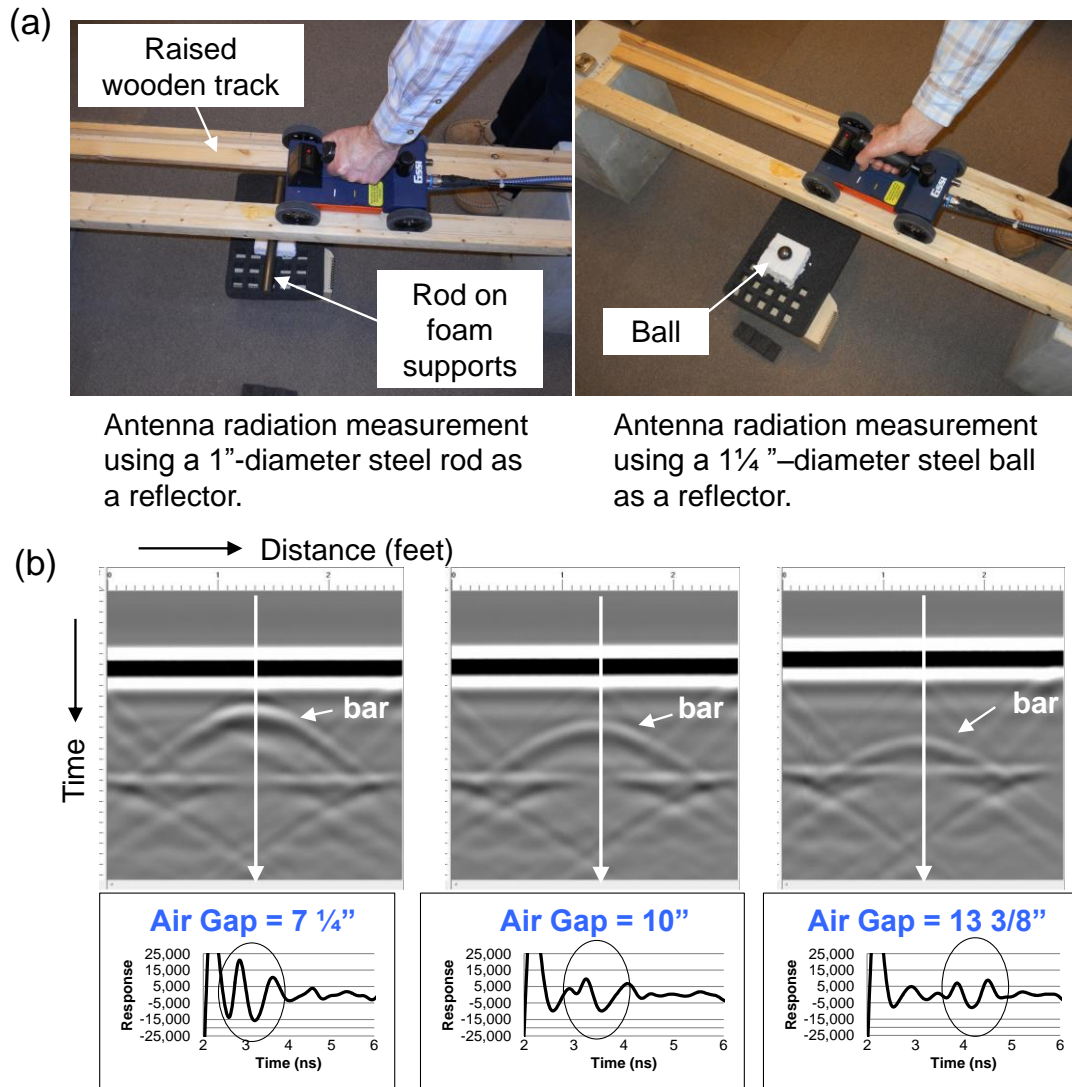
Figure 63. (a) Mapping the antenna radiation pattern using rod and ball targets and (b) B-scans for three choices of the air gap between the antenna and the rod target and corresponding A-scans for the peak response points
