Center Islands with Raised Curbing for Rural Traffic Calming

A number of traffic-calming devices were evaluated to determine their effectiveness in reducing speeds along the main road through a small rural community. Five different treatments were selected and installed in six rural Iowa communities. This tech brief highlights use of temporary curbing to create center islands.

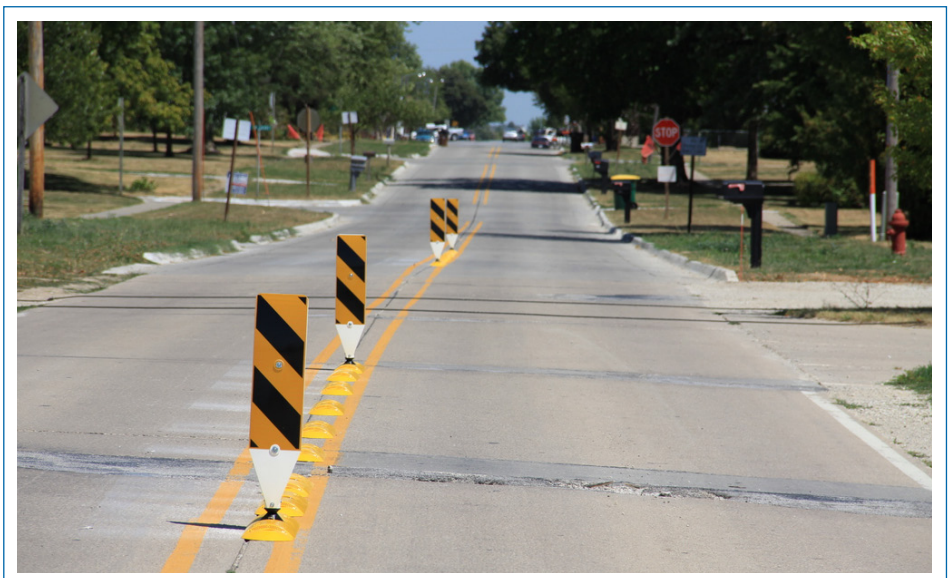
Mountable curbing at south entrance to St. Charles

The treatment was installed at three locations in the community of St. Charles, Iowa (population 653). Speed problems were present at all four community entrances. County Road R-35 is oriented north/south and has a volume of 410 vehicles per day (vpd) at the north community entrance and 940 vpd at the south entrance. State Highway 251/West Main Street is oriented east/west and has a volume of 1,200 vpd at the west community entrance and 2,240 at the east entrance. The roadway serves as a major collector route for drivers commuting to metro Des Moines, Iowa.

Temporary islands were created using mountable curbing at the north, west, and south entrances. (A different treatment was placed at the east entrance to St. Charles). Mountable curbing was not appropriate for the east entrance given a horizontal curve, which may lead to some sight-distance issues for drivers being able to see the curbing in time.

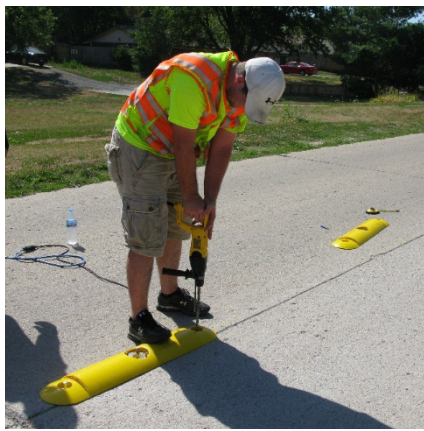
Installation of raised curbing using bolts

The treatment was affixed to the pavement using bolts. As a result, the treatment could be removed and replaced as needed. This was important given the treatment needed to be removed for the winter months so city and county snowplow operators did not need to worry about maneuvering around the treatments during winter storm events.

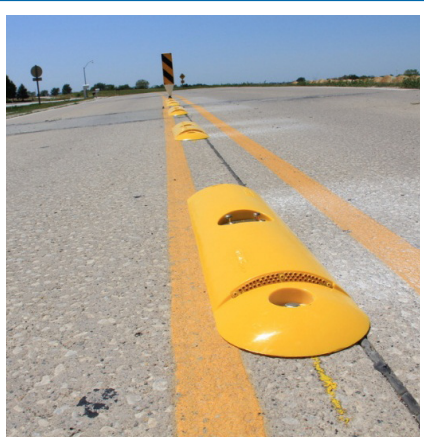
Close-up of mountable curbing

The temporary curbing that was purchased is approximately 2 inches high by 40 inches long by 8 inches wide. The curbing has a rounded design that can be mounted by errant vehicles.

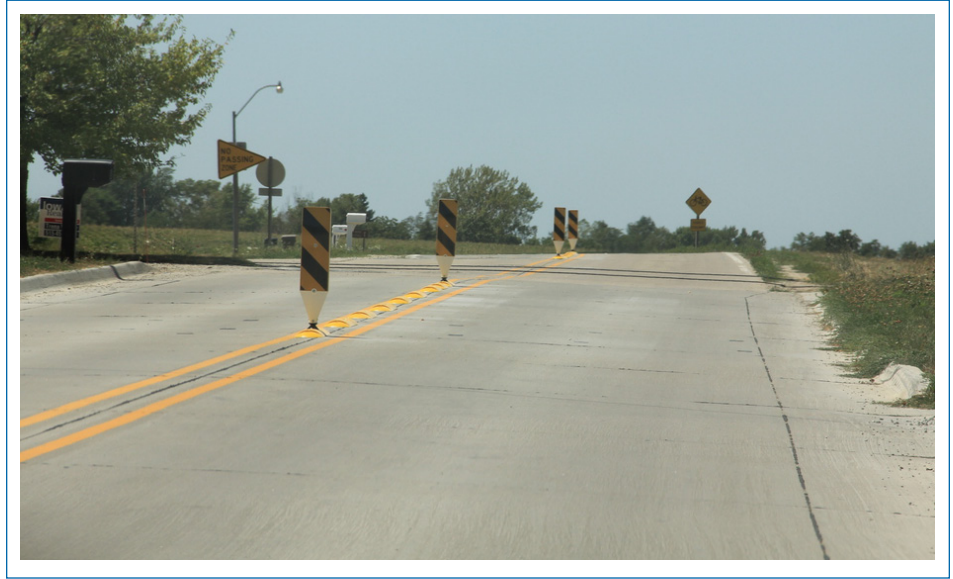
Mountable curbing installed at west St. Charles community entrance

St. Charles North	St. Charles South	St. Charles West
Mean Speed	-2.2	-1.9	0.4
85th Percentile Speed	-3	-1	0
Fraction of Vehicles Traveling Over Posted Speed Limit			
≥ 5 mph	-28.6%	-23.4%	5.9%*
≥ 10 mph	-45.8%	-28.6%	11.1%*
≥ 15 mph	-71.4%	-28.6%	0.0%*
≥ 20 mph	-100.0%	-50.0%	0.0%*
