FINAL REPORT ON A COLD CLIMATE PERMEABLE INTERLOCKING
CONCRETE PAVEMENT TEST FACILITY AT THE
UNIVERSITY OF NEW HAMPSHIRE STORMWATER CENTER

May 2013

**FINAL REPORT ON A COLD CLIMATE PERMEABLE INTERLOCKING CONCRETE
PAVEMENT TEST FACILITY - MAY 2013
BY THE UNIVERSITY OF NEW HAMPSHIRE STORMWATER CENTER**

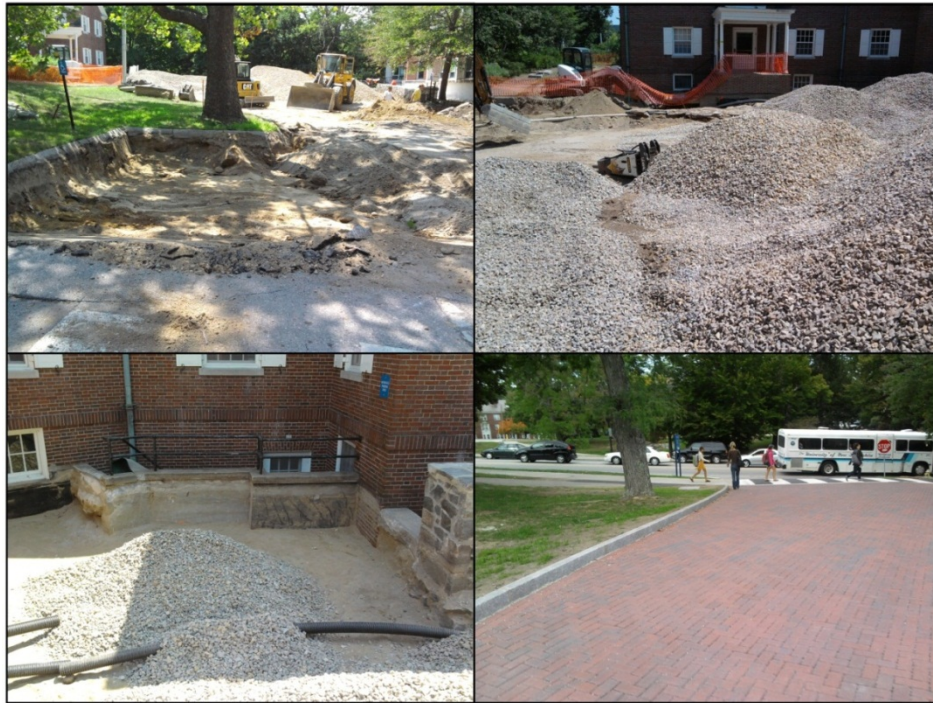
Figure 1: August 2010 installation of PICP system (clockwise from top left) demolition and excavation, placement of subbase aggregate, finished product, underdrain installation.

The UNH test site is a 13,500 square foot PICP system installed in the summer of 2010 on the UNH main campus in Durham, NH (Figure 1, Figure 2). The pre-existing Hood House Drive (7,000 square foot) and J Lot (6,500 square foot) were standard asphalt surfaces. The areas

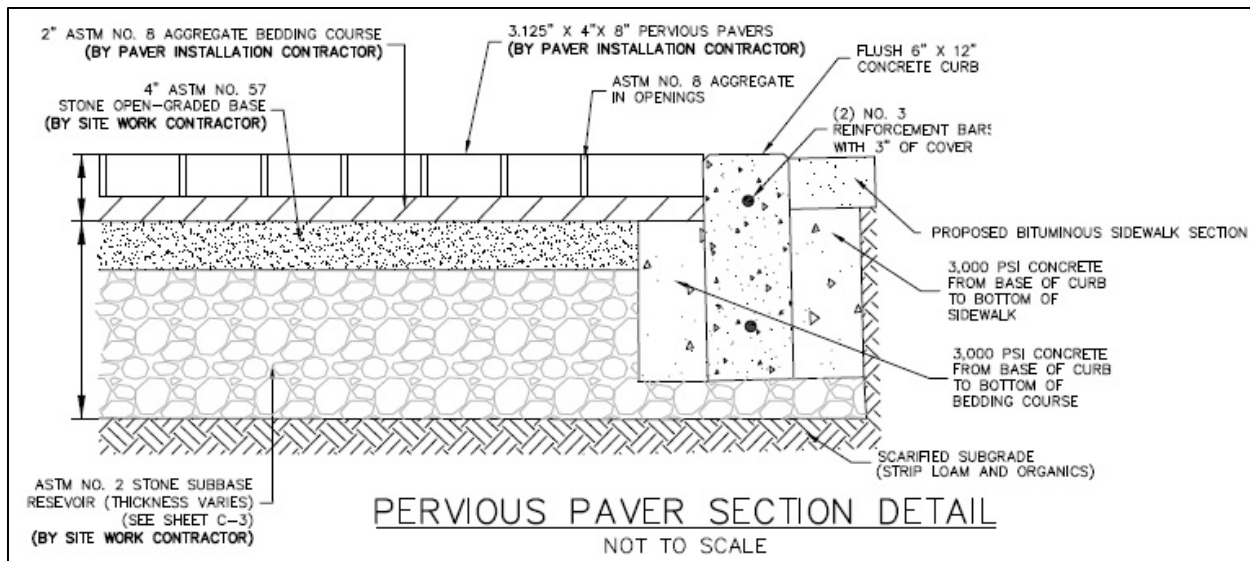
Figure 3: Typical PICP Hood House Drive Cross Section. The concrete haunches on both sides of the granite curbs are not typical to most PICP applications. The use of the concrete in this detail is specific to the University of New Hampshire.

Appendix A includes project construction drawings and details. System configuration is an ICPI recommended profile (Figure 3). Concrete pavers were placed on a 2-inch bedding course of ASTM No. 8 aggregate. Appendix H provides test results on the concrete pavers which conform to ASTM C 936. The No. 8 aggregate was also used to fill the joints between the pavers. The bedding course is supported by a 4-inch open graded base layer of No. 57 aggregate. This layer was placed on a stone subbase reservoir of variable thickness of ASTM No. 2 aggregate. The thickness of the No. 2 subbase was 20 inches in the J Lot (the upper portion) areas, and 17 inches thick along the drive portion leading to Main Street. Below the subbase are native soils of sandy loam which have a high infiltration capacity of approximately 3 in/hr., measured in a test pit location prior to installation. The subbase and surface slopes of the PICP system are 6% and designed with internal grade controls. Two check dam and perforated underdrain configurations (Figure 4) were installed in the reservoir layer; one draining J Lot and the other Hood House Drive into an underground monitoring chamber. The J Lot underdrains are installed downstream of the check dams while the Hood House Drive underdrains are installed upstream. The check dams are constructed of 30 mil (0.762 mm) impermeable PVC liner installed in a stepped pattern (Figure 4). The perforated underdrains are placed 4 inches above the native soils. The J Lot configuration is intended to retain stormwater between events to promote denitrification within the subbase. The Hood House Drive configuration is intended to allow high flow events to bypass through the system more quickly. Both configurations allow the design storm event to infiltrate into the native soils. Each configuration has a unique outlet into the monitoring chamber. To date monitoring efforts have focused on the main parking area (J Lot) of the PICP system.

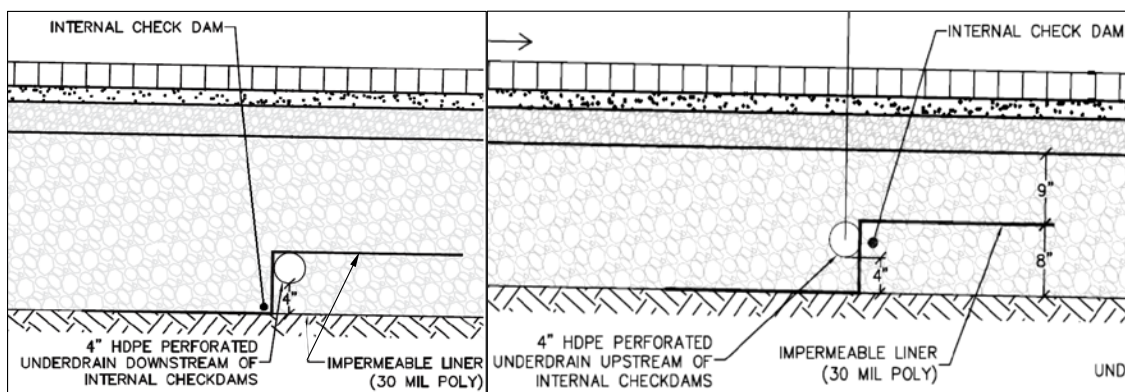
Figure 4: Check dam and perforated underdrain configurations. On the left is J Lot and the right is Hood House Drive. J Lot is the section being monitored for this study.

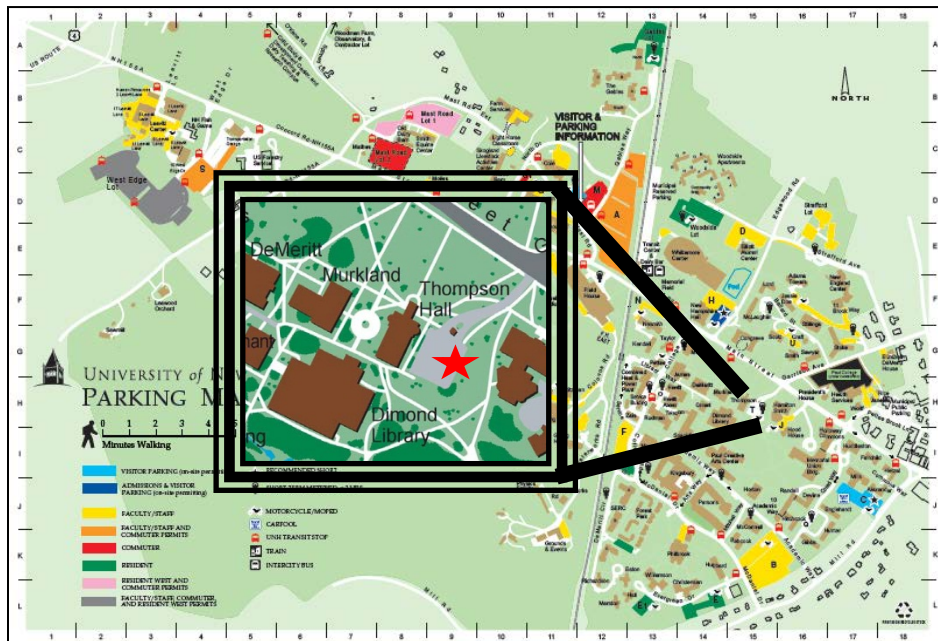
Figure 5: T Lot – PICP influent monitoring location

The reference influent monitoring and rain gauge were located off T Lot (Figure 5), which is approximately 400 feet from the PICP effluent monitoring location. T Lot is adjacent to Thompson Hall and Dimond Library on the main University campus and is similar in size, usage, and rainfall characteristics. T Lot is a 12,000 square foot standard asphalt lot with approximately 50 parking spaces, granite curbing, and traffic consisting of both passenger vehicles and routine bus traffic. The area, like Hood House Drive and J Lot, is subject to frequent plowing, and deicing (salting) throughout winter months. Literature reviews indicate that pollutant concentrations from T Lot are above or equal to national norms for parking lot runoff. T Lot is drained by a typical catch basin and piping network. A 12 inch HDPE pipe conveys a portion of T Lot runoff to a surface location (Figure 6) where monitoring equipment is installed to collect data, gather samples, and monitor flow and rainfall depths.

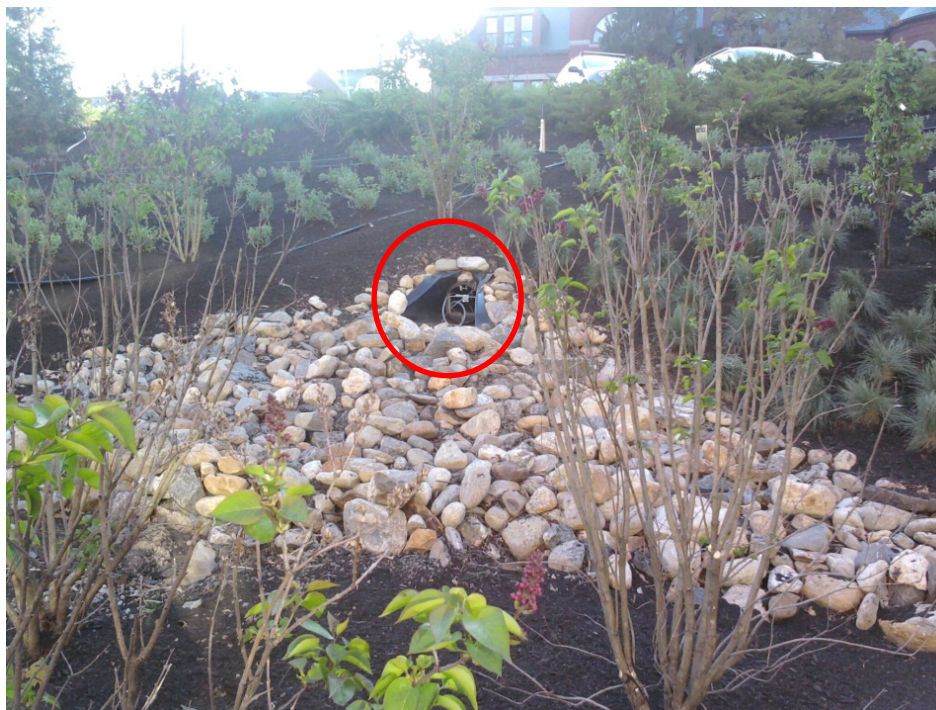
Figure 6: Picture of T Lot effluent location. T Lot is to the upper right in this picture.

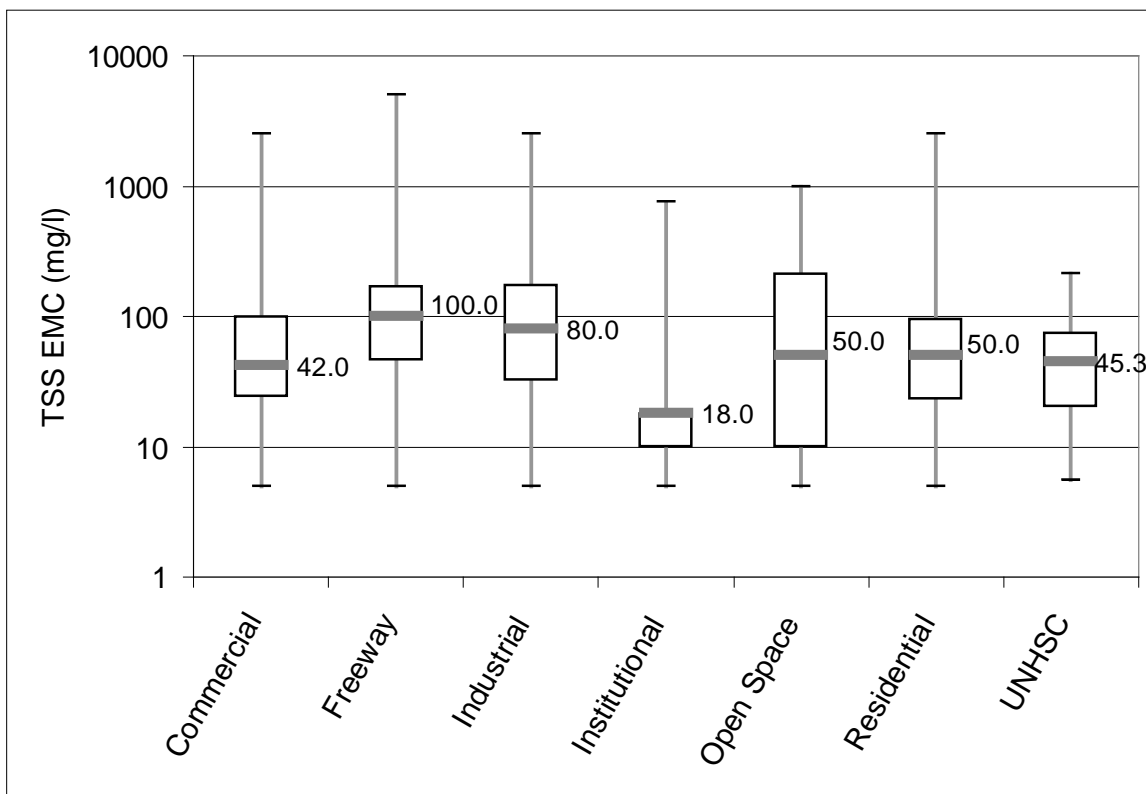
Figure 7: Total suspended solids (TSS) concentrations for varied land uses and at UNH Stormwater Center (Source: National Stormwater Quality Database, 2005, UNHSC, 2007)

Comparisons of the TSS concentrations for varied land uses are presented in Figure 7. Urban highway pollutant concentrations tend to be twice the mean concentration measured for parking lots and residential uses. Historical data collected from the UNH facility is within the national norm for commercial parking lots and is within the range of typical concentrations observed for a range of land uses. Occasional storms are monitored that have exceptionally high solids concentrations.

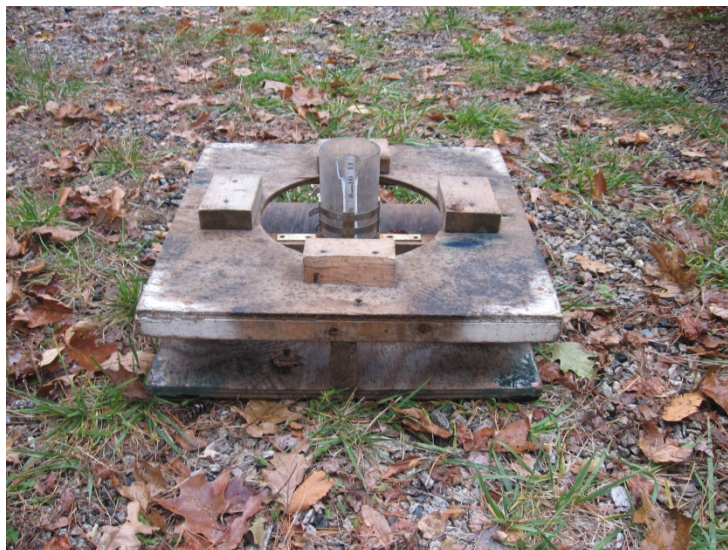
Figure 8: Surface Inundation Test Equipment; A variation on ASTM C 1701 and D 3385-03

Infiltration rate (IR) measurements are developed using a modified surface inundation (SI) device. The modified SI is a falling head test that measures the time to infiltrate a known volume of water (0.56 gallons) through the permeable surface (Figure 8). SI measurements were taken at three separate locations on the PICP lot over 11 times throughout the study. The SI test is a modification of an ASTM Standard D 3385-03 (ASTM, 1988) in which the falling head SI test involves placing a cylinder of known diameter onto the pavement surface which is then sealed to the pavement surface (Briggs, 2006). The UNHSC SI test is similar to ASTM C 1701 for pervious concrete in which both methods measure the infiltration rate of a known volume of water through a pervious pavement. The difference is that the SI is a falling head test that starts time zero when the full volume of water is delivered to the infiltration device. C 1701 specifies that the known volume be delivered to the device at a rate that maintains a surface depth between 10mm to 15mm and starts time zero as soon as water contacts the pavement surface. Another difference is that the SI uses a closed-cell foam foot to seal the cylinder to the pavement surface and C 1701 specifies the use of plumbers putty as a sealant. Also, C 1701 generally requires at least 5 gallons of water to conduct, whereas the modified SI requires 0.56 gallons.

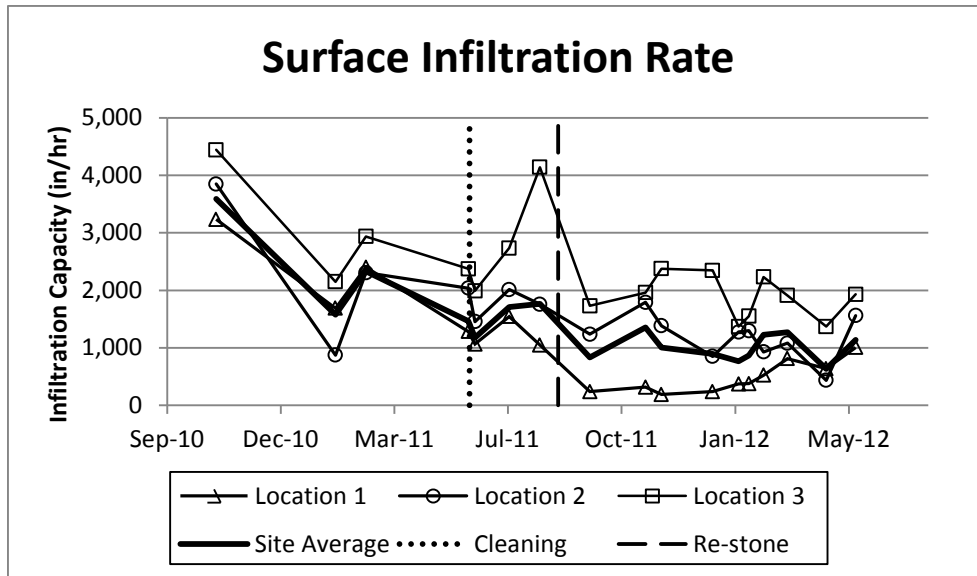
Figure 9: Infiltration rate monitoring over time of 3 separate locations representing different loading and usage characteristics.

Surface infiltration testing shows modest average performance for the PICP installation. A substantial decline in infiltration was observed for areas subjected to run-on. Infiltration rates declined 69% over 21 months yet still retained greater than 1000 inches per hour capacity. Minimal maintenance was performed during the period of monitoring. Impacts from run-on underscore the importance of designs minimizing run-on.

SI tests were used to monitor the infiltration capacity of the PICP system through the duration of the study. Locations for infiltration capacity measurement were chosen to represent different use scenarios. Location 1 is located near the entrance to Hood House Drive and represents a high use area. This location receives run on from Memorial Union Building Drive, sediment tracking from vehicles entering the lot, and leaf litter from a pair of deciduous trees. Location 2 is subject to less vehicle traffic, less impervious surface run on, is located on a more gradual slope, and has an evergreen tree that drops needles onto the surface of the test lot. Location 3 is located in a level parking stall that receives little traffic, has no organic litter build up, and is representative of a low loading area. IR measurements over the research period are shown in Figure 9. A site average for the study area is plotted and based on relative area contributions and infiltration capacity.

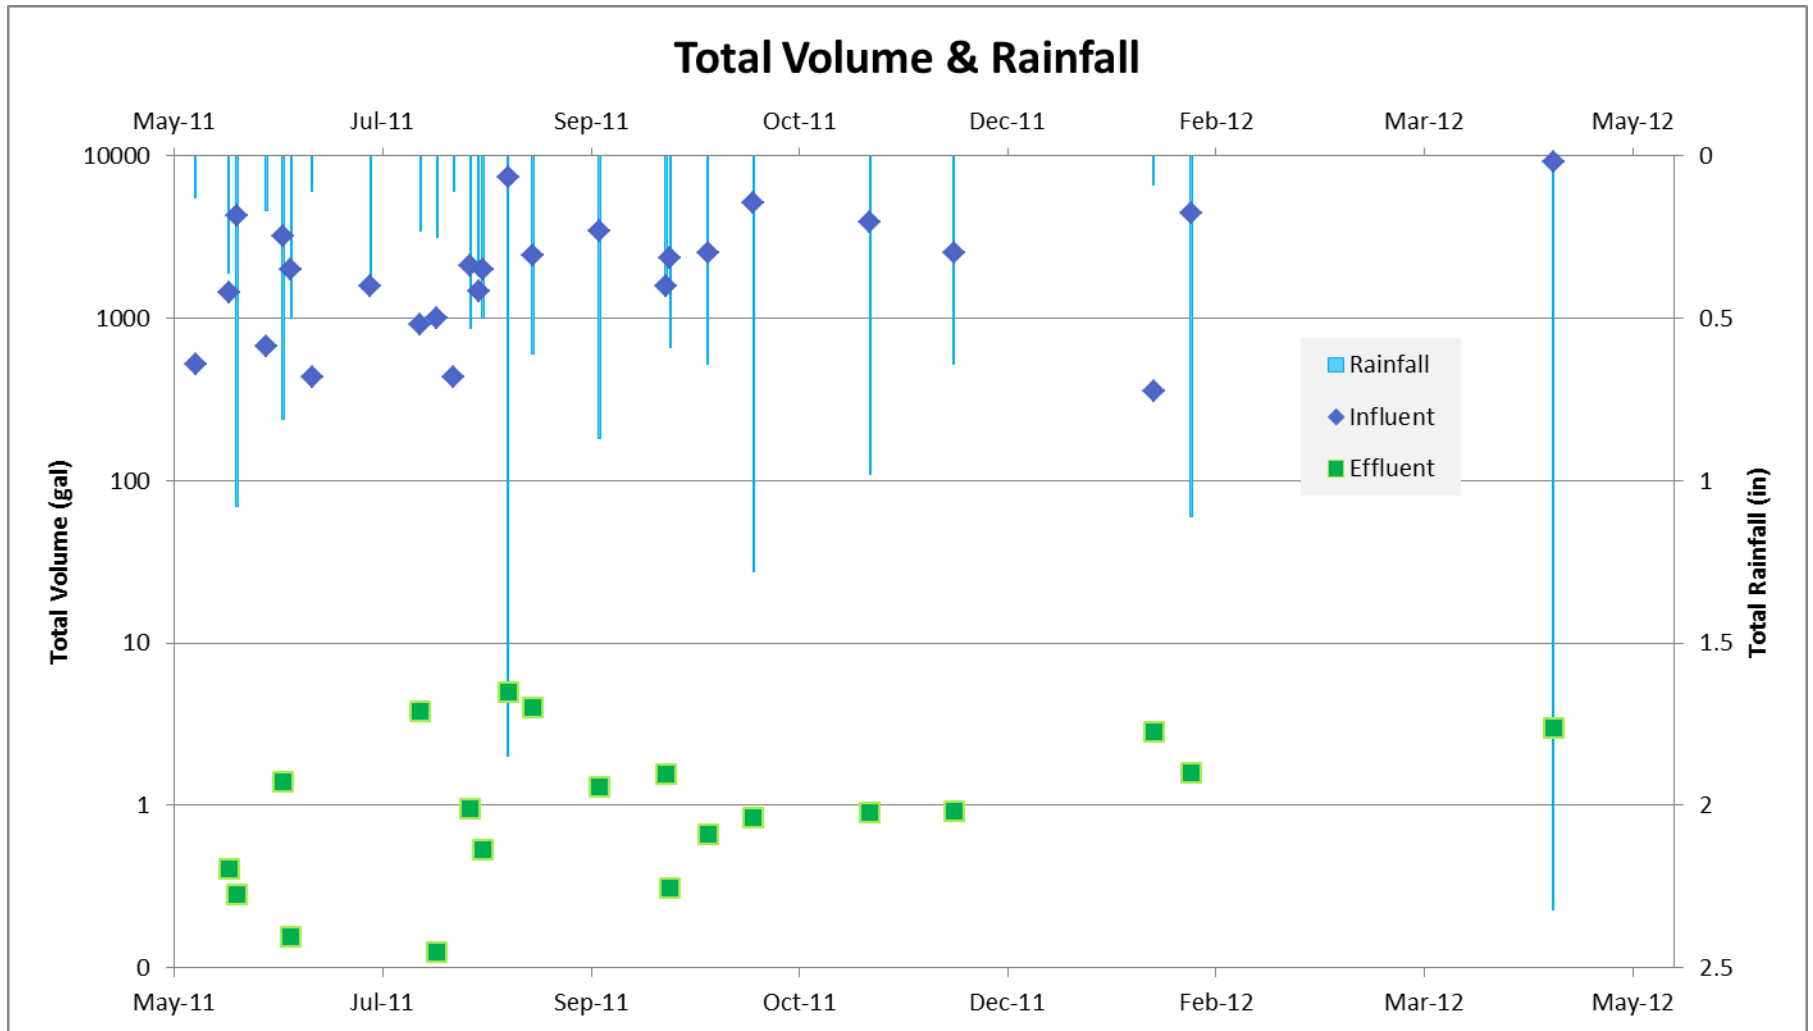
Figure 10: Total Volume of Influent and Effluent and Rainfall Depth for the Research Period of the Permeable Interlocking Concrete Pavement Treatment System.

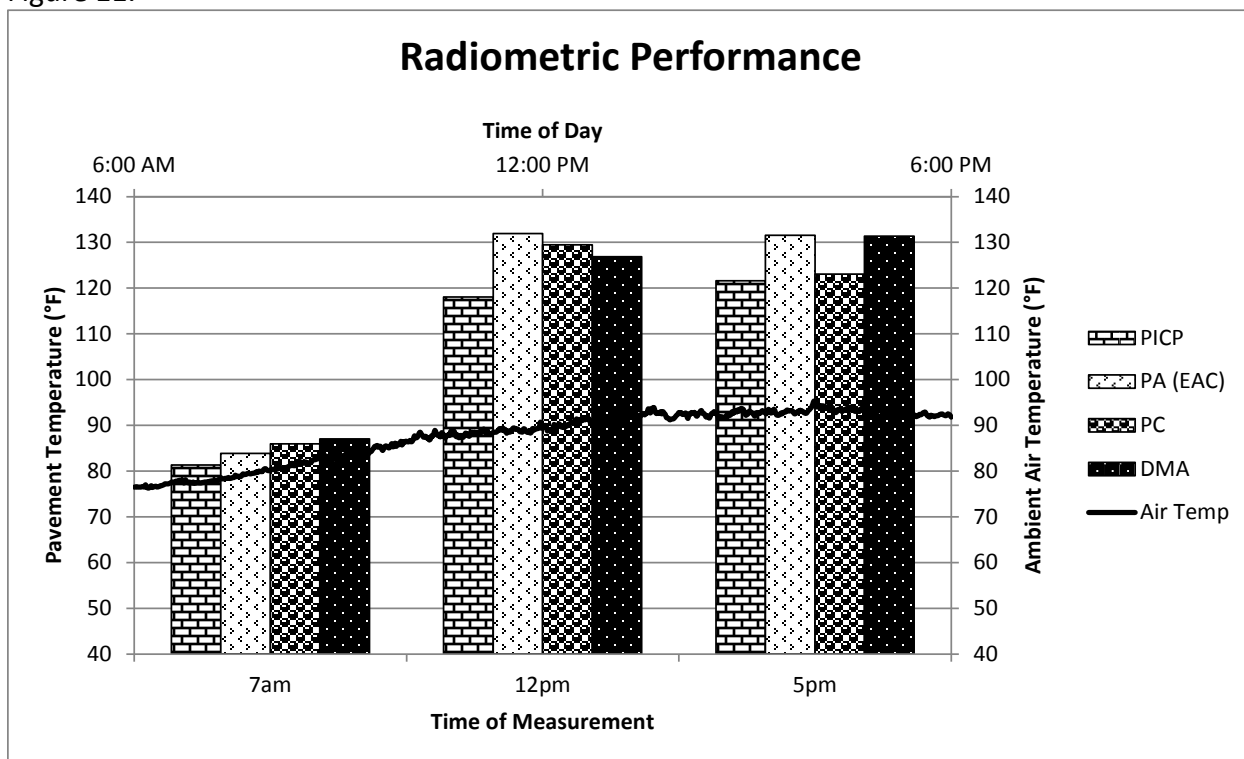
Figure 11: Thermal performance comparison of PICP, porous asphalt, pervious concrete and conventional asphalt. Measurements taken on June 21, 2012.

Thermal performance in the form of surface reflectivity was examined on June, 21, 2012 for the PICP lot in comparison with three other pavements types. Thermal performance examined the surface temperature of various pavements when exposed to direct sunlight throughout an entire summer day. Measurements were taken on each surface at 7 a.m., 12 p.m., and 5 p.m. with an infrared thermometer, Mastercool model #52224-A. The device measures near infrared or 750 to 2,500 nm wavelengths, and emissivity is set at 0.95. Pavement types selected to compare with PICP are porous asphalt, pervious concrete, and conventional asphalt. This nm range is similar to that used to determine solar reflective index or SRI. Results can be found in Figure 11.

The thermal performance of the PICP surface was compared to porous asphalt, pervious concrete, and standard dense mix asphalt on June 21, 2012. The weather was sunny all day and the measurement locations were exposed to direct sunlight throughout the study period. The average ambient air temp was 88°F. The PICP consistently remained cooler than each of the other pavement types indicating the potential for thermal buffering. Previous studies have demonstrated that that stormwater control measures like PICP that provide treatment by infiltration and filtration can moderate runoff temperatures by thermal exchange with cool subsurface materials (Roseen et al 2011). Numerous agencies and locales are beginning to consider the thermal impacts of stormwater management upon cold water streams.

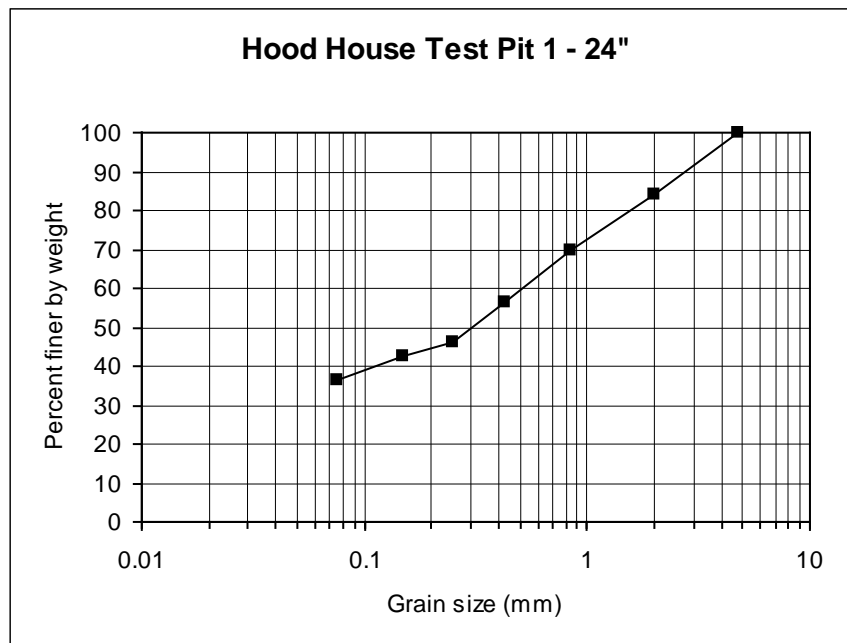
D₁₀ = < 0.075mm

D₃₀ = < 0.075mm

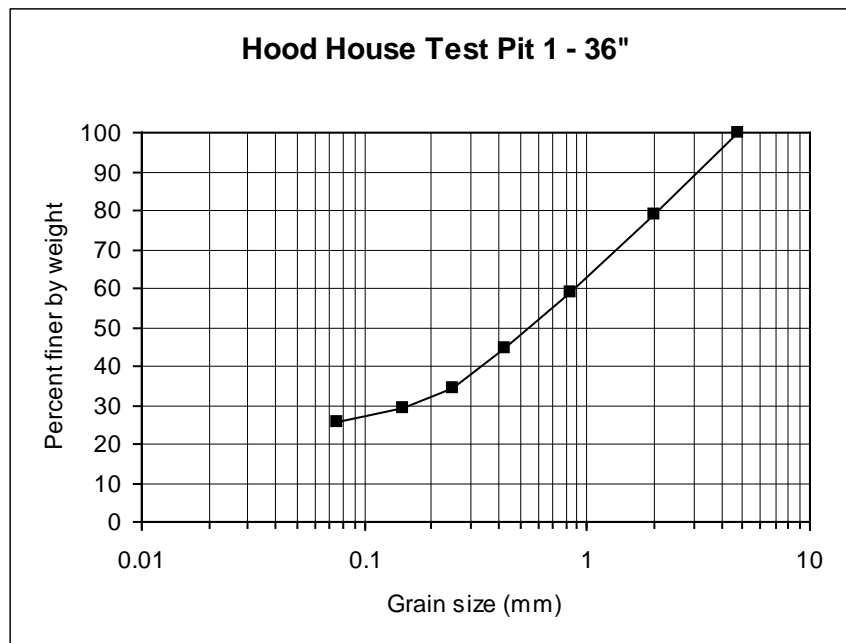
D₁₀ = < 0.075mm

D₃₀ = 0.160 mm

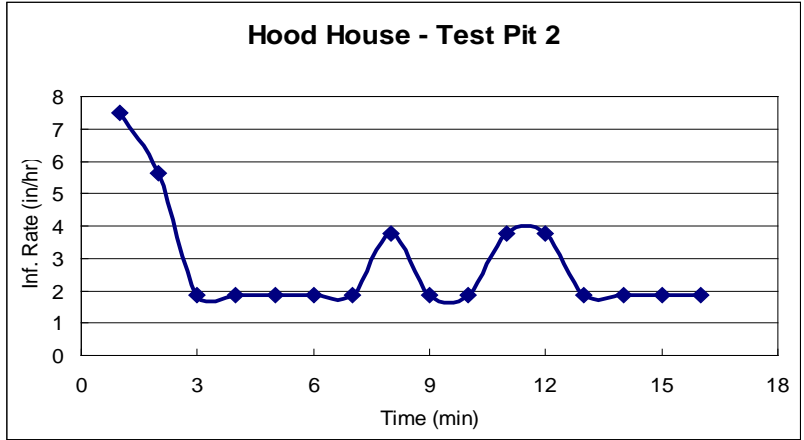
Particle Size Distribution of Soil Samples

- Soil Sample taken at 24" depth

Prior to system design and construction, subgrade soils were examined. Soils categorized as Hydrologic Soil Group (HSG) B (NEH630.07, 2007) with an average infiltration rate of 3 inches per hour. Three test pits were dug however due to ledge outcrops were discovered at two of the test locations average infiltration rate from measured at one location on Hood House Drive was used. Appendix B (page 32) details test pit investigations. Two test pits (test pit #1 and #3) were dug down to 48 inches or until ledge outcrops impeded further excavation. Appendix B contains infiltration capacity (IC) and particle size distribution (PSD) of subbase soils located under Hood House Drive. Infiltration data is only available for Test Pit #2 and was measured at an average 3 inches per hour.

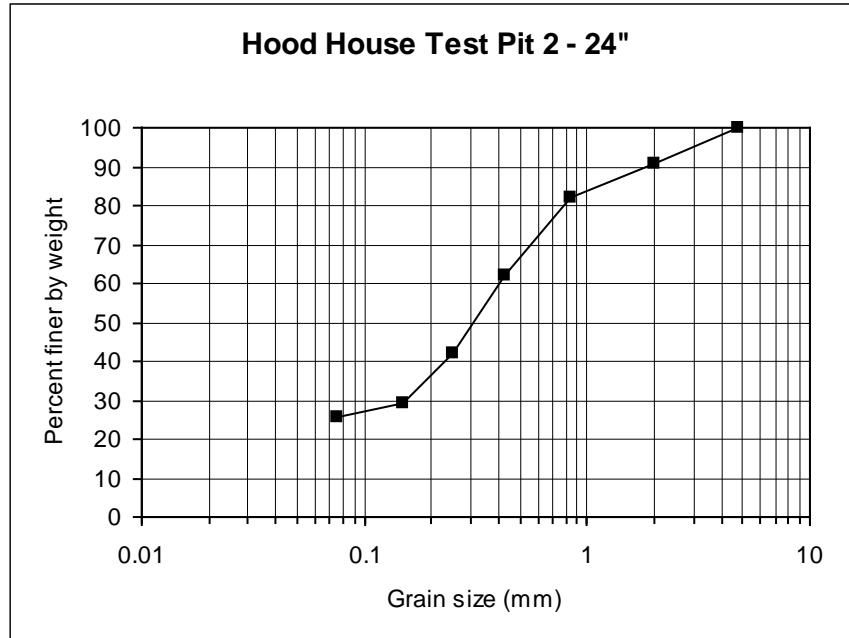
$D_{10} = < 0.075\text{mm}$
 $D_{30} = 0.160\text{ mm}$
 $D_{50} = 0.300\text{ mm}$
 $D_{60} = 0.400\text{ mm}$

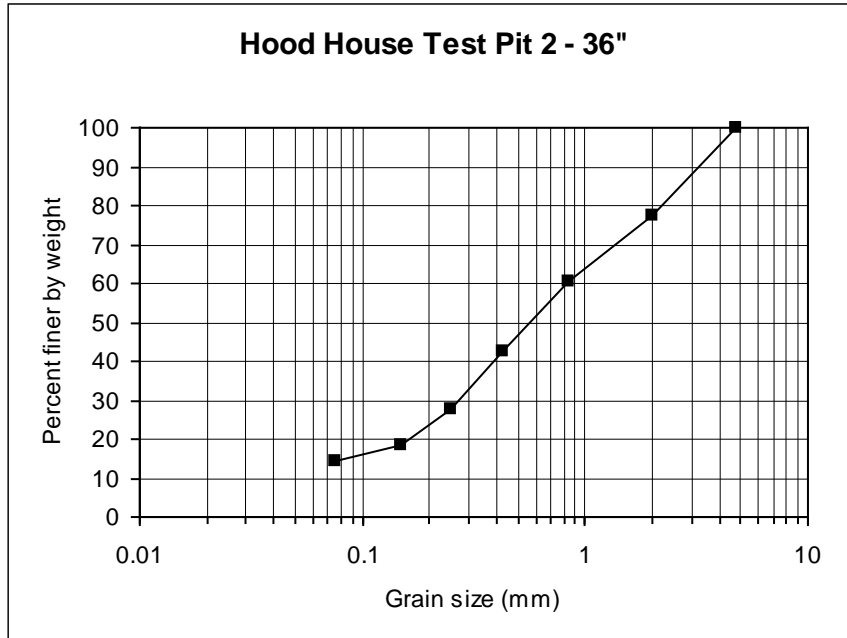
$D_{10} = < 0.075\text{mm}$

$D_{30} = 0.270 \text{ mm}$

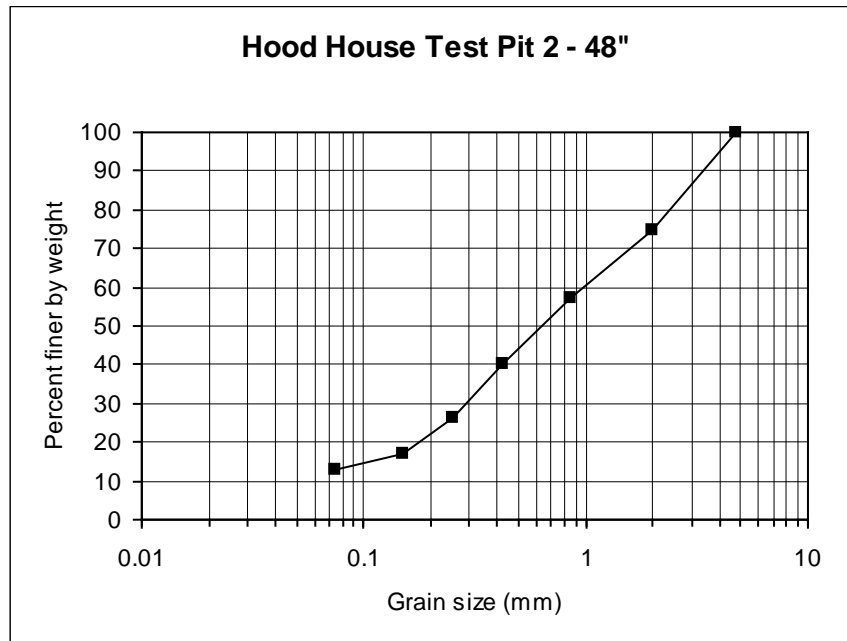
$D_{10} = < 0.075\text{mm}$
 $D_{30} = 0.290\text{ mm}$
 $D_{50} = 0.605\text{ mm}$
 $D_{60} = 0.990\text{ mm}$

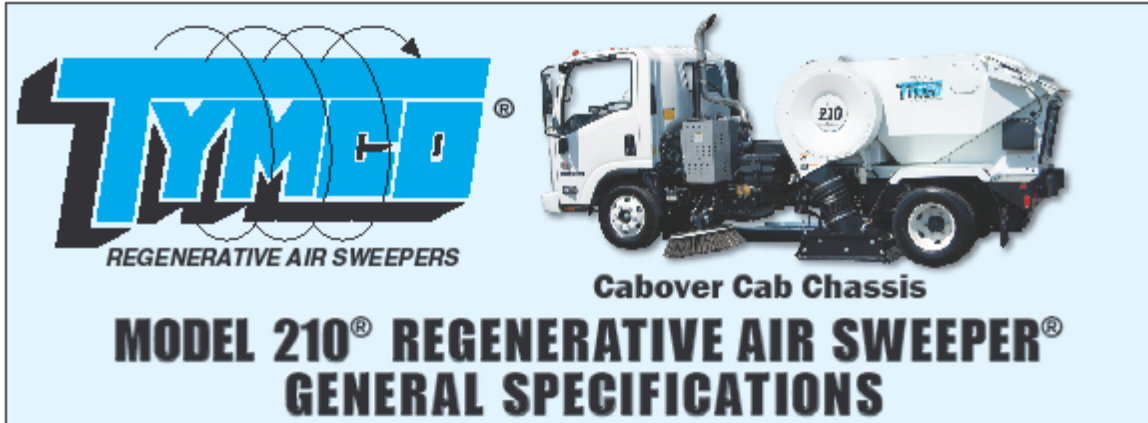
APPENDIX C: General specifications for Tymco 210 Regenerative Air Sweeper.

EngineKubota V2403MT, 4 cyl. (Tier 4)
 Displacement148.5 cubic inches (2426cc)
 Horsepower56 @ 2,600 RPM (41.7 kW)
 Net torque121 ft-lb @ 1800 RPM (164 Nm)
 Air cleaner, heavy dutyDry type
 Oil filter, spin onFull flow
 CoolingLiquid
 Auxiliary engine shutdown system
 Fuel water separator

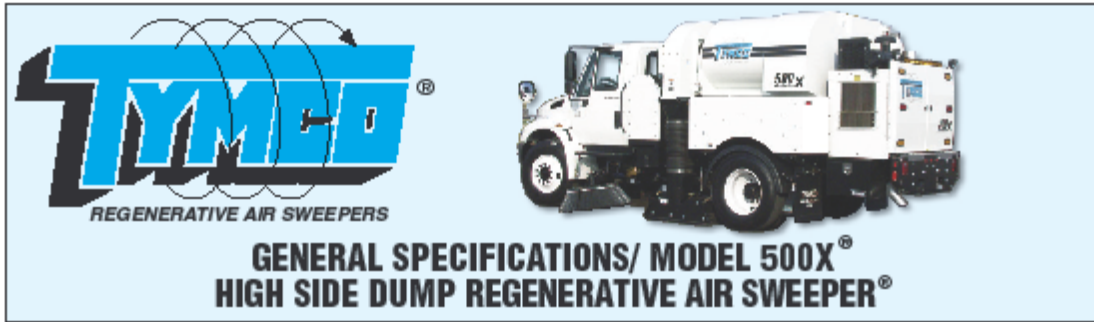
APPENDIX D: General specifications for Tymco 500X High Side Dump Regenerative Air Sweeper.

Make John Deere, 4045T, 4 cyl. (Tier 3)
Displacement 275 cubic inches (4.5 L)
Horsepower 115 @ 2,200 rpm (86 kW)
Net torque 355 ft/lbs. @ 1500 rpm (481 Nm)
Air cleaner Two stage, radial seal with safety element
Oil Filter, spin on Full flow

Volumetric Capacity 5.7 cubic yards (4.3m³)
Usable Capacity 4.0 cubic yards (3.06m³)
Construction Welded non-magnetic stainless steel plate with integral stiffeners
Floor dump angle 50°
Dump door opening 69" x 57" (1.58 cm x 1.29 cm)
Dump door Self locking
Chute 72" x 48" stainless steel lined
Chute reach 22' without side shift
Dumping direction Right side
Lifting method Two stage scissor lift, dual hydraulic cylinders with integral holding valves
Lift capacity 10,000 lbs.
Dump height Variable
Minimum 2' from bottom of chute to ground
Maximum 11' from bottom of chute to ground
Hopper screen 2 piece stainless steel screen with access for cleaning top side
Hopper drain system

A second attempt at vacuum cleaning was conducted with a Tymco 500X High Side Dump Regenerative Air Sweeper (see Appendix D, page 42, for general specifications). The machine alone was ineffective at removing packed debris from between the pavers in these areas of concern. The use of a leaf blower and pressure washer helped to dislodge some of the upper layer of debris, but more was packed underneath. In areas that were not clogged the No. 8 joint stones had settled approximately 1 inch. In these areas debris such as cigarette butts, sticks, and trash were observed lodged in the paver joints. With the stones at this depth the Tymco could dislodge more of the stones, but did not pull many directly into the hopper. Some of the stones were seen bouncing away from the vacuum head as the Tymco passed over the

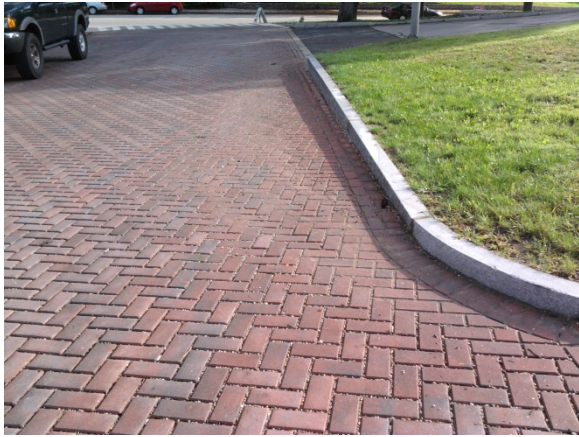
Figure 12: Run on from an intersecting pedestrian walkway.

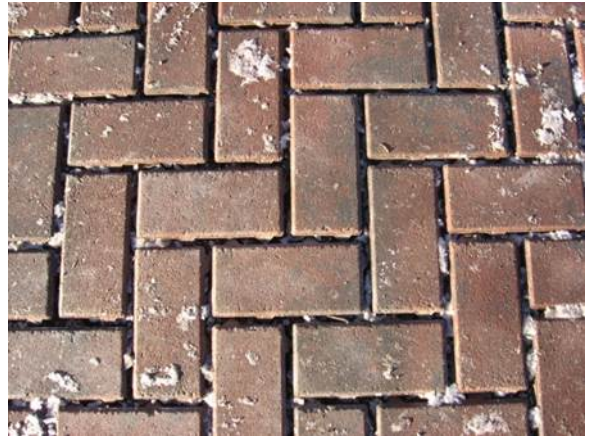
Figure 15: No. 8 joint stone has settled approximately 1 inch.

pavement. It was also evident that many of the pavers were loose and could be wobbled by foot. Winter plowing and freeze-thaw did not dislodge any of the pavers. In August 2011, additional No. 8 joint stone was used to fill in the seams. This proved to stabilize the loose pavers and no further settling was observed through the monitoring period. Photo documentation of various conditions is provided in Appendix E. An operation and maintenance procedure for PICP placements is an area of acute interest for additional research.

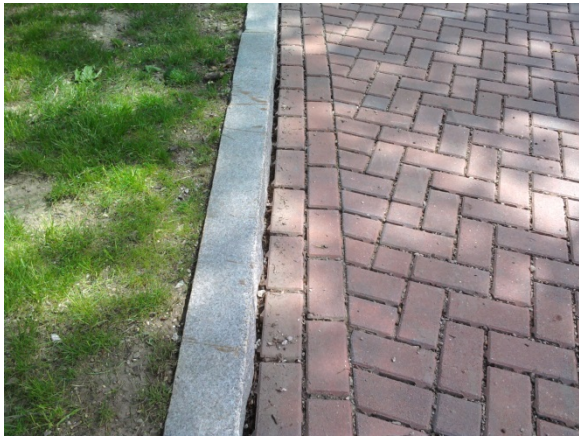
Figure 13: Loss of No. 8 stone along curb line due to erosion and cleaning.

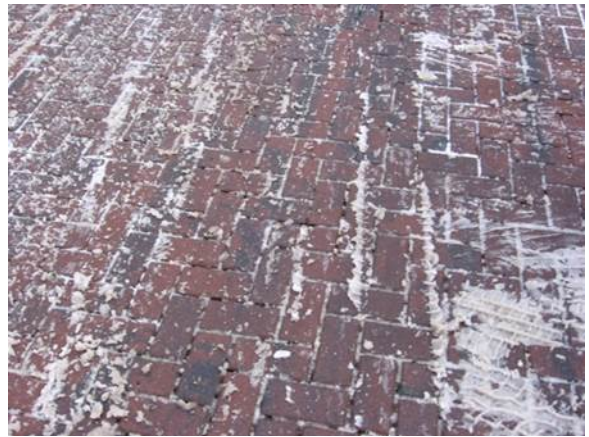
Figure 16: Snow cover after plowing but before sun begins to warm up pavement.

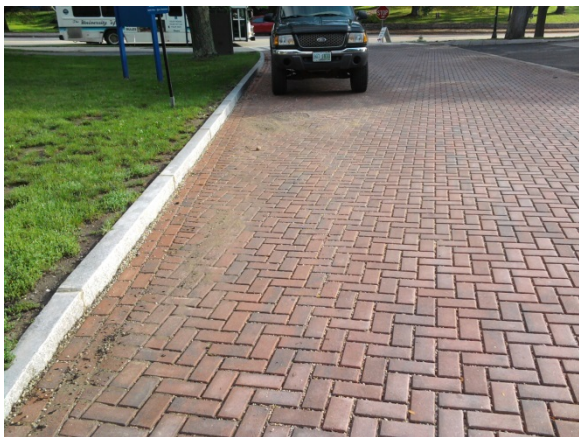
Figure 14: Another area of run on from an intersecting pedestrian walkway.

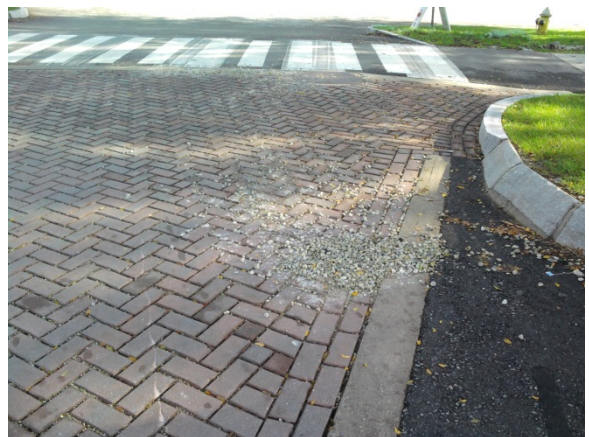
Figure 17: Run on from intersecting MUB drive.

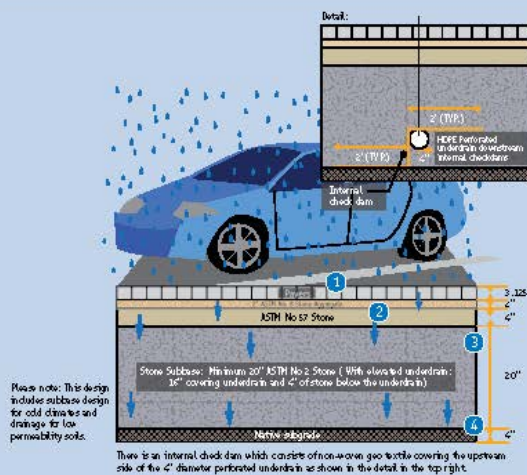
WATER QUALITY TREATMENT PROCESS

1. Rainfall infiltrates into the paver joints that are filled with clean aggregate (ASTM No. 8 stone) into the bedding course (ASTM No. 8).
2. Stormwater drains through the bedding course, through the open-graded base (ASTM No. 57 stone), and into the stone subbase reservoir (ASTM No.2 stone). Through these layers the physical process of filtration provides treatment of the stormwater runoff.
3. Installed in the stone subbase are perforated underdrains placed 4 inches above the native soils which provides retention and infiltration. Internal check dams constructed of an impermeable liner are installed for every 12" drop of elevation to provide storage on a sloped grade.
4. Excess water flows through the elevated underdrains to the municipal storm sewers or receiving water.
