RR 13-35 | August 2013

## TESTING OF WIDE-GAP WELDS AT EASTERN MEGA SITE

In 2005, Transportation Technology Center, Inc. (TTCI) and Norfolk Southern Railway (NS) began a test of wide-gap welds (WGWs) at the eastern mega site near Bluefield, WV.

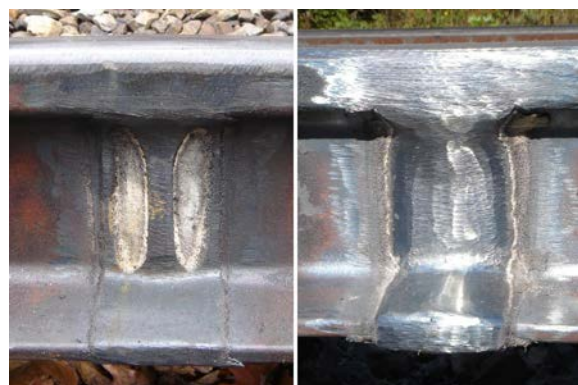
Figure 1. WGWs—Railtech Boutet (left); Orgo-Thermit (right)

Two types of WGWs were installed adjacent to a high strength rail test: 16 Orgo-Thermit welds in 2005 and 16 Railtech Boutet welds in 2006 (see Figure 1). The WGWs have accumulated 355 and 300 million gross tons (MGT) of traffic, respectively. The following are the main findings from this test:

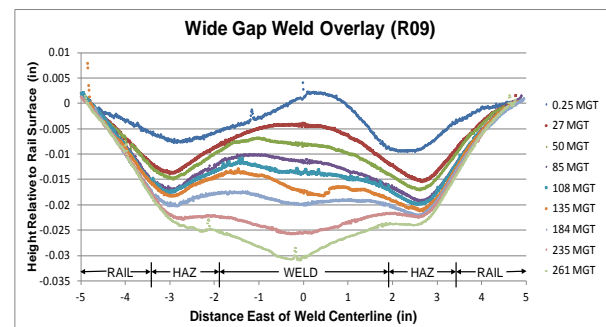
Measurements of weld profiles and hardness showed trends consistent with those observed for standard thermite welds. Figure 2 shows longitudinal running surface profiles for one WGW measured at different MGT levels. The softer heat-affected zones (HAZ) quickly battered under HAL, but the rate of batter slowed in comparison with the rate of batter for the adjacent zones. (Batter is metal deformation and flow at the running surface resulting from high wheel-rail forces.) By contrast, the center of the weld experienced a steady batter rate resulting from wheel impacts as they traversed the HAZ.

Figure 2. Weld Profile Degradation—Primary Direction of Loaded Traffic is Left to Right

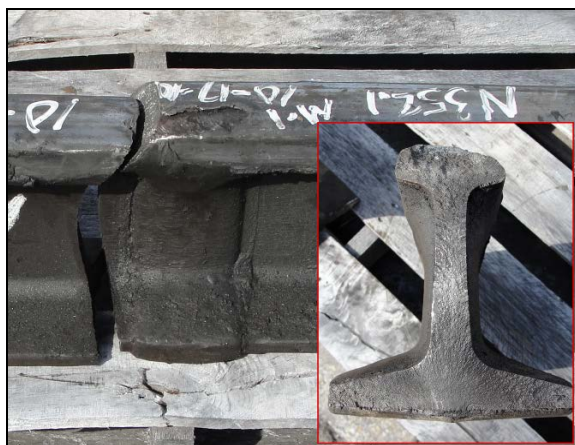
Figure 3 shows the weld that was removed due to base fatigue that occurred approximately 2 months after it developed a shell on the running surface. Figure 4 shows the two welds with internal gas-hole defects after removal and cross-sectional examination.

**Figure 3. WGW O6 with Shelling on Gage Corner and Fatigue Fracture from Base of Weld—Inset Shows Fracture Face—Fatigue Initiated at Runout at Base of Weld**

Two Orgo-Thermit WGWs were removed. One weld experienced a fatigue fracture that initiated at flashing under the base. The fracture occurred shortly after the weld developed a shell on the gage corner. The second weld was removed when inspection revealed a similar gage corner shell.

Weld ID	Reason Removed	Defect	Date	MGT
WGW R4	Ultrasonic Indication	Gas Hole in Web	10/2006	0
WGW R12	Ultrasonic Indication	Gas Hole in Web	10/12/2010	209
WGW O6	Service Failure	Runout, Bottom Base	10/17/2010	265
WGW O3	Surface Condition	Shelling of Gage Corner	11/2011	321

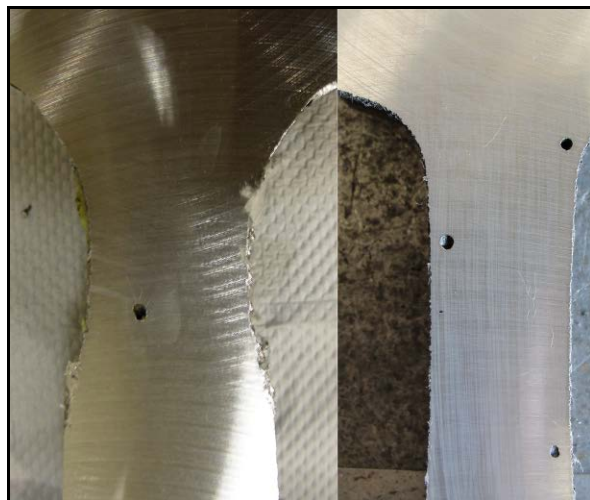
**Figure 4. Gas Holes in Railtech Welds R4 (left) and R12 (right)**

Two Railtech Boutet WGWs were removed because of internal porosity defects detected by ultrasonic inspection. The first defect was found upon installation, and the weld was replaced. The second defect was found after 209 MGT, and the weld was removed from the test.
