POST WELD AND EPOXY ANCHORAGE VARIATIONS FOR W-BEAM GUARDRAIL ATTACHED TO LOW-FILL CULVERTS

MIDWEST ROADSIDE SAFETY FACILITY

MwRSF Research Report No. TRP-03-278-13

August 12, 2013

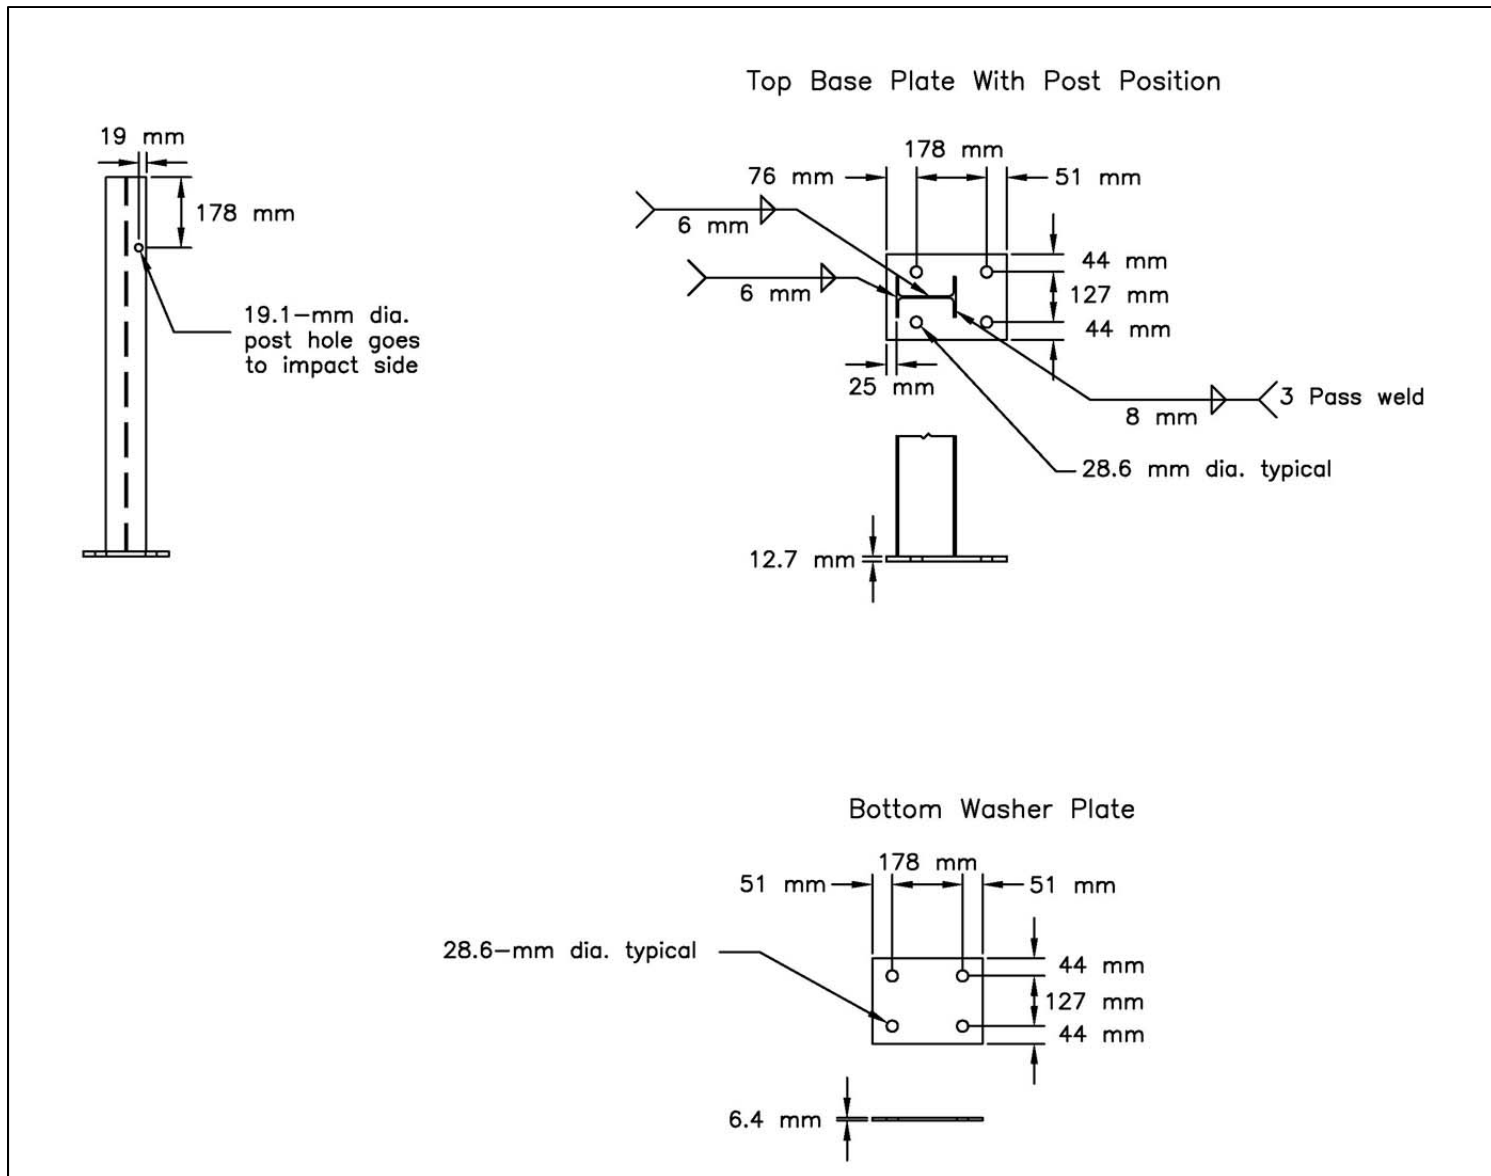
Figure 2. Original System Post and Weld Details [1]

W-beam guardrail systems often span across reinforced concrete box culverts in order to prevent motorists from encountering hazardous conditions near the openings. For low-fill culverts of widths exceeding the maximum unsupported length of long-span systems, a few W-beam guardrail designs are available for direct attachment to the top culvert slab. One such guardrail system was developed in 2002 by the Midwest Roadside Safety Facility (MwRSF) [1]. This system utilized a ½-in. (13-mm) thick steel plate welded to the bottom of each guardrail post with a 5/16-in. (8-mm) three-pass fillet weld on the front (tension) flange and a ¼-in. (6-mm) fillet weld on the web and back (compression) flange. The post assembly was anchored to the culvert slab using four 1-in. (25-mm) diameter through bolts. Finally, the back-side of the post was offset 18 in. (457 mm) from the inside of the culvert headwall to prevent interaction between the posts and the rigid headwall as the system deflects during an impact event. This system was successfully developed and full-scale crash tested according to the Test Level 3 (TL-3) safety performance guidelines found in National Cooperative Highway Research Program (NCHRP) Report No. 350 [2]. Drawings for this system are shown in Figures 1 and 2.

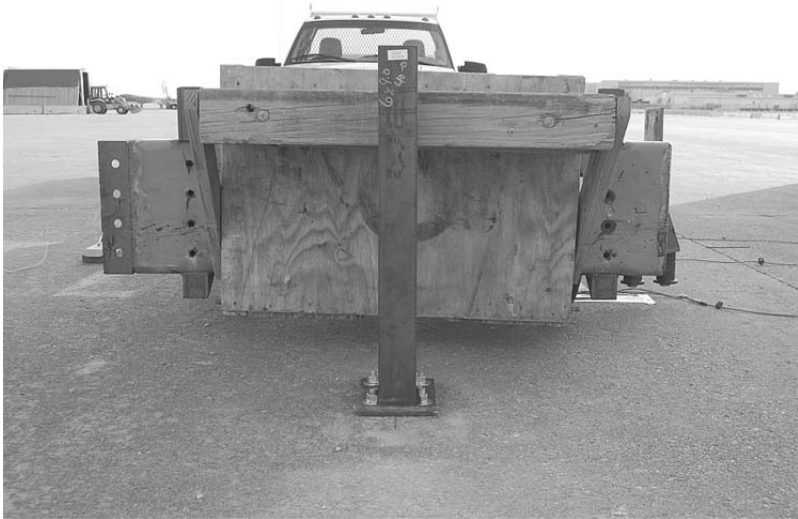
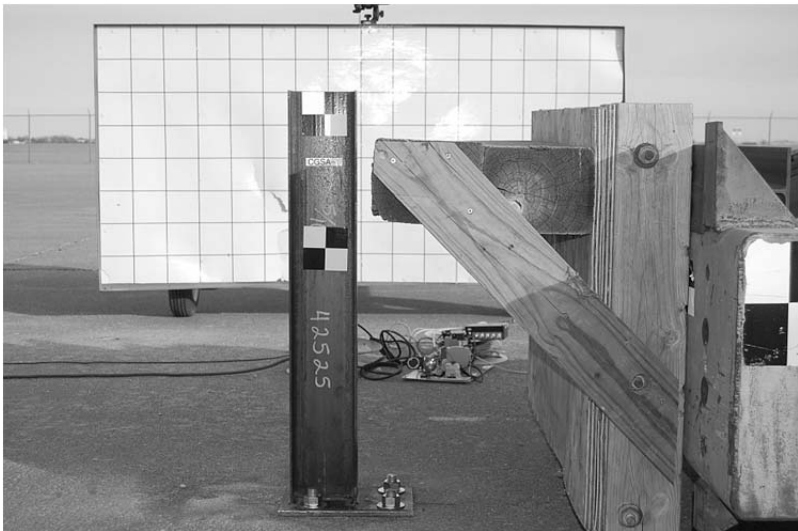
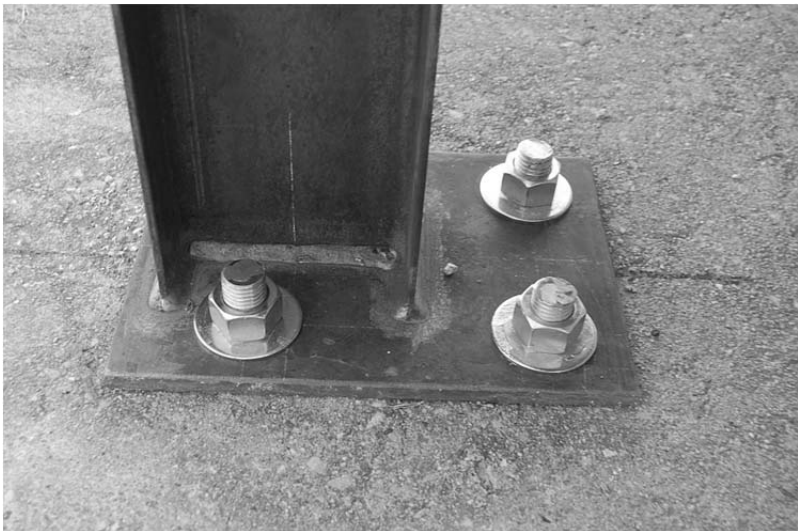
Figure 10. Pre-test Installation Photographs

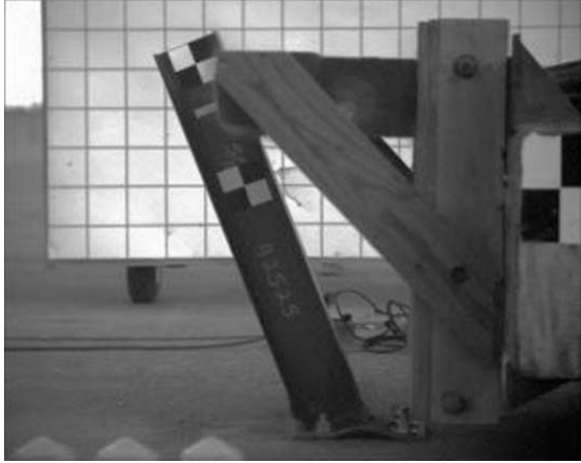
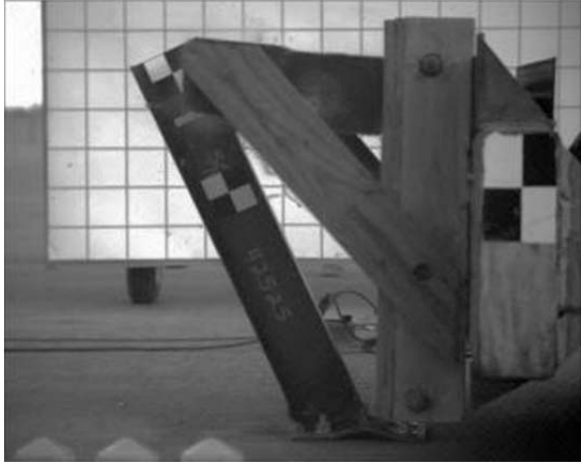
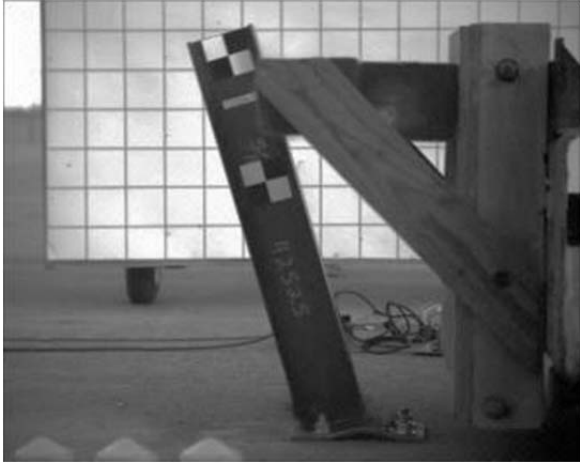
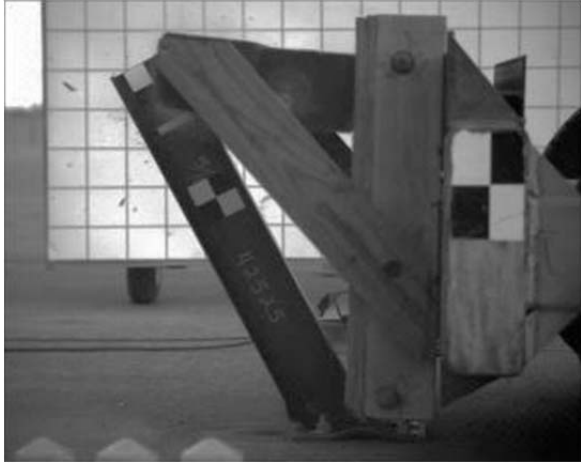
Figure 13. Time-Sequential Photographs, Test No. CGSA-1

Force vs. deflection and energy vs. deflection curves were created from the DTS accelerometer data, as shown in Figure 12. Early in the impact event, a maximum resistance of 18.1 kips (80.5 kN) was recorded at 4.7 in. (119 mm) of deflection. Video analysis confirmed this peak force corresponded to the time just prior to the plate beginning to tear, or 0.034 seconds after impact. After the onset of tearing, the resistance force decreased and remained relatively constant. At the maximum deflection of 21.7 in. (551 mm), the post assembly had absorbed 191.7 k-in. (21.7 kJ) of energy. Time-sequential and post-impact photographs are shown in Figures 13 through 15.

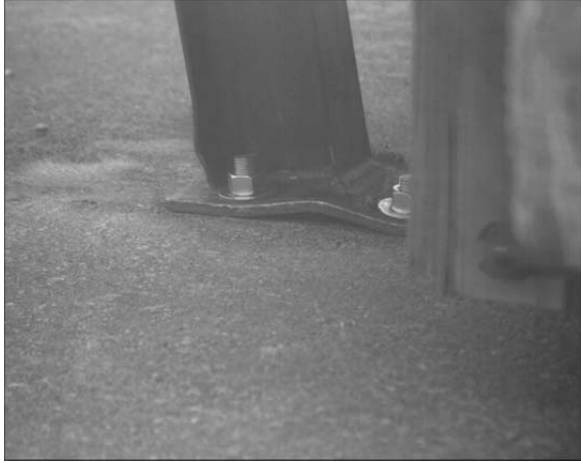
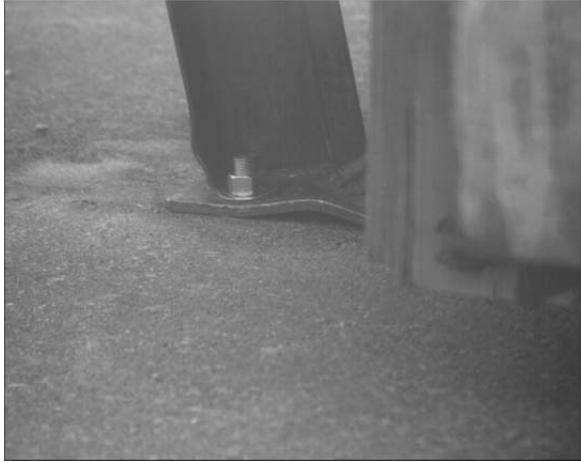
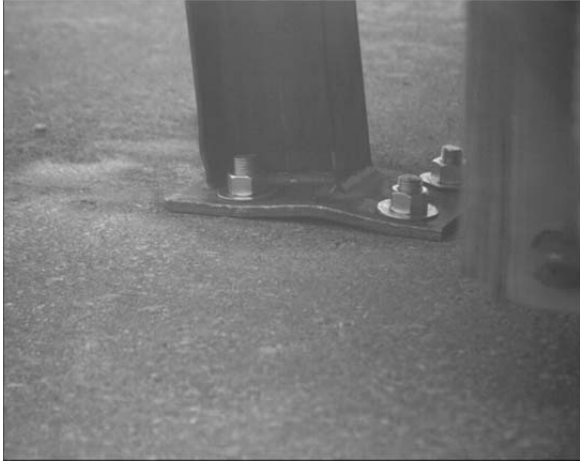
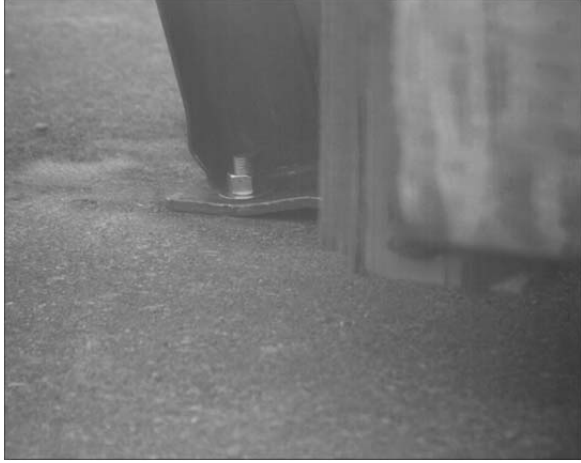
Figure 14. Time-Sequential Photographs, Test No. CGSA-1

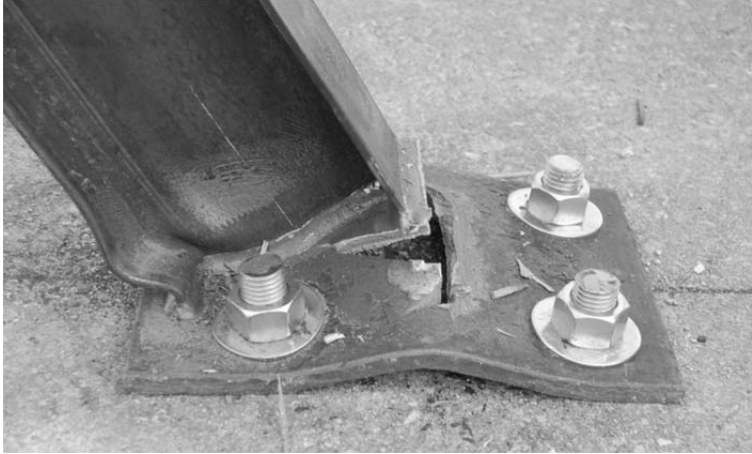
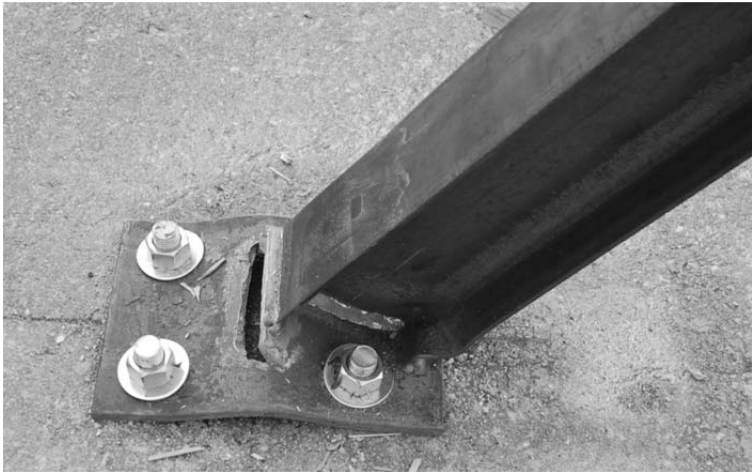
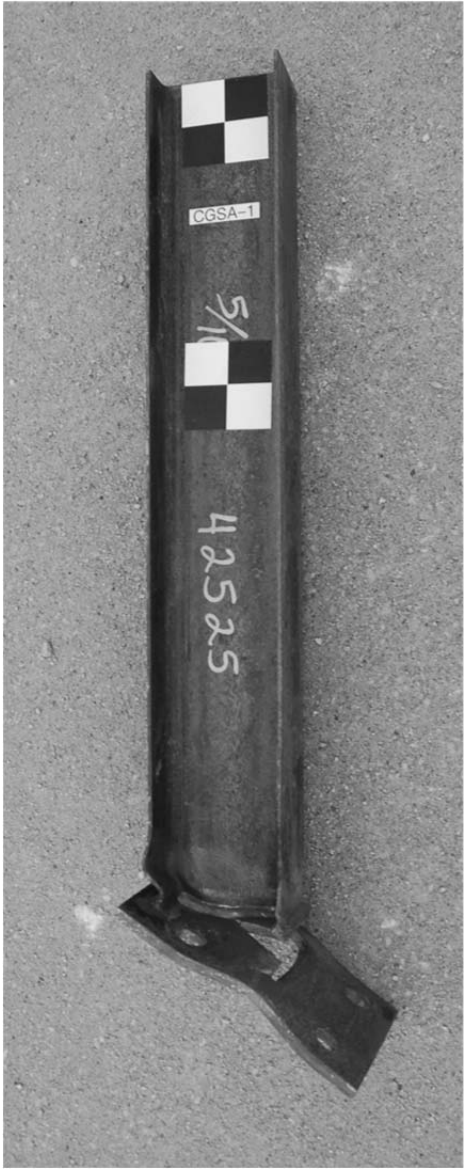
Figure 15. Post-Impact Photographs, Test No. CGSA-1

For test no. CGSA-1, the post was connected to the base plate using a $\frac{5}{16}$ -in. (8-mm) fillet weld all around the base of the post. To anchor the post assembly, four 1-in. (25-mm) diameter threaded rods were epoxied into the tarmac with an embedment depth of 12 in. (305 mm). During test no. CGSA-1, the bogie impacted the post at a speed of 9.8 mph (15.8 km/h). As a result, the post rotated backward, and the bogie was eventually brought to a stop at a displacement of 21.7 in. (546 mm) as determined from the DTS data. Post-test inspection revealed that both the back flange and the web of the post had buckled and the base plate was bent upward. Although the weld held, the plate was torn adjacent to the weld on the front flange, and the tearing extended around the flange and 1 in. (25 mm) toward the back of the plate on both sides.

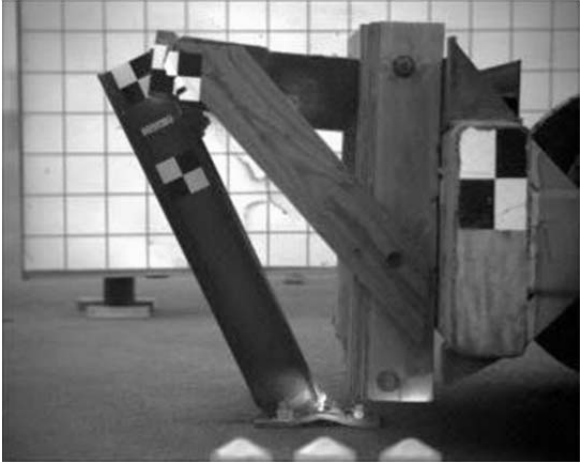
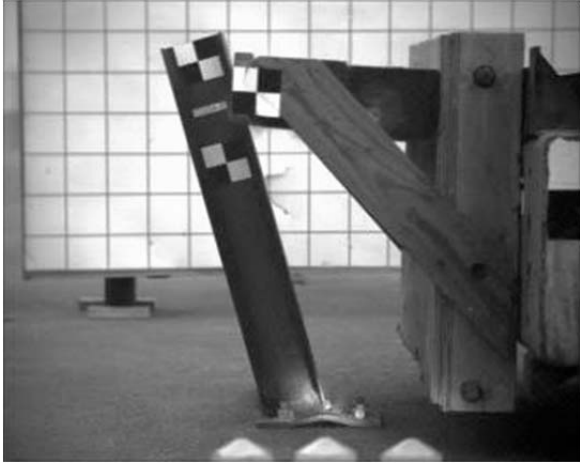
Figure 17. Time-Sequential Photographs, Test No. CGSA-2

Force vs. deflection and energy vs. deflection curves were created from the DTS accelerometer data, as shown in Figure 16. Early in the impact event, a maximum force of 13.8 kips (61.4 kN) was recorded at a deflection of 5.0 in. (127 mm). Video analysis confirmed this peak force occurred just prior to the onset of plate tearing, or 0.030 seconds after impact. Once tearing began, the resistance force decreased and remained relatively constant. At a maximum deflection of 23.2 in. (589 mm), the post assembly had absorbed 183.2 k-in. (20.7 kJ) of energy. Time-sequential and post-impact photographs are shown in Figures 17 through 19.

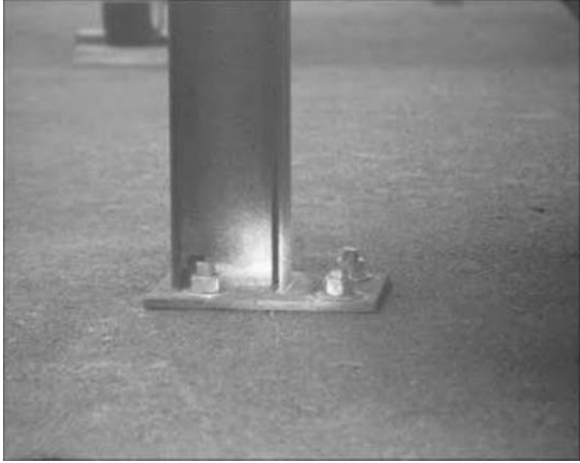
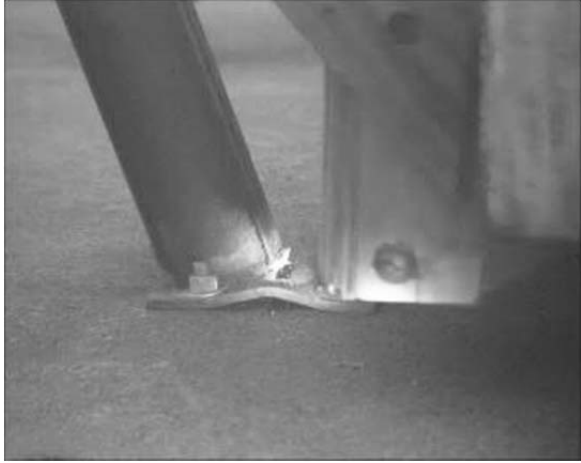
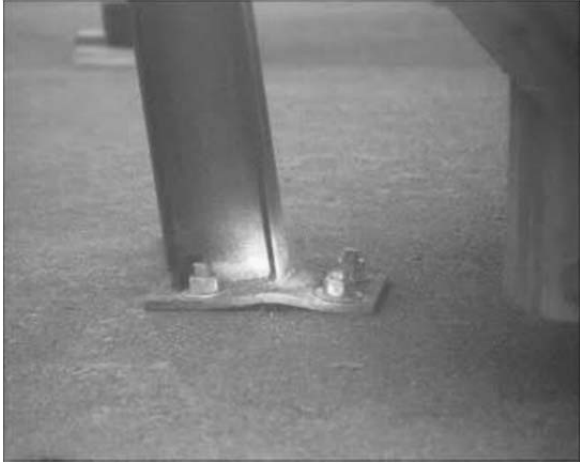
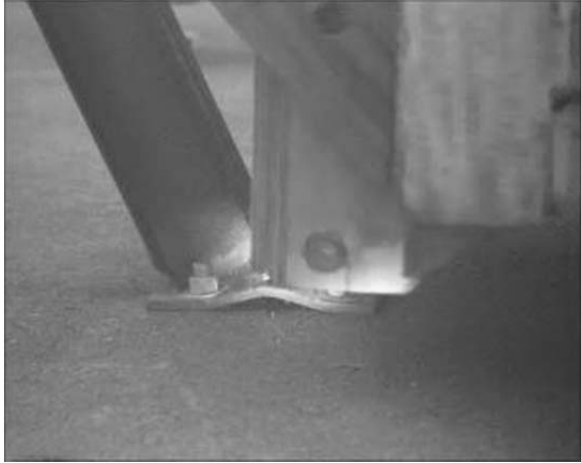
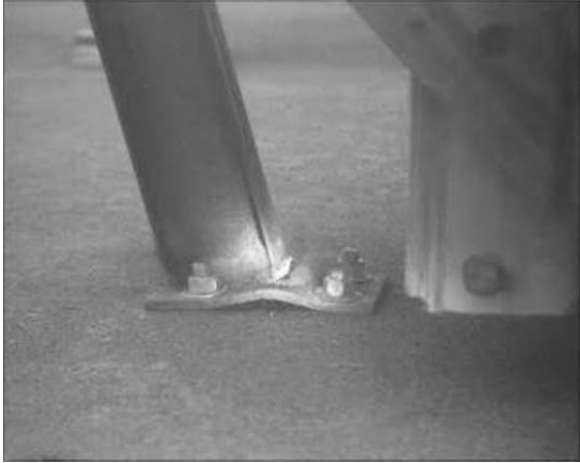
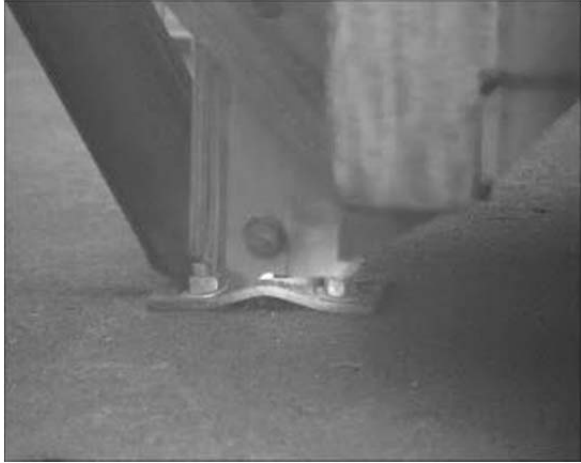
Figure 18. Time-Sequential Photographs, Test No. CGSA-2

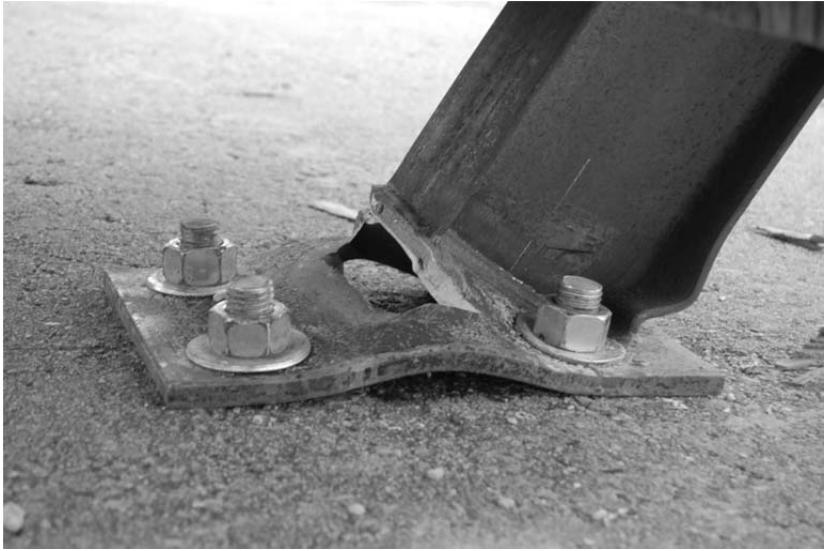
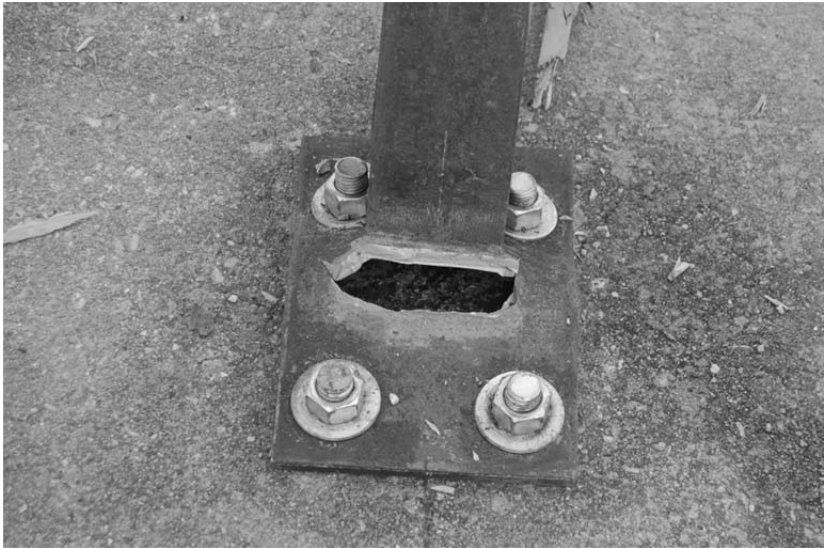
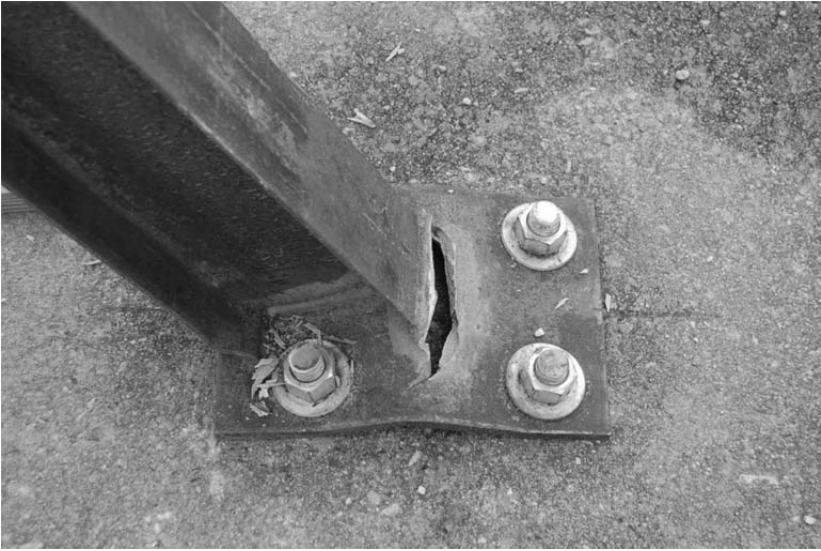
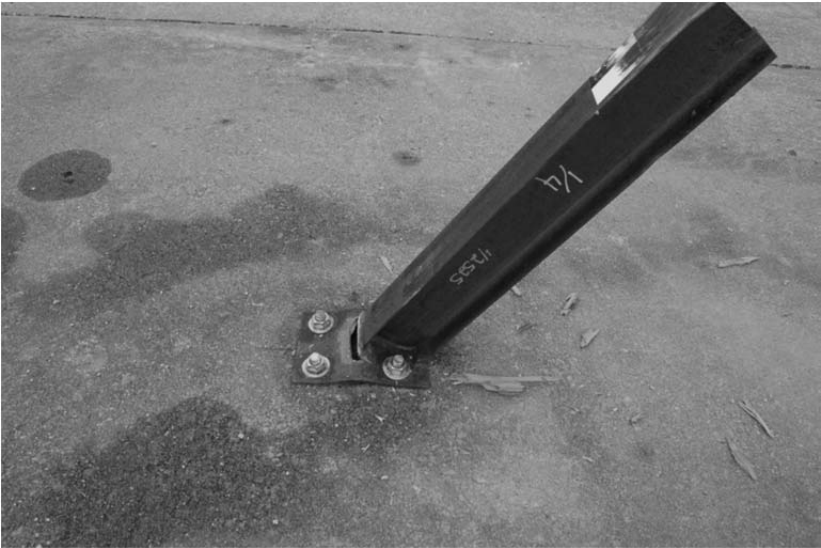
Figure 19. Post-Impact Photographs, Test No. CGSA-2

For test no. CGSA-2, the post was connected to the base plate using a ¼-in. (6-mm) fillet weld all around the base of the post. To anchor the post assembly, four 1-in. (25-mm) diameter threaded rods were epoxied into the tarmac with an embedment depth of 12 in. (305 mm). During test no. CGSA-2, the bogie impacted the post at a speed of 9.6 mph (15.4 km/h). As a result, the post rotated backward, and the bogie eventually overrode the top of the post at a displacement of 23.2 in. (589 mm) as determined from the DTS data. Post-test examination revealed failure modes similar to test no. CGSA-1. The back flange of the post had buckled, and the plate was torn adjacent to the front flange weld and continued approximately ¾ in. (19 mm) backward on each side.

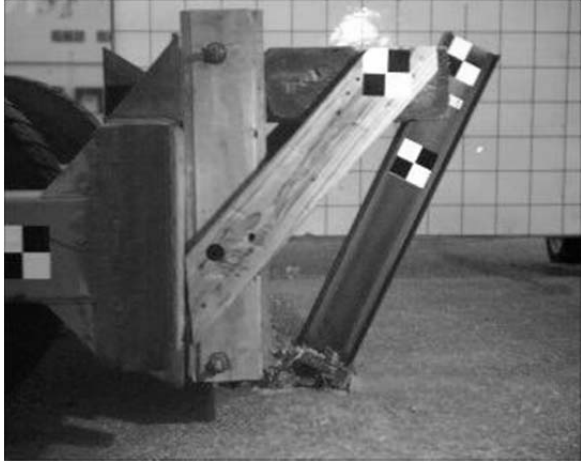
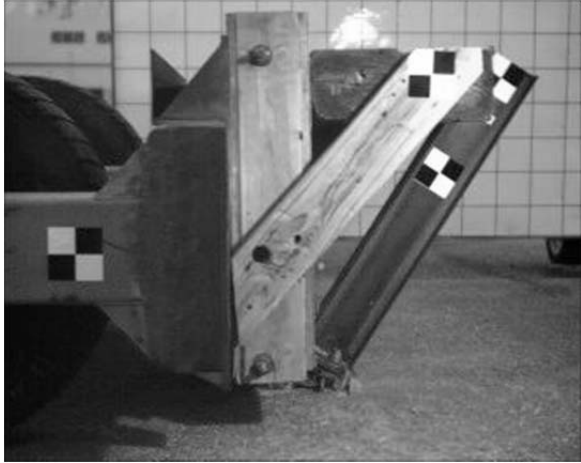
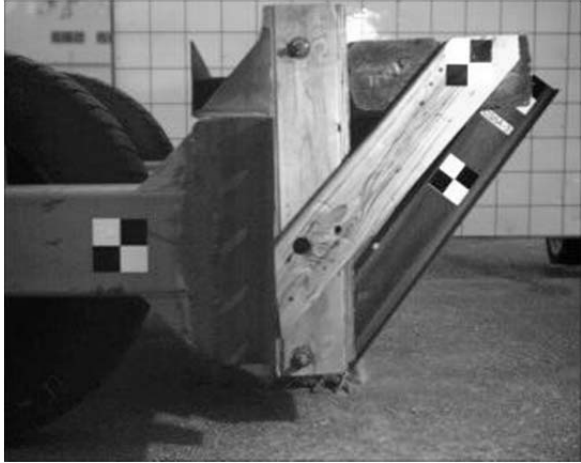
Figure 21. Time-Sequential Photographs, Test No. CGSA-3

Force vs. deflection and energy vs. deflection curves were created from the DTS accelerometer data, as shown in Figure 20. Note, the curves only show the interaction forces and energies related to the primary impact. The plotted data was extracted prior to the secondary impact between the bottom of the bogie head and the base of the post. Early in the test, peak forces of 16.0 kips and 13.0 kips (71.2 kN and 57.8 kN) were recorded. Once the anchorage failed at approximately 5 in. (127 mm) of deflection, the resistance force decreased quickly and was nearly zero when the base of bogie impacted the post at 15.1 in. (384 mm) of deflection. Prior to this secondary impact, the assembly had absorbed 80.4 k-in. (9.1 kJ) of energy. Time-sequential and post-impact photographs are shown in Figures 21 through 23.

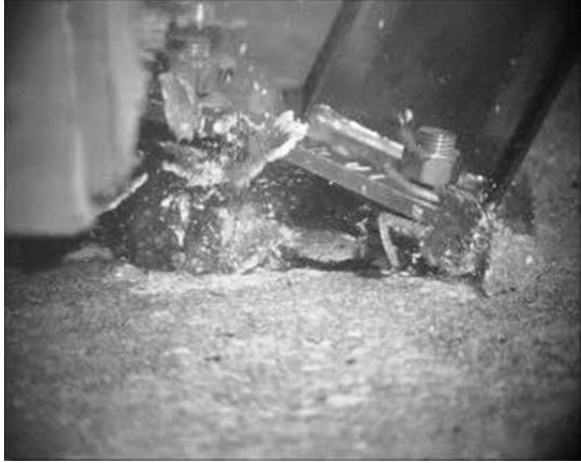
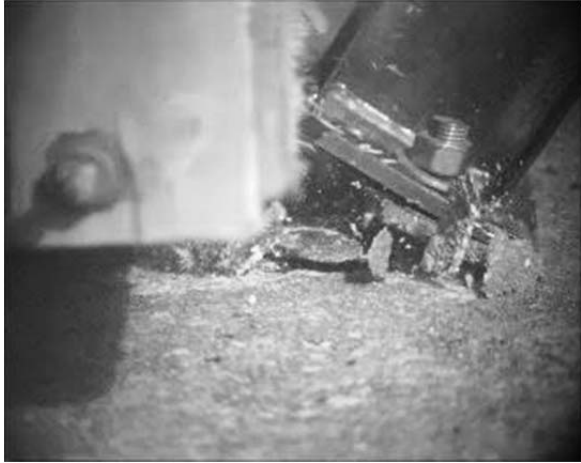
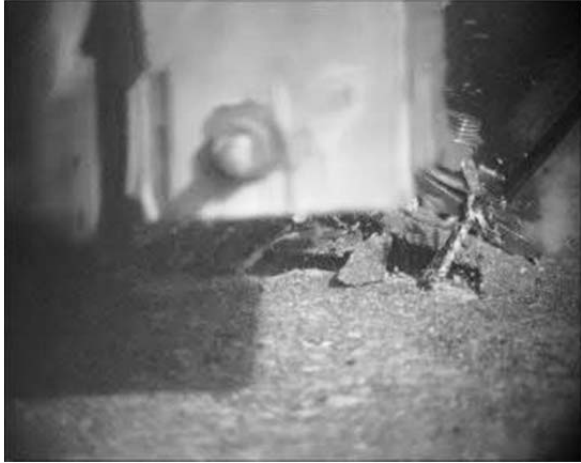
Figure 22. Time-Sequential Photographs, Test No. CGSA-3

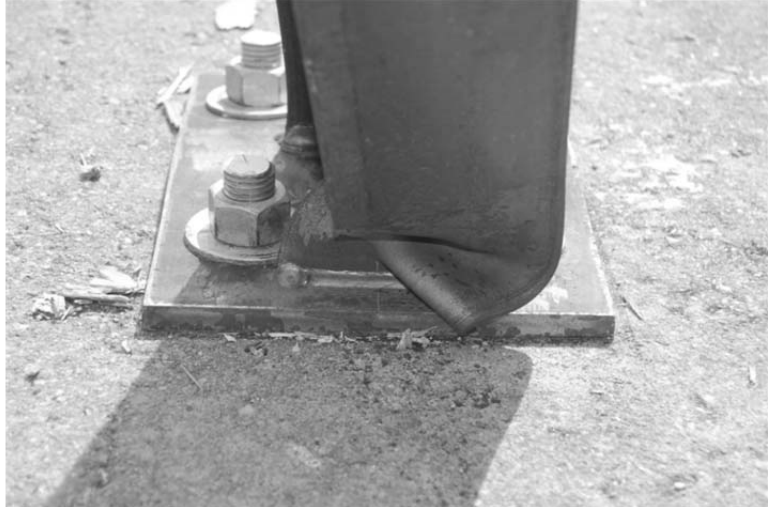
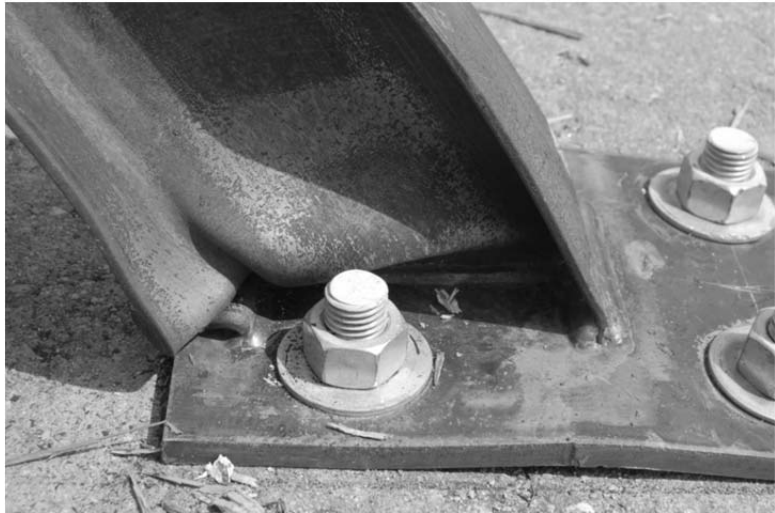
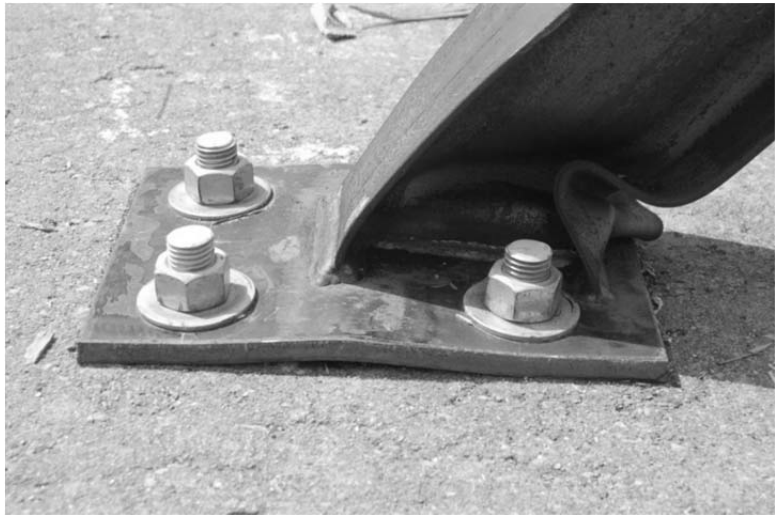
Figure 27. Post-Impact Photographs, Test No. CGSA-4

For test no. CGSA-4, the post was connected to the base plate using a 3-pass, $\frac{5}{16}$ -in. (8-mm) fillet weld on the front flange and a single-pass $\frac{1}{4}$ -in. (6-mm) fillet weld on the web and back flange. To anchor the post assembly, four 1-in. (25-mm) diameter threaded rods were epoxied into the tarmac with an embedment depth of 8 in. (203 mm). During test no. CGSA-4, the bogie impacted the post at a speed of 11.6 mph (18.7 km/h). As a result, the post bent backward, and the bogie eventually overrode the top of the post at a displacement of 20.3 in. (516 mm) as determined from the DTS-SLICE data. Post-test examination revealed buckling of the back flange and web of the post along with bending of the base plate. No evidence of plate tearing or weld failure was present.

Force vs. deflection and energy vs. deflection curves were created from the DTS-SLICE accelerometer data, as shown in Figure 24. Early in the test, multiple force spikes of around 20 kips (89 kN) were recorded within the first 6 in. (152 mm) of deflection. The resistance force then steadily declined until the bogie overrode the post at a deflection of 20.3 in. (516 mm). The post assembly absorbed a total of 189.7 k-in. (21.4 kJ) of energy. Time-sequential and post-impact photographs are shown in Figures 25 through 27.
