Test and Evaluation Report

Laboratory Testing of Precast Paving Notch System

February 25, 2008

**Iowa Department
of Transportation**

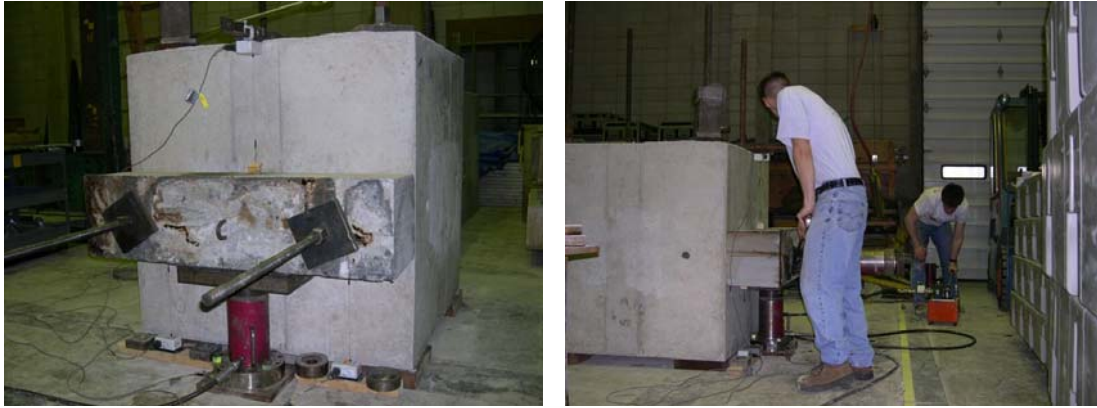
(a) Assembled precast paving notch system (b) Application of PT force
Figure 2. Photographs of the assembled precast paving notch system and the application of PT force.

The first phase of testing was intended to investigate the post-tensioning (PT) force needed to prevent slip of the paving notch system (i.e., friction force between the abutment and the paving notch specimen) without using an adhesive. Assembly of the paving notch system involved attaching the paving notch specimen to the abutment block with 1 in. diameter Dywidag threaded rods – 127.5-kip ultimate strength capacity [1] – spaced at 3 ft on centers. After placement of the paving notch specimen to the abutment, the paving notch system was post-tensioned using a compact lightweight hydraulic jack containing a socket wrench and ratchet device that allows the nut to be tightened as the rod elongates. The paving notch system was instrumented with three displacement transducers: one transducer on top surface of the paving notch specimen directly above the load point and two transducers on the bottom surface of the paving notch specimen directly below the Dywidag threaded rods. Photographs of the assembled precast paving notch system instrumented with displacement transducers and the application of PT force are presented in Fig. 2.

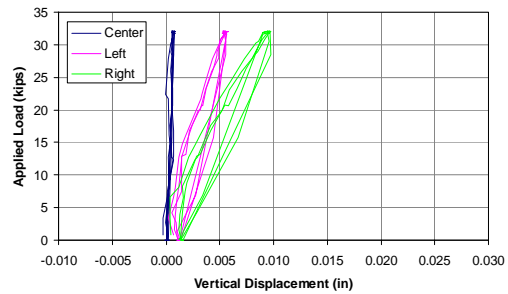
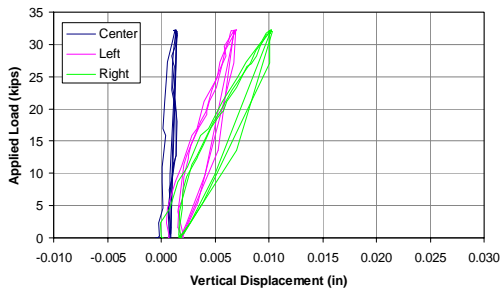
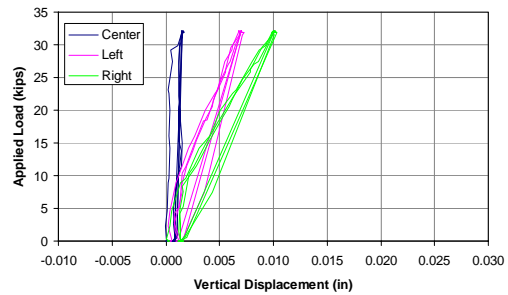
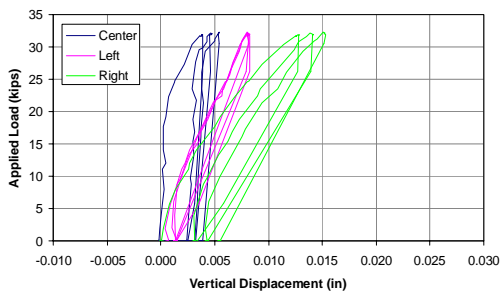
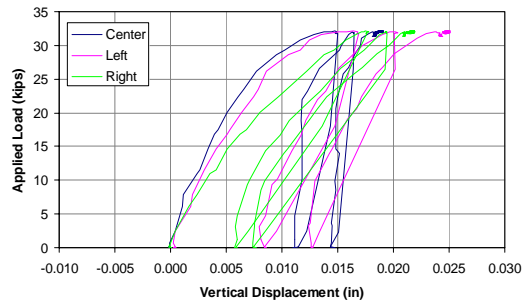
Figure 3. Load-slip test results for Phase 1

(a) PT force: 77 kips

(b) PT force: 64 kips

(b) PT force: 51 kips

(c) PT force: 38 kips

(e) PT force: 26 kips

(f) PT force: 13 kips

Before the first static load test started, the paving notch system was post-tensioned at 77 kips, which is equivalent to approximately 60 % of the ultimate strength of the Dywidag PT rods [1]. During testing, a single point load, using a hydraulic jack placed under the center of the paving notch specimen, was slowly applied up to 32 kips. The force was then slowly released to zero and this loading sequence was repeated three times. A total of six static load tests were conducted with each test completed in a similar manner with the exception of the PT force applied to the system; the next static load test involved the specimen with 10% less PT force applied to the system (i.e., 50% of the ultimate strength of the rods). The static load test was repeated until the PT force was down to 13 kips (i.e., approximately 10% of the ultimate strength of the rods). The load-slip measurements were made for each static load test and are presented in Fig. 3.

Before testing, it was expected that, when there was adequate frictional resistance, any displacement induced by an applied load would return to zero when the load was removed. This was confirmed by the first static load testing where virtually no residual displacement (slip) occurred at the connection of the paving notch system when the specimen was attached to the abutment with 77 kips of PT force. The initial indication of slippage was observed at 26 kips of PT force and the slippage continued to increase as the PT force was further reduced. The testing was stopped at 13 kips of the PT force as the manifestation of residual displacement (slip) was obvious.

From this test, the research team learned and realized that the PT force needed to prevent the slippage at the connection of the paving notch system was less than originally anticipated. It was further thought that an even smaller level of PT force could be used when an adhesive is used as part of the connection. This led to a modification to the original proposed solution. The next phase of the testing program describes the static load testing of the modified solution.

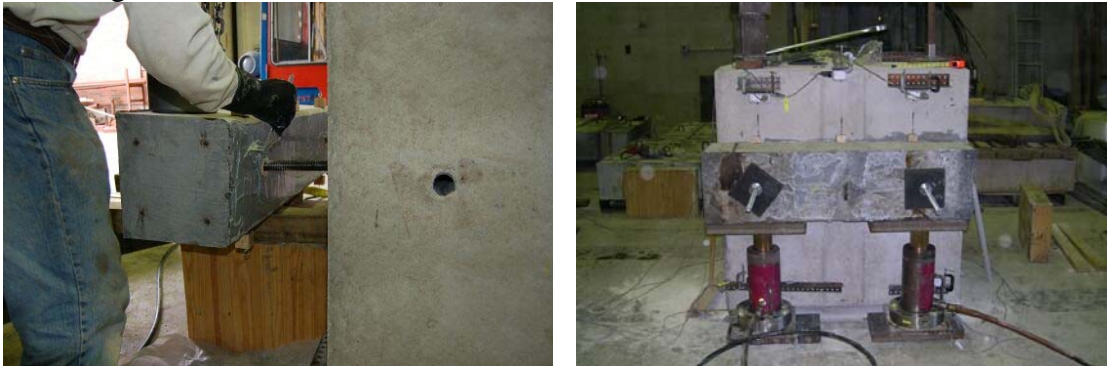
(a) Application of epoxy adhesive (b) Assembled paving notch specimen
Figure 4. Photographs of the application of epoxy adhesive and the assembled precast paving notch system.

The proposed solution was modified to provide a simpler, easier to install system. Two $\frac{3}{4}$ in. diameter stainless steel threaded rods were drilled in approximately 10 in. in depth, at 3 ft centers, anchored with Epcon anchoring adhesive [2] into the abutment; Unitex epoxy adhesives [3] were applied to the interface between the abutment and the paving notch specimen (Fig. 4a); and the specimen was then tightened to the abutment by hand with a long wrench.

During testing, the specimen was instrumented with five displacement transducers: three on the top surface of the paving notch specimen and two on the bottom surface of the specimen. The specimen was then loaded with two hydraulic jacks placed directly below the stainless rods as shown in Fig. 4b. The same basic loading procedure used in Phase 1 was used except, in this test, the zero-to-32-kip load cycle (16 kips for each jack) was repeated four times. After the four cycles of the test, the specimen was loaded to failure. Presented in Fig. 5 are the results of this testing. As shown, virtually no slip was observed during the four cyclic loadings and the specimen failed at approximately 62 kips.

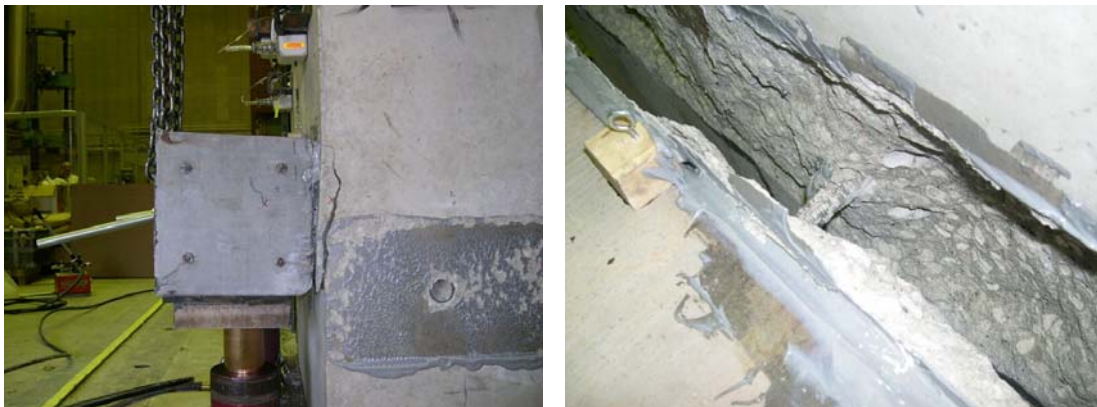
(a) Side view of the failed specimen

(b) Failed abutment concrete

Figure 6. Posttest specimen illustrating typical cracking failure.

After testing was completed, the failed connection of the paving notch system was visually inspected. Figure 6a shows a crack pattern in the abutment concrete that seemed to propagate upward near the connection. It appeared that this type of failure was a result of a combination of shear and prying effect. It was speculated that this phenomenon was due to the vertical force applied eccentrically about the connection, which caused bending stresses at the connection. Although the bond of the adhesives provides some level of flexural capacity, the PT force at the mid depth of the specimen principally provides axial compression. In order to accommodate this weakness, an additional row of stainless steel rods was added to the design (i.e., two sets of rods close to the top and

bottom of the specimen were included to provide resistance against prying effect), which will be discussed in Phase 4.

After the specimen was loaded to a failure, the paving notch specimen was pulled out from the abutment (Fig. 6b) for a close-up inspection. From this visual inspection, there was an obvious indication that the failure of the system occurred primarily in the abutment concrete. This indicates that the strength of the epoxy adhesives were adequate.

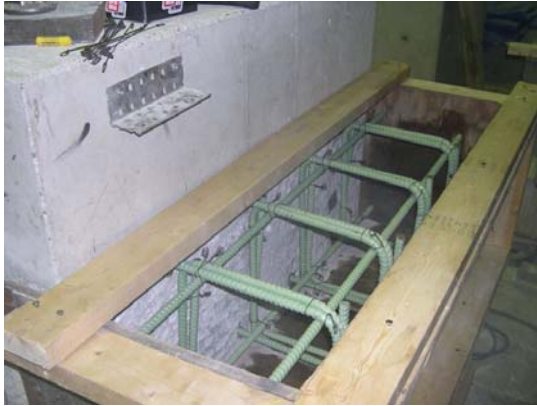
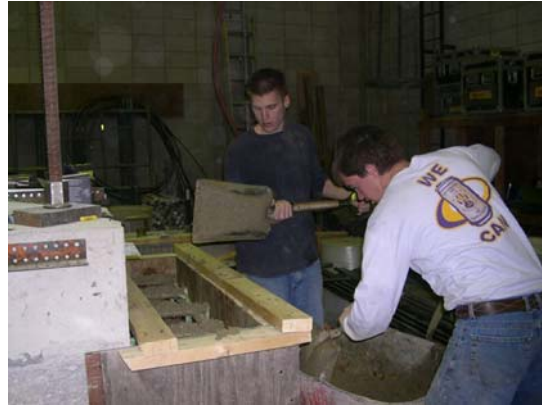
Figure 7. Construction of the cast-in-place repair specimen.

(a) Reinforcement inside a wooden form

(b) Concrete placement

At the end of Phase 2, the Iowa DOT desired to compare the strength of the proposed system to their current CIP repair system. Based on the details provided by the Iowa DOT, a CIP paving notch repair system was constructed as show in Fig. 7. The Iowa DOT's CIP repair specimen consists of bent epoxy-coated reinforcing bars inserted into drilled holes and fastened with epoxy adhesive. Conventional plywood forms were

constructed around the cage for the placement of normal weight concrete to complete the construction of the paving notch. Upon the completion of the construction, the CIP repair system was loaded to failure with two hydraulic jacks placed at the same location where the stainless steel threaded rods would have been located in the previous static load tests. The CIP repair system failed at approximately 46 kips.

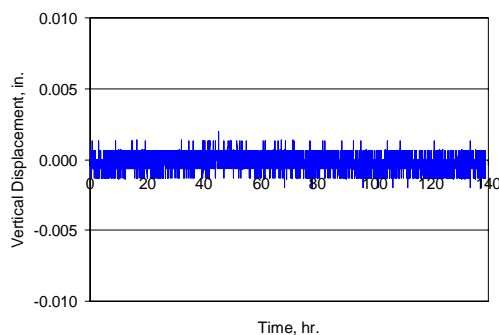
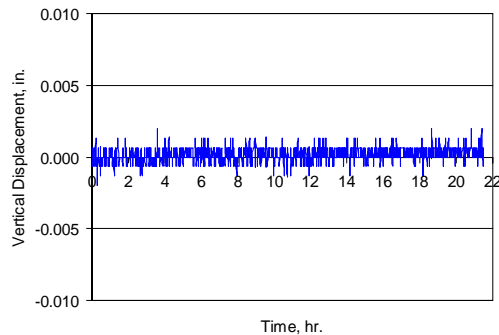
Figure 8. Fatigue load test results.

(a) One million cycles of 16 kips

(b) 100,000 cycles of 32 kips

The last phase of the testing program consisted of the application of a fatigue load to the precast paving notch specimen to simulate a finite number of wheel load applications. The purpose of this testing was to investigate the long term performance of the system subjected to repeated loadings. Due to the prying effect observed in Phase 2, the design was modified so that the precast paving notch system has two sets (rows) of $\frac{3}{4}$ in. diameter stainless steel rods that were drilled and grouted approximately 10 in. into the abutment. Two fatigue load tests were conducted on the system: the first with one million cycles of a 16-kip load and the other with 100,000 cycles of a 32-kip load. From this testing, no obvious slip was observed at the connection of the system (Fig. 8).

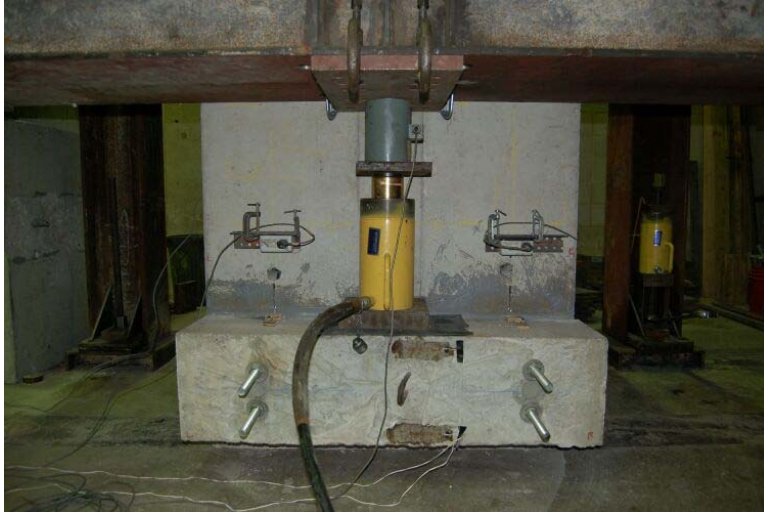
Figure 9. Ultimate load test on a specimen with four stainless rods.

Following successful completion of the fatigue load testing, the precast paving notch system specimen was loaded to failure to obtain a measure of the ultimate strength of the

precast concrete components and connection details as shown in Fig. 9. The specimen failed at 112 kips. Photographs of the failed specimen are presented in Fig. 10.

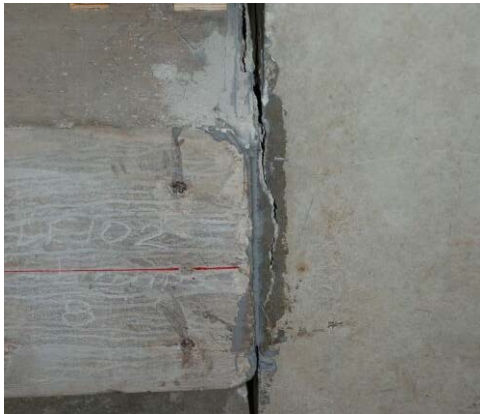
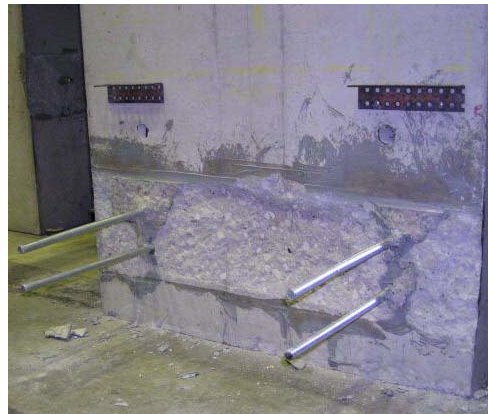
Figure 10. Posttest specimen illustrating typical cracking failure.

(a) Side view of the failed specimen

(b) Failed abutment concrete

Based upon the post-test visual inspection of the failed specimen, it appeared that the failure of the system was a result of the abutment concrete cracking that initiated at the connection due to tension stresses developed at the connection. It was noted that the crack propagated along the abutment concrete. After the initial failure, the research team continued to load the specimen until the paving notch specimen broke away from the abutment for a close-up inspection. In general, the failure pattern was similar to what was observed in Phase 2.

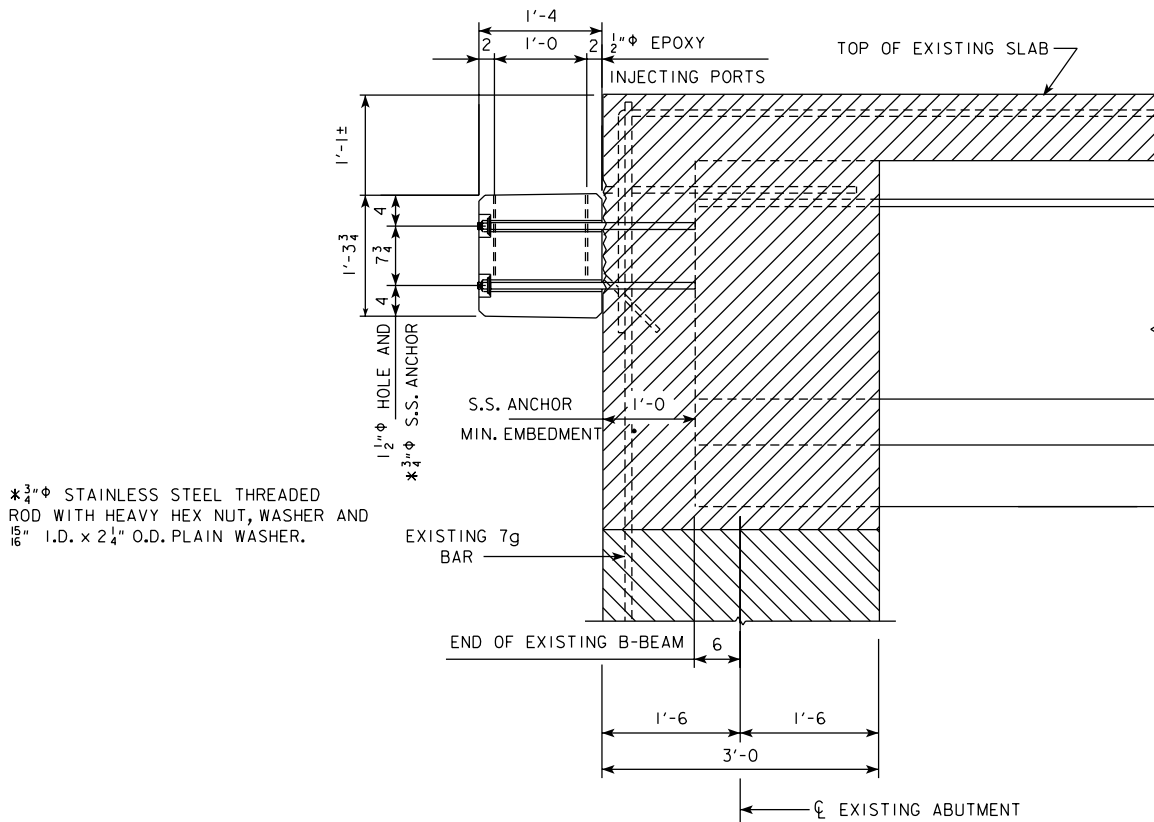
Figure 11. Precast paving notch system selected for field implementation.

Following the successful laboratory testing, a field implementation site in Marion County, IA was selected. The new system, which is an updated version of the one tested in this work, exhibits a very strong potential for replacing failed approach slab supports much more quickly than is possible with current cast-in-place concrete methods. The final design for the field implementation, which was modified from the original design based on the findings and lessons learned from the laboratory testing, is shown in Fig. 11.
