**EVALUATION OF A MOBILE WORK
ZONE BARRIER SYSTEM**

Final Report

SPR 746

Oregon Department of Transportation

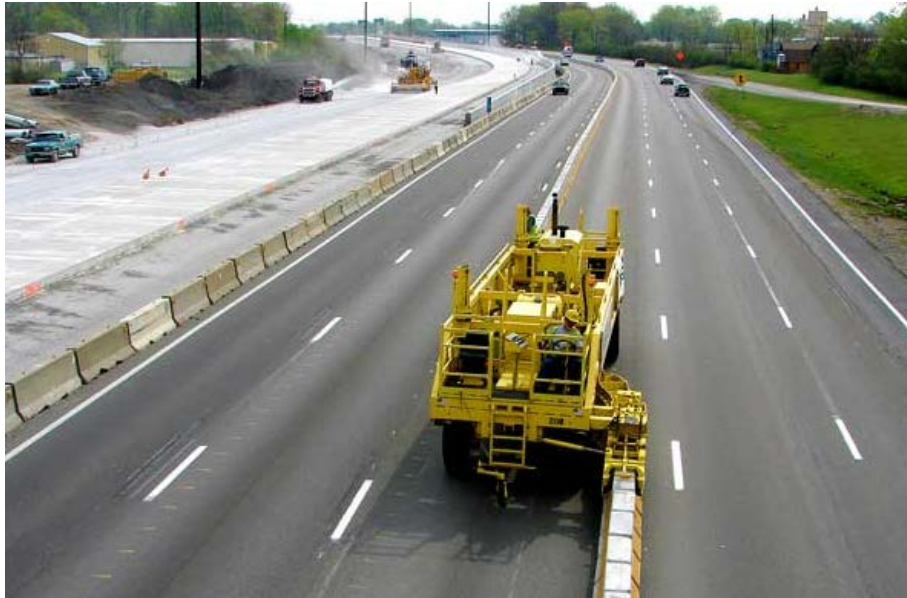
According to the manufacturer, the BTM can transfer the blocks at a traveling speed of 10 mph. The system can be used in permanent and construction applications, on highways with high traffic volume, and at locations where right-of-way is not available. Figure 2.1 shows a picture of a QBMS at work on a construction site. The picture was obtained from the Barrier Systems website (*Barrier Systems 2008*).

Figure 2.1: QBMS in Operation on a Construction Project (*Barrier Systems 2008*)

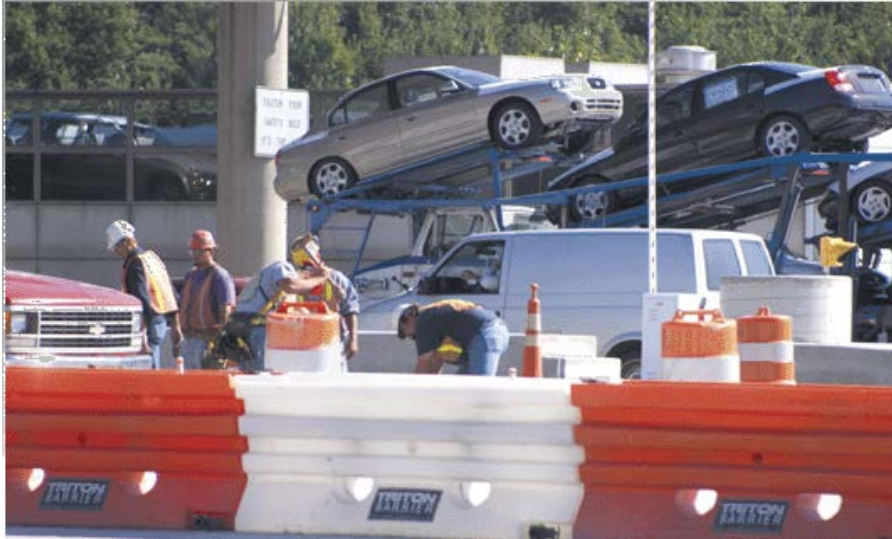
The Triton system manufacturer claims that 600 feet of the system can be deployed in under one hour by three workers. This high productivity rate is due to the low weight of each section, approximately 140 lbs. when not filled with water. Water-filled sections have a weight of 1,350 lbs, and have a capacity of 145 gallons. A picture of the system, obtained from the manufacturer's website, is shown in Figure 2.2 (*EAS 2012a, 2012b*).

Figure 2.2: Triton TL-2 Barrier (*EAS 2012a*)

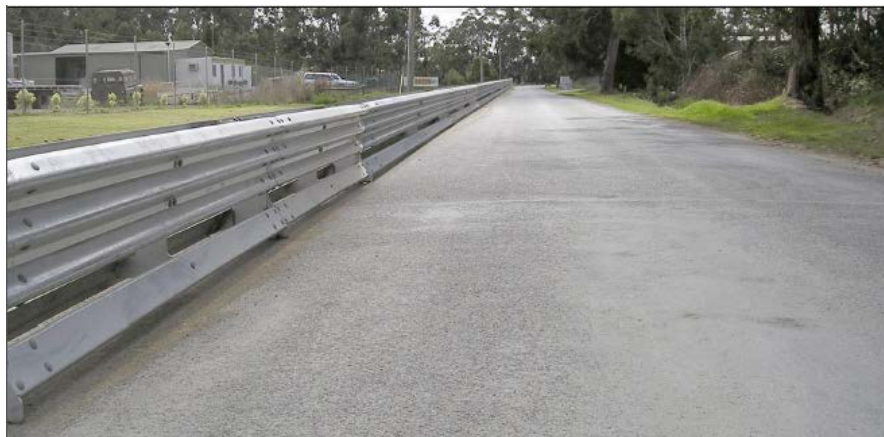
The Vulcan Barrier is also manufactured by Energy Absorption Systems, Inc. This barrier system consists of portable steel longitudinal sections that are pinned to each other to create a continuous barrier. Each section has a length of 13.5 feet, height of 32 inches, and width of 21.5 inches. The weight of each section is 871 lbs. (*EAS 2012c*). Due to the weight of the sections, their installation requires a forklift, crane, or other type of hoisting equipment to be available at the worksite. A picture of the barrier is shown in Figure 2.3. The image was obtained from the manufacturer's website (*EAS 2012c*).

Figure 2.3: Vulcan Barrier (*EAS 2012c*)

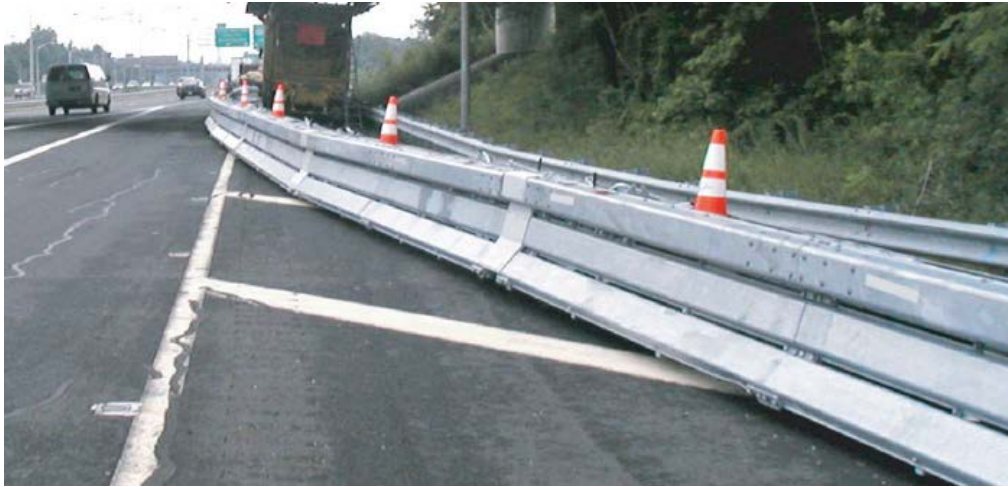
The Armor Guard Barrier system is produced by Barrier Systems and is comparable to the Vulcan Barrier produced by Energy Absorption Systems, Inc. The Armor Guard Barrier also consists of steel sections. Each steel section has a length of 28 feet, height of 32 inches, and width of 28 inches. Each segment weighs 3,700 lbs., and their installation also requires a forklift, crane, or other hoisting equipment. A picture of the Armor Guard System, obtained from the manufacturer's website, is shown in Figure 2.4.

Figure 2.4: Armor Guard Barrier (*Barrier System 2008*)

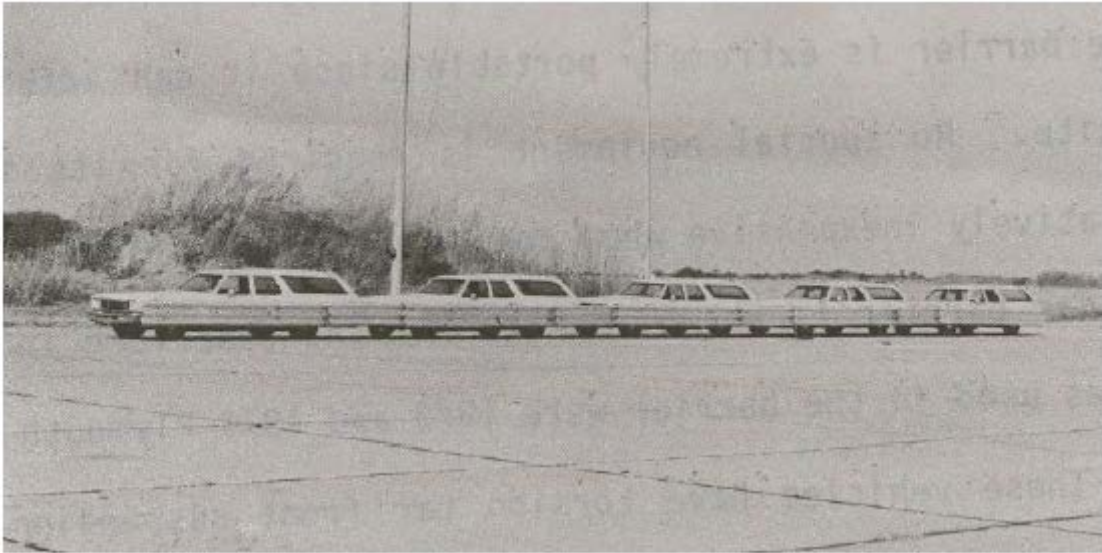
Figure 2.5: TTI Portable Traffic Barrier (*Jewell and Caldwell 2008*)

condition and it was used to tow the other 4 vehicles in the assembly. The assembly had a turning radius about double that of a normal vehicle, and its total length was 100 feet (*Sicking et al. 1982*).

Two crash-tests were conducted on the assembly using a vehicle weighing 4,500 lbs. and with impact angles of 7 and 15 degrees resulting to deformations of 2.5 inches and 8.4 inches, respectively. In both cases there was minor damage on the thrie beam, but the barrier was driven from the test site without need of repair (*Sicking et al. 1982*).

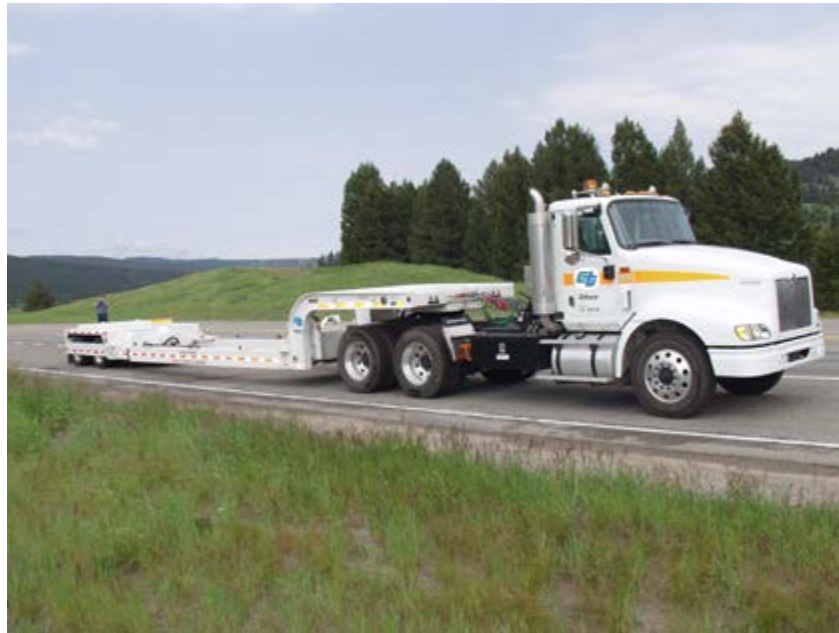
As shown in Figure 2.7, a Balsi Beam trailer system consists of a semi-truck tractor and a trailer. The trailer has two telescoping expandable steel beams along each side of the trailer that rotate to provide a stackable two beam protection barrier on either side of the trailer. The beams can be rotated to either side depending on the location of the work that

needs to be performed. Approximately 20-30 feet of work space is available behind the beams. The first working prototype of the Balsi Beam was completed in 2003 and the trailer passed the NCHRP Report 350 test, Level 2 (*Caltrans DRI 2007, Caldwell 2008*).

Figure 2.7: Balsi Beam Mobile Barrier (www.dot.ca.gov)

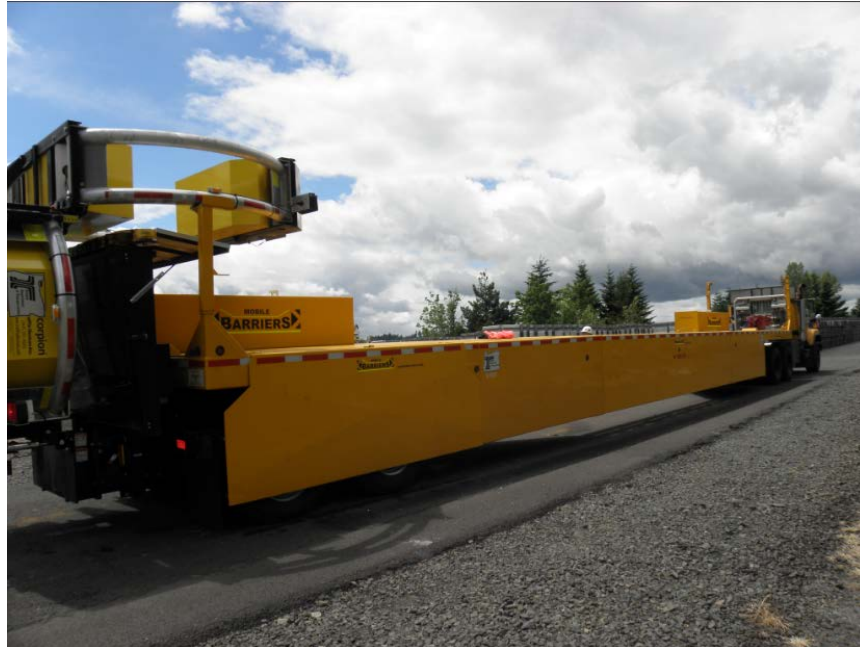
The length of the MBT-1® trailer can be modified in the field. Starting from the two wheeled platforms and a length of about 40 feet, the trailer can be expanded to a maximum length of 100 feet by adding three 20-foot wall sections. The trailer can be towed from either end, allowing it to be used for protection on either side (*Mobile*

Barriers 2010). A picture of the MBT-1® at the ODOT laydown yard is shown in Figure 2.8.

Figure 2.8: MBT-1® at the ODOT Laydown Site

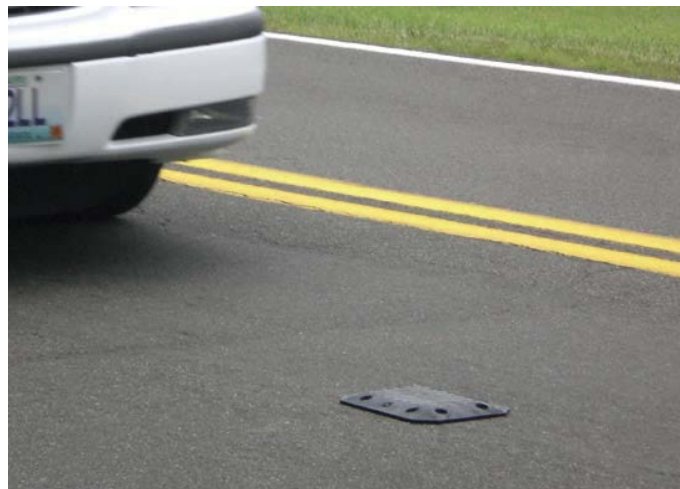
The speed of passing vehicles was measured using NC-200 Portable Traffic Analyzers (PTAs) that are produced by Vaisala Nu-metrics. The devices are programmable and can detect vehicles traveling from 8 to 120 mph using Vehicle Magnetic Imaging technology. The NC-200s are battery powered and designed to capture up to 300,000 vehicles or 21 days of data before recharging, whichever occurs first (*Vaisala 2010*). The data collected is exported using Highway Data Management (HDM) software provided by the PTA manufacturer. The analyzers are calibrated by the manufacturer at the time of purchase. For this study, the data collected was downloaded from the analyzers, and the PTA reprogrammed for the next use, after every work shift (approximately 6-8 hours of data collection). The PTA analyzers are placed on the roadway and covered by an adhesive tape for protection and to attach them to the roadway surface. A picture showing an NC-200 device on a roadway is shown in Figure 3.1 (*Vaisala 2010*). The same NC-200 devices were used in all but one case study. Case study #4 (see Section 3.9) on US 26 used a Wavetronix SmartSensor HD device.

Figure 3.1: NC-200 Portable Traffic Analyzer (*Vaisala 2010*)

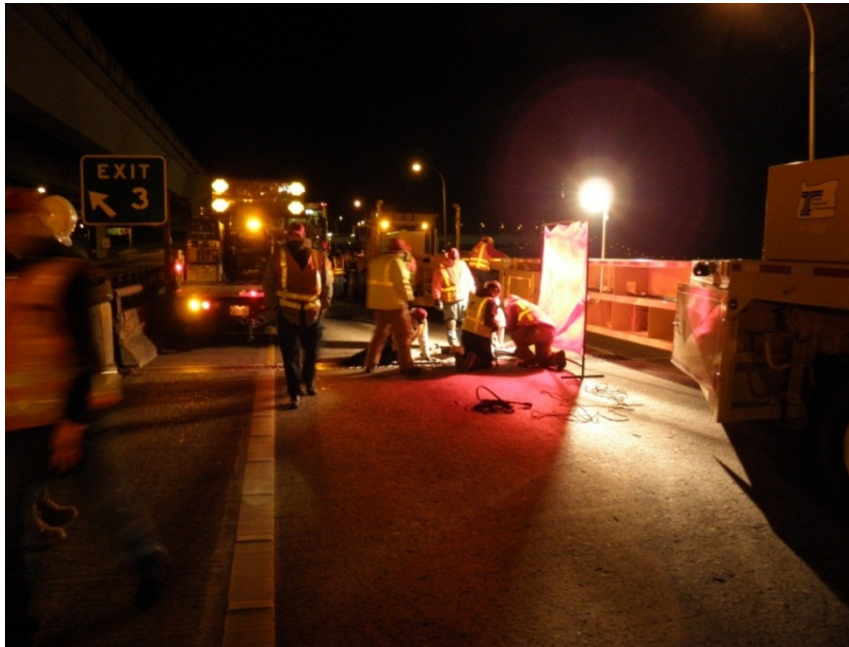
Figure 3.3: ODOT Bridge Crew Working on Repair of Fremont Bridge Joint with the MBT-1® (Case Study #1)

With the end of the traffic control placement, the bridge crew was called, and a few minutes later at 10:17 p.m. the mobile barrier entered the work zone, along with the bridge crew and the support vehicles. The mobile barrier required some time to be situated at the precise point where the work was to take place. Once it was in place, the work crew observed that the barrier’s attenuator was not lowering to its work position. An additional vehicle with an attenuator attached to it was called in and parked behind the mobile barrier. Work on the bridge joint started at 10:28 p.m. To conduct the work, the bridge maintenance crew required two additional vehicles, a welding truck, and a tool van. These vehicles were parked within the work zone on the A-lane and the A-lane shoulder (Figure 3.3). Present at the worksite were five members of the traffic control crew and eight members of the bridge repair crew, as well as the ODOT regional safety manager.

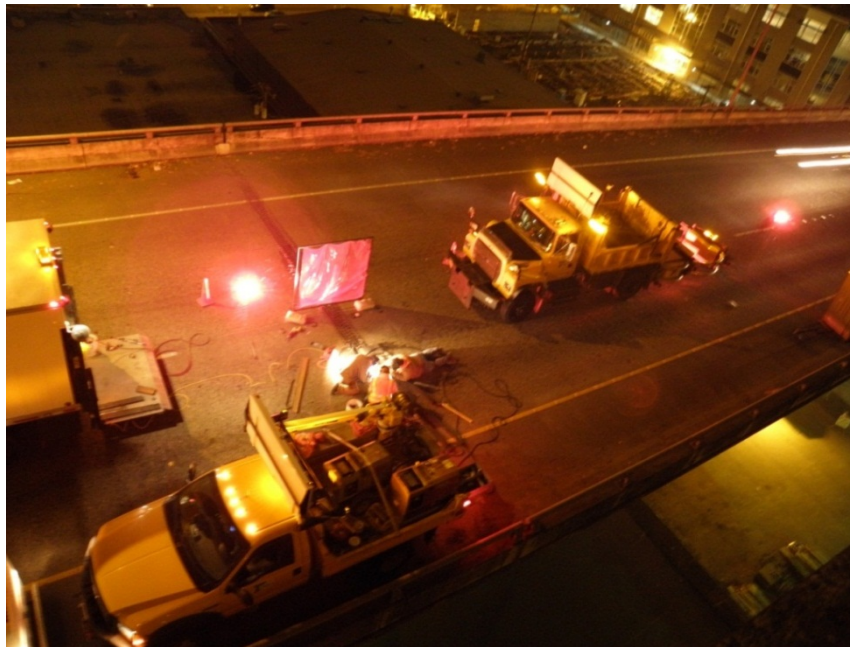
Figure 3.4: ODOT Bridge Crew Working on Repair of Fremont Bridge Joint without the MBT-1® (Case Study #1)

Present at the worksite were five members of the traffic control crew and eight members of the bridge repair crew. The bridge crew required three additional vehicles: the work van, welding truck, and a support truck with compressor (Figure 3.4).

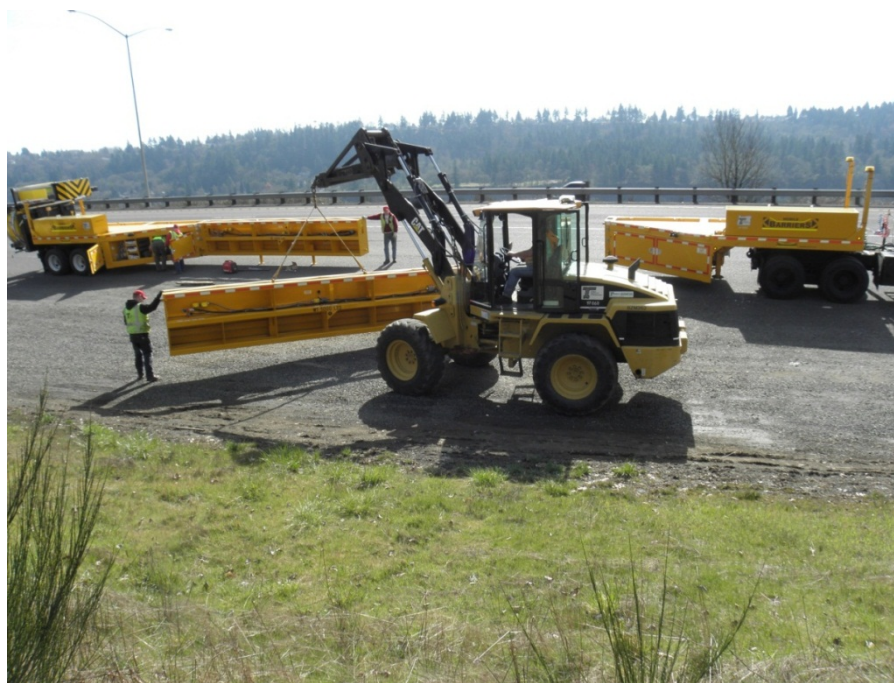
The research team met the construction personnel and ODOT staff at the jobsite to discuss the logistics of implementing the MBT-1® on the site. The initial traffic control plan for the jobsite was obtained from ODOT personnel at this time. To utilize the mobile barrier on the project, the MBT-1® needed one additional 20-foot section installed on the trailer for a total trailer length of 80 feet (two 20-foot sections total on barrier). In addition, the barrier needed to be switched from one side to the other. The procedure for adding the sections and rotating the trailer from A-lane configuration to B-lane configuration took place at the ODOT laydown yard on I-205 near the 10th Street exit in Portland. The research team observed the operations, and the processes were filmed and timed (see Figure 3.5)

Figure 3.5: Adding a 20-foot Extension on the MBT-1® (Case Study #2)

Time (min)	Work Description (adding 20' section)
March 7, 2012	
0	Move MBT-1® to location
8	Bring 20' section with a forklift
10	20' section placed adjacent to MBT-1®
11	Lower support wheels and remove bolts from connection
48	Separate the MBT-1®
115	Finish bolting section
118	Finish work
March 16, 2012	
0	MBT-1® arrived at the shoulder close to the exit to the MP 240 rest area on I-5
15	Set up of work zone
45	Start removing bolts from middle section
83	Finished unbolting section to be removed
145	Removal of ballast tank to straighten the MBT-1® section (even distribution of weight)
150	Truck attached to the MBT-1® and started bolting
167	Finished bolting MBT-1® sections together
175	Place ballast tank on trailer
205	Place section on MBT-1® and strap it down
215	Finish work - Strapping 20' section on MBT-1®

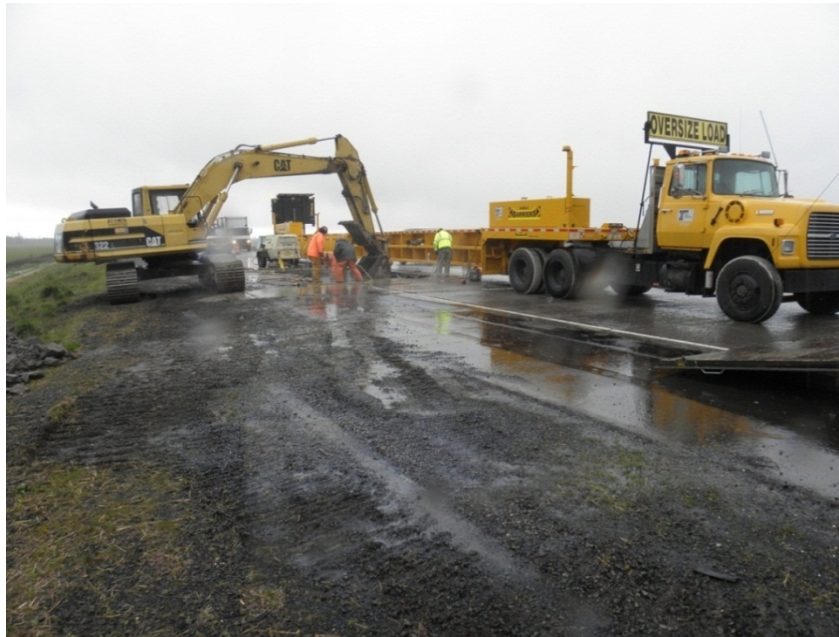
Figure 3.6: Workers Removing Concrete Pavement (Case Study #2)

The next day workers started to remove the concrete pavement in the northbound work zone (see Figure 3.6). The research team visited the site to conduct additional investigations. Present at the site were five workers from the construction firm, and two ODOT personnel. The contractor had two jackhammers, an excavator, and two generators for the jackhammers. In addition, there was a tool van that has hitched to a truck. Parked on the shoulder and within the closed section of the B-lane were the workers' personal vehicles and the two trucks belonging to ODOT. At a distance of about 325 feet south of the northbound work zone on the B-lane there was a truck with an attenuator attached to it inside the taper.

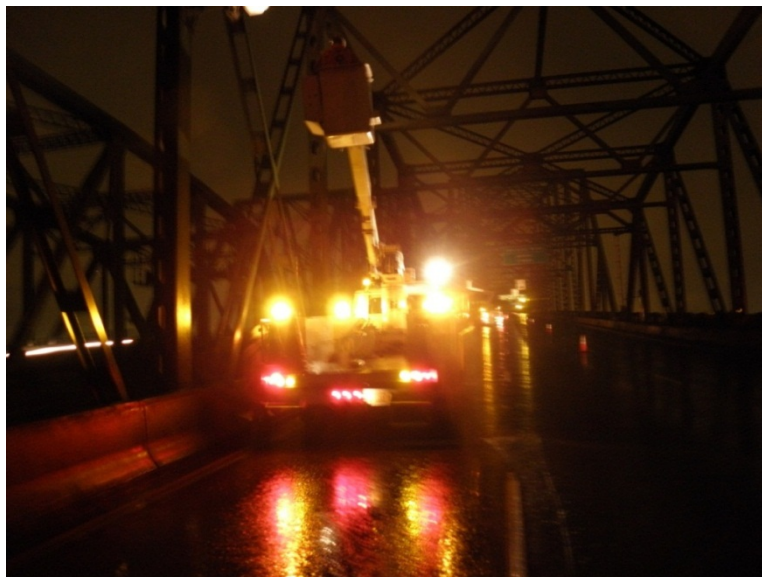
Figure 3.7: Crew Repairing Lights on I-5 Interstate Bridge without the MBT-1® (Case Study #3)

The work that was performed included the repair of lights and their wiring on the bridge. The electrical contractor performed the work with two boom trucks and six workers (see Figure 3.7).

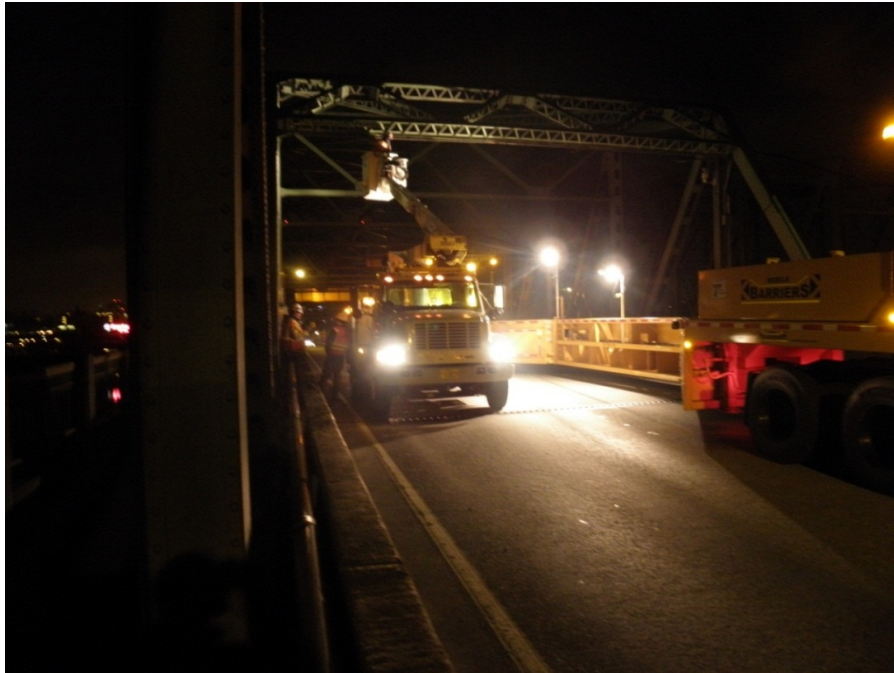
Figure 3.10: Workers Repairing Electrical Circuits on I-5 Interstate Bridge with MBT-1® (Case Study #3)

As indicated above, work was performed throughout the night at various locations along the bridge. Figure 3.10 shows one of the work site locations. Below are summary descriptions of the work performed at each location:

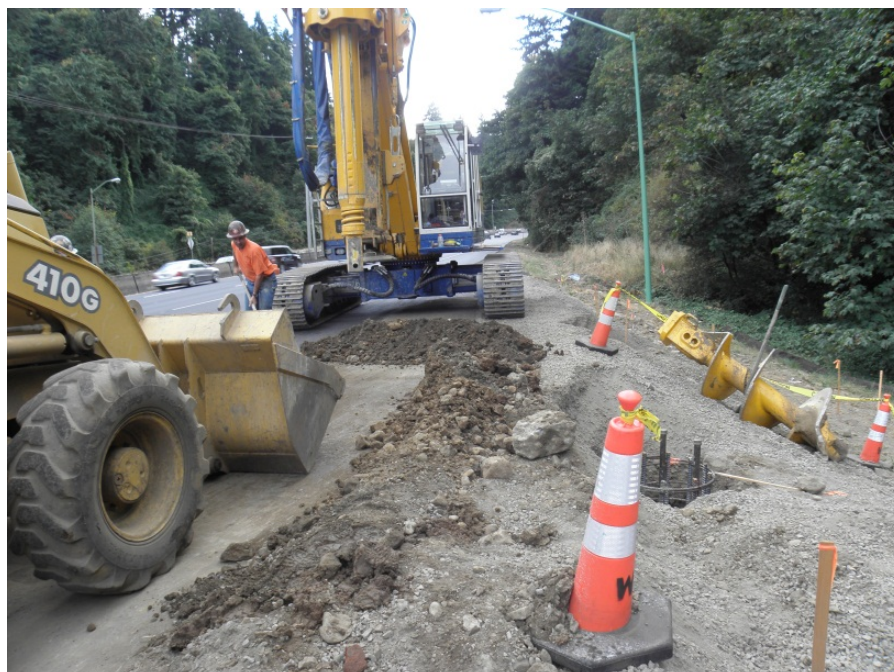
Figure 3.12: Workers Working on the Site, September 10 (Case Study #4)

There was a crew of four workers working at the site who were preoccupied with drilling the shaft. Present also were a forklift, a drill, and a wheel loader. Traditional safety measures were used, and the only hazard that was observed was the high speed vehicles traveling next to the work zone. Workers were moving on the shoulder (as shown in Figure 3.12) but they were within the area marked with barrels and cones. The controlled work area was on the shoulder and far enough from the passing traffic that the work was not affected by the traffic.

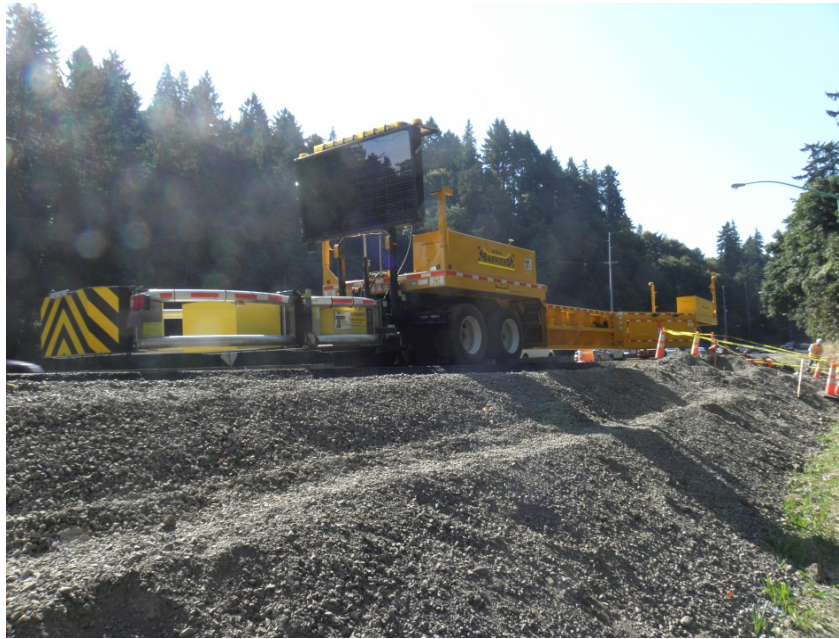
After work was completed on the second day, the MBT-1® was moved and parked in front of the completed drilled shaft for two days after which it was then moved back to the ODOT laydown yard on I-205. There were no workers on site and the MBT-1® was parked as shown in Figure 3.14. On the third day, the research team downloaded information from the Wavetronix sensor, took pictures of the work zone, and completed the data collection worksheet.

Figure 3.14: MBT-1® Parked Next to Drill Shaft

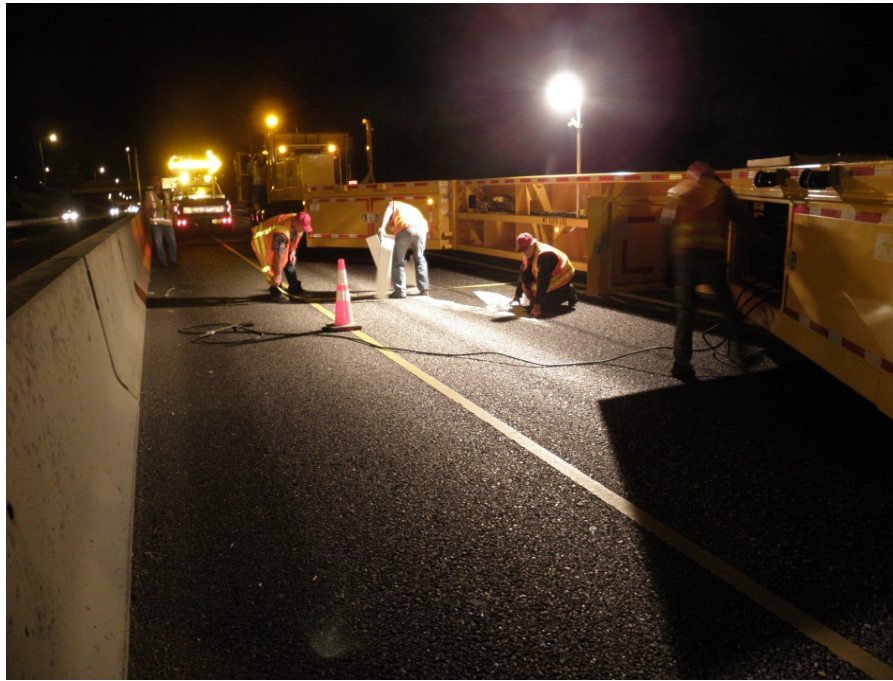
Figure 3.15 shows the workers placing one of the HOV markers.

Figure 3.15: Installation of HOV Markers on I-5 Northbound (Case Study #5)

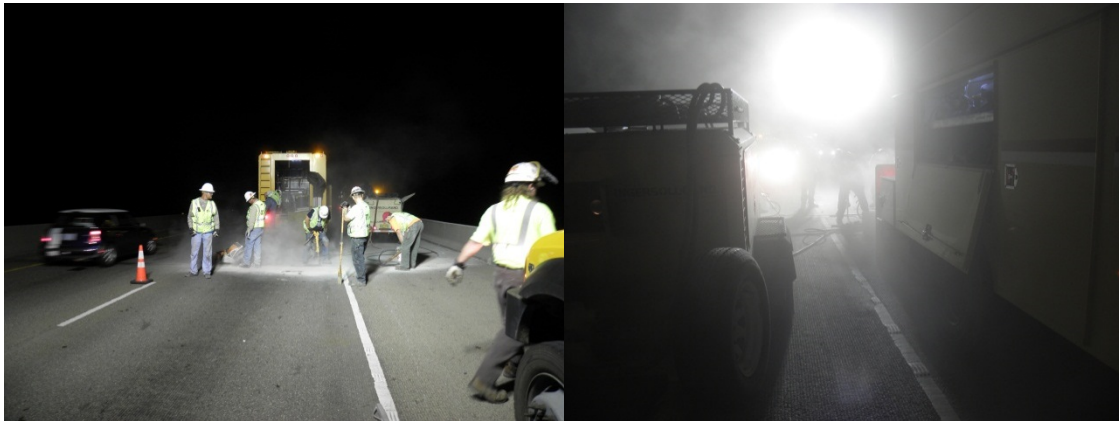
Pictures from the night's work are shown in Figure 3.18 (jackhammering), Figure 3.19 (sandblasting and sealing), and Figure 3.20 (welding & placement of mortar).

Figure 3.18: Jackhammering and Concrete Cutting (left); Dust from Concrete Cutter 'Fogging' Work Area (right) (Case Study #6)

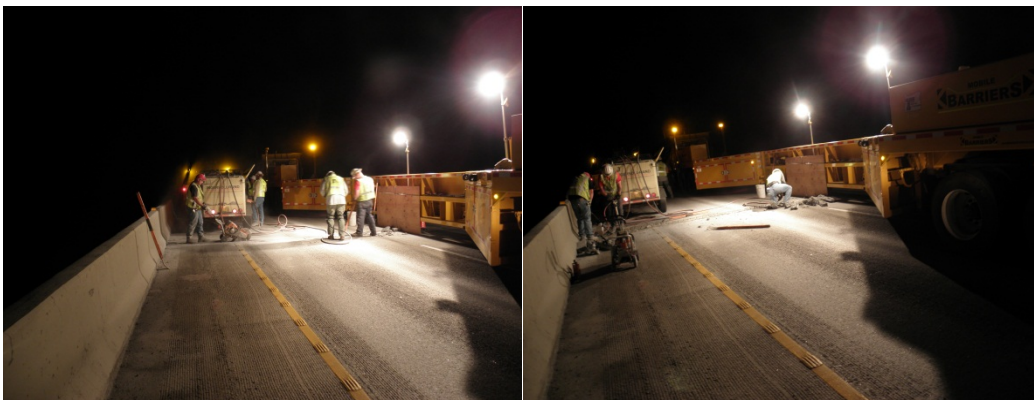
Figure 3.21: Workers Cutting Concrete (left); Workers Jackhammering Concrete (right) (Case Study #6)

The researchers completed the work site worksheet, noting down the layout of the site and information regarding the work performed and the site conditions. The work that took place was identical as the previous night with the only difference being that the work was performed on the A-lane instead of the B-lane. Pictures from the night's work are shown in Figure 3.21 (saw cutting and jackhammering of concrete), and Figure 3.22 (placement of steel joint and removal of wrong concrete mix).

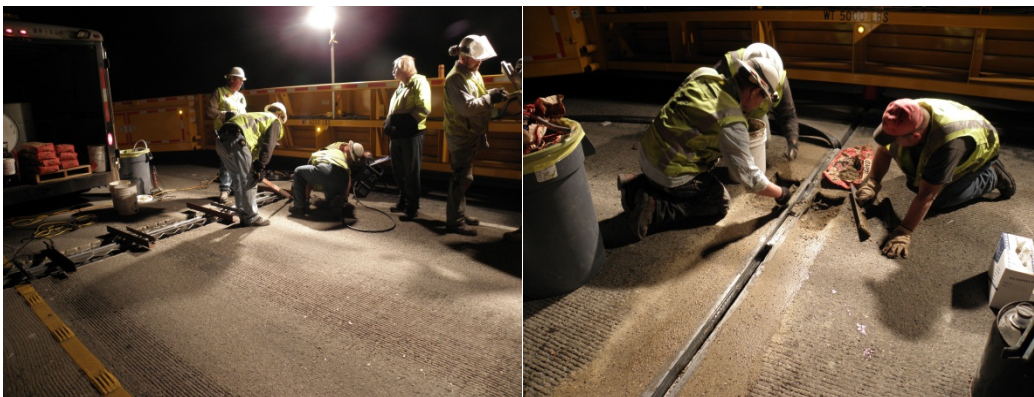
Figure 3.22: Workers Placing Joint (left); Workers Removing Concrete (right) (Case Study #6)

The bridge crew saw about 45 minutes of productivity increase over the course of the night. At the final stage though when they were placing the concrete, they discovered that for one batch of concrete they did not add the accelerator, and the workers had to remove the concrete and mix another batch. That removal and remixing of the concrete eliminated all the time gains they had accumulated.

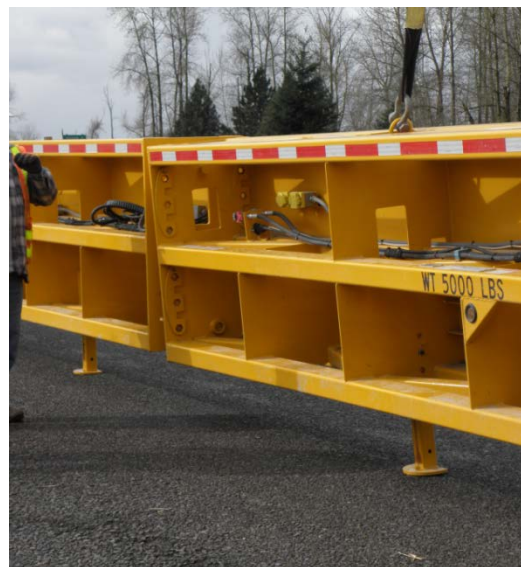
During the removal of the section on March 28, it was observed that the sloping ground caused the truck and a section of the trailer to become twisted as observed in Figure 4.53. To counteract this issue, the ballast tank on the MBT-1® was removed in order to allow the MBT-1® to be connected properly. This issue caused a significant amount of the delay experienced by the crew².

Figure 4.53: MBT-1® Twisting during Assembly

² The manufacturer recommends assembly at a level location (*Mobile Barriers, 2010*)
