Consistency of the New York State Bridge Inspection Program

SPR PROJECT # C-07-17

FINAL REPORT

September 30, 2013

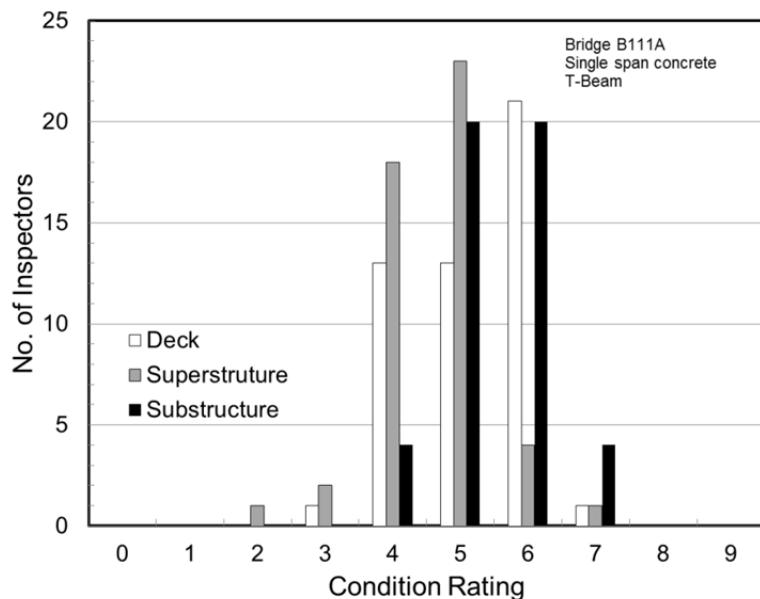
Figure 1-1: Condition Rating Distribution for a Concrete T-Beam Bridge.

simple, common bridge. Rating results varied between 2 (critical) and 7 (good) for the superstructure of the bridge.

Statistical analysis of the routine inspection results indicated that only 68 % of the inspection results varied within +/-1 of the average rating assigned [Moore et al. (2001)]. A sample of these results is shown in Figure 1-1. As shown in the Figure 1-1, which documents the NBIS component ratings for the deck, superstructure and substructure for the single-span concrete T-Beam bridge, there was significant variation in the component ratings for this

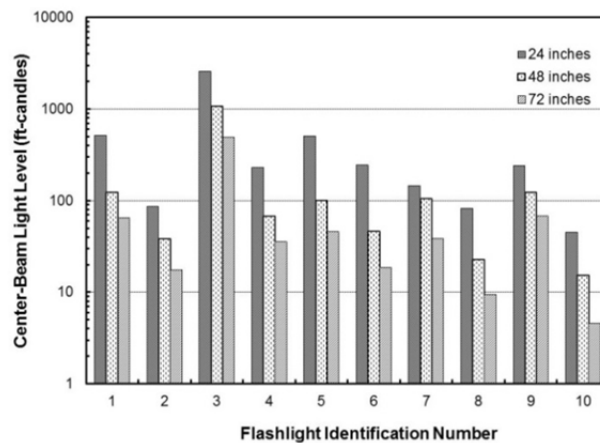
A simple method for improving the reliability of inspection would be to establish a lighting standard that specifies light characteristics to be used during inspections. Flashlights that meet that standard could be identified and supplied as additional inspection tools. Prices for flashlights meeting a 100 ft-cdl illumination standard in Figure 1-5 range from \$10 to \$100. Hence, this requirement can be

Figure 1-5: Illuminance Provided by Commercially Available Flashlights at Distances of 24, 48 and 72 inches.

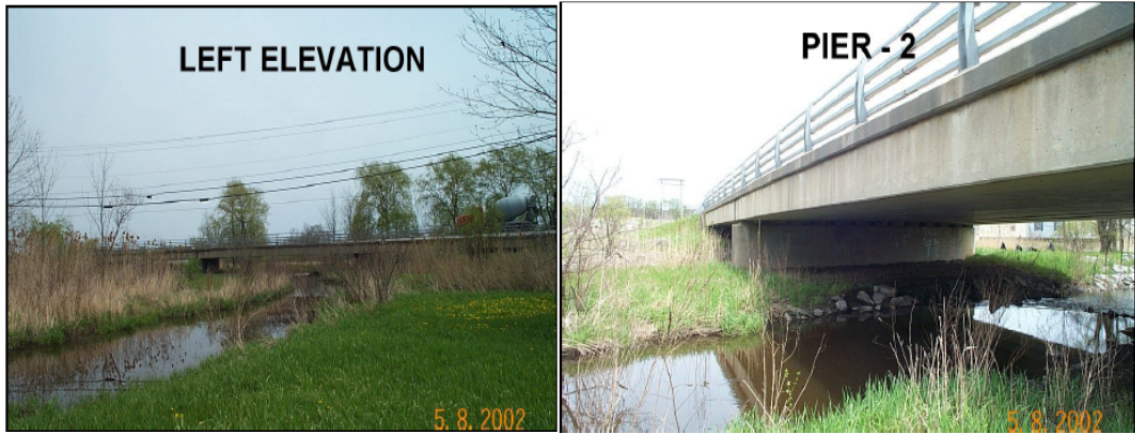
Figure 2-3: Elevation Views of BIN 1026170.

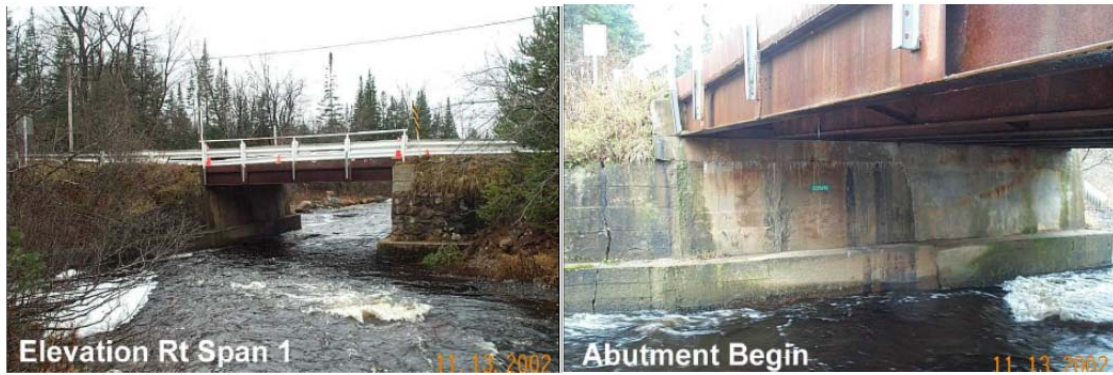
Figure 2-4: Elevation Views of BIN 2205690.

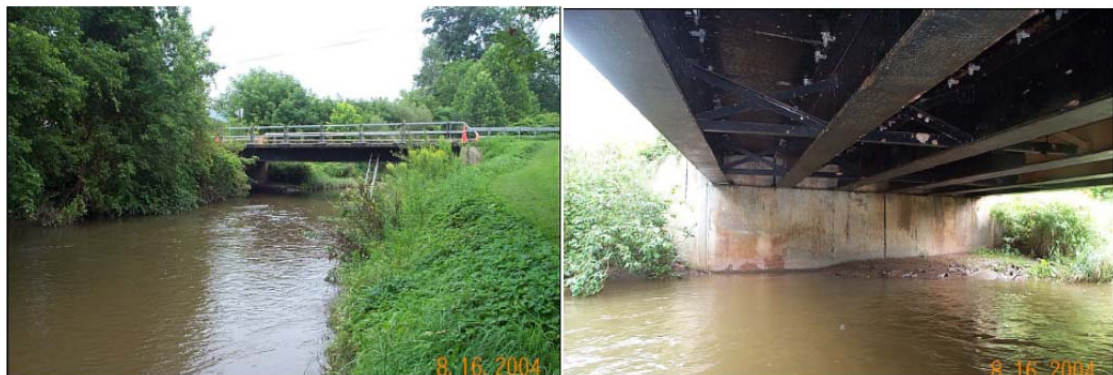
Figure 2-5: Elevation Views of BIN 3308970.

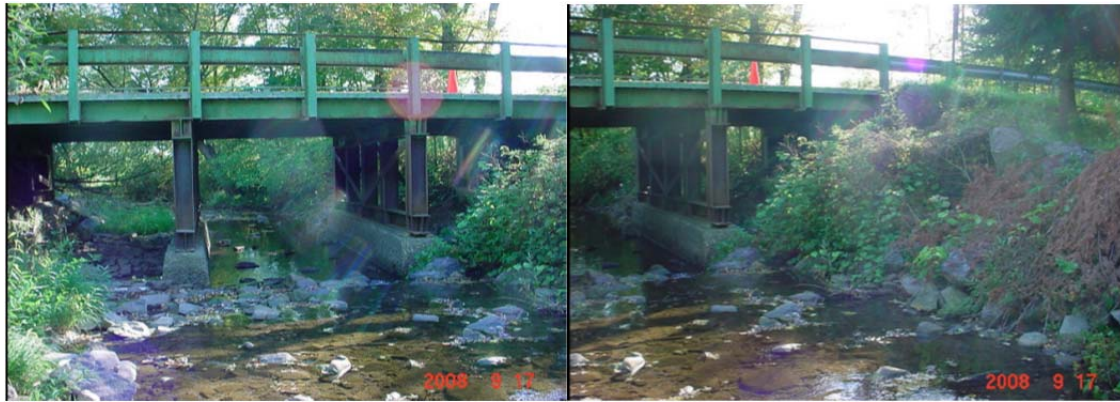
Figure 2-6: Elevation Views of BIN 3350660.

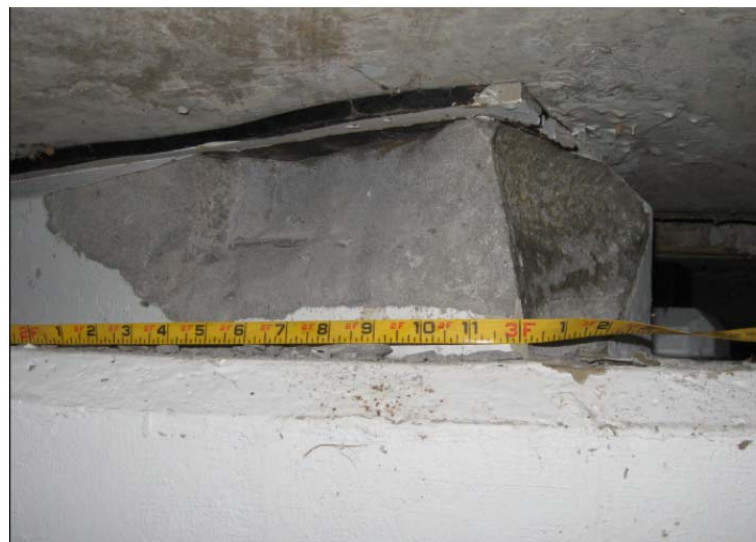
Figure 3-6: Spalled Portion of the Pedestal 12 at the Pier 2 in the Bridge 1026170.

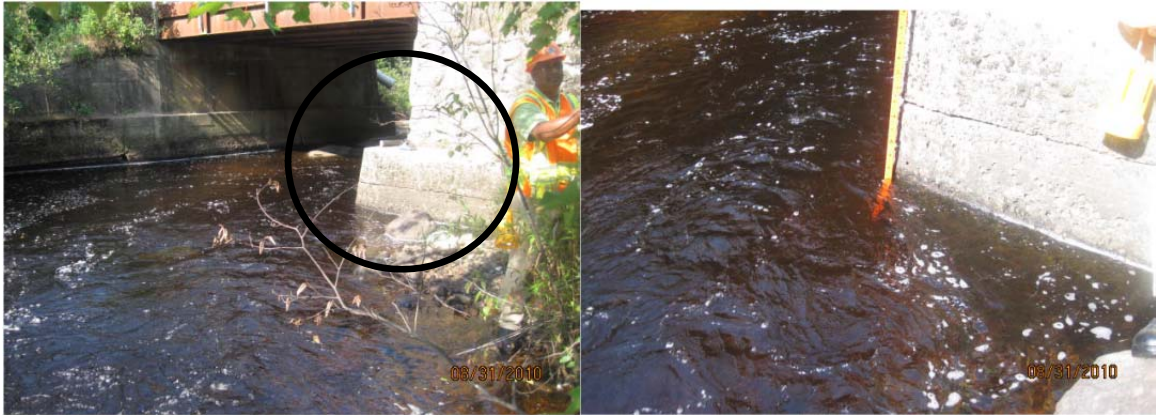
Figure 3-7: Photographs Showing Substructures of Bridge 2205690 Protruding into the Channel.

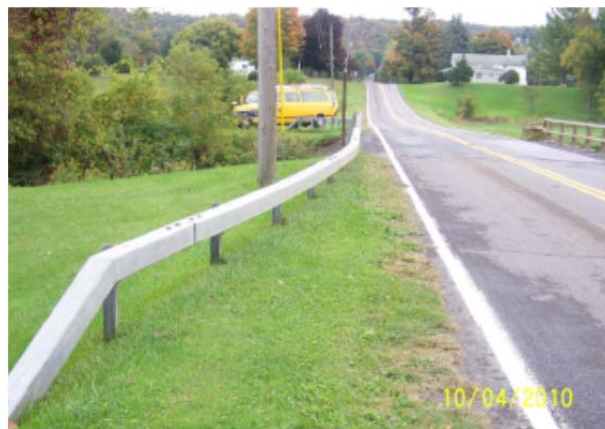
Figure 3-13: Narrowing of Usable Shoulders in the Bridge 3308970.

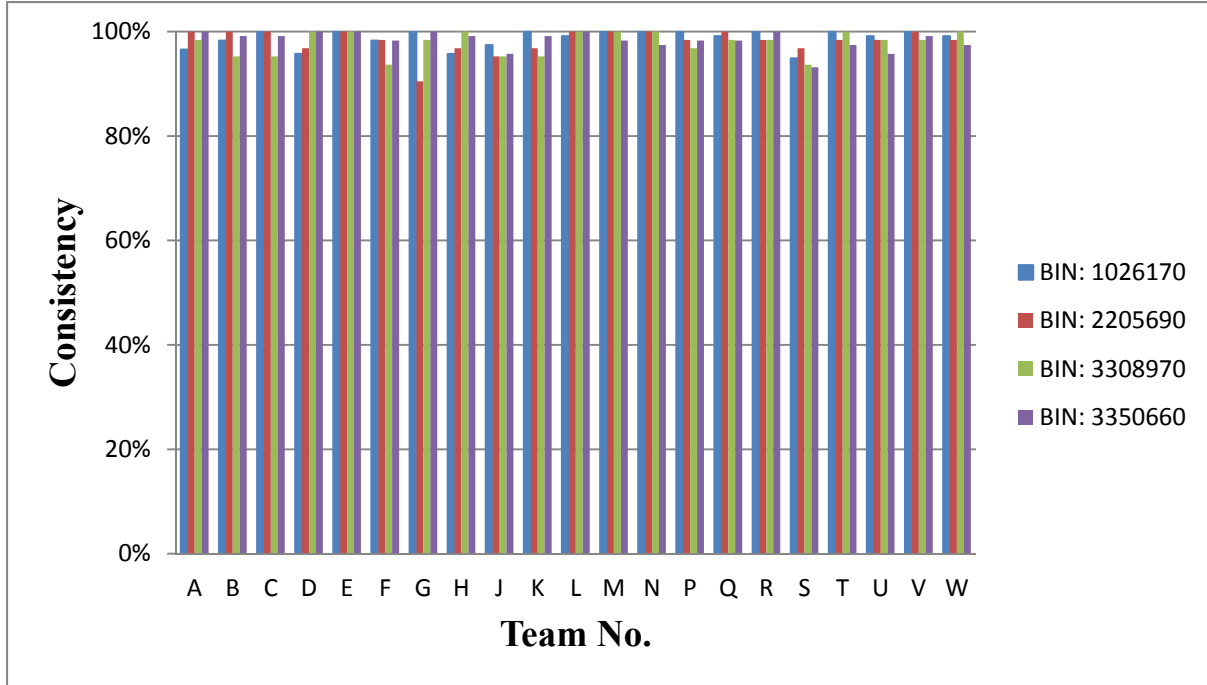
3350660, minimum values of team consistency are approximately 95%, 90%, 94% and 93%, respectively. Hence, all inspection teams have an average consistency higher than 90%. Overall, average team consistency for 21 inspection teams is approximately 98%. Further improvements in the team consistency can be achieved by addressing issues identified previously with the inspection of various bridge elements.

Figure 3-17: Team Consistency of Inspection Teams during the Inspection of 4 Bridges.

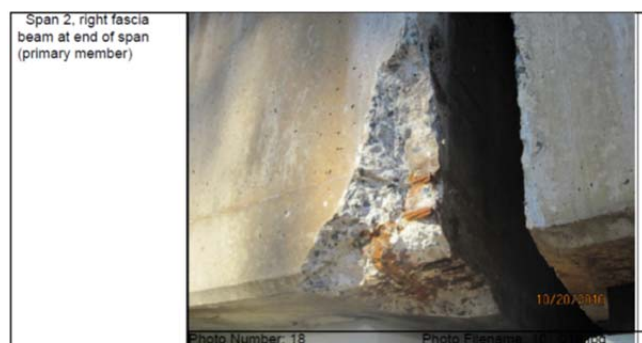
Figure 4-1 shows an example of a very good up-close photograph. The photograph clearly displays extent and severity of spalling at the end of a fascia girder. The photograph is clear, with good lighting, and is referenced in the accompanying note, which describes the condition shown in the photograph. Figure 4-2 shows another example of a very good photograph showing the elevation view of the fascia girder with vertical cracking clearly observable in the image. Figure 4-3 shows an example of a poor photograph. The photograph is blurry. It is very difficult to see the subject of the photo. Details of the bridge condition cannot be determined from the photograph, and the angle of the photograph makes it difficult to discern the point of interest. Each photograph in every report was assessed based on this simple rating scale to determine the quality of photographs in the inspection reports.

Figure 4-1: Example of a Very Good Photograph.

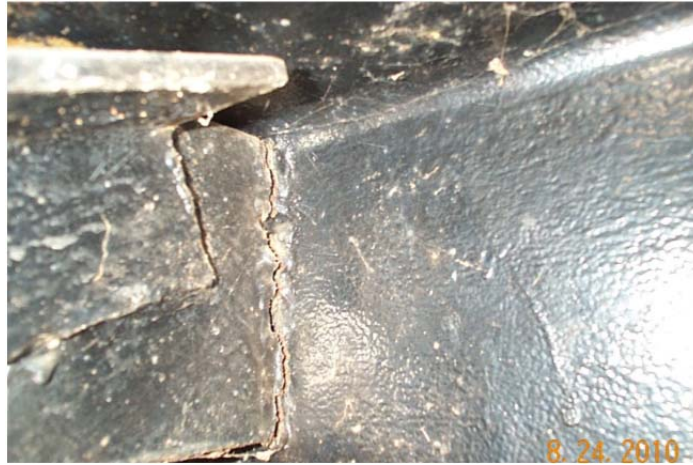
Figure 4-6: Photograph of Cracked Diaphragm Bracing Connection.

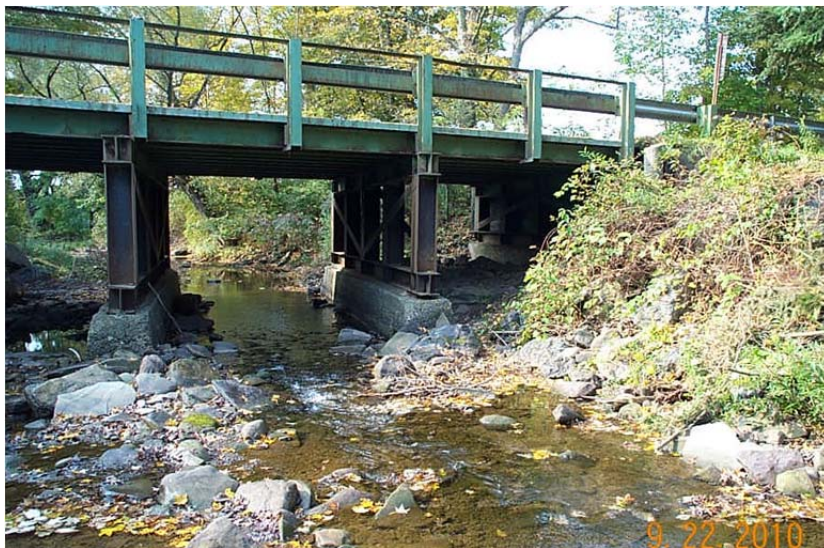
Figure 4-9: Elevation View of Bridge 3350660 Showing Footings Exposed to Scour.
