## Freeze-Thaw Performance Testing of Whole Concrete Railroad Ties

1. AGENCY USE ONLY (Leave blank)		2. REPORT DATE  October 2013		3. REPORT TYPE AND DATES COVERED  Technical Report
4. TITLE AND SUBTITLE Freeze-Thaw Performance Testing of Whole Concrete Railroad Ties			5. FUNDING NUMBERS

6. AUTHOR(S) Kyle Riding, Mohammed Albahtiti, Ahmad Ghadban, Cameron Stuart				
7. PERFORMING ORGANIZATION NAME(S) AND ADDRESS(ES) Kansas State University 2118 Fiedler Hall Manhattan, Kansas 66506-5000			8. PERFORMING ORGANIZATION REPORT NUMBER

9. SPONSORING/MONITORING AGENCY NAME(S) AND ADDRESS(ES) U.S. Department of Transportation Federal Railroad Administration Office of Railroad Policy and Development Office of Research and Development Washington, DC 20590			10. SPONSORING/MONITORING AGENCY REPORT NUMBER  DOT/FRA/ORD-13/39

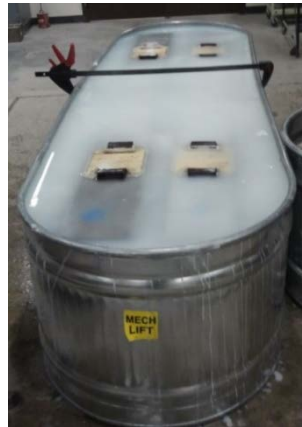
**Figure 3: Railroad tie immersed in lime water in two Behlen galvanized round end tanks.**

To begin the freeze-thaw testing, concrete railroad ties were soaked in saturated limewater. The railroad ties were immersed at  $73.4 \pm 3$  °F ( $23 \pm 1.7$  °C) for 48 hours. The ties were immersed in two large water tanks, with up to four ties stacked two deep per tank, as shown in Figure 3.

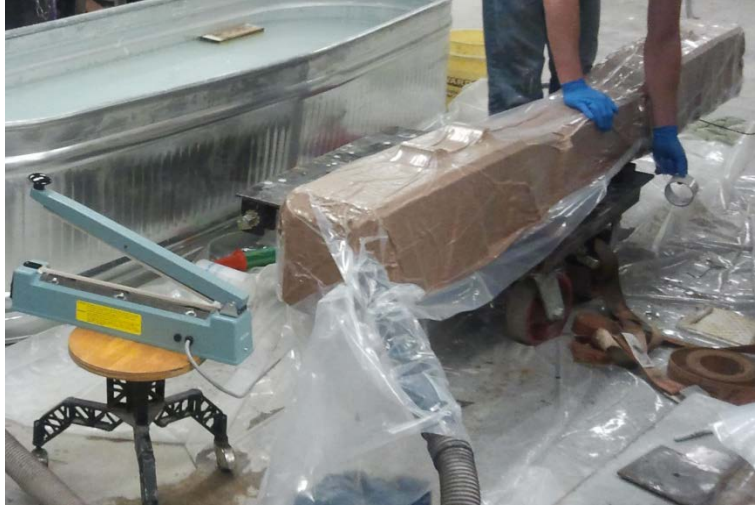
**Figure 4: Railroad tie vacuum sealed and wrapped with packing tape.**

After the soaking period, the ties were removed from the lime water tanks and wrapped with wet burlap sheets. The wet burlap was placed around the tie to ensure that free water was present all around the tie for the duration of the test, instead of simply collecting underneath the tie. The wrapped ties were covered with plastic tubing with one end of the tubing sealed. A wet and dry vacuum was used to remove air from the tubing through the open end, as shown in Figure 4. After removing the air, the open end of the tube was sealed and the tie was wrapped with packing tape to ensure that the plastic tubing was held tightly around the tie. Wrapping the burlap and plastic close to the tie surface was intended to limit the insulating effects of the burlap and tubing.

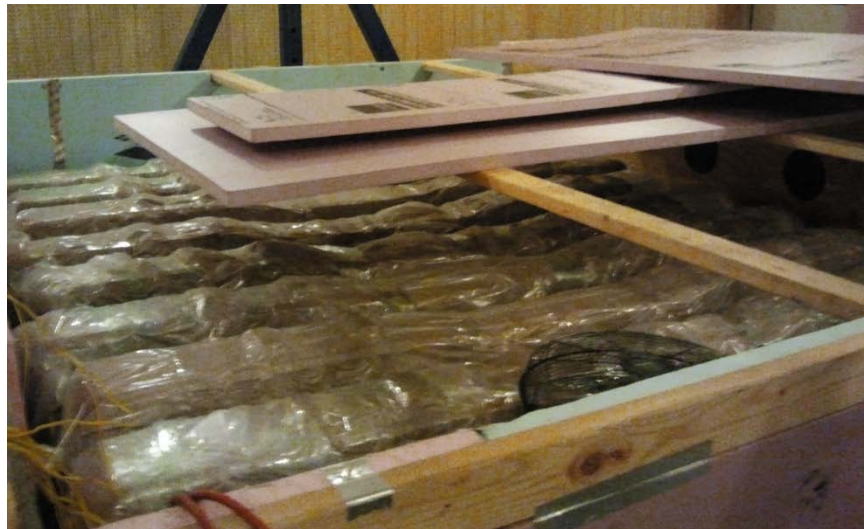
**Figure 6: Railroad ties in the testing chamber.**

Figure 6 shows the ties in the assembled chamber. Locations of the ties in the chamber were rotated each time measurements were taken to prevent bias from tie location.

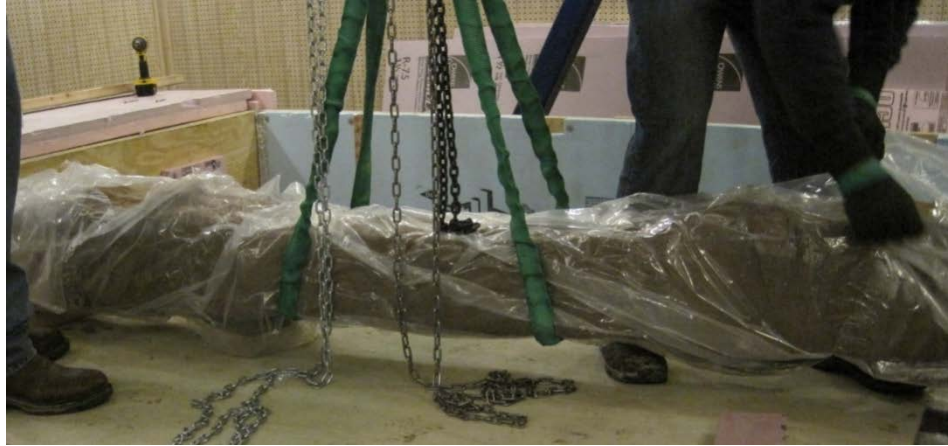
**Figure 8: Railroad ties unwrapping.**

After placing the ties in the chamber, initial readings of the tie weight, distance between Whittemore points, and resonant frequency were taken after the ties reached 40 °F (4 °C) and before commencing the freeze-thaw cycles. Once the cycling commenced, length change, weight, and resonant frequency measurements were taken every 20 to 36 cycles. ASTM C666 specifies that measurements should be taken at least every 36 cycles, but more frequent measurements are permitted to accommodate standard Monday through Friday work schedules. To perform the testing, tubes were unsealed, as shown in Figure 8, and burlap was collected in separate bags to gather concrete particles stuck to the fabric in order to measure mass loss. After measurements were completed, the ties were wrapped in wet burlap and sealed in plastic for additional freeze-thaw cycling.

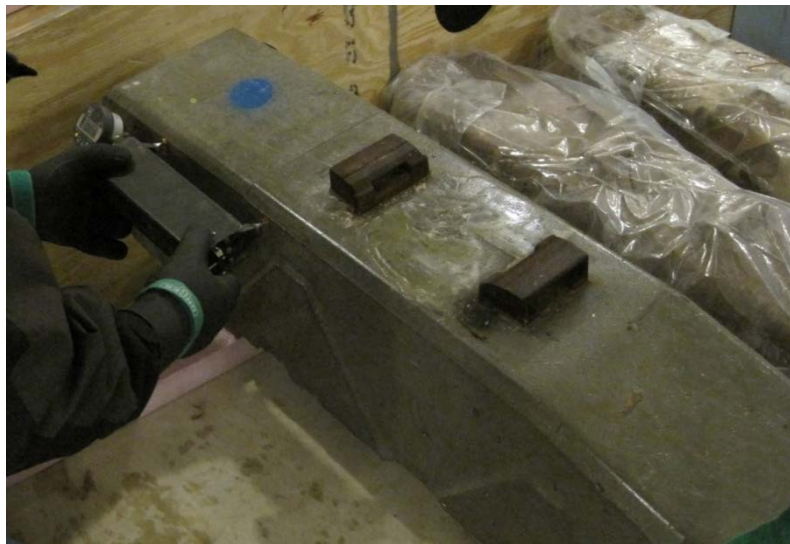
**Figure 9: Whittemore point length measurements.**

The ties were weighed using a 1,000-pound (454 kg) crane scale with a resolution of 0.1 lb (0.05 kg). The crane scale was attached to a 2-ton gantry crane with a 14.5-foot (4.4 m) span. During the testing period, the ties were kept wet using a sponge. The concrete expansion was measured using a Whittemore mechanical strain gauge at four locations on the tie, as shown in Figure 9.

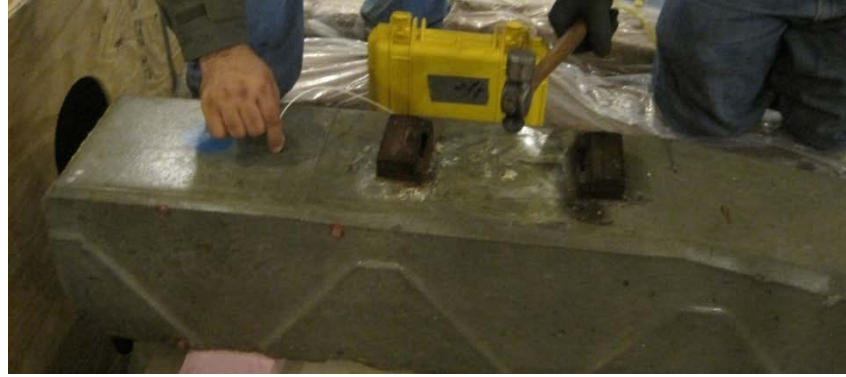
**Figure 10: Resonant frequency measurements.**

Concrete resonant frequency is measured to detect concrete deterioration from freezing and thawing cycles. Cracking and other forms of damage will slow down waves that travel through the concrete. These internal damages will not show up in visual observations but can be indicated by a decrease in the concrete resonant frequency. In this test program, the resonant frequency change in ties was measured using the impact resonance method shown in Figure 10. With this method, the concrete at one location is impacted with a light hammer. The waves transmitted through the concrete from the impact are detected using an accelerometer at another location. The resonant frequency of the concrete is then calculated from the measured waves. This was repeated for the points shown in Figures 11 and 12. Values equivalent to the relative

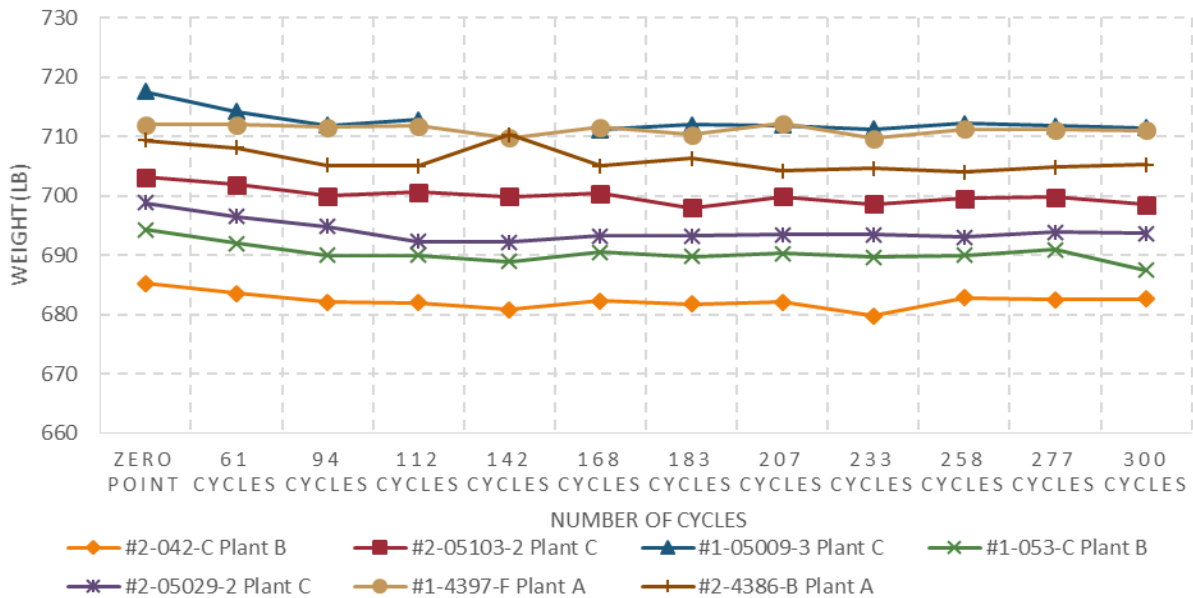
**Figure 15: Concrete tie weight.**

Concrete weight loss from scaling, pop-outs, or crumbling is a common result of freeze-thaw damage. There is no commonly accepted limit for weight loss since a lack of weight loss does not necessarily equal good performance. (The concrete can develop internal micro-cracking without losing any weight.). A large amount of weight loss, however, is an indicator of damage. Measurements of concrete weight throughout the testing period showed that concrete ties did not lose a significant amount of weight from freeze-thaw testing, as shown in Figure 15. Small fluctuations in weight values could be attributed to slight changes in water content on the surface of the specimens.

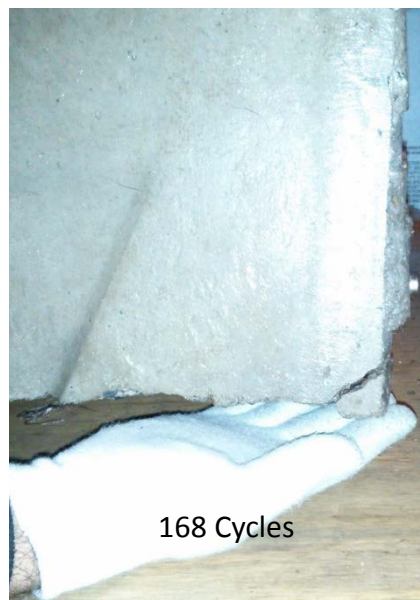
The ties suffered some surface damage represented by pop-outs and small, shallow surface cracking, resulting, in some cases, in pop-outs. This shallow surface damage was typically not deeper than 0.25 in (6 mm) and did not affect the strength capacity of the ties. Tie #2-4386-B, which came from Plant A, suffered pop-outs and the loss of a piece of a corner weighing approximately 1.4 oz (40 gm), as shown in Figure 23 and Figure 24.

**Figure 24: Tie #2-4386-B corner piece after fracture.**

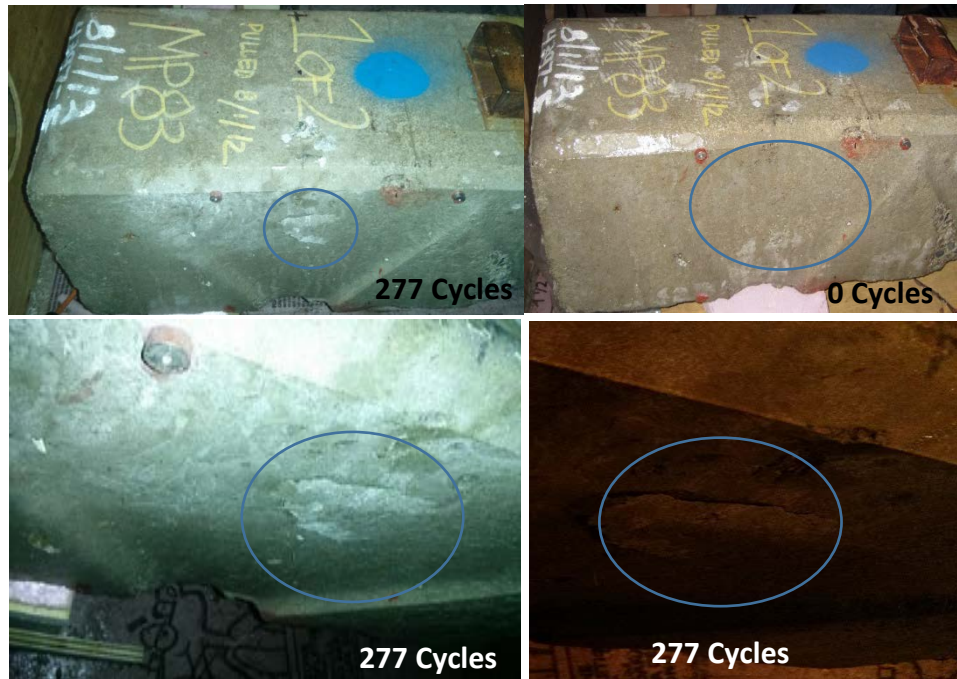
Tie #1-4397-F experienced a shallow crack several inches in length between cycles 258 and 277. Figure 25 shows this crack that likely will eventually result in a pop-out. A smaller pop-out on top of the same tie is shown in Figure 26.

**Figure 25: Tie #1-4397-F shallow cracking.**

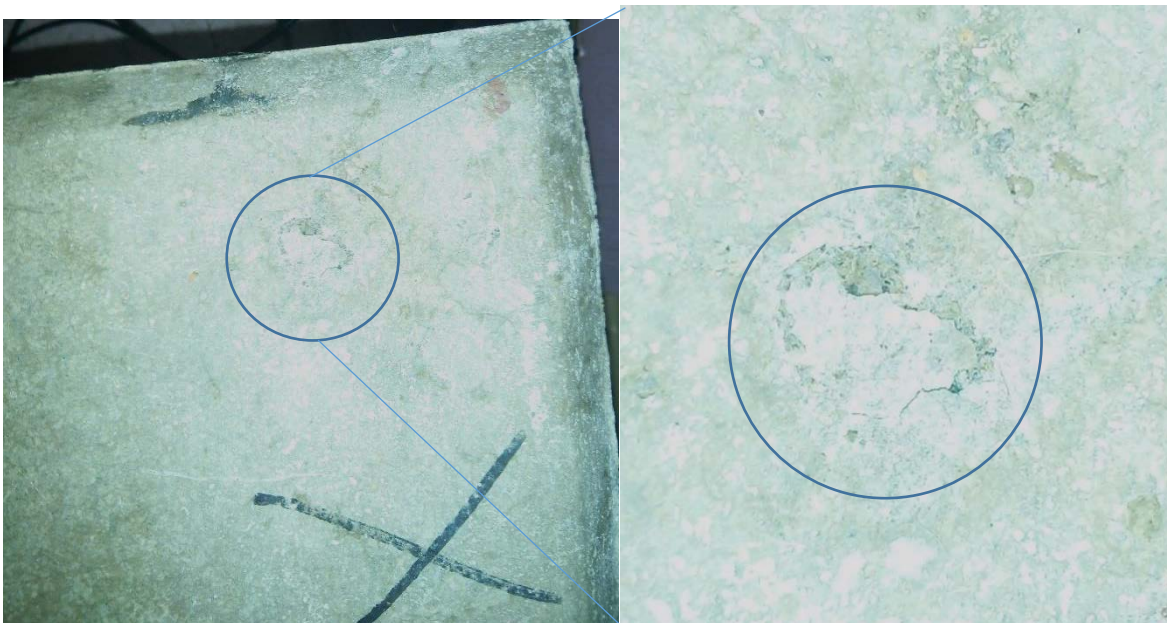
**Figure 26: Small pop-out/crack in tie #1-4397-F.**
