# LOAD RATING AND RETROFIT TESTING OF BRIDGE TIMBER PILES SUBJECTED TO ECCENTRIC LOADING

Prepared By  
**Pablo Caiza**  
**Moochul Shin**  
**Bassem Andrawes**  
University of Illinois at Urbana-Champaign

Research Report FHWA-ICT-12-014

A report of the findings of  
**ICT-R27-82**  
**Strengthening of Bridge Wood Pilings Retrofits for Moment Resistance**

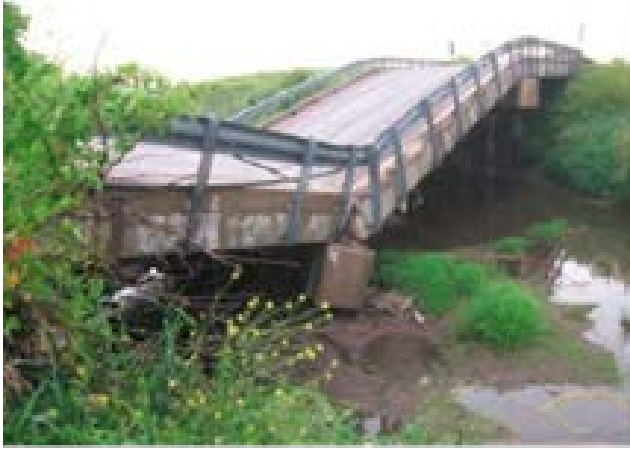
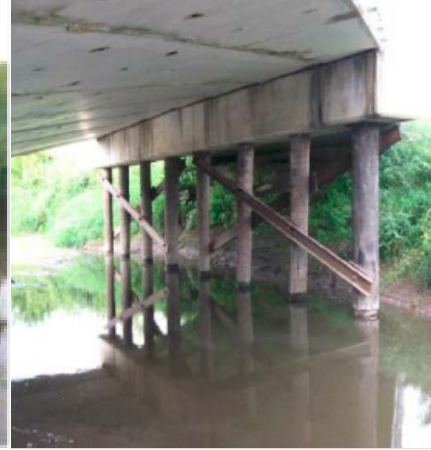
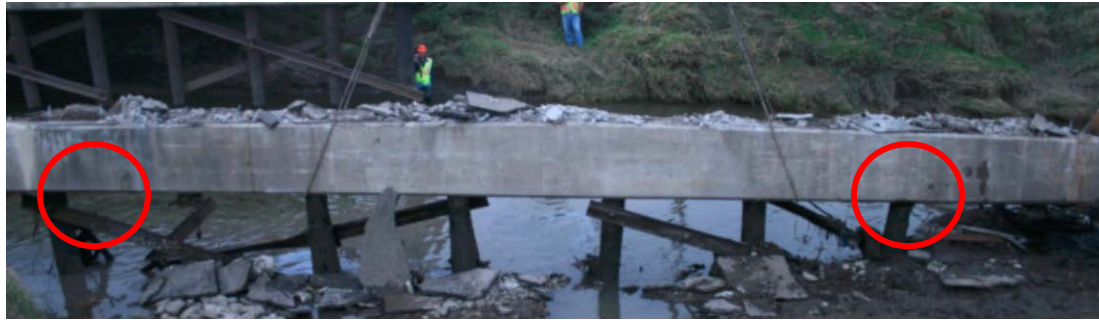
Figure 1-1. Collapse of Bridge No. 019-5010 DeKalb County, Illinois, 8-19-2008: (a) mid-span bent after collapse, (b) remaining mid-span bent (identical to the one that failed), (c) position of uprooted piles.

The bridge consisted of three 42-foot spans skewed 45°. The superstructure comprised prestressed concrete deck beams simply supported on concrete pile caps and timber piles. The bridge was constructed in 1976 according to American Association of State Highway Officials (AASHTO) HS-20 load criteria. One of the mid-span bents failed and, as a result, two spans of the bridge collapsed (Figure 1-1a). The collapsed bent had eight piles and additional diagonal cross bracings (Figure 1-1b). It is important to note that the top 6 feet of two of the piles were removed and replaced in the year 2000 during maintenance work, yet these two piles were completely uprooted during the bridge collapse. Figure 1-1c shows the position of these uprooted piles. A forensic study (Borello et al. 2009) indicated that the current load rating method, which takes only the concentric load into account, can lead to the over-rating of the capacity of timber piles. Most important, the study concluded that the effect of eccentrically applied loads should be considered when determining the capacity of bridges supported on timber piles.

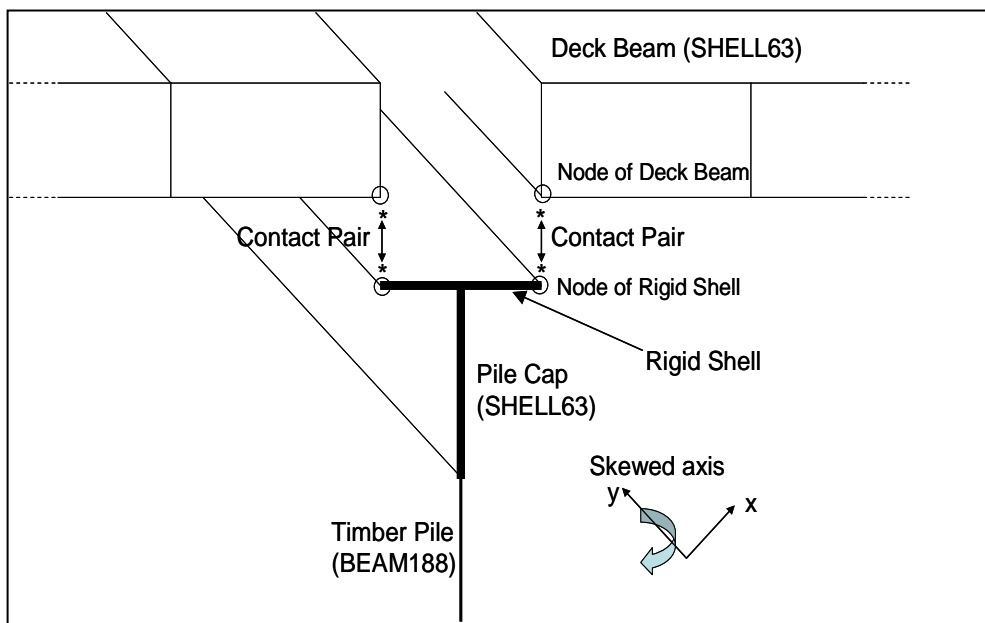
Figure 3-4. Modeling technique of the deck to pile cap connection.

To capture the effect of the moment transfer, a rigid shell element is used to connect the shell elements representing the beam-deck system to the pile cap as shown in Figure 3-4. To model the second feature, the nodes of the rigid shell at the interface of the deck and shell are connected by means of contact pair elements (CONTA175). CONTA175 is used to represent the nature of contact between two distinct nodes by defining the relationship between the degrees of freedom at the two nodes (ANSYS 2004). The nodes on the deck and on the rigid shell are assigned the same displacements for all degrees of freedom except for the rotation about the skewed y-axis. This accurately simulates the nature of this connection.

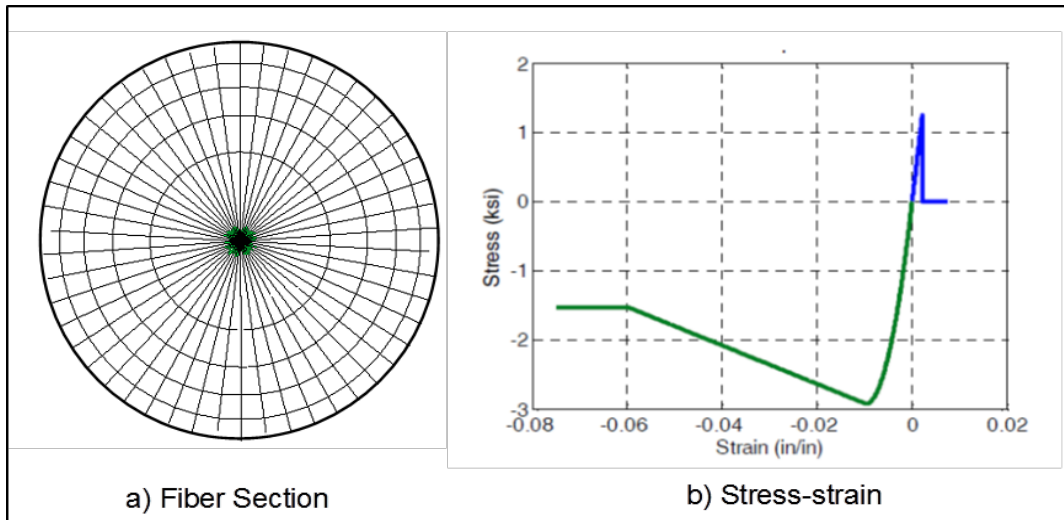
Figure 3-5. (a) Fiber section of the undamaged pile, and (b) stress-strain relationship used to describe the constitutive behavior of the wood.

The timber pile comprised two portions, 13 ft (3.96 m) length above the soil and 15 ft (4.57 m) embedment into the soil. Preliminary results showed that for the type of soil considered and the level of axial load in the piles, the pile reaches fixity at approximately 5 ft (1.52 m) below the mud line. Therefore, for the purpose of FE modeling, an embedment of 5 ft (1.52 m) below the mud-line, ending in a pin support with translational restraints, was utilized. The timber piles were modeled using 3-D beam element (BEAM188) with a length of 6 in. (152 mm). The element is capable of undergoing large deformations and capturing geometrical and material non-linearity (ANSYS 2004). The fiber section technique is used to define the cross section of the pile. Using FiberSIM-ANSYS, for the undamaged pile, the cross section is divided into fibers in the radial and circumferential directions as shown in Figure 3-5a.

The non-linear material behavior of wood was assigned to each fiber. This was done using the cast-iron plasticity model (ANSYS 2004), which simulates the uniaxial non-linear constitutive relationship up to the peak compressive strain and peak rupture strain in tension as illustrated in Figure 3-5b. The input parameters required to define this model include an initial modulus of elasticity and the stress-strain data. The input data was obtained from the results of a previous experimental study conducted on real timber piles retrieved from a collapsed bridge in Illinois (Borello et al. 2009).

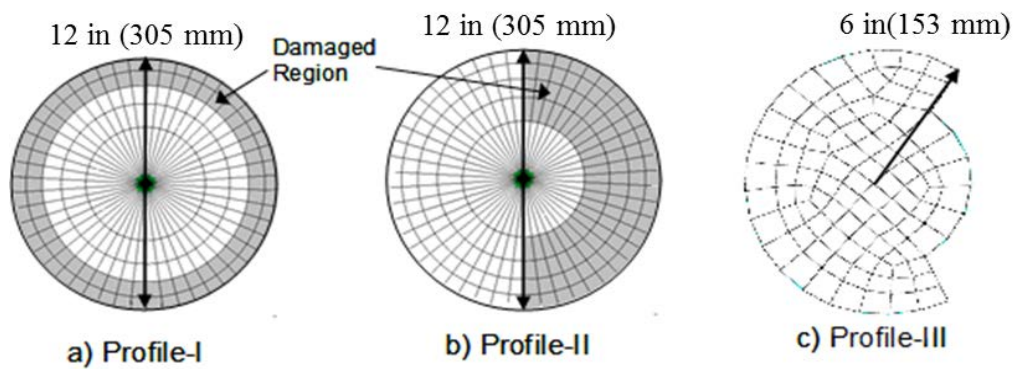
Figure 3-6. Fiber sections used in the FE analysis of the three deterioration profiles.

The cross-sections of the deteriorated piles shown in Figure 3-1 are discretized into fiber sections as shown in Figure 3-6. The deteriorated sections are assigned to those elements which correspond to the pile with the critical/lowest structural rating in the undamaged pile analyses. The damaged area is incapable of sustaining load and the corresponding fiber cells in this region are assumed to have negligible stiffness.

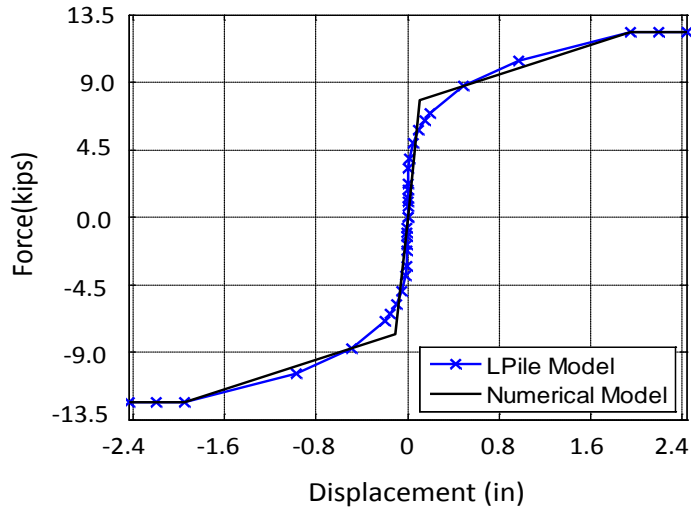
Figure 3-7. L-Pile and tri-linear numerical constitutive behaviors of the soil springs used in the study.

The LPILE and tri-linear constitutive behaviors of the soil springs used in the study are shown in Figure 3-7. As shown in the figure, the initial spring constant was found to be 800 kip/ft (11675 kN/m). The soil was modeled to behave linearly within a displacement limit of  $\pm 0.75$  in. (19 mm), after which the soil is expected to behave non-linearly. The results of the FE analysis that was carried out in this study showed that the displacement of these elements was well within the range of  $\pm 0.75$  in. (19 mm).

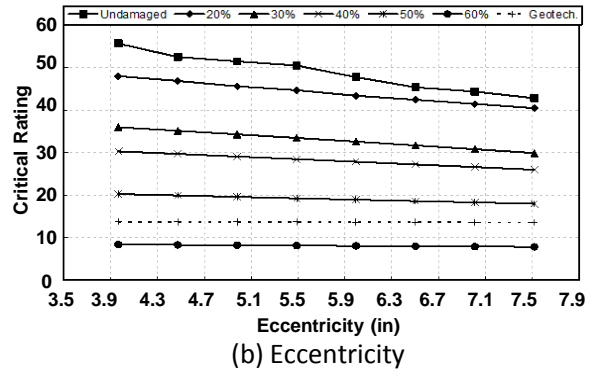
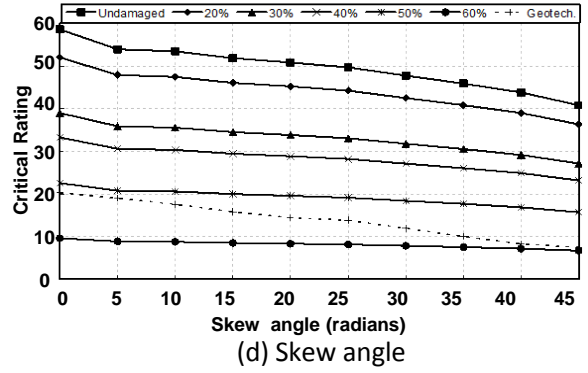
Figure 3-9. Parametric results of critical rating of timber piles with deterioration Profile I at various percentages of damage.

Figure 3-9, which presents the results of deterioration Profile I (Figure 3-1a) with damage levels varying from 20% to 60%, illustrates that the variation in the pile critical rating follows similar trends regardless of the level of damage. It also shows that for moderate levels of damage of this type (i.e., below 30%) the geotechnical-based concentric load rating governs over the eccentric load rating. The eccentric structural load rating, however, started to become more critical when the damage level reached 50%. Furthermore, from the slopes of the curves in all four plots presented in the figure, it can be concluded that the pile length parameter has the most severe effect on the critical rating among the four studied parameters. This is also confirmed by the regression coefficient values presented in Table 3-2, where the coefficient  $\beta_3$  corresponding to pile length parameter for deterioration Profile I with 60% damage has the greatest value among all coefficients. Similarly, it can be concluded that for this damage type, the eccentricity has the least impact on the pile critical rating.

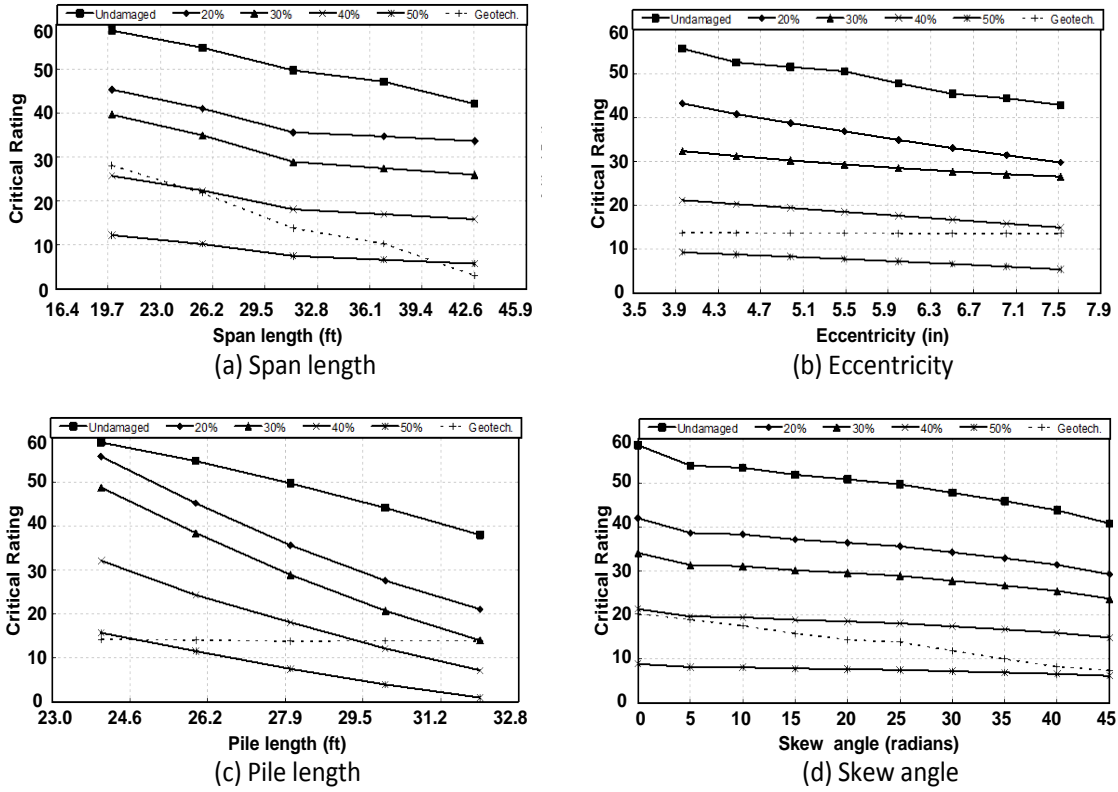
Figure 3-10. Parametric results of critical rating of timber piles with deterioration Profile II at various percentages of damage.

Figure 3-10 presents the results of deterioration Profile II (Figure 3-1b), with damage levels varying from 20% to 50%. The figure shows that the variation in the pile critical rating follows similar trends regardless of the level of damage. It also shows that for damage levels below 30%, the load rating based on the expected geometrical capacity governs over eccentric structural load rating. However, eccentric load rating becomes more critical when the damage level reached 40%, especially for longer piles. These observations indicate that deterioration Profile II is more critical compared to deterioration Profile I. This could be attributed to the eccentric distribution of the deterioration within the pile section that characterizes Profile II. Similar to the observations made about Figure 3-9, the slopes of the curves in all four plots presented in Figure 3-10, along with the regression coefficients presented in Table 3-2, suggest that the critical rating of piles with deterioration Profile II is most affected by the pile length parameter. As evidenced by its smallest regression coefficient value among all four

parameters, it can be concluded that for this type of damage, the skew angle has the least impact on the critical rating of piles.

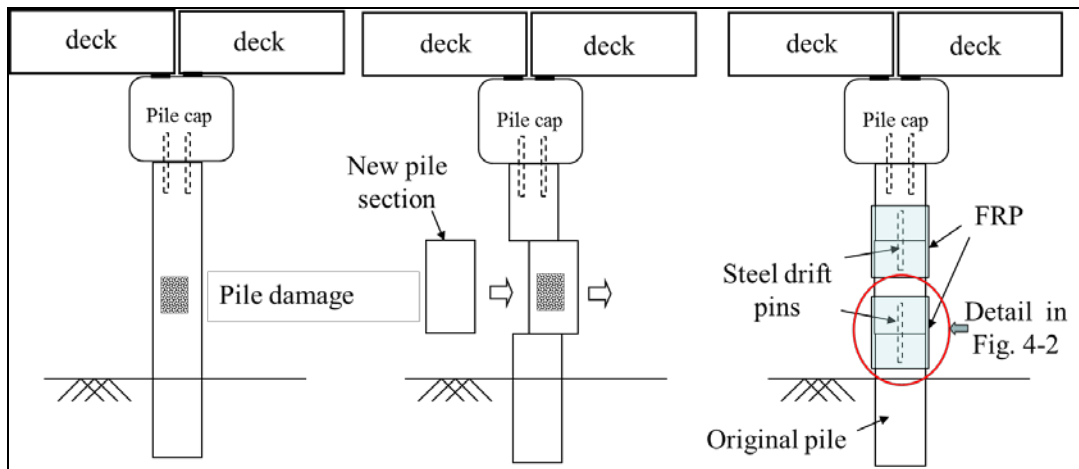
Figure 4-1. Proposed retrofit technique.

Figure 4-1 shows schematics of the proposed retrofit technique that was adopted in this study. The first step is to align the timber post and the existing pile and connect them using a vertical steel drift pin at the center of the round pile (Figure 4-2a) or by using nails driven at the sides of the pile (Figure 4-2b).

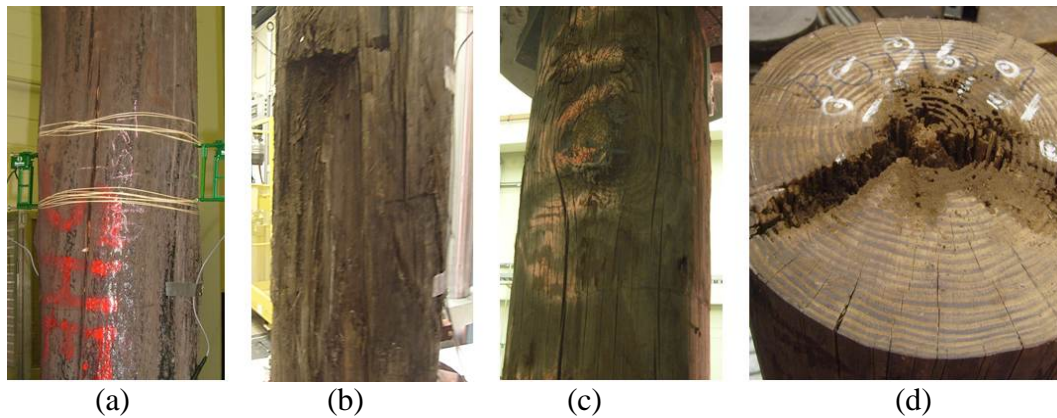
Figure 4-3. Types of decay observed in the tested pile specimens: (a) vertical crack, (b) partially crushed fibers, (c) irregular shape, and (d) mold and fungus inside of cracks.

The experimental specimens used in this study were cut from pile samples retrieved from several bridges in Illinois. The retrieved samples varied in dimension (length and diameter) and age, which directly affected the level of deterioration in each specimen. It should be noted, however, that all timber piles had relatively moderate grades of decay. Figure 4-3 shows different types of decay observed in the tested specimens, including vertical cracks (Figure 4-3a), partially crushed fibers (Figure 4-3b), irregular shape of the section due to existence of a knot (Figure 4-3c), and cracks filled with mold and fungus (Figure 4-3d).

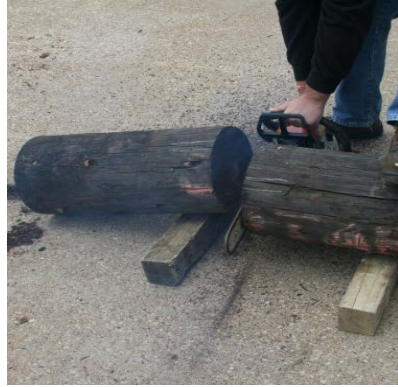
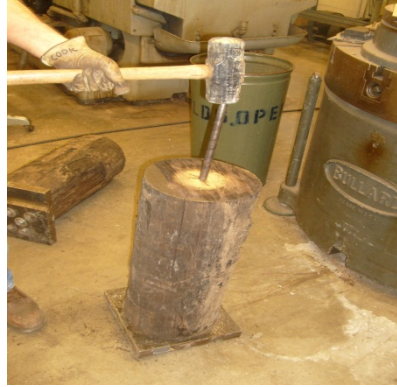
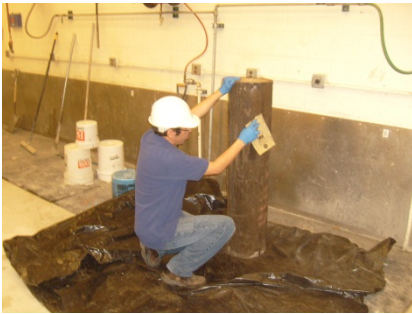
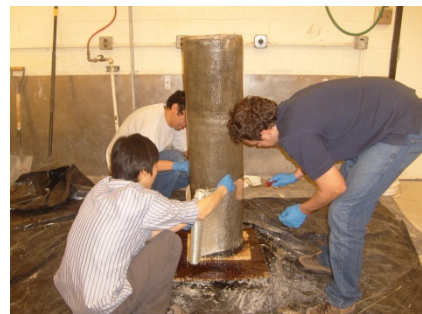
(a) Pile cut

(b) Steel pin installation

(c) Sanding

(d) Mortar shell

(e) FRP wrapping

Figure 4-5. Details of the pile retrofit procedure.

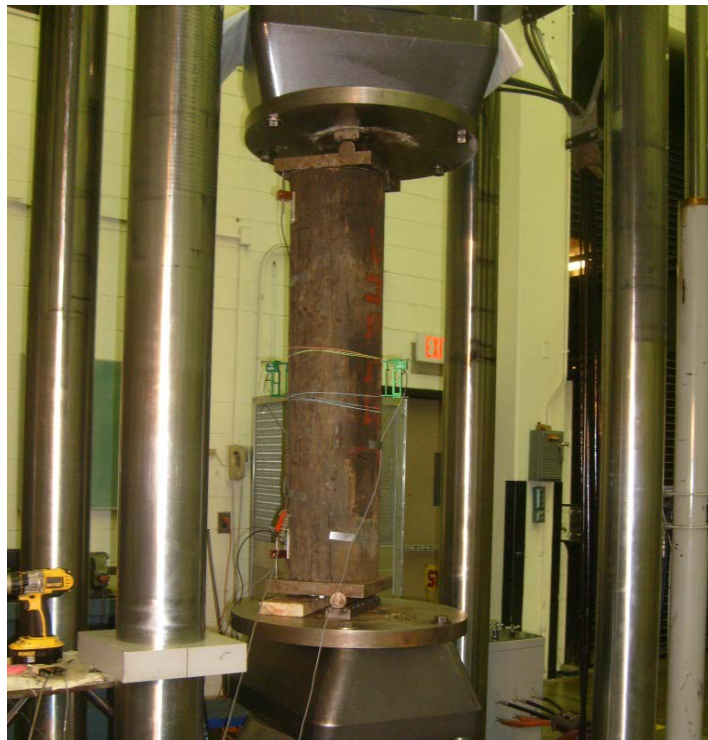
Figure 4-10. An installed specimen on the MTS testing machine.

The plates were loaded through 2 in. (51 mm) rollers that were placed a distance of 3 in. (76 mm) from the centroidal axis of the pile specimen (Figure 4-9). Figure 4-10 shows an installed specimen in the 600 kip (2670 kN) machine frame.

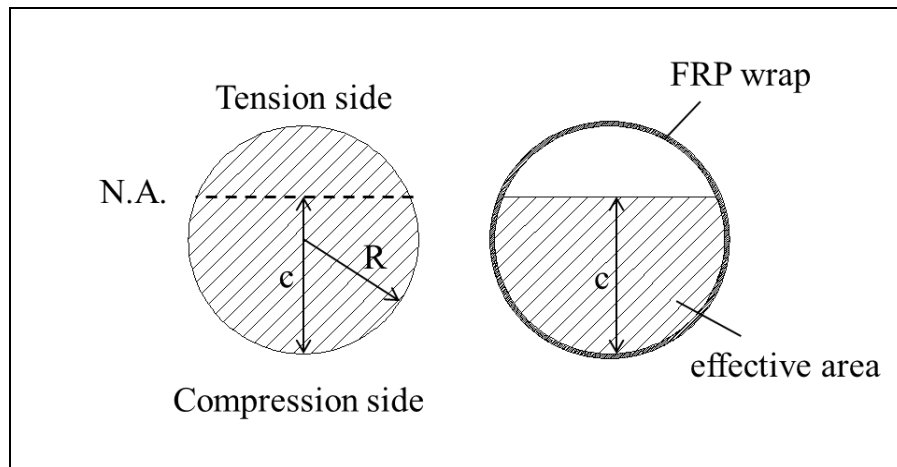
(a) Original section      (b) Retrofitted section

Figure 4-11. Original vs. retrofitted section at the post connection interface.

To determine the number of FRP layers needed for the retrofitting of the piles tested in compression-flexure, an elastic design procedure was adopted. The procedure was based on the assumption that at the interface section between the new section and the old pile, the tensile stresses are resisted entirely by the FRP and the compressive stresses are resisted by both wood and FRP. At the retrofitted section, the portion of the wood resisting compression is called “effective area” (Figure 4-11).

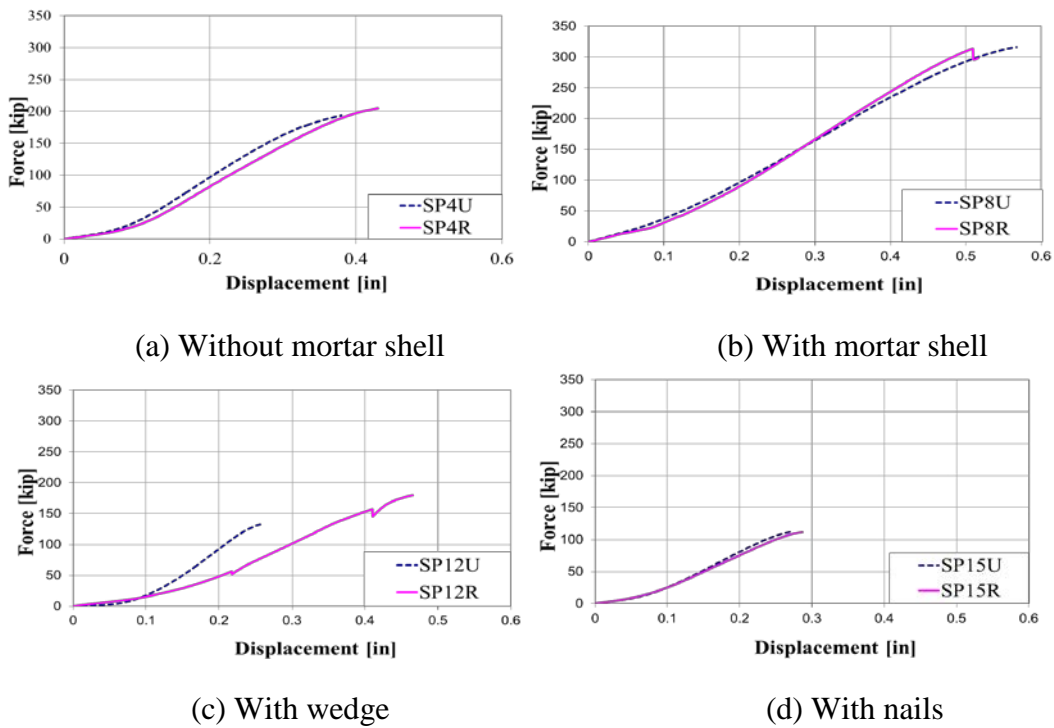
Figure 5-1. Force-displacement relationship for specimens with different retrofit conditions.

Moreover, it was found that the use of mortar shell with FRP sheets helped restore the strength and stiffness of the pile (Figure 5-1b). Hence, using mortar shell could be recommended when piles have higher levels of damage. In the case where a mortar-filled wedge is introduced prior to wrapping the specimen with FRP, since the elastic modulus of mortar was higher than the elastic modulus of the wood, the retrofitted pile showed higher stiffness than that of the unretrofitted pile at the initial stage (Figure 5-1.c). However, as the testing progressed, the specimen became softer due to the weak out-of-plane resistance of the CFRP jacket, as mentioned earlier, which provided very little confinement for the filling mortar, resulting in its early crushing. As shown in Figure 5-1d, using nails or drift pins does not significantly impact the capacity or stiffness of the retrofitted piles.

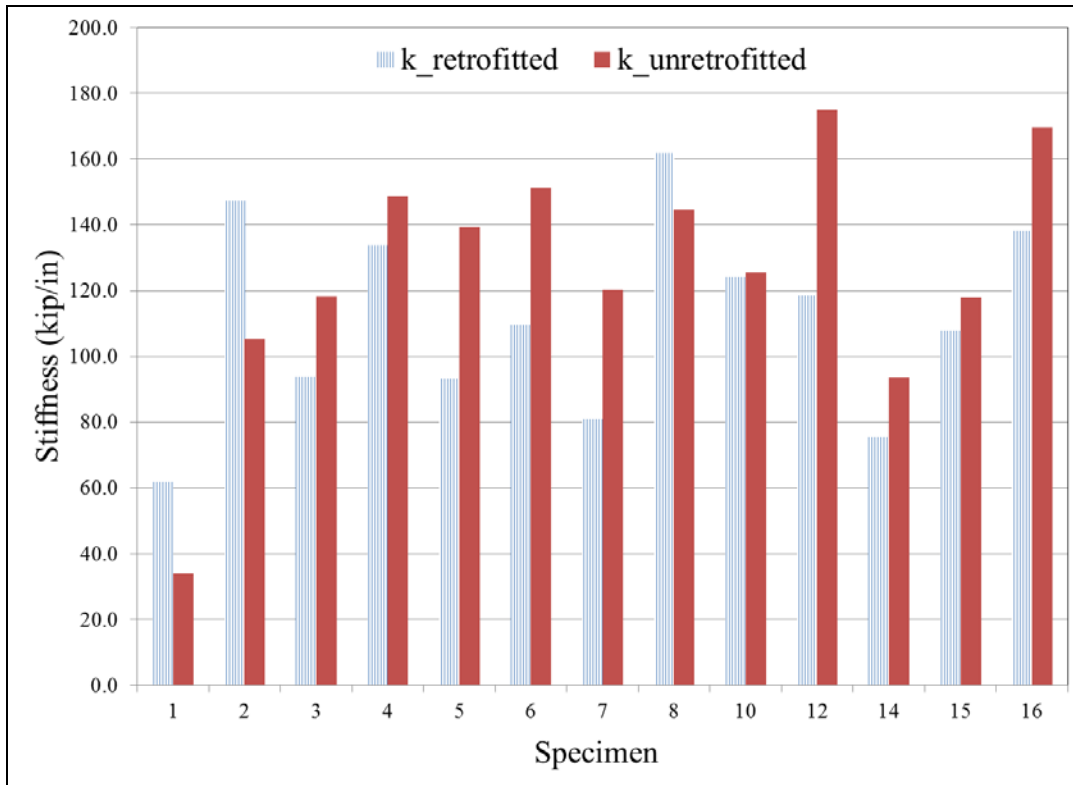
Figure 5-3. Stiffness (kip/in.) for unretrofitted and retrofitted specimens.

The retrofitted specimens SP1, SP2 and SP8 show higher stiffness than that of the unretrofitted specimens, as evidenced by the extremely minor damage shown by those specimens during the unretrofitted test. By using mortar shell, the stiffness of the retrofitted specimens was fully restored, and the stiffness of specimens SP8R and SP10R was found to be 112% and 99% of the unretrofitted specimens, respectively. The stiffness results presented in Figure 5-3 show a mean stiffness reduction of 5% and median stiffness reduction of 14% for the retrofitted specimens compared with the unretrofitted specimens.

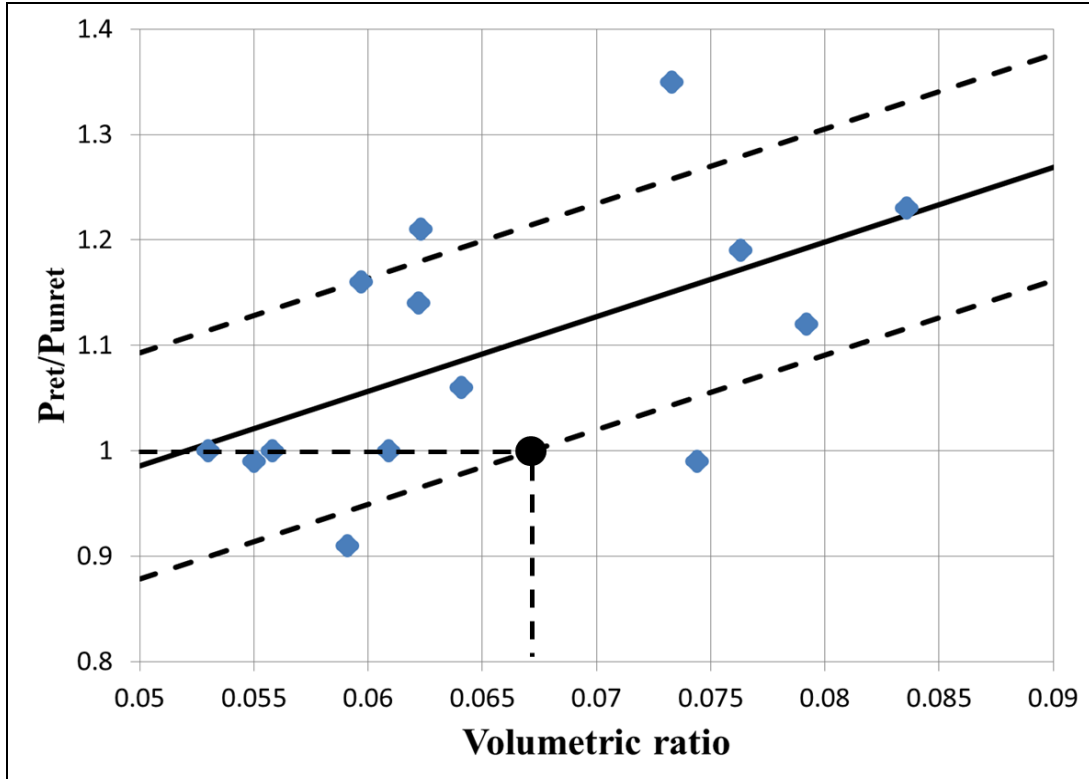
Figure 5-4. Regression analysis of the FRP volumetric ratio vs.  $\rho_{ret} / \rho_{unret}$  data points.

Figure 5-4 shows a graph of the ratios of the maximum retrofitted forces to the maximum unretrofitted forces with respect to the GFRP volumetric ratio used for the retrofitted specimens. A linear regression analysis was conducted and the result is shown as a solid straight line in the figure. The two dashed lines drawn in the figure represent  $\mu \pm 2\sigma$  where,  $\mu$  is the mean and  $\sigma$  is the standard deviation of the data points. As shown in the figure, only two data points lie below the lower dashed line; hence, it was deemed appropriate to base the design on the  $\mu \pm 2\sigma$  value. The design point is considered when the  $\mu \pm 2\sigma$  line intersects the horizontal line corresponding to a  $\rho_{ret}/\rho_{unret}$  ratio equal to 1.0. Therefore, the design volumetric ratio of GFRP is found to be 0.068. Note that only the tests with GFRP were used to calculate the results shown in Figure 5-4. It is important to note also that the 1.08 is the average ratio of the retrofitted to the unretrofitted stiffnesses of the five specimens whose volumetric ratios were higher than the proposed value of 0.068. This confirms that, while similar strength can be expected by using the proposed volumetric ratio, the stiffness of the retrofitted specimens will not be jeopardized.
